REPORT NO. 5467-08-4

NEWFOUNDLAND POWER CO.

GAS PATH INSPECTION OF GRAND BANK  
MOD POD 25 POWER TURBINE  
FOR CONTINUED OPERATION  
AT 20 MW AND UNDER

July 29, 2001

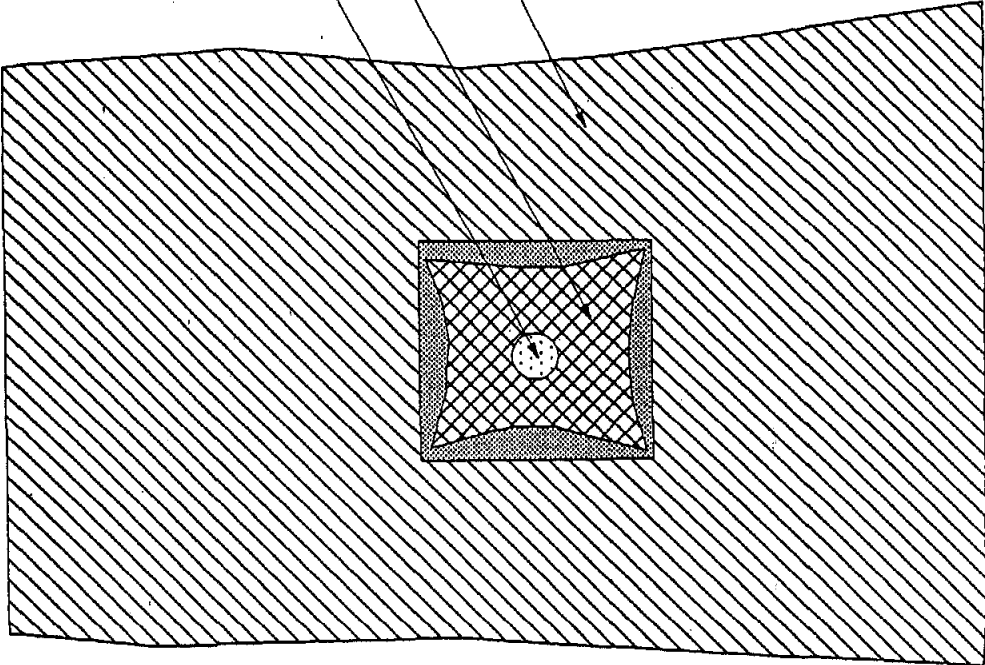
Prior to removal of the blankets for inspection of the inlet housing surfaces for cracks, it was noted that the T6 thermocouple blanket aperture fill pads were too small for the aperture thus exposing bare metal sections. See Sketch 1. All blankets were removed and the inlet housing assembly surfaces were cleaned of debris. The surfaces were visually examined for evidence of cracking. Suspicious areas were dye checked. No cracks were detected. The thermocouple mounting boss keyways were examined for damage. All were satisfactory.

T6 THERMOCOUPLE PAD DISTORTION IN BLANKET APERTURE

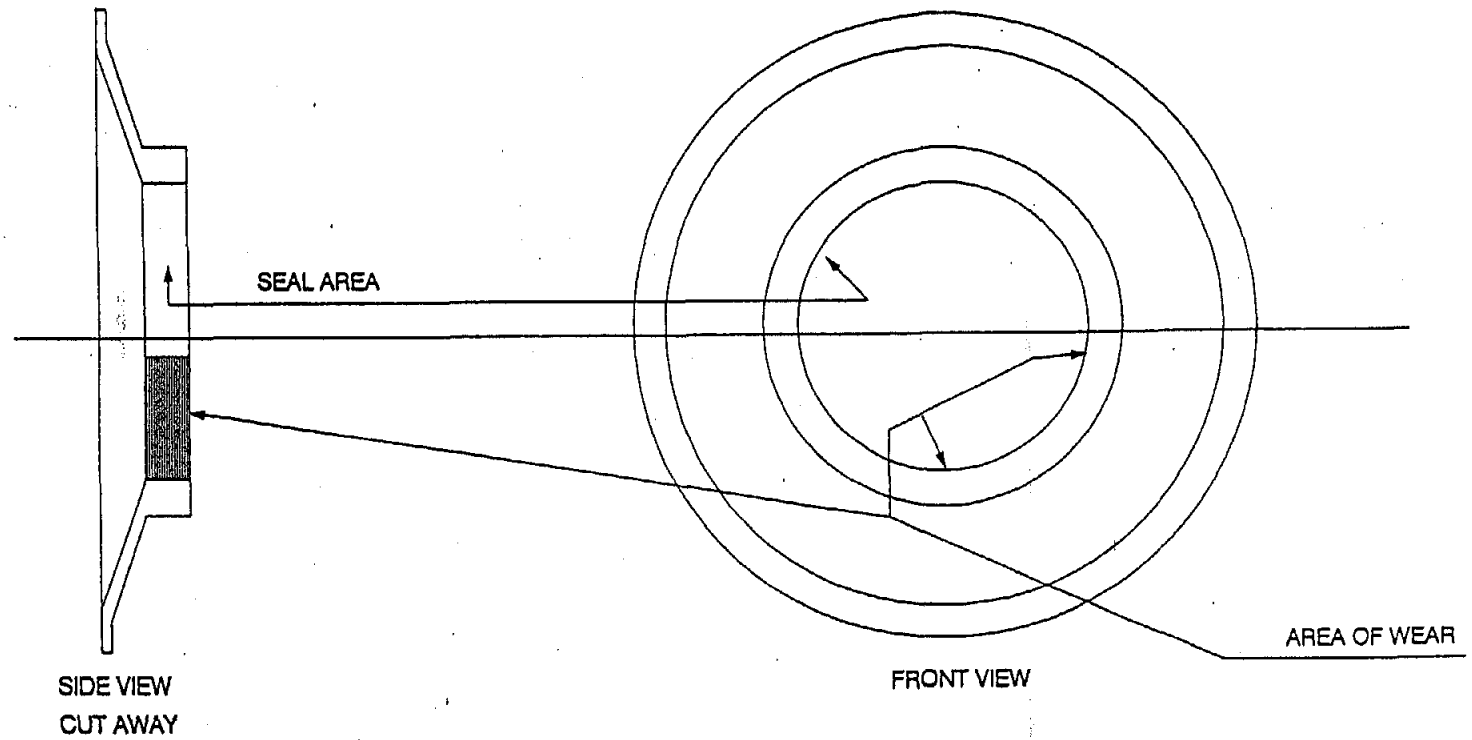
NPC GRAND BANK  
REPORT 6574-08-3  
SKETCH 3

3. The turbine rotor front labyrinth seal shroud, P/N 181327, exhibited moderate to heavy rubbing at the lower left quadrant (180 - 270 deg.). See Sketch 3.

Turbine rotor front labyrinth seal to front labyrinth shroud axial position and radial fits were measured and found satisfactory for continued use. See TIB 003 Page 4, Fits 5 & 6. The shroud (PN181327) was removed to inspect for extent of circumferential wear. A newly worn section appears between 6 and 9 o'clock. See Sketch 3. \*\*

181327 STATIONARY PT FRONT LABYRINT SEAL WEAR

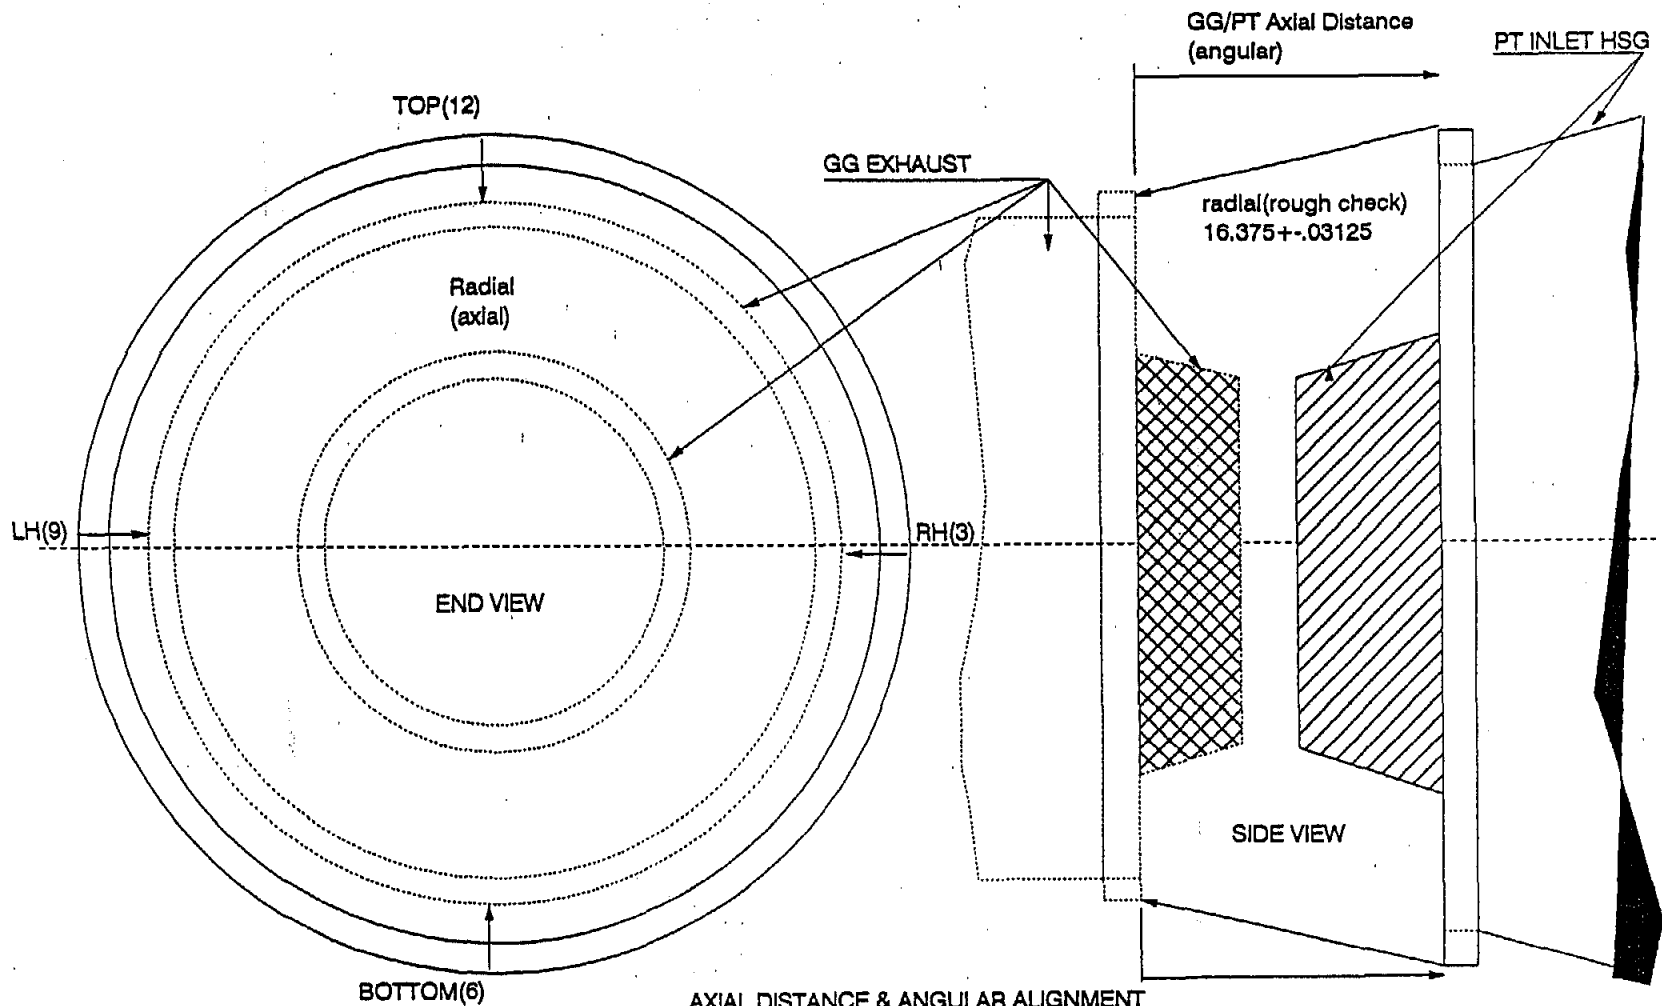
NPC GRAND BANK  
 REPORT 6574-08-3  
 SKETCH 4A

A rough diagonal length measurement from the top of the GG to the bottom of the inlet housing with a tape measure and a similar measurement side-to-side indicated the centers are within 1/32" inch to each other which is minimal and acceptable. See Sketch 4A. This whole area will have to be revisited any time there is an expansion joint replacement \*\*

Alignment of GG Exhaust to PT Inlet Housing

AXIAL DISTANCE & ANGULAR ALIGNMENT  
 DRAWING BASIC DISTANCE 16.229 +/- .059  
 ACTUAL BASIC AVERAGE = 16.359"  
 MEASUREMENTS (+/- FROM GAGE)  
 CLOCK

DEVIATIONS  
 12 = +.002"  
 3 = +.053"  
 6 = +.059"  
 9 = +.088"

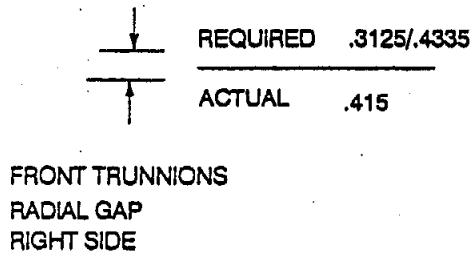
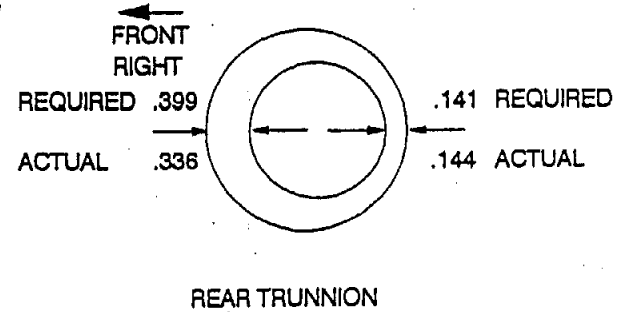
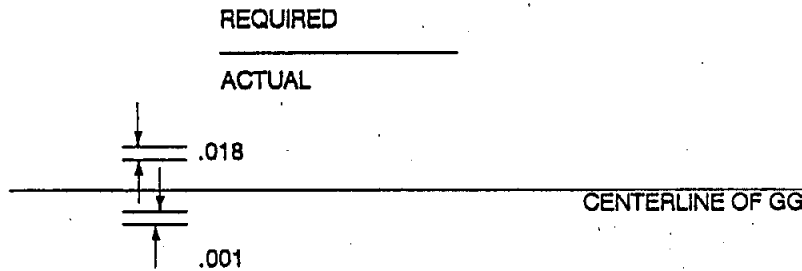
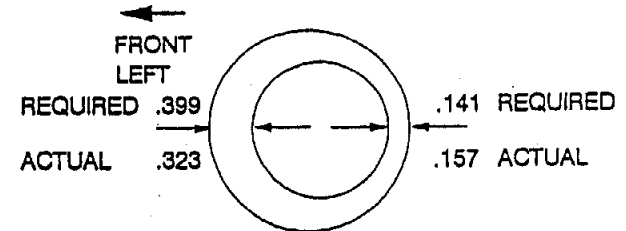
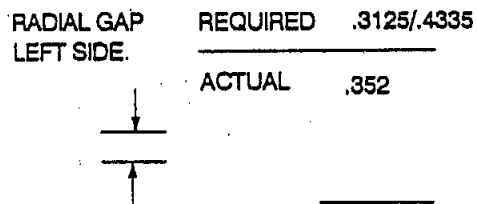
The resilient bushing carriage adjusts laterally through its growth/slide design. Once seated the gap between the bushing and the rear mount is measured to ensure the engine is centrally located laterally. The GG mount radial gaps were measured and the results indicated that the GG was central to the mounts per MM power train outline drawing. See Sketch 4B.

ALIGNMENT CHECK OF GG MOUNTS  
FRONT MOUNT CAPS INSTALLED  
REAR TRUNNION AXLES CENTERED VERTICALLY  
AXLES FREE TO SLIDE IN AND OUT  
GG REAR WEIGHT SUPPORTED CENTRALLY  
AIRCRAFT CONVENTION  
RADIAL GAPS VIEWED FROM TOP  
REAR TRUNNION AXIAL GAPS SIDE VIEW

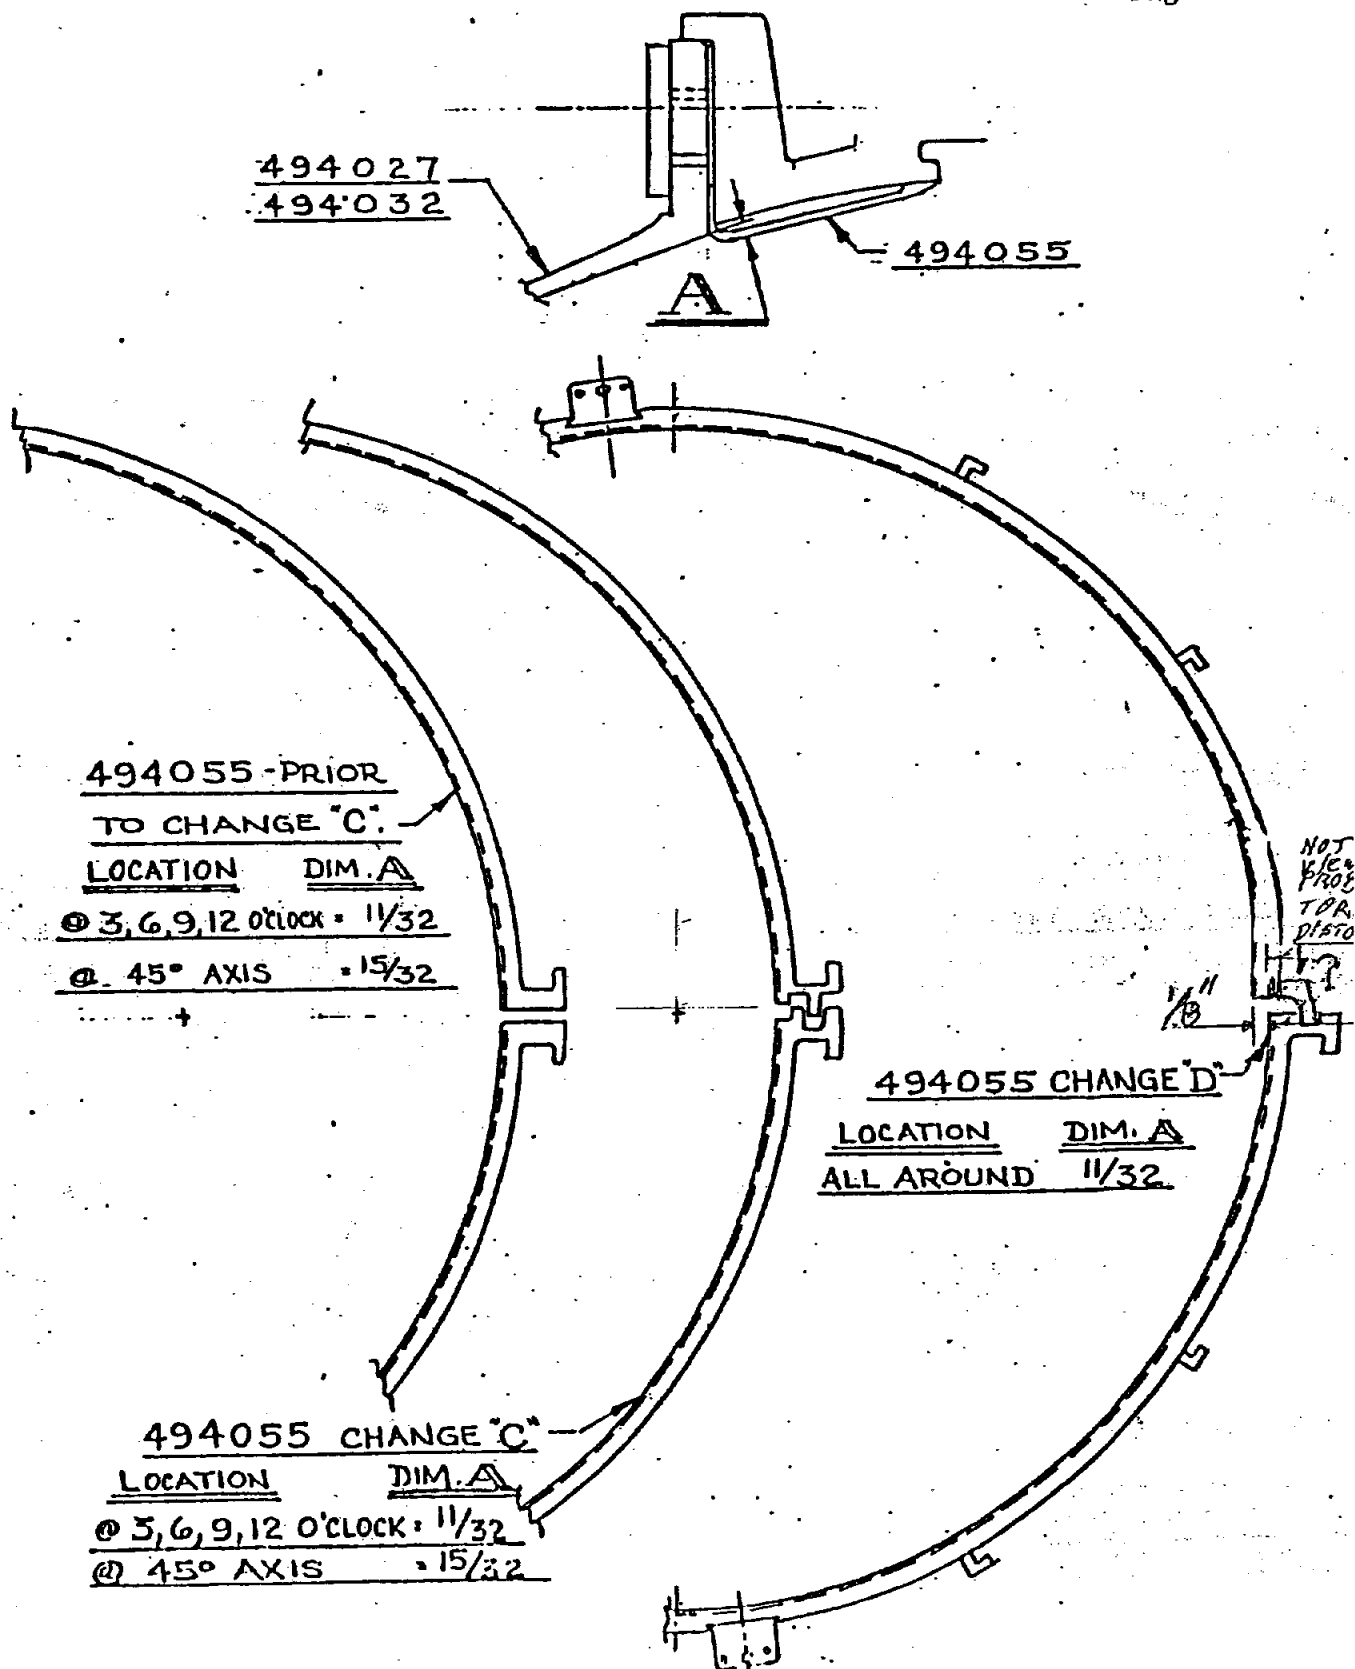
Figure 5

The gas path internal area forward of the first stage stator vanes (1st stage vane retaining land) and the area between vane airfoil spaces was visually examined for axial and transverse cracks and/or missing sections. The first stage stator vane air foils and first stage rotor blade leading edges were also viewed for damage (FOD). A few axial cracks of the housing lip were noted. No missing sections or transverse cracking was noted. No FOD was noted. The front internal shroud (PN494055) was checked for intrusion into the gas stream. At 3 o'clock the upper seal had moved into the gas stream approximately 1/8 inch at the split. (See SIB Page 9, Fig. 5, attached. This

type deterioration is expected and CW issued repair bulletin SIB16, 3/18,77. This should be reviewed after another 200 hours of operation.\*\*

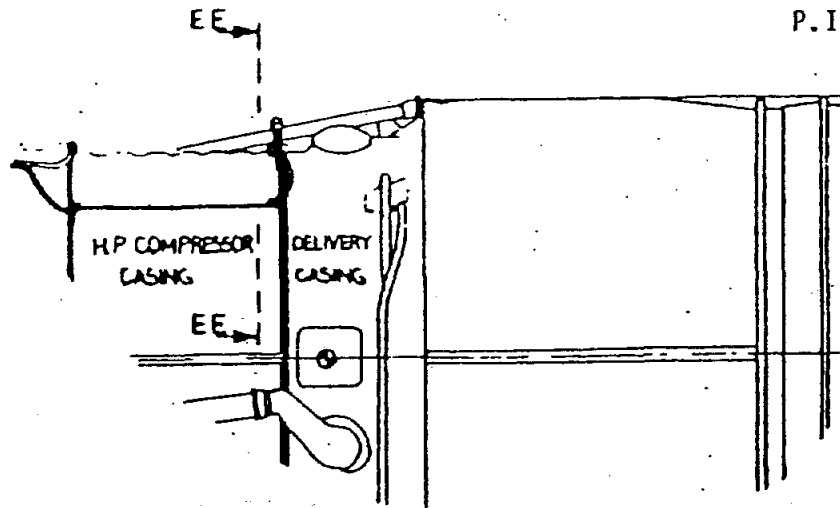
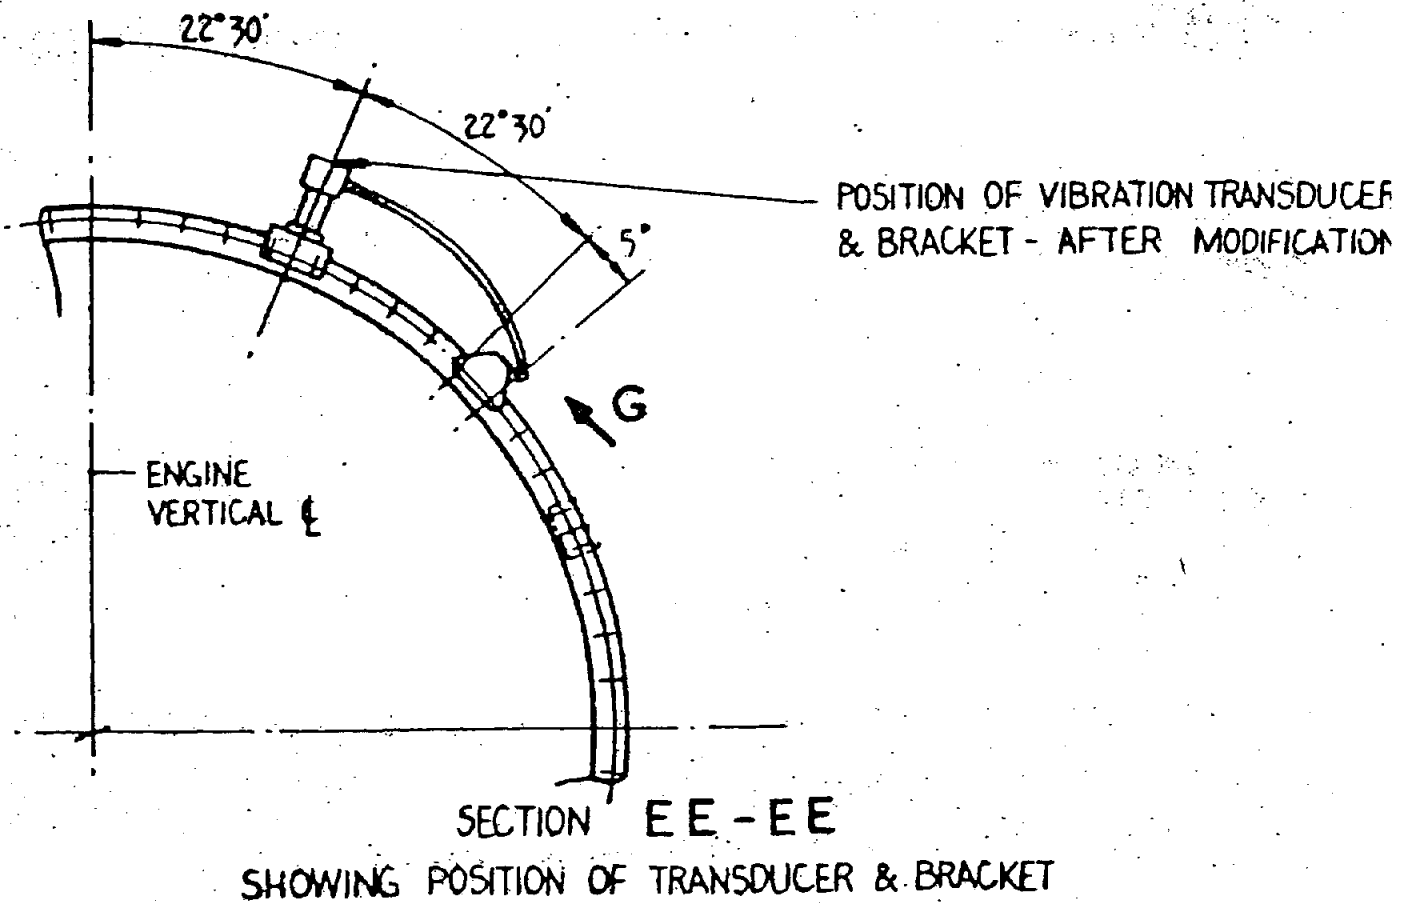
8. Inlet filter house down stream of the filters is in excellent condition.
9. CWC PIB 1020A (ref. RR MOD OLP 4035), Relocation of the GG vibration pickup had not been incorporated.

During a casual overall look at the GG, it was noted that the vibration pick up was located at the original CW selected location. Subsequently, Rolls Royce issued a bulletin to relocate the pickup to a different location that was in accordance with their standard test stand location at the front of the delivery case. See Page 2, Figure 1, PIB1020A, attached. A vibration pick up for this higher temperature area was also recommended. After pointing this bulletin out to John Budgell, the bracket and pickup was moved to the new location. The current pick up must be checked to verify if it is satisfactory for a potential temperature of approximately 500 F. Following re-commissioning, a complete power train vibration survey will quantify this new location.

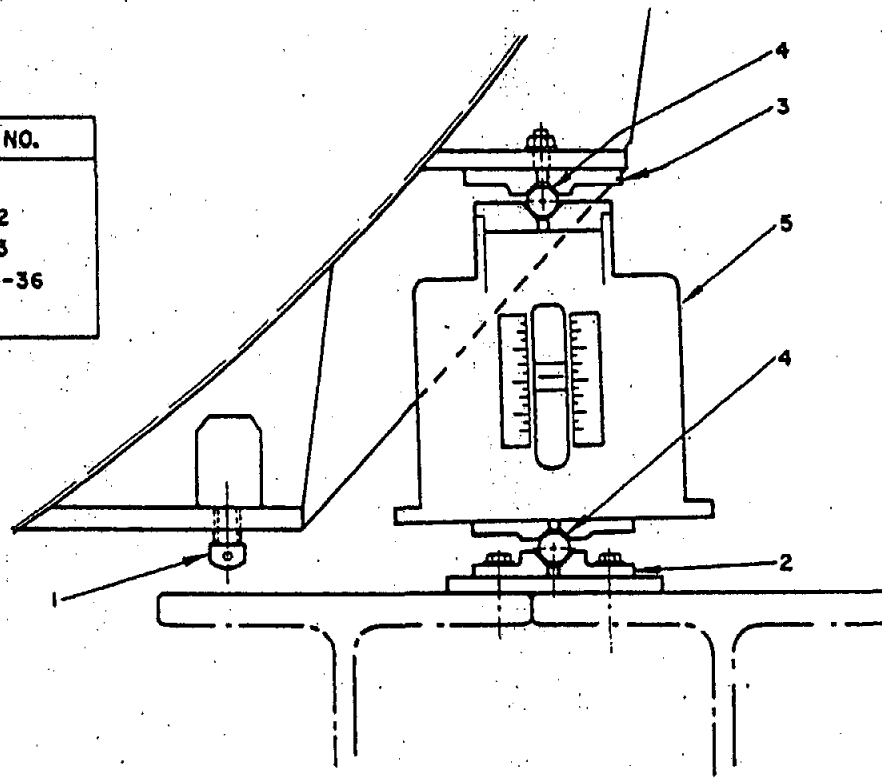
Figure 2.2-4 Volute Mount Supports

6. Turbine exhaust stack (down stream of the exhaust volute) is severely deteriorated.
7. Exhaust volute rear support spring packs load settings were set higher than recommended.

The volute rear spring packs were removed, cleaned, and tested on a hydraulic press device with a 3.5 inch piston and a pressure gage. The old set scribe on the packs were not correct, having been set at a heavier support load than required. Load setting should be 1585 pounds dead weight. This relates to a psig setting of approximately 165 psig on the hydraulic press utilized. (Load = piston area x psig = 9.62 x 164.7)

The spring packs were inscribed with this load line and reinstalled. The 4 loading ball bearings were free of spalling and were reused for assembly. See MM pg 2-148 Figure 2-2-4 attached.
