Diesel Power Plant Review

NEWFOUNDLAND POWER
DIESEL POWER PLANT REVIEW

JULY, 1997

# Diesel Generator Review

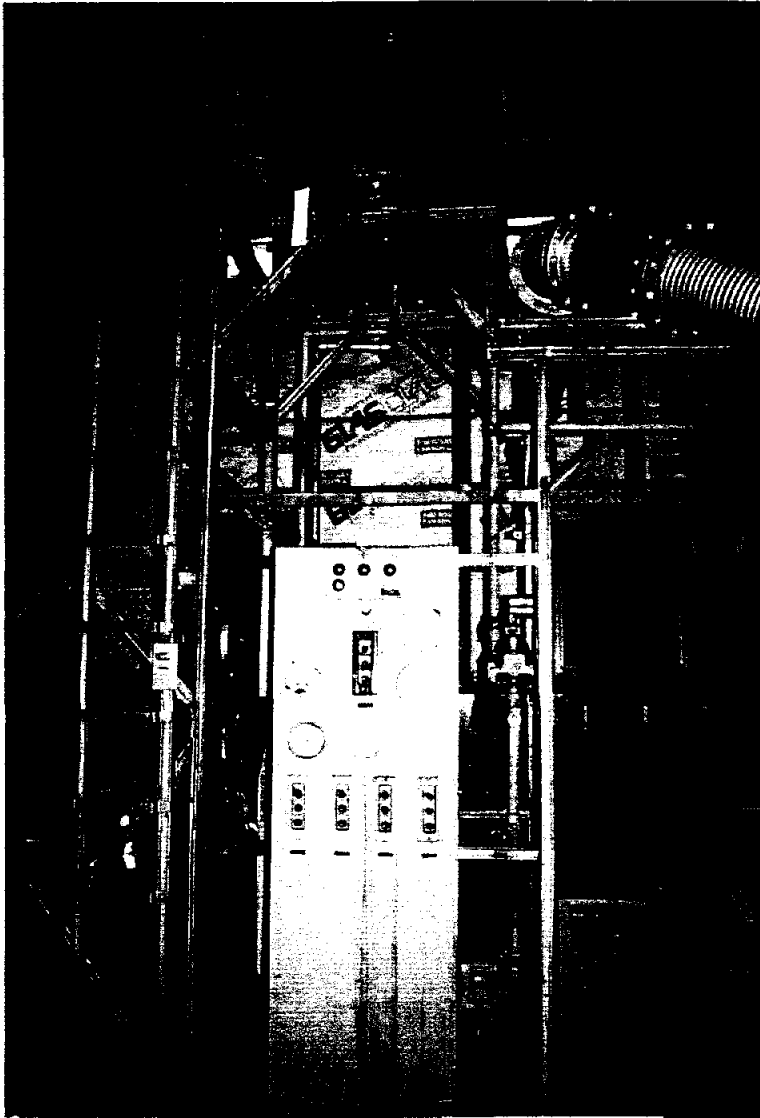
Consultant's Comments - Engines have operated beyond the usual manufacturer's recommended major overhaul period. Three day tanks in the building are vented in the building and do not have high level alarms or shut off devices. Floor trenches contain pools of oil. Unit # 3 should not be operated due to the possibility of crankshaft failure. Instrumentation inadequate. Some parts may be available but would be expensive and have long delivery times. Major components likely not available.

**Photo 9**  
Salt Pond - Fuel tank and exhaust in  
close proximity

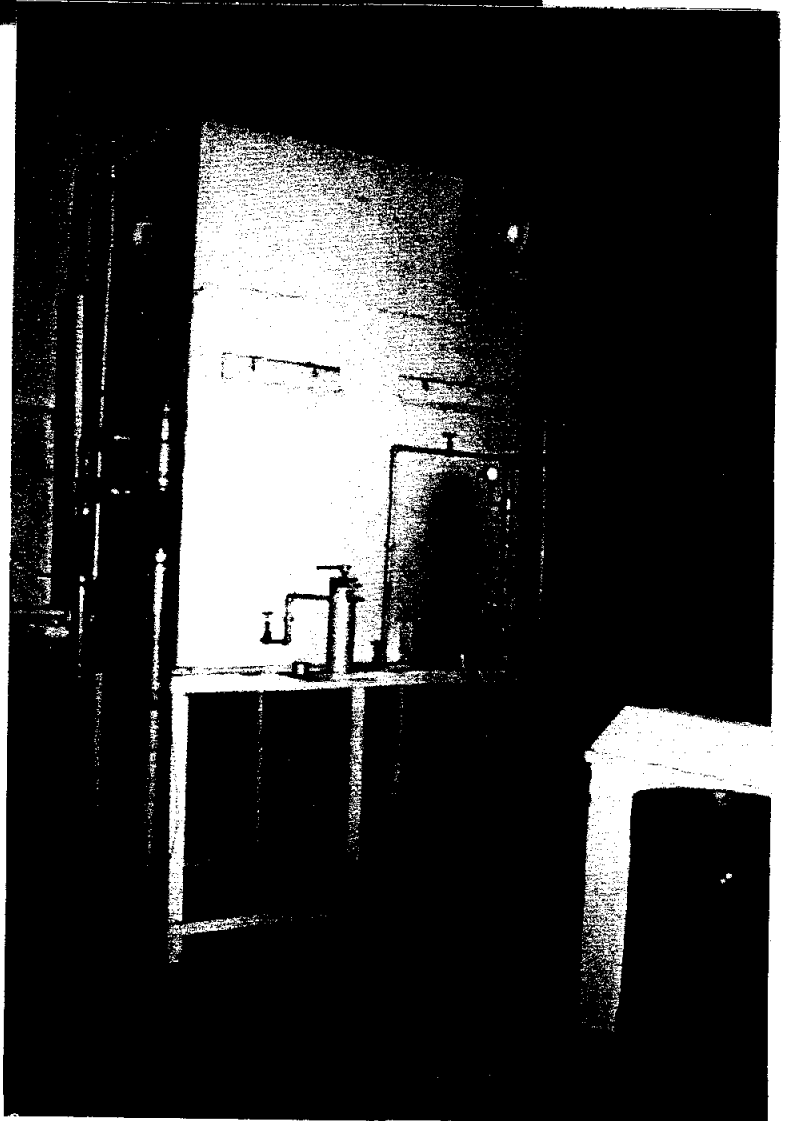
Evaporative cooler systems require major work. All instrumentation and controls need to be replaced. A limited number of parts are available for these engines. Suppliers indicate that major components may be difficult and costly to obtain.

**Photo 22**  
Gander - Unit No.3 evaporative cooler  
and damaged engine components

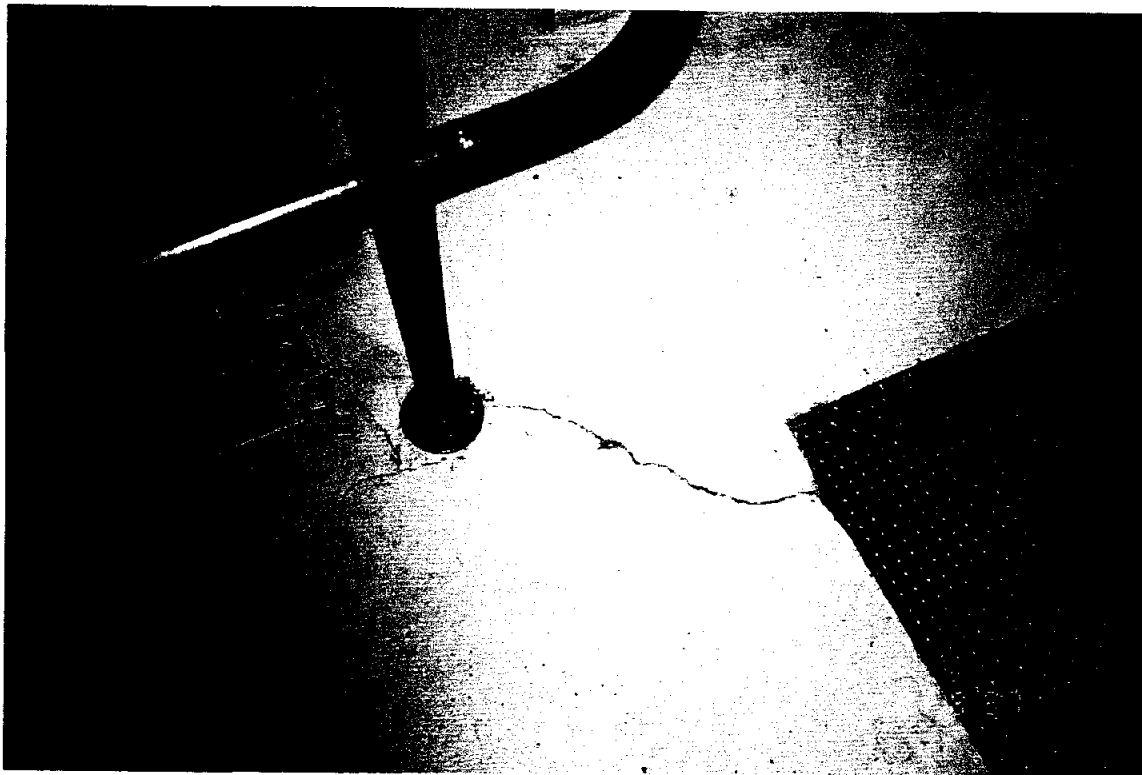
**Photo 26**

Consultant's Comments - Engines and auxiliary systems are in need of substantial repair. Unit # 2 had large amounts of oil leak from the hot exhaust manifold resulting in a dangerous condition. Foundation on Unit # 3 requires major repair work as does the drive mechanism on the scavenger blower. Units have accumulated about 100,000 hours each and are overdue for major overhauls.

Gander - Unit No.3 showing cracked foundations

Consultant's Recommendation - A substantial investment would be required to make the plant safe and operable. It is recommended that the plant be decommissioned.

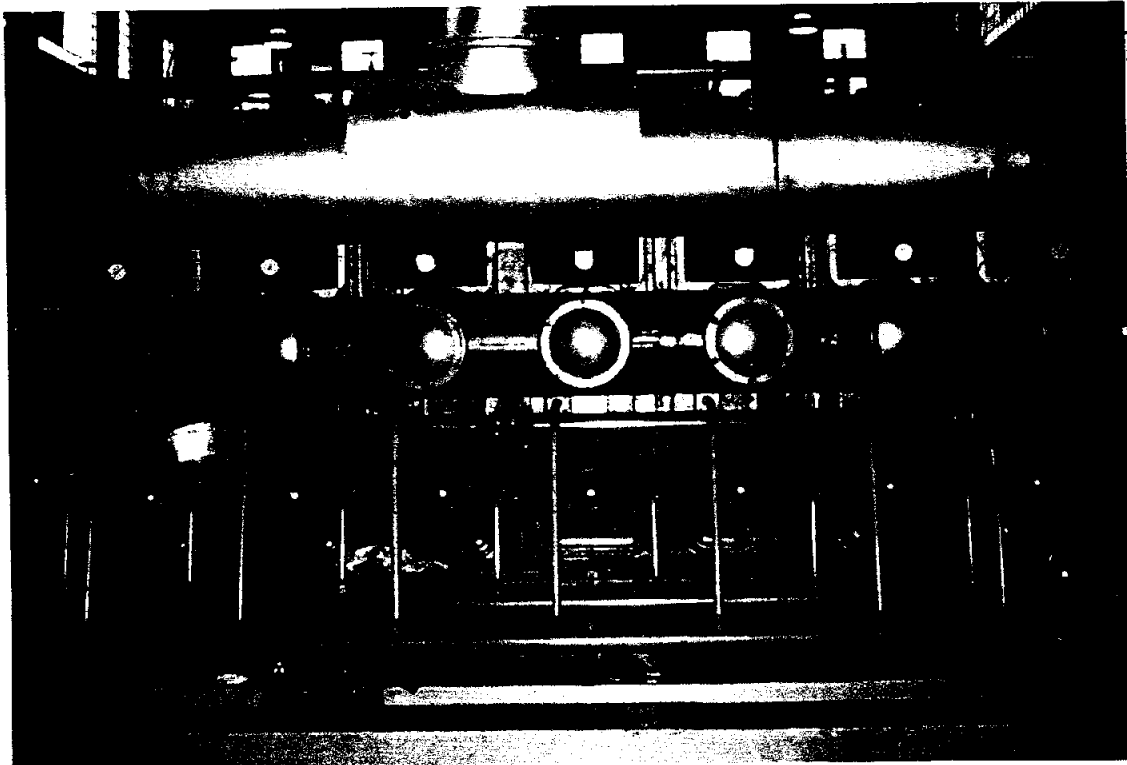
**Photo 28**  
Gander - Unit No.2 showing excessive exhaust oil drips onto air manifold

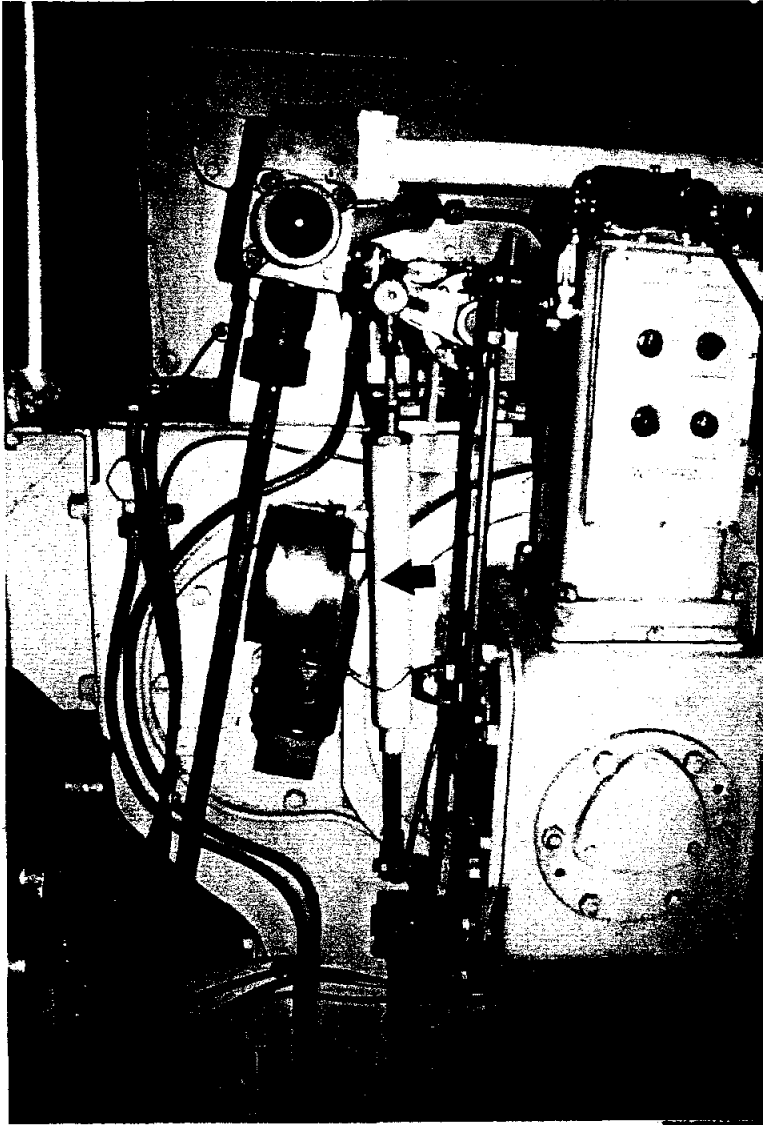
Consultant's Comments - Numerous minor water and oil leaks. Asbestos wrap on exhaust in bad condition. Collapsible link on governor safety system seized resulting in the overspeed shutdown system being inactive. Engine due for a major overhaul. Piston blow-by creates a health and fire hazard. The disabled overspeed mechanism creates a serious danger. Instrumentation inadequate. The manufacturer no longer makes diesel engines and parts are no longer available.

**Photo 35**  
Aguathuna - Governor linkage with collapsible link shown

Consultant's Recommendation - Extensive costs would be involved with rehabilitating this unit. This combined with the manufacturer no longer supporting the engine leads to the conclusion that the unit be decommissioned.

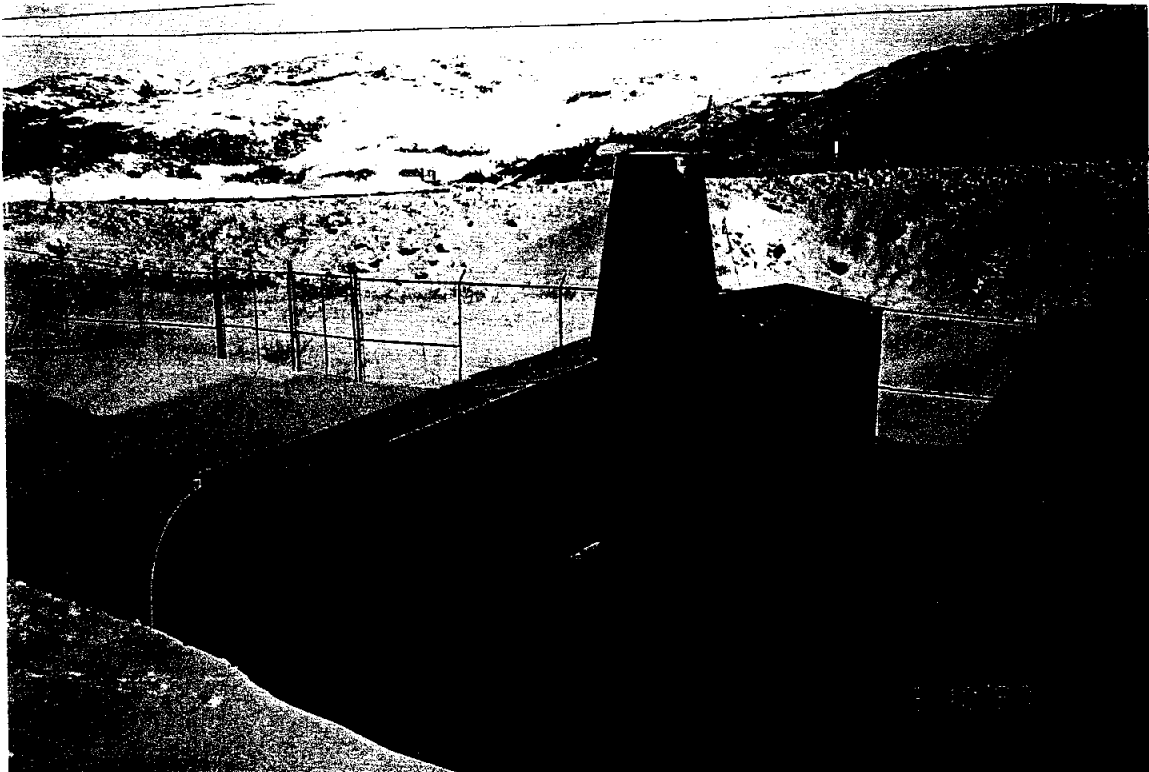
**Photo 43**

Unit # 10 - Enclosure is corroded. Overall unit in good condition and operates well. Unit is still manufactured and is supported with both maintenance and service spares.

Port-aux-Basques - EMD unit enclosure, open to weather at radiator end, top and side

Unit # 10 - Consideration should be given to moving the unit indoors due to the condition of the enclosure.

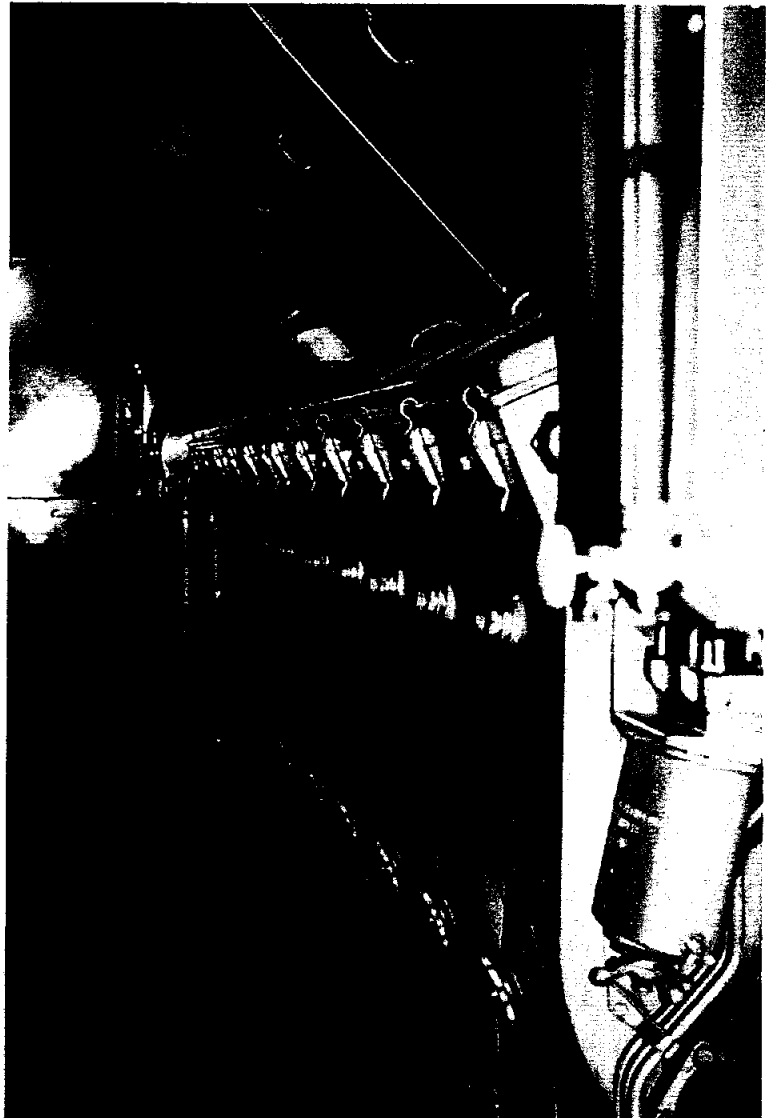
**Photo 46**  
Port-aux-Basques - General view of EMD enclosure showing limited maintenance space between engine and container wall

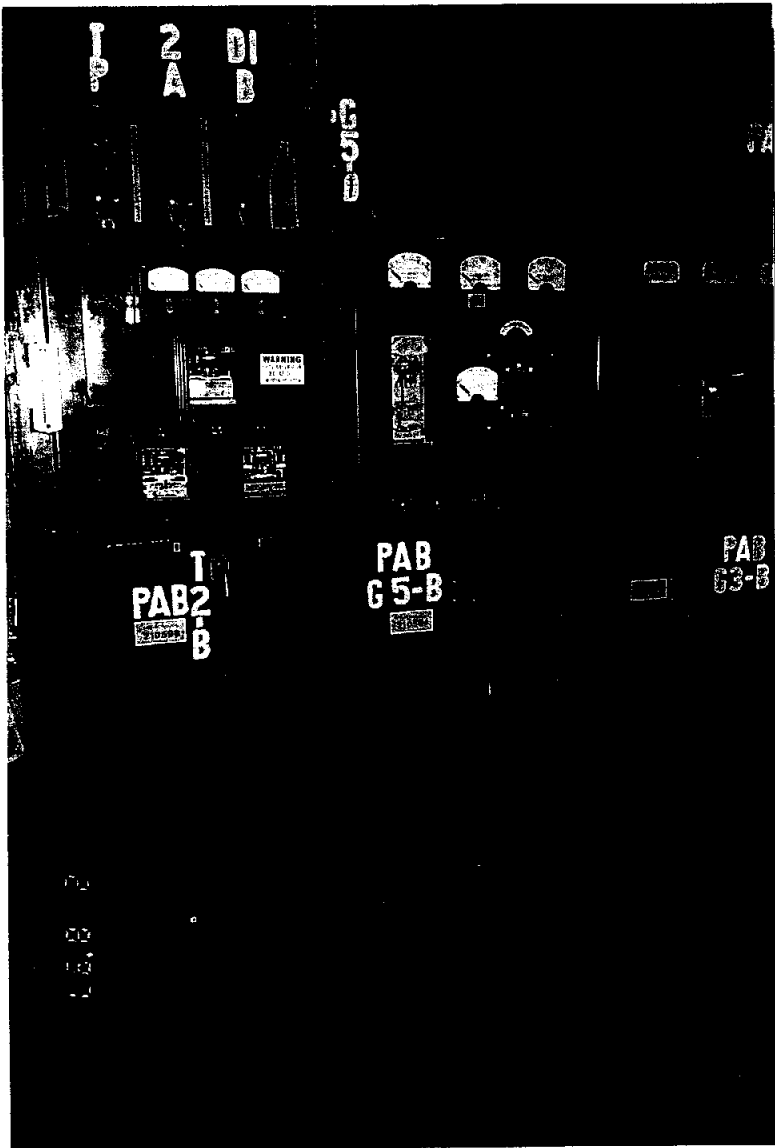
Switchgear in main plant is obsolete and dangerous to operate. Fault levels exceed breaker ratings. Operations changed to limit risk. Unit # 2 generator is faulted. Instrumentation/controls unreliable. Inadequate ventilation in plant. Four machines are obsolete with a very limited number of parts available. Two other small units have not been manufactured since 1980 but parts can still be obtained. Unit # 10 in good condition and is still supported by the manufacturer.

**Photo 51**  
Port-aux-Basques - Outdated switchgear
