# 1999 Dam Safety Inspection Reports

## Cape Broyle/Horsechops Development

# NEWFOUNDLAND POWER

Subject: 1999 Dam Safety Inspection Reports  
Cape Broyle / Horsechops Development

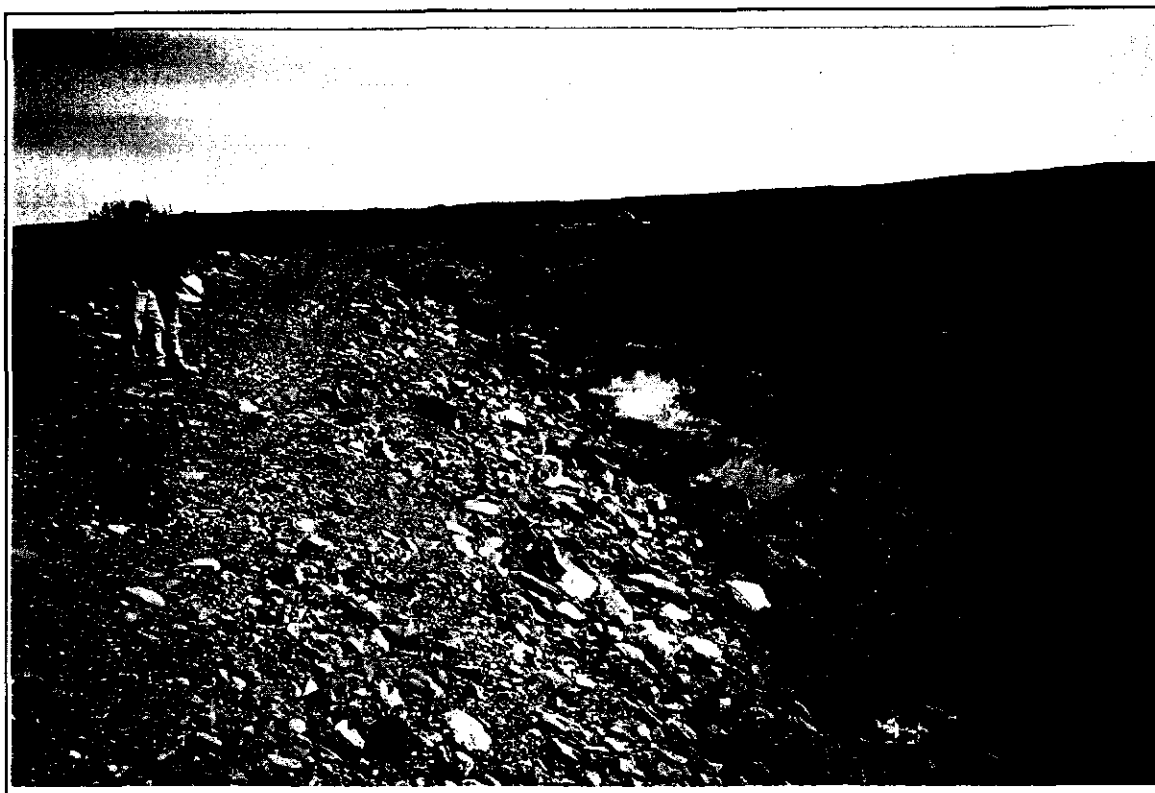
Slide movements	<u>None observed</u>
Signs of movements	<u>None observed</u>
Cracks	<u>None observed</u>
Seepage or wet areas	<u>Ponded water should be drained.</u>
Unusual conditions	<u>None observed</u>

Wet areas along downstream toe.

Ponded water should be drained

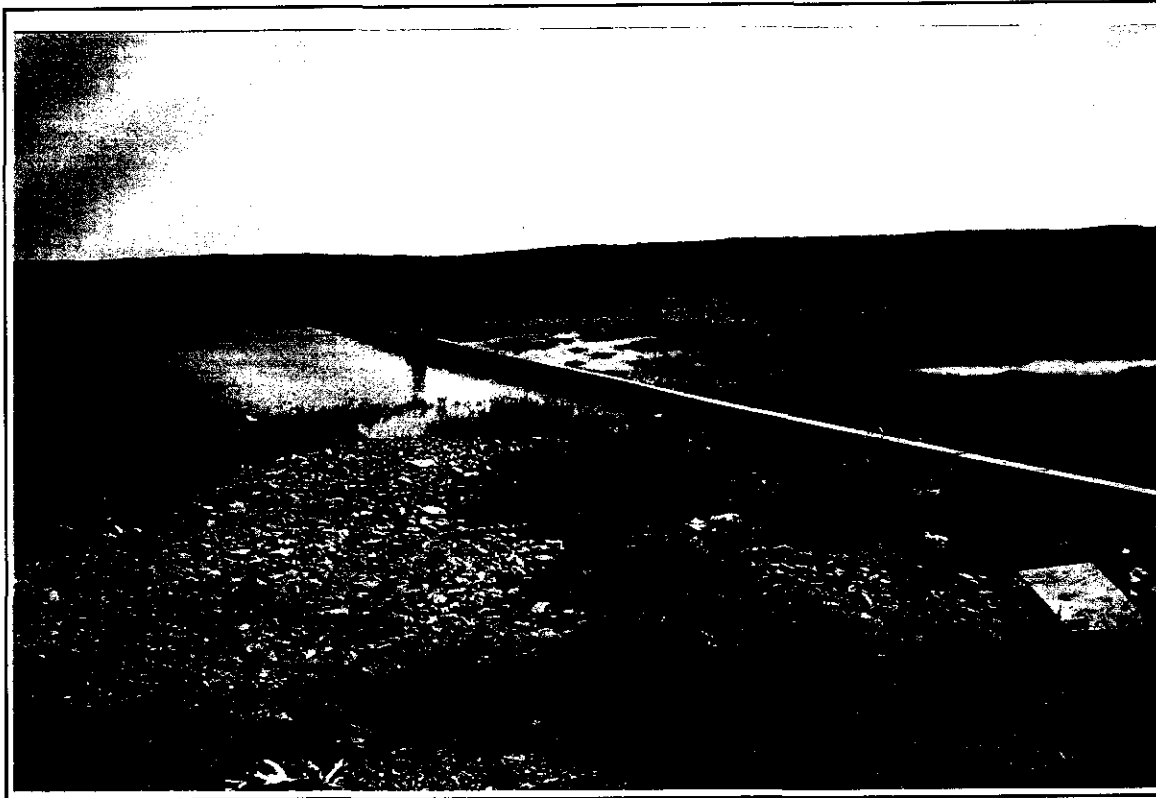
Timber Structural Members	<u>Severely rotted</u>
Timber Planking	<u>Poor condition</u>
Crib Contents	<u>N/A</u>

Alignment	<u>Tilted near left abutment</u>
Sinkholes	<u>None observed</u>
Debris	<u>None Observed</u>
Unusual conditions	<u>Structure very deteriorated.</u>

Upstream side

**Remarks** Structure should be replaced.

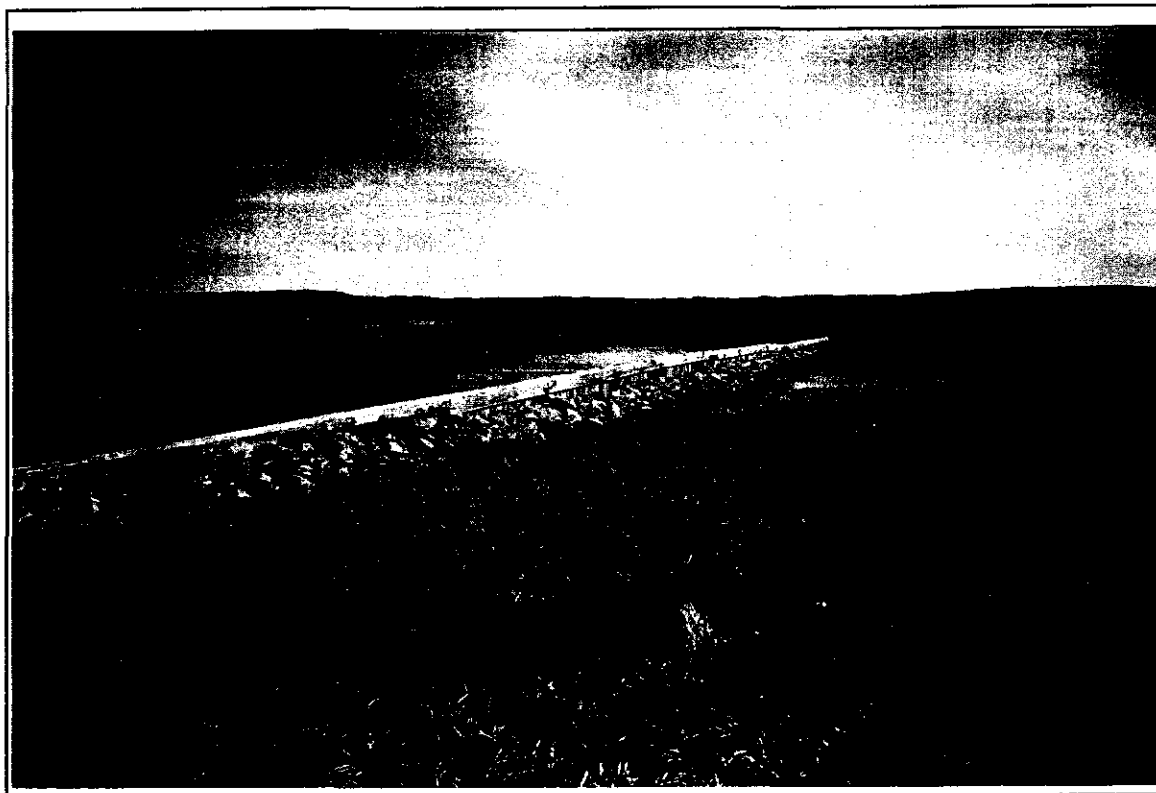
Slide movements	<u>None observed</u>
Signs of movements	<u>Displacement in some areas.</u>
Cracks	<u>Prevalent</u>
Seepage or wet areas	<u>Boggy area downstream with ponded water</u>
Unusual conditions	<u>Poor condition</u>

Downstream side

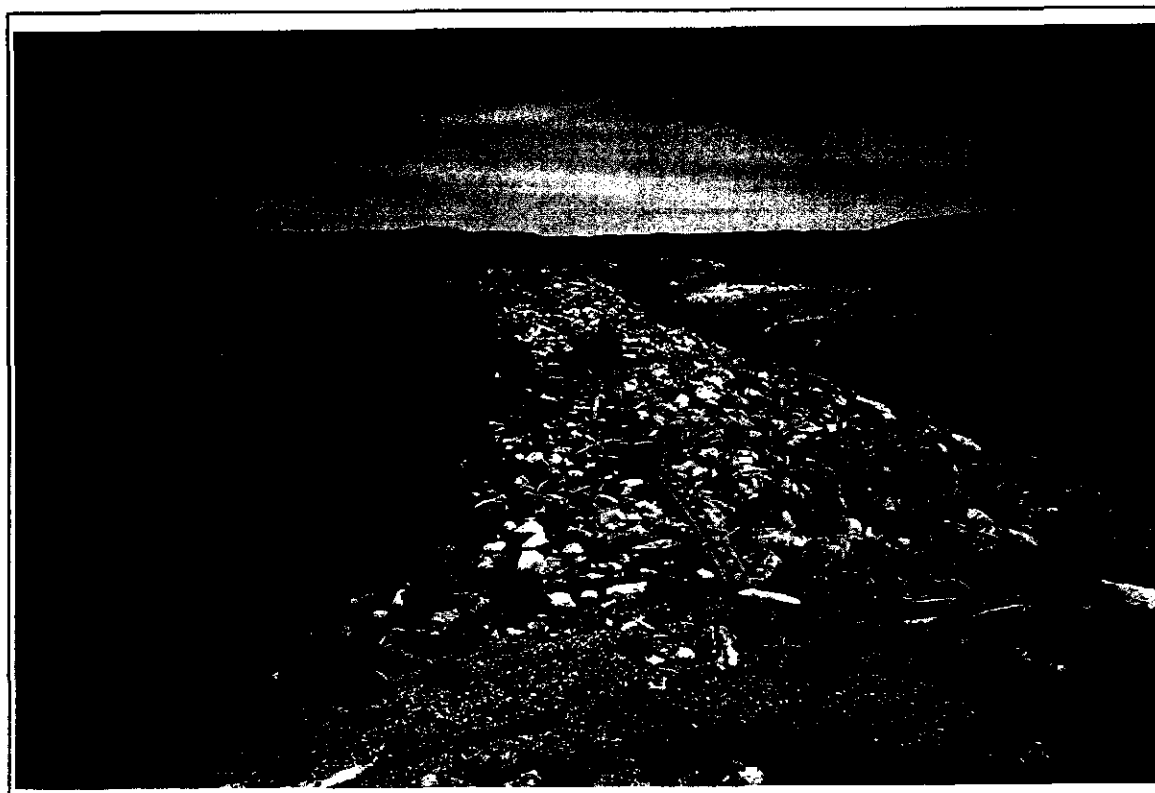
View from right abutment. Note mound of bog downstream which may restrict spill flows.

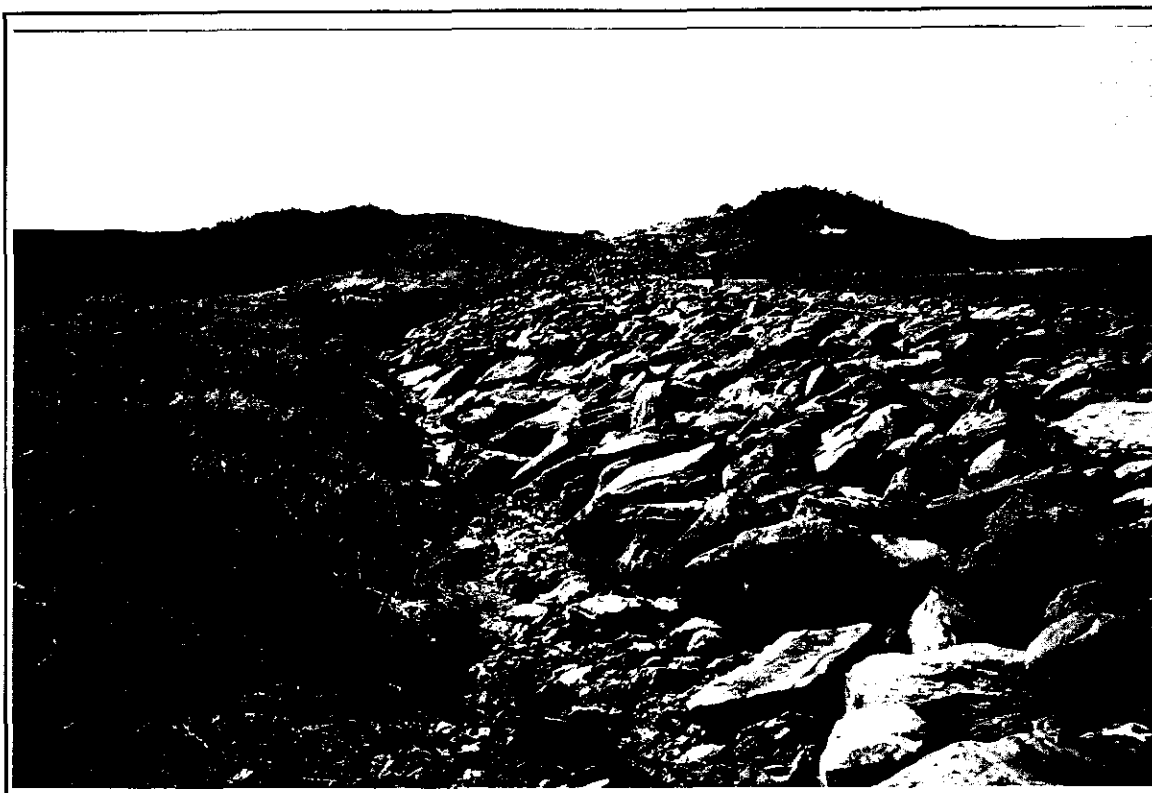
Slide movements	<u>None observed</u>
Signs of movements	<u>Some spaces between large pieces of riprap</u>
Cracks	<u>None observed</u>
Seepage or wet areas	<u>Few minor leaks through cutoff</u>

Downstream slope from left abutment.

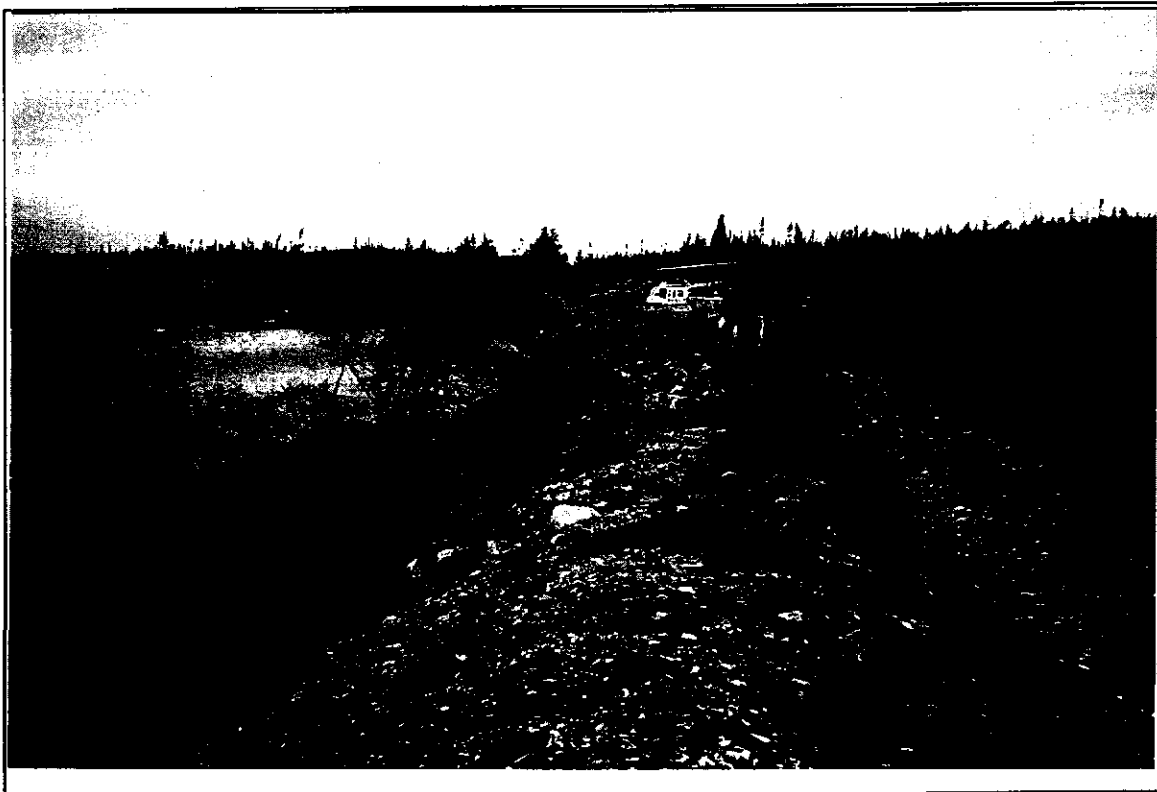
Slide movements	<u>None observed</u>
Slope protection	<u>Poor- minimal riprap</u>
Erosion - beaching	<u>None observed</u>
Cracks	<u>None observed</u>
Sinkholes	<u>None observed</u>
Settlement	<u>None observed</u>
Displacement	<u>None observed</u>
Debris	<u>None observed</u>
Unusual conditions	<u>Brush should be cleared</u>

**Remarks:** Structure is in poor condition and is poorly constructed compared to other structures in the system

Crest and upstream slope. Note irregular construction.

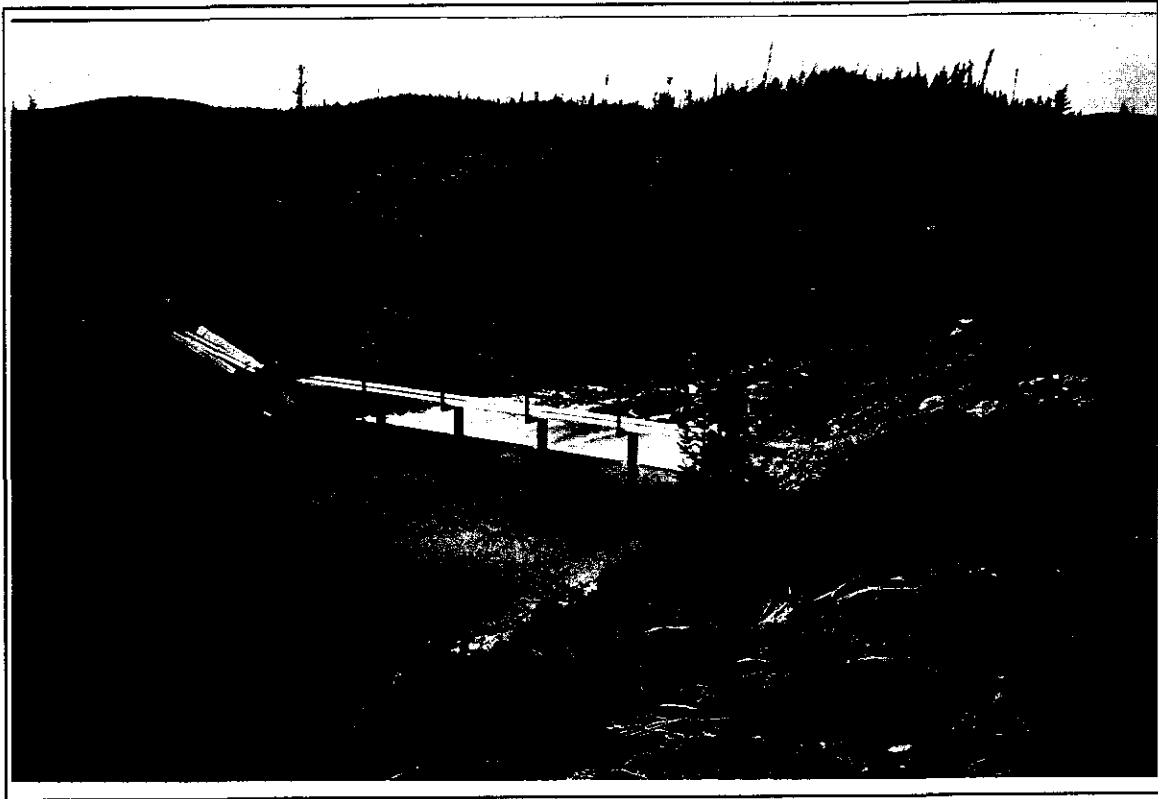
Debris	<u>None observed</u>
Walls	
Movement (offsets)	<u>None observed</u>
Settlement	<u>None observed</u>
Cracks or areas of distress	<u>Minor cracking in abutment concrete foundations</u>
Outlet Channel	
Slope Protection	<u>Good</u>
Stability of Side Slopes	<u>Channel excavated through rock</u>
Vegetation and other

General view from upstream

**Remarks** Stoplog structure is in good condition. Cracks in concrete should be monitored.
