**Newfoundland Power
2004 Capital Budget Application
Filing Contents**

**Volume I
Application, Schedules and Prefiled Evidence**

**Volume II
Expenditure Details, Reports and Studies**

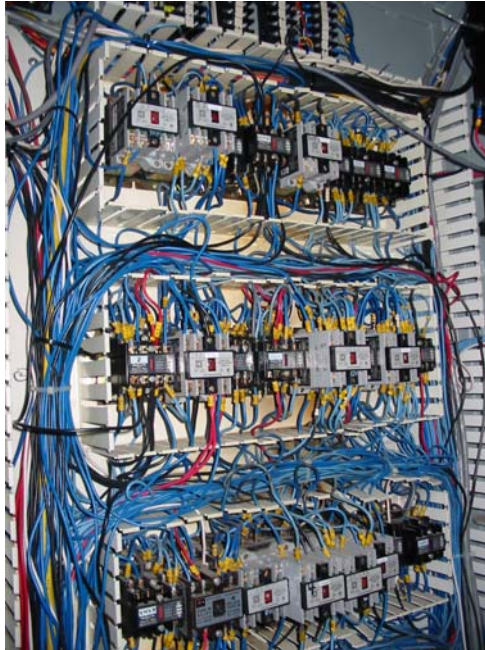
Interposing Relays

The interposing relays associated with the sequencing logic were under designed by the OEM and as a result are the cause of many unit trips. Over the years, numerous relays have been replaced and the number of trips has been reduced. However, relay failures still account for a significant number of unit trips.

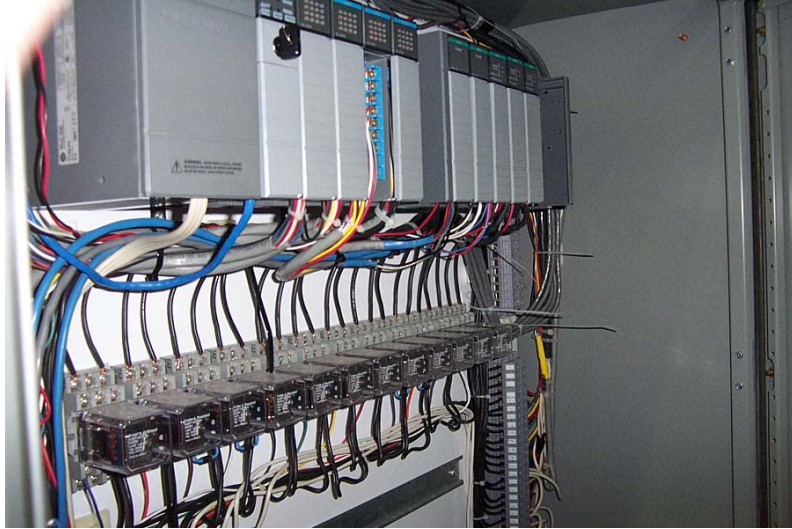
Allen-Bradley PLC System

The existing PLC is an Allen-Bradley SLC model 5/03 acting as a buffer between the electronic governor controller and the hydraulic pressure unit. This modification was completed to increase the reliability of unit synchronization, as the electronic controller was unable to maintain synchronous speed at speed no load conditions. The 5/03 processor has insufficient computing to provide a governing function. In addition, the number of input/output points is limited due to the size of the equipment enclosure.

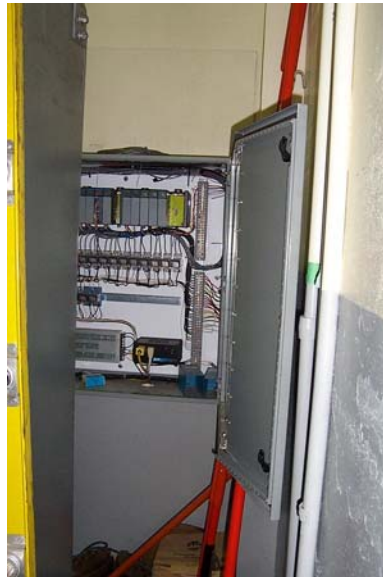
Location of existing PLC

The existing equipment cabinets have utilized all available floor space in the plant. The existing PLC cabinet is positioned on a rear wall behind the existing switchgear. Access to the cabinet is limited and there is no room to expand.

To provide the necessary space for a governor PLC, it will be necessary to replace an existing equipment enclosure with an enclosure that also includes the governor function.

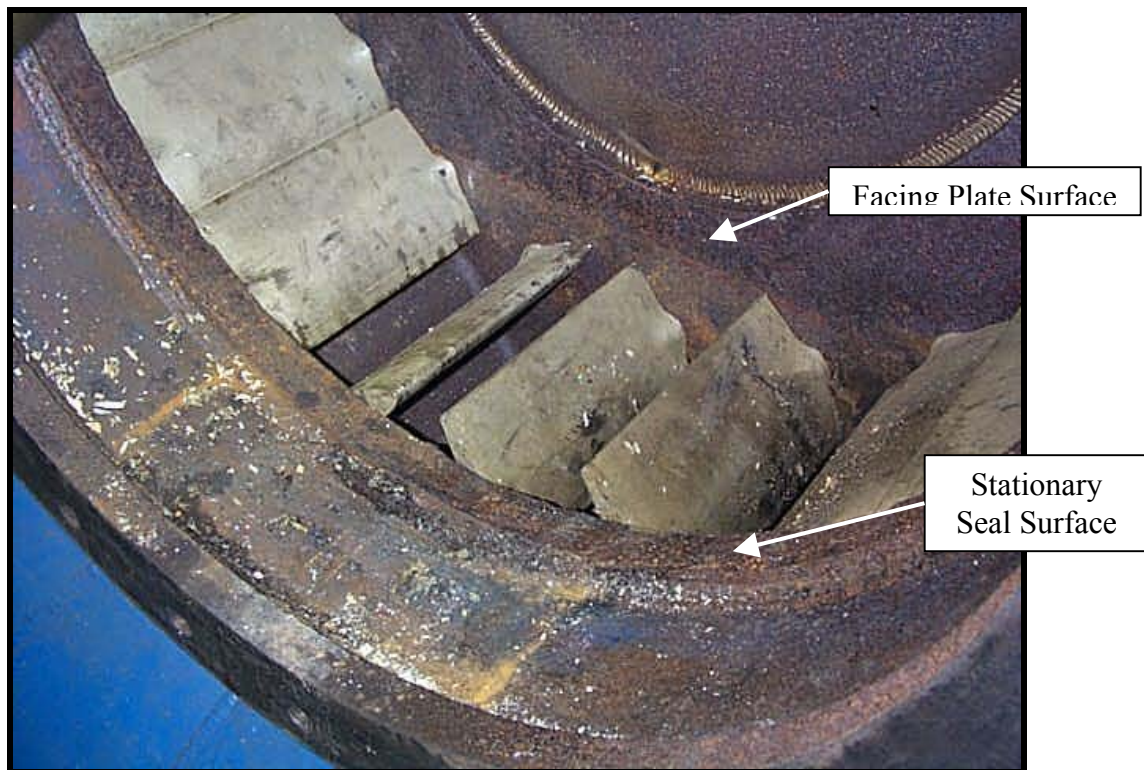
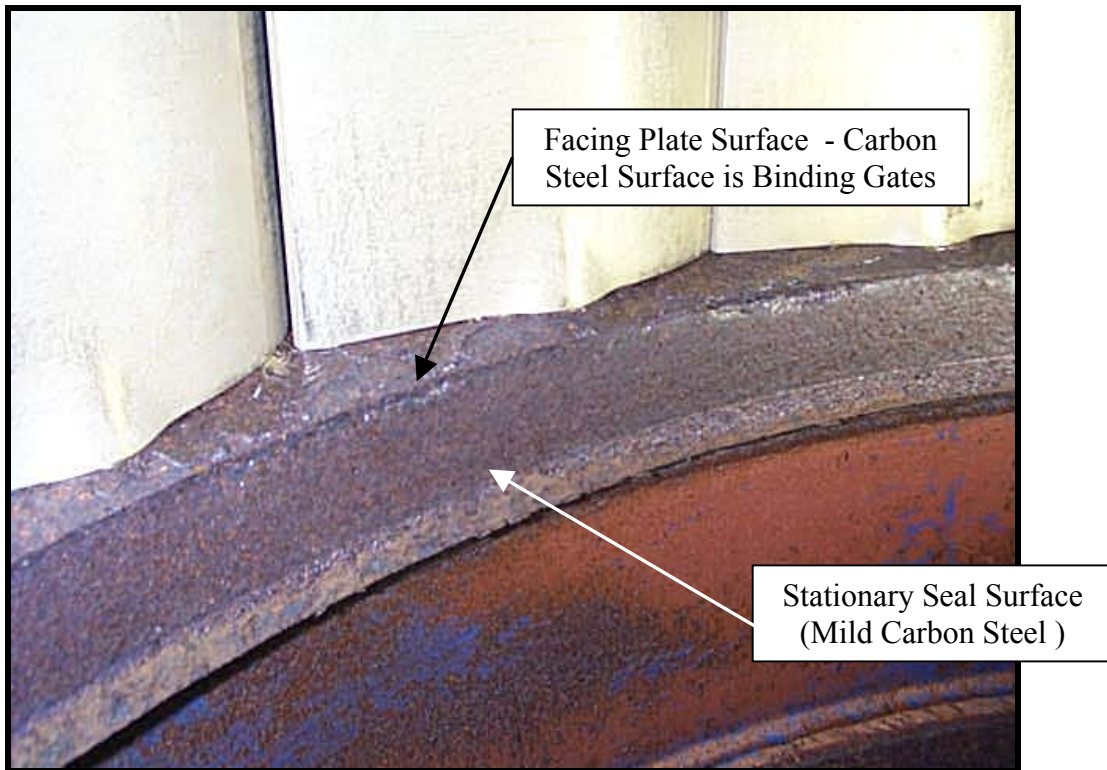
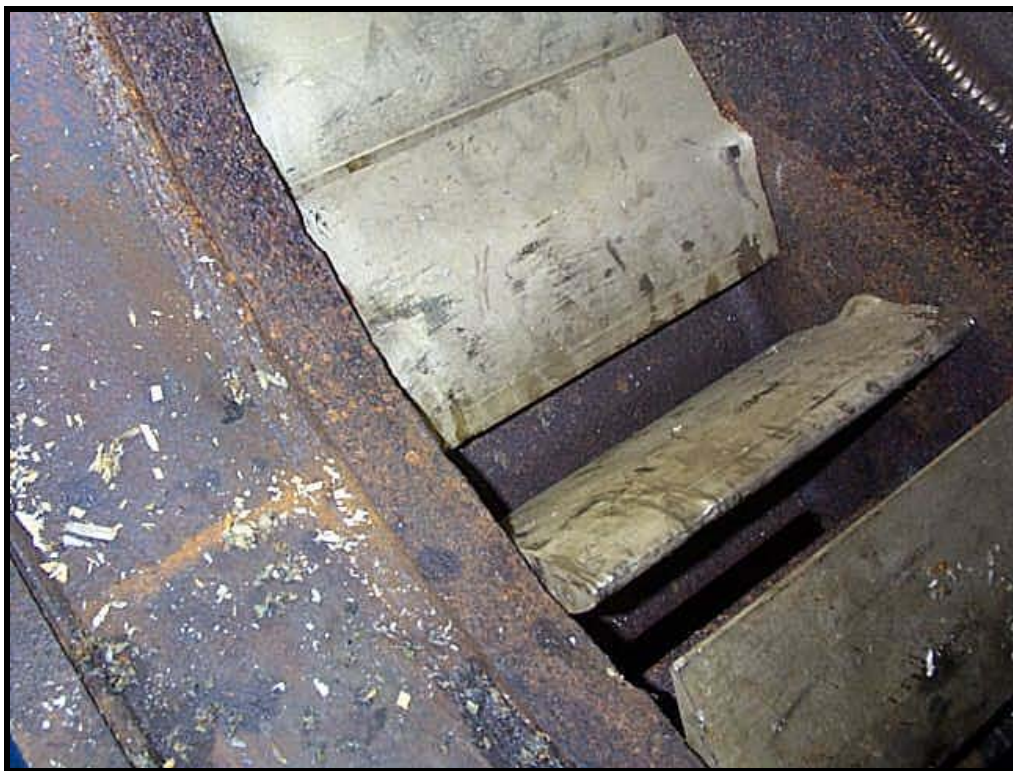
This unit was installed as a new plant in 1983 by Barber Hydraulic Turbines. The turbine is a horizontal Francis Turbine. In April 2000 operators were experiencing problems with the wicket gate operating ring jamming and acting sluggishly. The turbine was opened up and inspected and it was found that the stationary seals in this turbine were mild carbon steel, and not Type 410 stainless steel or ASTM B271 centrifugally cast nickel-aluminum-bronze alloy typically found in our other hydro plants. The carbon steel stationary seals had corroded and rust had accumulated to the point that the two ends of the wicket gates were getting jammed in between the two stationary seals. The photo attached below shows the mild carbon steel stationary seals on the Morris Hydro Plant Turbine.

The next photo shows the area where the stainless steel wicket gates were getting jammed due to the rust accumulation on the carbon steel stationary seals.

The carbon steel stationary seals should be replaced with either Type 410 stainless steel or ASTM B271 centrifugally cast nickel-aluminium-bronze alloy typically found in our other hydro plants.

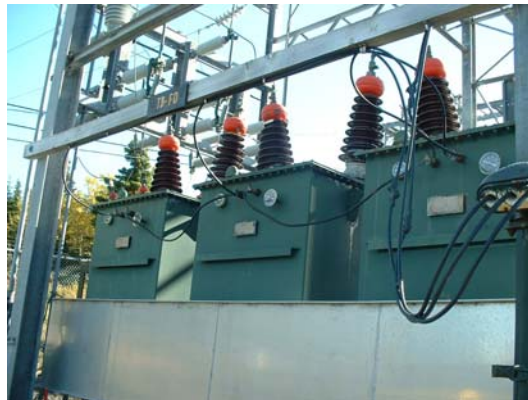
Station Service Transformers

The existing 69,000-volt to 600-volt delta station transformers will be replaced. This secondary voltage is non-standard voltage and there are no spares available for the three single-phase transformers. The potential failure of one or more of these transformers places the operation of the plant at risk. They will be replaced with a 6,900-volt to 120/208 volt, wye, three-phase dry-type transformer located inside the plant in a new switchgear cabinet. In addition, a backup station service will be provided from the substation yard using three standard pole mounted transformers and connected to the switchgear with a manual transfer switch. This will provide a contingency in the event of the failure of the dry-type transformer.

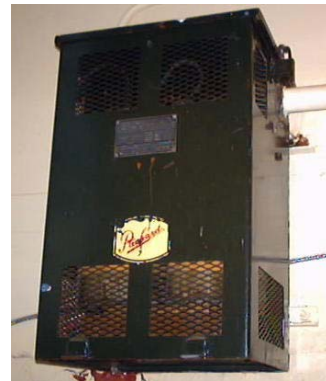
Station Service

The existing 600 volt 3 phase AC service is antiquated and there are numerous auxiliary panels associated with the distribution system. The system needs to be modernized and consolidated into a 600 volt three phase panel and a 120/240 single-phase panel. Another option would be to provide a 120/208 three-phase panel if the existing 600 volt equipment is to be replaced.

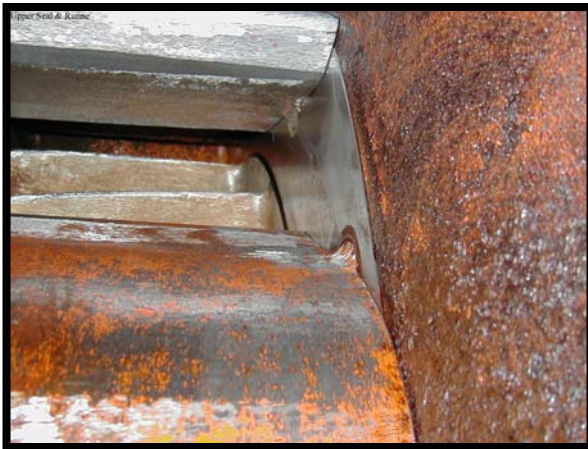
Photo 1 – Wicket Gates

The wicket gates are in good condition with very little wear on the sealing surfaces. The heel to toe clearance on the gates is excessive approximately 1/8" in the closed position. This maybe corrected on the eccentrics. If not the gates will have to be repositioned and the gate arms re-doweled. See photo 1 - wicket gates and stay vanes.

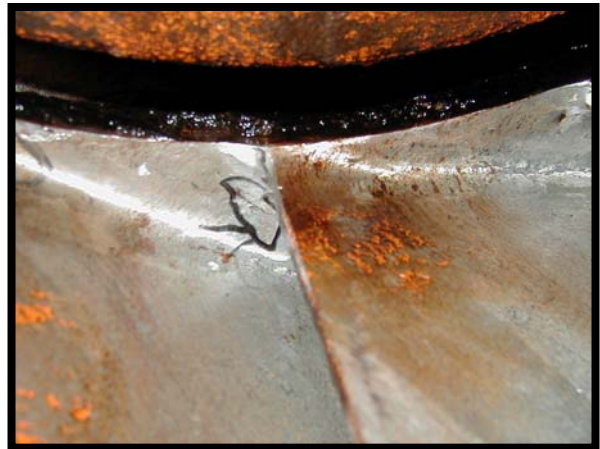
Photo 2 – Upper Seal & Runner

The runner is stainless steel welded construction. The elevation of the runner in the water passage is approximately 3/16" low however this has not caused any erosion to the runner components. See photo 2 - upper seal and runner.

There are small cracks near the root of the weld on several of the runner blades to the inner band. These are most likely surface cracks and do not pose any immediate threat to the integrity of the runner. These will be checked during the next inspection.

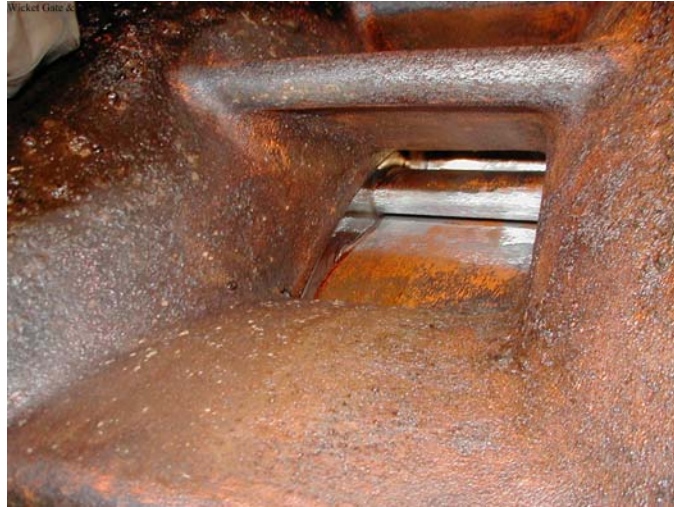
Photo3 – Wicket Gate

The scroll case is in relatively good condition with no signs of major pitting or erosion of the base metal. No cracks in the casing sectional welds that were accessible for viewing. The stay vanes are in good condition with no signs of impact damage or major wear. See photo 3 and 5 - scroll case, wicket gate and stay vane.

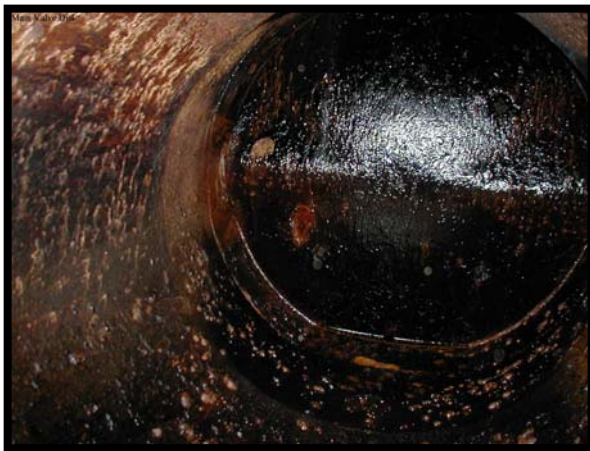
Photo 4 – Main Valve

A full inspection of the main valve could not be completed due to leakage in the head gate that prohibited the opening of the valve. There is some erosion on the downstream side of the disc, a section approximately 3" in diameter and 1/4" deep has delaminated from the base metal. See photo 4 of the Main Valve. The drive sleeve on the valve actuator was weld repaired this year, as replacement parts were unavailable from the manufacturer due to the vintage of the unit.

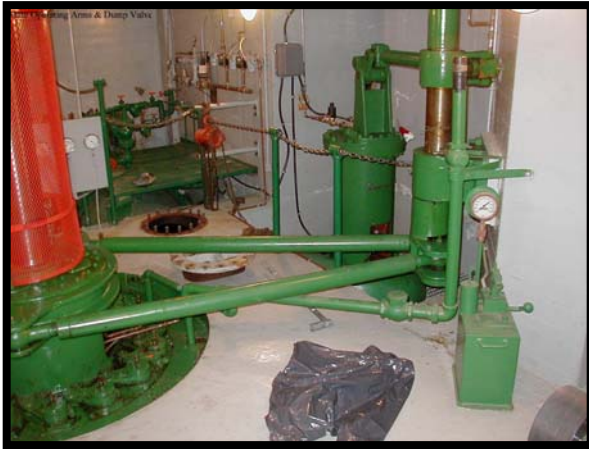
Photo 6 – Gate Operator Arms

The governor and control linkages were inspected for worn bushings and lost motion. The cross head on the dump valve connecting arm needs to be re-bushed to reduce the excessive play in the cross head. See photo 6 -Gate operating Arms and Dump valve.

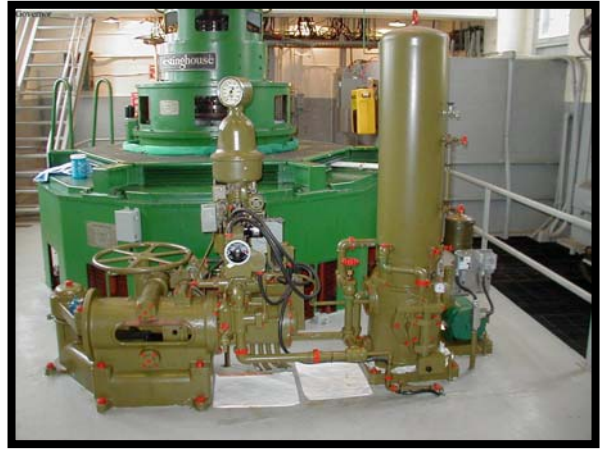
Photo 7 - Governor

There is a small amount of play in the governor-operating arm. The needle valve in the dashpot on the governor control head is worn and cannot be properly adjusted. See photo 7 - Governor. The manual gate limit adjustment is seized, and this is left at maximum or 100%.

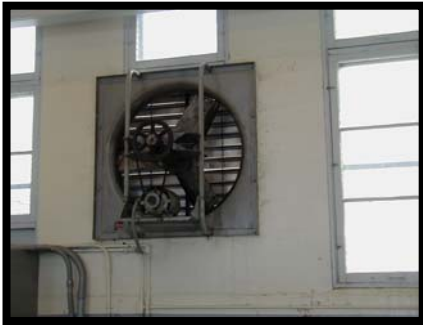
Photo 8 – Exhaust Fan

The air intake louver and exhaust fan are in a poor state of disrepair and will need to be replaced within the next couple of years. See photos below:

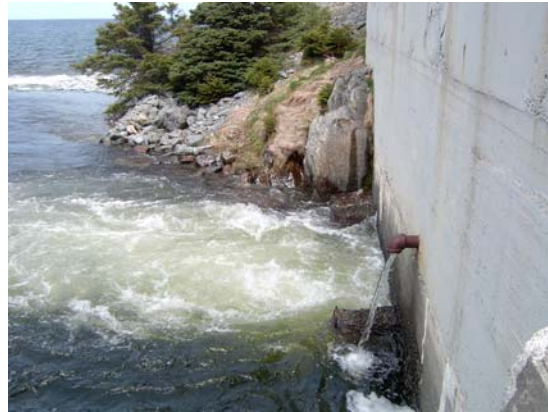
Piers in Tailrace Requiring Repairs

The powerhouse is in good condition. The exterior of the building and roof appear to be satisfactory. Some concrete repairs are required in the tailrace area at the water line. This area is susceptible to salt water spray and numerous freeze thaw cycles.

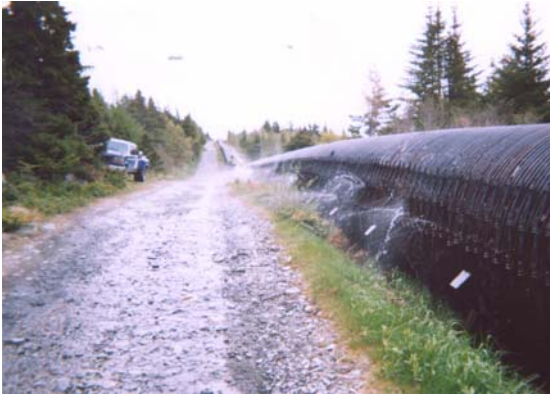
Woodstave Section

the New Chelsea pipe. Both the woodstave and steel sections of the penstock are in poor condition and need to be replaced.

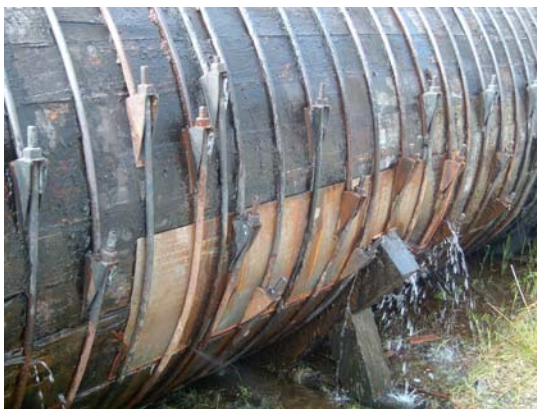
Steel Plate Bridging Missing Woodstave

A recent inspection of the woodstave penstock indicates that the woodstaves continue to deteriorate. The majority of the woodstaves along the spring line are crushed and some are starting to bulge and feather around the steel rings. Numerous holes have been plugged in the penstock with wooden wedges (approximately 20,000) over the last few years and in the last year two major blowouts had to be repaired. Overall, the frequency of repairs has increased in recent years. There are three or four areas where large sections of woodstave have blown out and were repaired by bridging the missing woodstave with steel plate and gasket material.

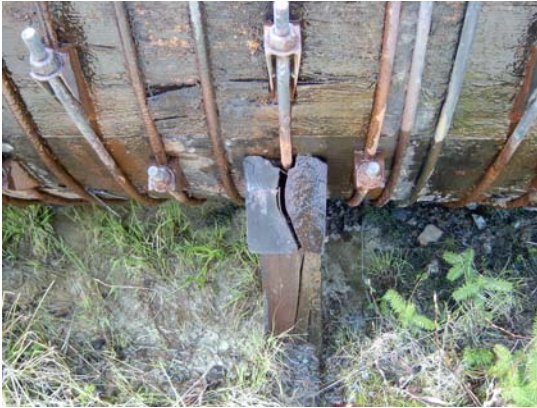
Failed Cradle

Due to the excessive amount of leakage the bedding material below the penstock is saturated and drainage is poor. In some areas the timber cradles have settled into the bedding material and notable sags can be seen in the penstock alignment. In some areas the penstock is in contact with the ground. Several cradles are cracked and showing signs of failure. The operator reports that in recent years over 100 plates have been installed to repair cracked cradles.

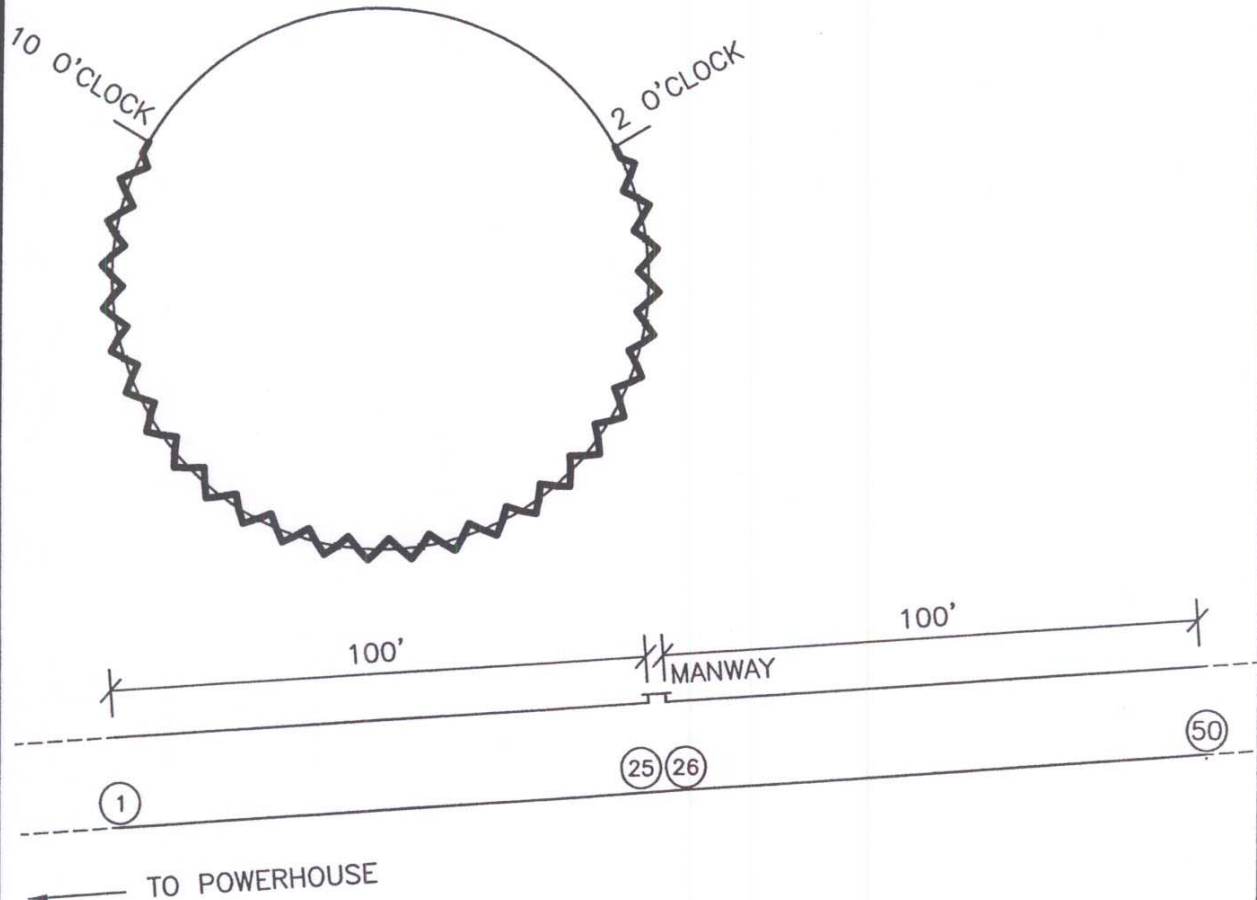
AREAS AT 2 O'CLOCK TO 10 O'CLOCK
POSITION VERY HEAVILY CORRODED/PITTED.

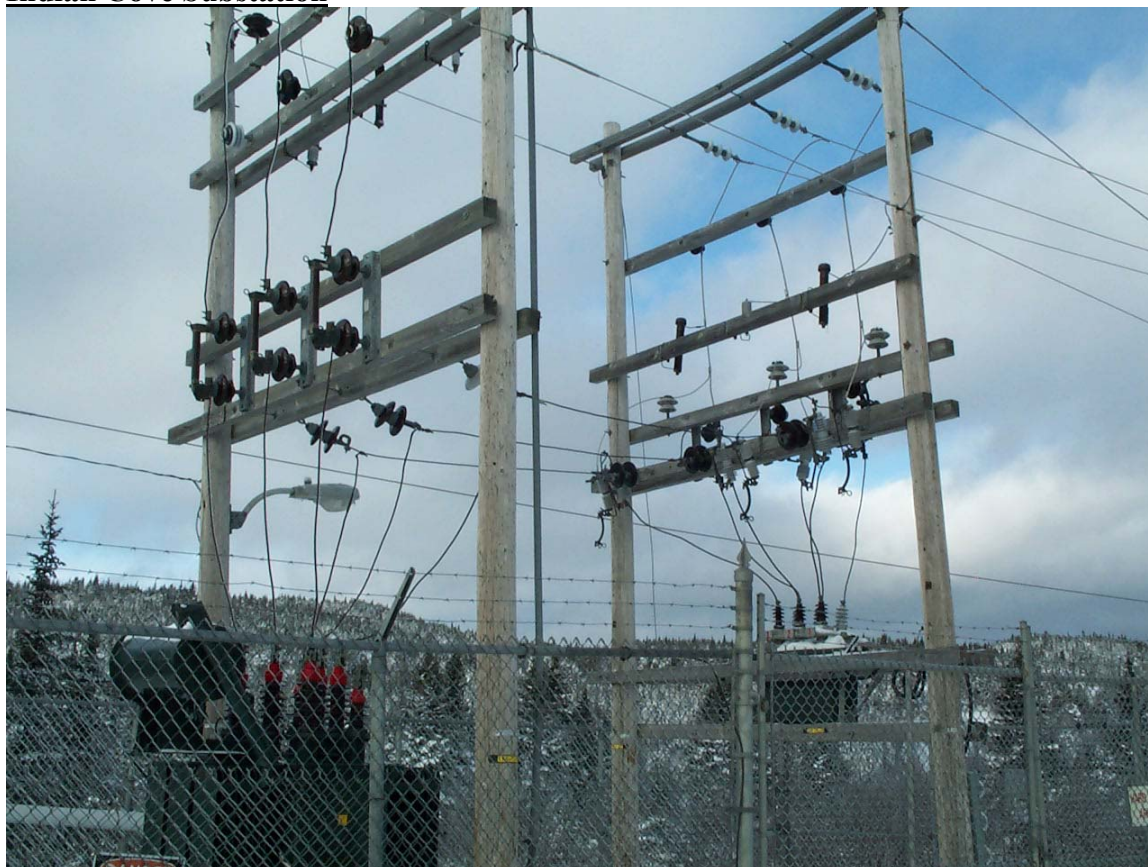
Indian Cove Substation

Operating Experience: Inspections have indicated that the power transformer and structure have deteriorated to the point of requiring replacement.

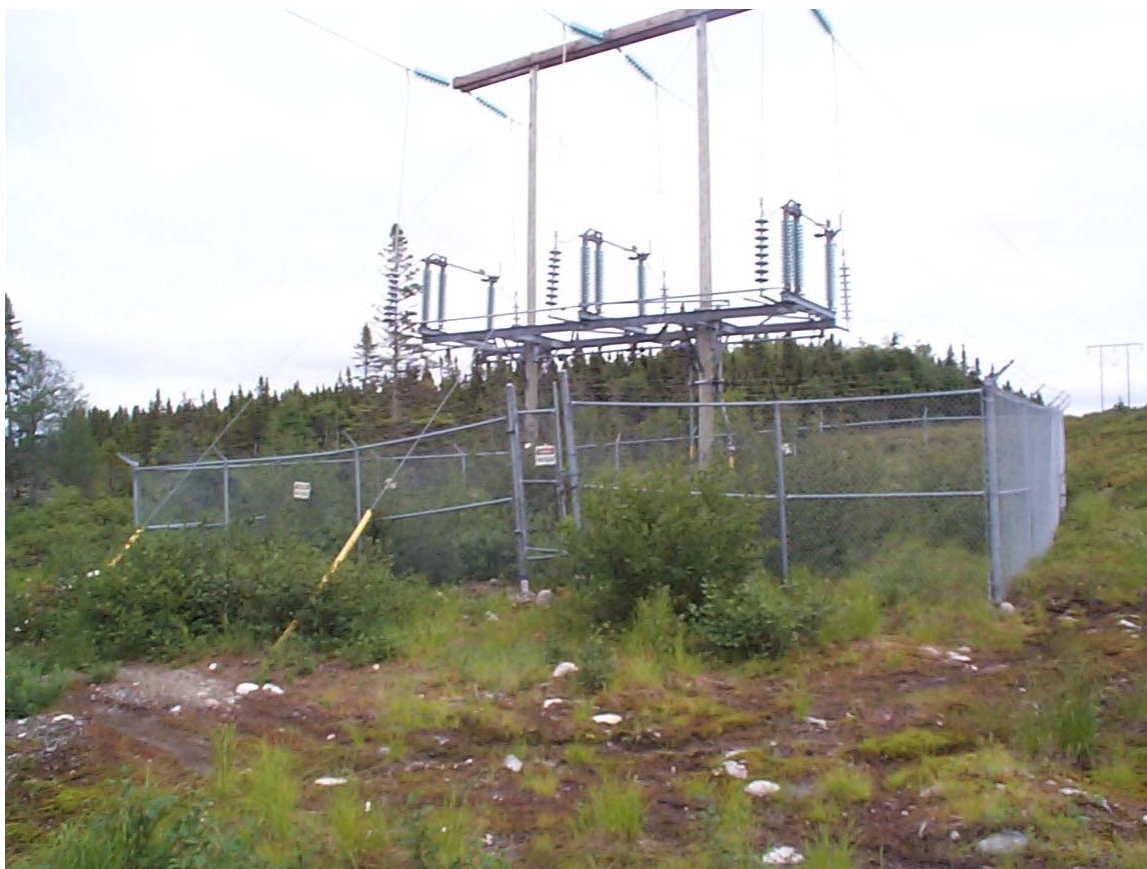
Port Blandford Switch

The switches are now tagged as “Out of Service” and will only be operated by first removing the power from 124L.
