**Re: Newfoundland Power's 2007 Capital Budget Application**

Prepared by:  
Gary L. Murray, P.Eng.

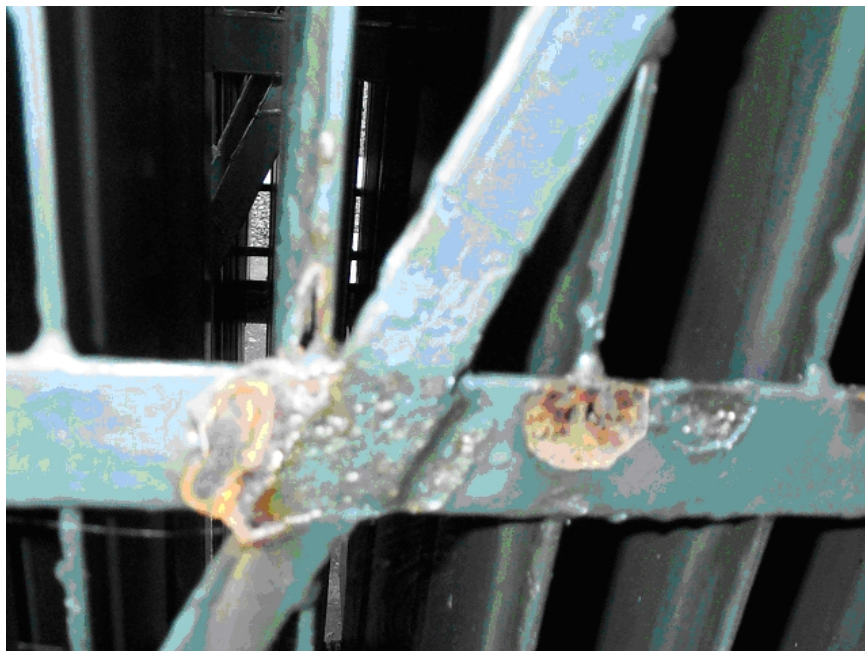
T3 transformer is in good condition. T2 transformer has cooling radiator fin edges that are perforated due to rusting. The perforated fin edges have been patched as a temporary measure to prevent leaking but require replacement. The lightning arrestors on T2 and T3 transformers are silicon carbide and require replacement with metal oxide arrestors. The air break switch on T2 transformer is 30 years old and requires replacement. Protection against small animals should be installed on the 25 kV equipment and bus. A maintenance overhaul is required for the T2 and T3 power transformers in 2007 which will be completed at the same time as the required capital work.

Deteriorated radiator fin edges – Blaketown Substation

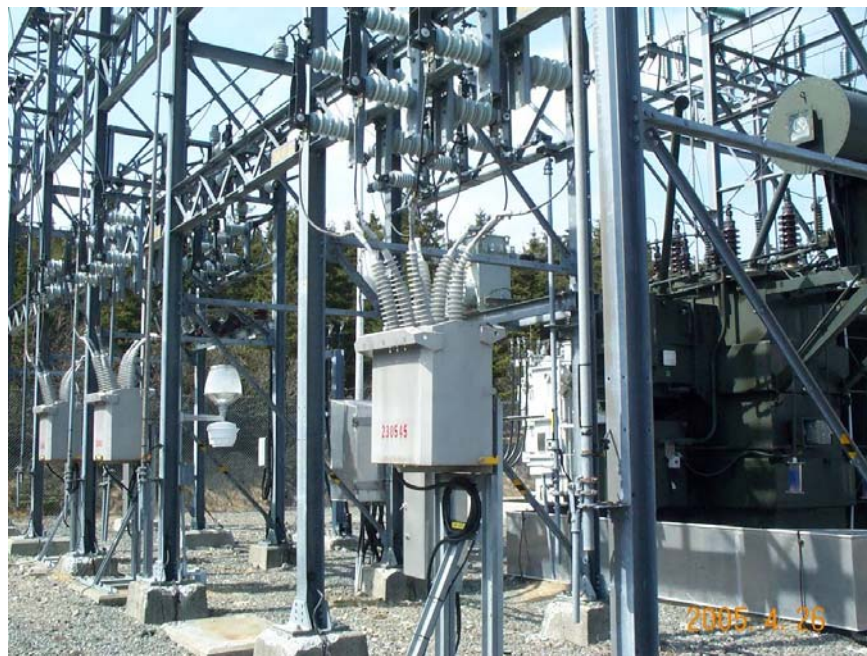
After reviewing maintenance records and conducting on-site engineering assessments, it was determined the 66 kV and 12.5 kV steel structures are in good condition with no sign of deterioration. Inspections of the concrete foundations show that there are two recloser and three bus structure concrete foundations that are crumbling and require replacement.

**Foundation damage at Clarkes Pond Substation**

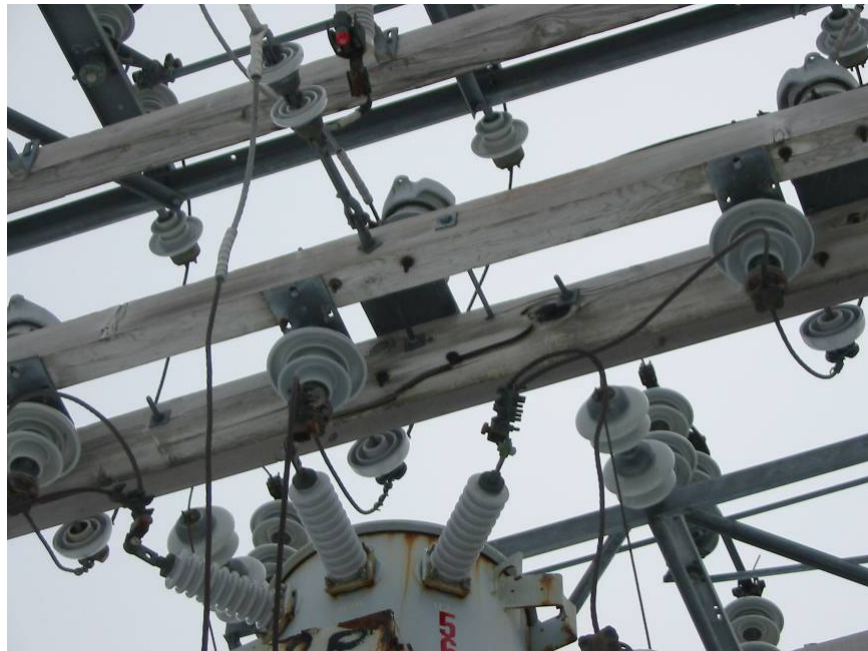
**Cracked crossarm Garnish Substation**

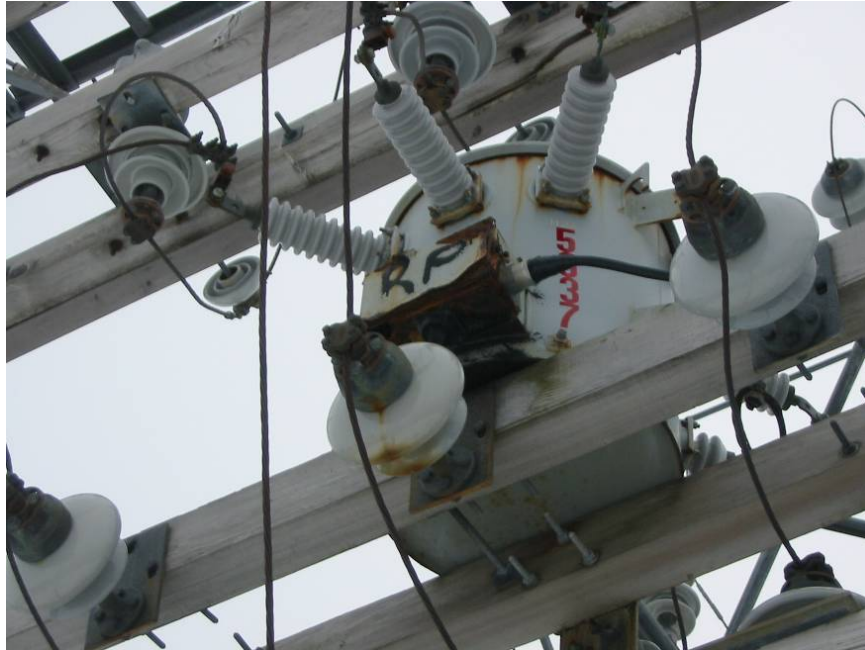
**Corrosion damage Garnish Substation**

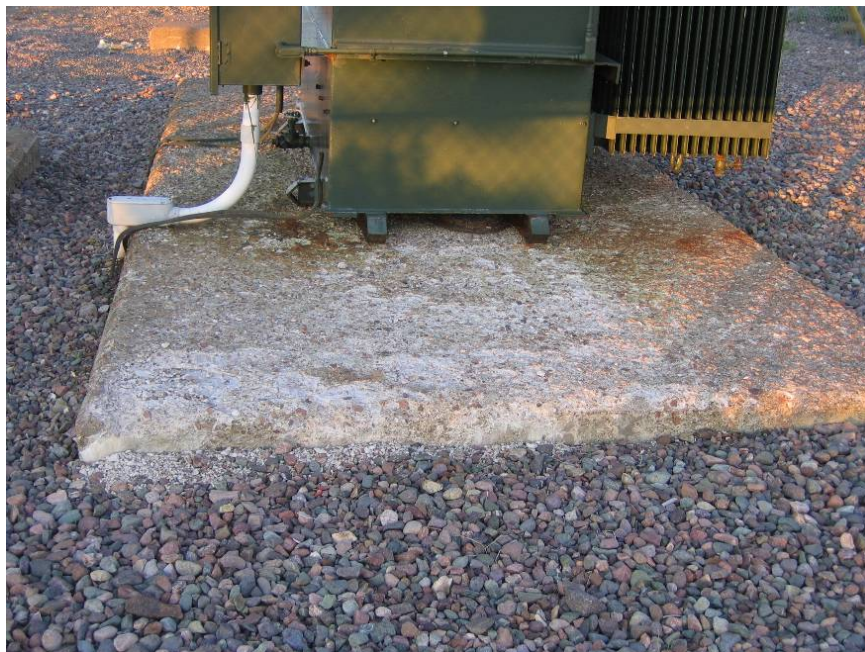
**Foundation damage Garnish Substation**

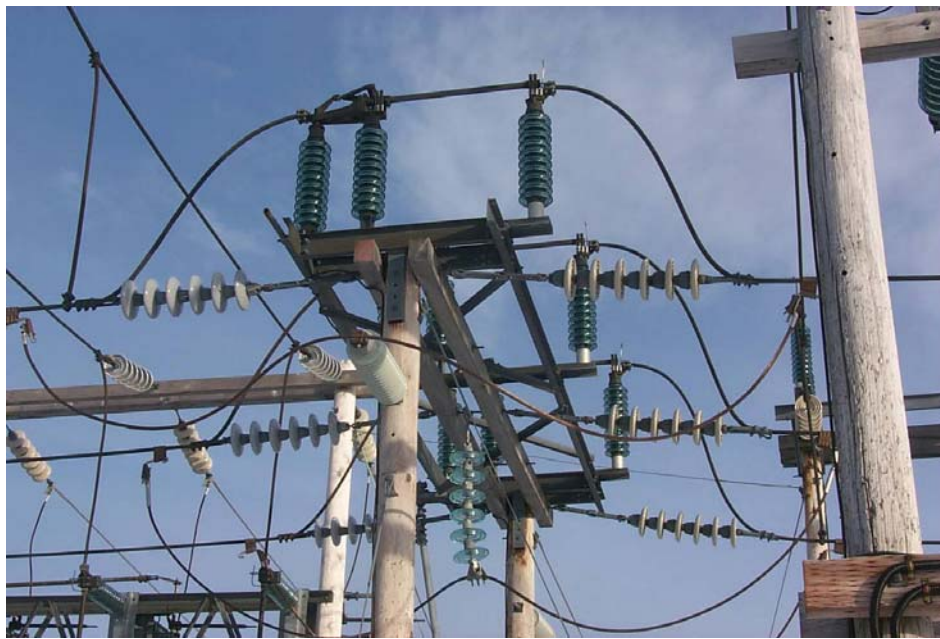
The radial line 17L to Big Pond substation requires a bypass switch to facilitate maintenance on the breaker. The 66 kV potential transformers are over 40 years old and showing signs of deterioration. These potential transformers are essential for providing protection for the transmission lines and equipment at Goulds substation and must be replaced to maintain reliability. A maintenance overhaul is required to be completed on the three power transformers in 2007 which will be completed at the same time as the required capital work.

**Bus Tie Switch Bypassed Goulds Substation**

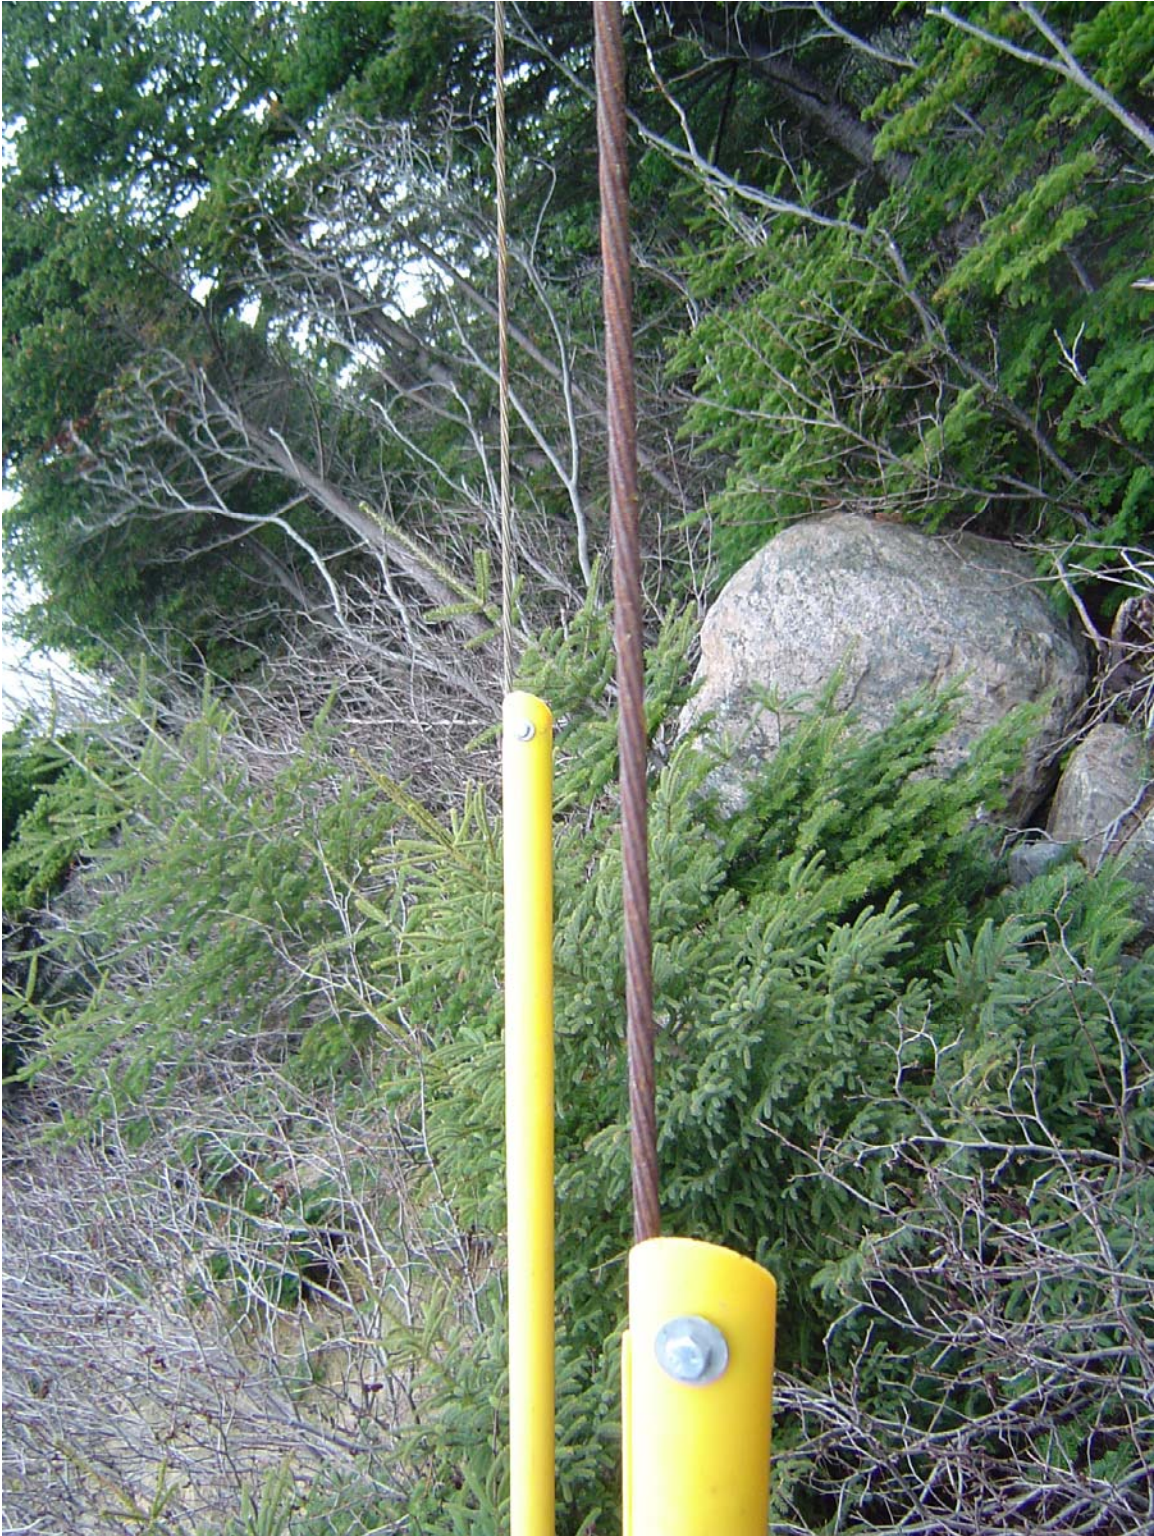
**Figure 1 - Rusty guy wire 43L**

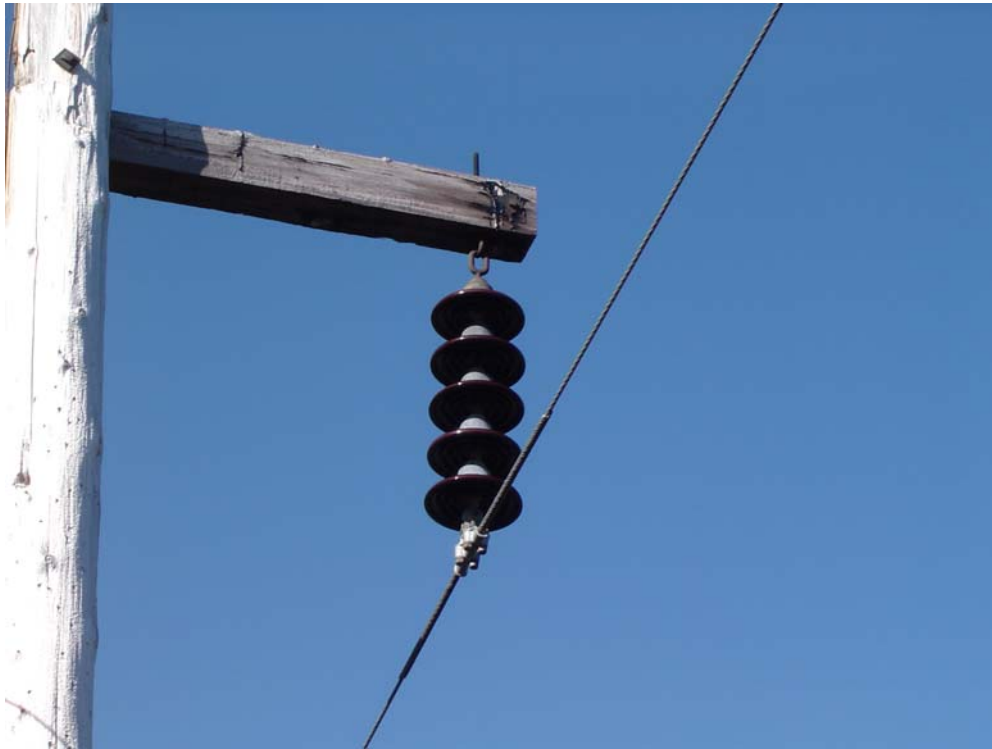
**Figure 2 - Old insulators 43L**

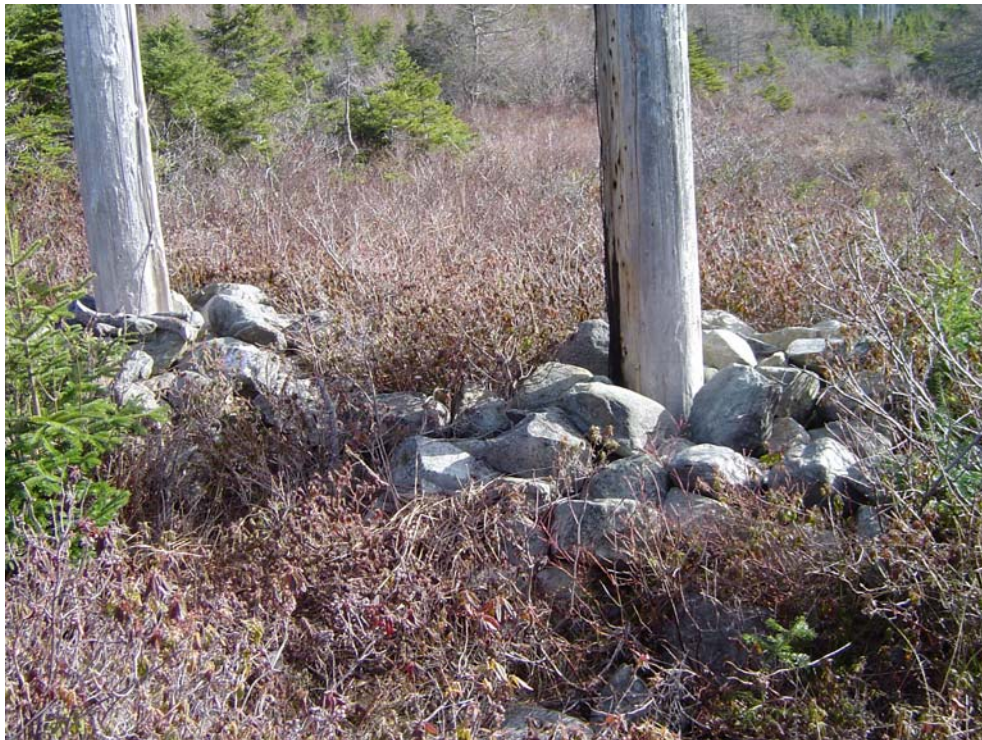
**Figure 3 - Deteriorated cribs 43L**

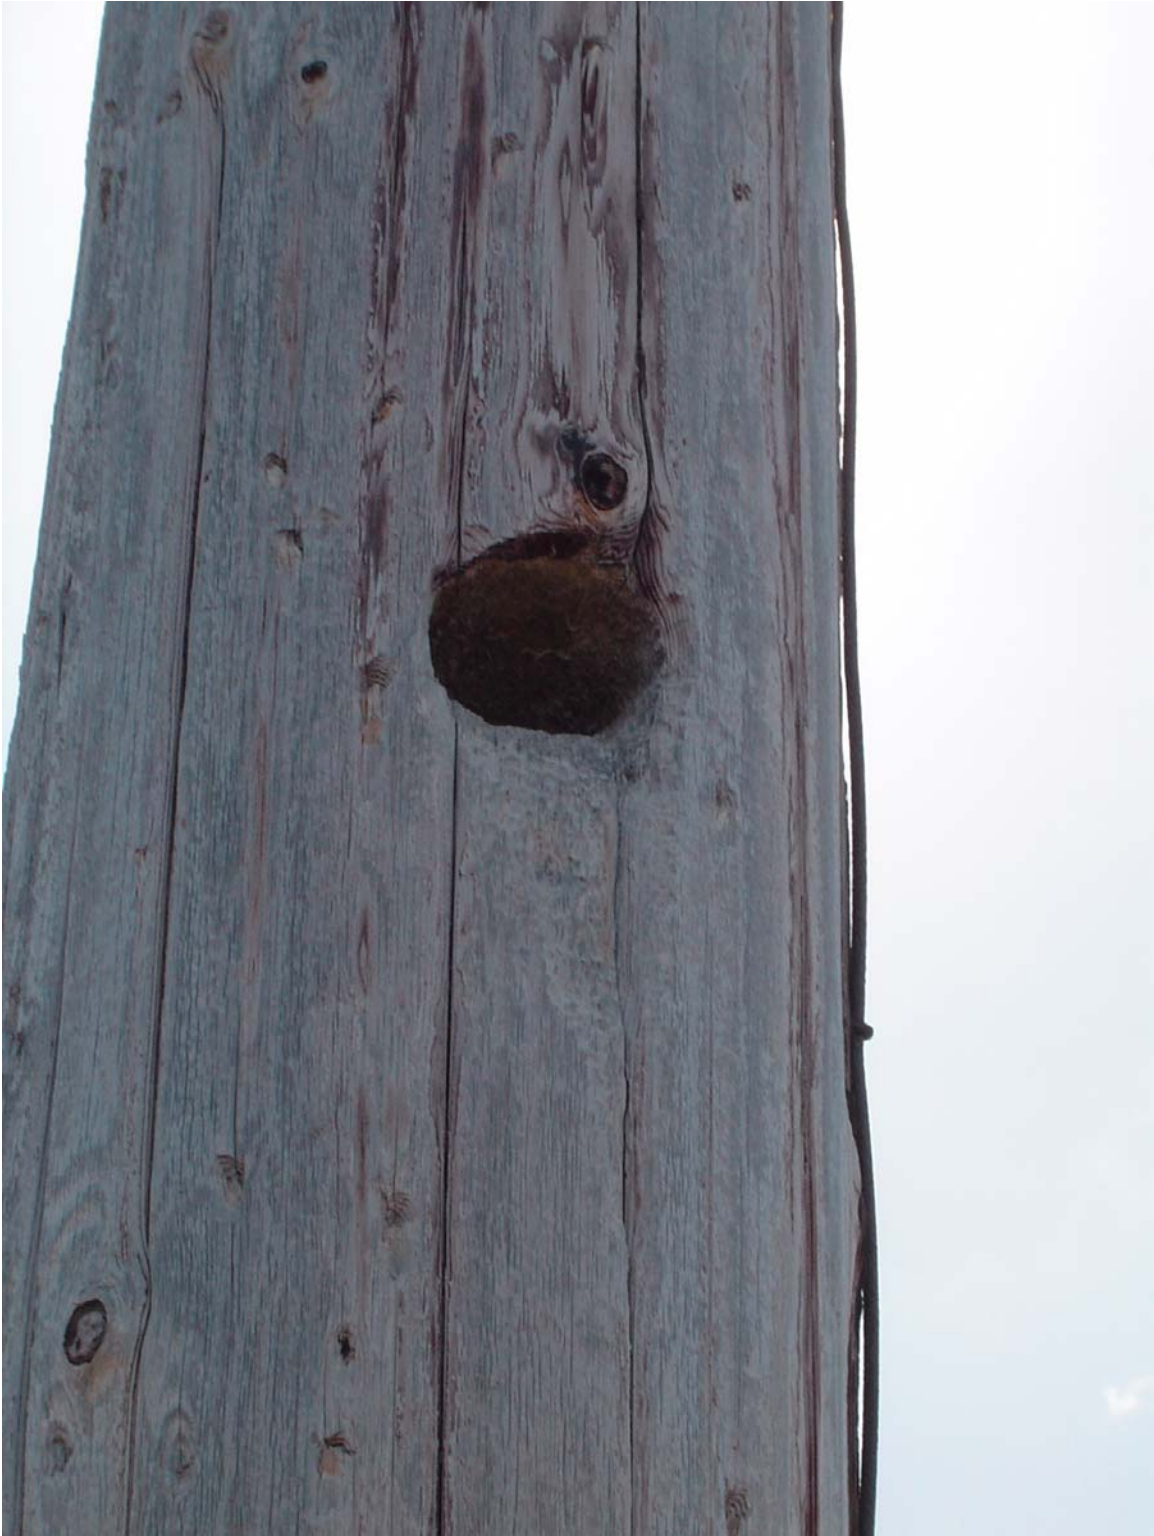
Figure 4 - Woodpecker damage 43L

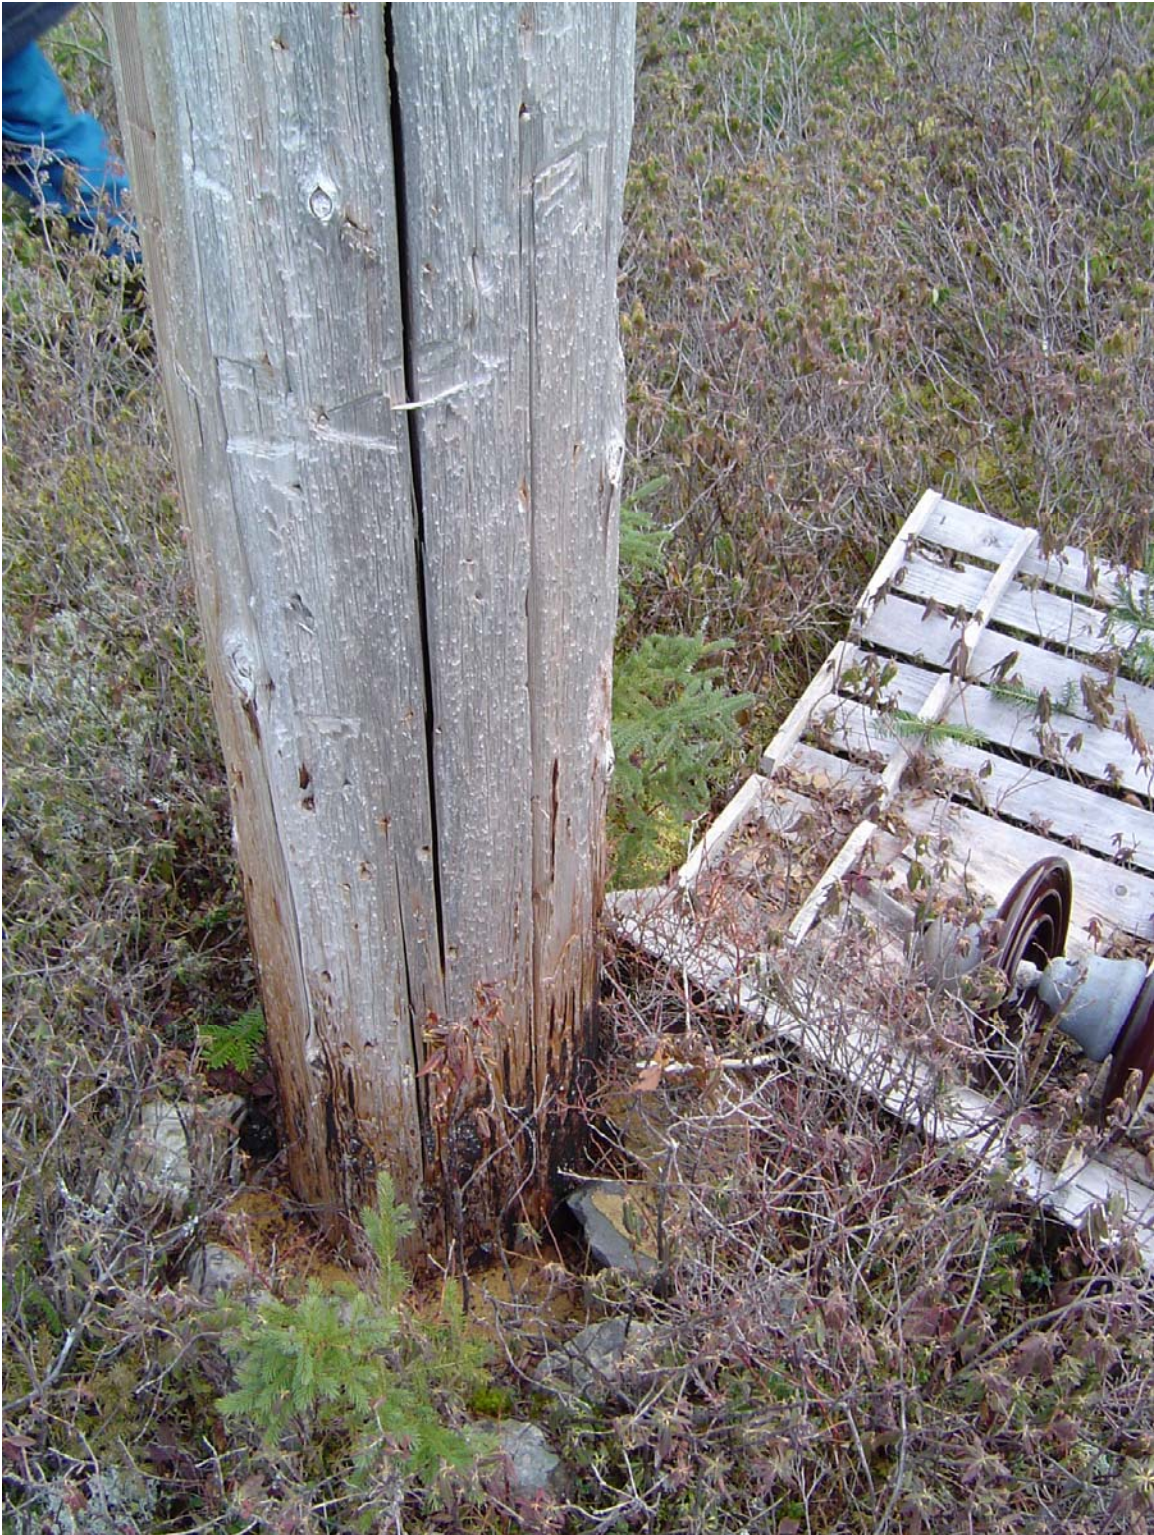
**Figure 5 - Deteriorated pole (ant damage) 43L**

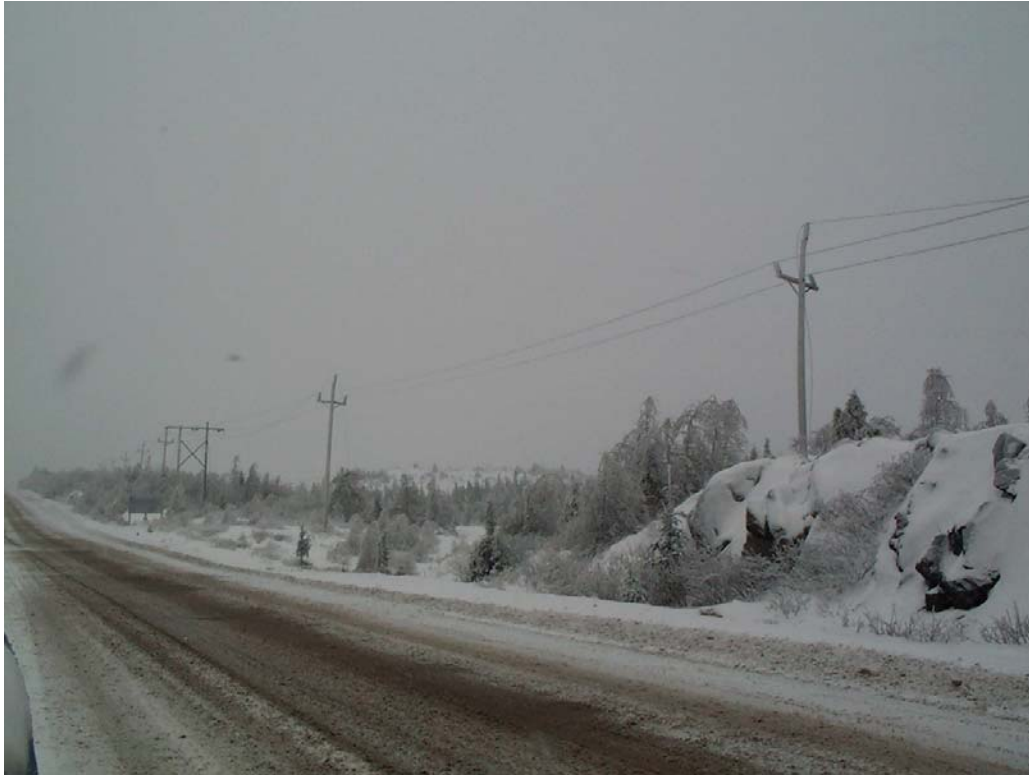
**Figure 6 - Ice Storm Damage December 2003 110L**

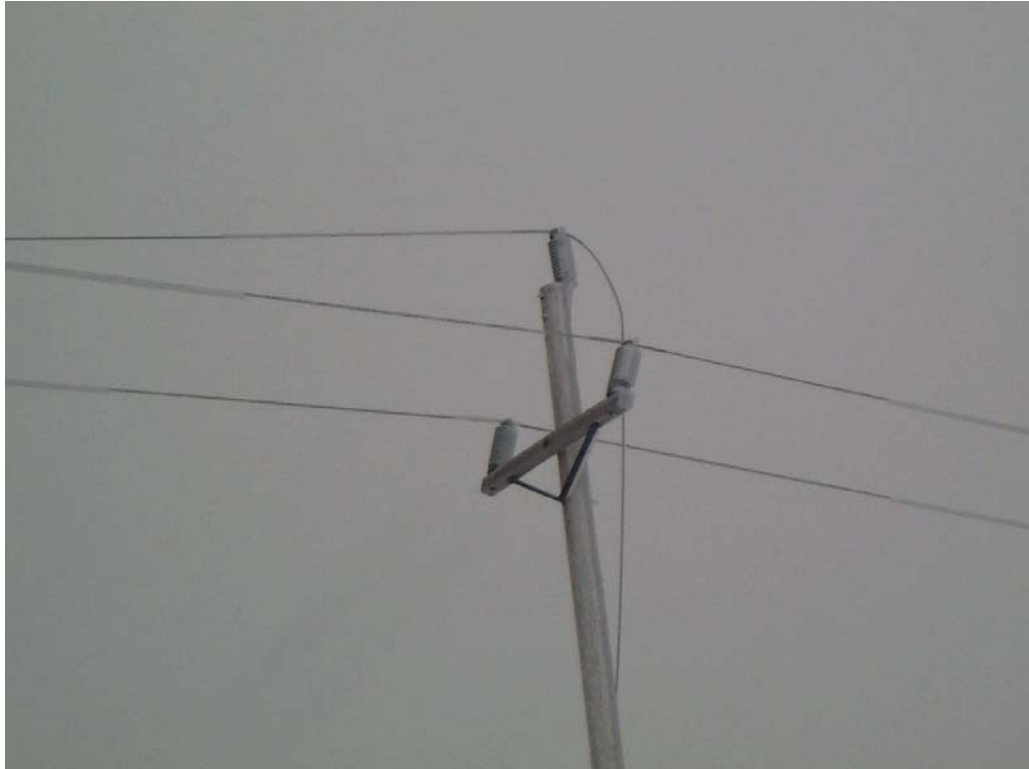
**Figure 7 - Broken conductor - ice build up December 2003 110L**

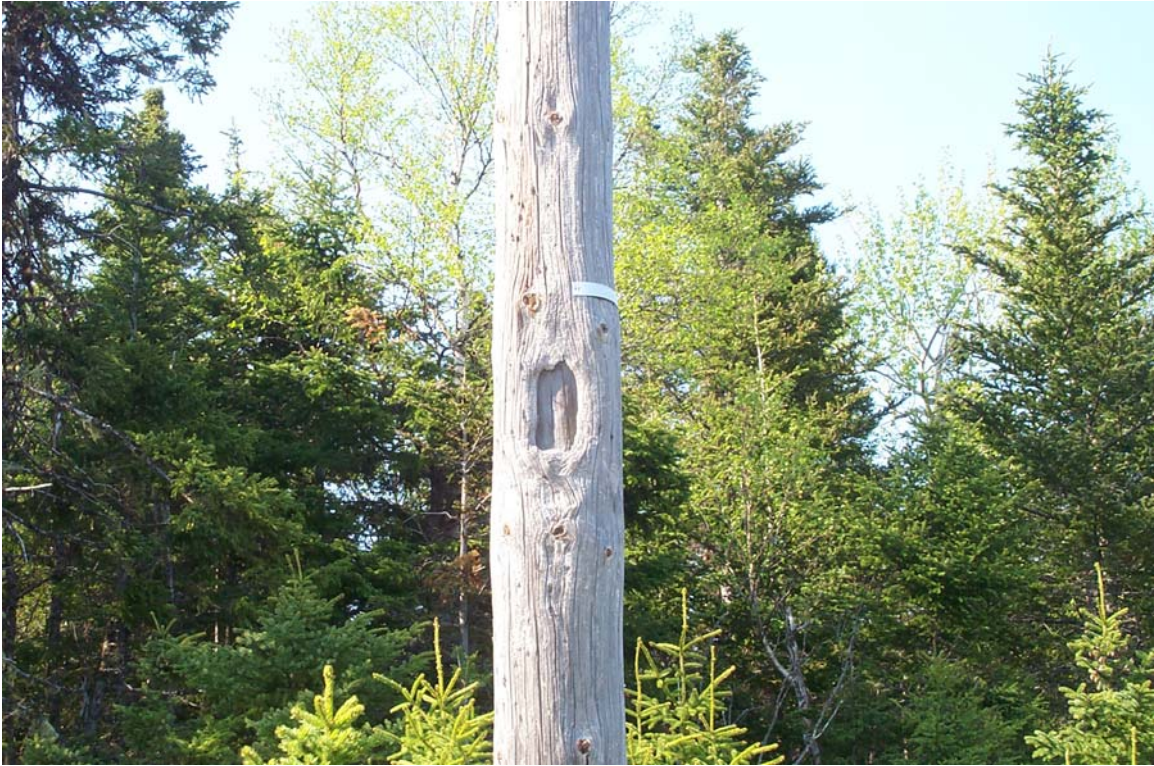
**Figure 8 - Deteriorated pole 110L**

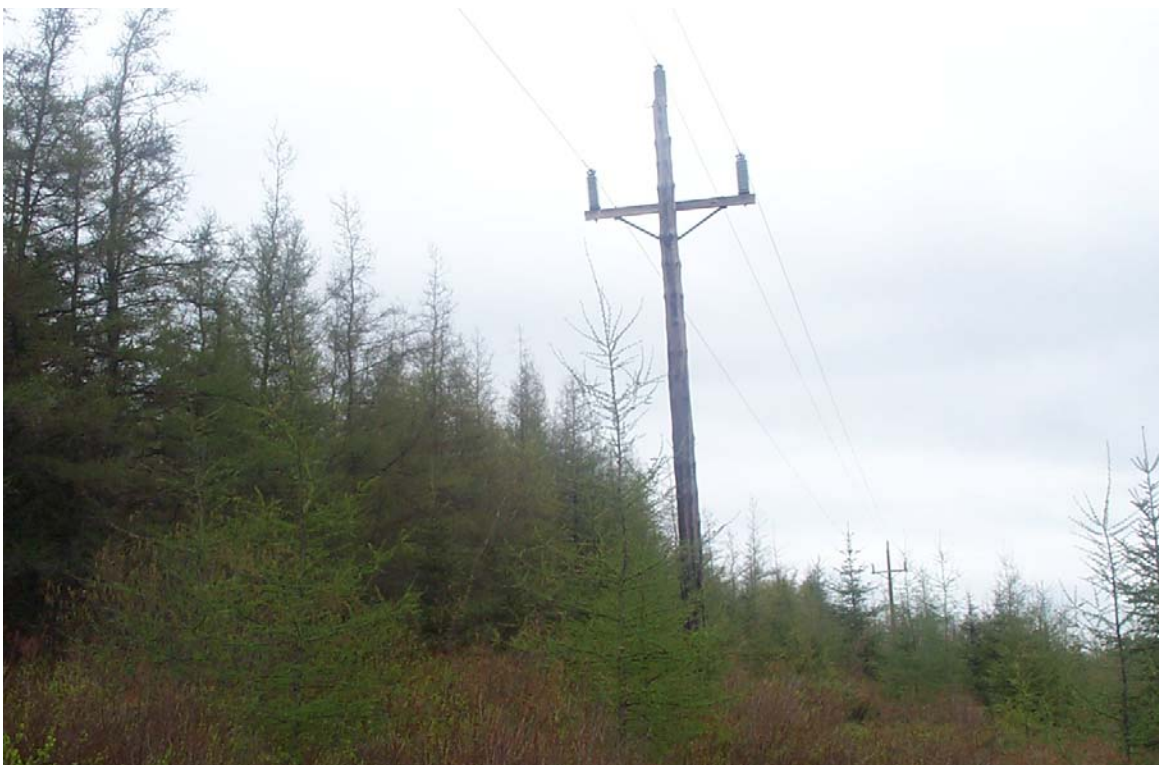
**Figure 9 - Deteriorated pole 110L**

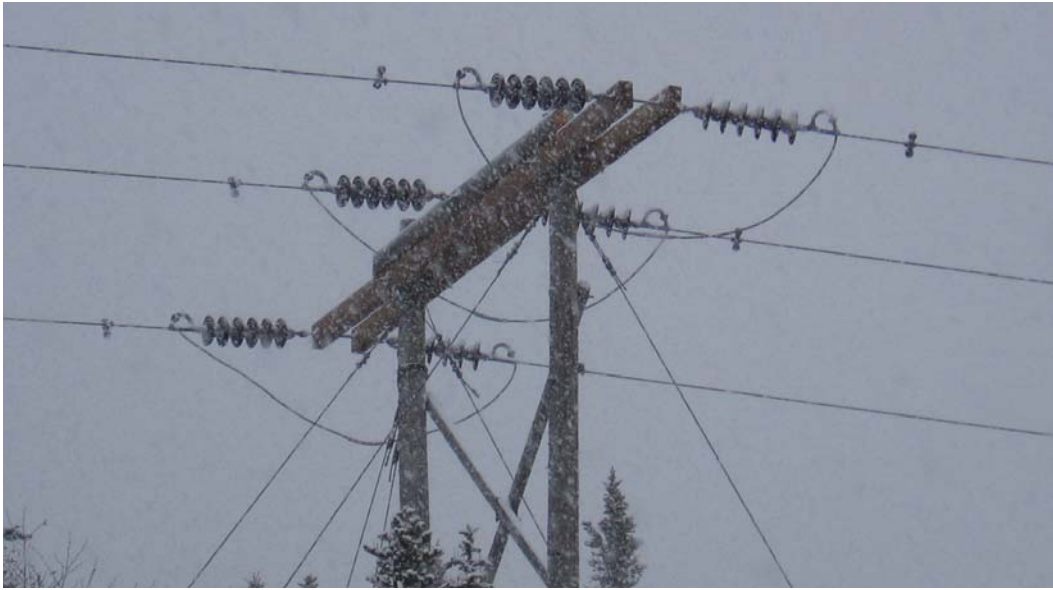
**Figure 10 - Temporary Repair 20L**

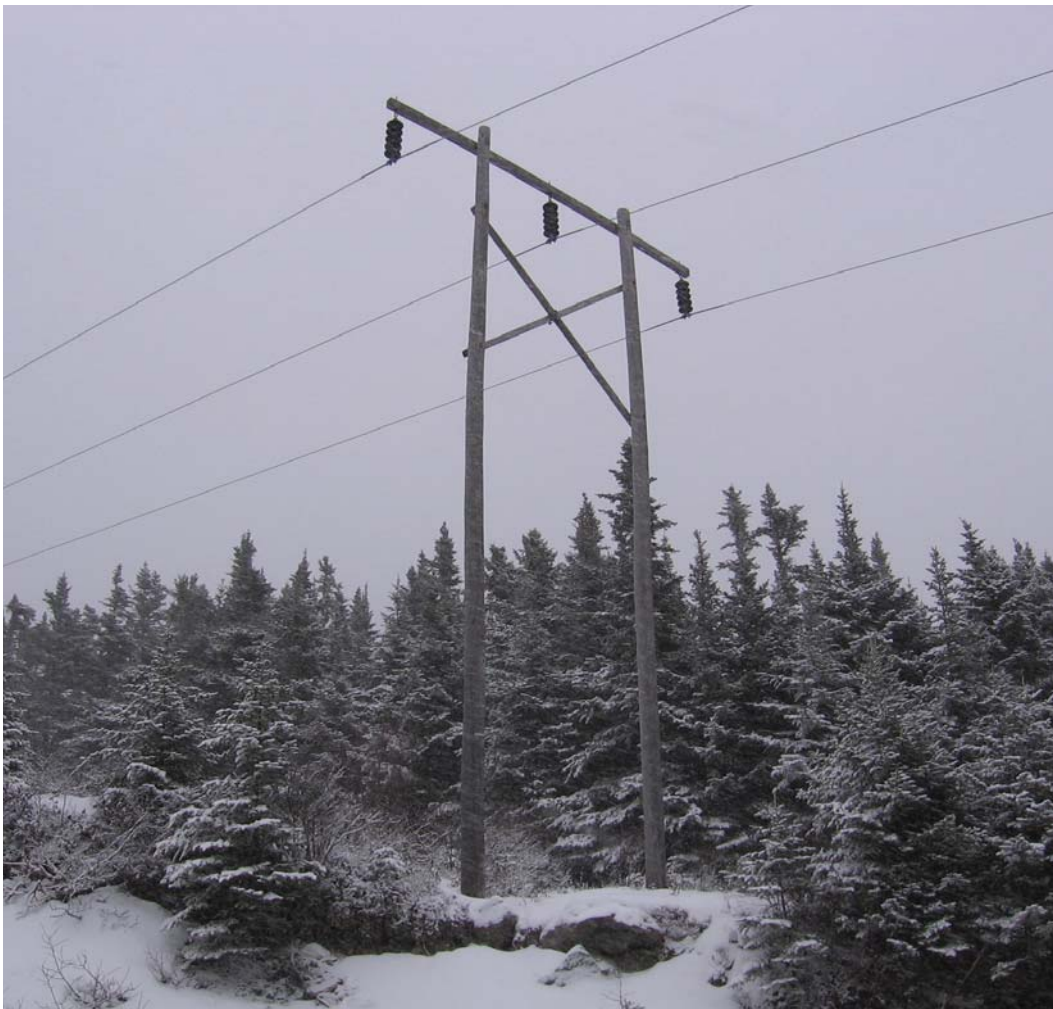
**Figure 11 - Erosion 20L**

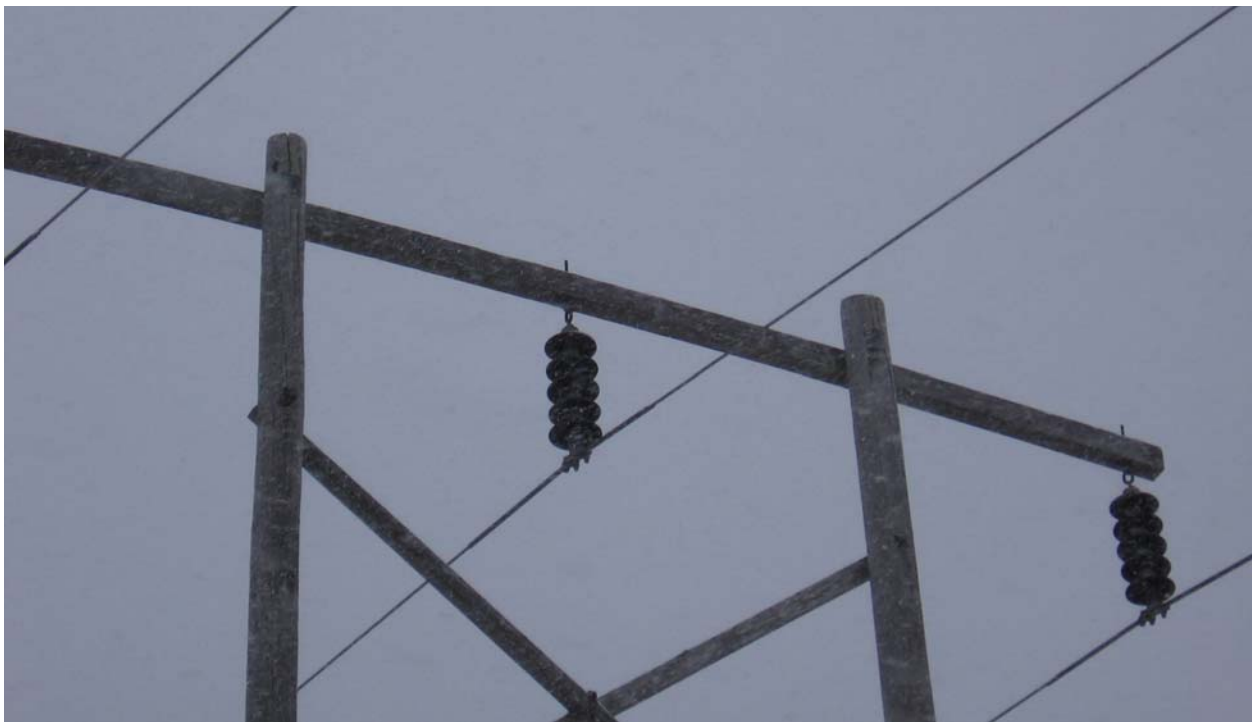
**Figure 13 - Deteriorated Poles (top split) 20L**

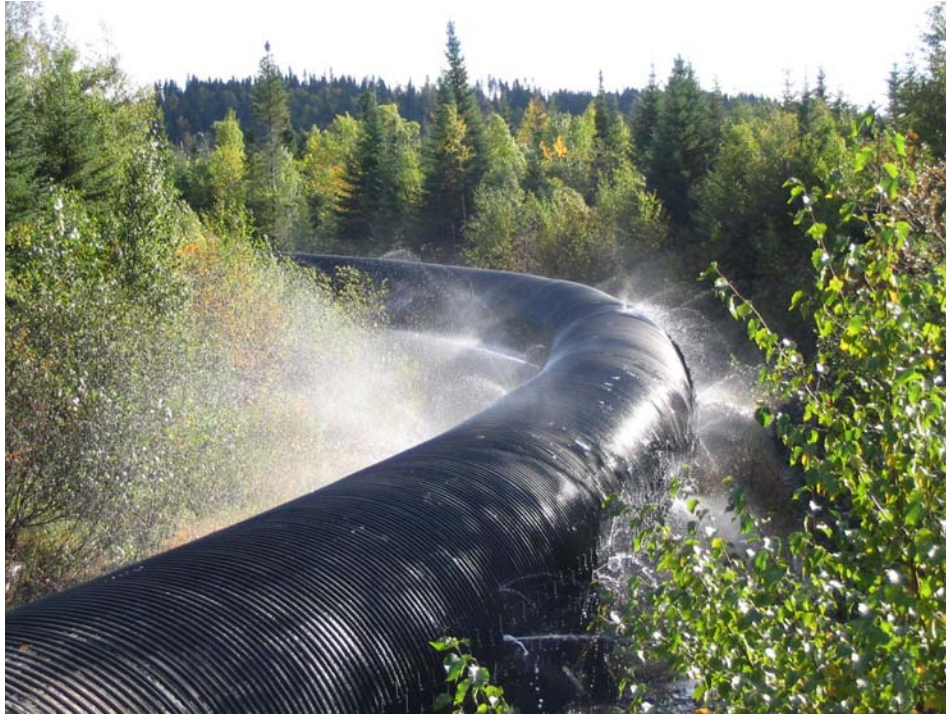
**Figure 5: Water Leakage from Penstock**

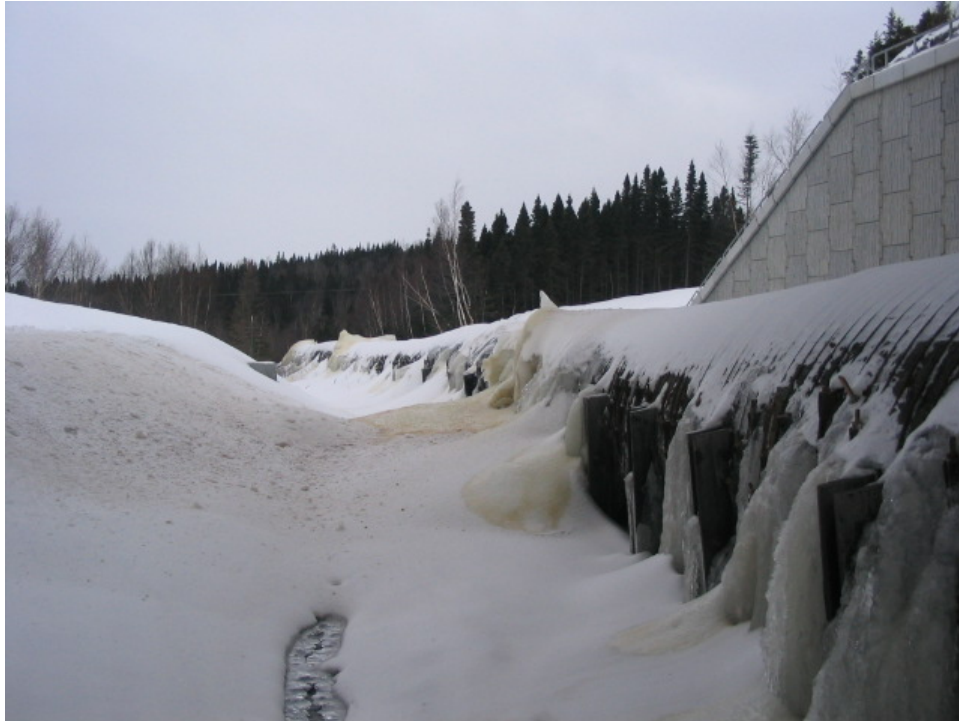
**Figure 10: Ice Forming on Penstock during Winter**

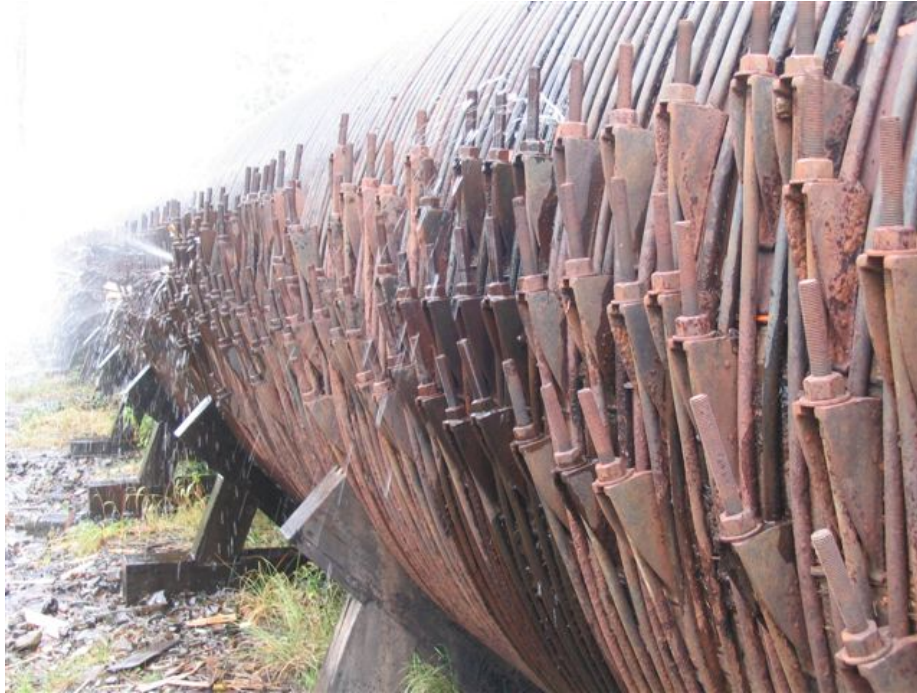
**Figure 16: Leakage at Lower Section of Penstock**

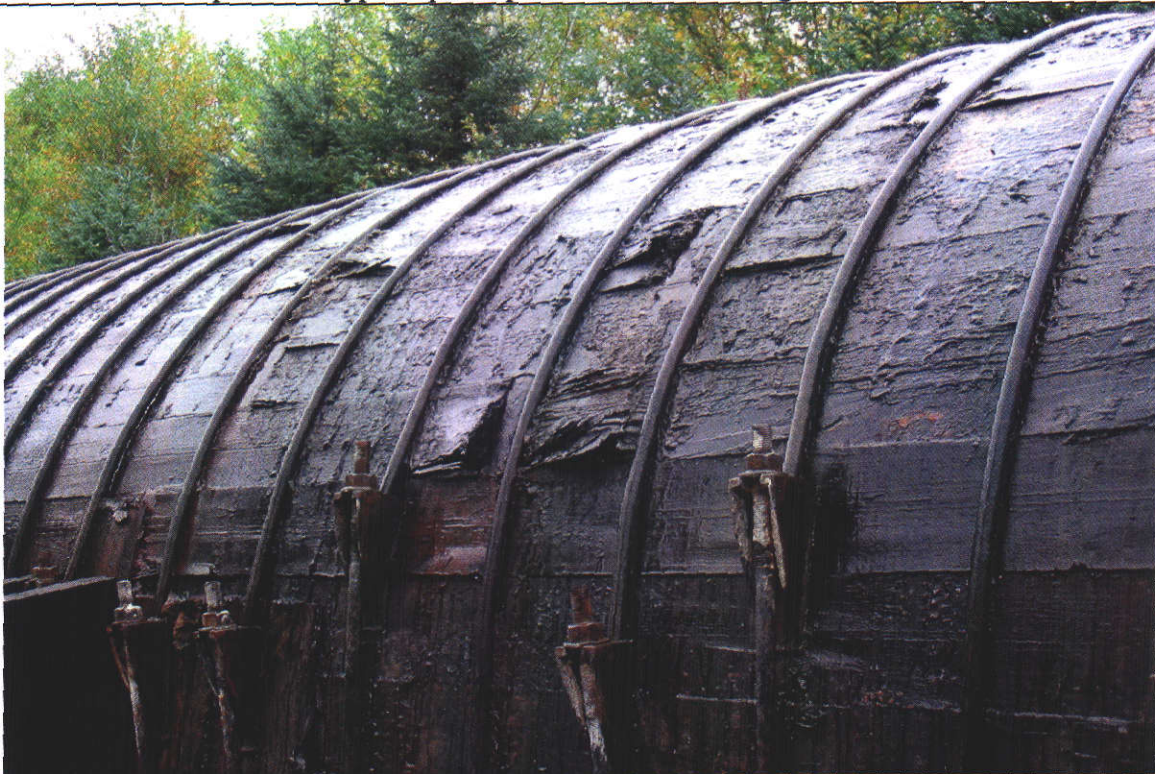
16. Wood stave penstock surface condition.

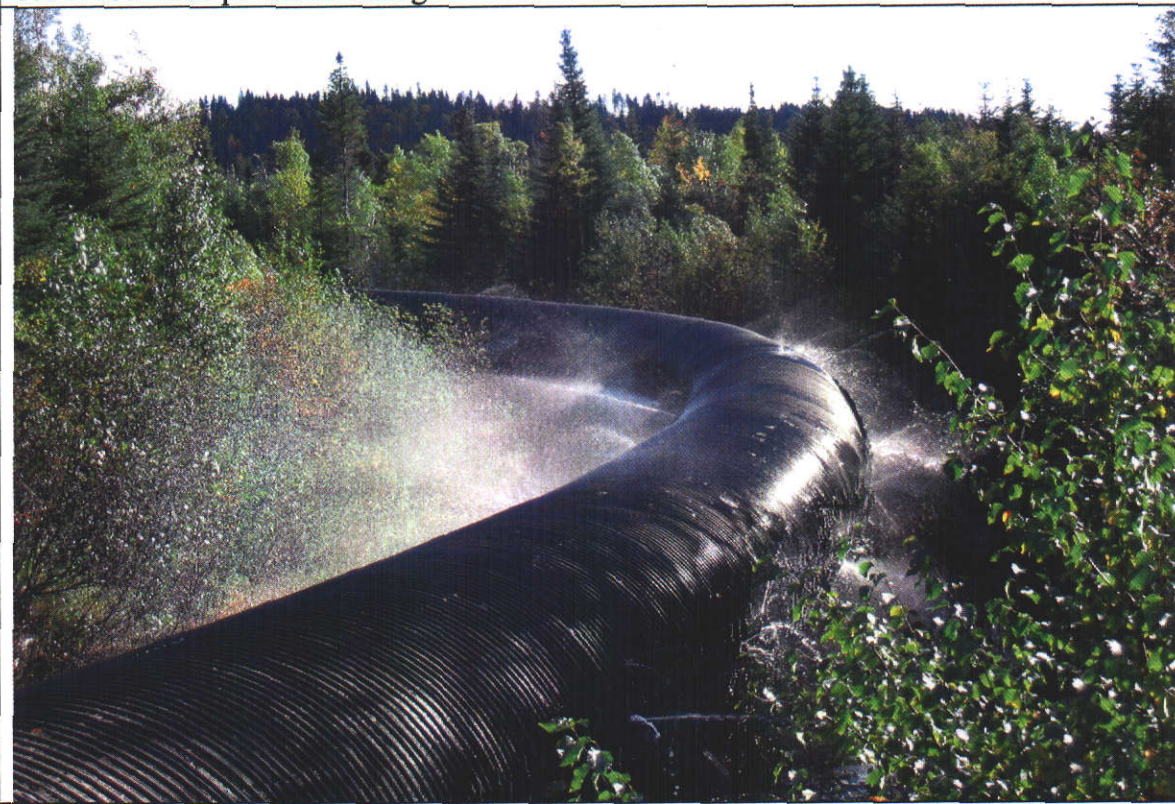
18. Wood stave penstock leakage.

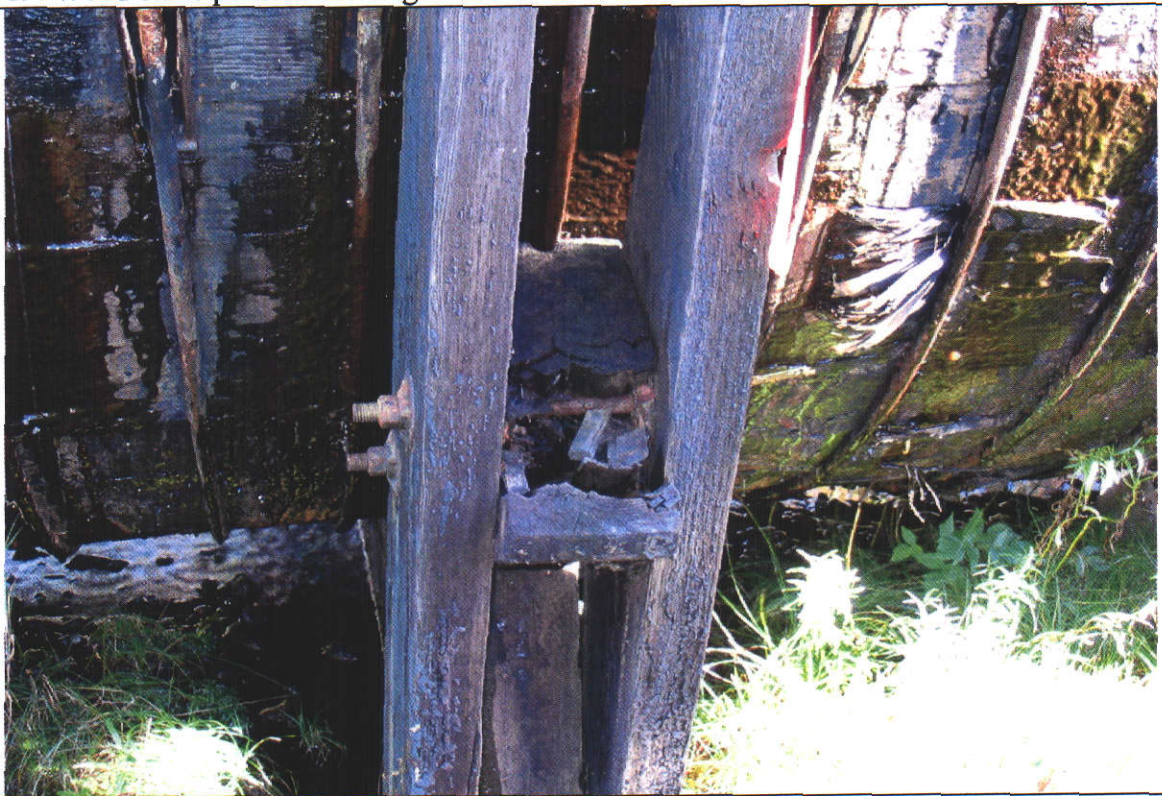
20. Wood stave penstock saddle deterioration.

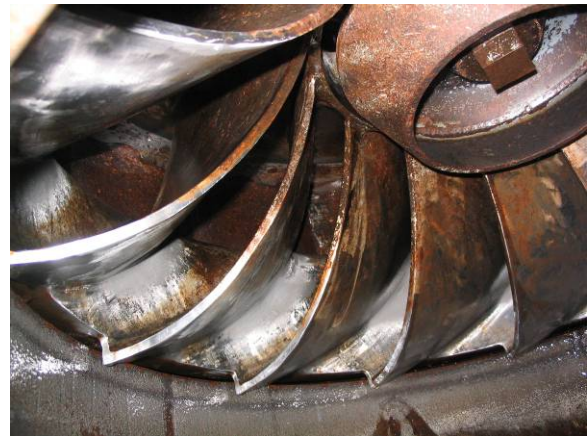
All but two wicket gates are in good condition. These two gates are located near the 2<sup>nd</sup> and 3<sup>rd</sup> stay vanes, counting from the area near the scroll case access hatch. These gates will be repaired as a temporary measure until the unit is overhauled in about 2012.

**Figure 8 – Turbine Blades Unit No. 1**
