Root Cause Analysis Report

Bay d'Espoir Penstock No. 1 Refurbishment

H352666-00000-220-066-0002

March 17, 2017

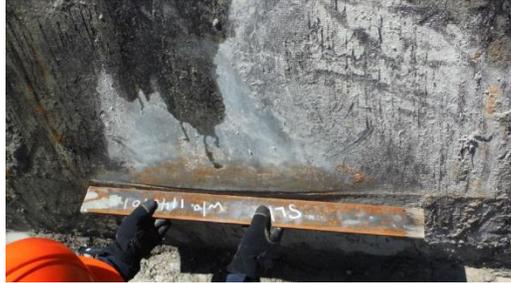
Difficulties with lining up the longitudinal seams at the time of construction in the 1960s are evident when examining the internals of the penstock and seeing evidence of extensive dogging¹ of the joints to bring the longitudinal seams together. The flat spots and induced stress from fitting the straight ends increase the residual stress at the joints. Below is an image of the longitudinal seam that failed in September. Large amounts of peaking were observed at the initial crack location, see Figure 3-2, and this would mean the weld was resisting significant residual stresses to maintain a round shape at the seam. The increased stress also makes the longitudinal joints more susceptible to material loss as they become sensitized to corrosion.

Figure 3-2: Longitudinal Weld Failure Showing Peaking

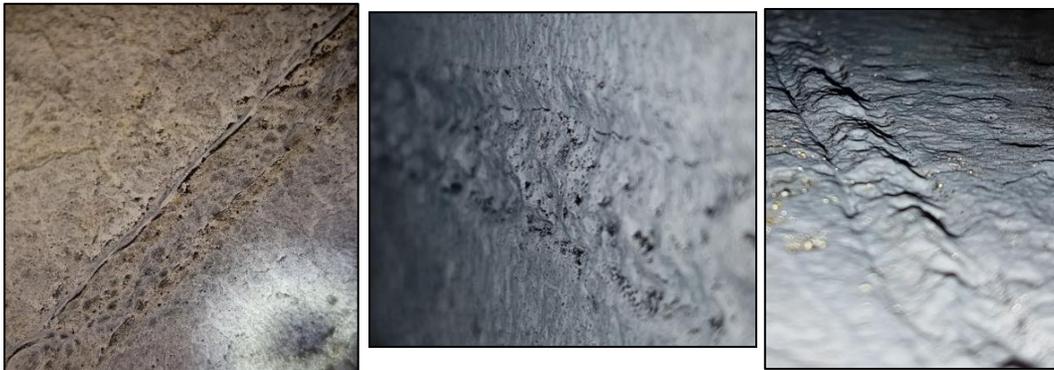
Throughout the upper section of the penstock it was noted that longitudinal seams were experiencing extensive pitting corrosion, material loss and well defined notches along the heat affected zone of the welds. This excess material loss and notching contributes to high stresses, crack initiation and propagation. Refer to Figure 3-3 and Figure 3-4 for images of the notching, excessive pitting corrosion, and material loss.

Figure 3-3: Longitudinal Seams in Penstock No.1 Section 16

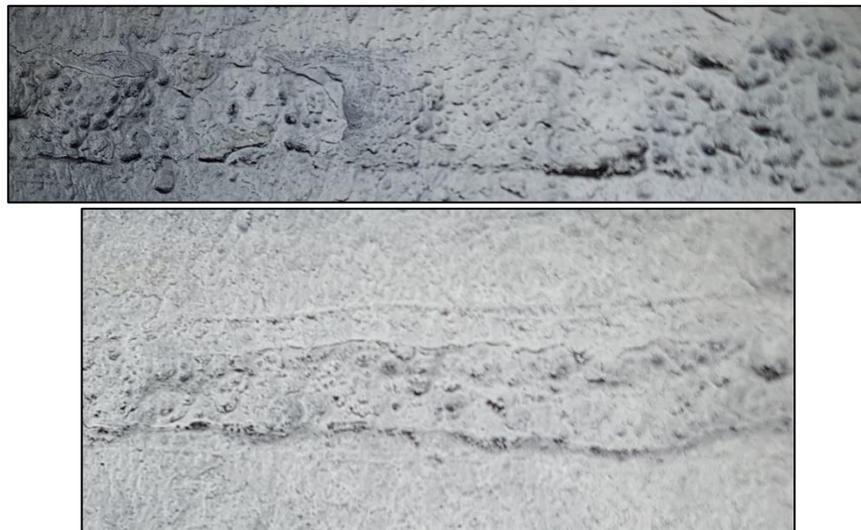
Figure 3-4: Longitudinal Seams in Penstock No.1 Section 16

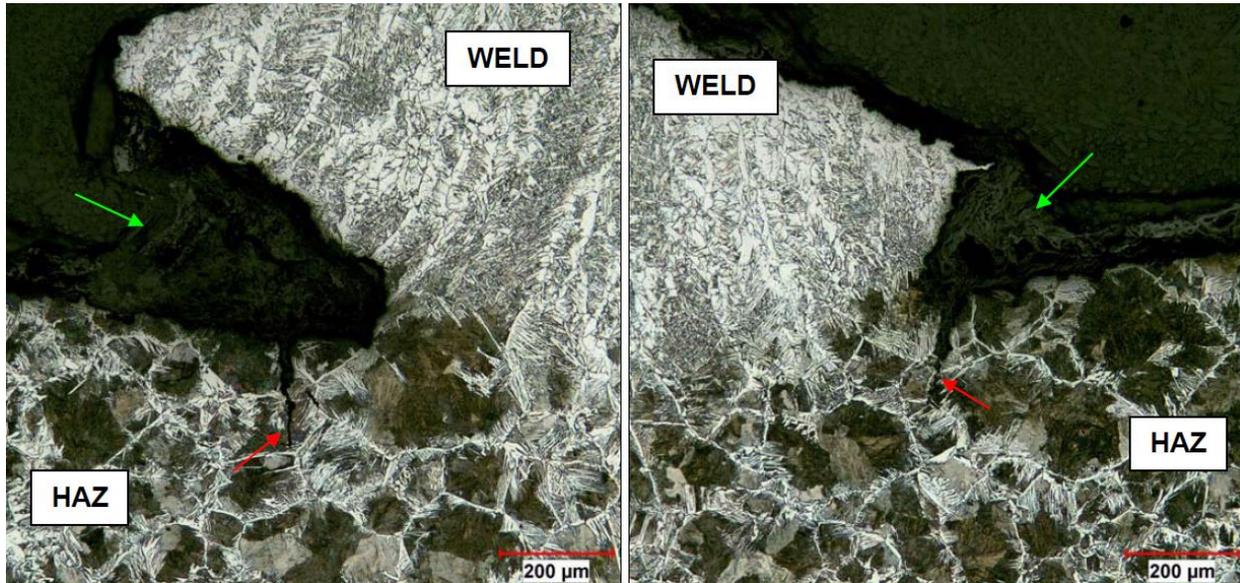
As indicated in the attached reports, both the weld metal and parent metal are high in Sulphur. High amounts of Sulphur, by itself, can produce porosity in the weld metal and heat affected zones, primarily at the surface. Surface porosity is one of the main contributors to pitting corrosion. The presence of pitting corrosion would accelerate the effects of preferential corrosion and stress corrosion cracking.

Figure 3-5: Coupon #1 Micro of Heat Affected Zone Transgranular Cracks

The macroetch and microetch of coupon #1 (longitudinal) show surface pitting corrosion and advanced stages of preferential pitting corrosion with cracks initiated from the cavities and are progressing through the heat affected zone.

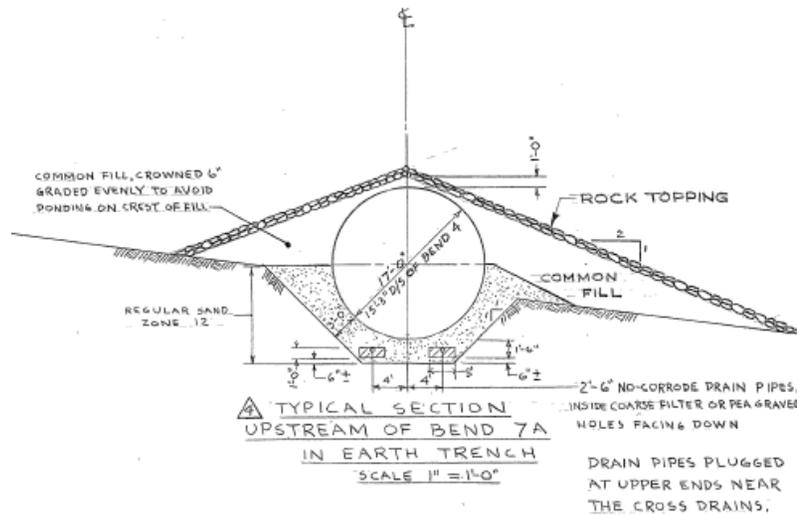
The "As Built" drawing shows a detail that has cover thicknesses in multiple locations below 1 ft.

Figure 3-8: Drawing Half Trench as per "As Built" Drawing

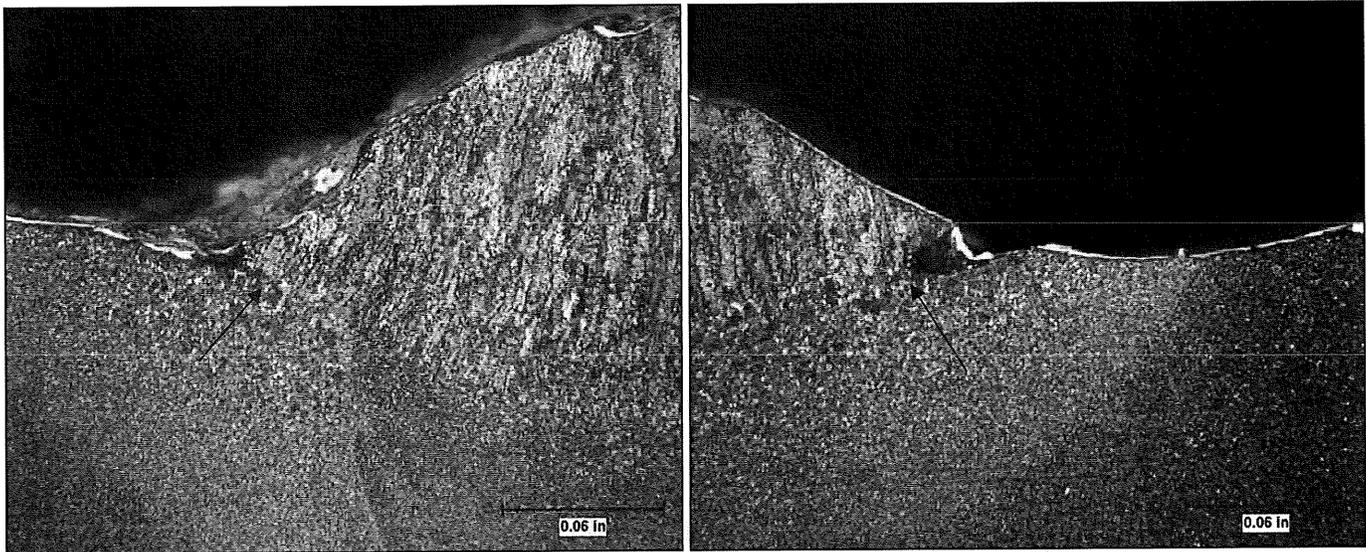
Figure 3: Photomicrographs of the Section 1. The discontinuities at the toes of the weld were revealed to be cracks propagating along the fusion line of the weld (red arrows).

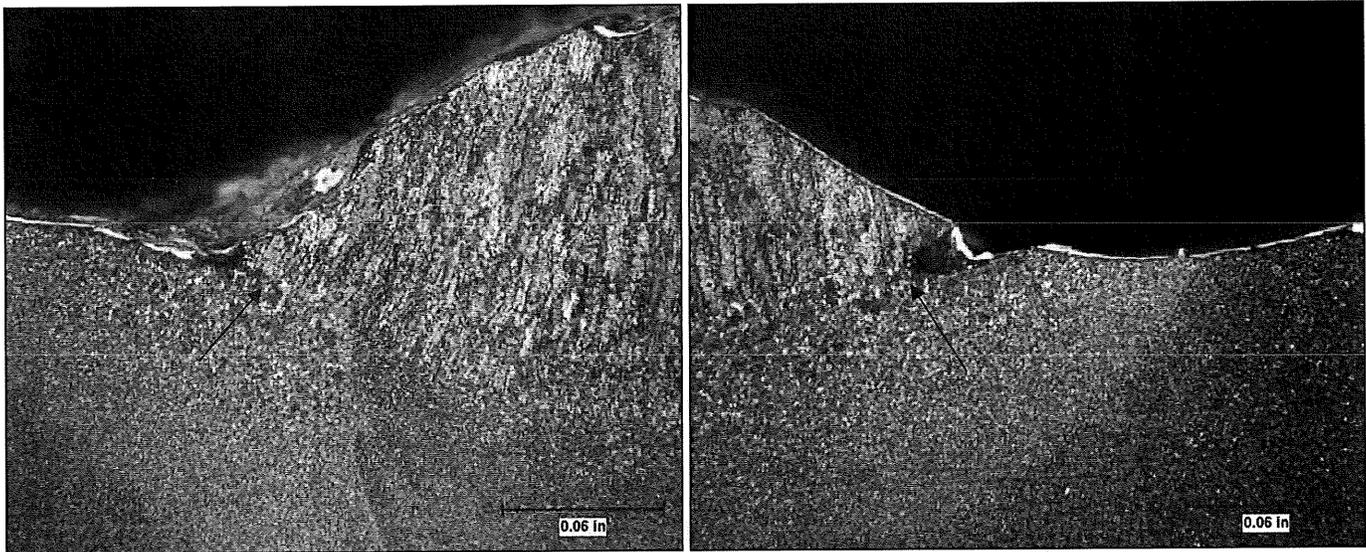
Figure 3: Photomicrographs of the Section 1. The discontinuities at the toes of the weld were revealed to be cracks propagating along the fusion line of the weld (red arrows).

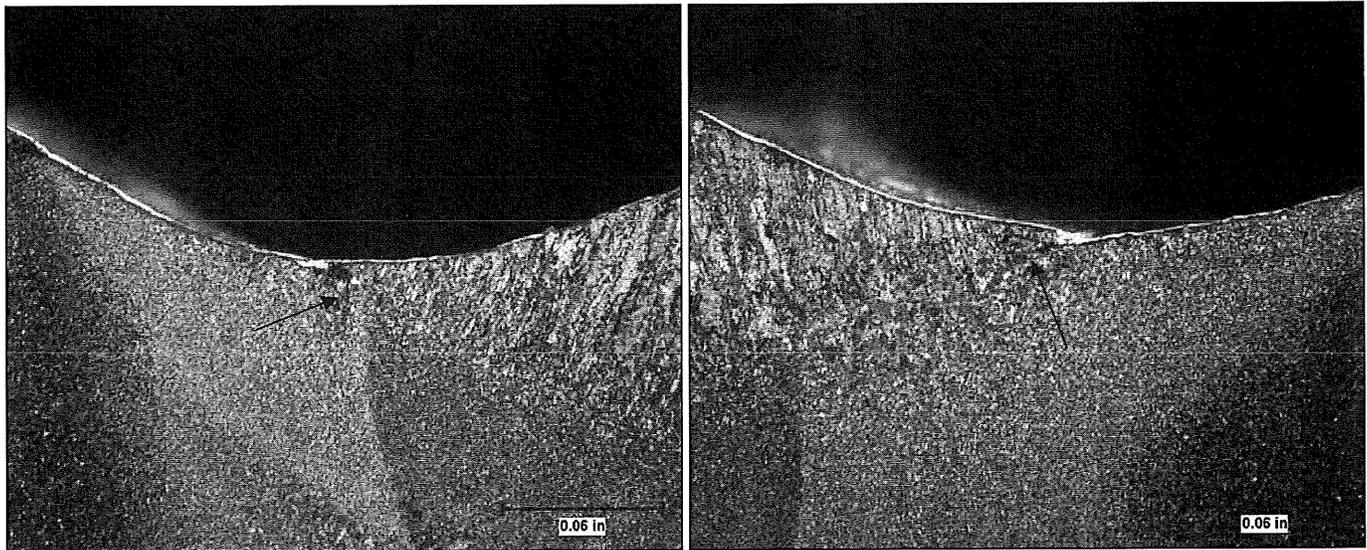
Figure 5: Photomicrographs of the Section 2. The discontinuities at the toes of the weld were revealed to be cracks propagating along the fusion line of the weld (red arrows).

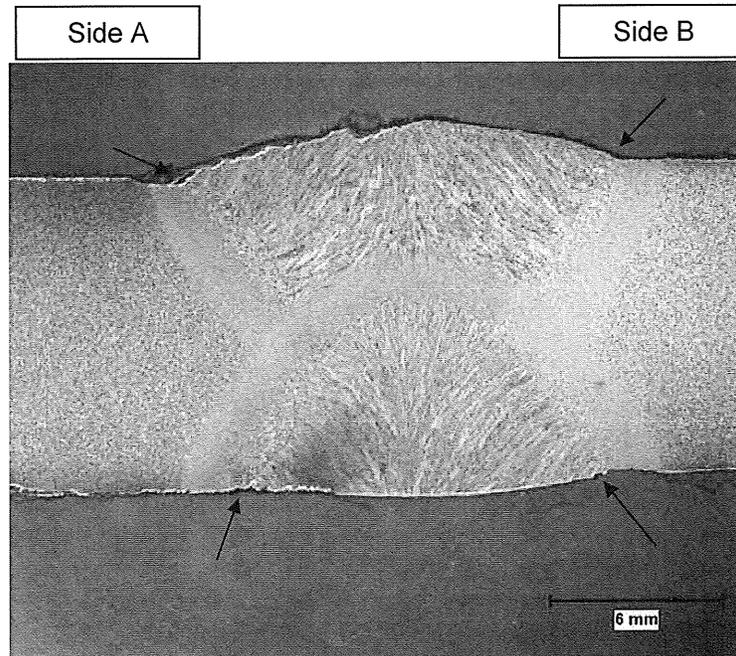
Figure 2: Photomicrograph of the Section 1, showing the pitting along the surface within the HAZ/at the weld toes.

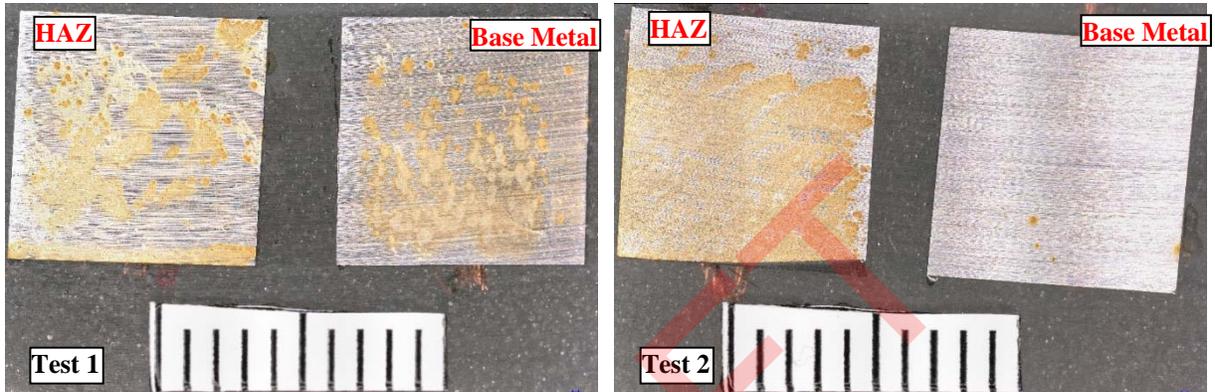
Figure 2. Low magnification morphology of HAZ/BM couple Sample 1.

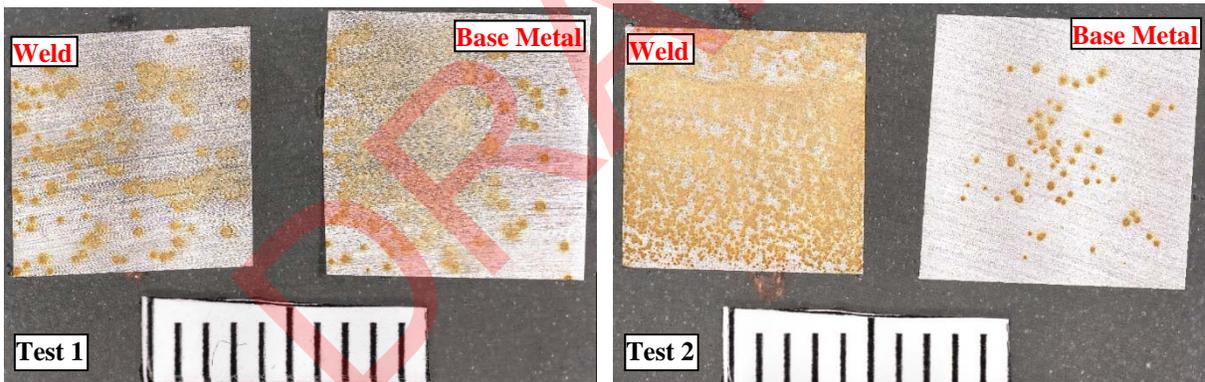
Figure 3. Low magnification morphology of WELD/BM couple Sample 1.

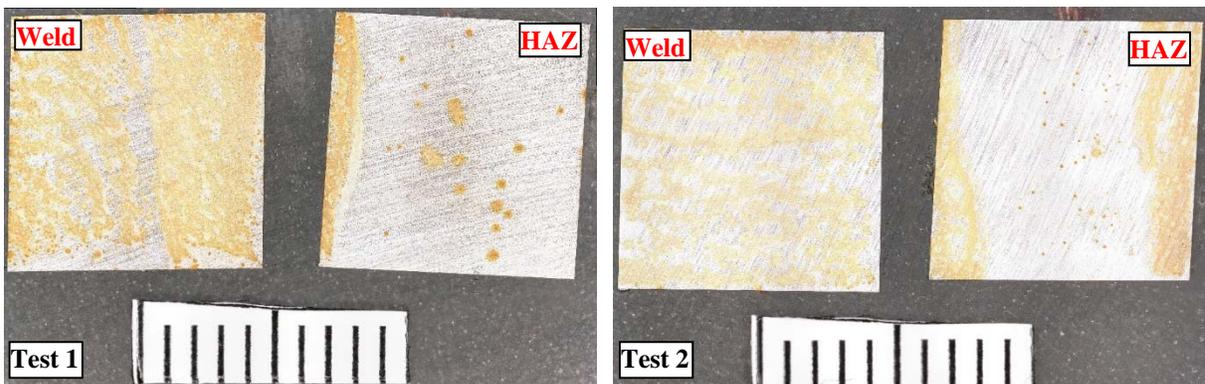
shown in Figure 4, HAZ was protected in both tests against the WELD. Based on the observations, it can be suggested that the weld has the least corrosion resistance in the galvanic setup and BM shows the best corrosion resistance.

Figure 4. Low magnification morphology of WELD/HAZ couple Sample 1.

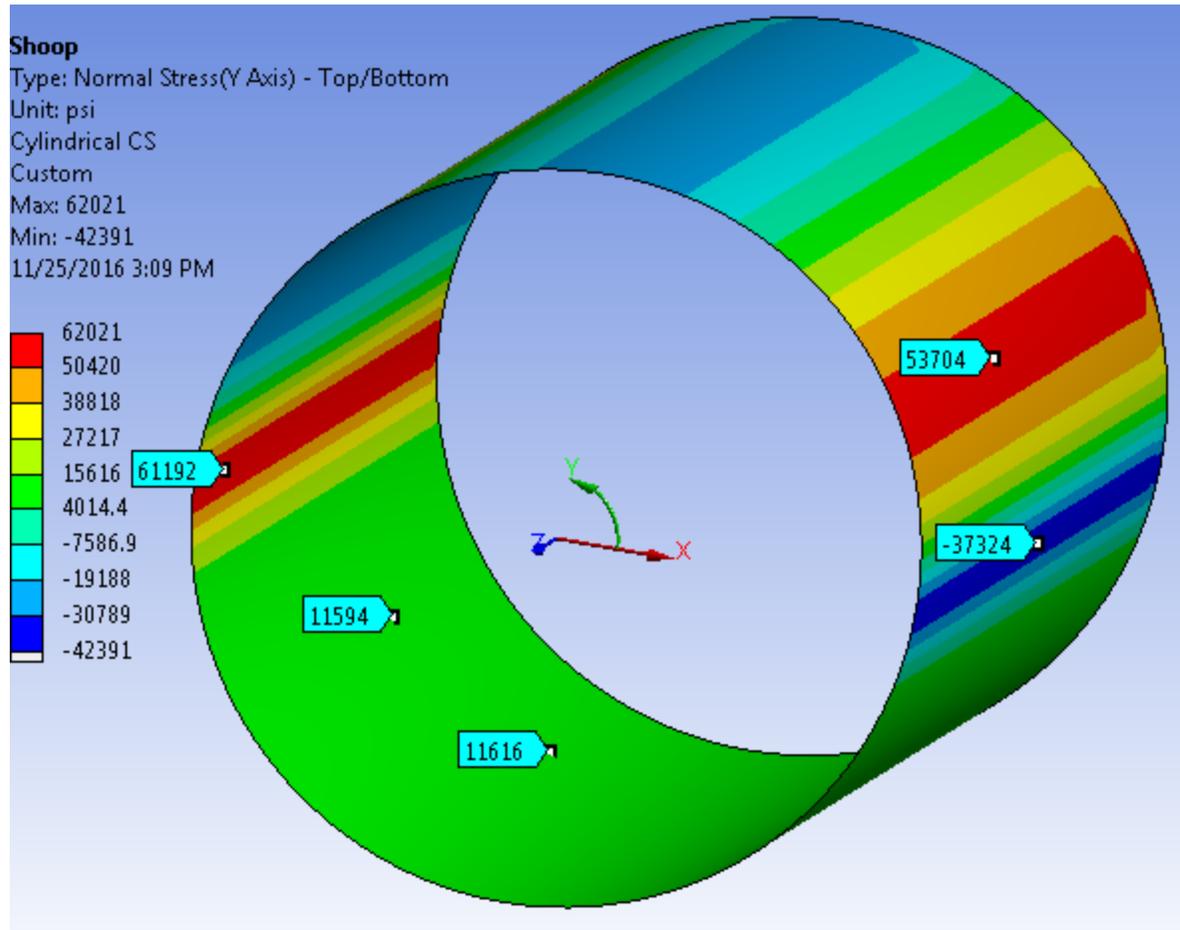
Figure 17: LS1 - Total hoop stress. Allowable for continuous plate $S_{a|A285I} = 30000 \cdot \text{psi}$. 100% overstress, more if longitudinal welded joint efficiency at 3 and 9 o'clock is taken into account.

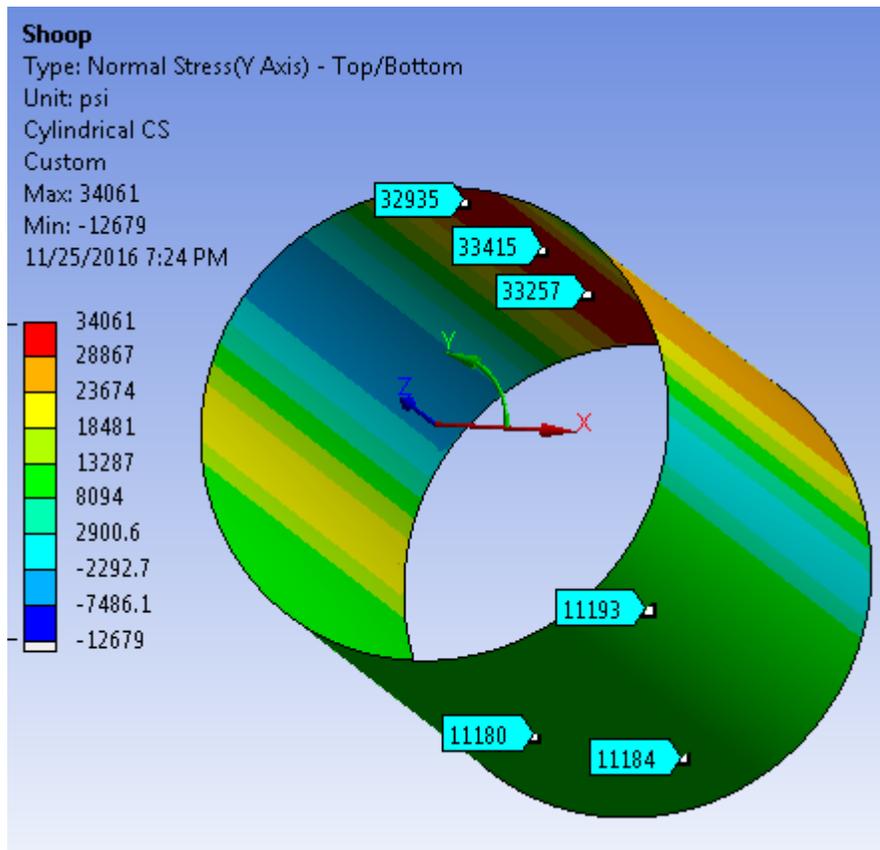
Figure 19: LS2 - Total hoop stress. Allowable for continuous plate $S_{a|A285I} = 30000 \cdot \text{psi}$. 12% overstress.

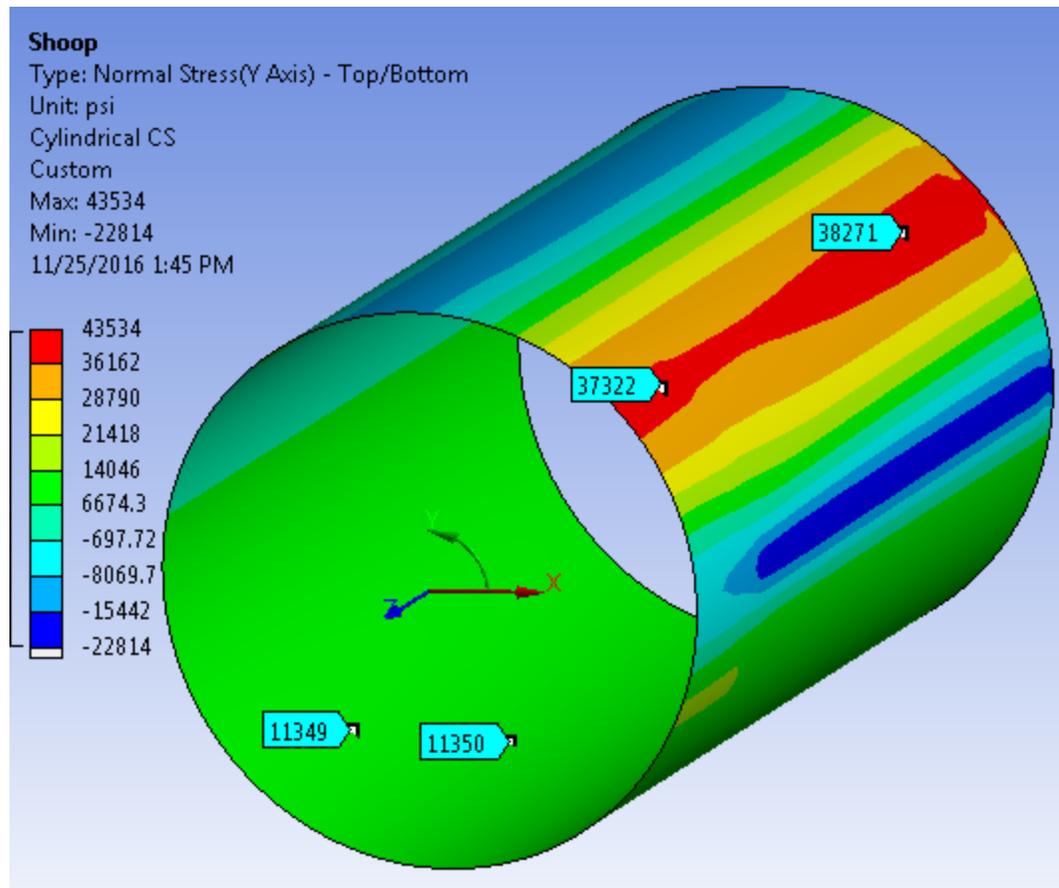
Figure 21: LS3 - Total hoop stress. Allowable for continuous plate $S_{a|A285I} = 30000 \cdot \text{psi}$. 45% overstress, more if longitudinal welded joint efficiency at 3 o'clock is taken into account.

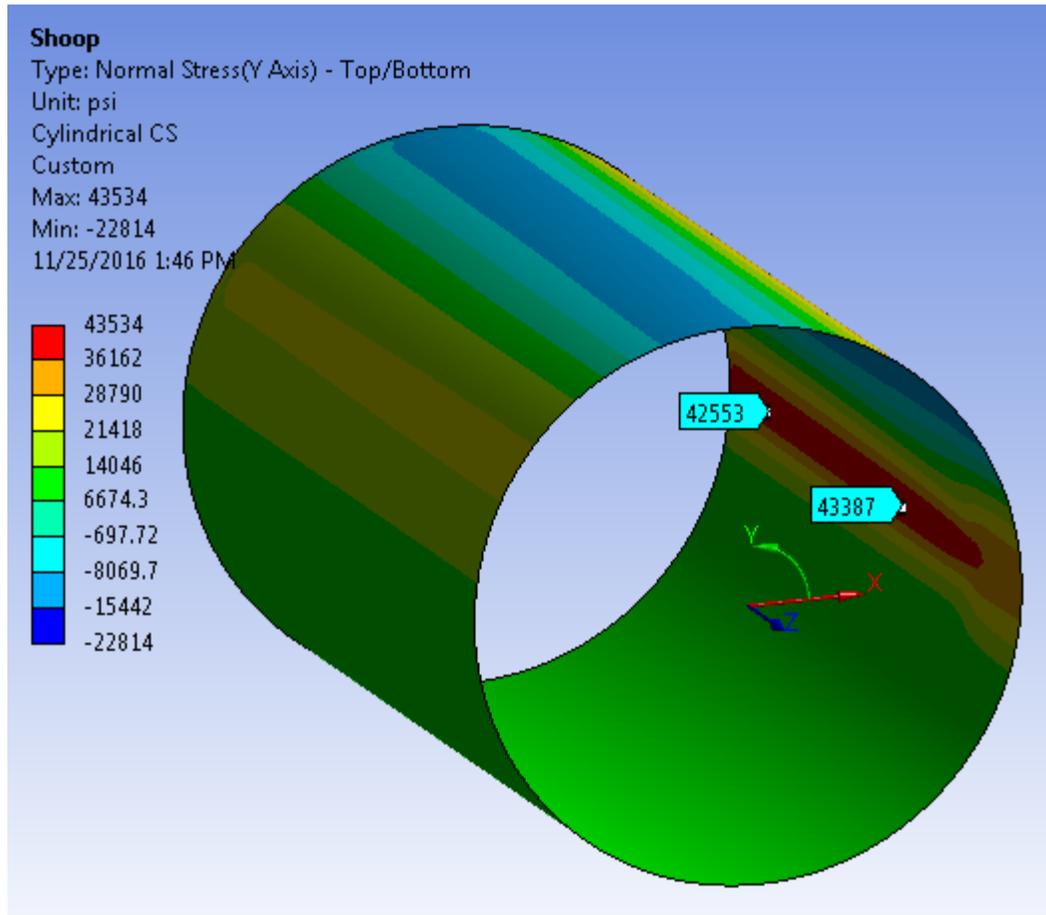
Figure 22: LS3 - Total hoop stress. Allowable for continuous plate $S_{a|A285I} = 30000 \cdot \text{psi}$. 45% overstress, more if longitudinal welded joint efficiency at 3 o'clock is taken into account.
