Re: An Application by Newfoundland and Labrador Hydro (Hydro) for approval of Reliability Improvements at the Holyrood Thermal Generating Station.

2017 Reliability Improvements Holyrood Thermal Generating Station

April 17, 2017

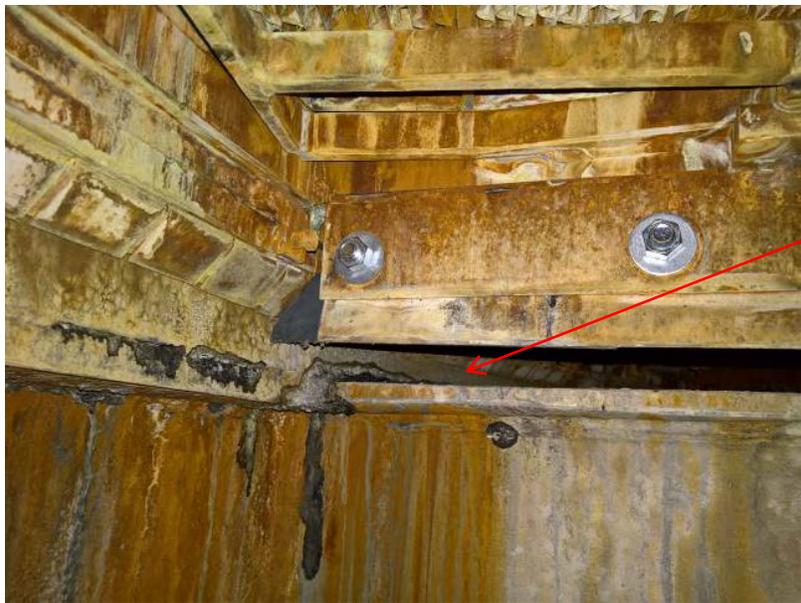
Figure 1: Boiler Air Heater Excessive Seal Clearance

3
4 During the annual Unit 1 and 2 outages in the summer and fall of 2016, Hydro contracted
5 Howden North America Inc. (Howden), the boiler air heater original equipment manufacturer
6 (OEM), to complete condition assessments on the air heaters to determine the cause of the de-
7 rating on Units 1 and 2 and make recommendations for future work necessary to ensure
8 reliable operation. Condition assessment reports were submitted to Hydro in October 2016 (the
9 Howden Reports). As referenced in Appendices A and B, the Howden Reports indicate that the
10 Units 1 and 2 boiler air heater radial and circumferential seal clearances are excessive due to
11 corrosion resulting in air leakage and recommend a replacement of the seals and sector plates
12 to restore the clearances to OEM specifications. Air heater excessive seal clearance is shown in
13 Figure 1.

Excessive Seal
Clearance
Contributing to
Air Leakage

14
15 To correct this air leakage, it is necessary to install liners on the sector plates and replace the
16 rotor seals. A cross section of a boiler air heater is shown in Figure 12. There was insufficient
17 time in 2016 to action the work that was identified by Howden.

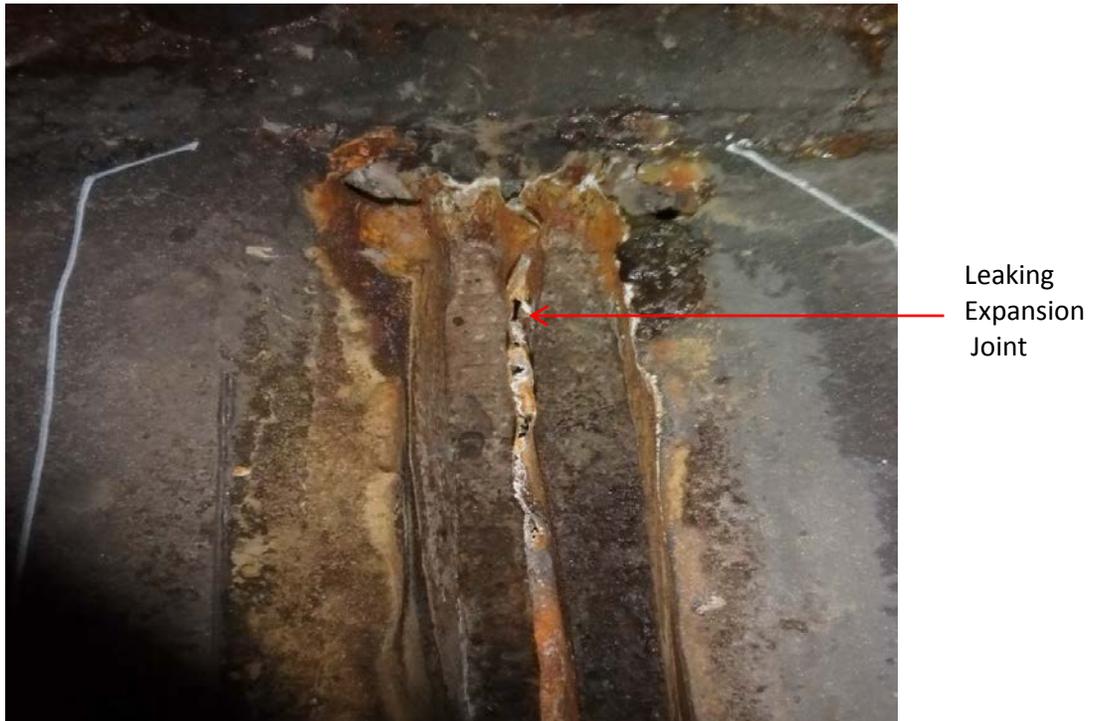
Figure 2: Boiler Ductwork Expansion Joint

1 Similarly, during the 2016 annual outages, Hydro contracted Babcock and Wilcox (B&W), the
2 boiler service provider, to complete a condition assessment on the combustion air ductwork
3 serving Units 1, 2, and 3 and the Unit 3 boiler air heaters. The B&W Condition Assessment
4 indicates that many of the ductwork expansion joints serving Units 1 and 2 have developed
5 holes due to erosion and corrosion and require replacement. Photos of leaking expansion joints
6 are shown in Figures 2, 3, and 4.

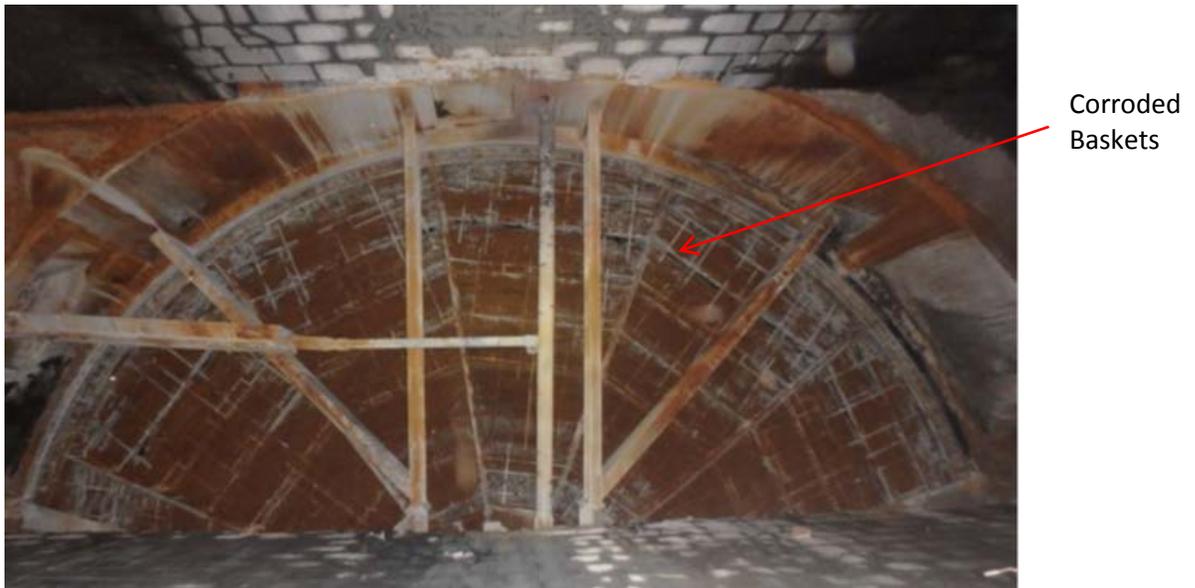
Figure 5: Unit 3 Boiler Air Heater Rotor

1 The B&W Condition Assessment also indicates that the Unit 3 boiler air heater baskets have
2 reached the end of life and require replacement. The baskets are extremely thin due to erosion
3 and corrosion and are dropping out of position on the rotor. Deteriorated baskets can increase
4 fouling and block air flow during operation causing air heater leakage and a reduction in
5 combustion air flow to the boiler. Air pressure drop across the boiler air heaters has been a
6 recent concern on Unit 3, indicating replacement is required this summer. Unit 3 has a
7 Maximum Continuous Rating of 150 MW. B&W indicates that if replacement of the air heater
8 baskets is delayed, there is a risk of de-rating Unit 3 due to boiler air flow issues. Photos of
9 deteriorated Unit 3 air heater baskets are shown in Figures 5, 6, and 7.

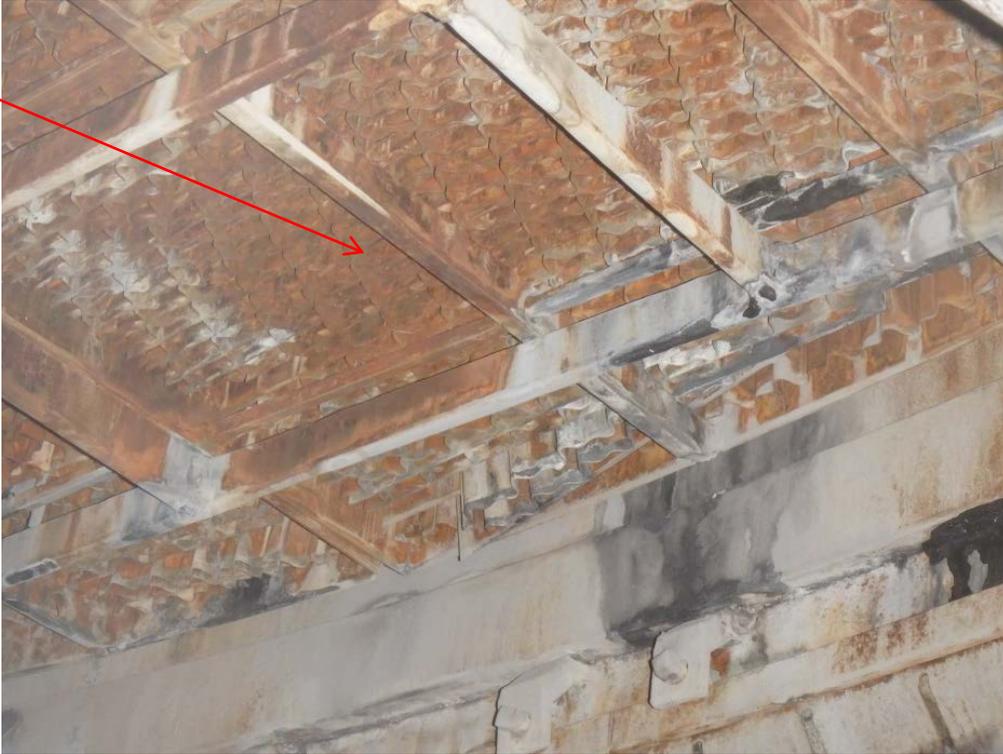
Figure 6: Deteriorated Unit 3 Air Heater Baskets

Corroded
Baskets

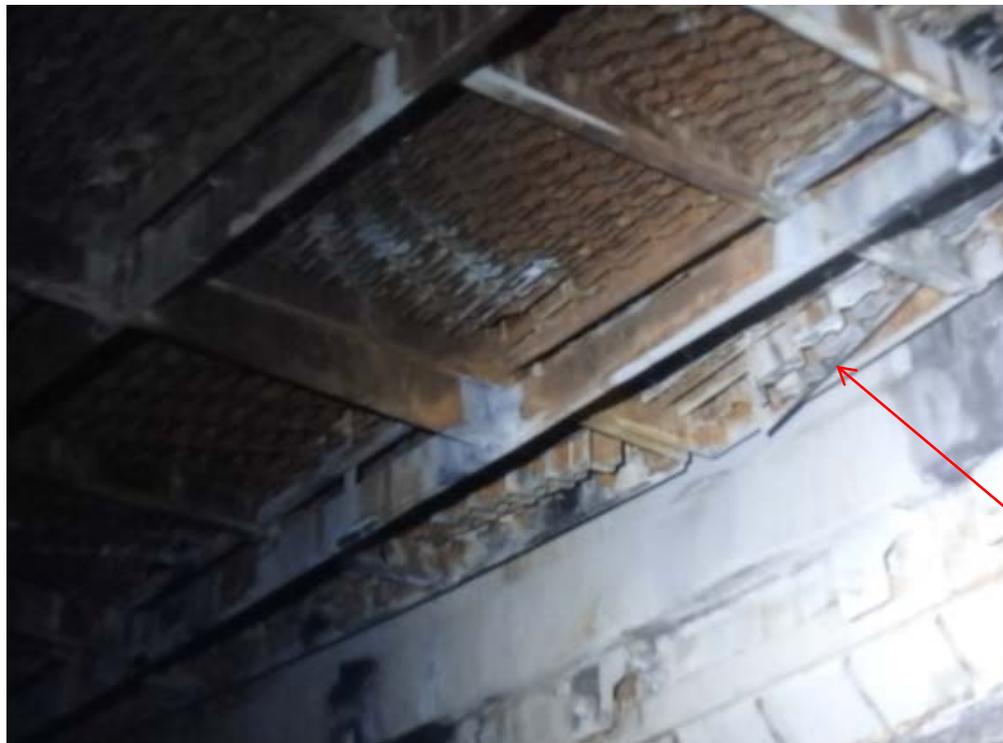
Figure 7: Deteriorated Unit 3 Air Heater Baskets

Corroded
Baskets
Dropping
Out of
Position

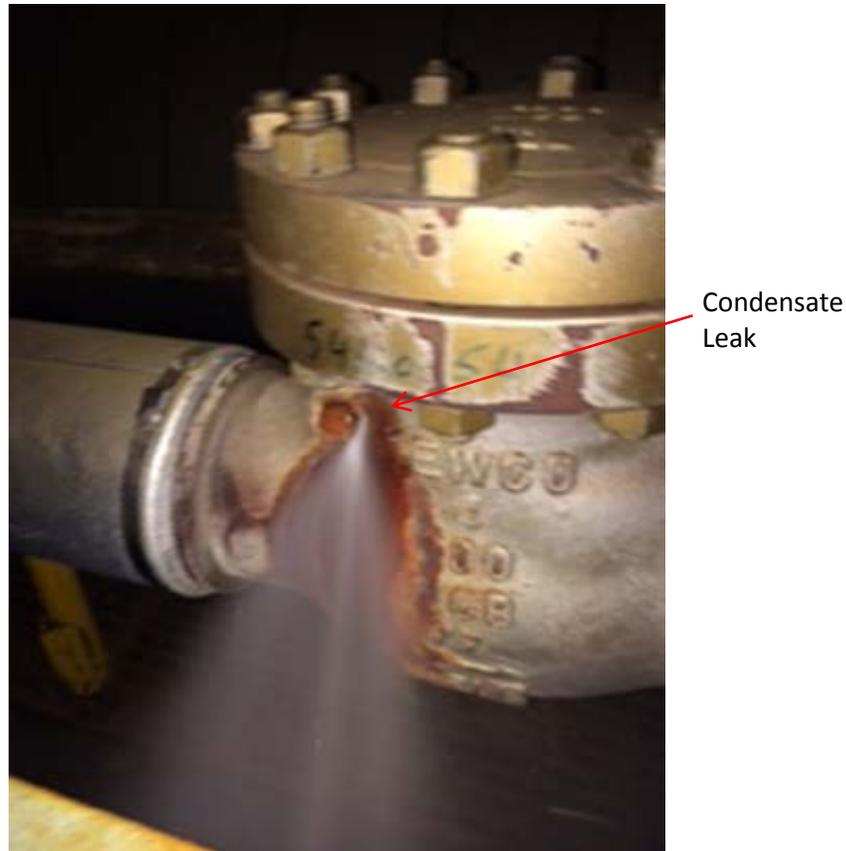
Figure 8: Leaking Valve

- 16 1. Valves. Hydro has identified a number of valves related to steam, boiler feed water and
17 compressed air systems that have reached the end of life and require replacement.
18 These valves are either leaking process fluid externally or are passing through internally
19 and can no longer provide isolations. A photo of a typical valve leaking condensate is
20 shown in Figure 8.

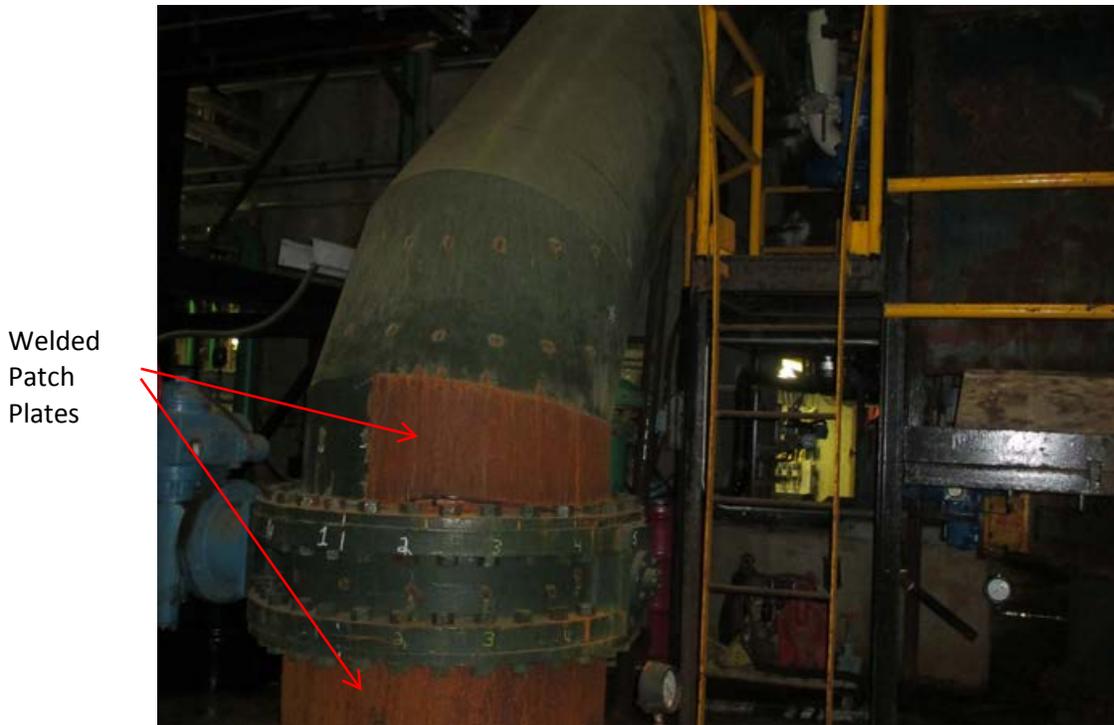
Figure 9: Condenser Cooling Water Piping

- 1 2. Turbine condenser cooling water piping. The Holyrood steam turbine condensers
- 2 utilize sea water to condense steam when it exits the low pressure stage of the turbine.
- 3 Cooling water enters the condenser on the bottom side via two (2) 36 inch diameter
- 4 steel pipes, condenses the turbine steam, and exits on the sides of the condenser. The
- 5 Unit 1 condenser cooling water outlet piping has reached the end of life due to
- 6 corrosion and requires replacement. A recent thickness survey indicates that he piping
- 7 has less than 1/3 of the original wall thickness remaining. In recent years, Hydro has
- 8 installed welded patch plates to repair leaks at a number of locations. Replacement is
- 9 now necessary to ensure reliable operation. Condenser cooling water outlet piping is
- 10 shown in Figure 9.

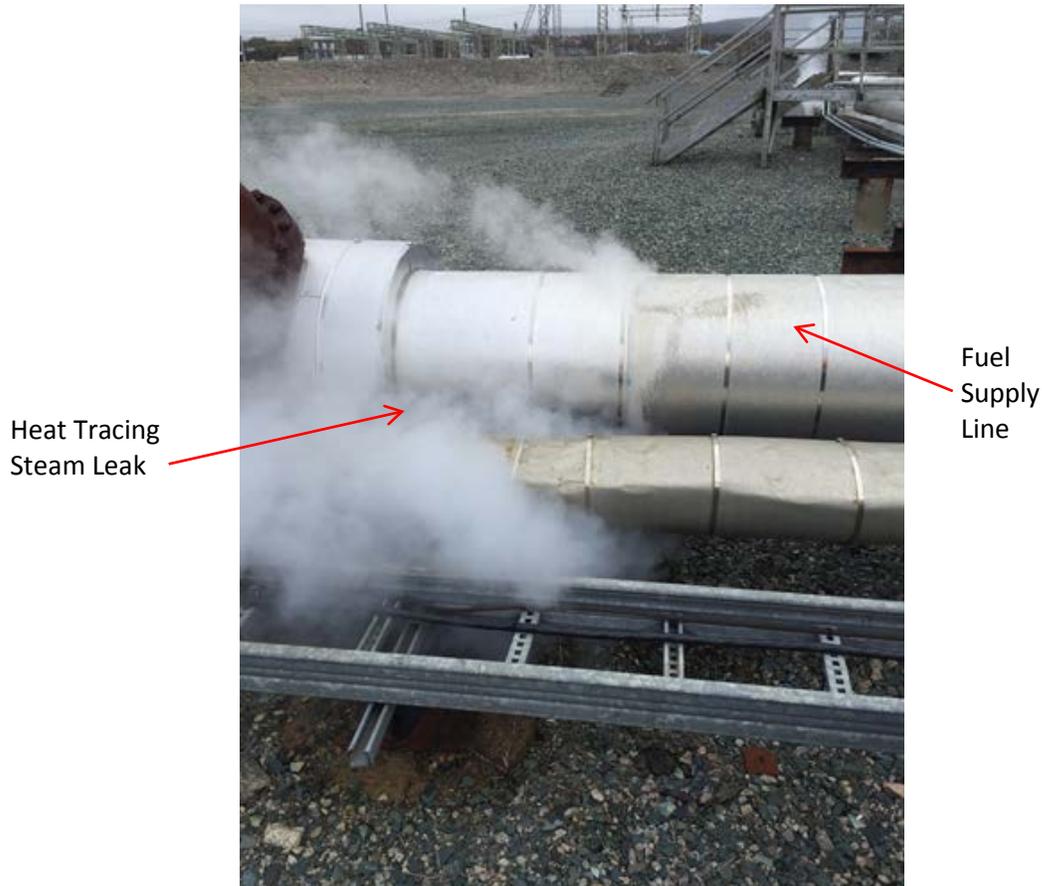
Figure 10: Steam Heat Tracing Failure

1 5. No.6 fuel oil steam heat tracing replacements. The fuel supply for Holyrood includes a
2 tank farm consisting of four (4) 250,000 barrel No.6 fuel oil storage tanks located to the
3 South of the plant. No.6 fuel oil is gravity fed to the plant from the tank farm via an 18
4 inch pipe. Steam heat tracing is used to heat the No.6 fuel oil to enable it to flow to the
5 plant and consists of a ¾ inch steam pipe that is attached to the 18 inch pipe line and
6 wrapped in external insulation. Many sections of the steam tracing have degraded over
7 time from erosion and corrosion and now require replacement. Hydro is proposing a
8 condition assessment of the steam heat tracing system and to complete targeted
9 replacements on sections that have reached the end of life. A section of failed heat
10 tracing is shown in Figure 10.

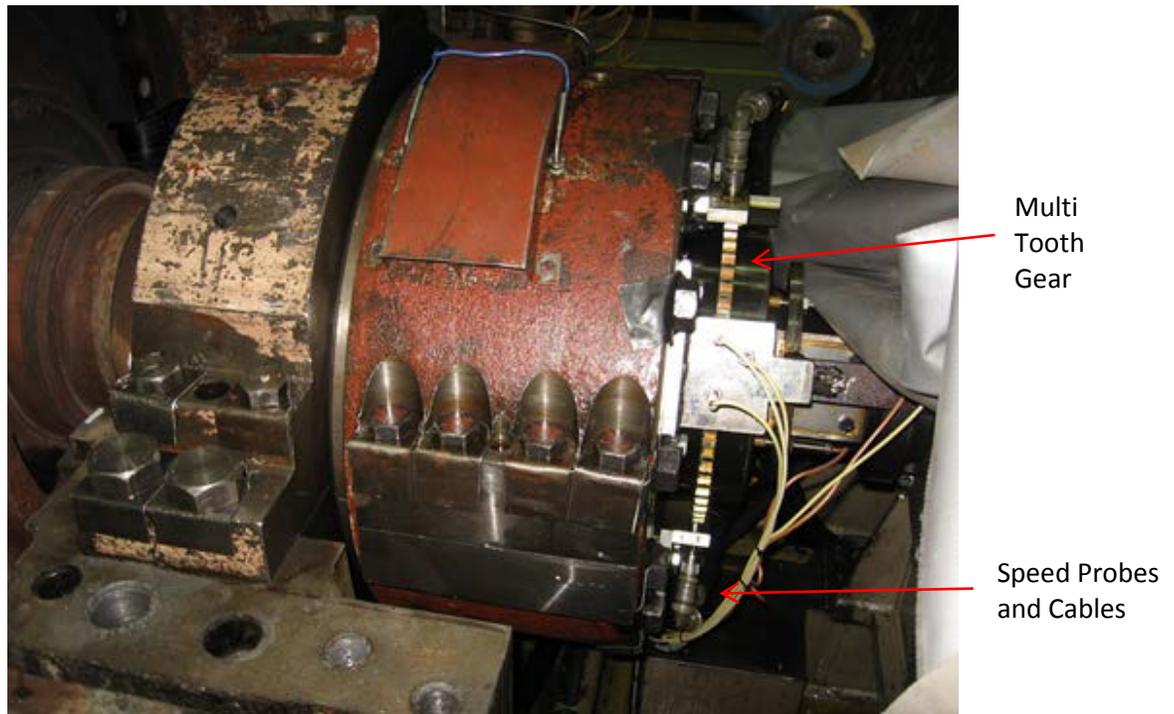
Figure 11: Turbine Speed Control System

6. Turbine speed probes and cables. The turbine control system receives the turbine speed via magnetic speed sensors to represent the turbine speed in RPM. The magnetic sensors are mounted next to a multi-tooth gear attached to the turbine shaft. A total of 6 sensors are used, 3 for control and 3 for trip protection. These sensors and associated interconnection cables are normally partially immersed in lubrication oil during operation as the assembly is in close proximity to the turning gear set. Turbine generator speed probes and cables are shown in Figure 11.

- 1 In 2016, there have been a number of occurrences where the turbine control system
2 has lost signal from the speed sensors, delaying the start-up of Unit 2 following the
3 annual outage and a smaller maintenance outage. Exposure to oil degrades electrical
4 equipment over time and reduces reliability. Oil attacks the insulating jacket on cables
5 making it ineffective in its primary role as an insulator and reduces the signal strength
6 of the cable and sensor. Accurate and reliable turbine speed signals are necessary for
7 safe and reliable governing of the turbine generator during operation. Hydro is

1 proposing to replace the six magnetic speed sensor cables on both Units 1 and 2 during
2 the 2017 annual maintenance outage.

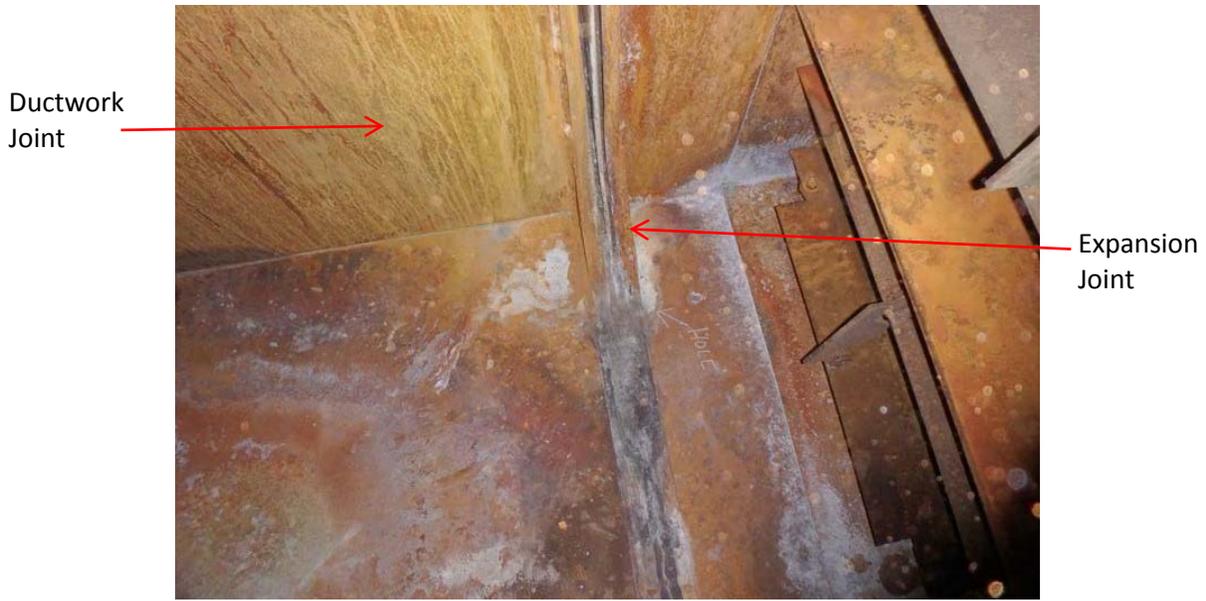
Figure 13: Boiler Ductwork Expansion Joint (1)

14 Expansion joints are a component of the ductwork that conveys combustion air to the boiler.
15 The primary function of expansion joints is to allow the ductwork to expand and contract during
16 operation and prevent cracking. Many of the ductwork expansion joints serving Unit 1 and Unit
17 2 have developed holes due to erosion and corrosion and require replacement. A complete
18 failure of expansion joints during operation will result in forced unplanned unit outages. Boiler
19 ductwork expansions joint are shown in Figures 13 and 14. Additional photos of deteriorated
20 expansion joints are shown in Figures 2, 3, and 4.

22 Boiler air heater refurbishments and expansion joint replacements will be completed during the
23 scheduled 2017 unit maintenance outages, pending Board approval.

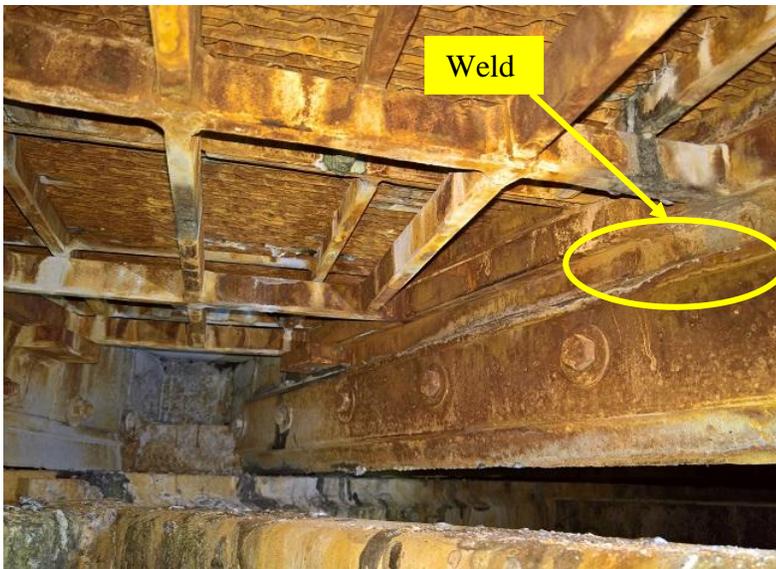
This is incorrect. The support grating is supported on the sides with blocks that are welded to the diaphragms. The grating is allowed to float freely without concern that it will fall out of the structure. The basketed element is also free to move on this grating during thermal expansion and deformation. Welding the grating to the diaphragms restricts this expansion and can cause stress in the rotor structure.

restricts this expansion and can cause stress in the rotor structure. During any outage that maybe scheduled next year, these welds should be removed and allow the rotor to be free from restriction on expansion and to conform to thermal deformation design and allowing proper sealing.

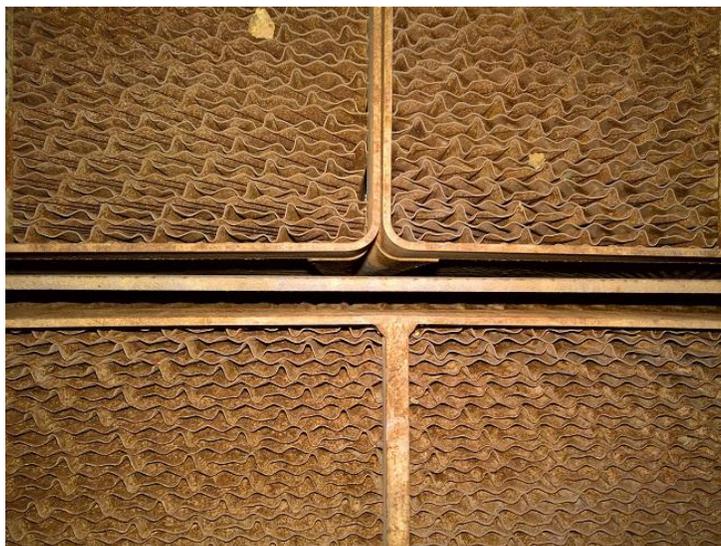
Although the hot end element is in good condition, it is suffering bypass from the basket to diaphragm gaps. This may be a result from smaller than normal baskets or to an oversize expanded compartment. Due to the lack of excessive heat evidence, it is suspected that the baskets are just small. The baskets can be used in this condition without problems if the gaps are just stripped with material to keep the flow from going around the basket.

These gaps exist at several locations including at the diaphragms and any of the stay plates. Any gaps larger than [REDACTED]” should be considered for closing off. Flow goes through here and is not absorbed by the element and contributes to a loss of return. Material that is stripped here must be tack welded to either the sides of the diaphragms or the baskets, but not from basket to basket or

to both diaphragms and baskets. The goal is to force the flow through the element without restricting the thermal movement and expansion of the rotor or the element. Tabbing these gaps can improve the gas outlet and air outlet temperatures by 6°F to 8°F.

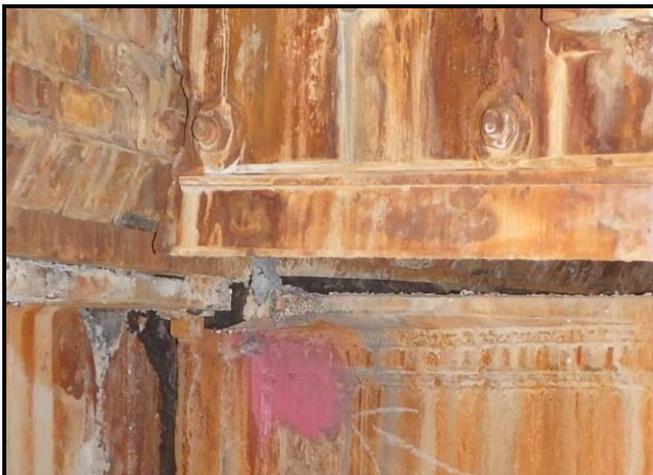
East APH CE GAS to AIR

- The East and West APH's CE sector plates are equally in poor condition. There is a significant discrepancy in the reduced thickness of the GAS to Air sector plate. The original [redacted] thick sector plate is reduced to approximately [redacted] thick in the middle and outboard portion of the sector plate.
- Radial seals set to the appropriate cold seal settings to the higher AIR to GAS sector plate there is a substantial gap and direct leakage path across the sector plate to the gas side. There was ash build up on top of the sector plates indicating that the CE radial seals are not making contact with the sector plate.

Recommend: Replace the GAS to AIR sector plate in both the East and West APH's.

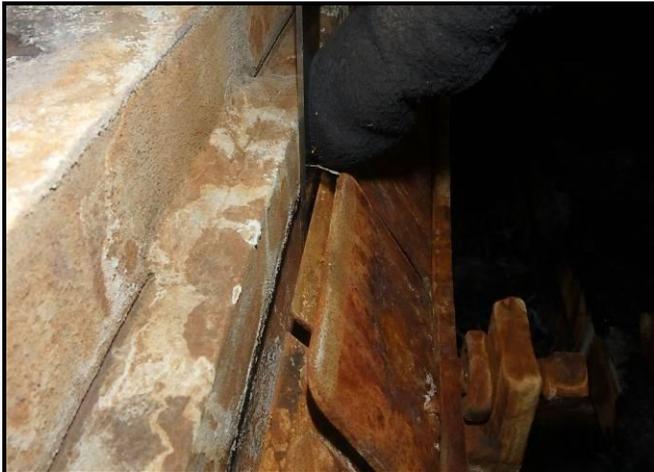
- The Circumferential sealing ring on the HE and CE has signs of contact wear on the East and West APH's. There are some excessive gaps up to [REDACTED]

Gas HE Cir seal ring wear up to [REDACTED]

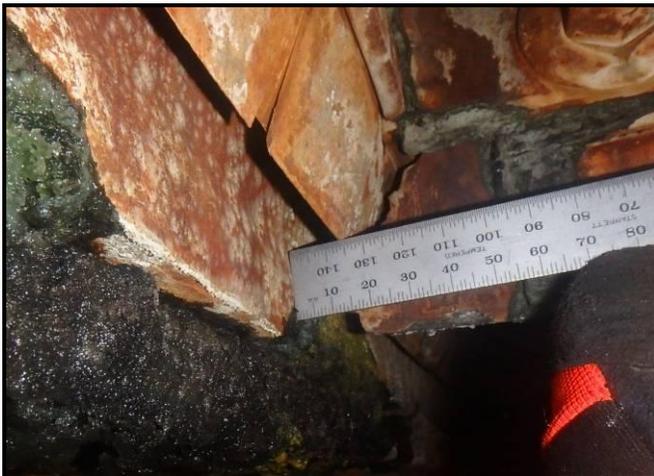
CE GAS circ seal gap of [REDACTED]

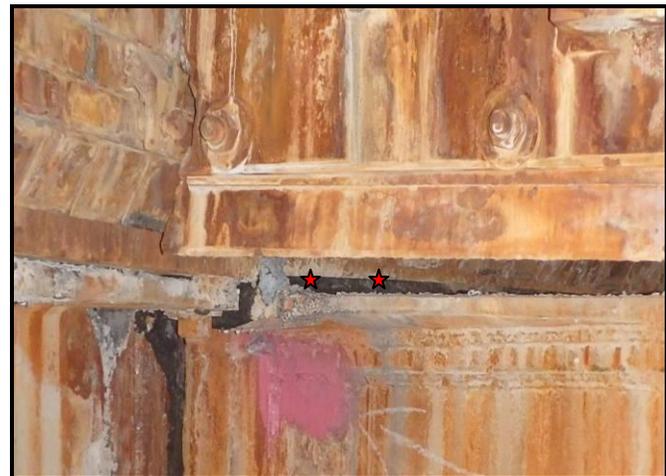
CE GAS circ seal ring eroded at sector plates

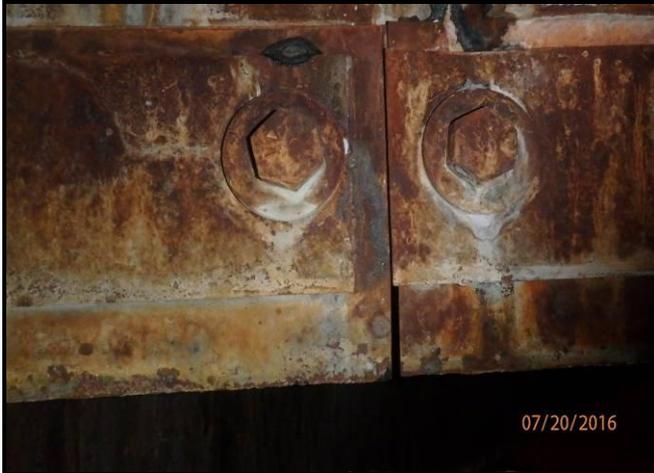
- The radial seals on both the east and west APH are in satisfactory condition. There are signs of bent, misalignment, overlapping and gaps with the HE and CE radial seals on both East and West APH's.

Abutting radial seals have some gaps

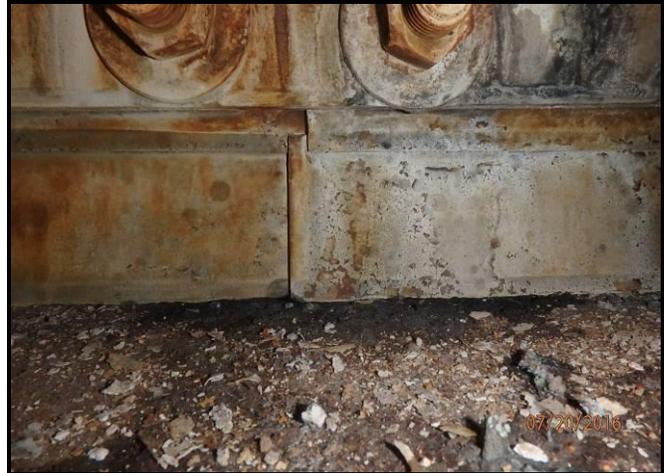
Over lapping radial seals

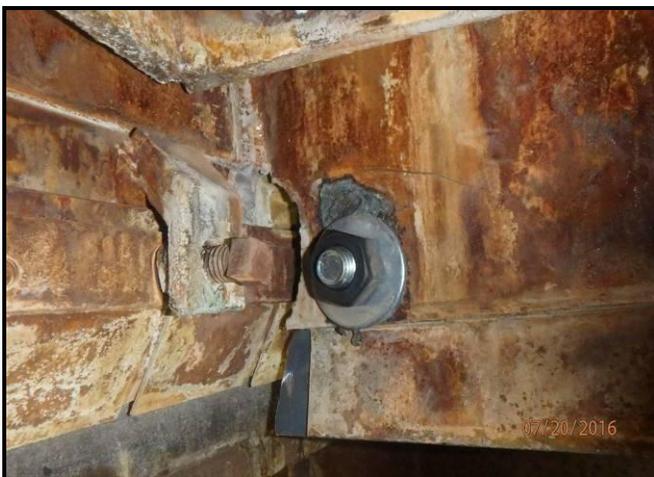
- The circumferential seals and holding strips were installed incorrectly. Signs that the Diaphragms have been relieved allowing the holding strip to pass thru. The holding strips should start/stop at the intersecting diaphragm to rotor shell. This is a direct leakage path.
- The cold seal settings on the HE and CE exceed the recommend settings.
Recommend: Replace circumferential seals and holding strips and hardware.

Holding strip passes thru diaphragm

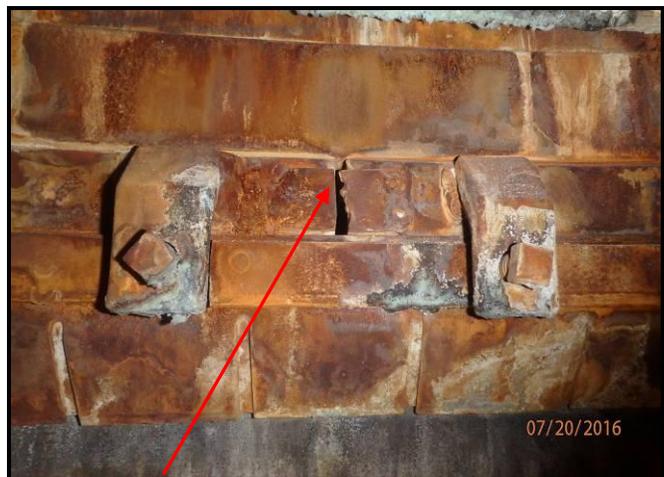
Missing sealing strips

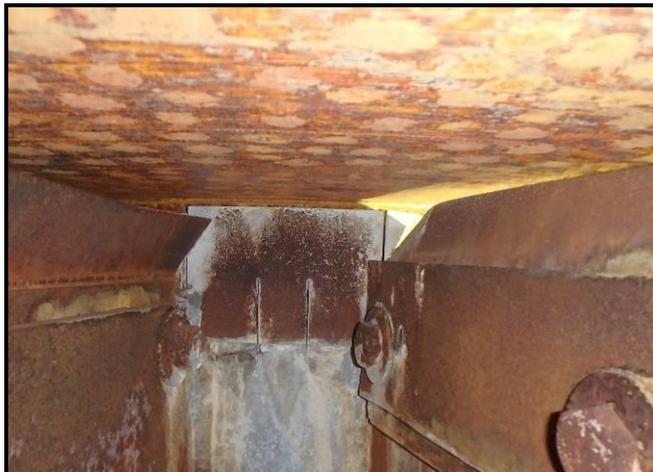
East HE post seal

- The hot end post seal have been previously repaired and showing signs of wear.
Recommend: Replace the HE and CE post seals in both the East and West APH's

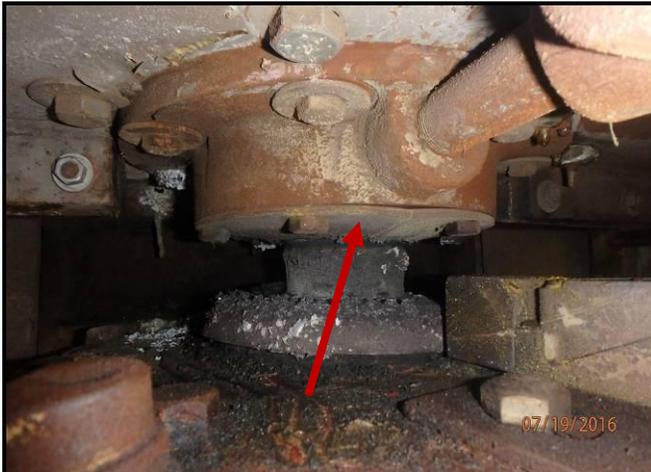
- The East and West drive unit has a Falk gear drive model [REDACTED] AP with a gear ratio of [REDACTED]. With one auxiliary air motor per APH. The units have new pinion gear shrouds installed and were not removed during this visit. Therefore no pin rack to pinion gear throat clearances were taken. The oil levels are very low and this was brought to the site contacts attention.
- The West APH was not available to rotate because of the top guide bearing was removed.
- The East APH was rotated by means of an Aluminum bar because the drive motor was removed and sent out to have the shaft keyway repaired.
- The up shaft positive air supply shaft seal appears to be good on the West APH and the EAST APH seal will need attention during the next scheduled outage.

Leaking seal

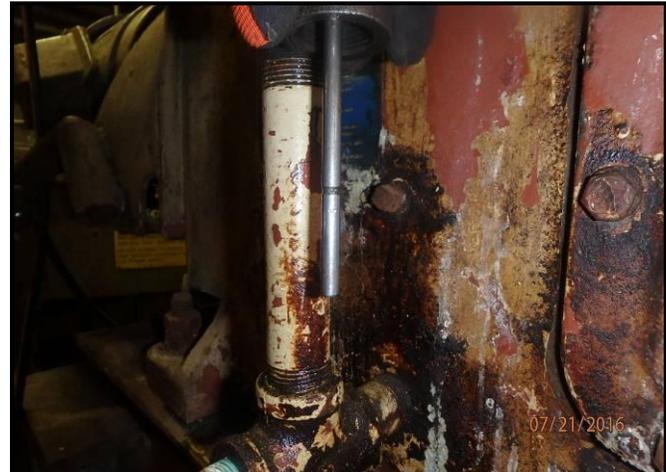
Low oil level

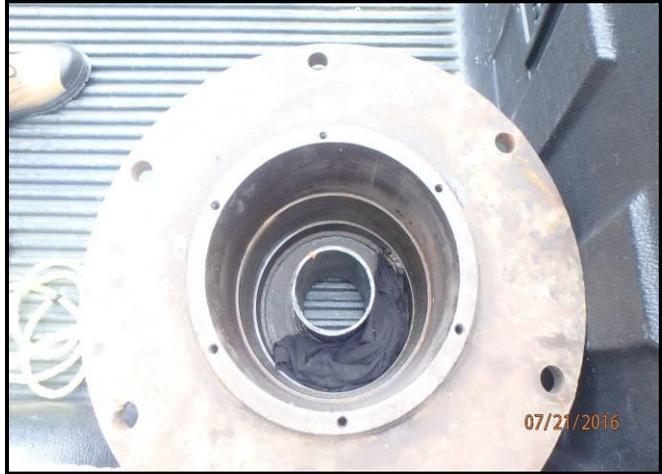
Center pipe burred

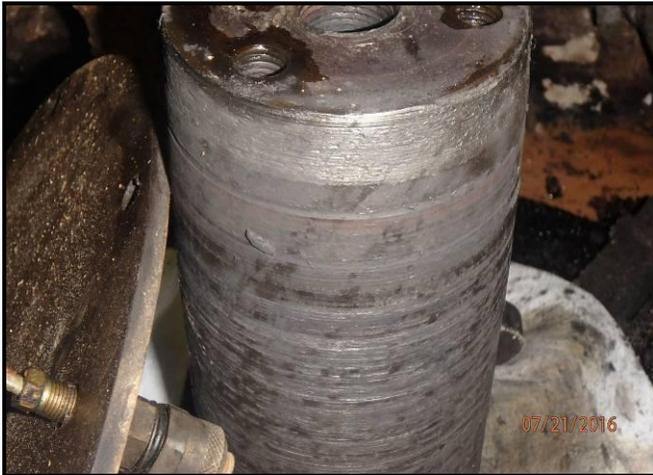
Trunnion shaft

- The West APH top cover was removed for a quick inspection. The three 1/2" bolts that hold the trunnion shaft locking plate were sheared off and the trunnion bearing sleeve adapter was not secured to the end of the trunnion shaft.

Recommend: To replace the top guide bearing and trunnion shaft and bearing assembly trunnion sleeve assembly and locking plate. Address the HE trunnion positive air shaft seal.

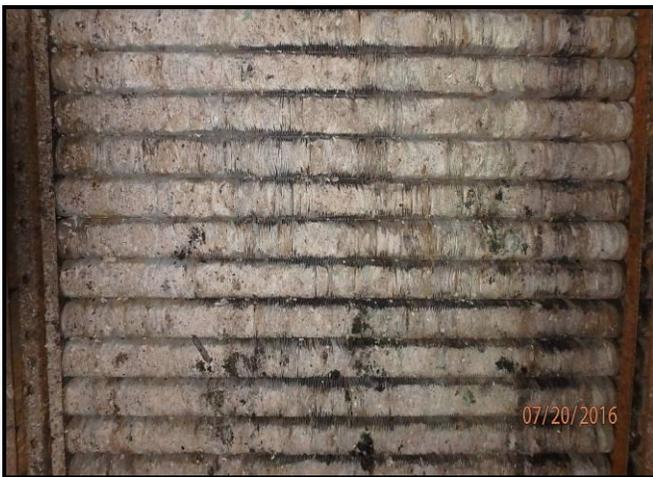
East APH Steam coils

- The East and West APH's have steam coils in the CE Air inlet side. They appear dirty and fouled and a good majority of the coils exterior fins are bent over. This may have an impact on the air flow, temperature and pressure entering the APH.

Recommend: To clean and replace damaged steam coils. Ensure there is decking installed above the steam coils to minimize foot traffic on top of the coils that damage the outer fins.
