**Re: Approval of Capital Expenditures Supplemental to Newfoundland Power Inc.'s  
(the "Company") 2018 Capital Budget Application – Duffy Place Roof Replacement**

**Duffy Place Roof Replacement**

**July 2018**

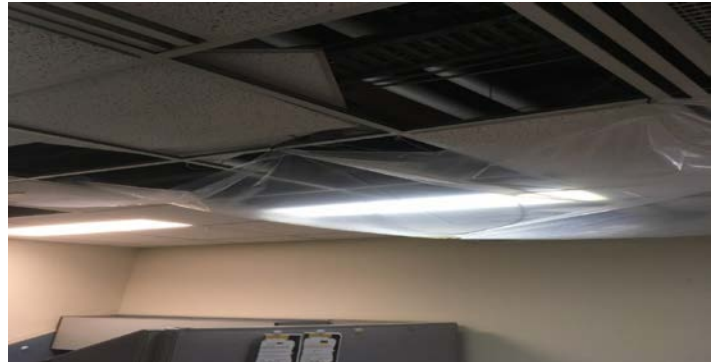
**Figure 2 – Field Service Representative Room**

This area is located under the upper level built-up roof and includes a meeting space and workstations. The Company attempted to repair leaks in this area by improving drainage and patching 42 m<sup>2</sup> of surrounding roof. The Field Service Representative Room continues to experience leaks in this area.

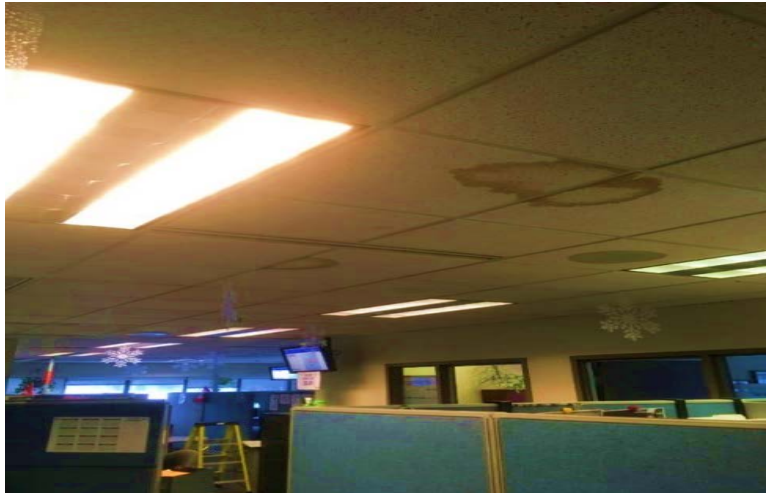
**Figure 3 – Customer Contact Centre**

This area is located under the upper level built-up roof and leaks have occurred directly above a number of workstations used by customer service representatives. The Company attempted to repair leaks in this area by improving drainage. The Customer Contact Center continues to experience leaks in this area.

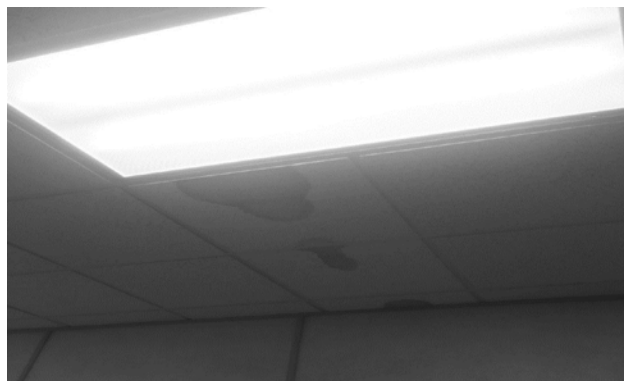
**Figure 4 – Meter Shop Office Space**

This area is located under the lower level built-up roof and leaks have occurred directly above a number of workstations used by meter technicians. The Company attempted to repair leaks in this area by improving drainage and replacing an expansion joint.<sup>5</sup> The Meter Shop office space continues to experience leaks in this area.

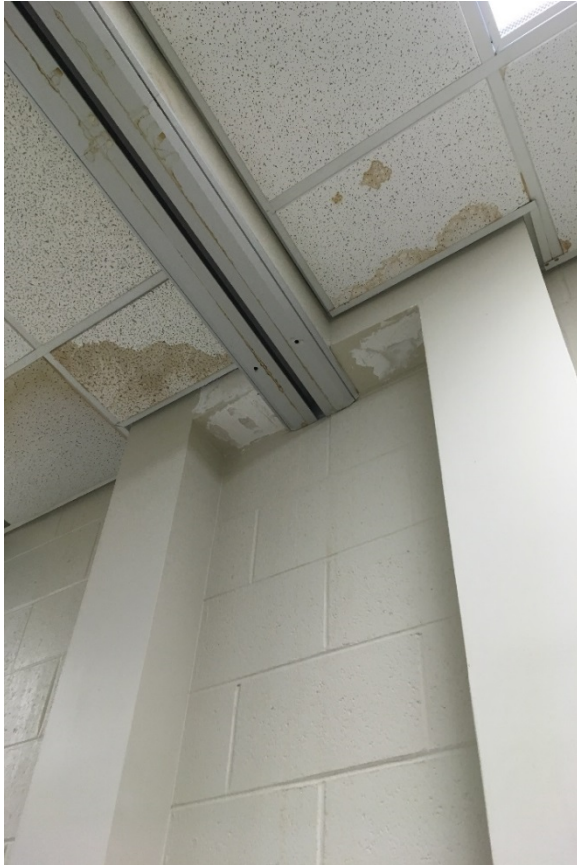
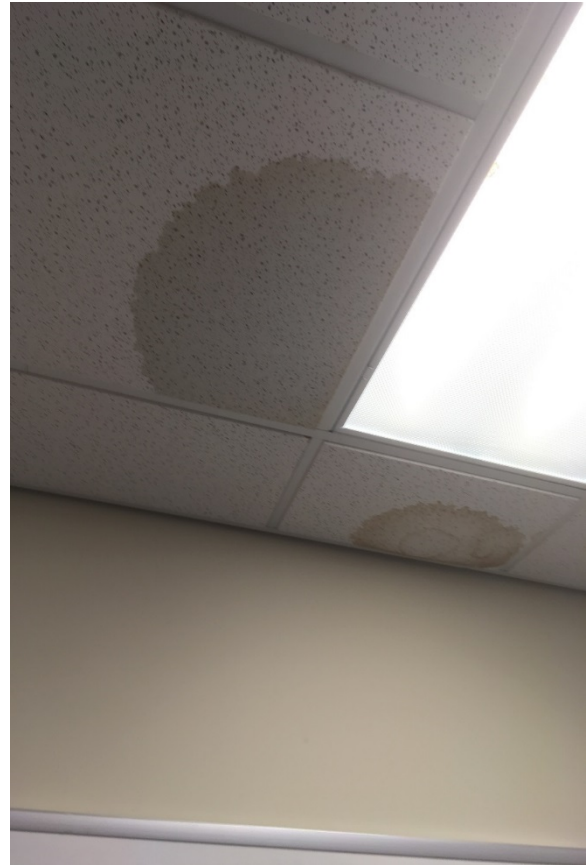
These areas are in adjacent rooms under the lower level built-up roof. The PLT Training Room is used for training and meetings. The Storm Room is critical for emergency operations during major outages. The Company attempted to repair leaks in these areas by improving drainage and completing patching work. Both rooms continue to experience leaks in these areas.

**Figure 5 – PLT Training Room**

**Figure 6 – Storm Room**

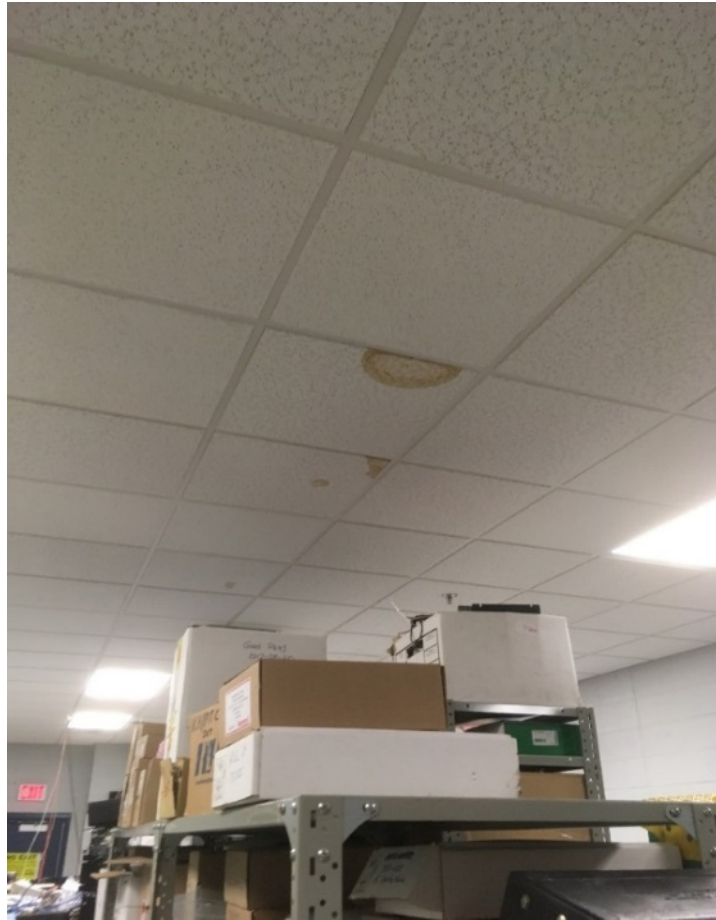
**Figure 7 – Telecommunications Shop**

This area is located under the lower level built-up roof and houses sensitive technology and spare equipment. The Company attempted to repair leaks in these areas by improving drainage and installing new roof material around the perimeter of the roof in that area. The Telecommunications Shop continues to experience leaks in this area.

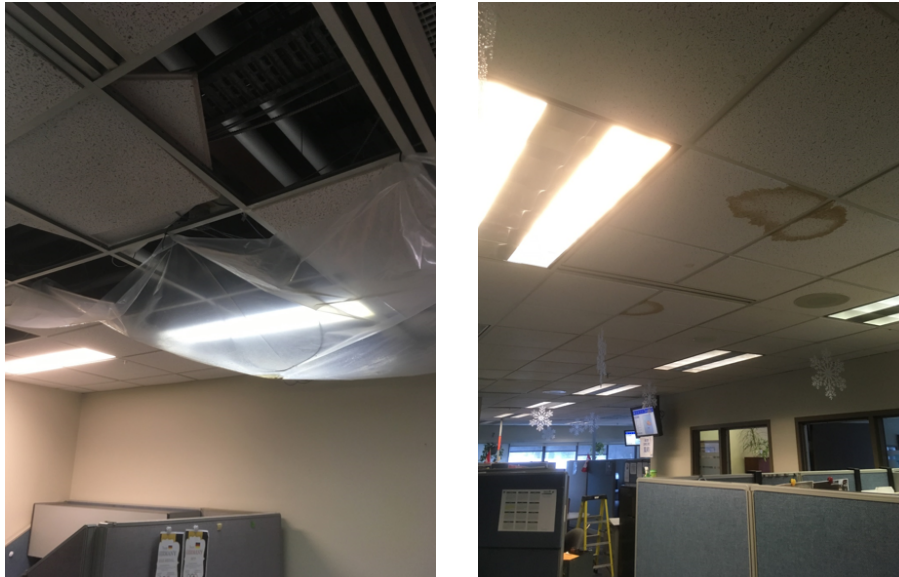
Figure 2 – Examples of typical water infiltration

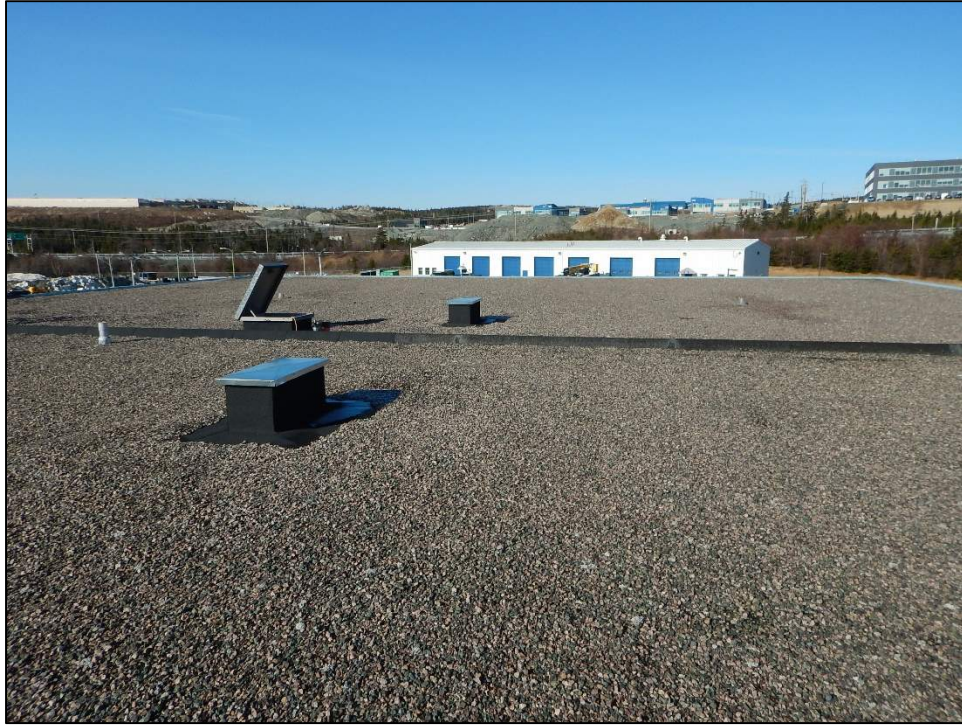
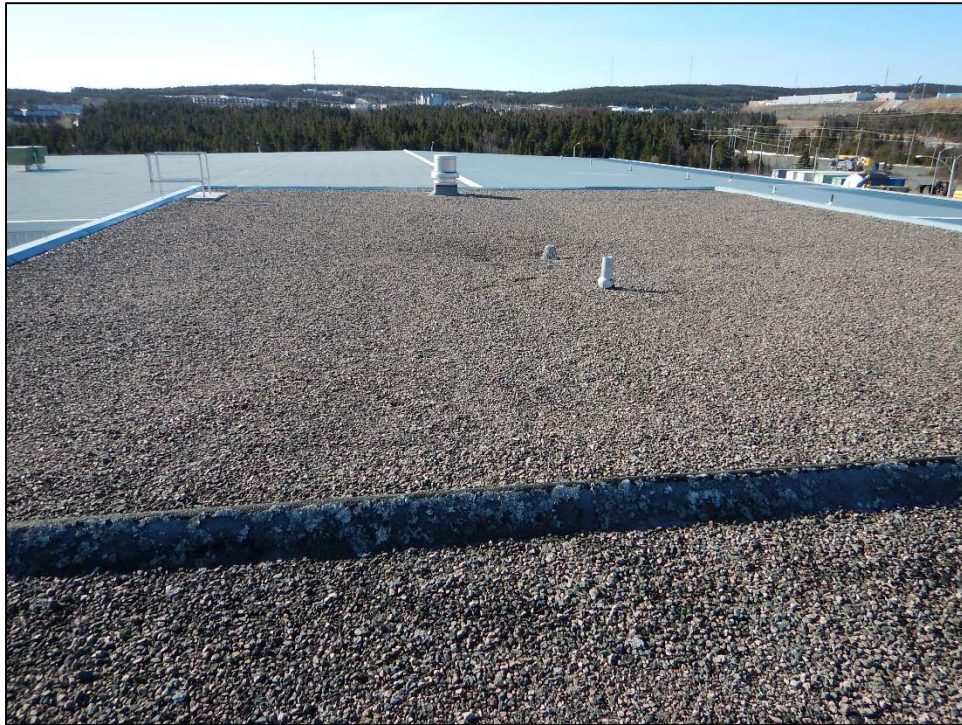
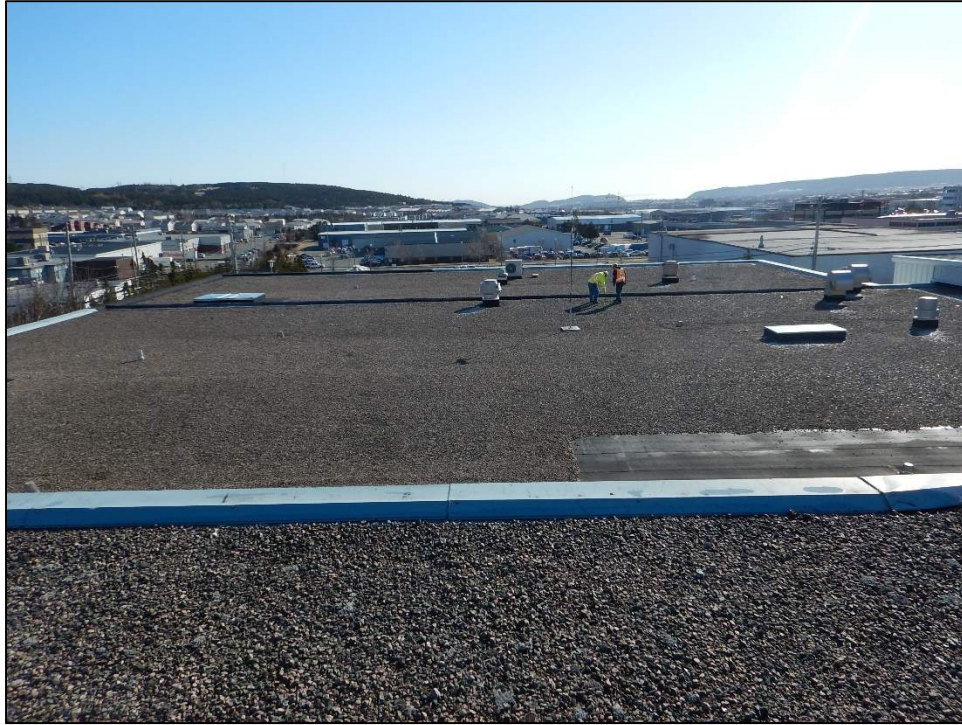
- In general, the condition of the build-up roof membrane was unable to be reviewed due to the presence to gravel surfacing (Photographs 1 to 4). However indicators such as, bitumen / asphalt blisters (i.e., “blueberry” blisters) and vegetative / moss growth were visible throughout the roof area (both levels). These are suggestive to potential roofing problems such as prolonged moisture exposure and weathering of the membrane.

**Photograph 1:** General view of upper level of the Main Building BUR roof (looking west). The Service Building is in the distance.

**Photograph 2:** General view of upper level of the Main Building BUR roof (looking south). The metal roof of the Main Building is in the distance.

**Photograph 3:** General view of lower level of the Main Building BUR roof (looking east).

Given the frequency and extent of water infiltration being observed, significant repairs to the built-up roofing are required in order to improve the water management control features. As such, in order to mitigate the water infiltration problems it is our opinion that some level of repair or intervention is required to be implemented over the entire roof area. Accordingly, a “do nothing” approach is not a feasible option and therefore will not be presented in this letter report. Similarly, an annual maintenance strategy would not provide the same level of water infiltration mitigation and would cost significantly more than the value of the roof. Replacement of the BUR assembly is the only option that can be reasonably be considered.

For the BUR, replacement of this roof is the only viable option that should be considered at this time (Option #2). This should be completed within the next year.

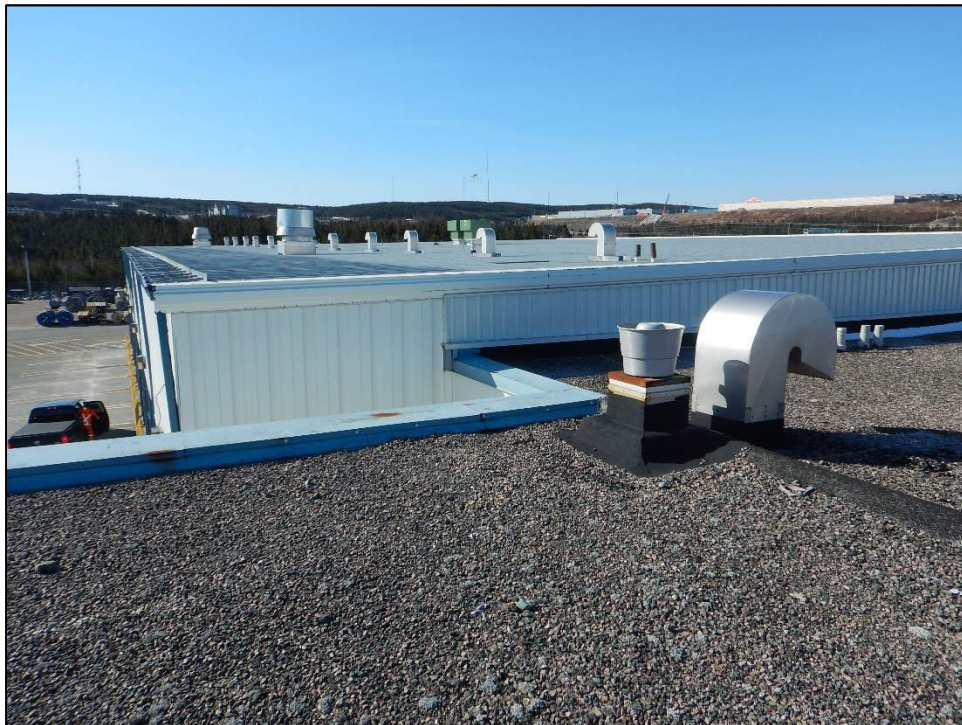
**Photograph 4:** General view of Main Building metal roof (looking south).

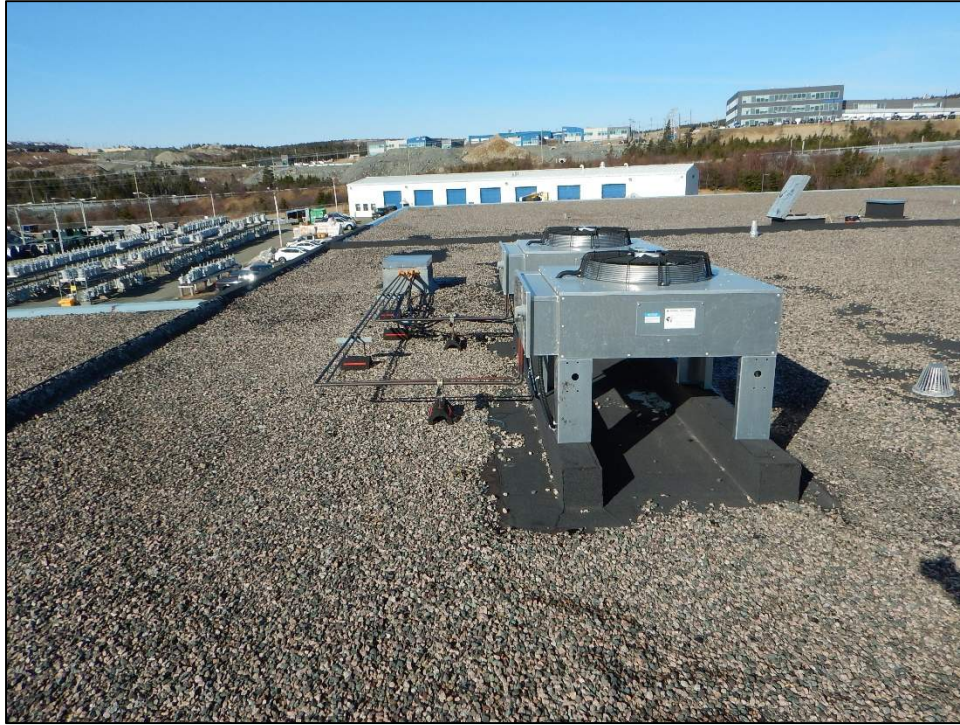
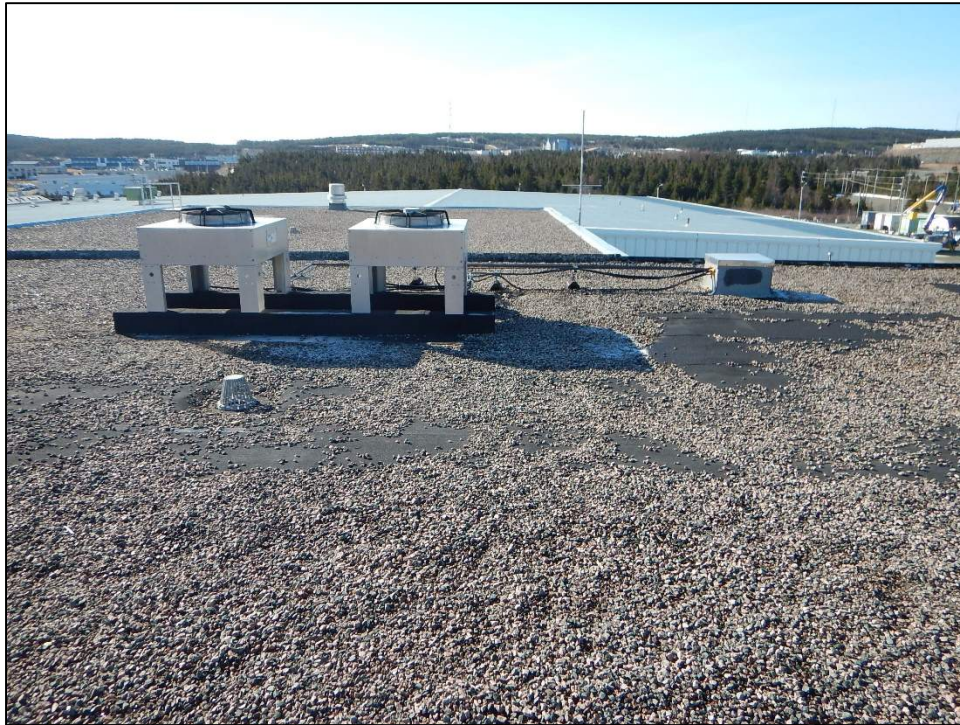
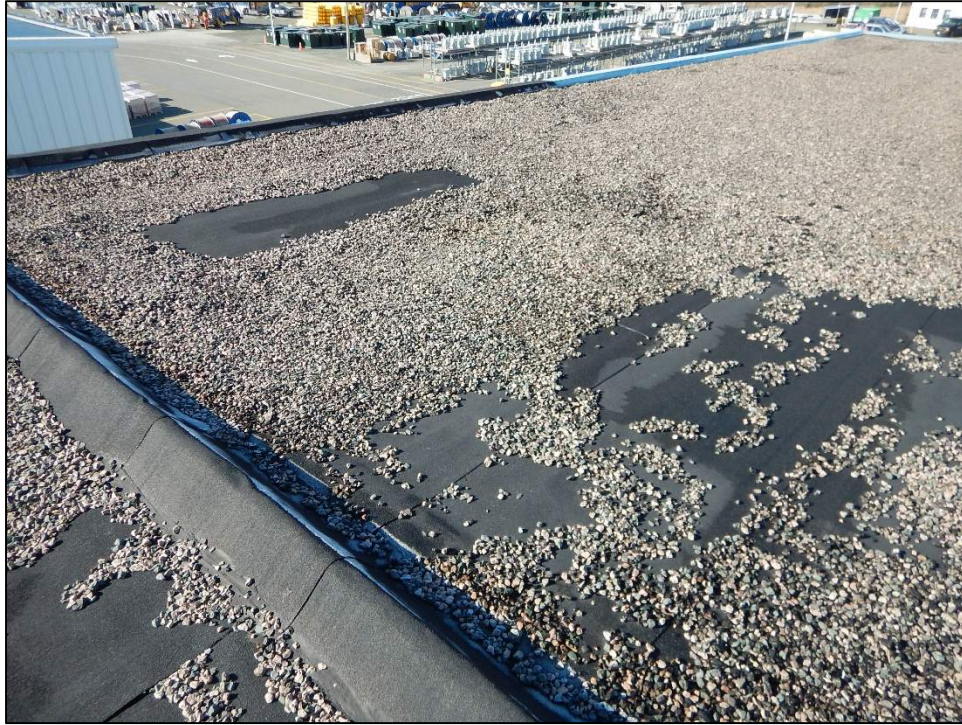
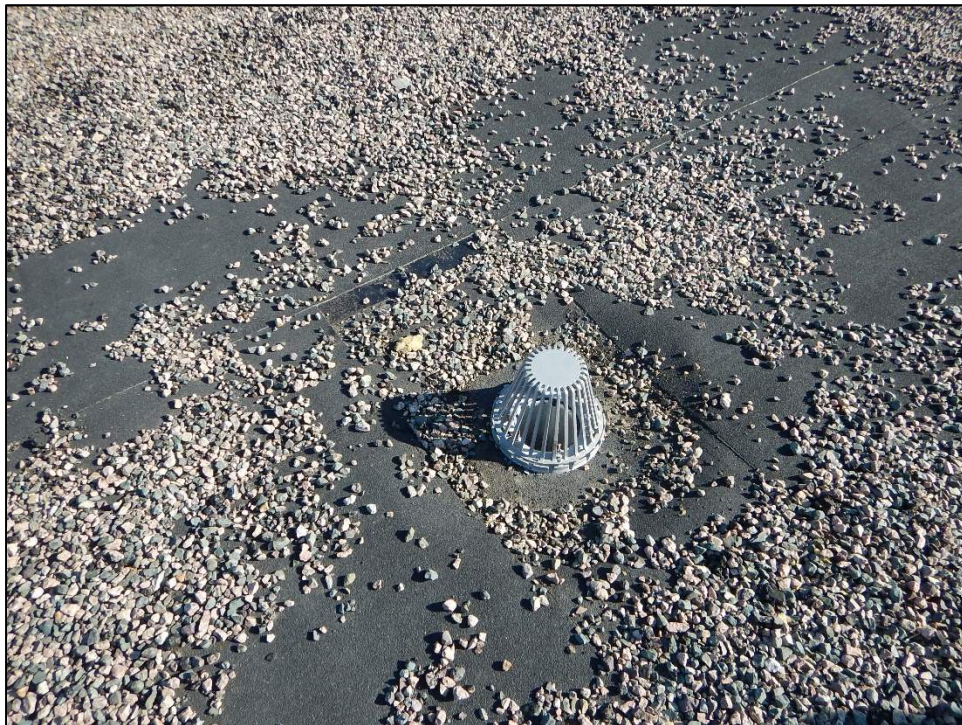
- Unsuccessful attempts to stop the roof leaks were made. We reviewed the previously “repaired” areas associated with existing mechanical penetrations, roof dividers and roof drains (Photographs 5 to 8). In general, the repair consisted of a granulated modified bitumen roof membrane applied directly over the existing BUR (with the gravel surfacing removed). Existing roof drains were left in place and retrofit drains installed. In general the repairs were found to be ineffective with the following additional observations:

**Photograph 5:** Typical rooftop equipment on the BUR roof with “repaired” modified bitumen roofing membrane around base, sleepers and curbs.

**Photograph 6:** Typical rooftop equipment on the BUR roof with “repaired” modified bitumen roofing membrane around base, sleepers, curbs and drains.

**Photograph 7:** Typical “repair” area on the BUR roof of the Main Building.

**Photograph 8:** Typical drain “repair” on the BUR roof of the Main Building.

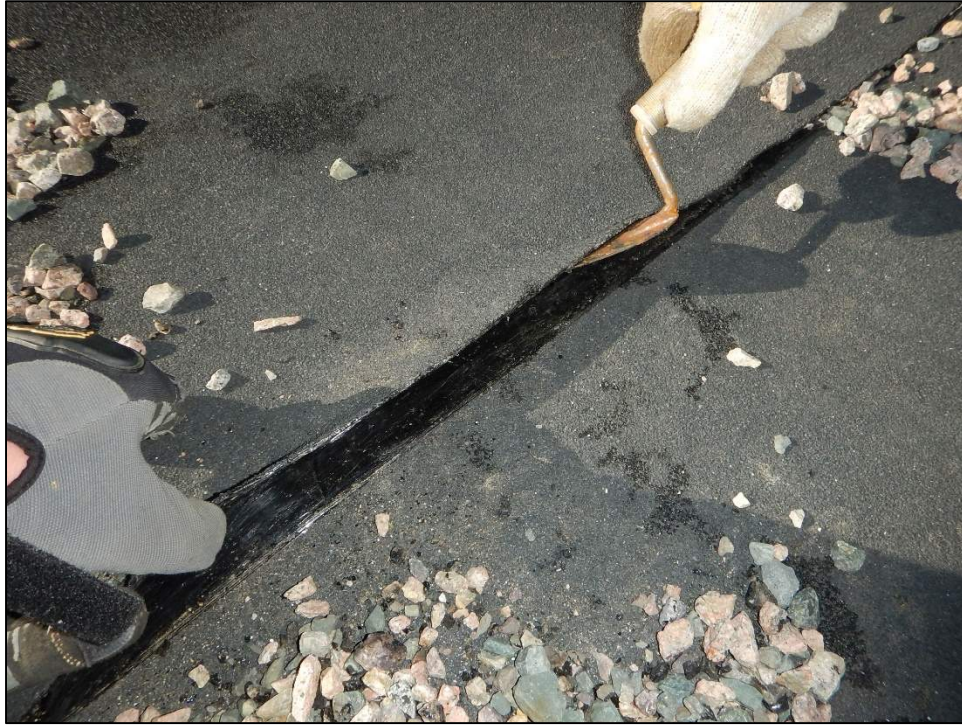
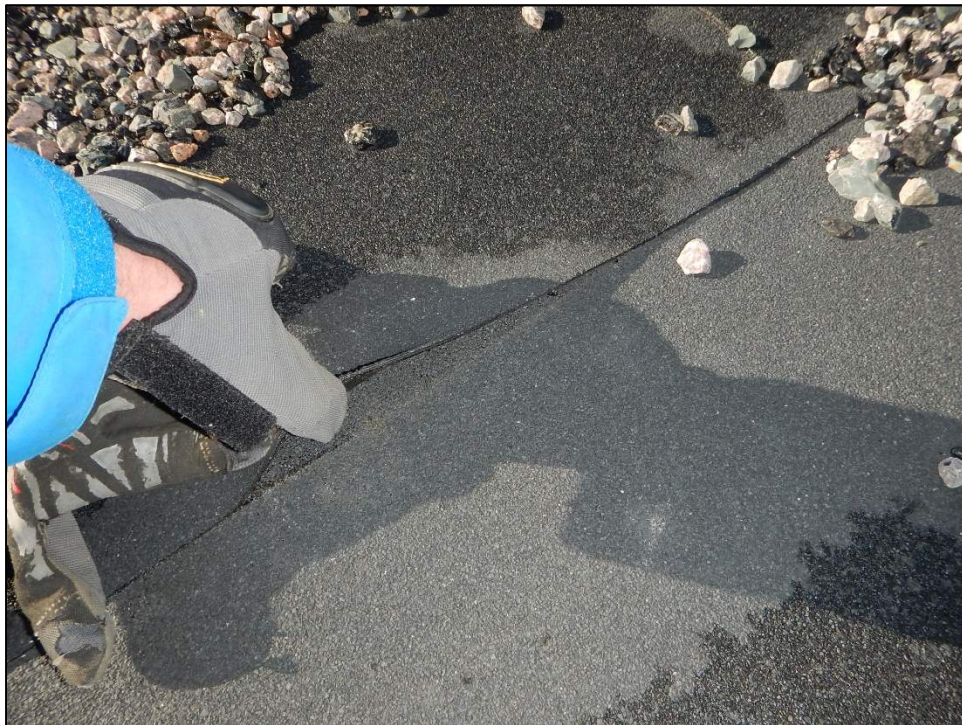
**Photograph 9:** Typical unbonded seam of the modified bitumen membrane in a “repair” area.

**Photograph 10:** Typical unbonded seam of the modified bitumen membrane in a “repair” area.

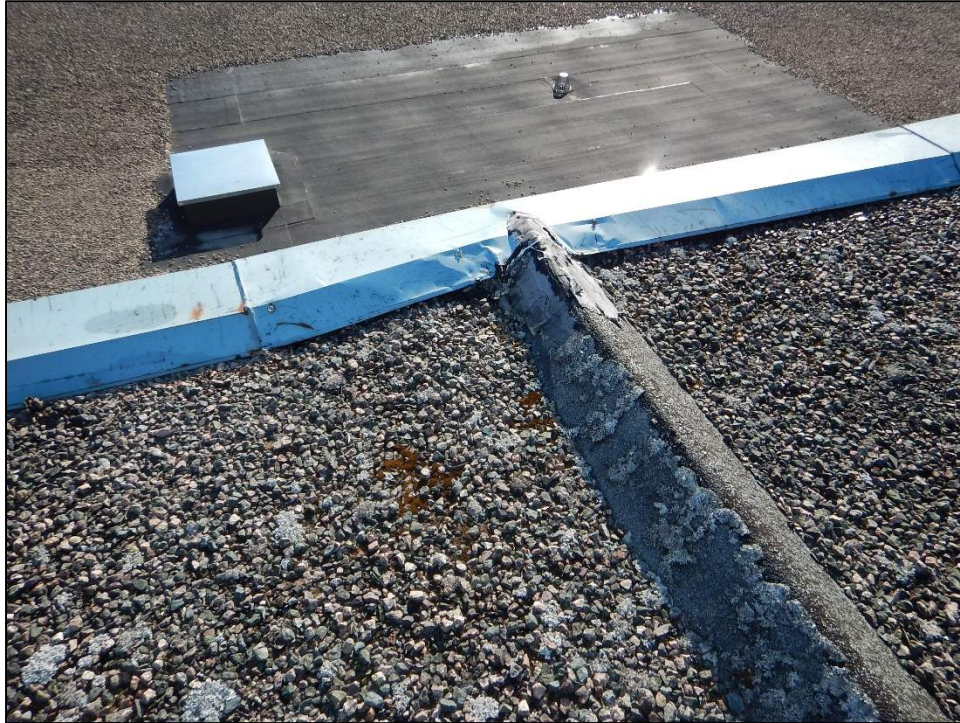
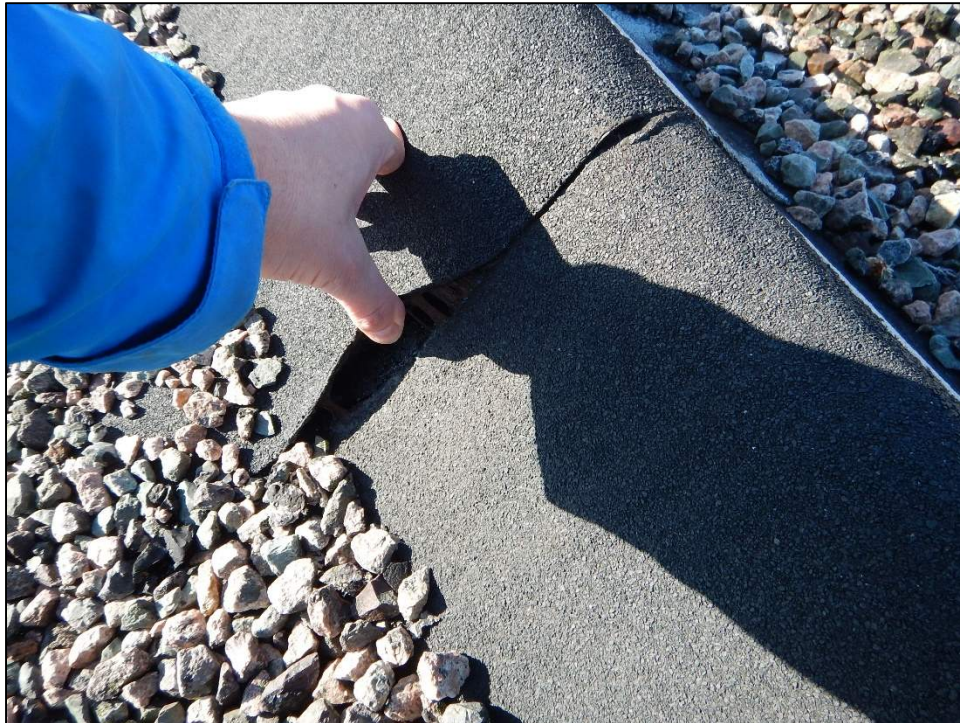
- o Poor installation detailing at curb corners.
- Existing junctions between the roof dividers and the roof edge / parapet were originally poorly constructed as the height of both the roof divider and parapet were insufficient resulting in a poorly executed parapet cap flashing (Photograph 11). Repairs to the BUR membrane over the roof divider exhibited similar poor construction installation practices (as noted above) with unbonded seams, etc. (Photograph 12).

**Photograph 11:** Typical junction between an existing roof divider and the roof edge on the upper BUR roof. A “repair” area to the lower BUR roof is in the distance.

**Photograph 12:** Typical unbonded seam of the modified bitumen membrane in a “repair” area of a roof divider.

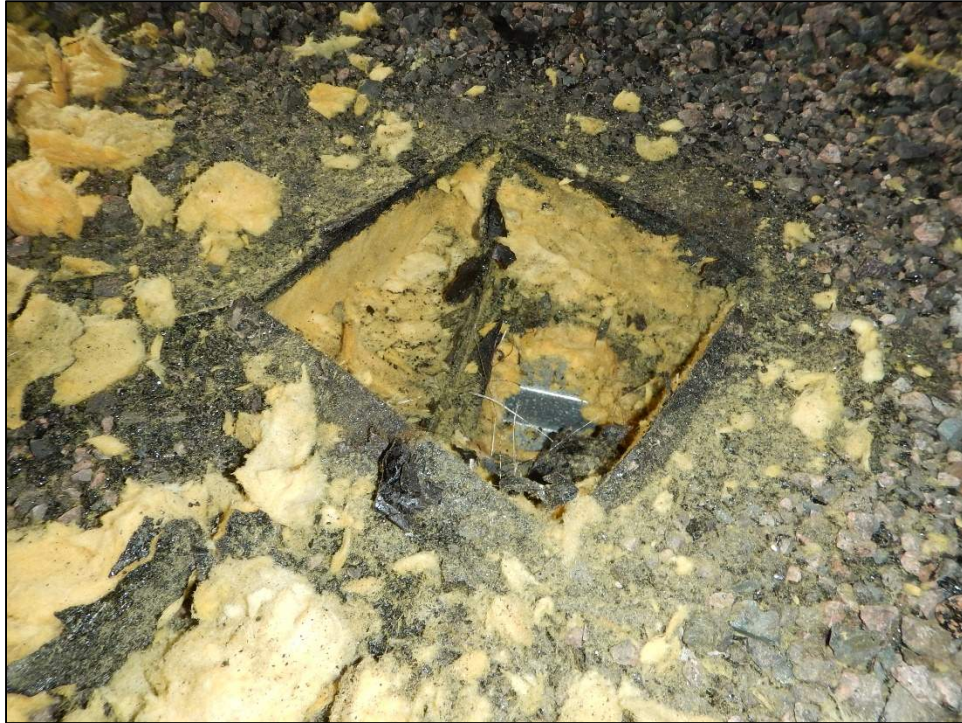
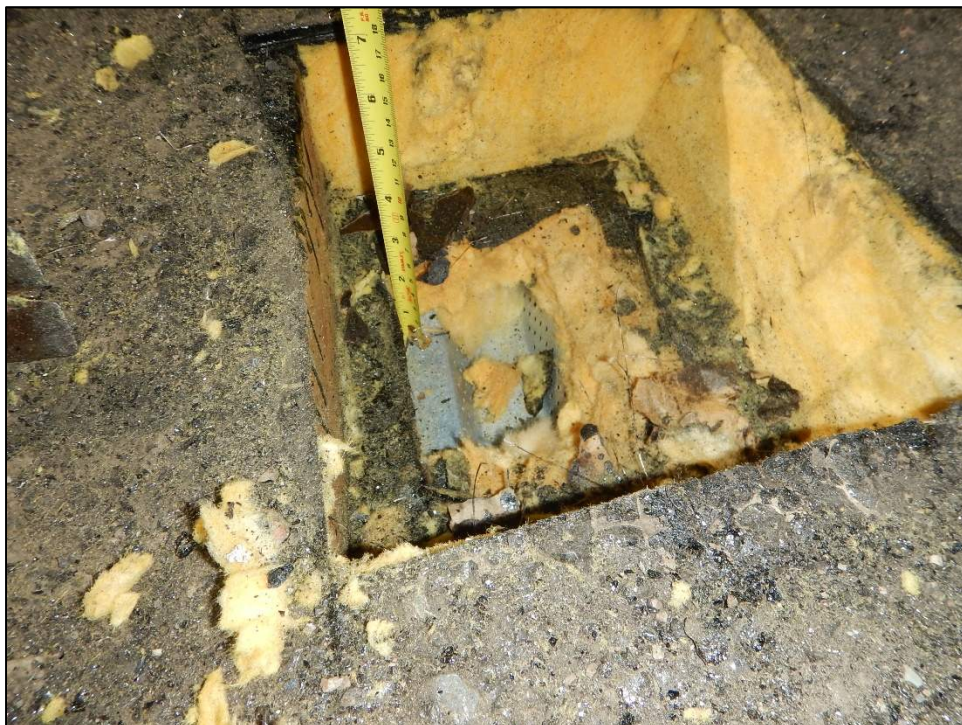
- Two (2) exploratory roof openings were conducted through the BUR assembly to expose the metal roof deck (Photographs 13 and 14). One opening was conducted on each level of the roof. It was noted that the insulation of the upper BUR roof assembly was wet.

**Photograph 13:** Exploratory Opening #1 through the BUR roof.

**Photograph 14:** Exploratory Opening #2 through the BUR roof.

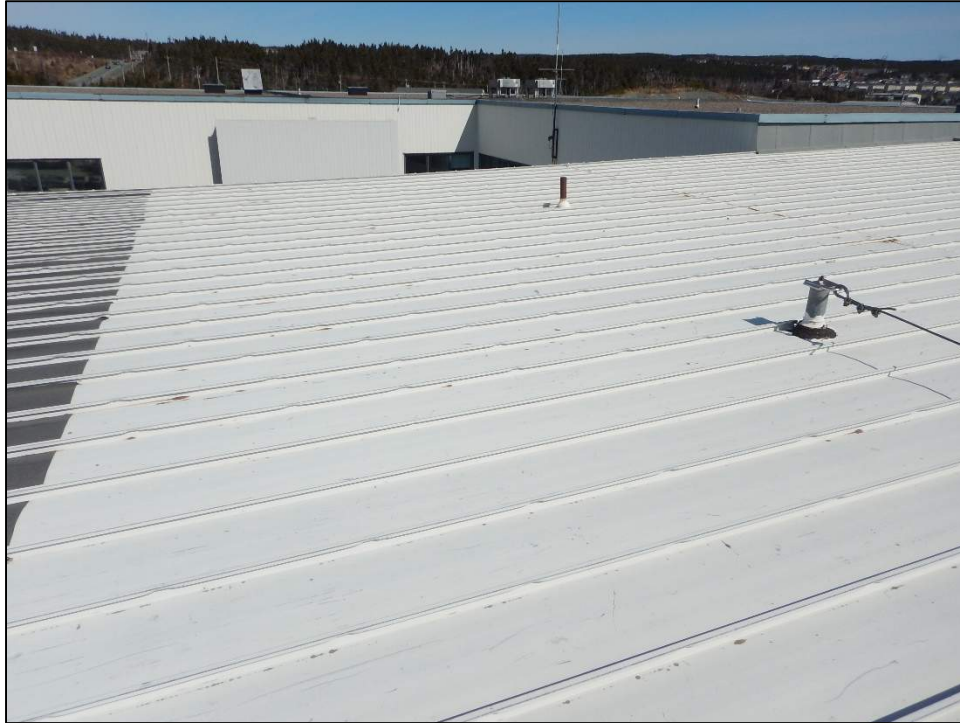
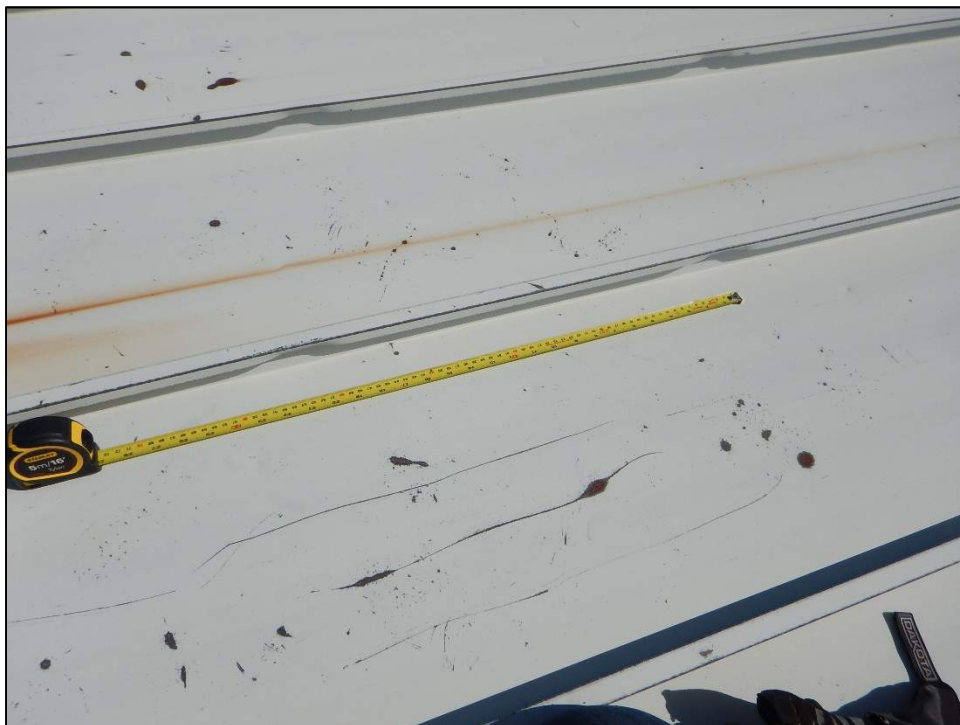
- The metal roof on the Main Building is a pitched standing-seam metal roof and is in fair condition. The standing seams are approximately 2" (50mm) high and spaced approximately 16" (400mm) on-center with a single crimp spaced approximately 20" (500mm) along the length of the seam (Photographs 15 and 16).

**Photograph 15:** Typical surface condition of the Main Building metal roof.

**Photograph 16:** Typical crimp of the standing seams.

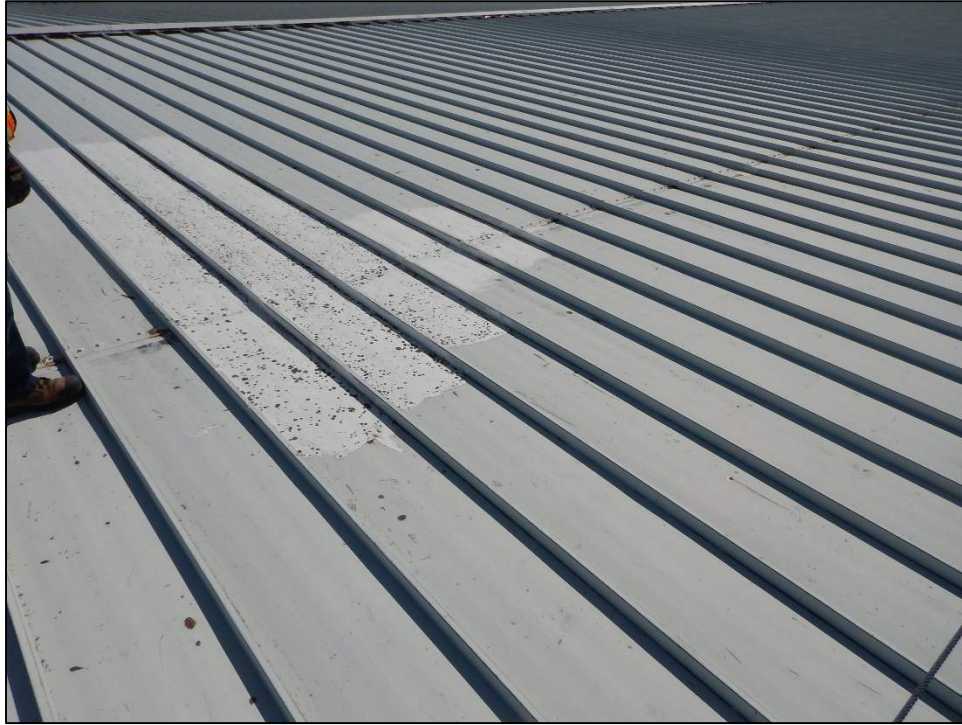
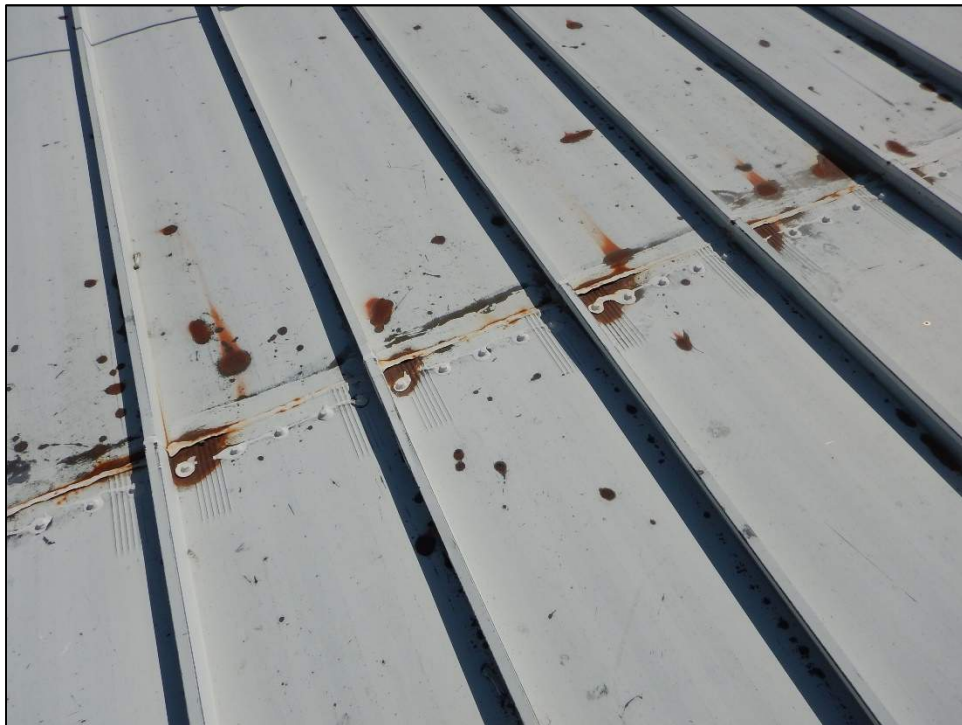
- In general, the surface / finishing of the metal panels is in fair to poor condition (Photographs 17 and 18). While no major deficiencies were observed that would effect performance, the general surface of the metal roof is "peppered" with numerous scratches, rust spots, etc. Previous repairs have been made at localized areas which included the application of a liquid-applied membrane in the field of the roof as well as at splice details (i.e., sheet overlaps) and at exposed fasteners.

**Photograph 17:** Typical patch/repair of the metal roof with a liquid-applied membrane.

**Photograph 18:** Typical splice condition / detailing of the Main Building metal roof.

For the metal roofs, there is still service life remaining which can be extended with annual maintenance. Therefore, we would recommend proceeding with Option #1 (Localized Repairs).

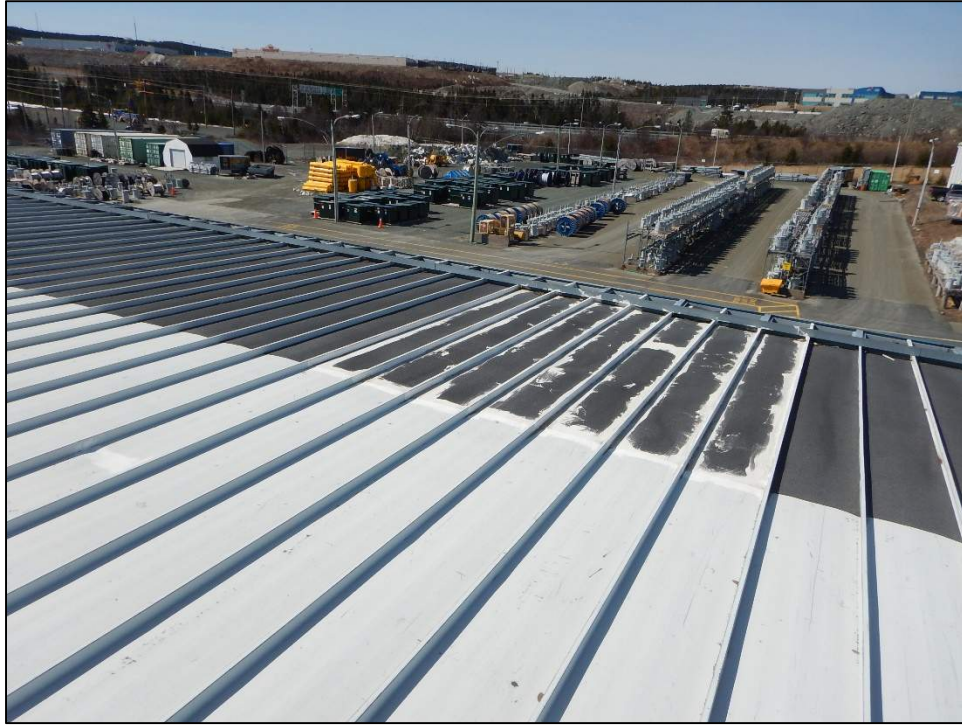
**Photograph 19:** Typical modified bitumen membrane installed between seams along with an area of repair with a liquid-applied membrane on the Main Building.

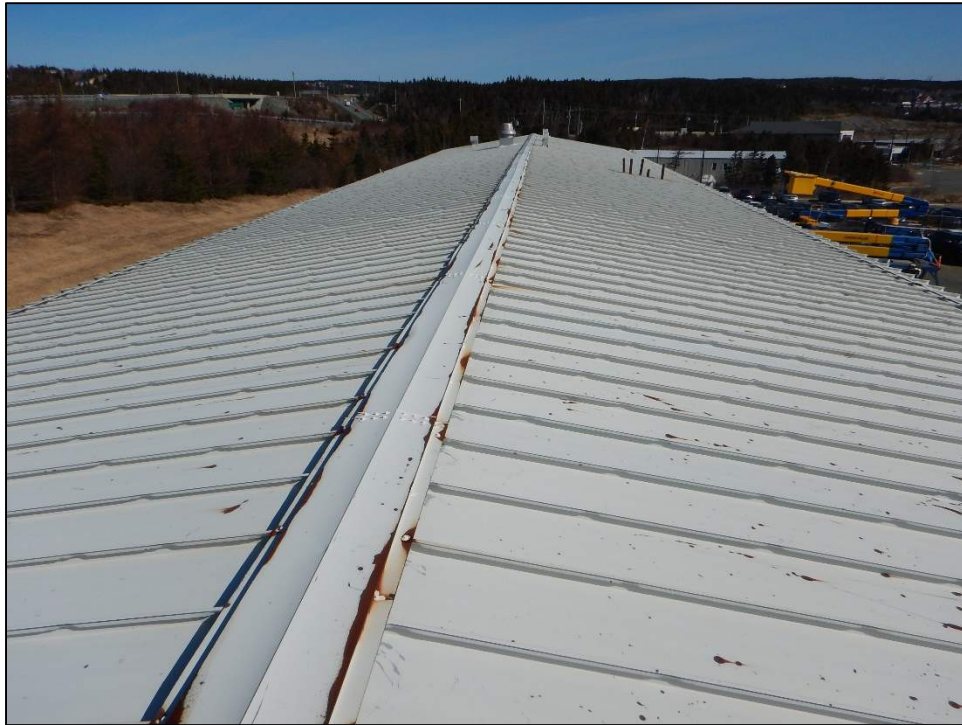
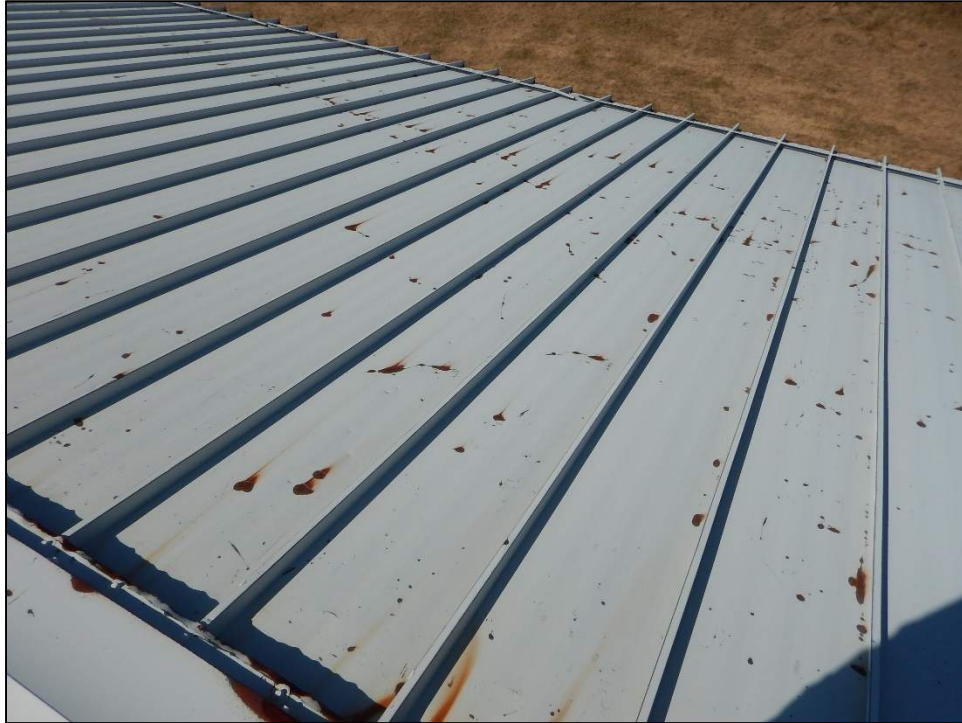
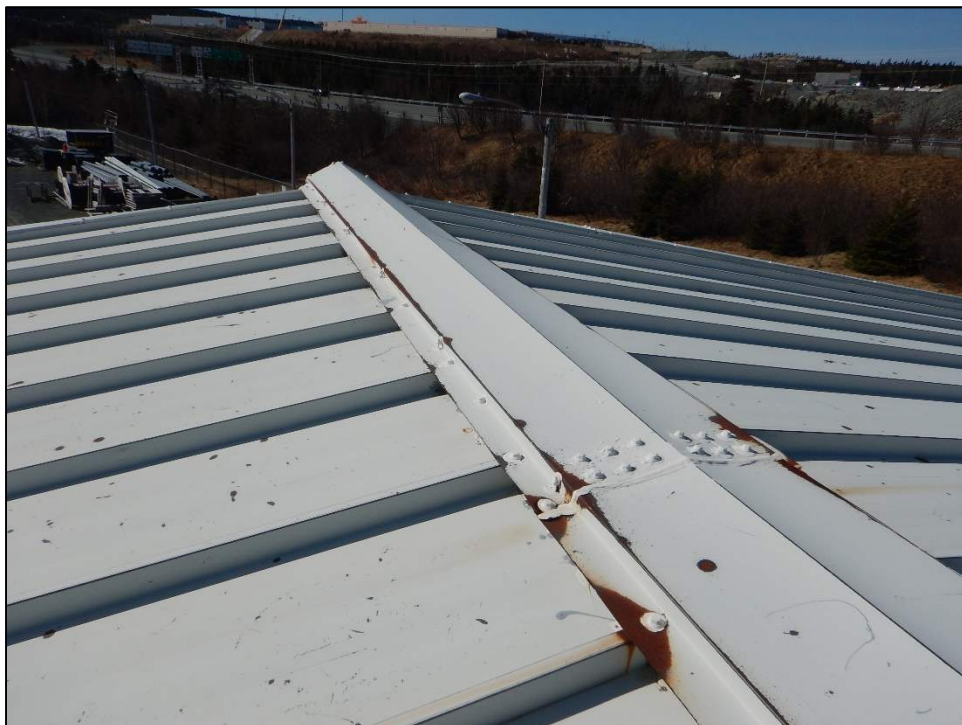
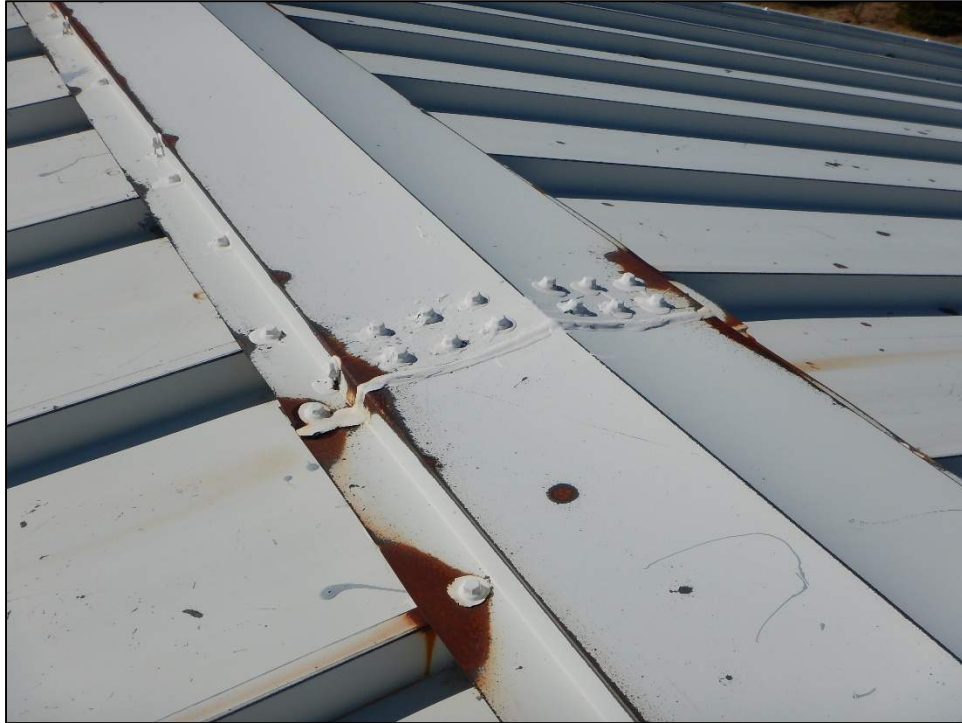
- In general, the condition and construction of the metal roof on the Service Building was similar to the Main Building (Photographs 20 to 23). In general, the surface / finishing of the metal panels is in fair to poor condition. While no major deficiencies were observed that would affect performance, the general surface of the metal roof is “peppered” with numerous scratches, rust spots, etc. Previous repairs have been made at localized areas which included the application of a liquid-applied membrane in the field of the roof as well as at splice details (i.e., sheet overlaps) and at exposed fasteners (Photograph 24).

**Photograph 20:** General view of the Service Building metal roof (looking north).

**Photograph 21:** Typical surface condition of the Service Building metal roof.

**Photograph 22:** Typical condition / detailing of the ridge cap flashing.

**Photograph 23:** Typical splice condition / detailing of the ridge cap flashing.

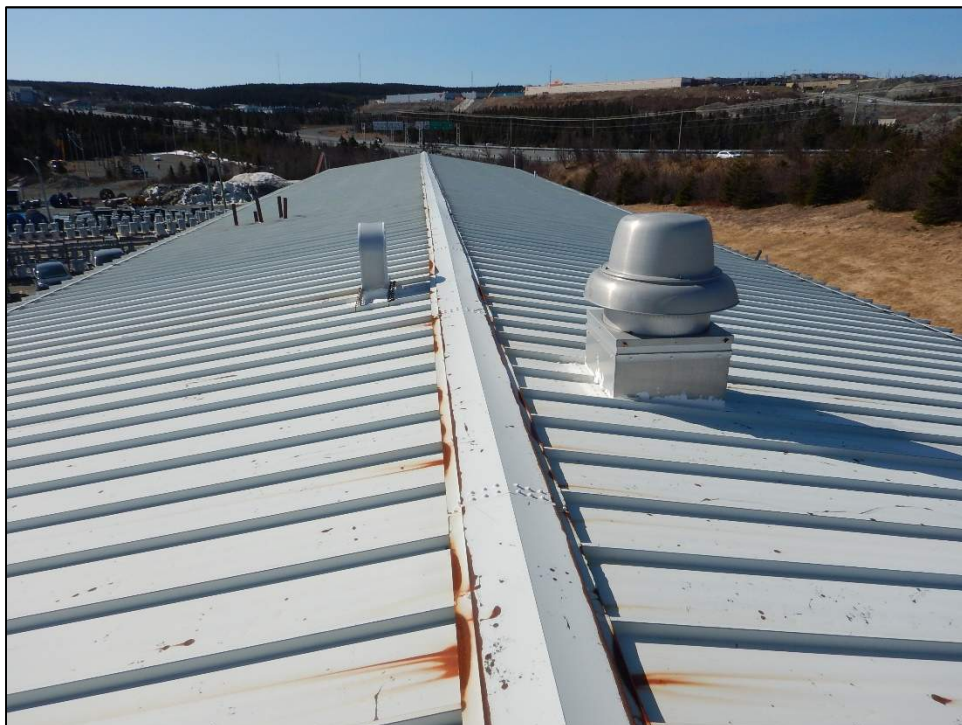
**Photograph 24:** Typical liquid-applied membrane installed around mechanical penetrations.
