**A REPORT TO  
THE BOARD OF COMMISSIONERS OF PUBLIC UTILITIES**

## UPGRADE ACCESS ROAD

### At the Bay d'Espoir Hydroelectric Generating Station

August 2009

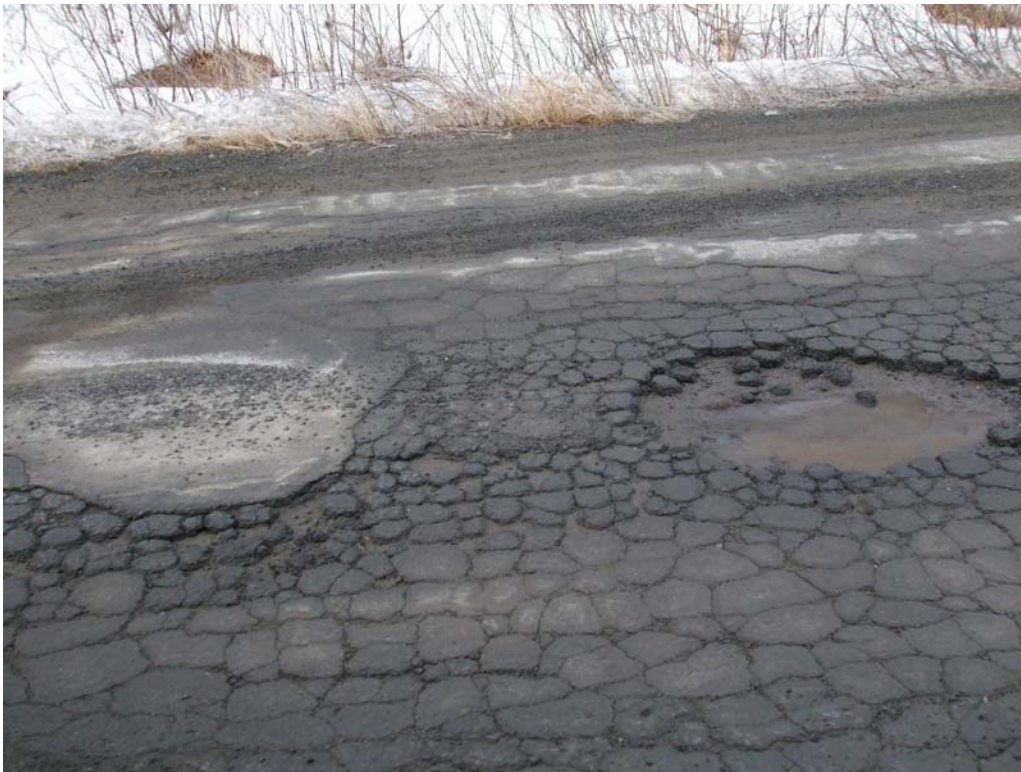
**Figure 1: Road Structural Failure due to Trapped Water**

The road is in a deteriorated condition due to structural failure caused by trapped water within the road structure, beneath the asphalt. The photos below illustrate some of the damage caused to the road.

Figure 1 shows extensive cracking of the pavement and holes in the asphalt topping. This has resulted from the trapped water underneath the road. Alternate freezing and thawing of the water wreak havoc on the road. Before any road repairs are carried out, some roadside clearing, ditching and culvert installations are also necessary in order to manage storm water and ground water. Good drainage must first be provided.

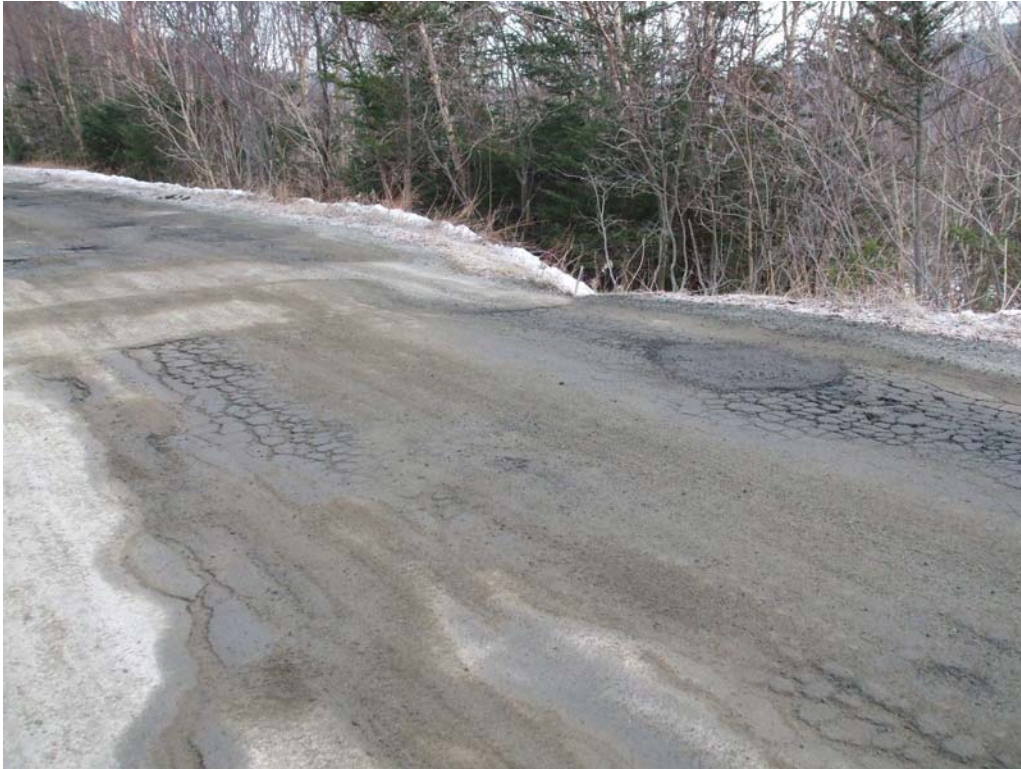
**Figure 2: Road Damage Caused by a Collapsed Cross-Culvert**

Figure 2 shows the results of a collapsed culvert. The culvert has weakened and deteriorated over time disabling it from being able to control water as it was originally designed. Figure 2 also illustrates erosion at the shoulder of the roadway where the culvert exits. Also, there is deep structural failure of the traveled lane.

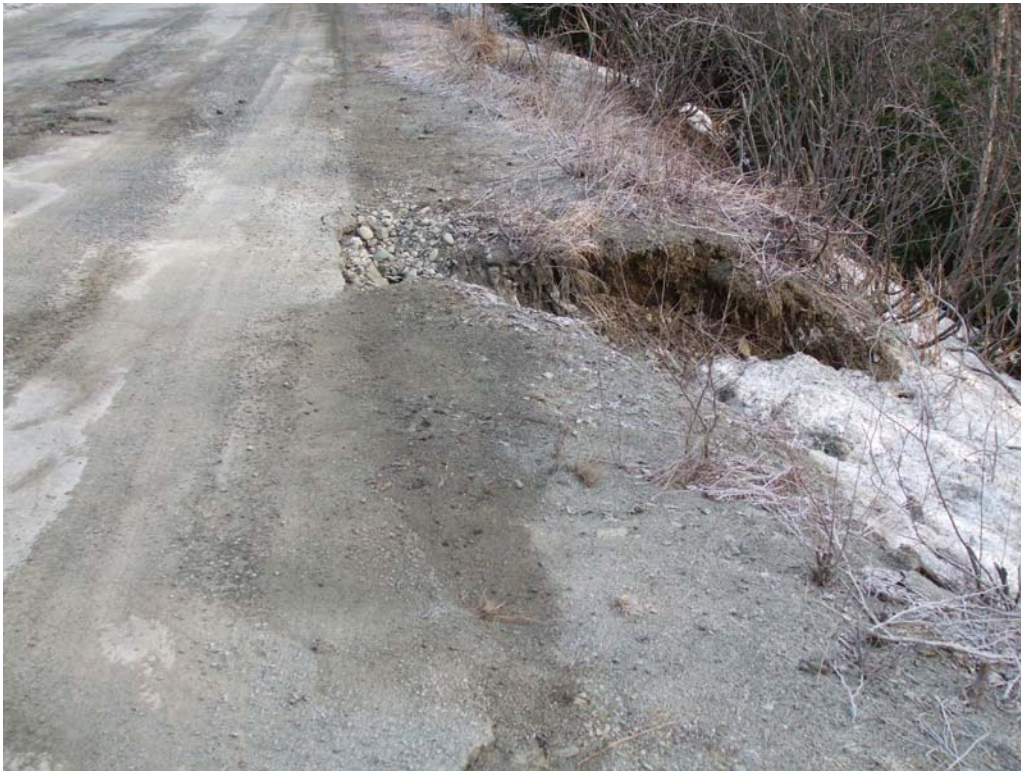
**Figure 3: Erosion of the Shoulder of the Road**

Figure 3 illustrates erosion caused mainly by uncontrolled water run-off. Water gathers on the road because of poor ditching and collapsed or plugged culverts.
