# **2010 CAPITAL BUDGET APPLICATION**

## PLANT LIFE EXTENSION UPGRADES

### Hardwoods Gas Turbine

June 2009

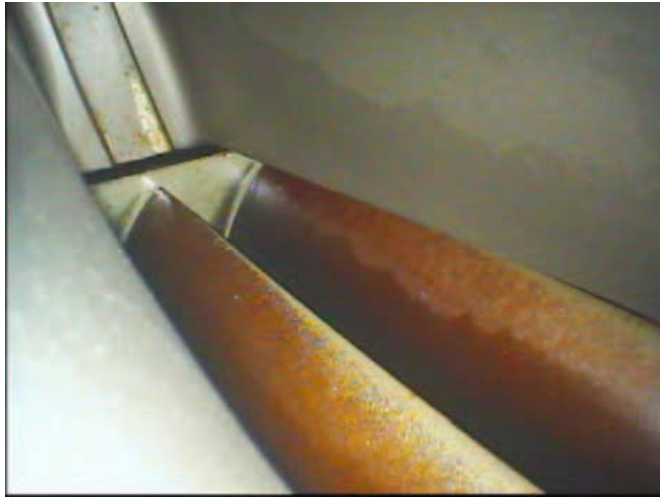
The photo below (Figure 3), taken during an internal inspection on May 30, 2007, shows corrosion due to coating loss inside the End B gas turbine engine at Hardwoods.

**Figure 3: Corrosion on End B Engine**

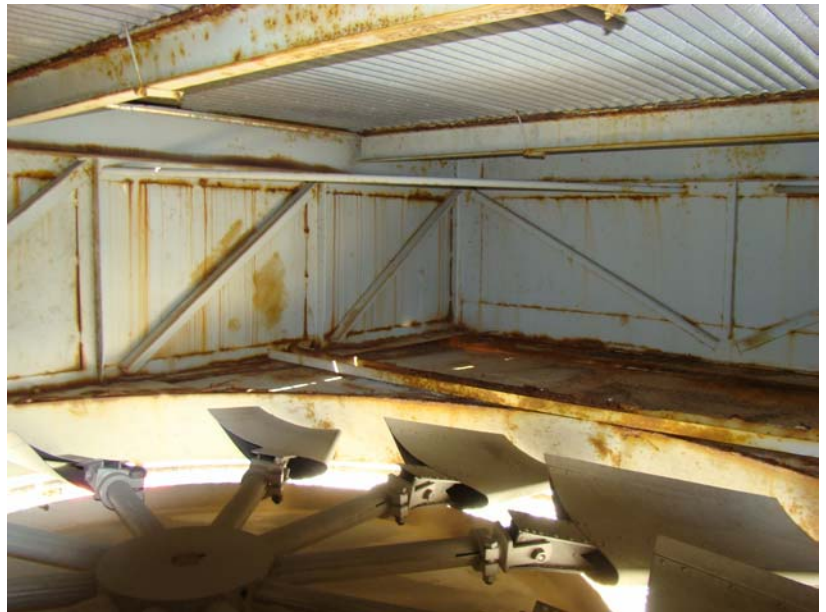
As shown in the photo (Figure 4), the floor of the wind box is extensively corroded causing rust debris to collect in the bottom of the unit. The air stream carries this debris through the cooler. Over time, the debris accumulates in the space between the glycol tubes. This impedes airflow which in turn reduces the cooling capability of the unit.

**Figure 3: Inside View of Wind Box – Alternator Glycol Cooler**

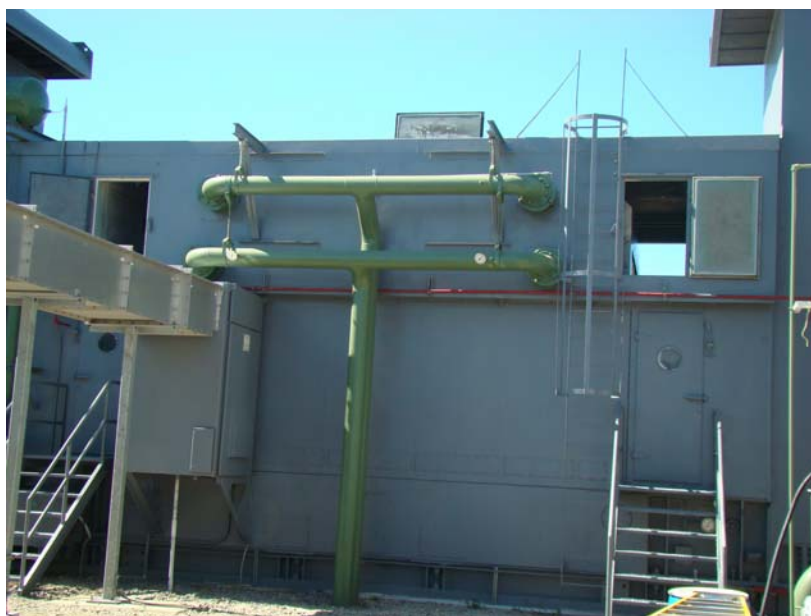
the manufacturer does not recommend opening the emergency cooling doors unless in an emergency because the entering air is not filtered. In addition, this puts the generator at risk because when the doors are open the generator is exposed directly to the weather.

**Figure 5: Alternator Enclosure – Emergency Doors Open**

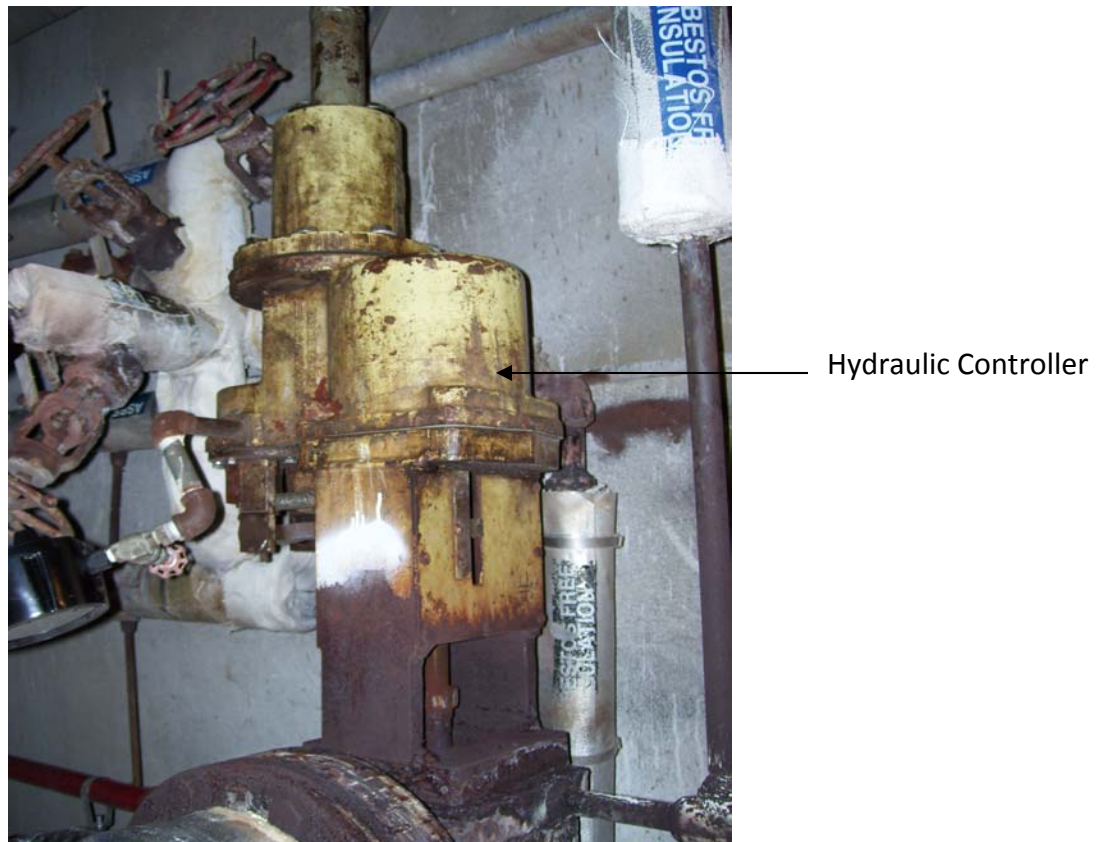
The existing Unit 1 steam seal regulator shown in Figure 2 below is an automated hydraulic system with many moving parts and wear points. A daily problem with binding and sticking of the moving parts requires an operator attendant to manually free them. Improper operation of the regulator, due to binding and sticking, allows steam to travel along the turbine rotor shaft and mix with the bearing lubrication oil where it condenses to water and accelerates deterioration of the bearings. Premature failure of the turbine bearings can result in an unplanned unit outage of 10 to 12 weeks duration and a repair cost estimated to be as high as \$1 million. An unscheduled unit outage during the peak winter load demand would result in a loss of 170 MW of power generation to the Island Interconnected System which represents approximately 11 percent of Hydro's Island Interconnected system capacity.

**Figure 2: Unit 1 Steam Seal Regulator**

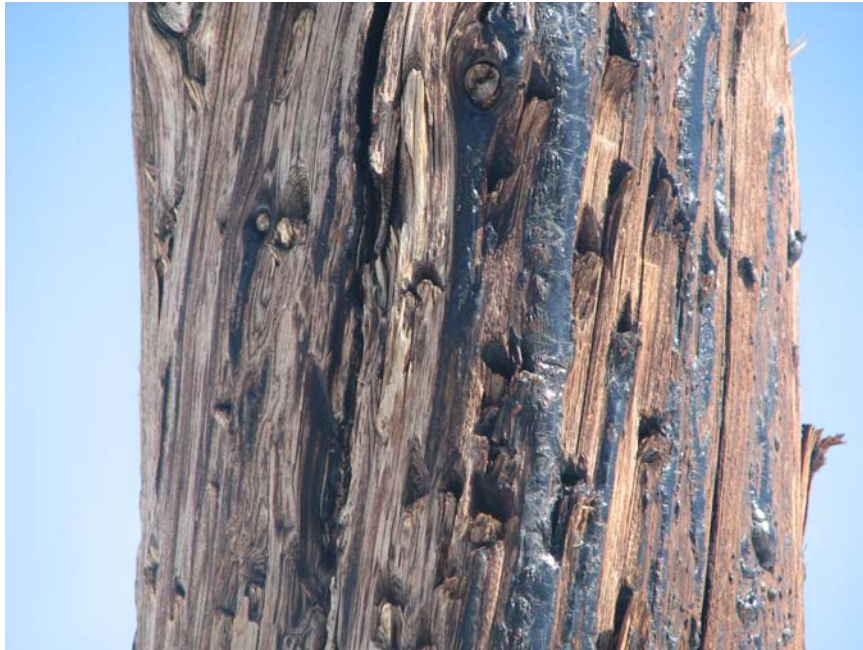
**Figure 3: Typical deteriorated pole (Blackjack).**

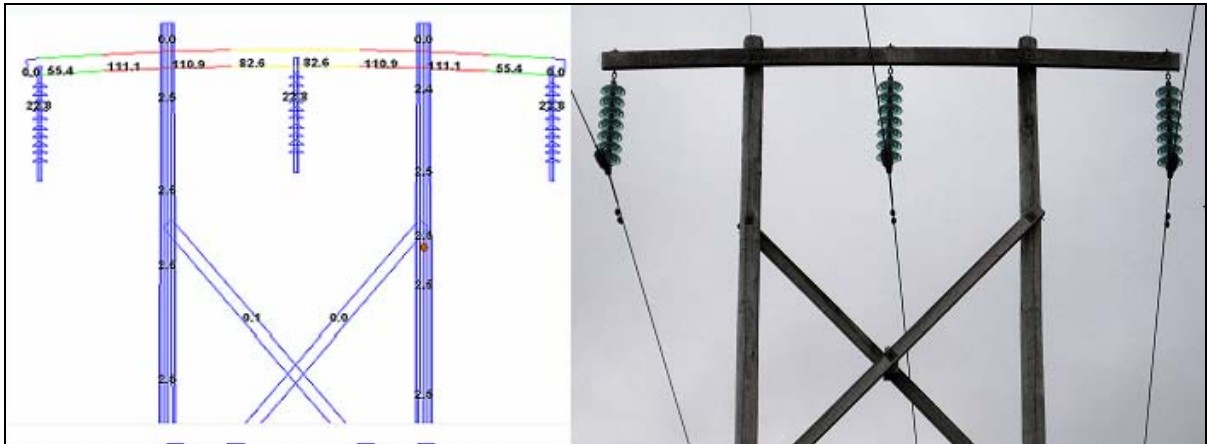
which are over-stressed. The crossarm is utilized to 111 percent of its maximum allowable stress and is clearly showing the crossarm bending under the load. The picture on the right shows the actual structure and it clearly shows that even under the everyday condition there is some obvious bending in the crossarm.

**Figure 5: Typical Crossarm Loading under a 31.75 millimetres Ice Load**

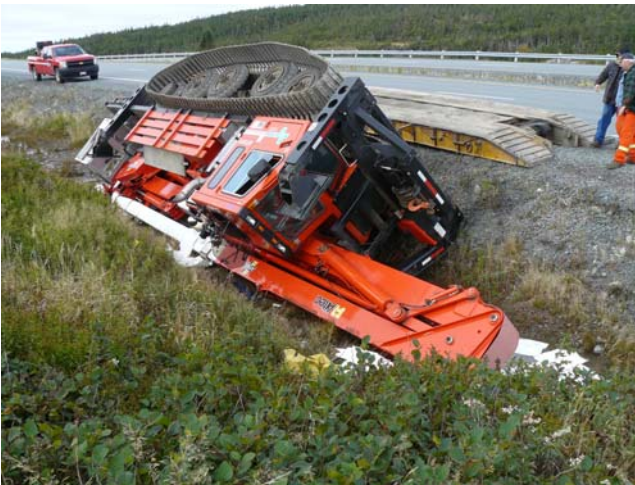
which gave way slightly and with its own weight, the machine toppled onto its right side resting on the outriggers and boom in the ditch by the roadside. The operator remained in the machine but there were no injuries. The deck was clear and dry at the time of the incident. Direct and indirect costs to Hydro arising from this incident totaled \$56,000. Figures 1 and 2 show pictures of this incident.

**Figure 1: Go-Track unit resting on damaged outriggers and boom.**

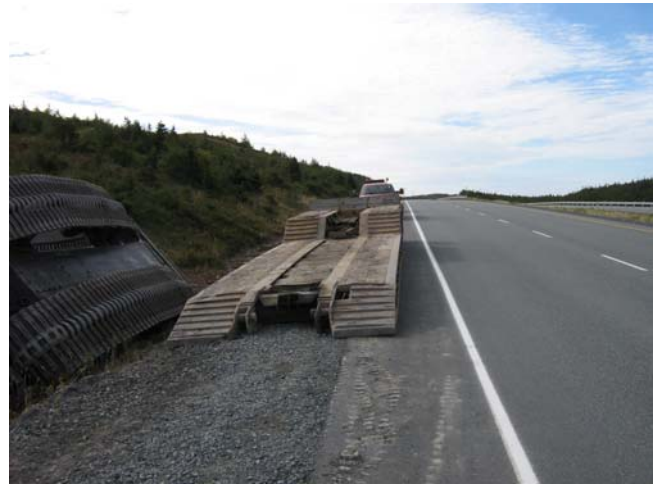
**Figure 2: Low bed trailer parked close to the edge of the ditch to maintain clearance to the driving lane as Go-Track unit overhangs trailer deck on both sides when loaded. Note the tilt of the trailer and the shape of the tracks on the Go-Track unit.**

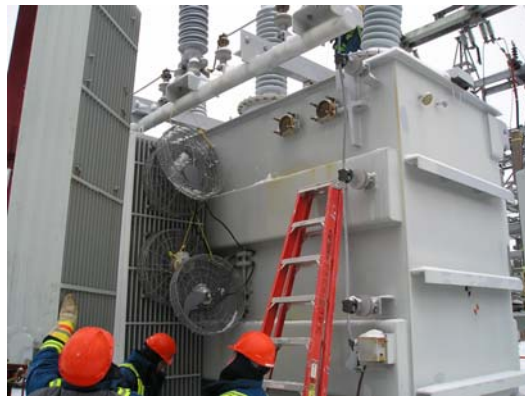
Historically radiators were manufactured from painted carbon steel and Newfoundland and Labrador's environmental conditions have resulted in corrosion causing damage beyond repair. In some cases, this damage has lead to oil leaks. Figure 4 shows radiators being replaced at Bottom Waters. Table 3 shows a list of work completed with transformer radiators in recent years.

**Figure 4: Radiators Being Replaced at Bottom Waters**

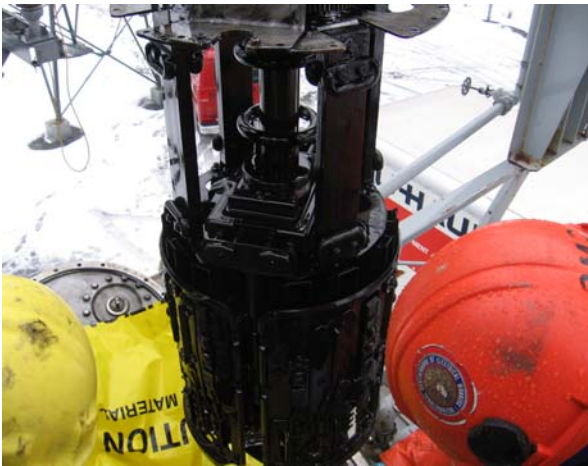
**Figure 5: Before Overhaul**

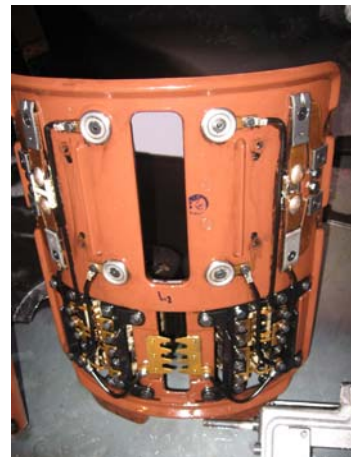
**Figure 6: After Overhaul**
