**2010 CAPITAL BUDGET
APPLICATION**

PLANT LIFE EXTENSION UPGRADES

Hardwoods Gas Turbine

June 2009

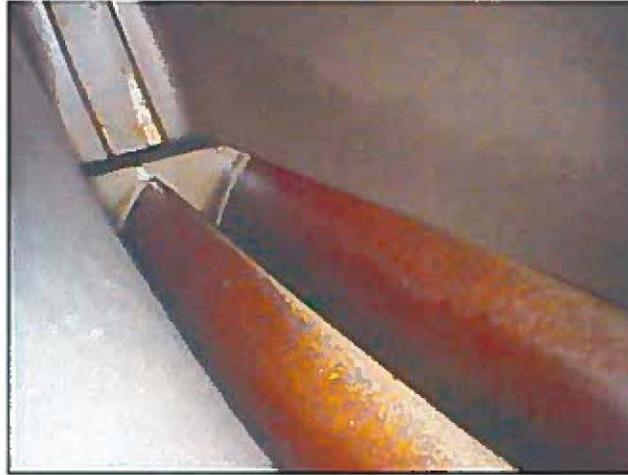
Figure 3: Corrosion on End B Engine

The photo below (Figure 3), taken during an internal inspection on May 30, 2007, shows corrosion due to coating loss inside the End B gas turbine engine at Hardwoods.

- Disassemble End A and End B gas turbine engines. Inspect and refurbish as required.
- Inspect End A and End B power turbines upon removal of gas turbine engines. Perform required repairs.
- Completely disassemble and inspect End A and End B clutches.
- Replace ignition igniters.
- Replace speed governors/fuel valve assemblies.
