**OVERHAUL GAS TURBINE
Holyrood Thermal Generating Station**

April 2010

Borescope Inspection of Avon 37029 1533 70L

Borescope inspection of Avon 37029 1533 70L

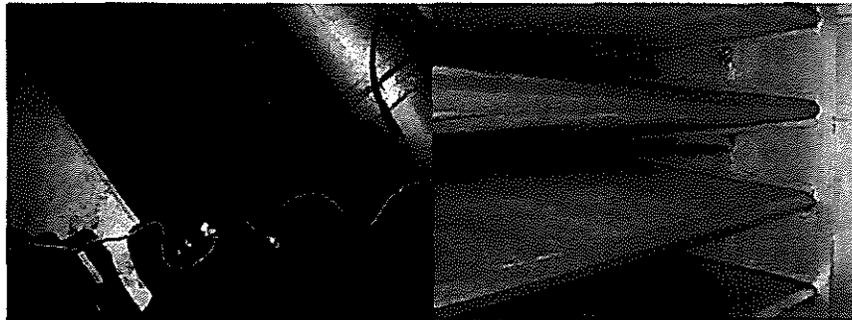
On entering the plenum it was noted that a large amount of water had gathered under the intake, this will have a significant impact on the units condition, corrosion and potential for FOD ingress. In addition 2 large holes were noted in the sidewall as well as a large amount of rust particles on the floor. All of these will have a risk of ingress attached.

Water in plenum

Hole in side wall

The unit showed greater salt ingress and corrosion this year, this would be attributed to the poor condition of the intake plenum, water ingress and flaking corrosion particles. This should be addressed prior to any further running.

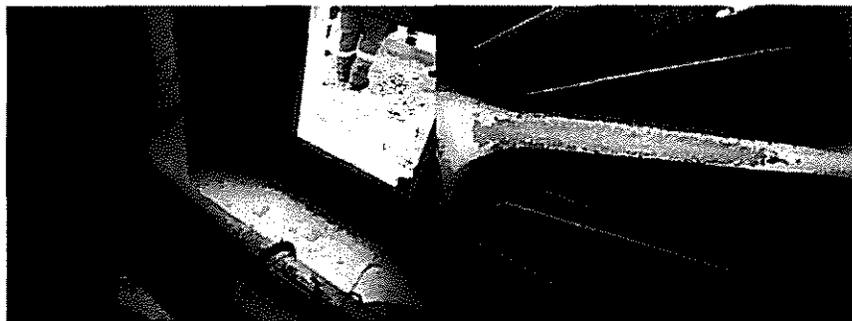
Rust particles

Corrosion on intake

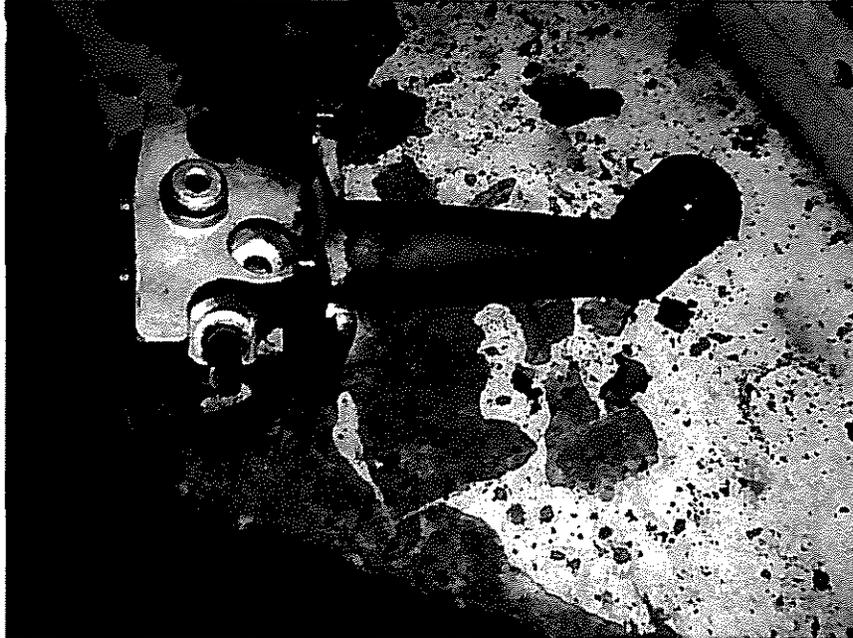
Burner No1 after removal
