1 Q. Please provide a copy of the 2011 AMEC Consulting report on the condition  
2 assessment of the Holyrood Gas Turbine.

Holyrood Thermal Generating Station (Holyrood) Gas Turbine Condition Assessment & Options Study –  
Final Report

### Gas Turbine Condition Assessment & Options Study

December 19, 2011

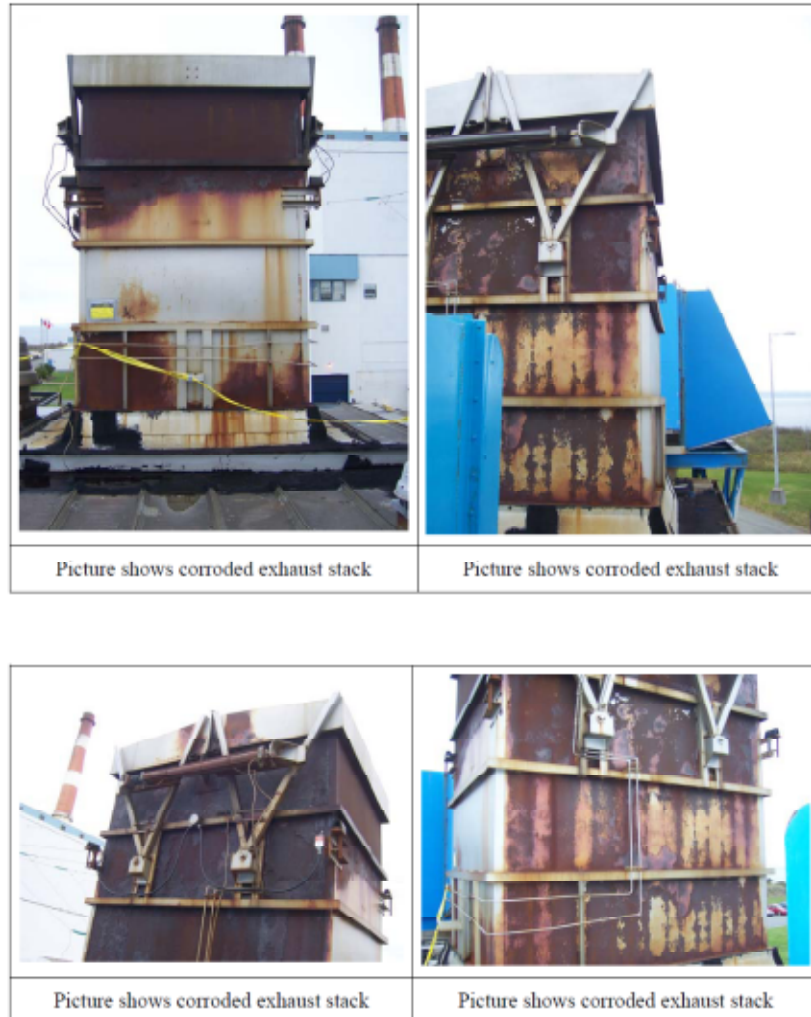
**FIGURE 2-7 CORRODED EXHAUST STACK (GAS TURBINE PLANT)**

**Exhaust Stack:** The exhaust stack is extensively corroded with leaks into the building and into the turbine, and should be replaced.

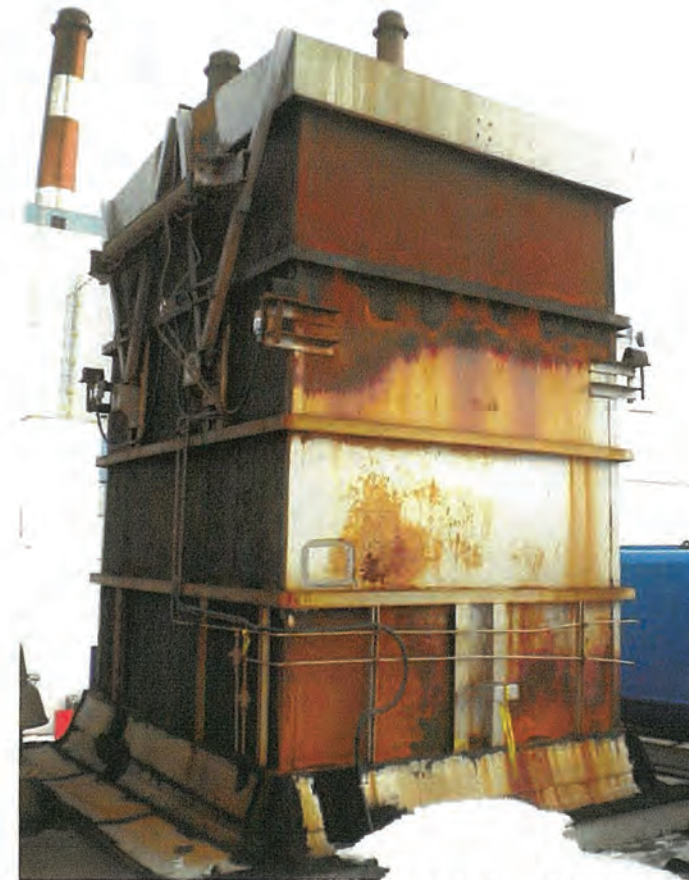
1. The exterior condition of the exhaust stack shows significant carbon steel crystallization, peeling of the carbon. CS casing is typically good for temperatures up to 750F (400C) There was no fatigue or cracking of any of the visual welds or any failure of welds (inspection was performed from roof on top of the turbine building). The top of the exhaust stack has a "snow-hood" which opens during operation to allow the exhaust gases to vent atmosphere. On the "south" side of the stack shows "bulging" of the stack, see photo 3.

Figure 1 – side wall of exhaust stack,

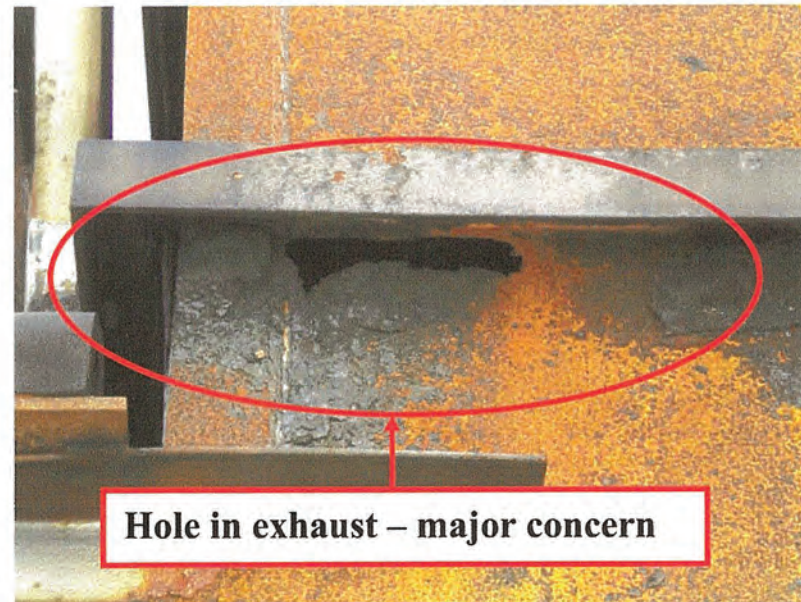
**Figure 2** – near top of the exhaust stack with carbon steel deterioration.

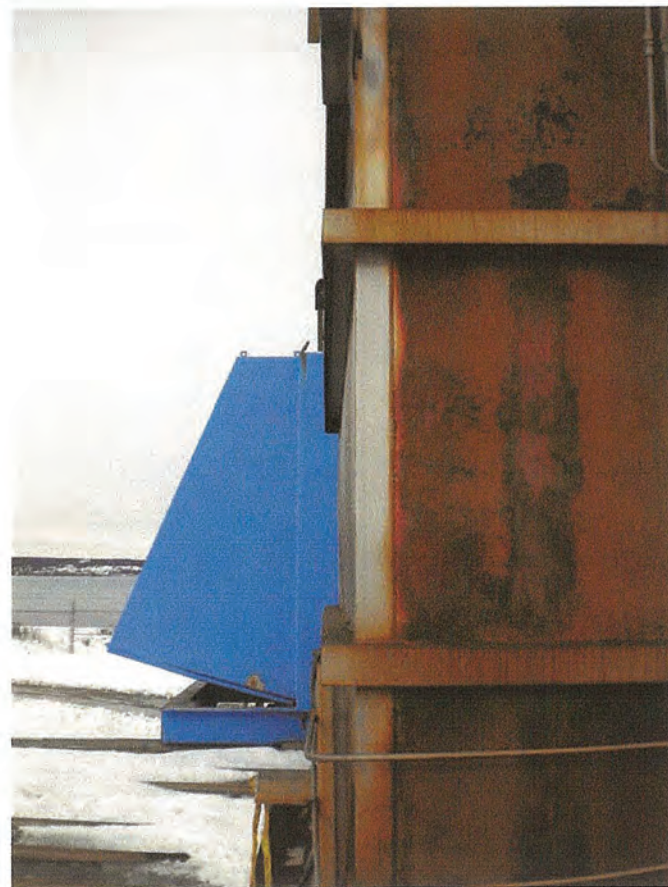
**Figure 3** – Slight bulge in sidewall.

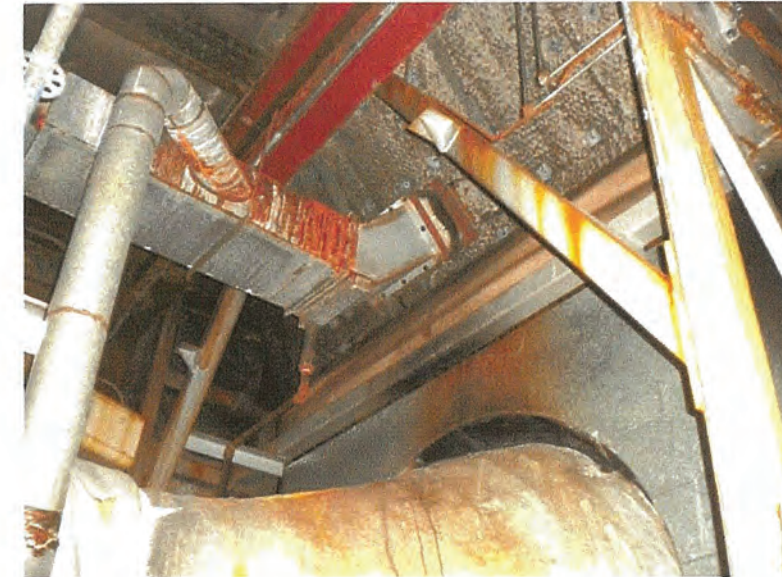
**Figure 4** Transition area of with external insulation above the exhaust plenum.

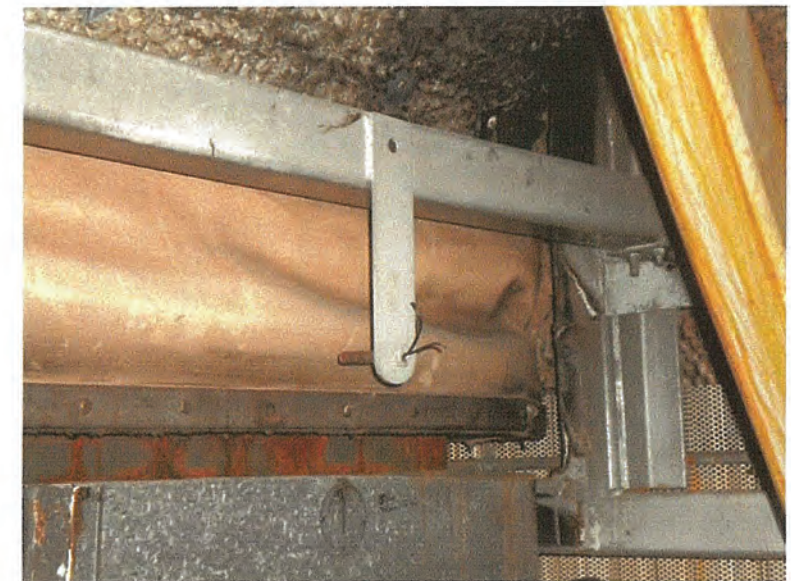
**Figure 5** Expansion joint belt in good condition.

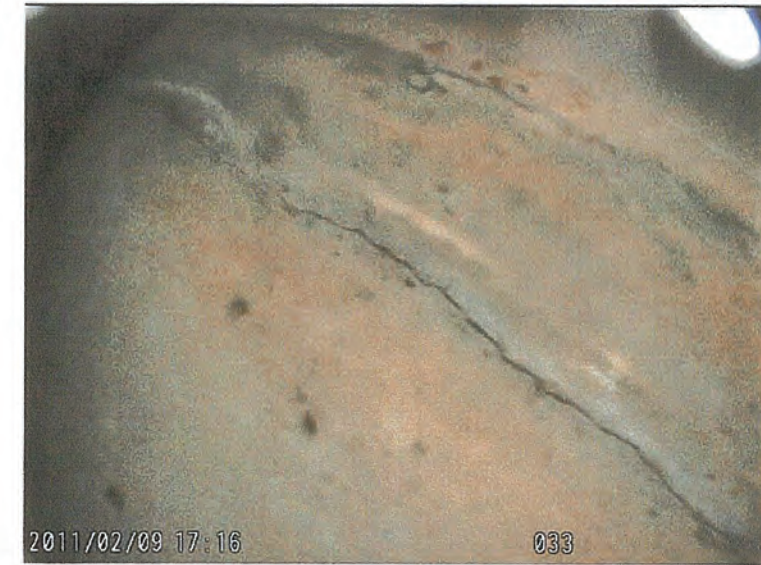
Photo 1. Showing crack around circumference of the PT cone.

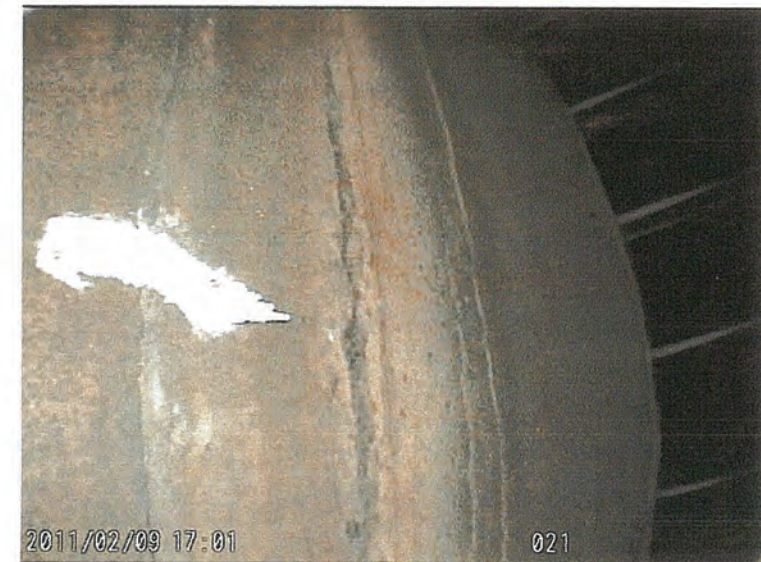
Photo 2. Showing crack around circumference of the PT cone.

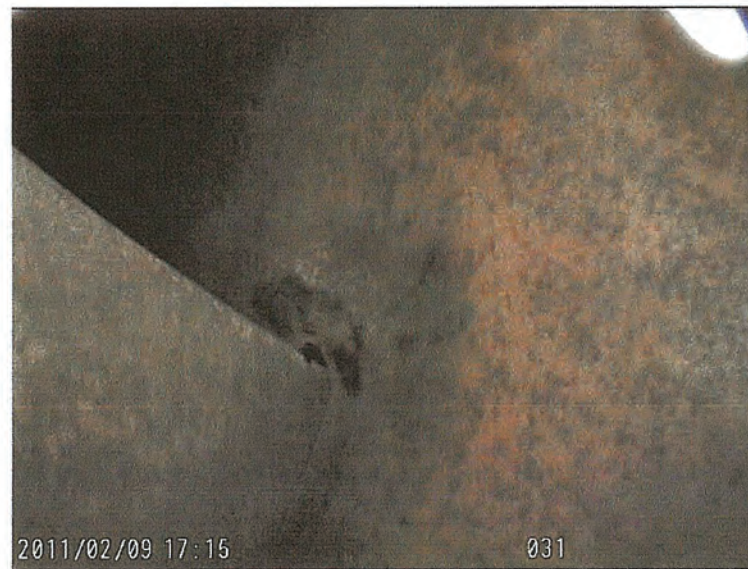
Photo 4. showing weld repair on cone spoke inner edge.

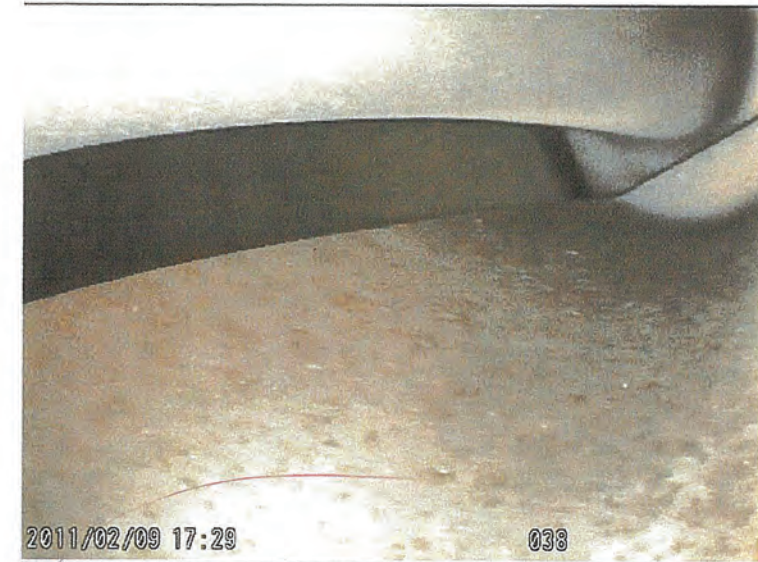
Photo 9. Showing corrosion on blades.

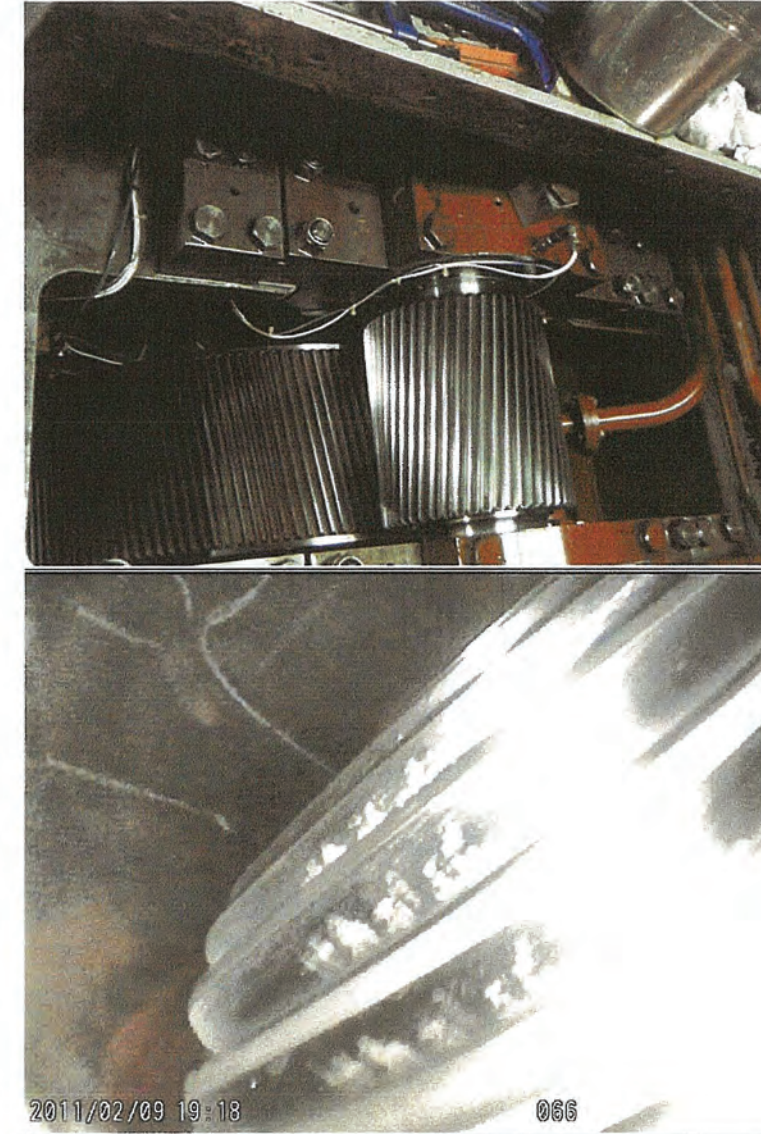
Photos 13 & 14 showing gearwheel condition.

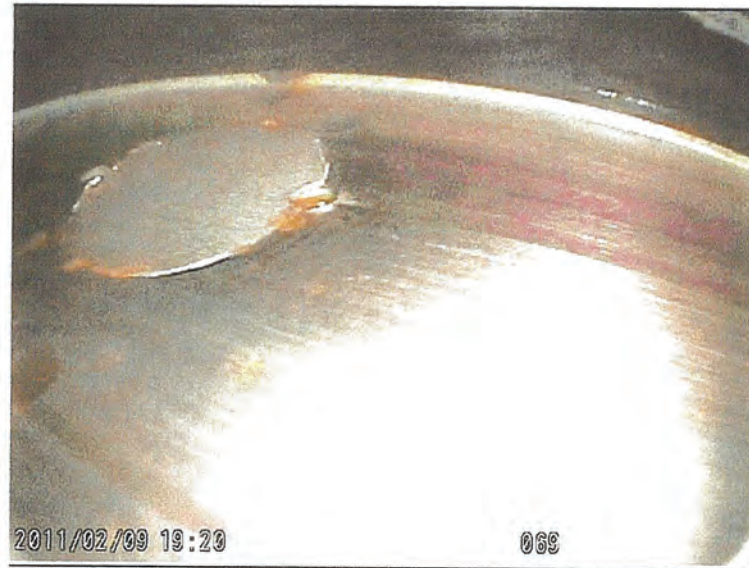
Photo 15. Showing gearwheel dowel pin.

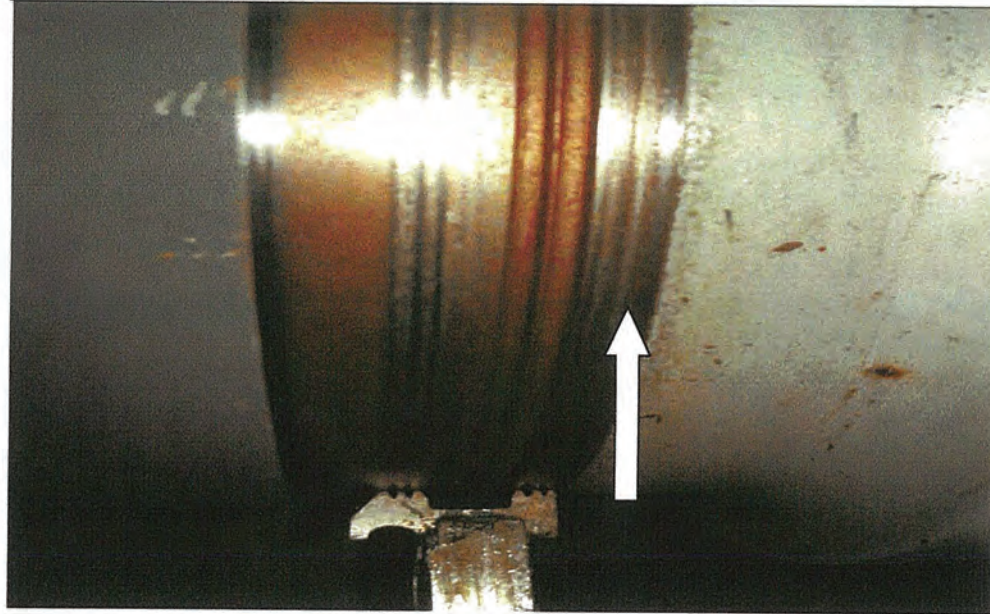
Inboard labyrinth seal and shaft seal (grooves wear marks) paint removal indicates thermal expansion

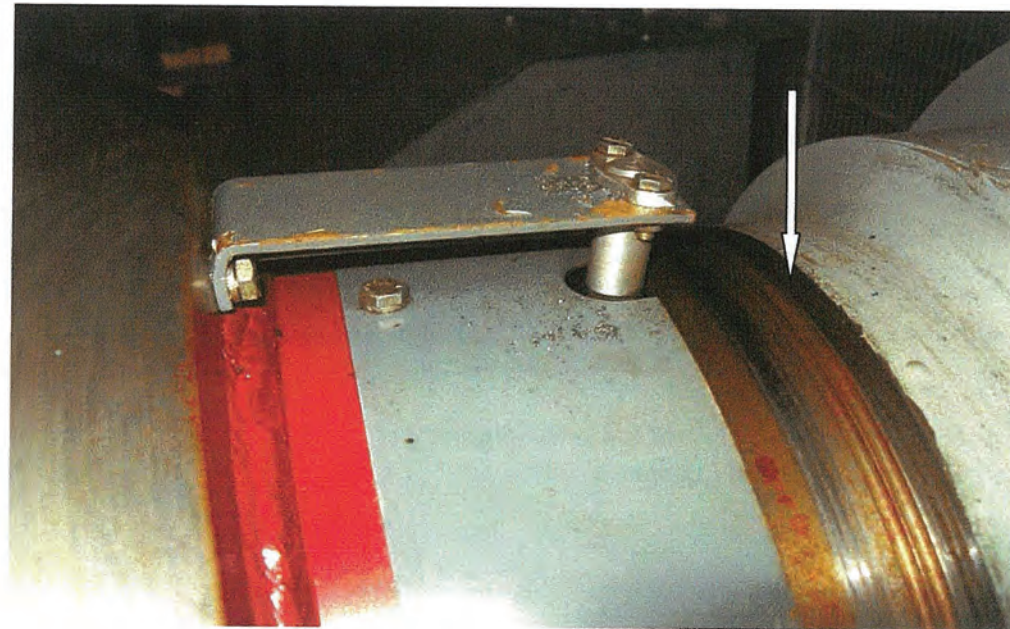
Inboard oil wiper setup and shaft seal condition (grooves wear marks)  
Same thing applied on the outboard end but in reverse direction

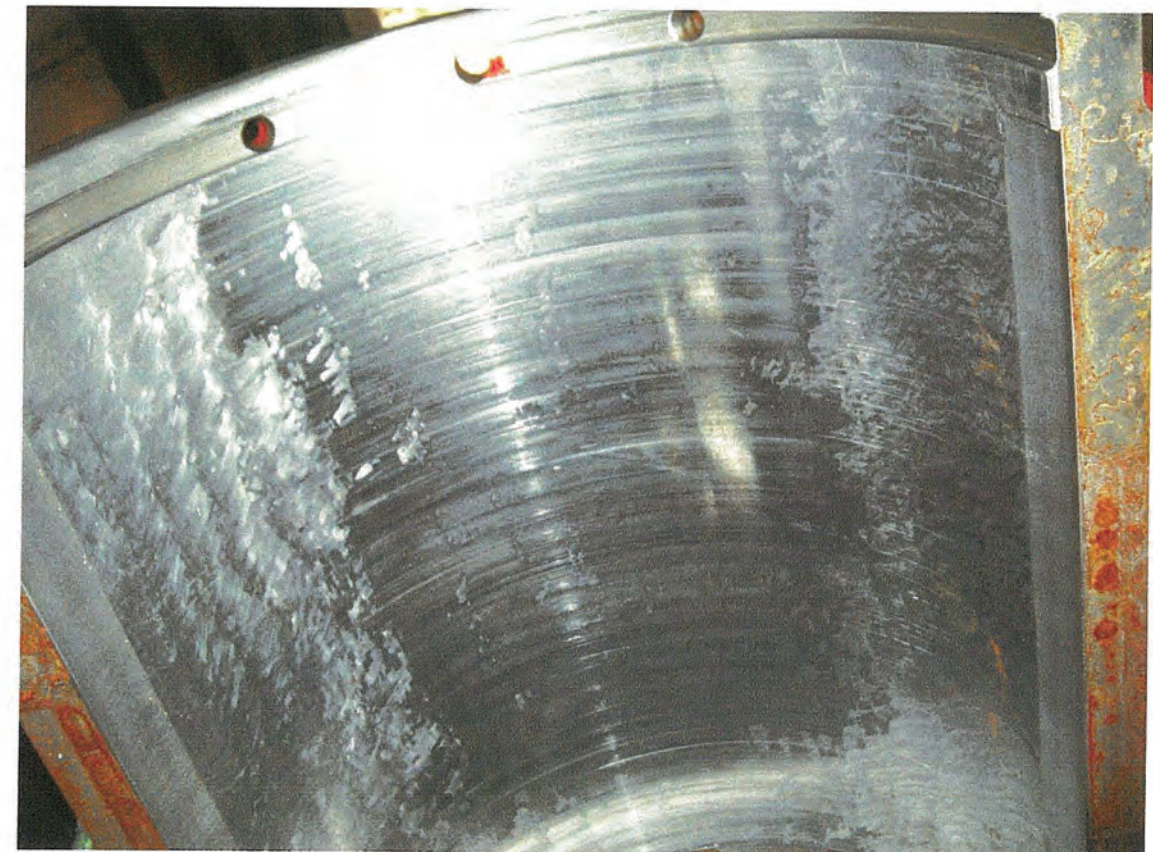
Babbitt liner of bottom half bearing

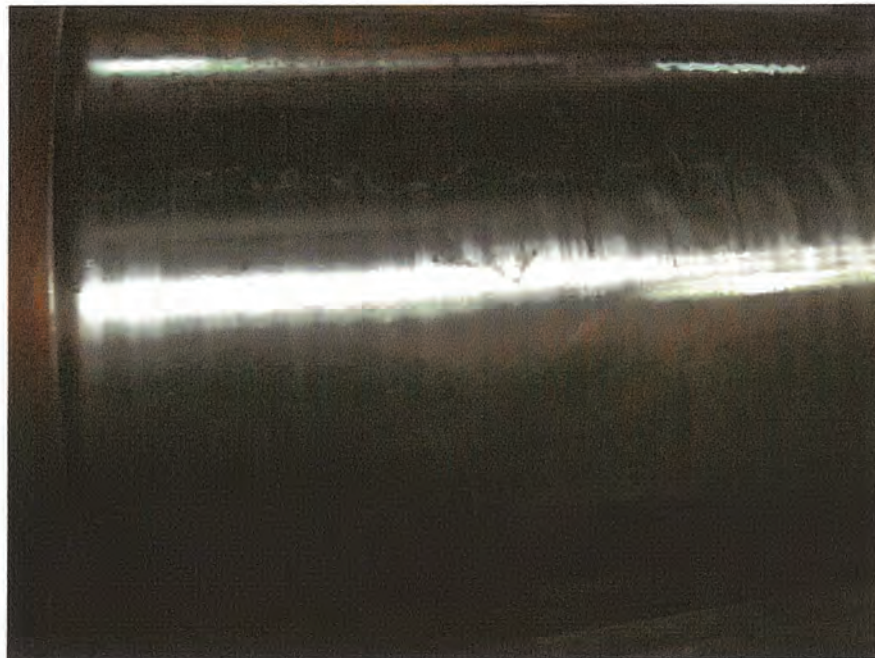
Shaft journal condition (marking of sitting idle for long period of time)

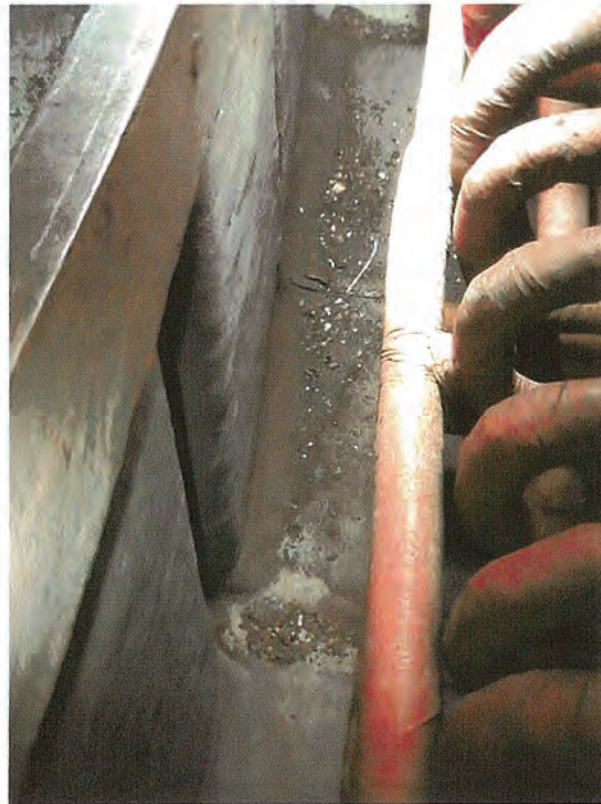
Rust flakes present in bottom of stator enclosure.

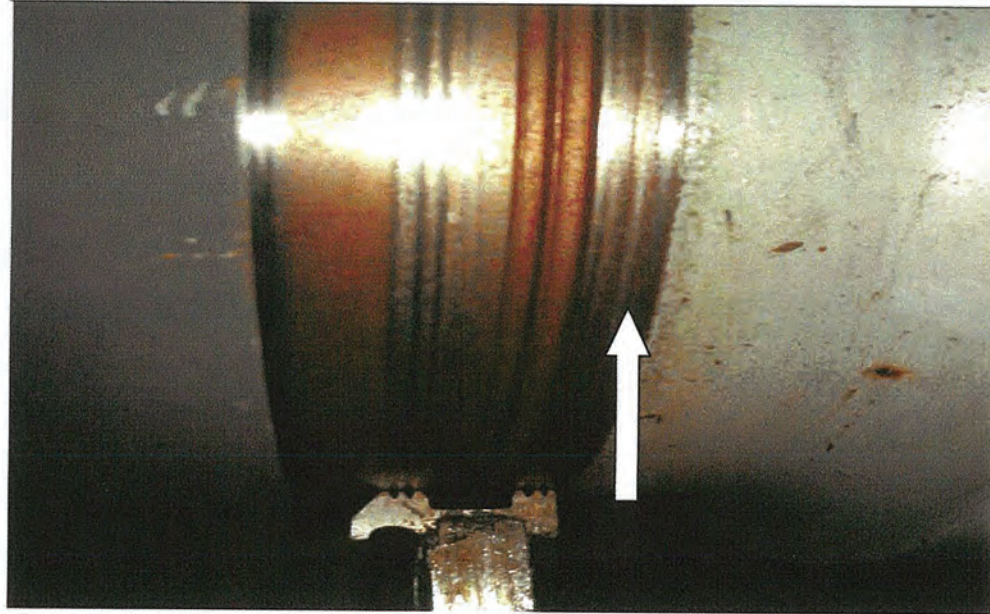
Inboard labyrinth seal and shaft seal (grooves wear marks) paint removal indicates thermal expansion

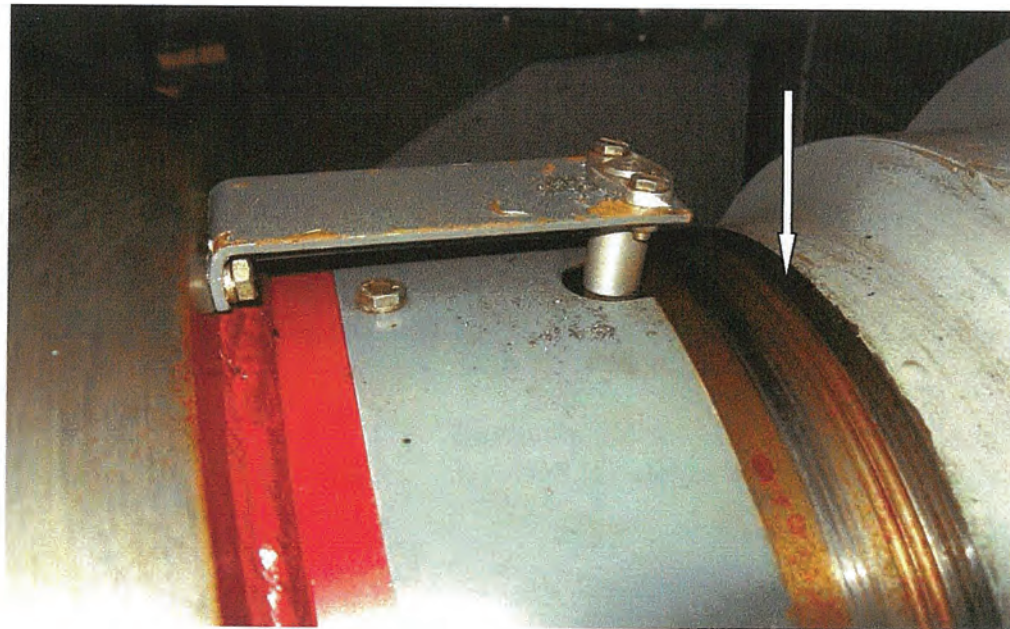
Inboard oil wiper setup and shaft seal condition (grooves wear marks)  
Same thing applied on the outboard end but in reverse direction

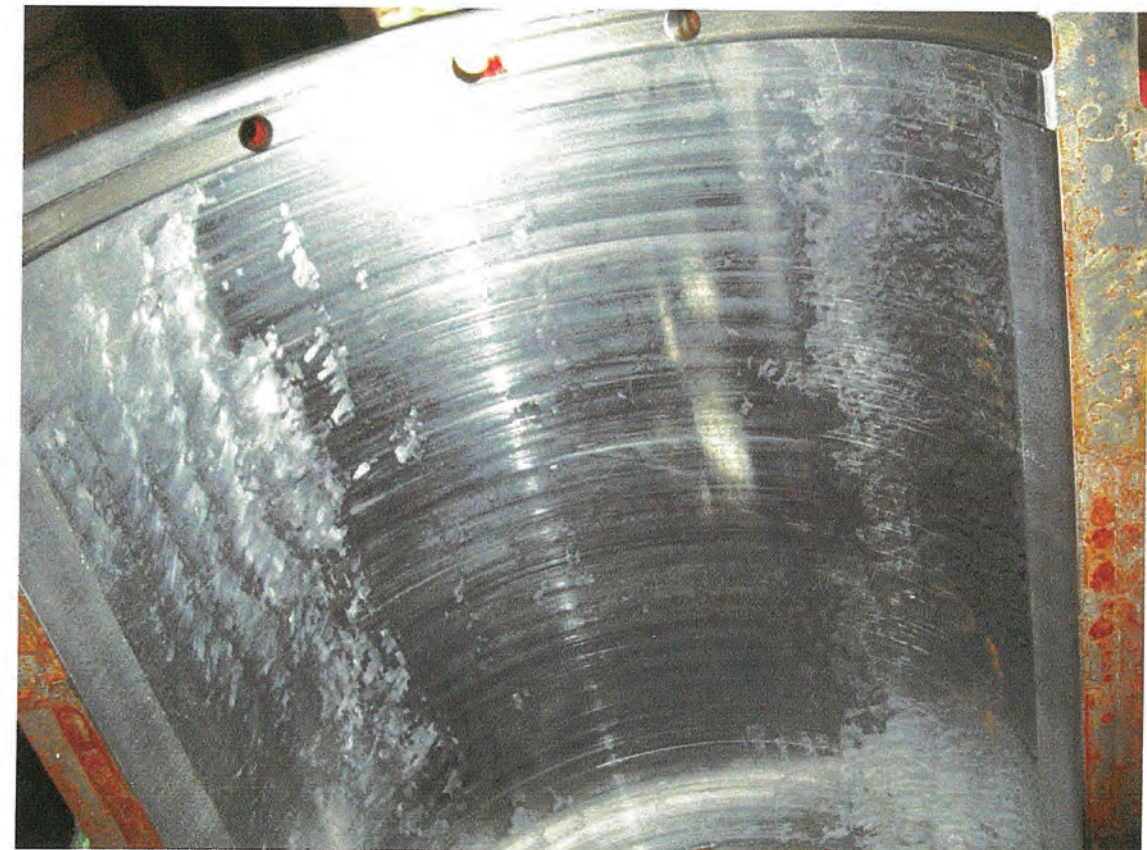
Babbitt liner of bottom half bearing

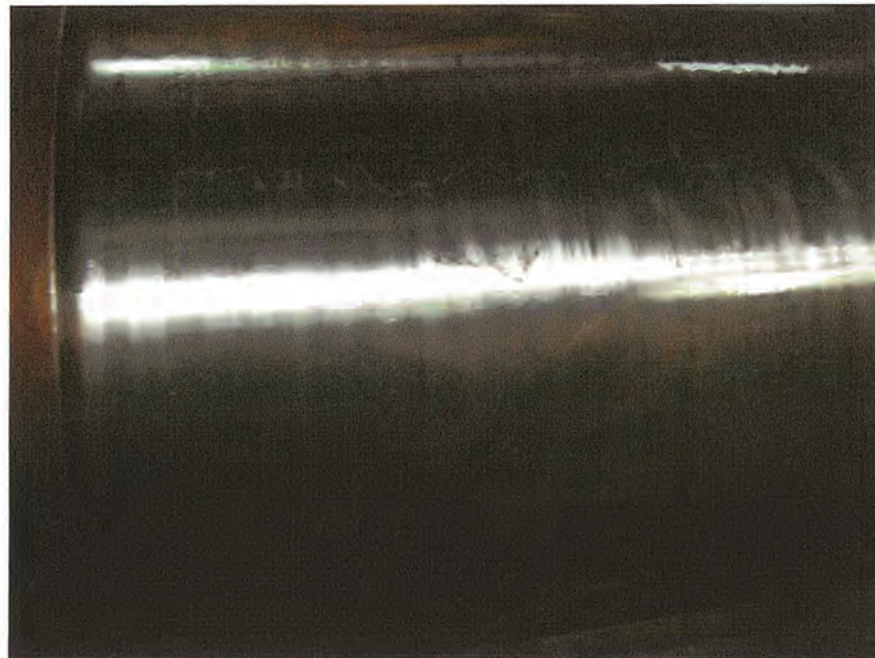
Shaft journal condition (marking of sitting idle for long period of time)

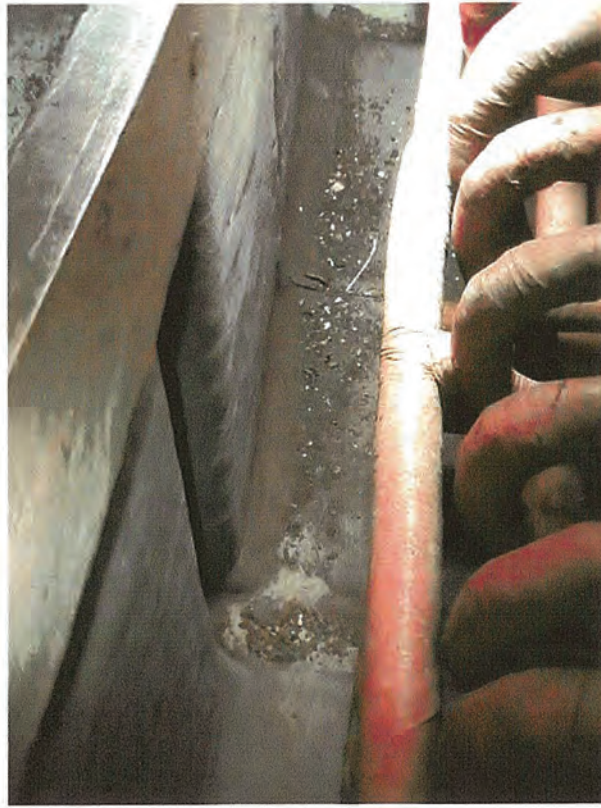
Rust flakes present in bottom of stator enclosure.

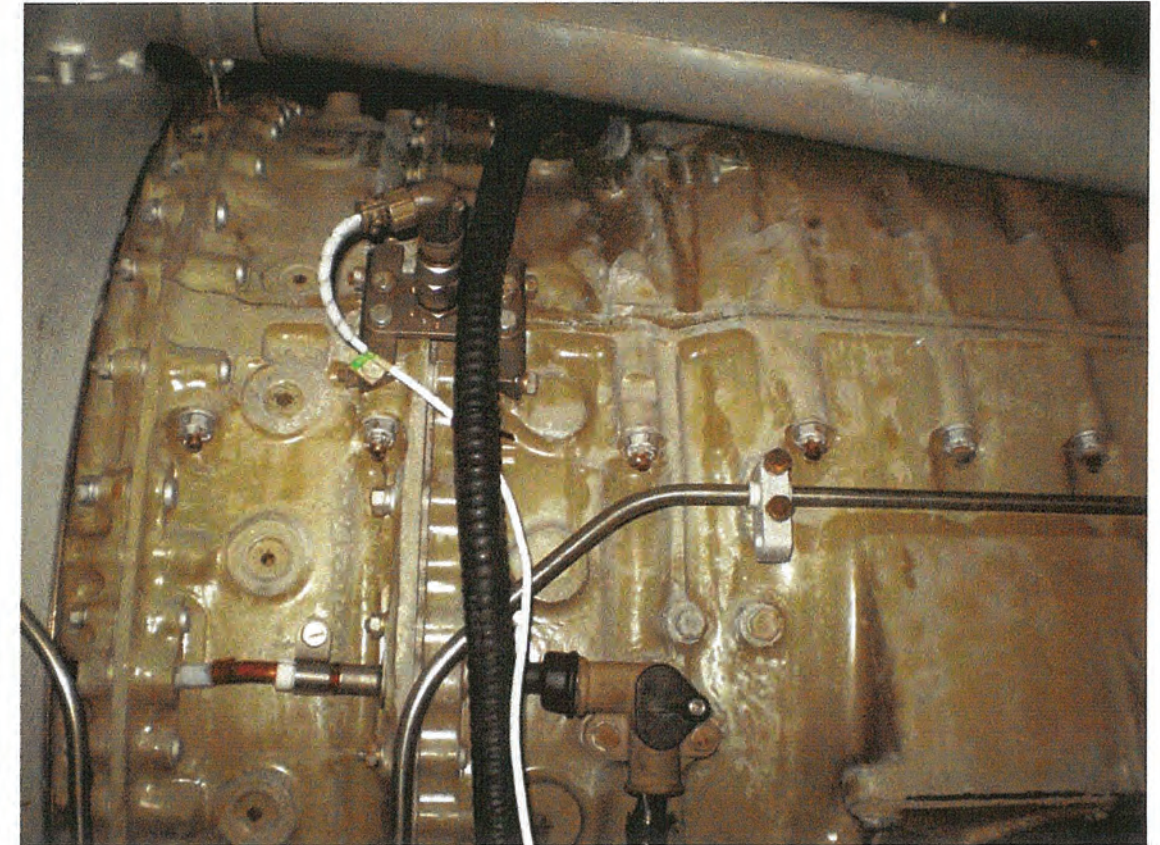
Light to medium loss of coating and corrosion to outer surfaces of the compressor casing
