1 Q. Please provide a copy of the 2011 AMEC Consulting report on the condition  
2 assessment of the Holyrood Gas Turbine.

Holyrood Thermal Generating Station (Holyrood) Gas Turbine Condition Assessment & Options Study –  
Final Report

### Gas Turbine Condition Assessment & Options Study

December 19, 2011

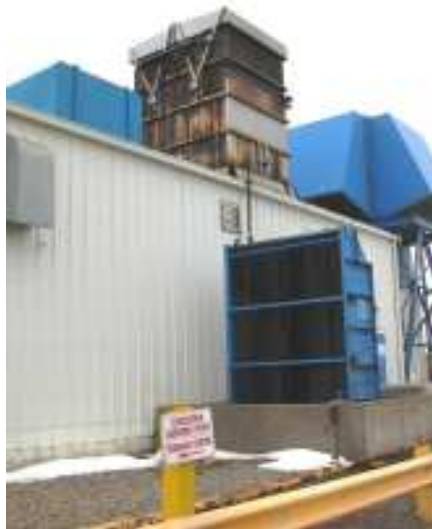
**FIGURE 2-4 LIGHT OIL RECEIVING & LUBE OIL RADIATOR**

- b. Venting system modifications required to reduce lube oil pressure buildup
    - c. Lube oil pump system requires upgrade for start-ups.
    - d. Lube oil cooling fan is experiencing some leaks and snow and ice and water build-ups in its containment can cause start-issues

- d. Lube oil cooling fan replacement
- iii) Gearbox bearings refurbishment or replacement and/or unit re-alignment
- iv) GT Generator testing and refurbishment

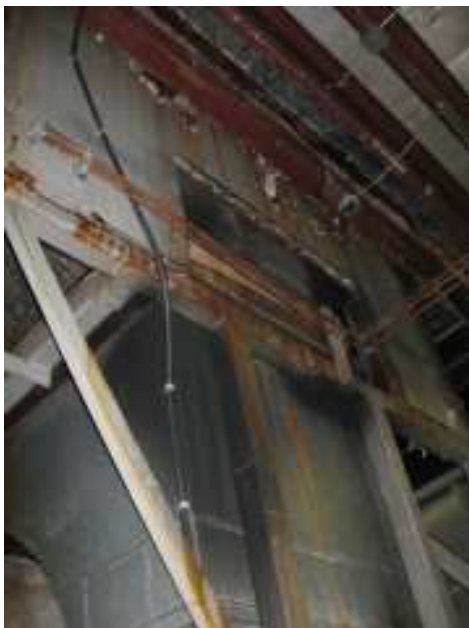
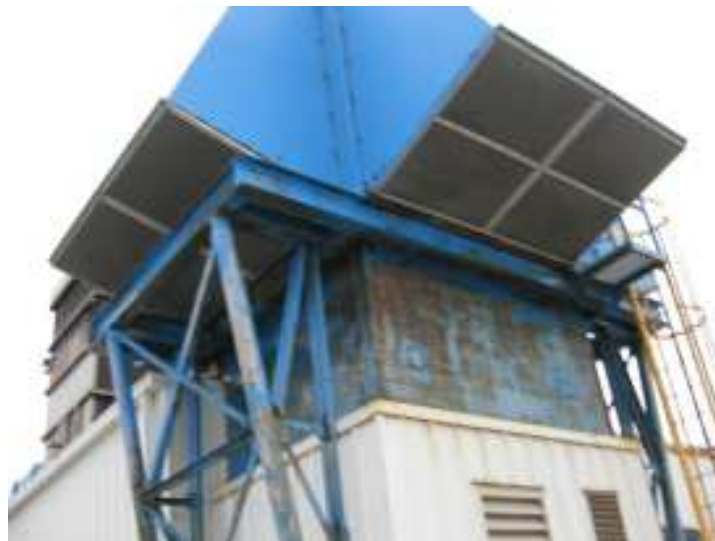
**FIGURE 2-5 GTG EXHAUST STACK & AIR INTAKE**

- v) Exhaust stack requires replacement or extensive repairs
  - vi) Gearbox lube oil system requires modification and refurbishment
    - a. Seals require replacement/modification

- Exhaust stack replacement or extensive repairs
  - Gearbox lube oil system modification and refurbishment
    - Seals replacement/modification;
    - Venting system modifications to reduce lube oil pressure buildup;

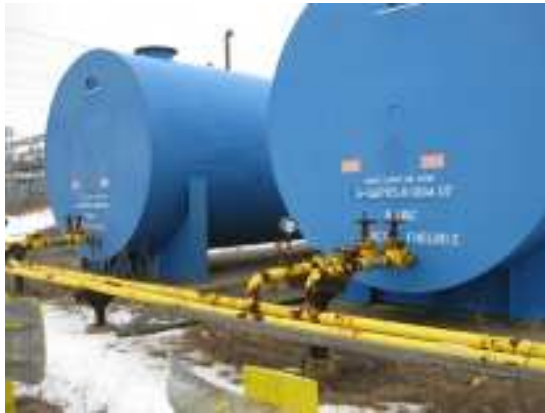
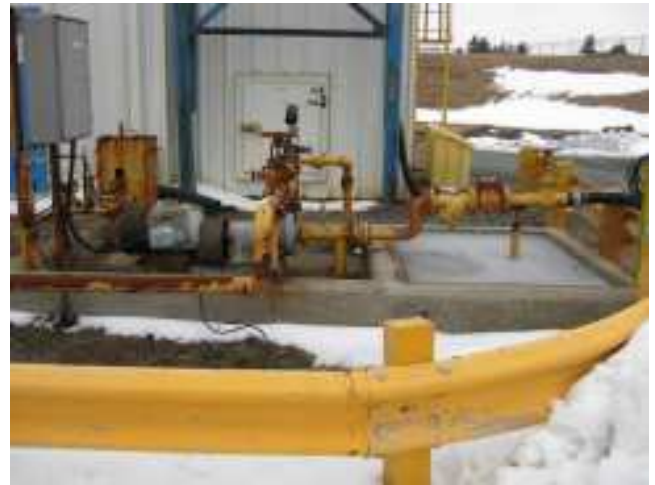
FIGURE 2-6 LIGHT OIL RECEIVING SYSTEM AND STORAGE TANKS

5. GT fuel oil receiving, forwarding, and delivery system are in operable condition, but climatic conditions (icing, snow-buildup, water build-ups from rain, rusting from salty ambient air) result in significant periods where starts may fail or be significantly delayed. The GT generator building is in generally good condition, except for:

The fuel lines in the dike area are in better condition likely as a result of being at least partially protected from the elements.

Some fuel forwarding pumps are located in a small enclosure to protect them from the elements. The concrete containment system in which the pumps sit was filled with approximately 4 inches of oily water at the time of the inspection.

- vii) GT fuel oil receiving, forwarding, and delivery system replacement in an enclosed shed.
- viii) GT generator building repairs:
  - a. Major leaks in and around the gas turbine exhaust stack

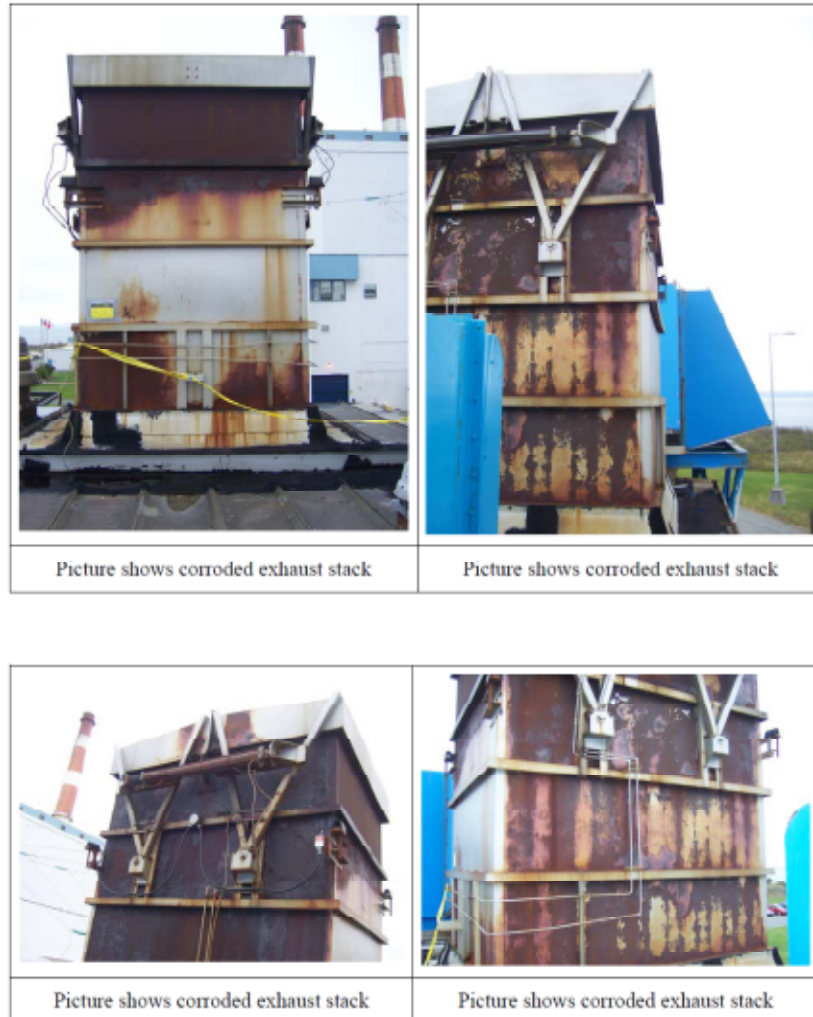
**FIGURE 2-7 CORRODED EXHAUST STACK (GAS TURBINE PLANT)**

- i) Major leaks in and around the GT exhaust stack which are impacting the gas turbine power turbine volute and back end blades;
  - ii) Minor leaks at generator ventilation stack; and

**Roofs & Siding:** The siding and roof of the gas turbine building, specifically in the area around the stack, at the roofliner, and at the base of the building, show evidence of significant corrosion.

**Exhaust Stack:** The exhaust stack is extensively corroded with leaks into the building and into the turbine, and should be replaced.
