1 Q. In response to CA-NLH-017 Hydro stated that:

- 1. January 11, 2013 Power System Outage Report**
- 2. Remedial Actions from the January 11, 2013 System Events**

**Unit 1 Failure – Holyrood  
Life Safety Review  
SWOP # 2013000599  
January 11, 2013**

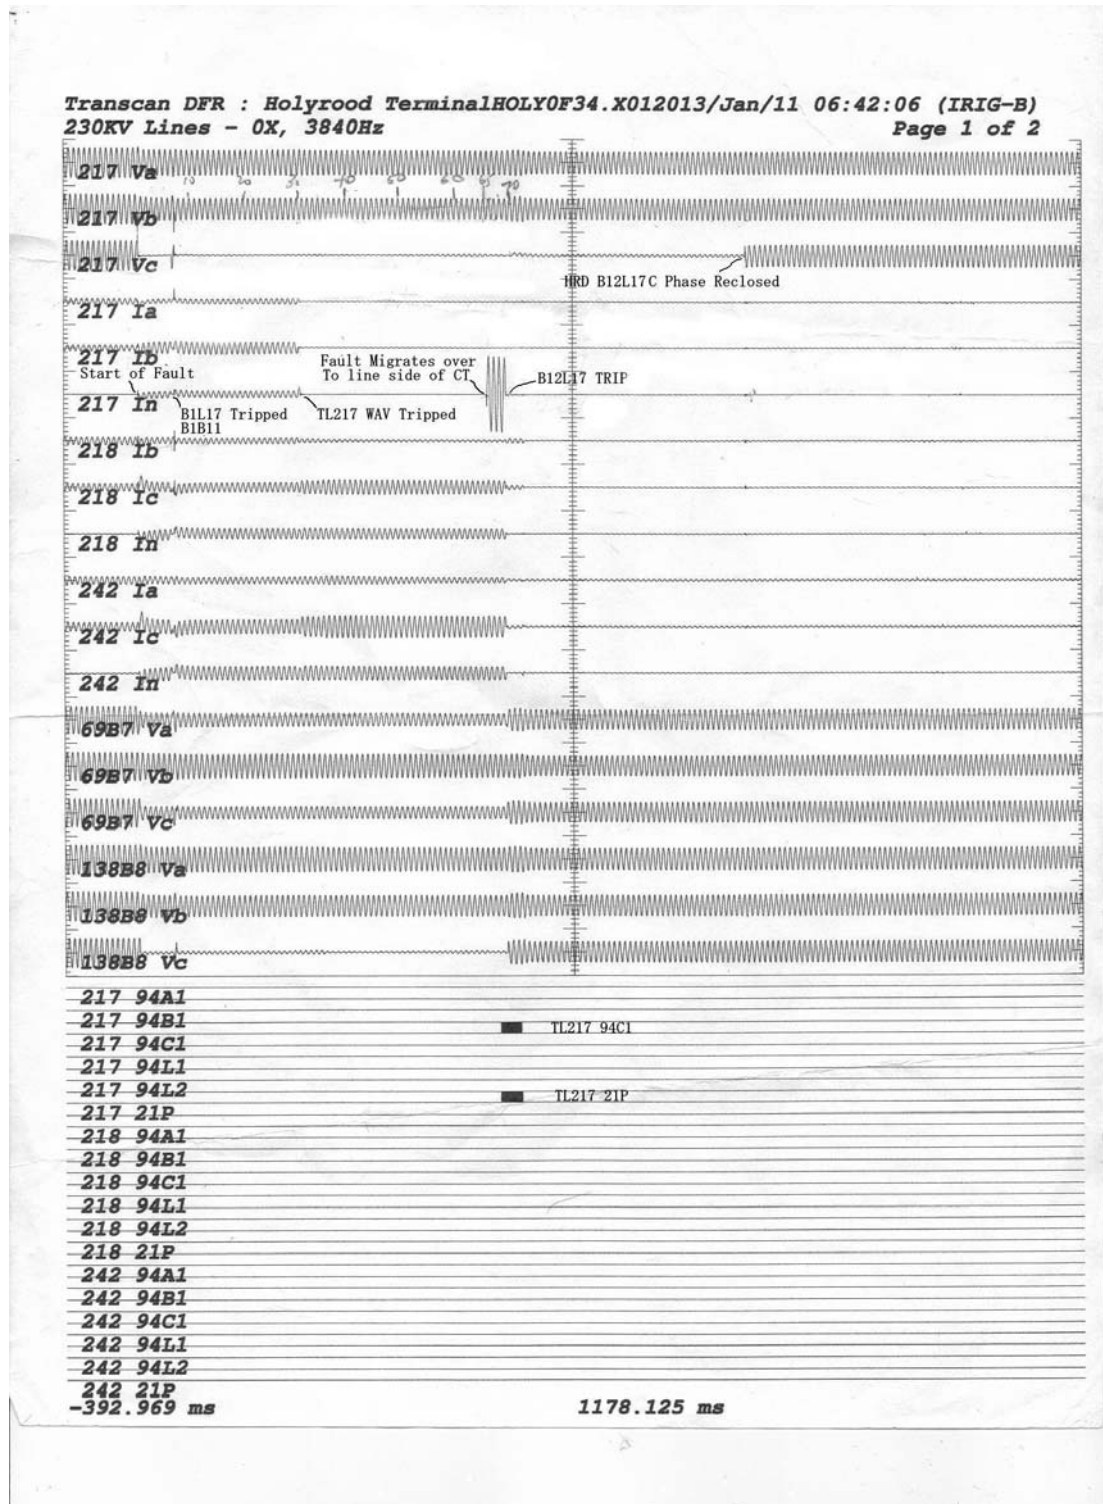
Figure 2-2: Holyrood DFR Trace at 0642 Hours during B1L17 Fault

There was a fair amount of confusion in the analysis of this event as the open/close indication for Holyrood breaker B12L17 does not appear to be functioning properly. This may be an indication of issues with the auxiliary contacts on the breaker.

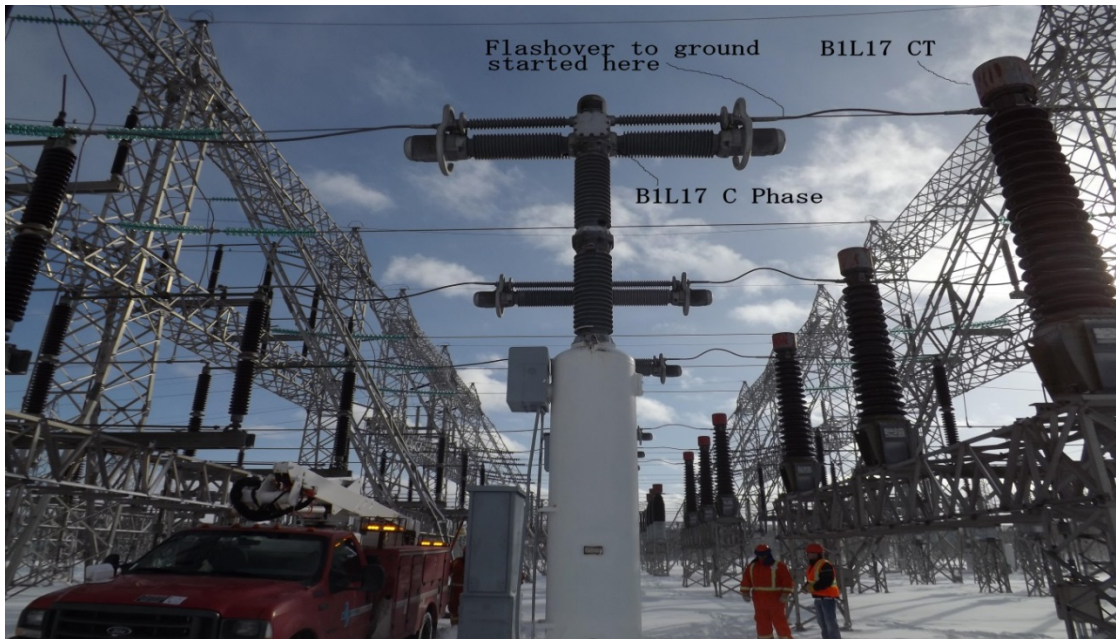
Figure 2-5a: Holyrood Breaker - B1L17 C Phase

At 06:42, while Holyrood plant personnel were in the process of restoring Unit 3, there were trips of Units 1 and 2 and transmission line TL 217 at the Western Avalon end. Both units were loaded to 110 MW. Newfoundland Power's 138 kV line, 39L, also tripped at this time. This resulted in a significant customer impact with nearly 250 MW of Newfoundland Power load loss, primarily on the Avalon Peninsula. This was caused by a fault on Unit 1 230 kV breaker B1L17, which was a result of salt contamination.

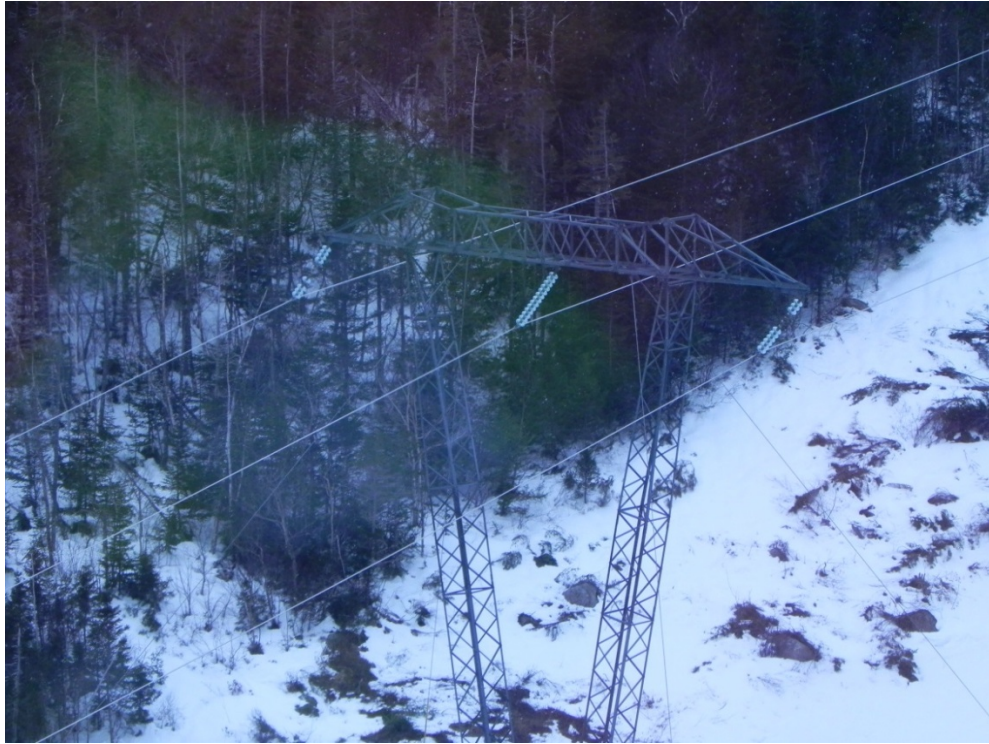
Figure 2-9a: Picture of TL217 Structure 282 with Damaged Insulators

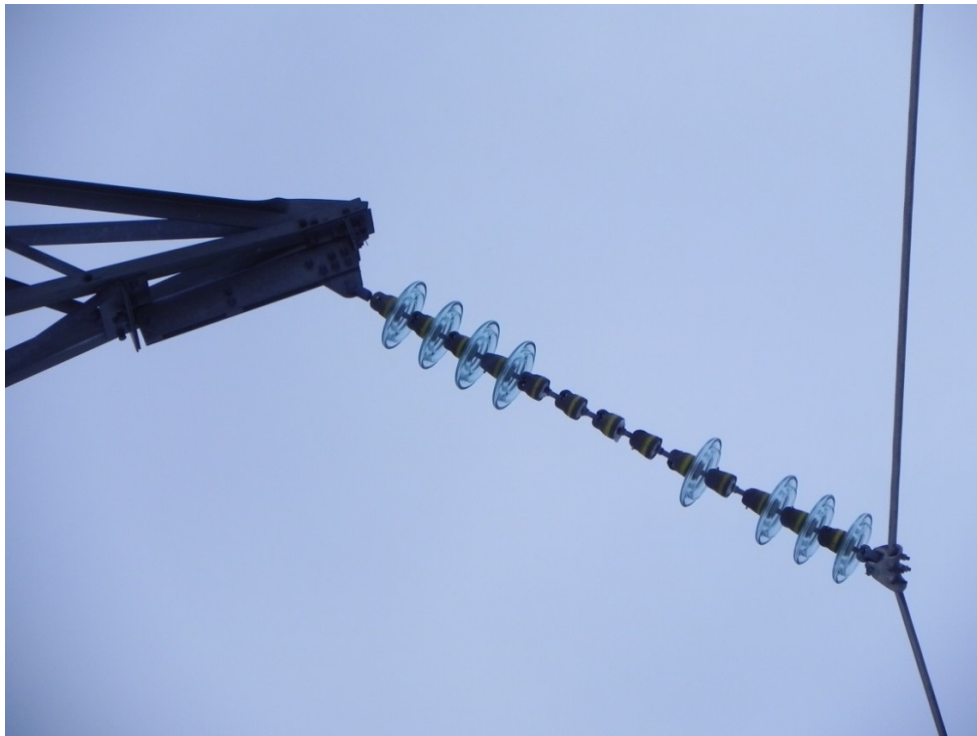
Figure 2-9b: Picture of TL217 Structure 282 Showing Damaged Insulators (one of two strings)

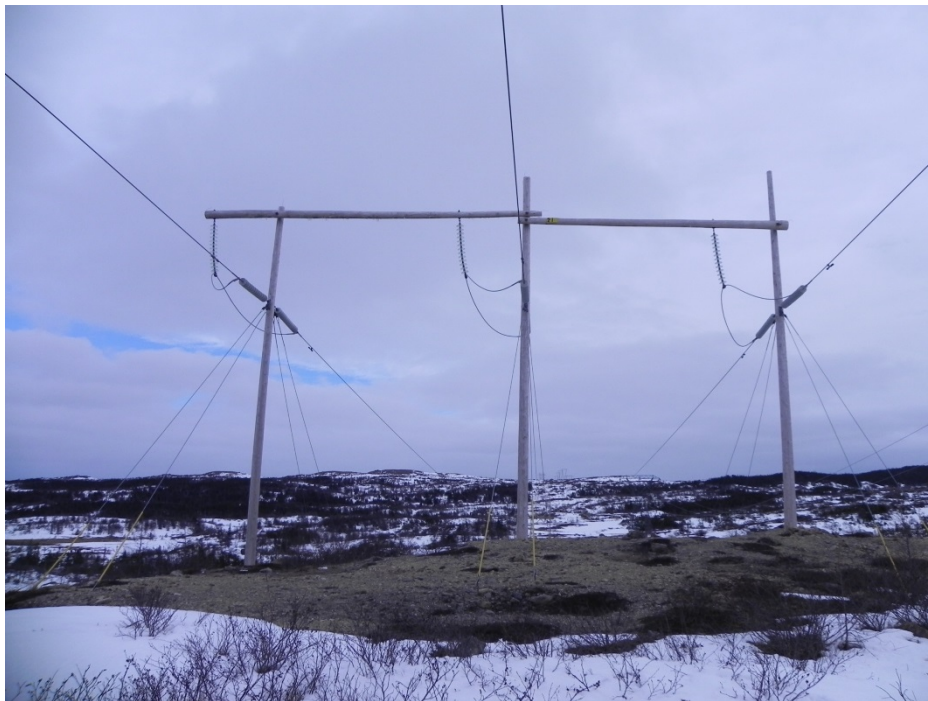
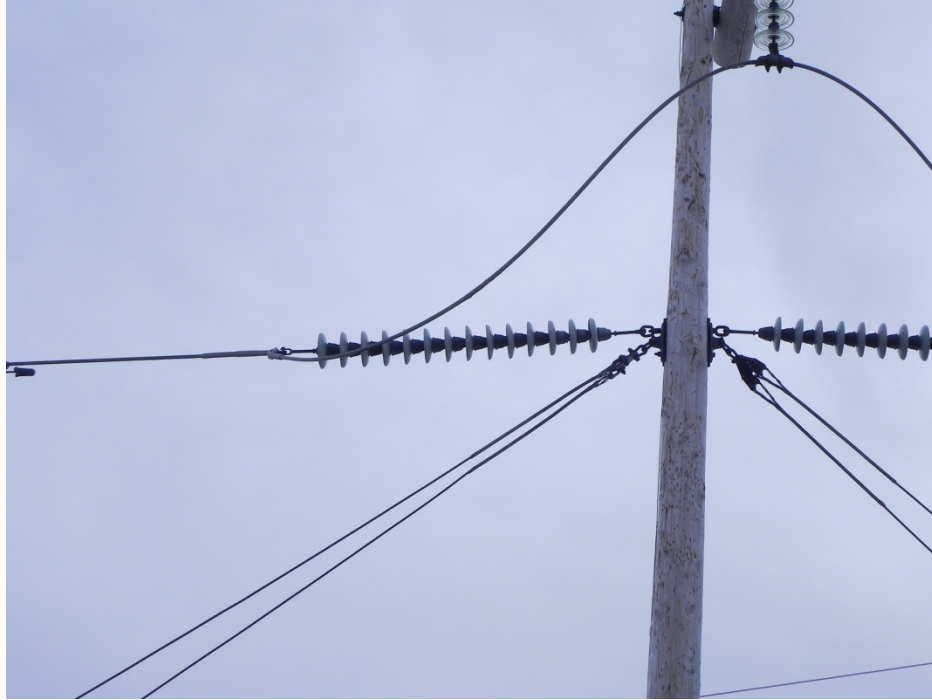
- The fault on TL201 was caused by a jumper on Structure 210 which was too long and flashed to the pole, see Figure 2-13 (a and b). This fault, from analysis of the SEL relay traces, had considerable resistance - estimated to be around the 100 ohm mark which is the resistance setting of both P1 and P2 protections. For the first C phase fault, the P2 protection failed to trip at the WAV end but operated for the second fault after the reclose. This is believed to be due to the fact that the fault resistance made operation marginal. If the resistance had been slightly higher neither distance protection would have operated and the fault would have been cleared via 51N protection after several seconds. No further action is recommended with regards to the protection of TL201 for this incident, however there should be a review of the standards applied for transmission line jumper length.

**Figure 2-13a: TL201 Structure 210 Looking East**

**Figure 2-13b: TL201 Structure 210 Right Phase Jumper**

A review of the standards applied to transmission line jumper length is recommended as a result of the fault and trip on TL 201.

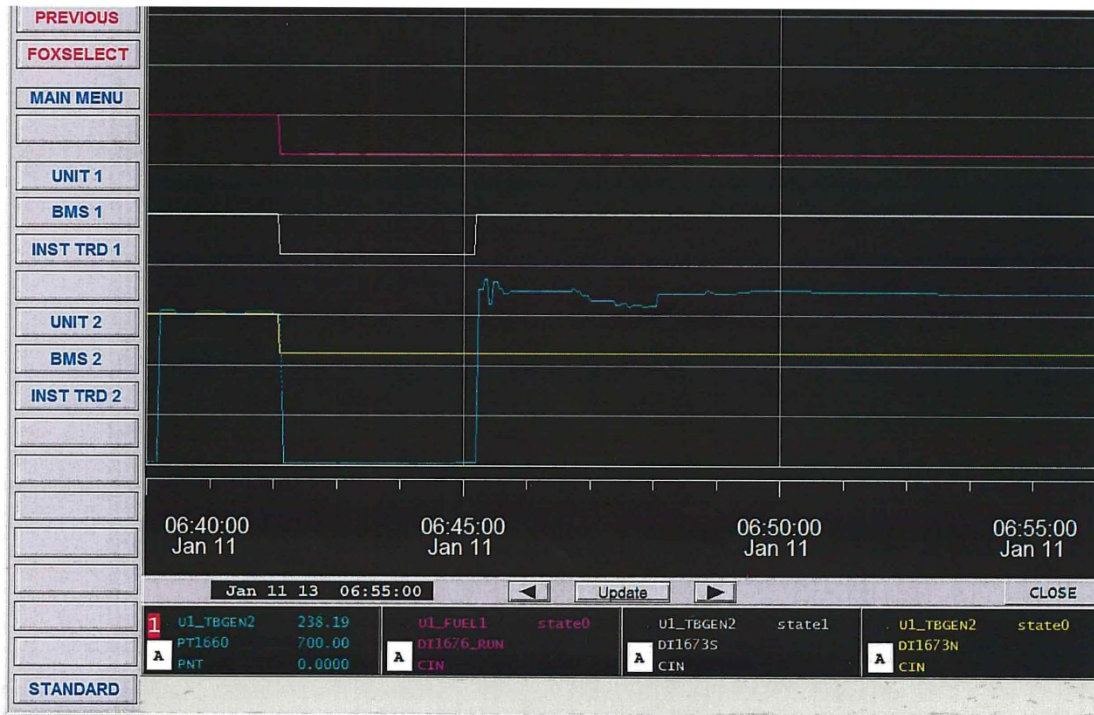
**Figure 2: Status of Unit 1 Lube Oil Pumps and Lubricating Pressure during January 11, 2013 event.** PT1660 (blue) is lubricating oil pressure at the front standard of the unit. DI1676\_RUN (magenta) is the run/stop status of the DC lube oil pump. (The DC pump's run status is triggered by a normally closed contact that opens to indicate run/start. Its running indication is opposite of both AC pumps North and South. i.e. run is indicated after the state change, the portion of the trend that is lower vertically.) DI1673s (white) is the run/stop status of the AC lube oil pump South. DI1673N is the run/stop status of the AC Lube Oil pump North. Upon loss of AC pumps, the lube oil pressure crashes, despite the fact that the DC lube oil pump started. Pressure is restored three minutes and fourteen seconds later after manual start of emergency diesel restores power to AC lube oil pump South.

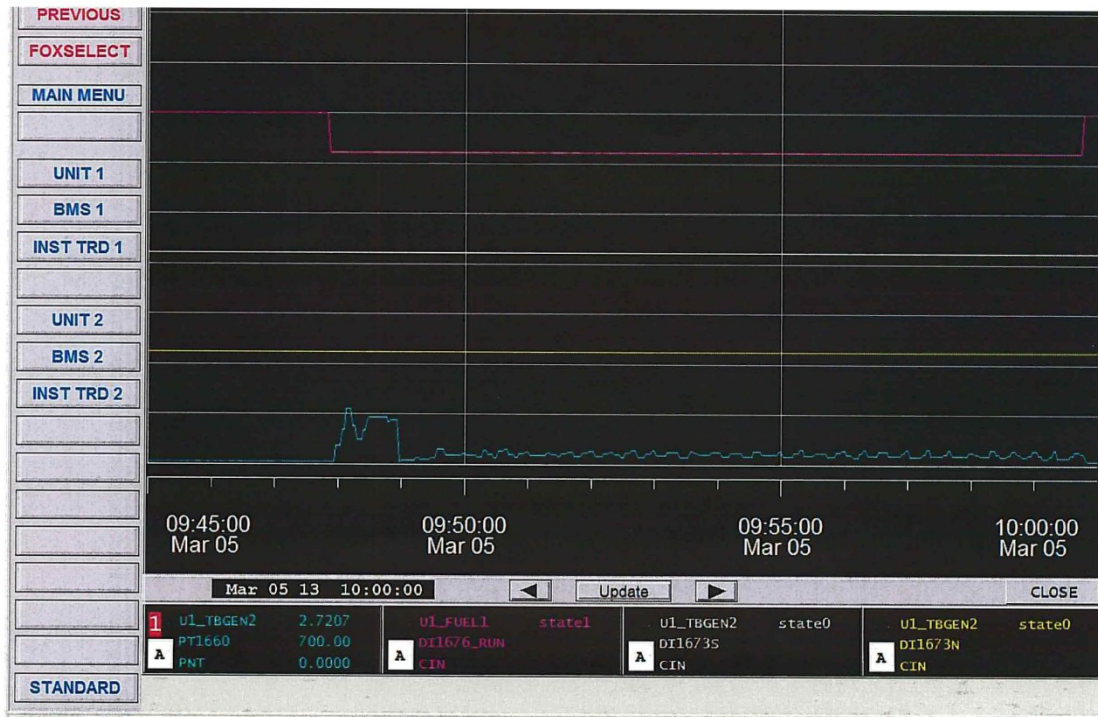
**Figure 2: DC lube oil pump test from March 5, 2013. Note the falling magenta line indicates starting of the DC lube oil pump. There is an increase in pressure (blue) for a short time before pressure crashes and cycles**

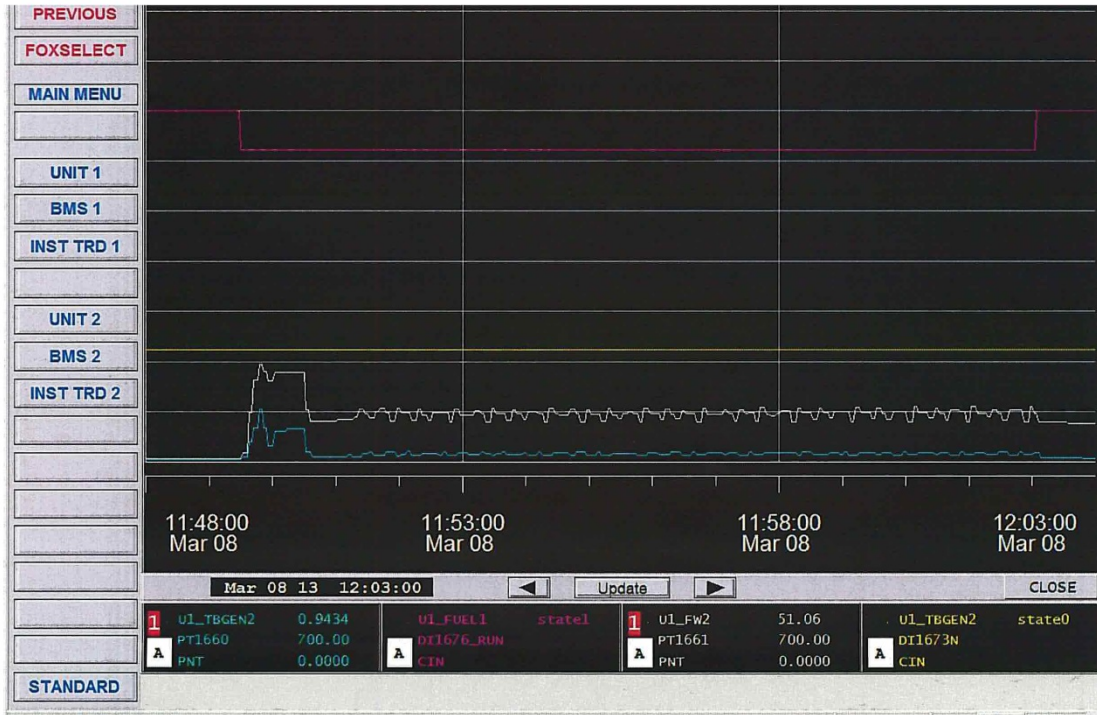
**Figure 3: DC lube oil pump test with tank control valve wide open. Magenta is the start/run status of the DC lube oil pump. White is the lube oil pressure in the tank (expect higher value as there is approximately 42 feet of vertical head between the tank and the turbine-generator). Blue is the pressure in the front standard of the turbine-generator. Note the same cyclic pattern in the pressure trend as in Figure 2.**

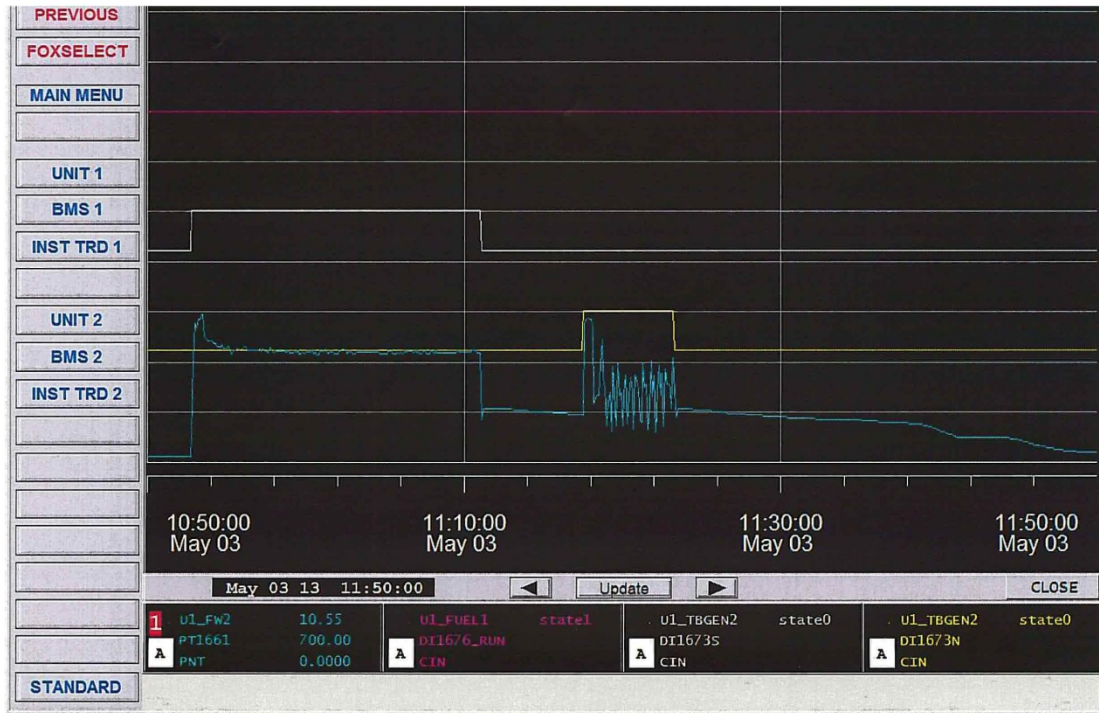
**Figure 4: Test of DC Pump when coupled to AC South motor. Note that a test of AC pump South (white) provides normal and stable lube oil pressure (blue). When the AC North motor (yellow) is ran while coupled to the DC pump a similar cyclic pattern is exhibited as when DC motor and pump are ran together.**
