**Re: An Application by Newfoundland and Labrador Hydro (Hydro) pursuant to Subsection 41 (3) of the Act for approval of a capital project to refurbish the marine terminal at the Holyrood Thermal Generating Station**

**AND IN THE MATTER OF** an Application by Newfoundland and Labrador Hydro pursuant to Subsections 41(3) of the Act, for the approval of refurbishment of the marine terminal at the Holyrood Thermal Generating Station.

Newfoundland and Labrador Hydro -  
Holyrood Marine Terminal 10 Year Life Extension Study  
Final Report - April 29, 2011

Holyrood Thermal Generating Station Marine Terminal -  
Jetty Structural Analysis  
- June 16, 2010

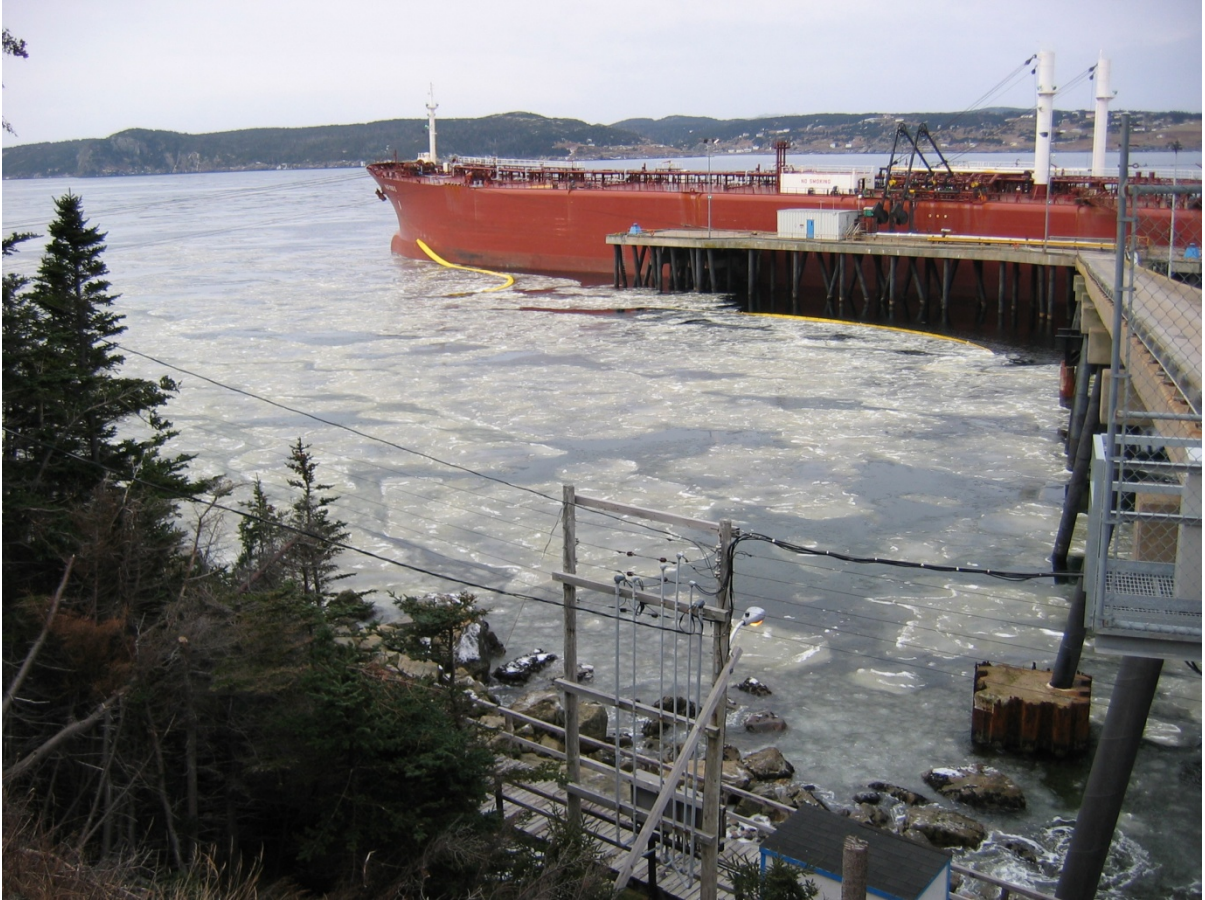
**Figure 2: Docking Vessel with Ice Present**

The primary concern with the Holyrood Marine Terminal facility is the inability of the structure to provide a safe docking environment for the vessels which utilize it to offload fuel oil. Figures 2 and 3 show vessels docking at the facility.

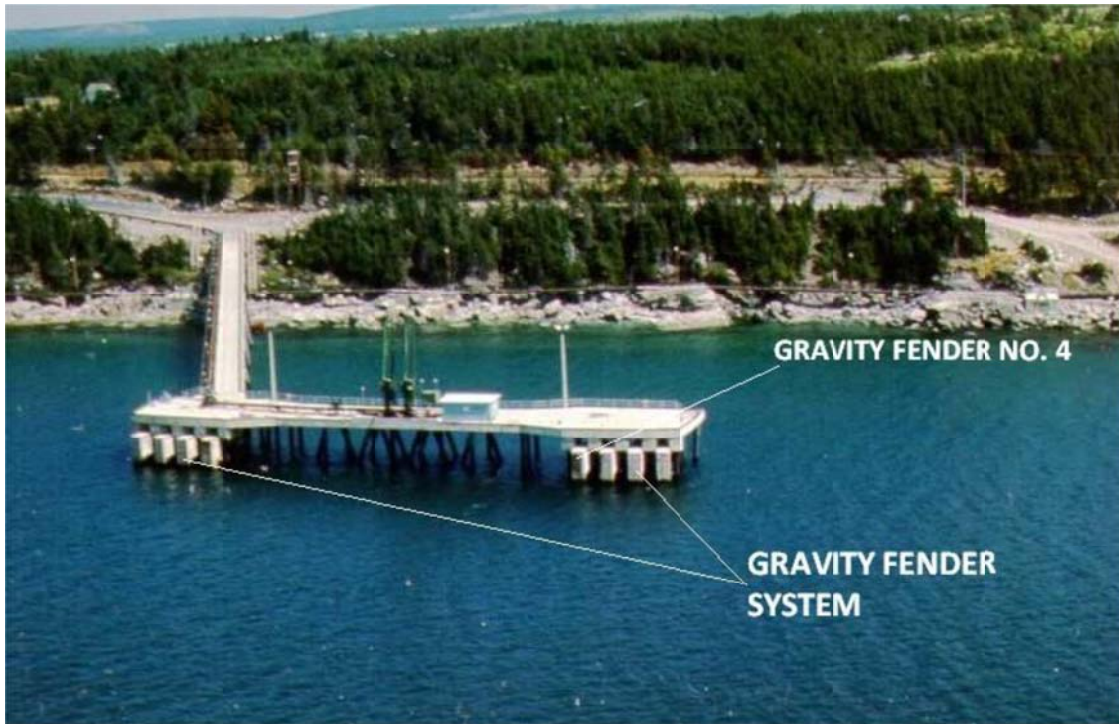
**Figure 4: Gravity Fender System (prior to 2008 fender failure)**

Throughout the years, the structure has aged and the condition of the gravity fender system (see Figure 4 below) has deteriorated. This has resulted in missing, worn, and inoperable gravity fenders. The fenders serve to protect the hull of the vessels from damage during docking and fuel oil offloading operations and are a critical component in the safe docking and fuel oil offloading processes.

A severe example of the fender deterioration occurred in 2008 when one of the 70 ton concrete gravity fenders detached from the structure and fell to the sea bottom. To mitigate the loss of this fender, Hydro engaged Hatch (engineering consultants) to investigate the cause of the failure and spearhead the completion of emergency repairs to the three remaining critical fenders to ensure that they were in no imminent danger of falling. The emergency repairs consisted of a major repair to fender 3 which involved the replacement of the secondary support arms on the fender. Temporary refurbishments were also completed on fenders 5 and 6. These repairs were not designed to be used on a permanent basis but were to facilitate fuel shipment through the winter of 2008-2009. Newfoundland and Labrador Hydro (Hydro) confirmed this position with Hatch, as indicated in the Hatch letter of May 16, 2012, attached as Appendix A.

1. Restoration of critical fenders 3, 5 and 6 of the swinging gravity fender system;
2. Replacement of detached swinging gravity fender no. 4;
3. Inspection of steel pile foundations, anodes, and attachment brackets; and
4. Improvements to life safety through the installation of devices such as a support vessel access system, a man-overboard recovery system, fall arrest system and improvements to the deck lighting system.

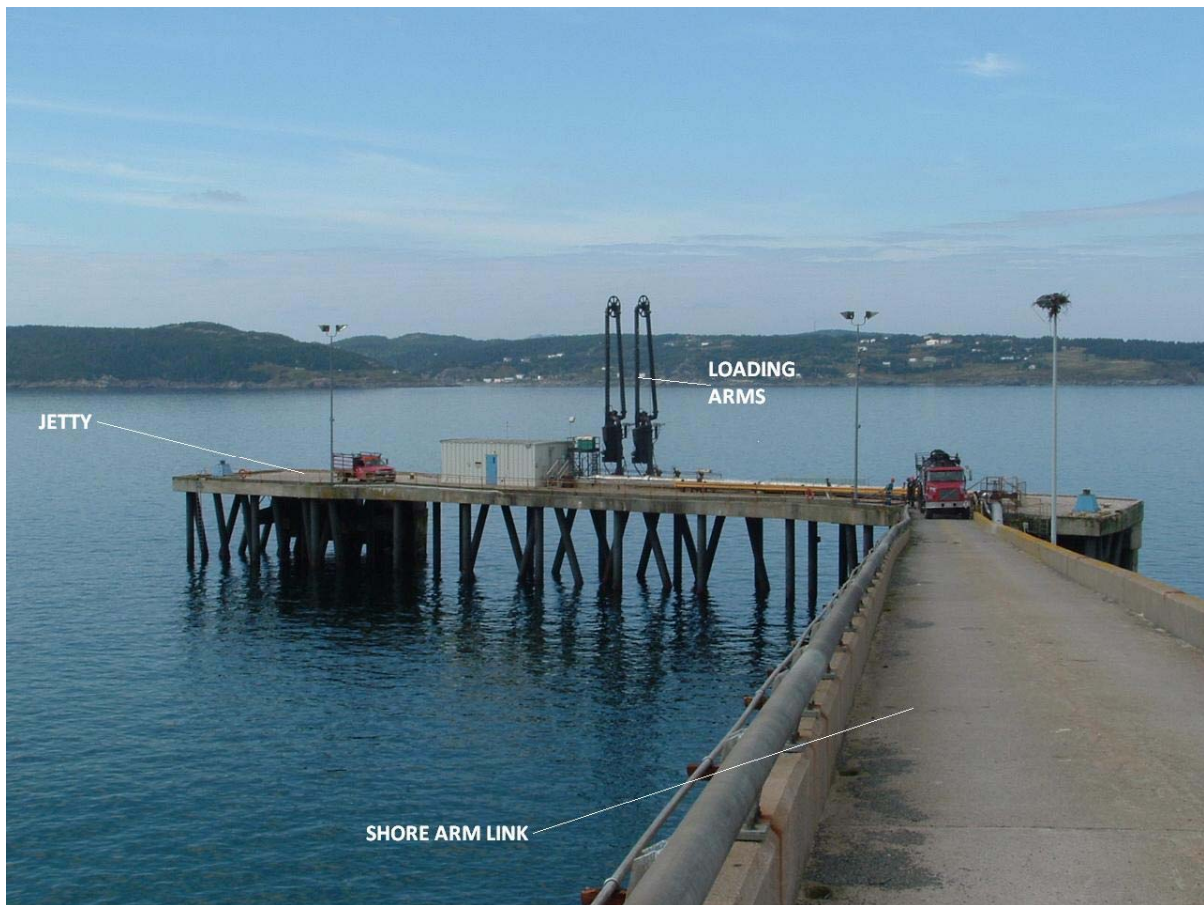
**Figure 5: Jetty and Shore Arm Link**

The Marine Terminal consists of a 125 meters shore arm link that bridges the jetty to the adjacent land (see Figure 5 below).

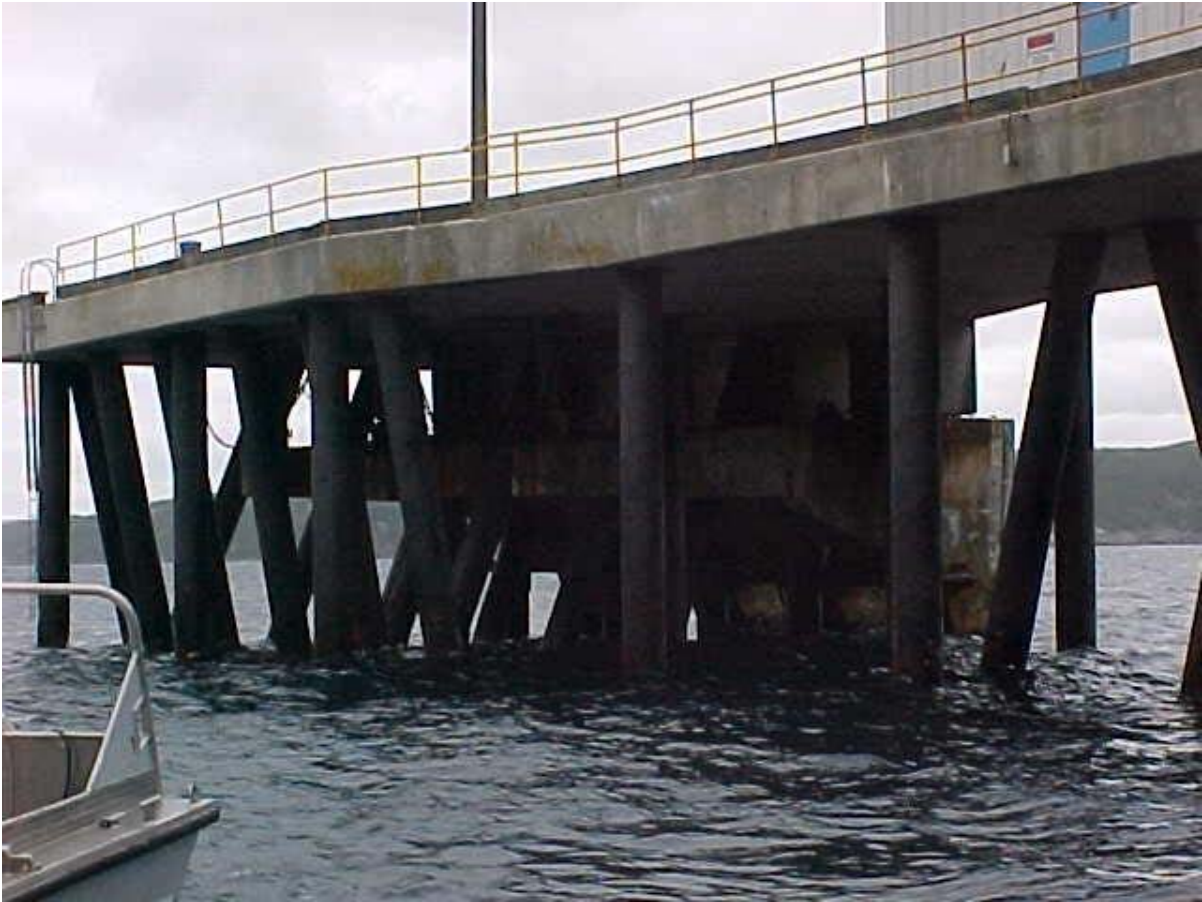
**Figure 6: Jetty Pile System**

The jetty is approximately 74 meters long by 12 meters wide and supports the fuel oil offloading arms and associated pipeline and controls related to the fuel oil offloading process. Both the shore arm link and jetty consist of a concrete superstructure supported on concrete filled circular steel piles (see Figure 6).
