Re: **An Application by Newfoundland and Labrador Hydro (Hydro) pursuant to Subsection 41 (3) of the Act for the approval of the Internal Assessment and Repair of Transformer VBN T1 at the Voisey's Bay Nickel Terminal Station.**

**Transformer T1
Major Internal Assessment and Repairs
Voisey's Bay Nickel Terminal Station**

October 2015

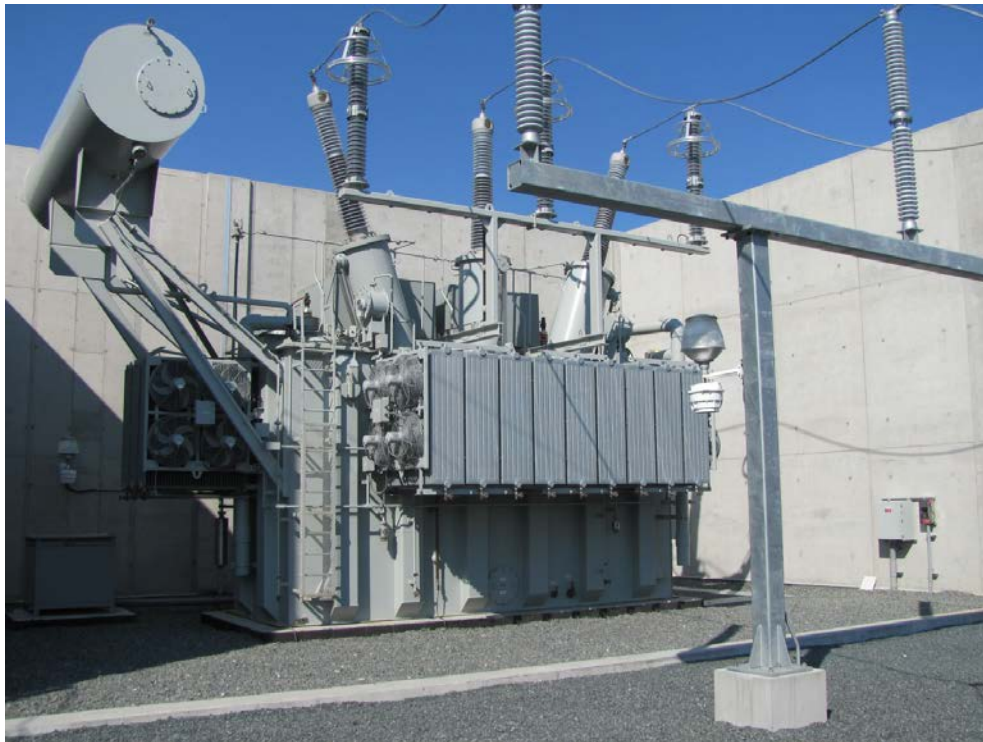
Figure 2 – VBN Transformer T1

Figure 2 provides a photo of this transformer which is located in the Voisey’s Bay Nickel (VBN) Terminal Station.

Testing of Transformer T1 indicates that this unit has developed a fault condition. An internal assessment is required to determine the nature of the issue, and repairs are planned to immediately follow the assessment.

The transformers within this station have been in service and providing energy since 2012. The gassing issues were identified during routine transformer oil testing and dissolved gas analysis. There have been no major issues with the other transformer in the station.

- isolation of the transformer;
- draining of the transformer oil;
- internal assessment by the OEM;
- completion of repairs, if possible;
- filling the transformer with oil;
- electrical testing after filling; and
- review of electrical test results by a transformer consultant and a failure analysis of why the transformer developed gassing at this early stage in its service life.

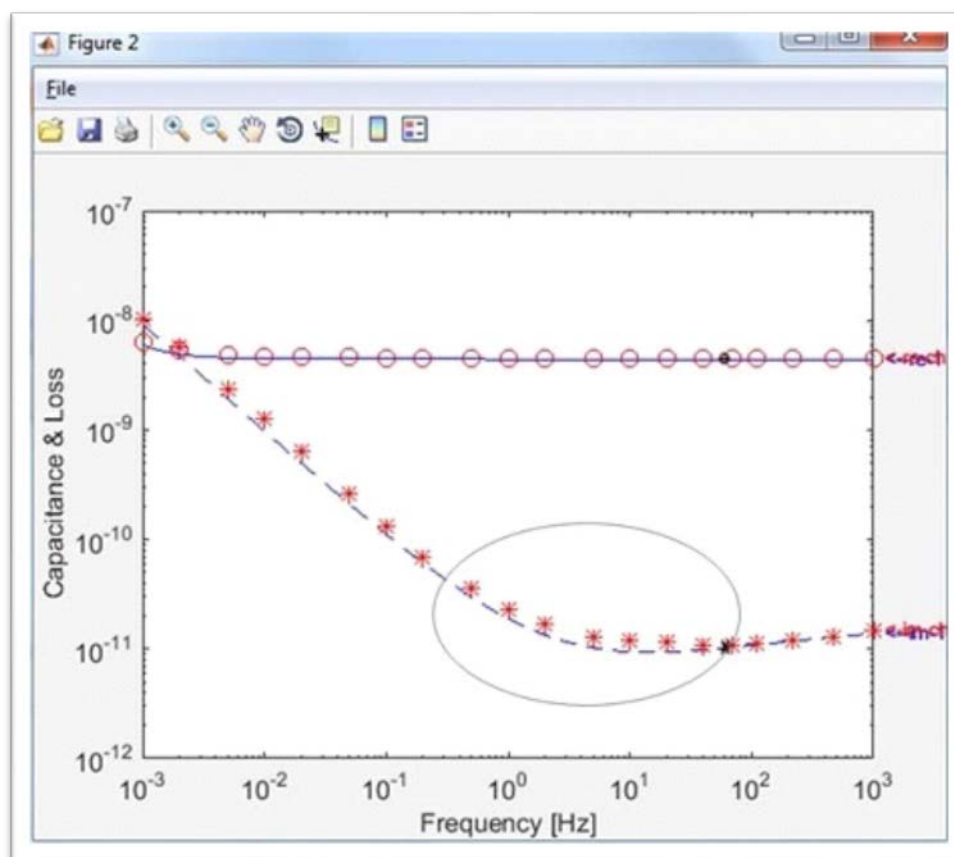
Figure A1 – Dielectric Frequency Response (DFR) Test Results

The diagnostic testing results indicate that the issue is most likely external to the windings and may be repairable during the internal assessment. If this is the case, repairs will be completed at site and the transformer will be returned to service. If this is not the case, then more extensive repairs may be required.

Appendix A provides a summary of the test results and analysis, including a graph of the Dielectric Frequency Response (DFR) test results for the high voltage to core connection highlighting the internal transformer issue.

The OEM has provided the above graph and analysis. The graph compares the measured value to the calculated value for capacitance and dielectric loss (using the insulation dimensions from the design). The circled portion of the graph highlights a deviation between the measured values and the calculated values. As experts, the OEM indicates this small deviation is significant. The issue is most likely due to a problem with the high voltage leads. The OEM expert is suggesting that this abnormality could be carbon contamination (which is in line with the measured hydrogen gassing.)
