Re: An Application by Newfoundland and Labrador Hydro (Hydro) pursuant to Subsection 41(3) of the Act for the approval of the Gas Generator Engine Refurbishments at the Hardwoods Gas Turbine Plant and the Stephenville Gas Turbine Plant

Gas Generator Engine Refurbishments
Hardwoods and Stephenville

Hot End Borescope Inspection Report For Gas Turbine 202205

Hot End Borescope Inspection Report For Gas Turbine 202204

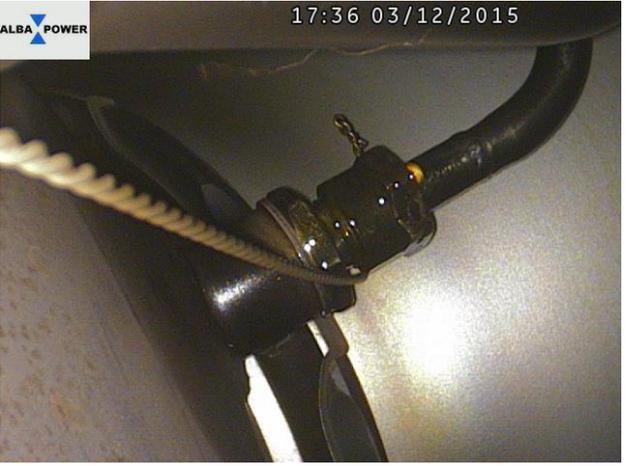
<p>Pipe Connection</p>	<p>Slight oil leak at number 7 bearing housing</p>

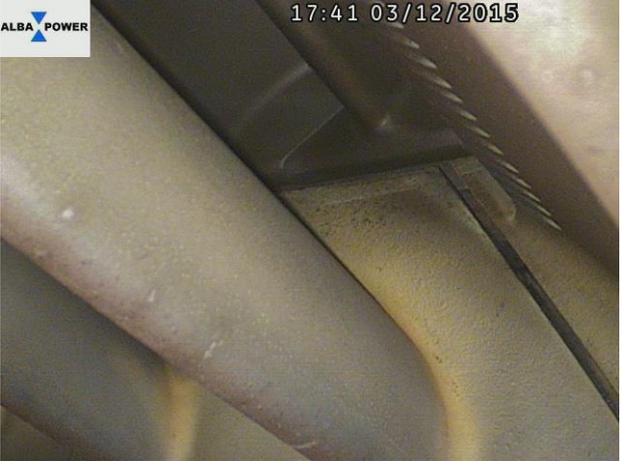
The HP nozzle guide vanes and LP nozzle guide vanes were noted as having no visual damage; however they did show some signs of coating loss and carbon built up. All are considered to be in a serviceable condition.

<p>Rear of HP Compressor</p>	<p>HP NGV's</p>

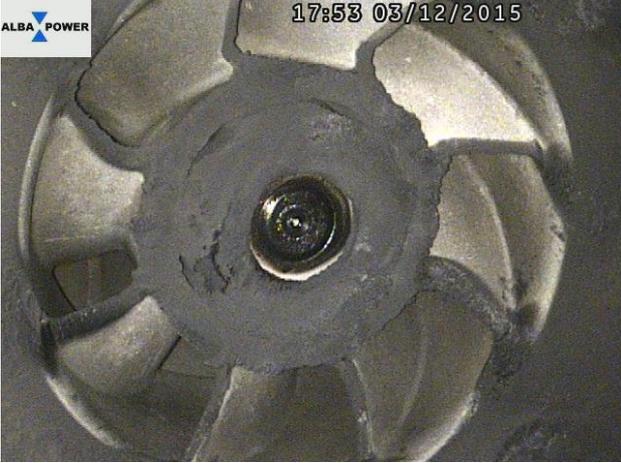
The fuel nozzles exhibit typical carbon deposit on the heads, no other defects or damage was noted.

<p>Carbon build up on Fuel Nozzle</p>	<p>Entry Snout</p>

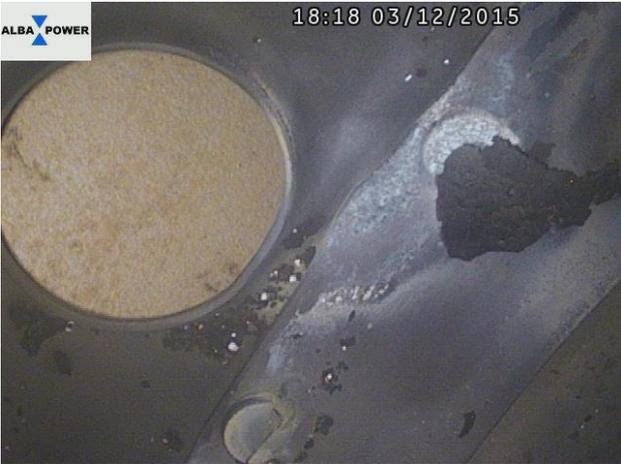
The snouts exhibit typical carbon deposits around the burner entry location, there is also evidence of a build-up of carbon inside the combustion chambers, there was no visual signs of any cracks within the combustion chambers of this unit.

<p>Carbon deposits</p>	<p>Crack at No6 Interconnector</p>

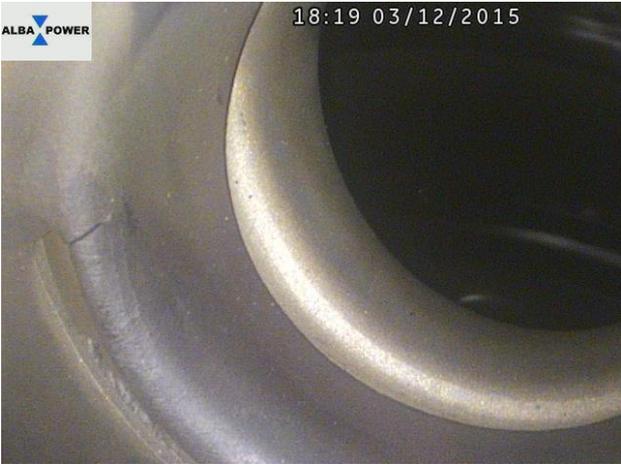
The No6 combustion chamber interconnector has a small crack but is within limits.

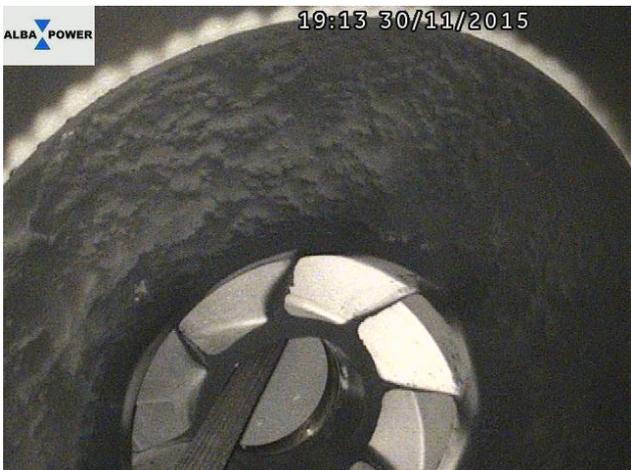
Carbon build up on base of combustion can

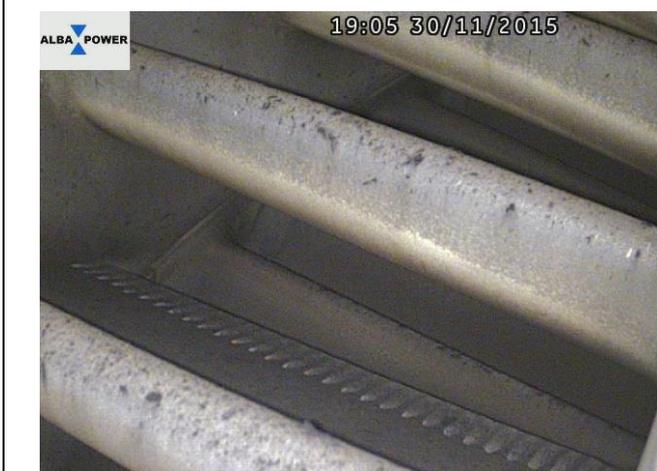
The HP nozzle guide vanes and LP nozzle guide vanes were noted as having no visual damage; however they did show some signs of coating loss and carbon built up. All are considered to be in a serviceable condition.

HP NGVs and turbine blades

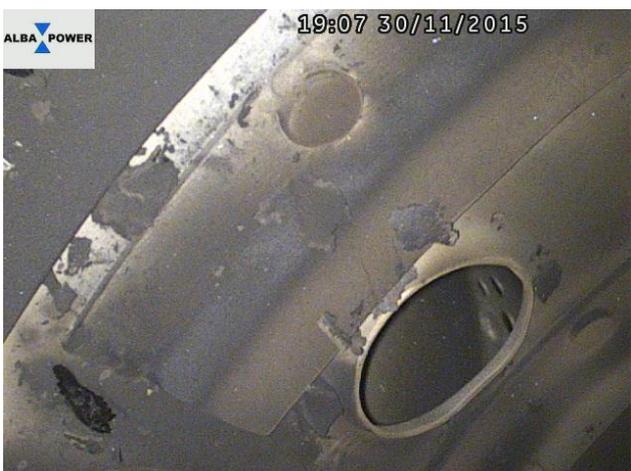
The snouts exhibit typical carbon deposits around the burner entry location, there is also evidence of a build-up of carbon inside the combustion chambers, there was no visual signs of any cracks within the combustion chambers of this unit.

Carbon build up on combustion chamber
