AND IN THE MATTER OF an Application by Newfoundland and Labrador Hydro pursuant to Subsection 41(3) of the Act, for the approval of the replacement of the excitation transformers at Bay d'Espoir.

**A REPORT TO
THE BOARD OF COMMISSIONERS OF PUBLIC UTILITIES**

Replacement of Excitation Transformers Bay d'Espoir

June 2014

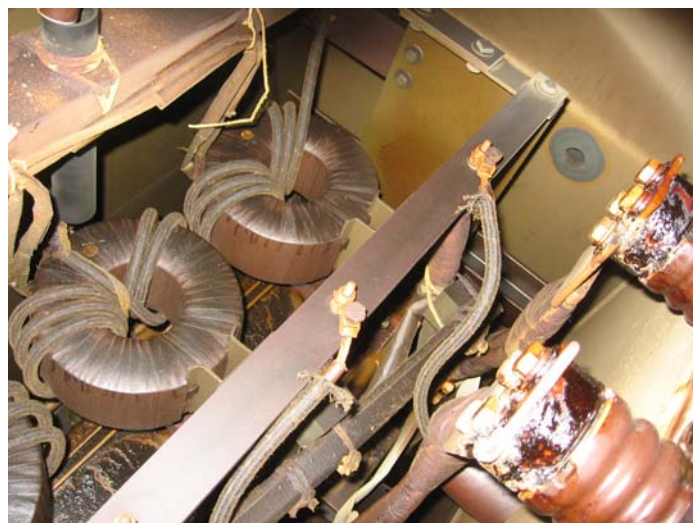
With the transformer oil removed from the unit inspection covers were removed by our team. Special safety provisions were employed for this work using SCBA's to limit personnel from the hazards of working with Perchloroethylene. Winding resistance electrical tests were performed to confirm the readings. The original readings that were provided were taken using an external connection to the HV bushing as the test points. The results of the testing (attached) confirm that the high reading in the B Phase was still present when connected internally at the winding. The picture below shows the lead configuration through the CT and onward to the winding connection.

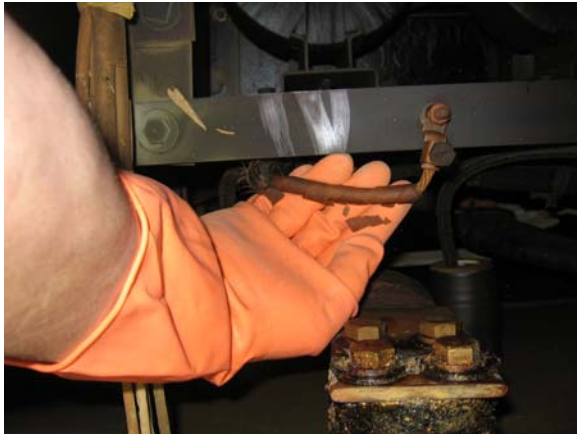
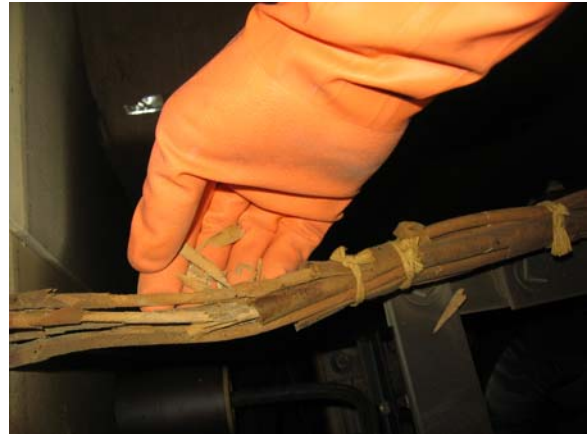
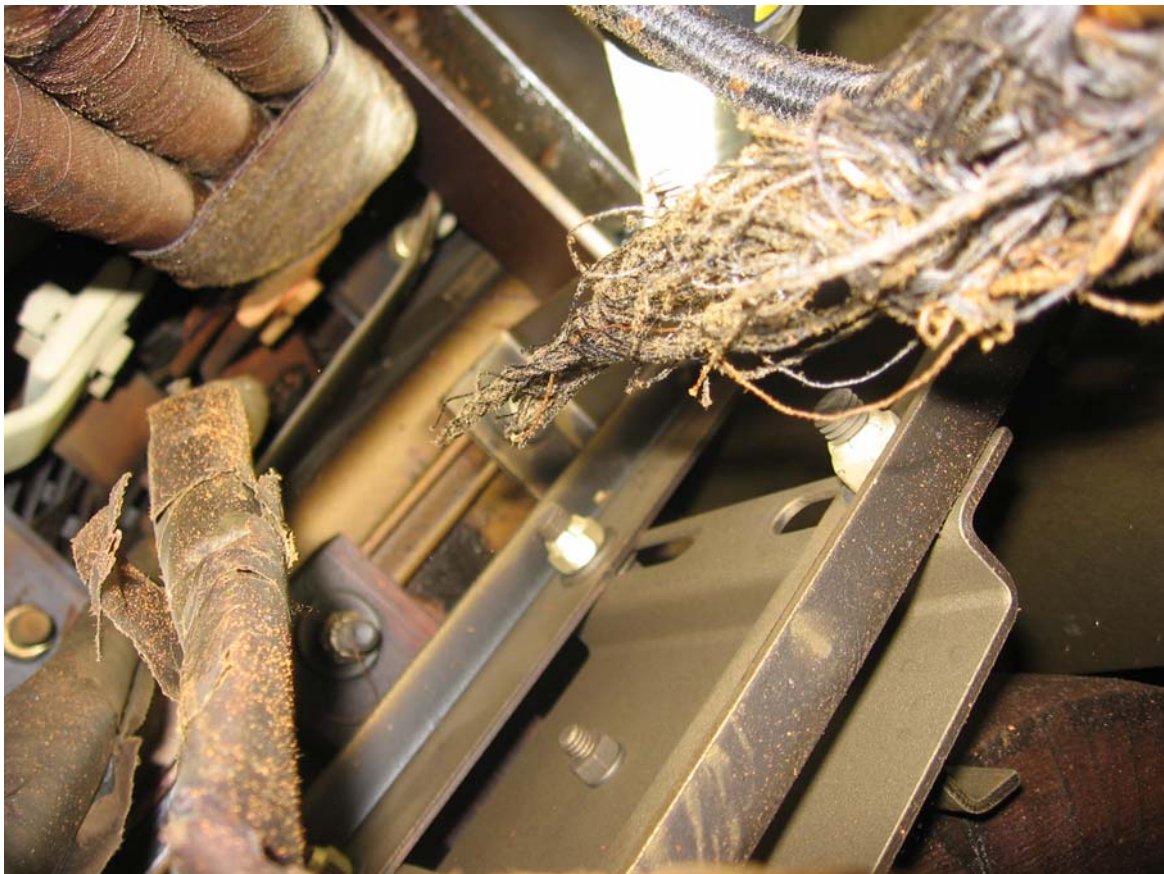
winding bushing connections and also disconnect the CT secondary wiring. The condition of the insulation on the winding leads and CT wiring was so poor that it crumbled when touched. The pictures below show some samples of this condition.
