**AND IN THE MATTER OF** an Application by Newfoundland and Labrador Hydro pursuant to Subsection 41(3) of the *Act*, for the approval of the replacement of insulators on Transmission Lines TL-201 and TL-203.

## Insulator Replacement TL-201 and TL-203

Newfoundland and Labrador Hydro

June 2014

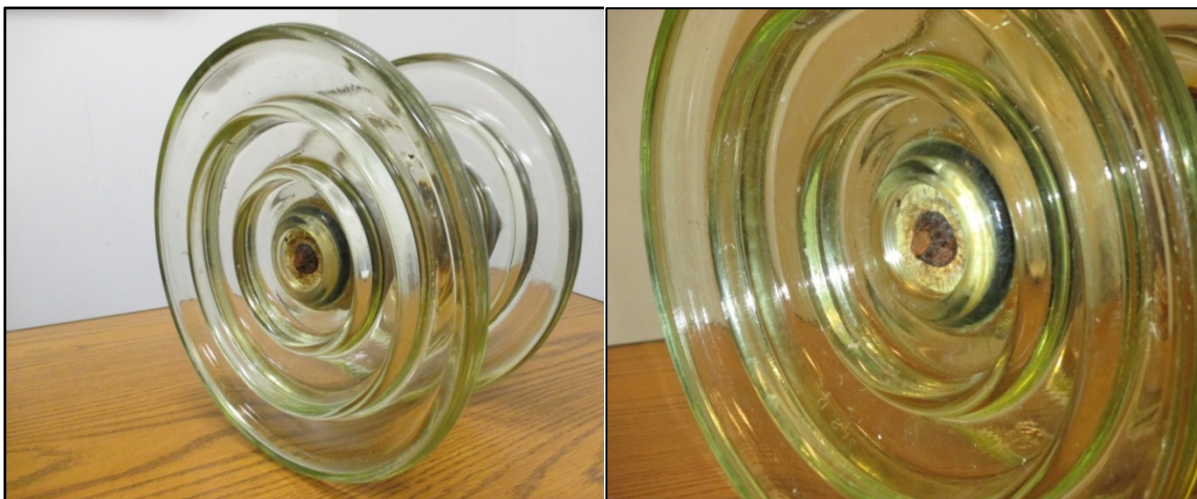
A concern with the Pilkington insulators became first evident in August 27, 2009 on TL-203. An insulator pin failure occurred on the center phase of Structure 167 causing an insulator string separation. Inspections were carried out in the general area and no other corrosion issues were identified so it was considered to be an isolated event.

Throughout the 2013-2014 winter season, high winds and adverse weather conditions were experienced on many transmission lines in Hydro's system. These weather conditions resulted in insulator pin failures on both TL-201 and TL-203. The first failure of the winter season occurred on Structure 163 (TL-203) on January 12, 2014. See Figure 2 below.

**Figure 2: TL-203 – Structure 163 Pilkington Insulator Pin Corrosion**

2  
3 Given the widespread extent of the corrosion and frequency of previous failures on TL-201,  
4 it is recommended that all insulators on this line be replaced. It is also recommended that  
5 TL-203 undergo insulator replacement on the identified structures. This will reduce the  
6 probability and risk of future failures and the associated safety concerns. Transmission line  
7 outages will be required; therefore any proposed work will have to consider this restriction.
