**A REPORT TO
THE BOARD OF COMMISSIONERS OF PUBLIC UTILITIES**

NEWFOUNDLAND AND LABRADOR HYDRO

Gas Turbine Failure Analysis

Final Report

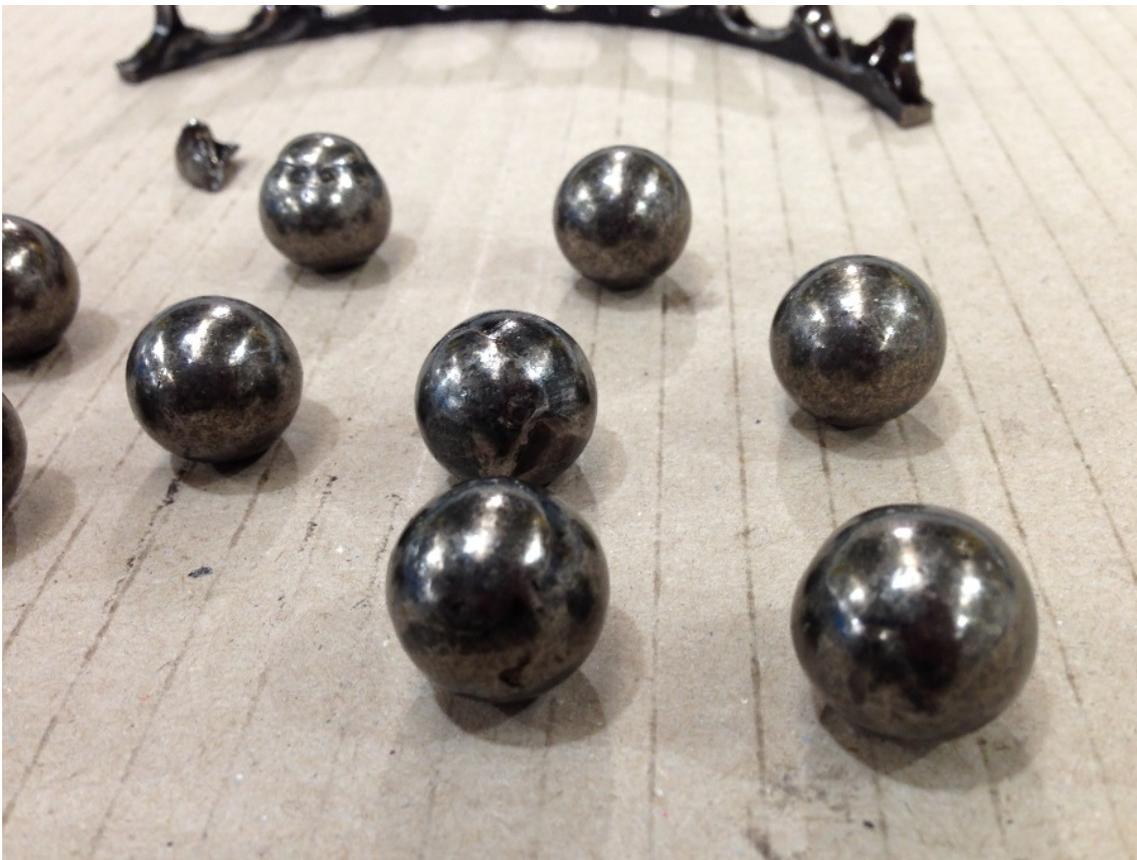
The photo below shows the surface conditions and misshape of the bearing balls. Multiple flat facets are clearly visible caused by skidding of the balls on the races which is thought to have resulted from the collapse of the lube oil film locally within the bearing due to the oil's oxidised condition. A segment of broken bearing cage is shown in the background.

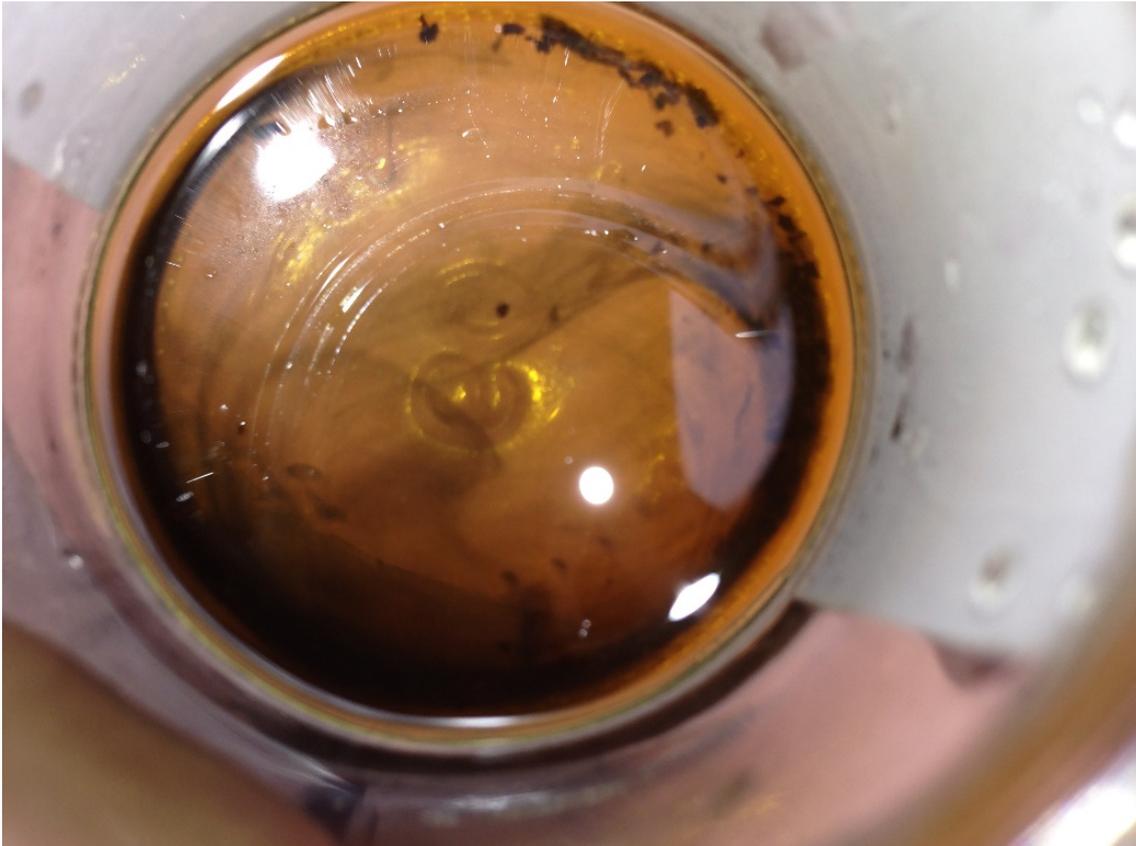
The photo below shows residual lube oil taken from the Pressure Filter during GG receipt inspection checks at Alba. Contaminant particles and fines (black areas and cloud swirls) are clearly visible.

Bench tests by PI using supply oil samples showed that metallic fines and particle contaminants could pass through the Pressure Filter gauze, and therefore to the bearings. The test thus demonstrated that the Pressure Filter is not sufficiently rated to protect the GG bearings from potentially damaging contaminants in the oil. The test also indicated that some metallic particles from the bearing damage must have been recirculating around the oil system and through the GG bearings, with the scavenge/return oil filter bypass having activated.

The Pressure Filter gauze was later confirmed to be a standard 60 mesh with a 250 microns nominal rating. Industry standard for turbo machinery oil filtration is typically 5 microns. Therefore, at 250 microns the Pressure Filter is critically inadequate to protect the GG bearings from potentially damaging particle contamination in the lube oil.

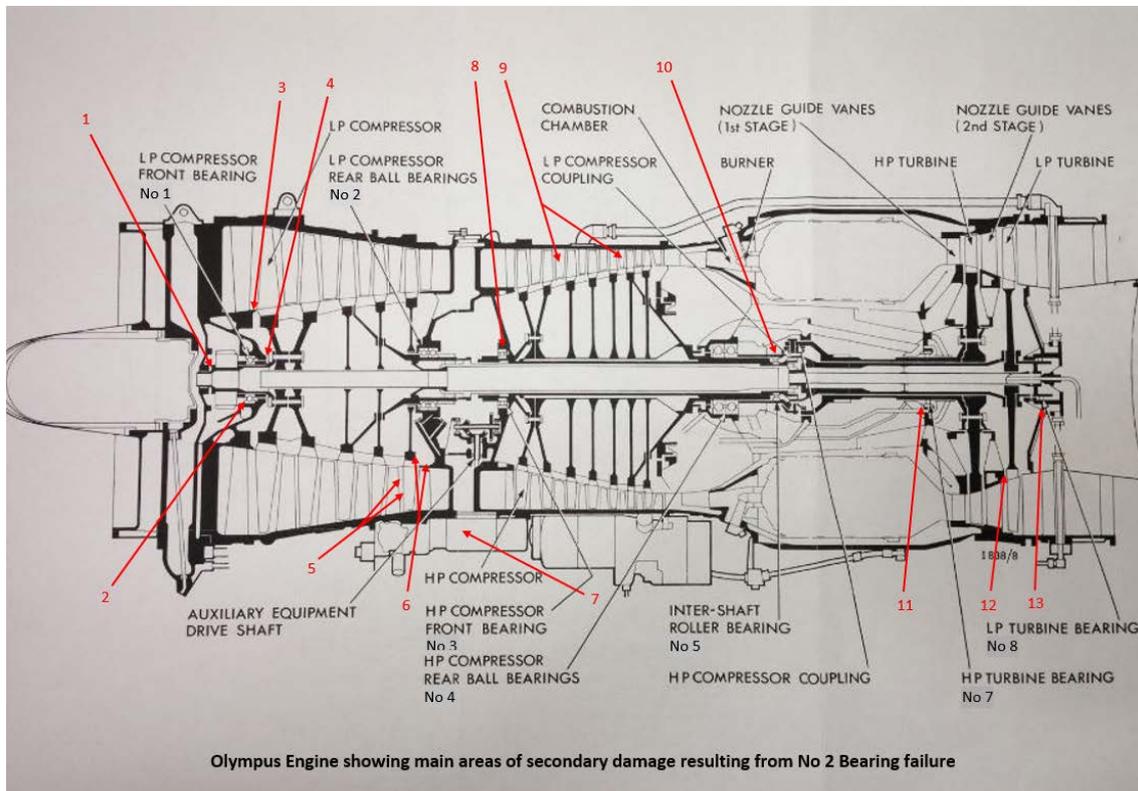
The GG illustration below shows the areas that incurred secondary damage resulting from the No 2 bearing failure. Details and explanations of the damage points are presented in PI's Secondary Damage Report contained in Appendix 9.

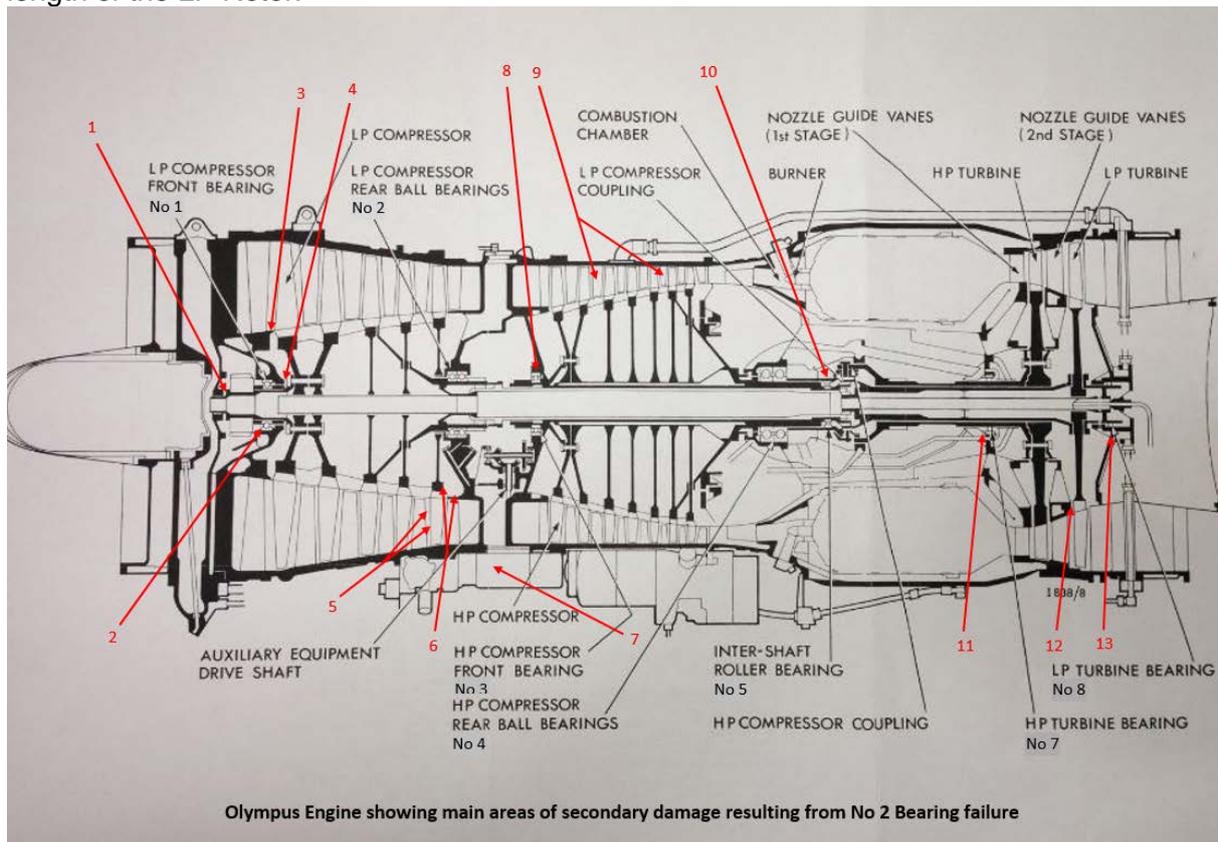
The GG illustration below shows the main areas of secondary damage found along the length of the LP Rotor.

The following listing summarises the secondary damage points shown above found during (Bulk and) Detail Strip inspections. The damage points are shown and described in more detail in a separate report which also includes sectional illustrations of the GG to help visualize the damage areas in context with the GG design layout. The Secondary Damage Report is contained in Appendix 7.

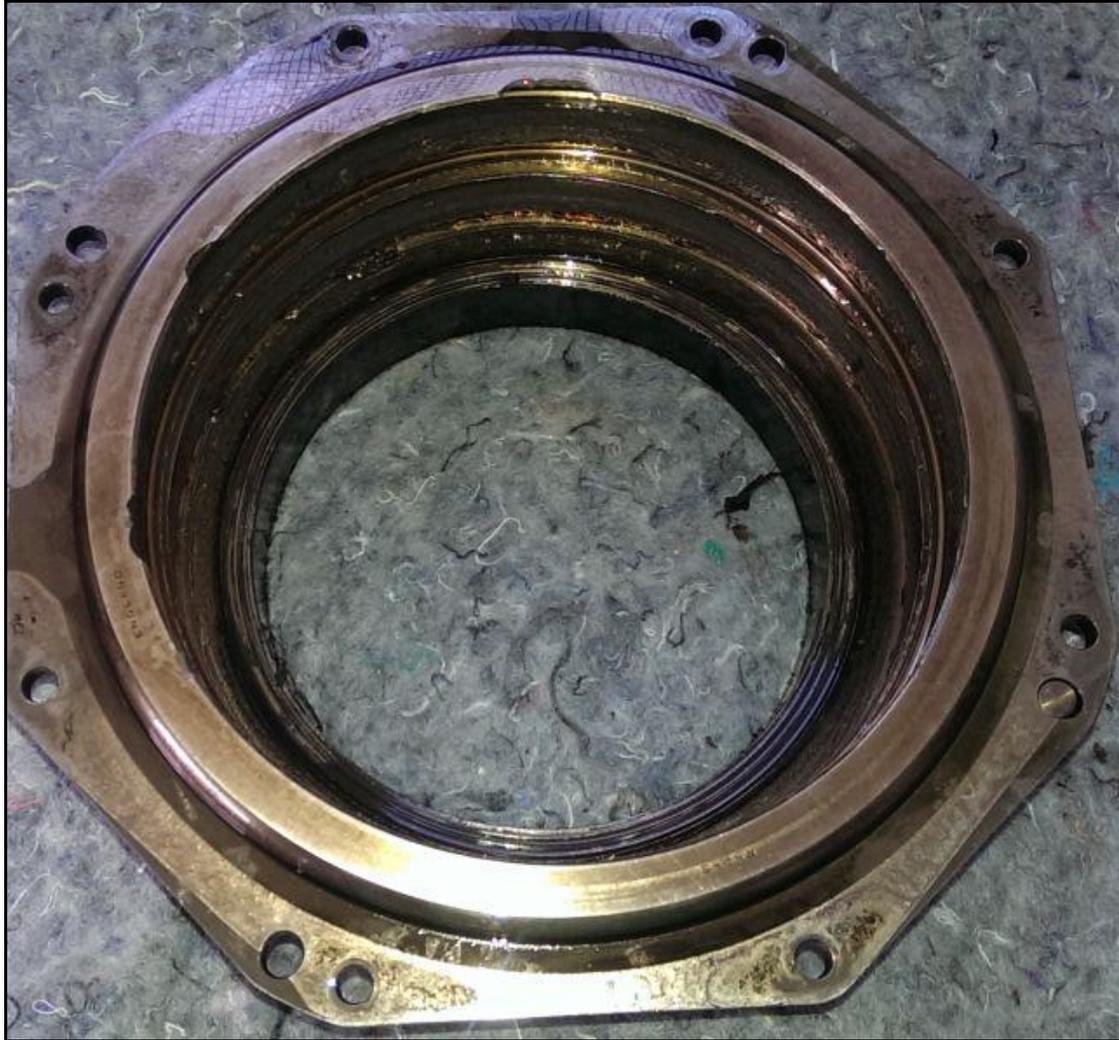
Figure 3 – Housing 'as received' with both outer rings in place. The Front bearing is uppermost in the photo.

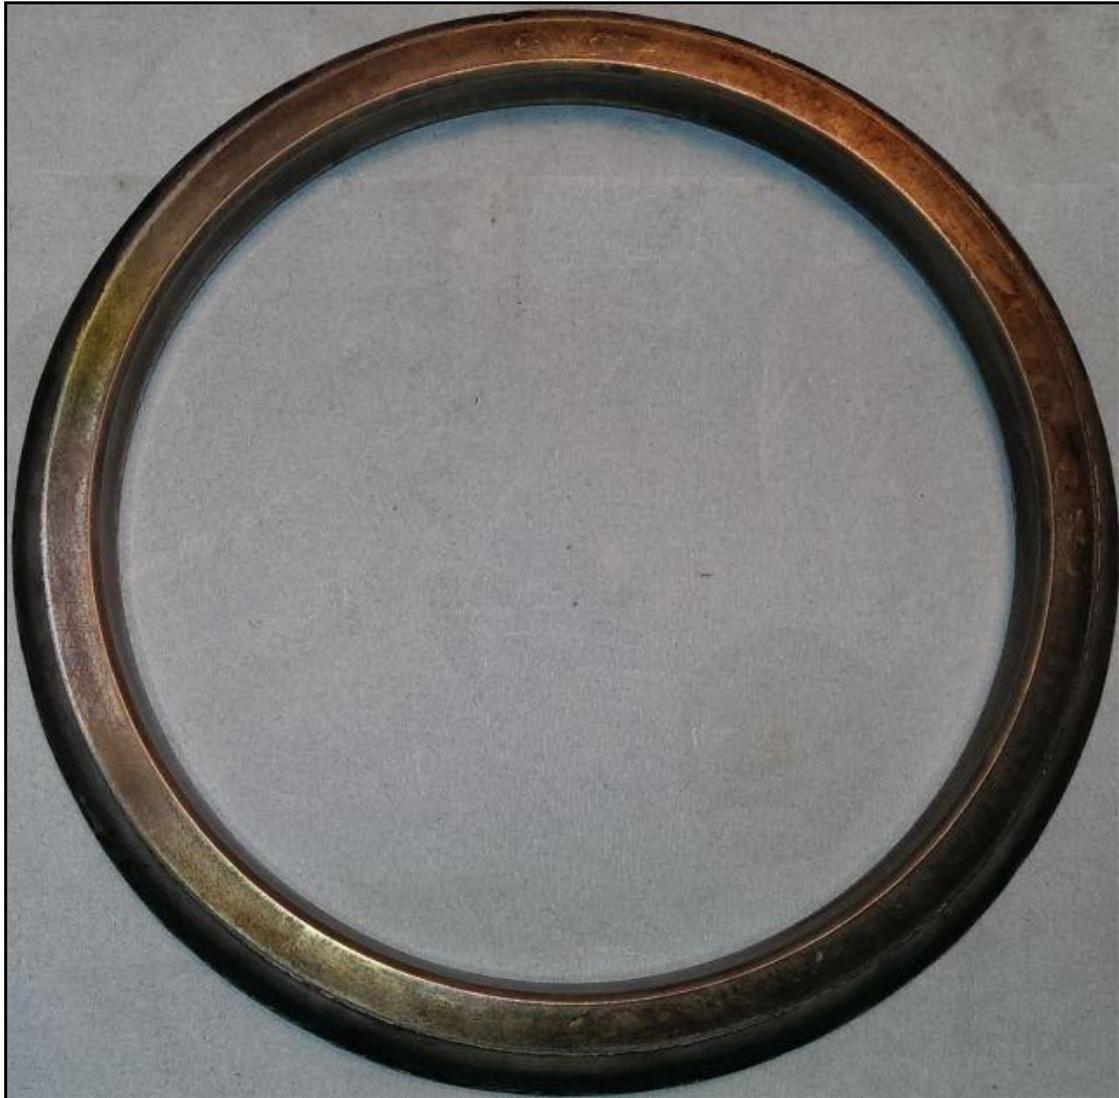
Figure 10 – *Inner ring #1 side face 2.*

Staining and bluing noted.

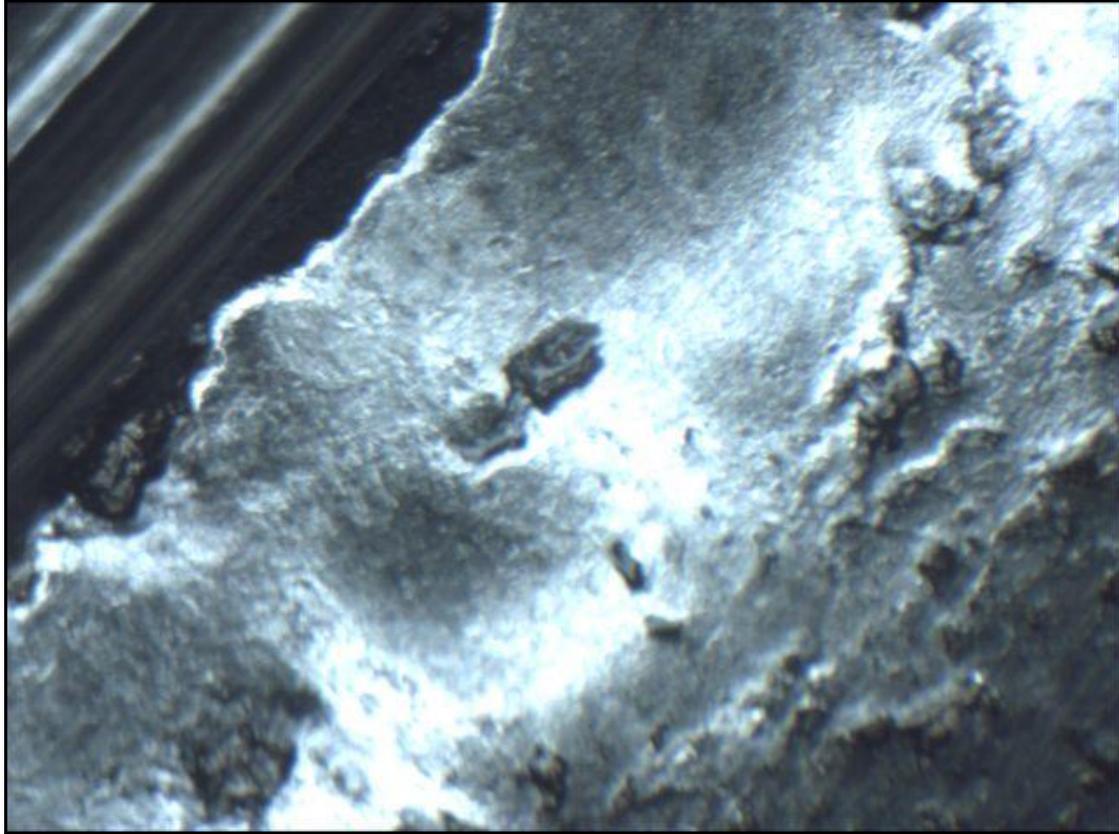
Figure 19 – Detail of outer ring raceway damage showing heavy spalling and large indentations (deformation) at edge of raceway.

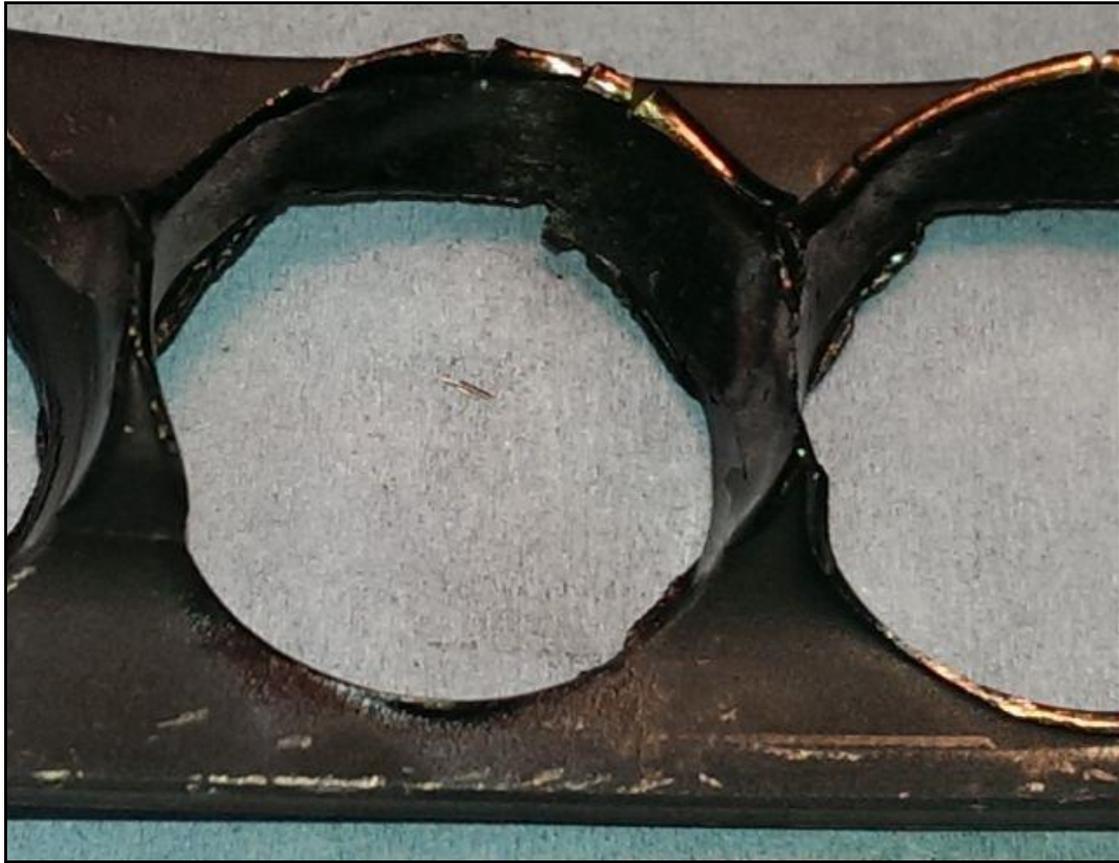
Figure 21 – Detail of cage showing flaring of material around the pockets.

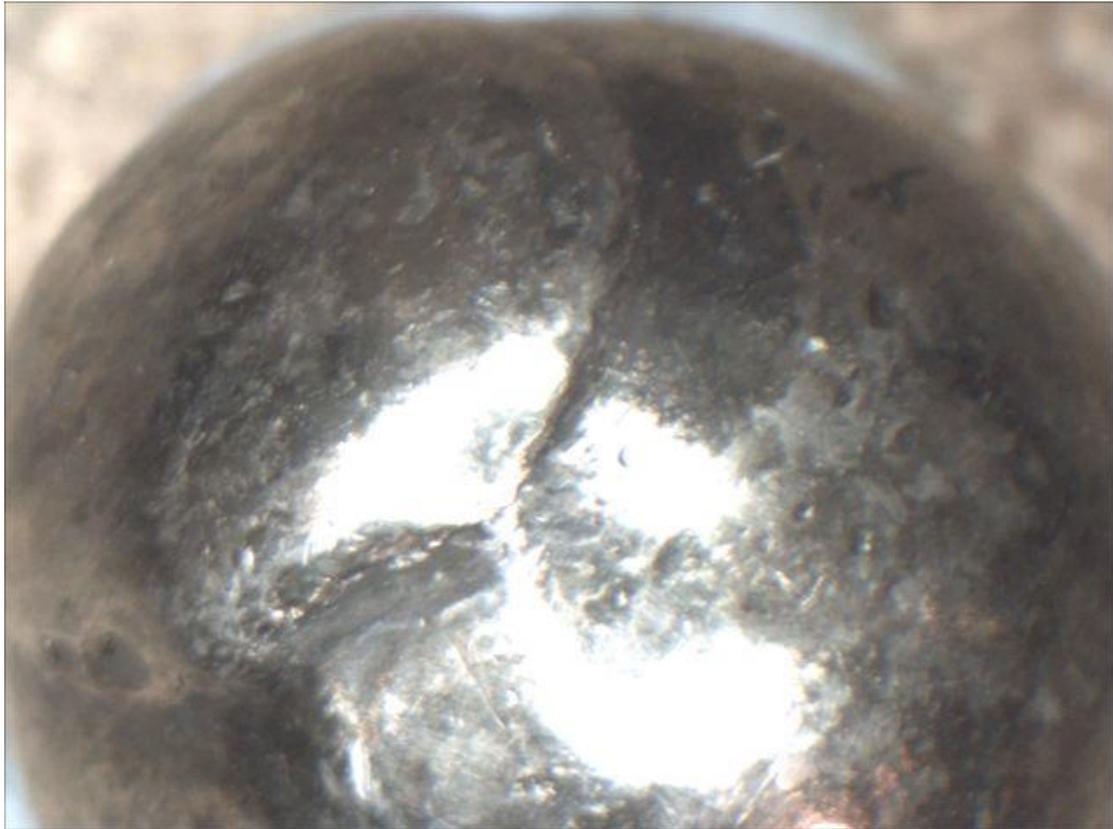
Figure 22 – example of typical ball condition. Note dents (deformation) and heavy surface damage.

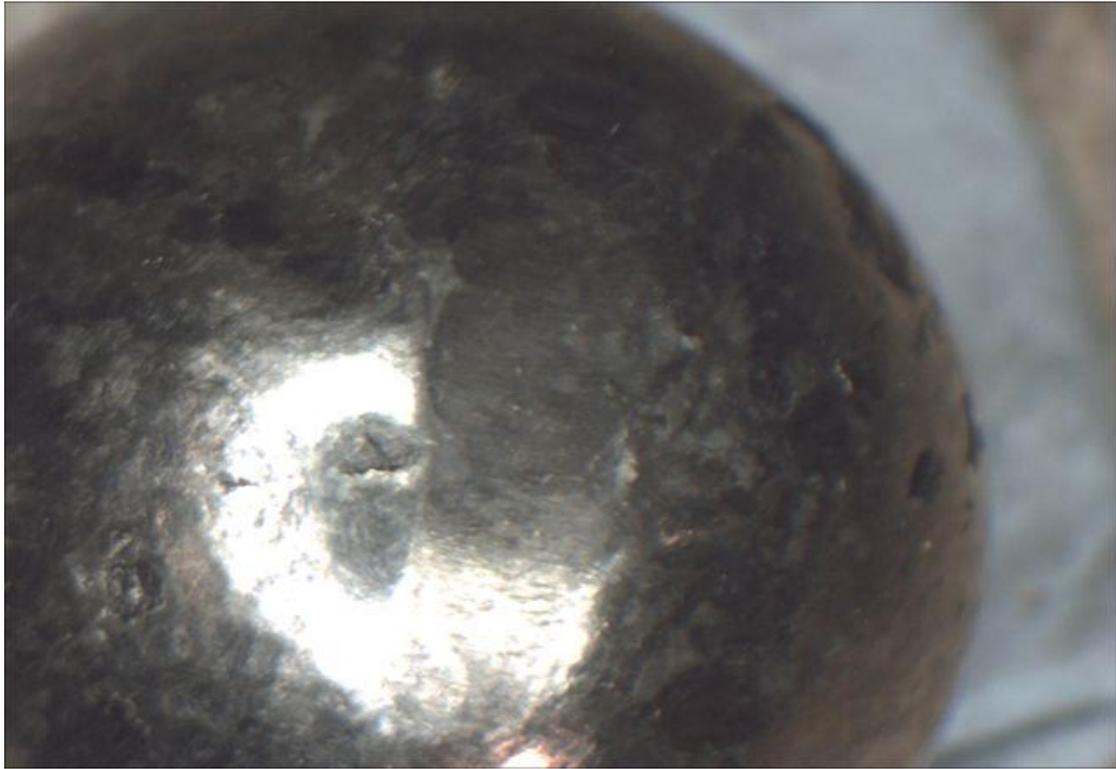
Figure 23 – example of deep gouge (deformation) on rolling element.

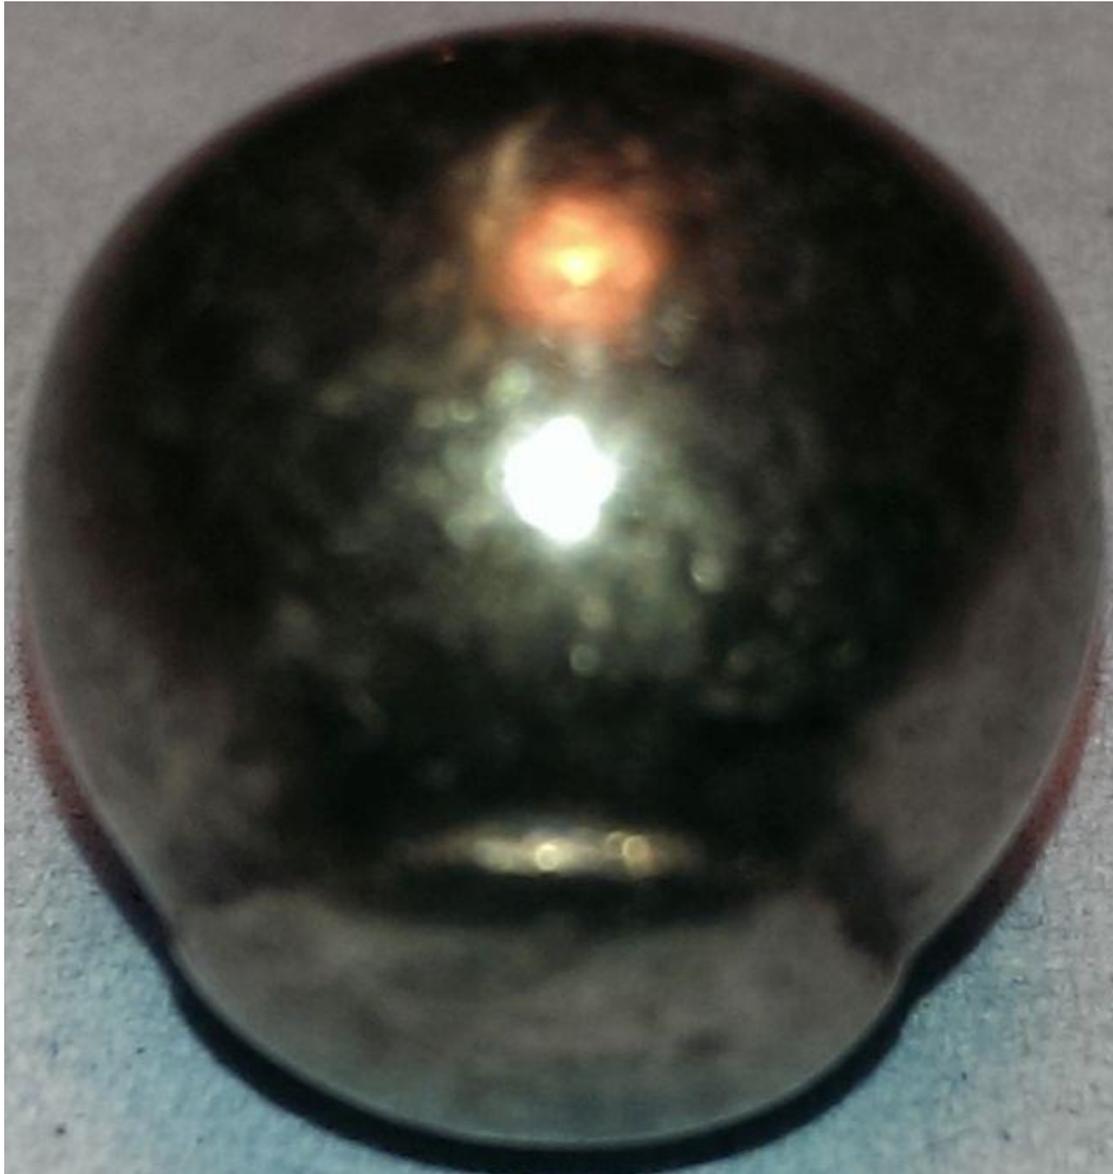
Figure 25 – Adhesive wear.

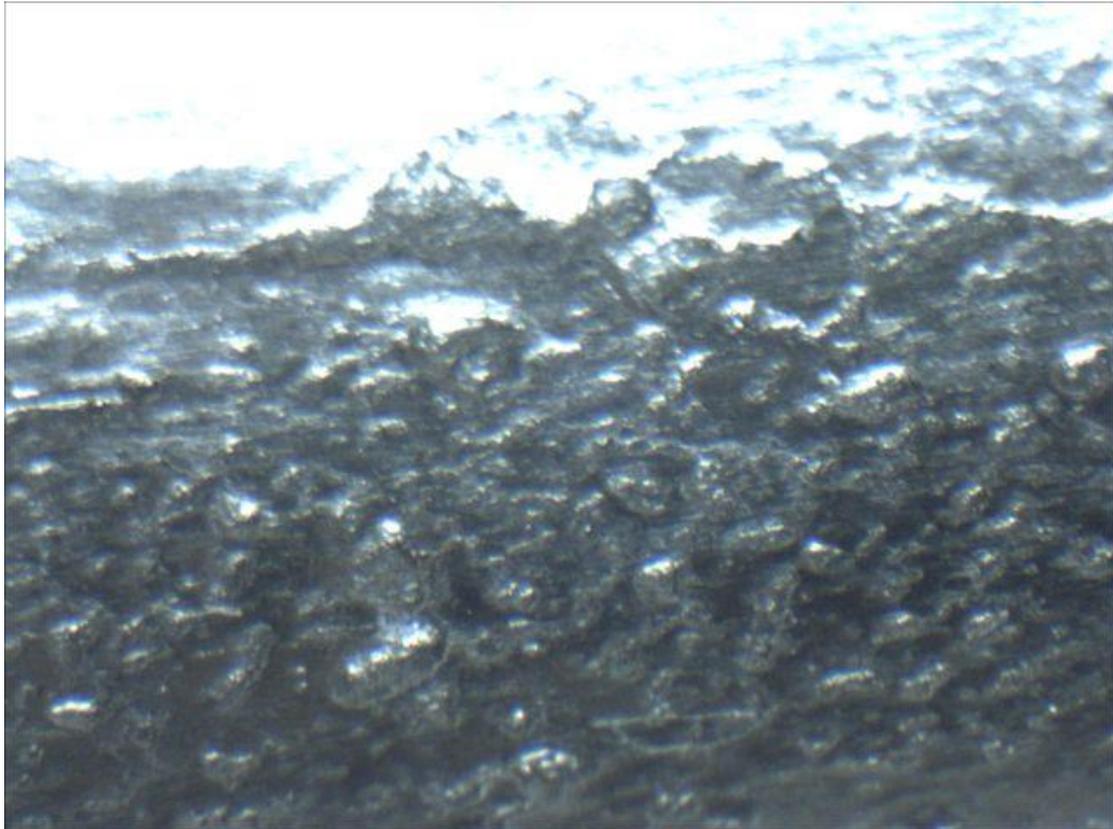
Figure 41 – Detail of outer ring raceway damage showing heavy spalling.

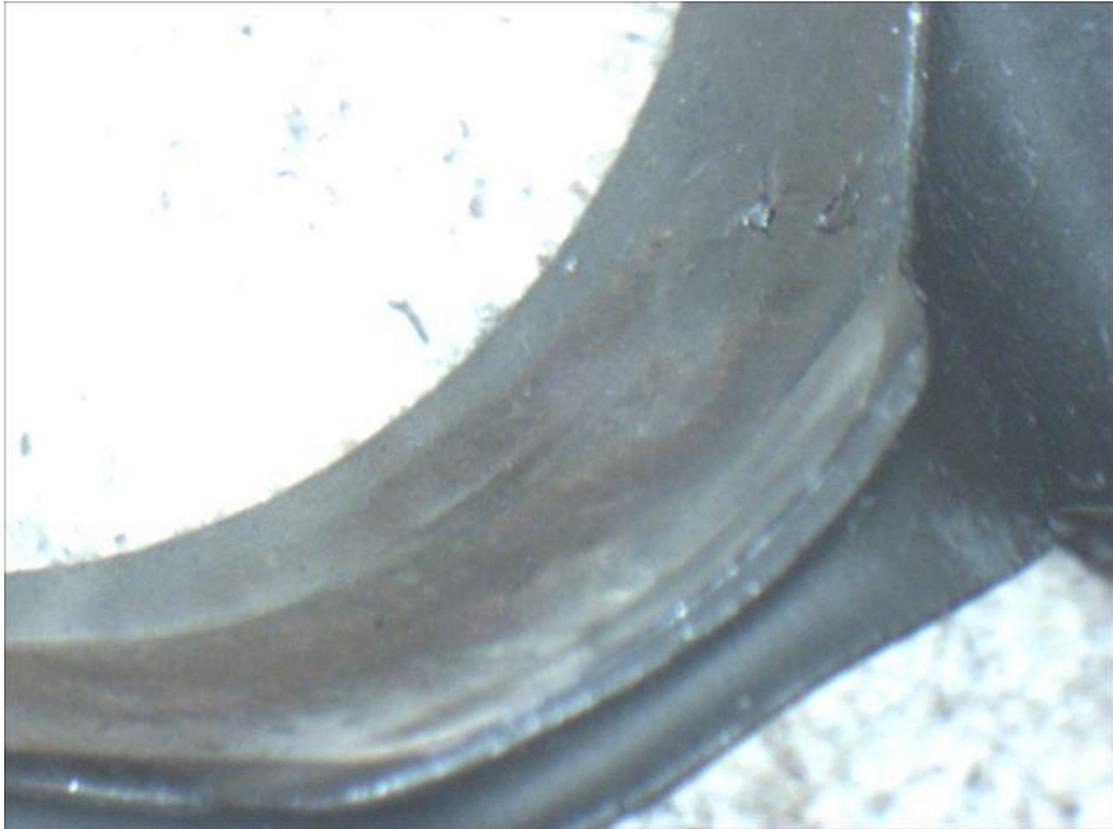
Figure 42 – Detail of cage showing discoloration and flaring of material around the pockets.

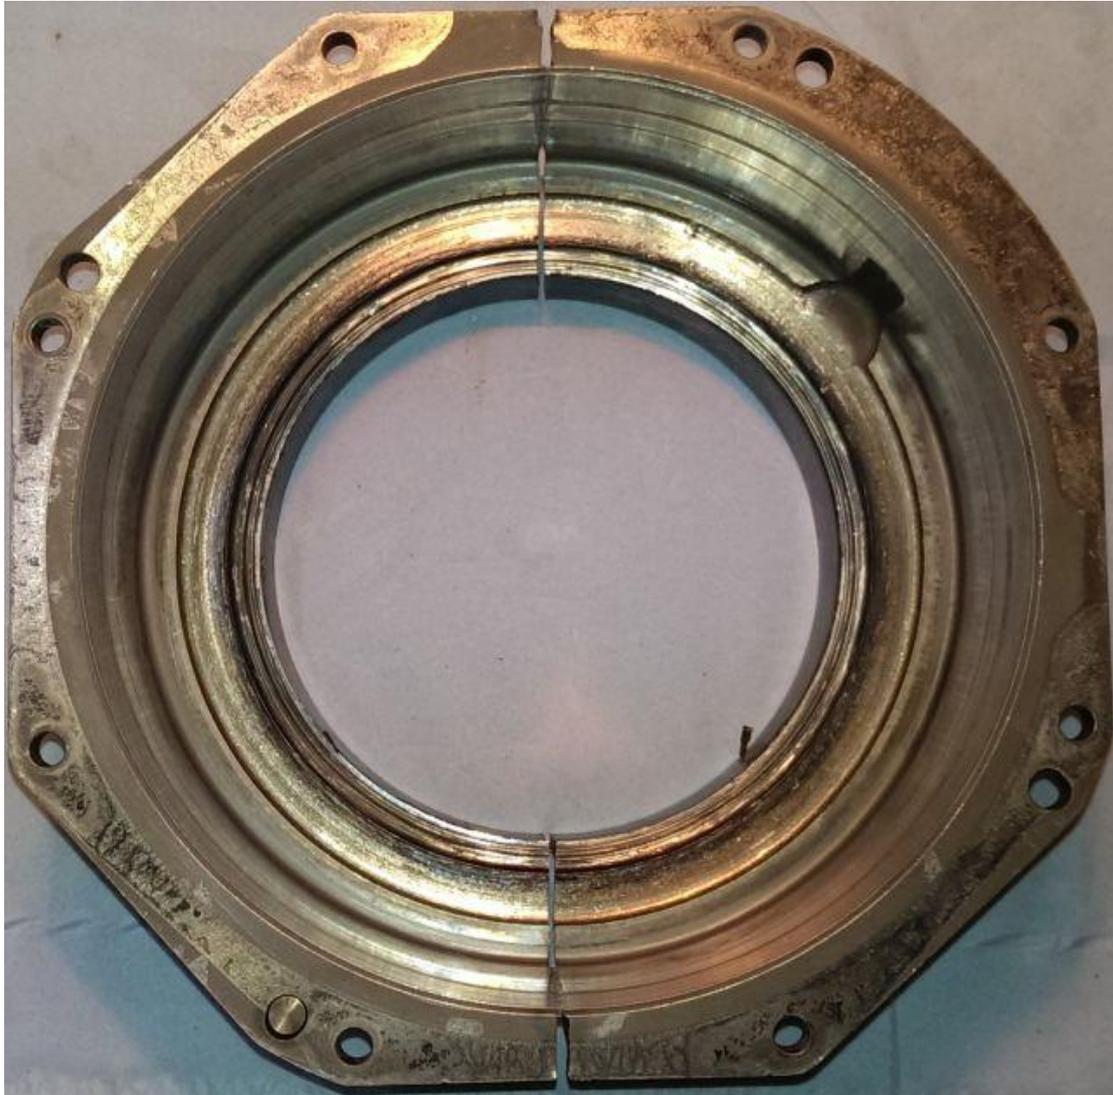
Figure 47 – interior of housing after removal of bearing races and cleaning. Note the circumferential scoring and wear.

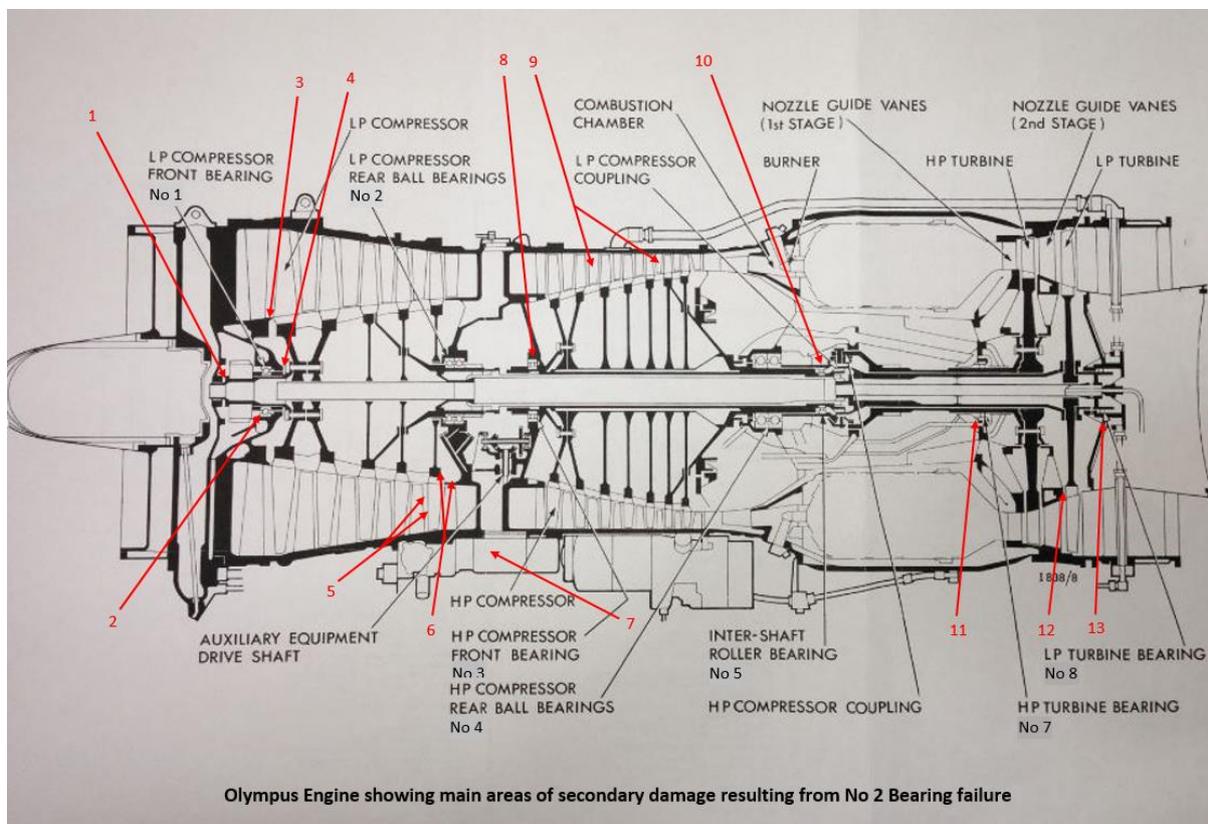
Photo numbers refer to damage area numbers shown in the Olympus sectional illustration below. Illustrations of the damage areas, numbered as per respective photos, showing the location and sectional details of the areas are contained in the Illustrations Section, starting on page 13.

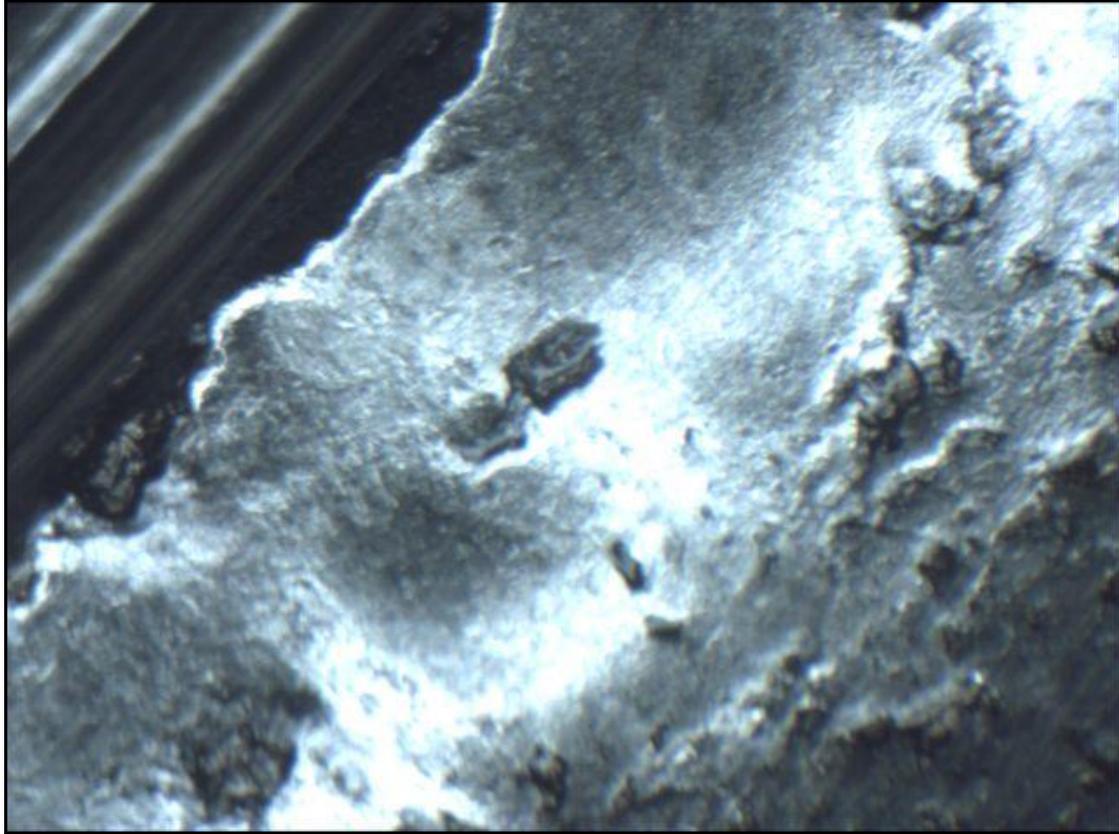
Figure 19 – Detail of outer ring raceway damage showing heavy spalling and large indentations (deformation) at edge of raceway.

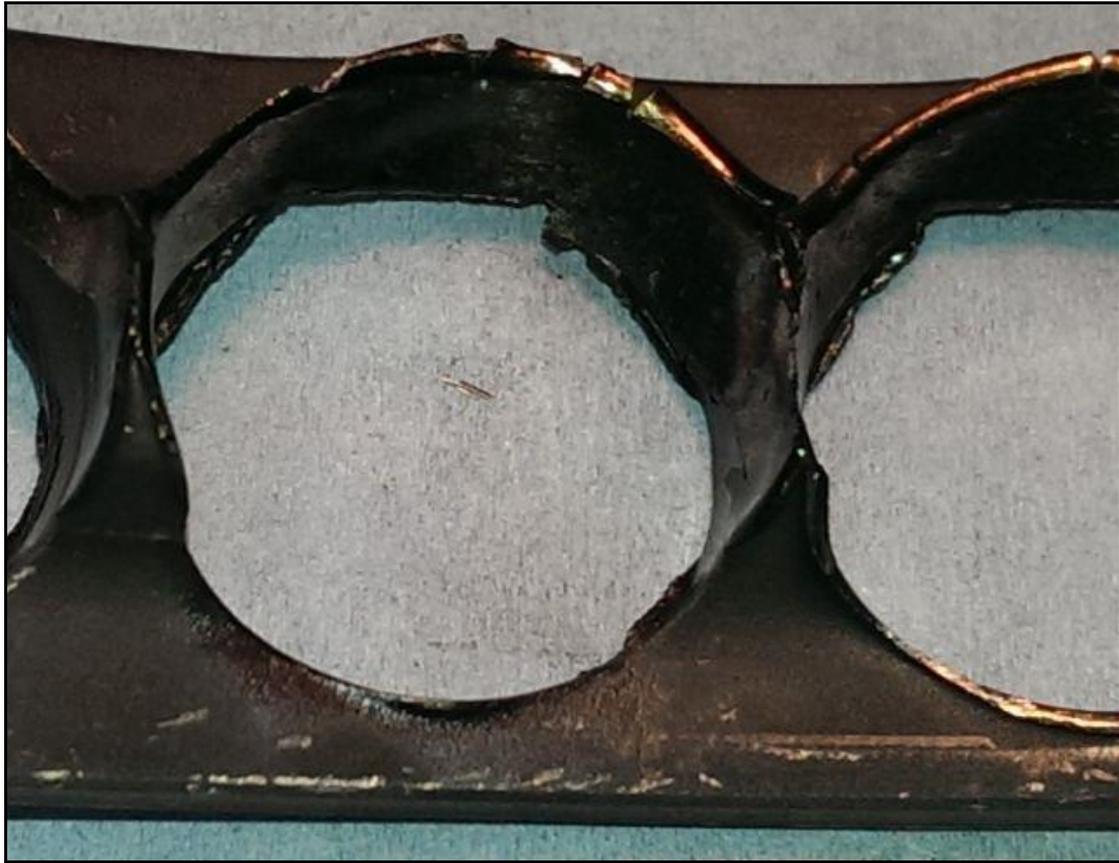
Figure 21 – Detail of cage showing flaring of material around the pockets.

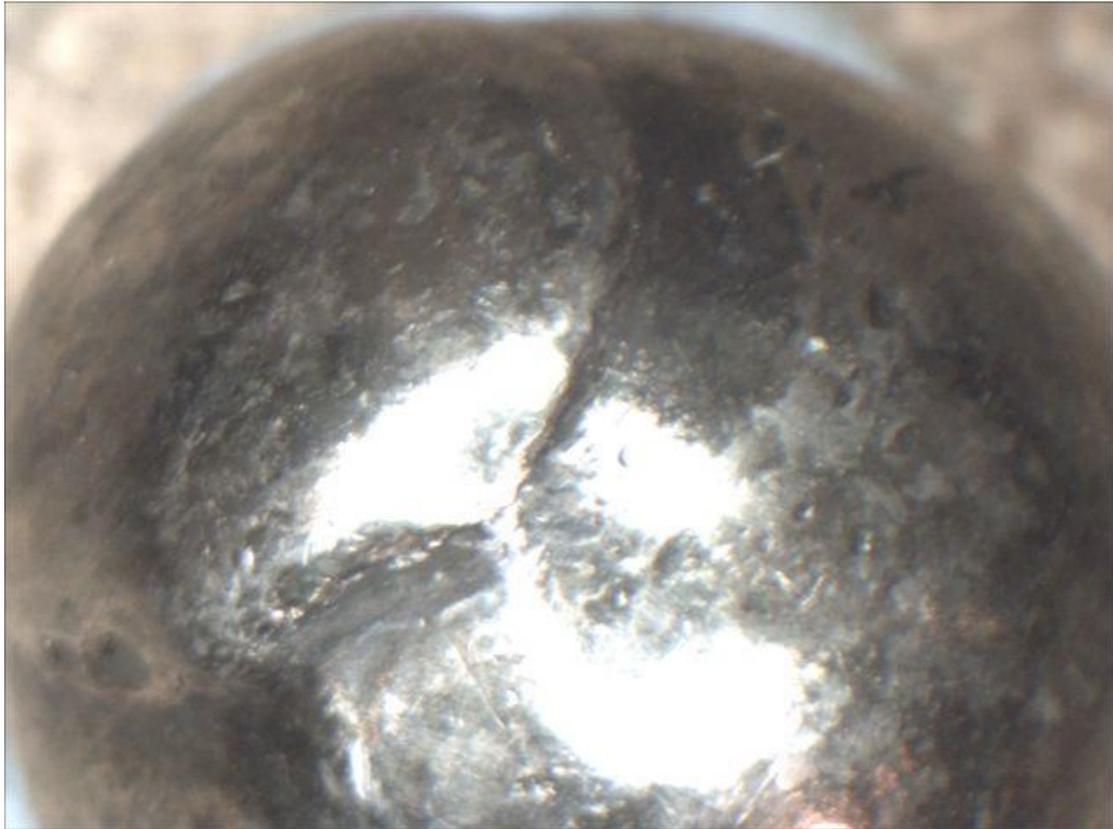
Figure 22 – example of typical ball condition. Note dents (deformation) and heavy surface damage.

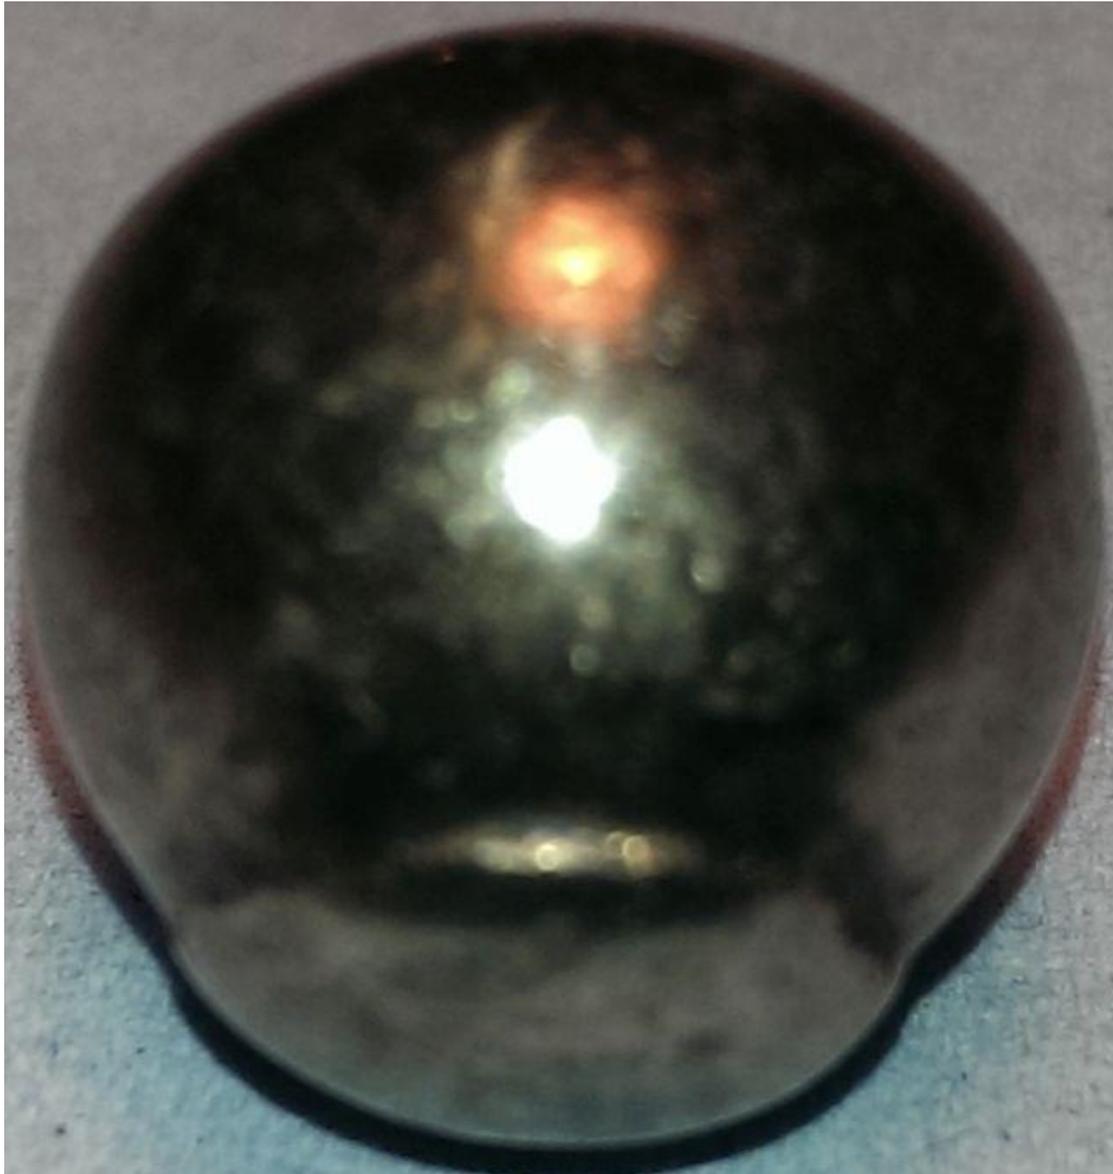
Figure 25 – Adhesive wear.

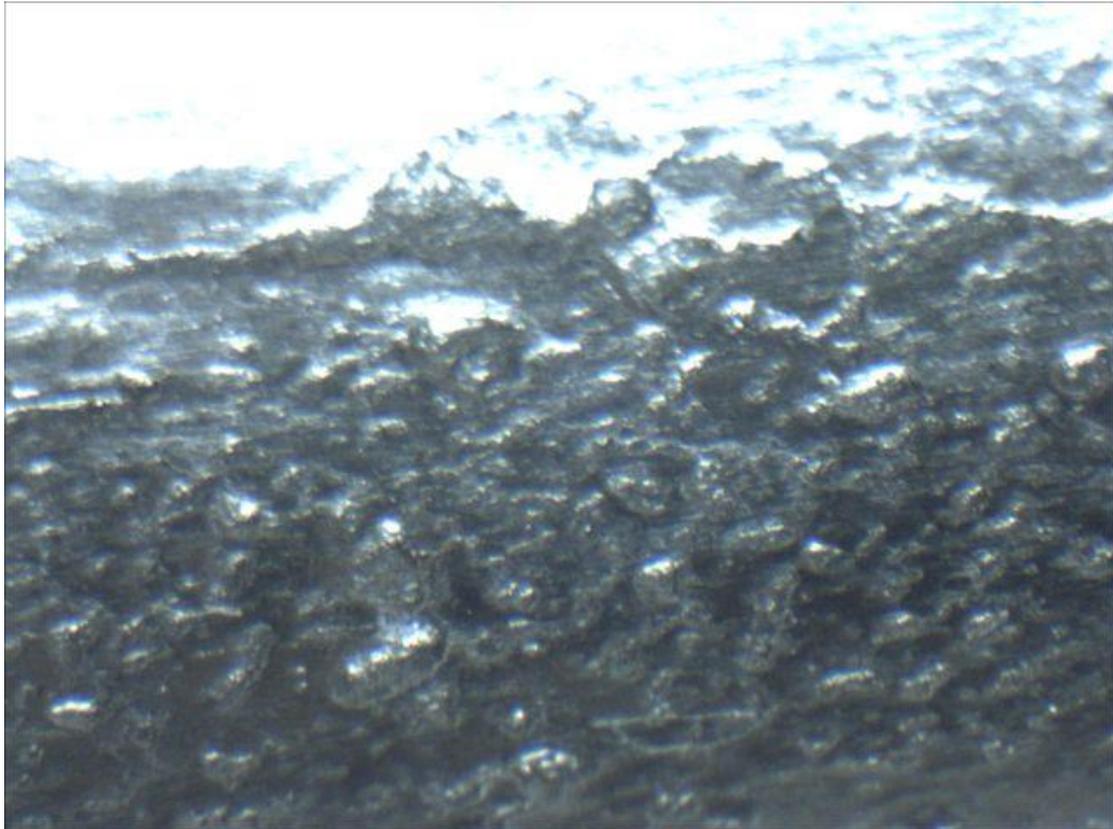
Figure 41 – Detail of outer ring raceway damage showing heavy spalling.

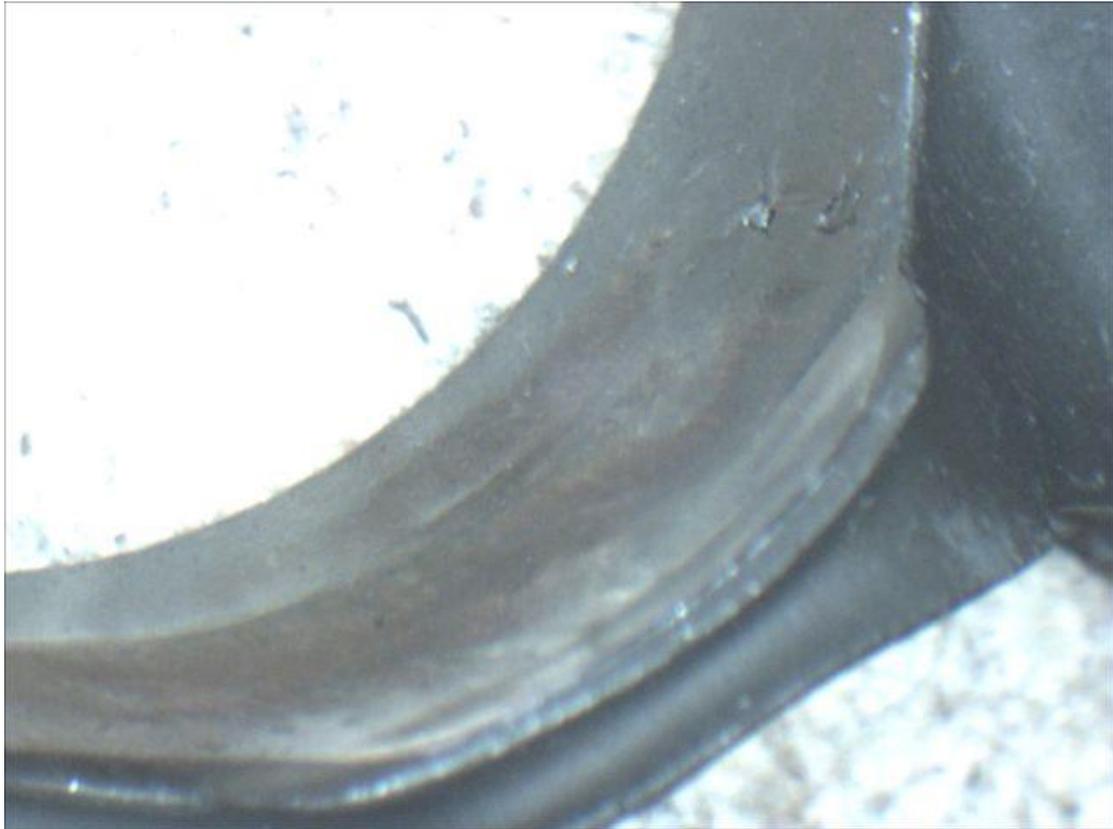
Figure 42 – Detail of cage showing discolouration and flaring of material around the pockets.
