**A REPORT TO
THE BOARD OF COMMISSIONERS OF PUBLIC UTILITIES**

NEWFOUNDLAND AND LABRADOR HYDRO

Gas Turbine Failure Analysis

Final Report

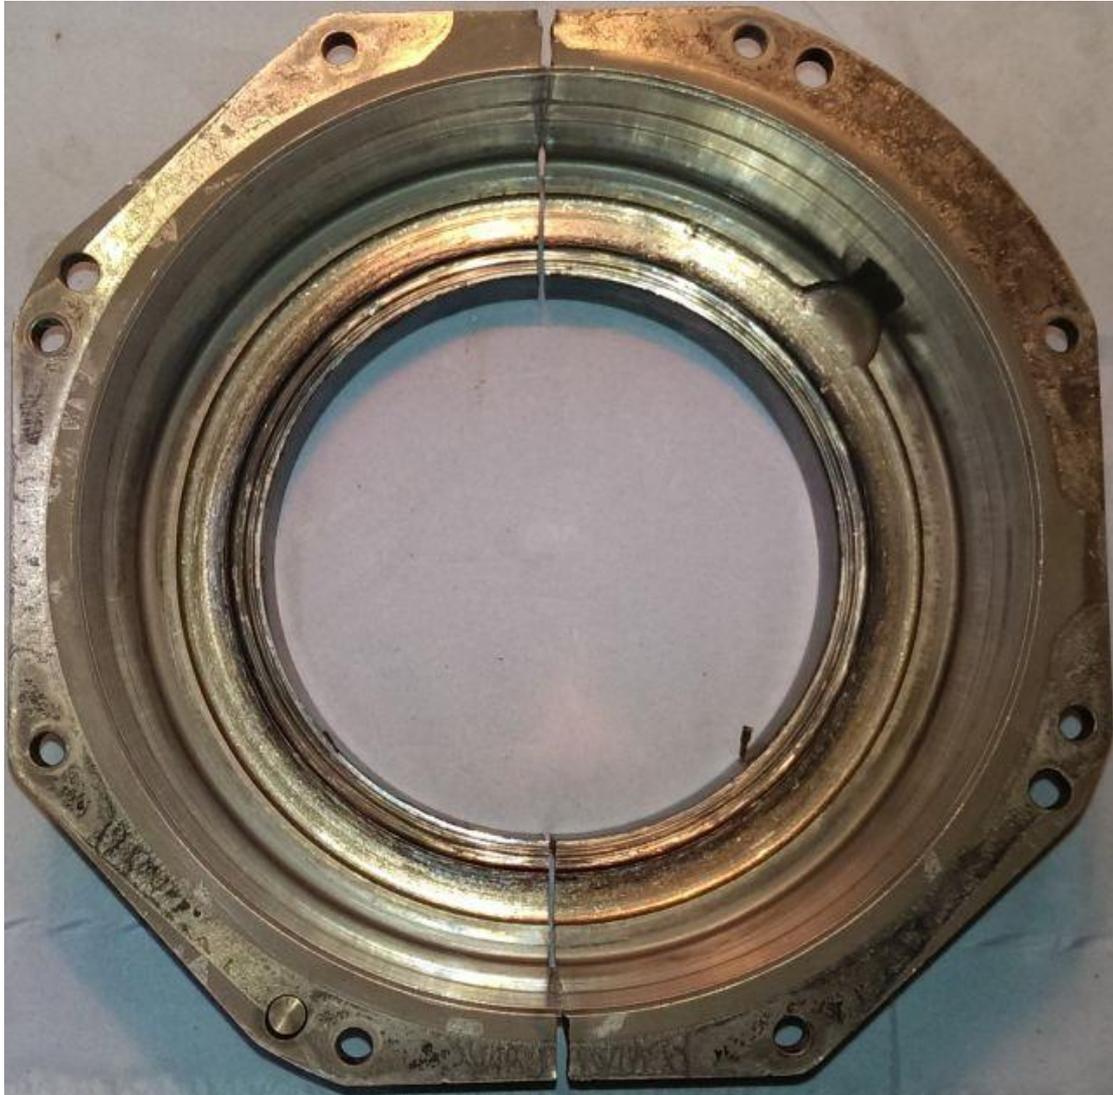
Figure 47 – interior of housing after removal of bearing races and cleaning. Note the circumferential scoring and wear.

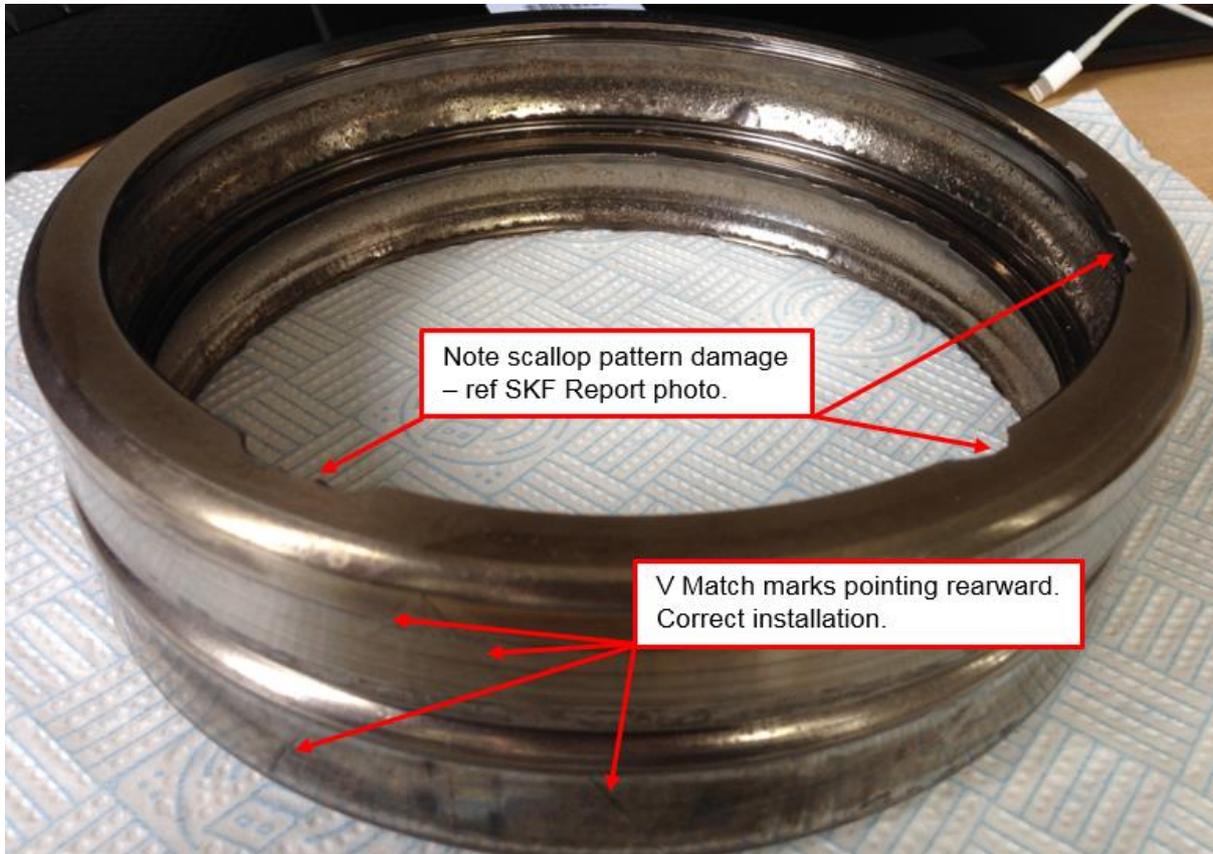
The photo below shows the outer races removed from the housing. The V match mark is visible spanning across the two races, pointing in a rearward direction per the installation drawing further above, albeit the rear race V is somewhat faded due to rotation scoring of the race in the housing during the bearing failure. (Again note the damage scallops on the rearward face of the rear bearing, as in above photo, demonstrating that the races were installed correctly. Also note the ball grooves worst abrasion damage being at the front side of the races due to the LP Compressor forward thrust.)

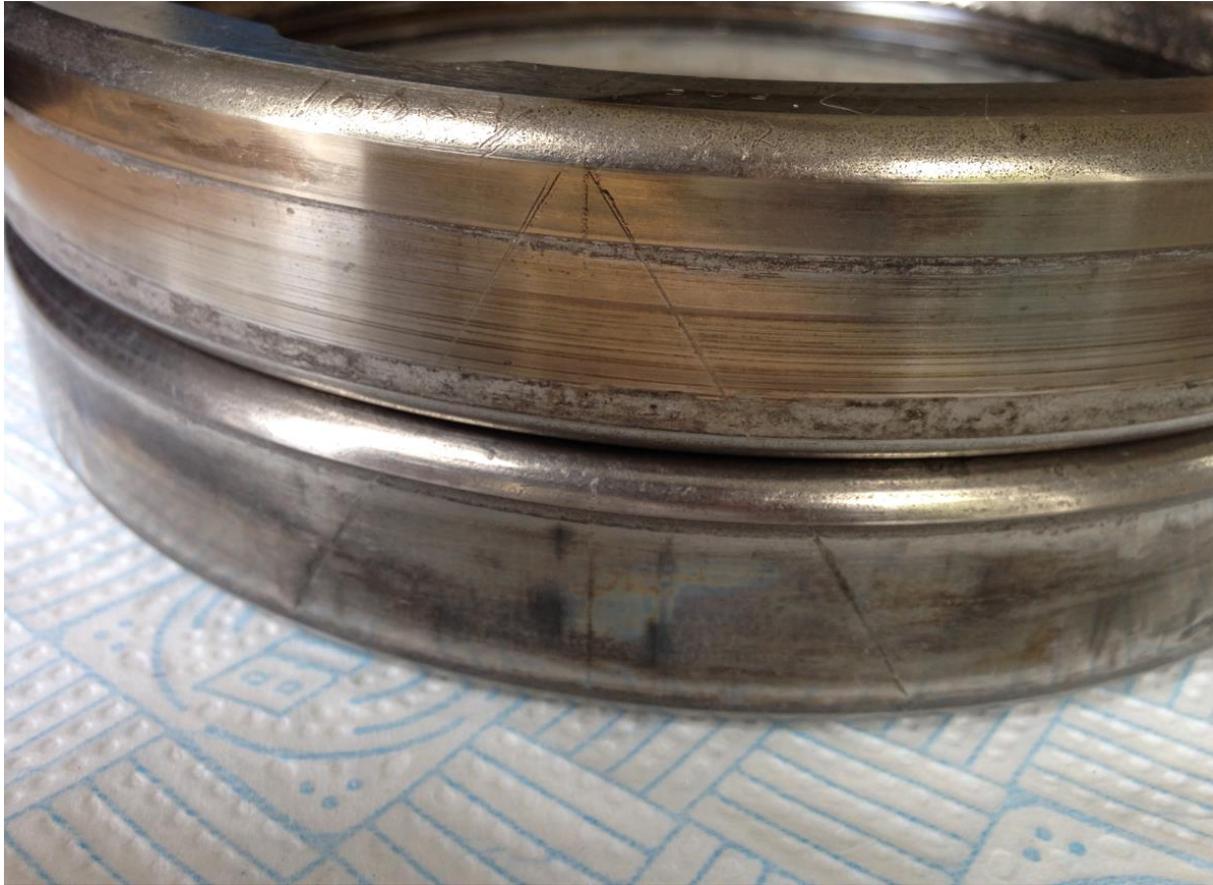
The photo below shows the V match marks on the outer races more clearly. Circumferential scoring is also visible particularly on the diameter of the rear race (top) caused by rotation of the race in the housing during the bearing failure process.

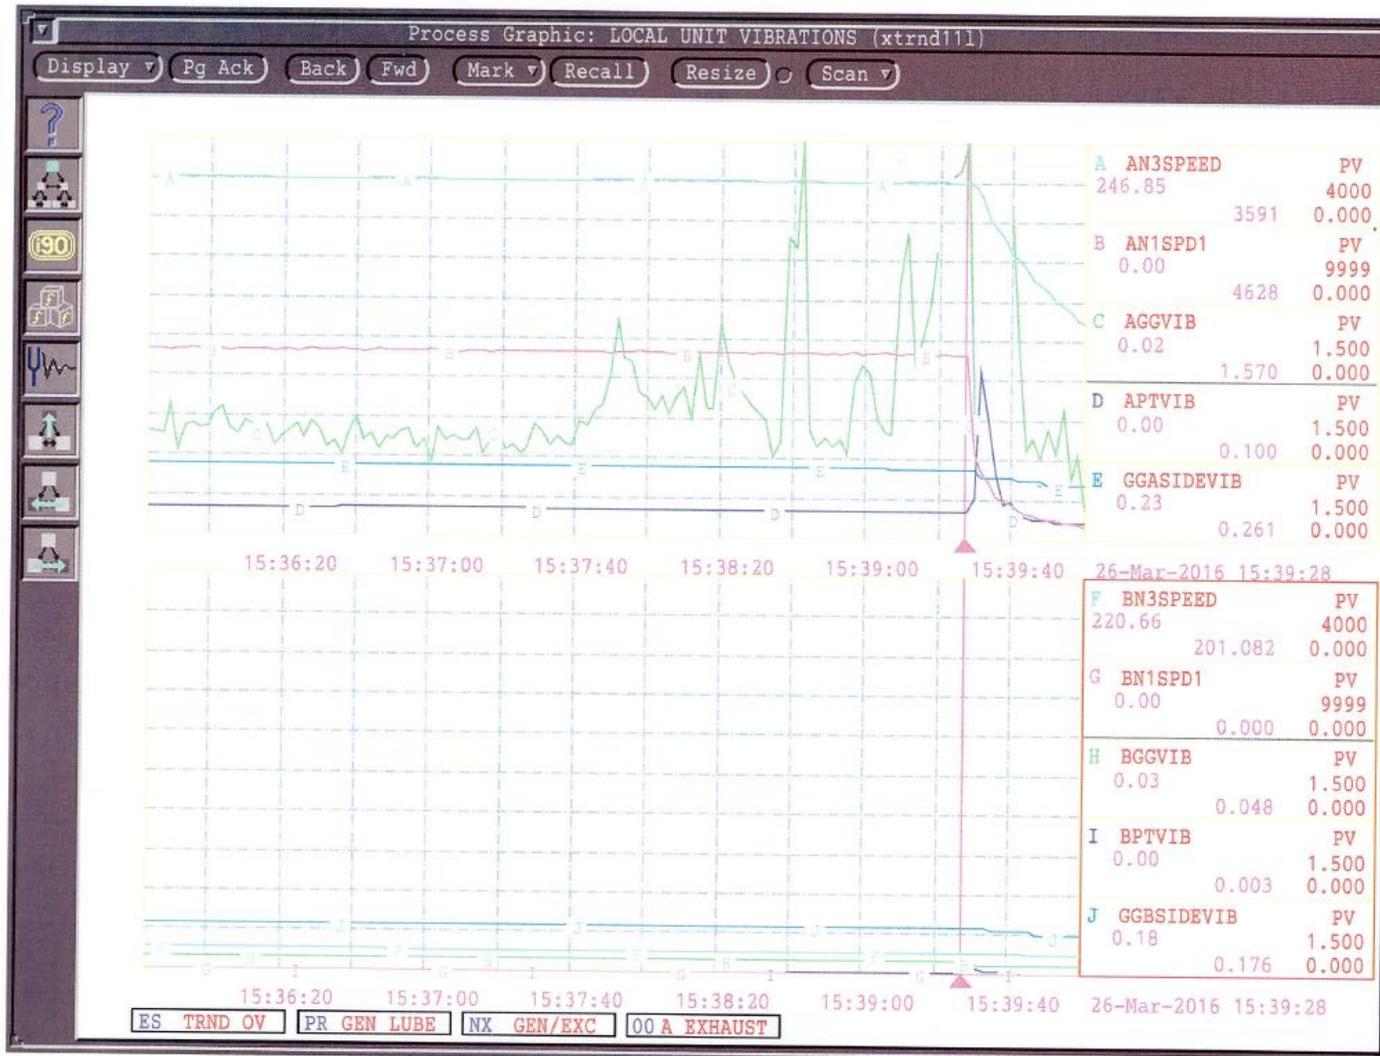
The Trend Graph below shows the GG vibration running steady at approx. 0.37 inches/sec peak, then suddenly increasing (start of No 2 bearing mechanical failure) and becoming erratic from approx. 15:37:40 onwards, with several high amplitude spikes before finally tripping at 15:39:27 (ref Turbine Events Log) at 1.570 inches/sec peak.

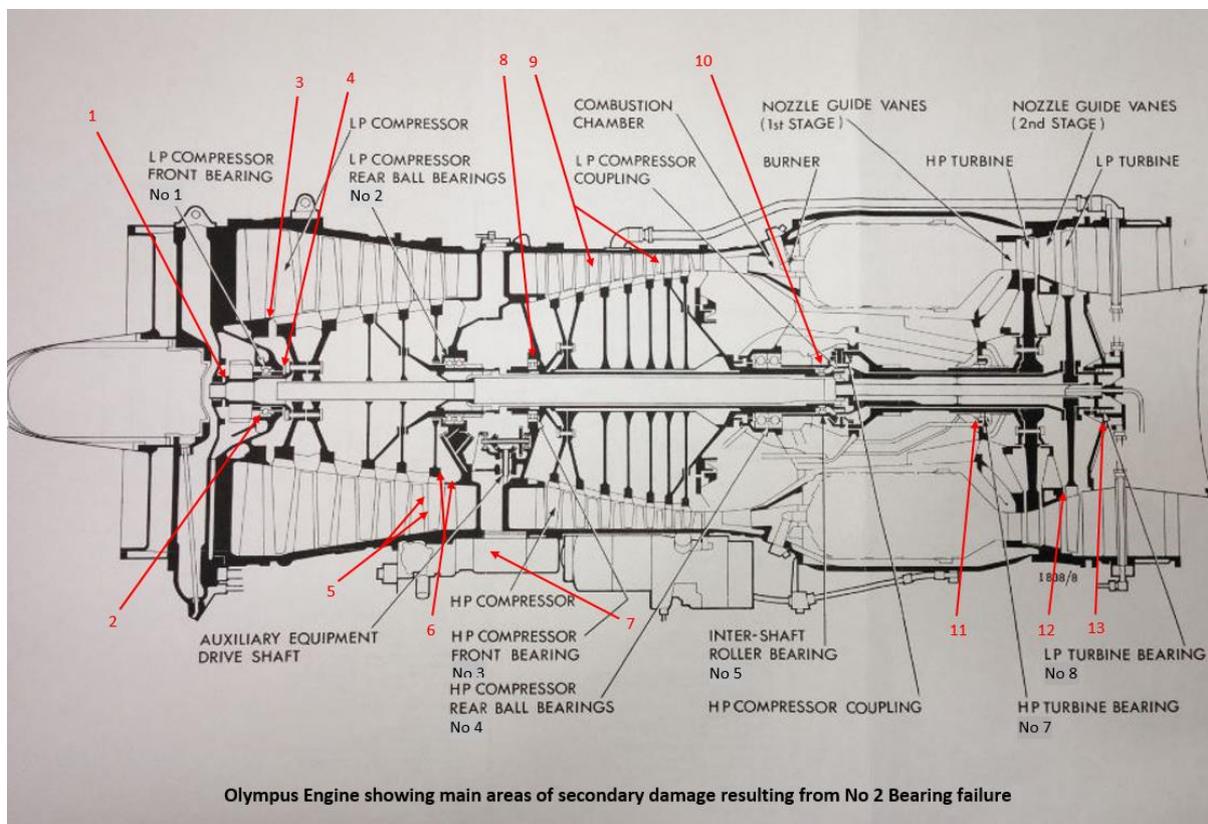
Photo numbers refer to damage area numbers shown in the Olympus sectional illustration below. Illustrations of the damage areas, numbered as per respective photos, showing the location and sectional details of the areas are contained in the Illustrations Section, starting on page 13.
