Re: *Reliability and Resource Adequacy Study Review - Assessment to Determine the Potential Long-Term Viability of the Holyrood Thermal Generating Station*

Holyrood Thermal Generating Station Condition Assessment

**Newfoundland and Labrador Hydro
HTGS Condition Assessment and Life Extension Study
Executive Summary**

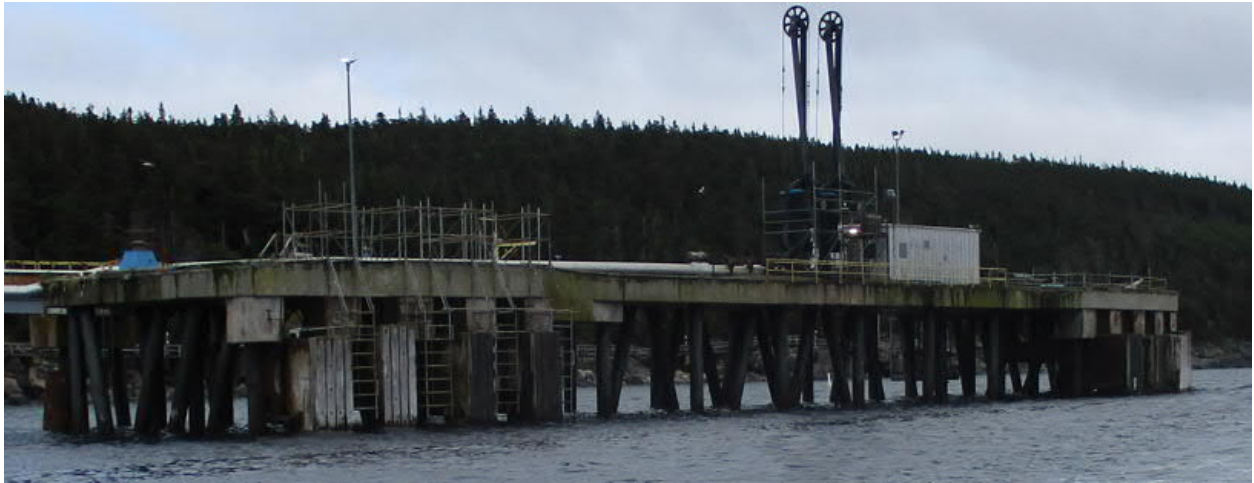
Figure 5-51: Berthing Jetty Facing Southwest

A significant number of piles have corrosion present at the splash zone. Above the splash zone, near the upper portion of the piles, the coating is in generally good condition. There is significant marine growth (barnacles, coral, etc.) on the piles under the water surface. Visual inspection below the water line was limited due to the excessive growth. In areas where there was visible coating, the coating appears in generally good condition. Areas that were scraped clean for previous inspection are still visible and remained in good condition. The remaining life condition of the anodes at the surface, mid and bottom level of the pile were also assessed. The anodes condition varies, ranging from 0% remaining (anode completely gone) to 100% remaining (anode showing no deterioration). The remaining condition on adjacent anodes varied significantly in each location, there were several locations where one anode was completely consumed, and the adjacent was entirely intact. During the inspection it was noted that some anodes on the north end showed signs of damage due to ice contact in Winter 2017. It is recommended that the piles and anodes undergo a visual (diving) inspection again within a 5-year time frame.

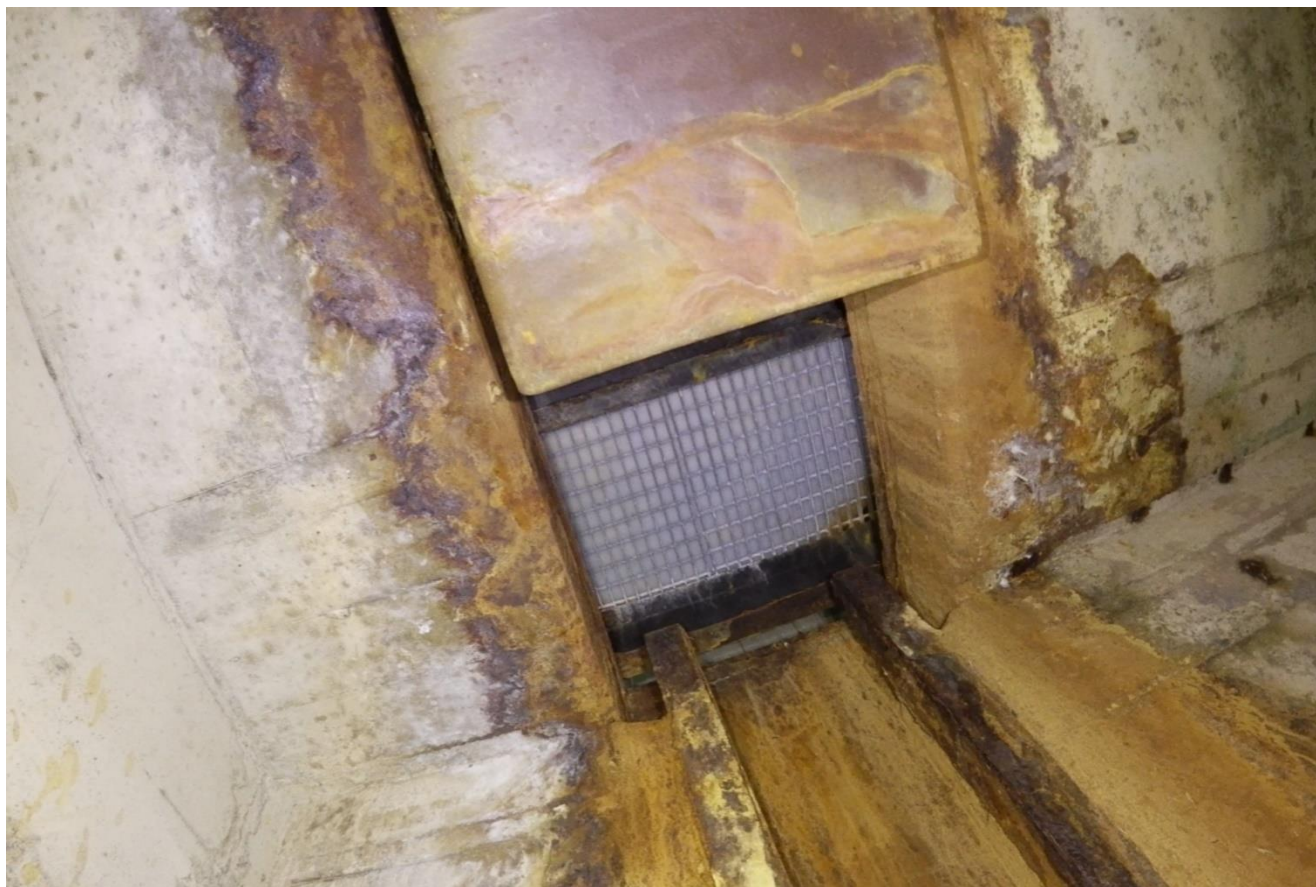
Anomaly (Y/N)	ID	Component	Component Tag	Type of Anomaly	Deg of Corrosion	Module	Level	Heat Map	Comments
Y	-	-	-	-	-	-	-	-	Standoff of entry access point. Deterioration of concrete present throughout

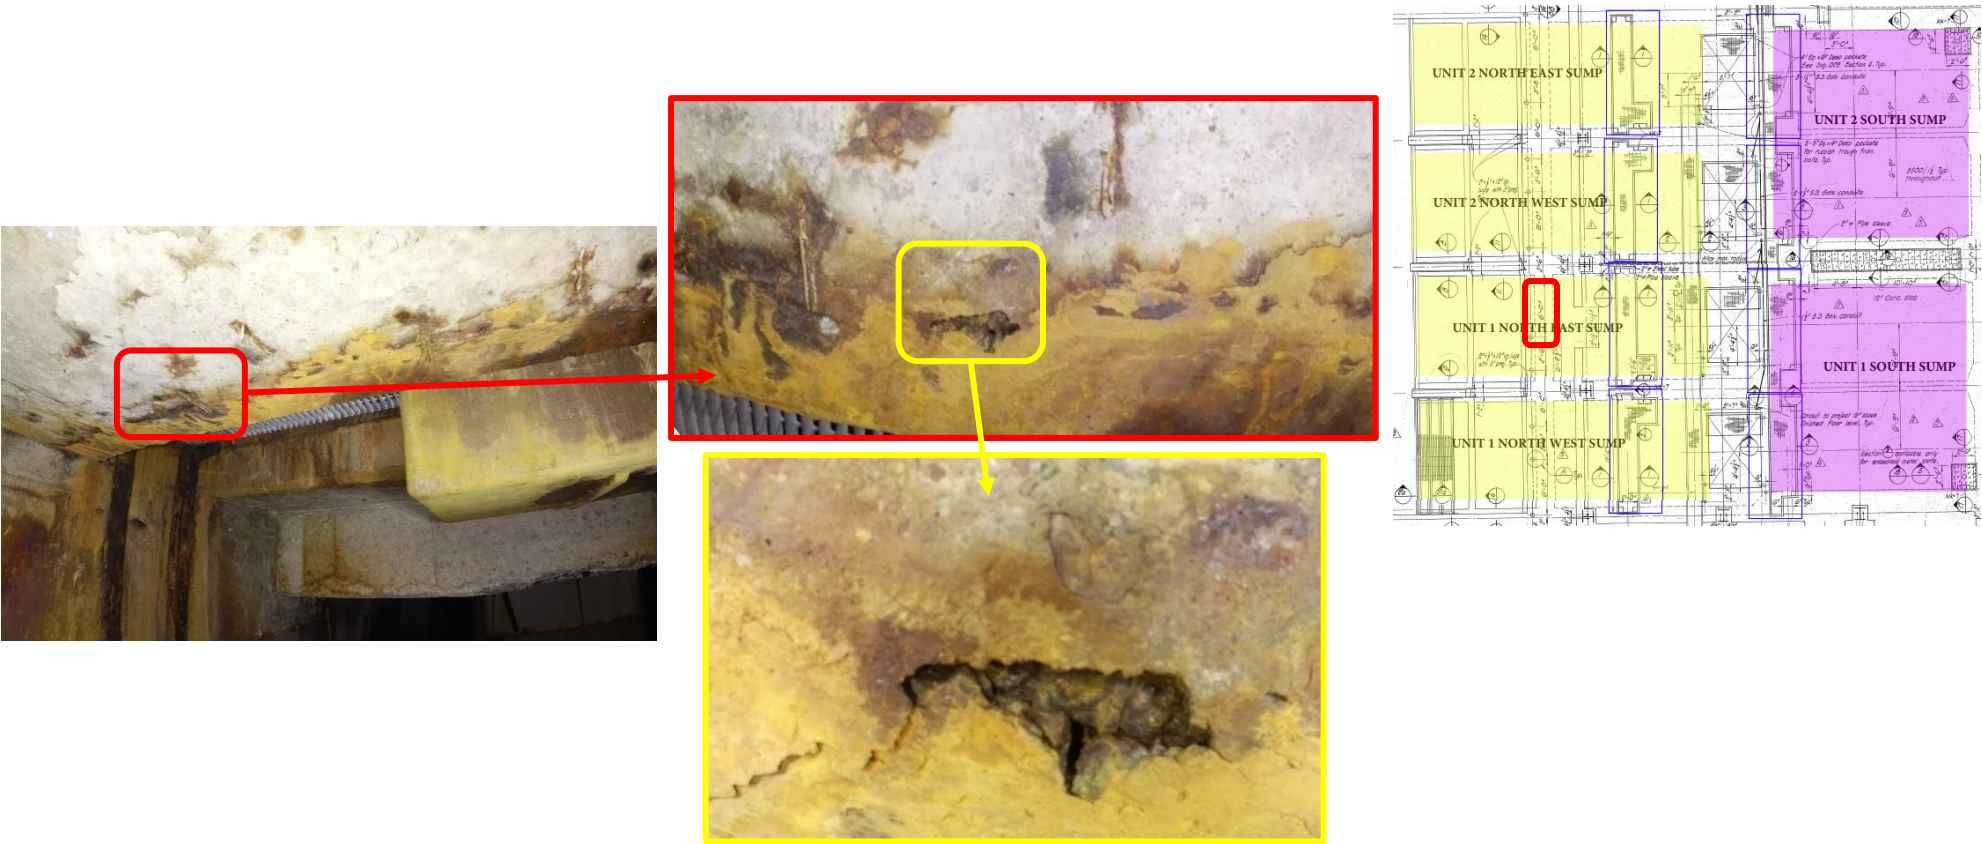
Anomaly (Y/N)	ID	Component	Component Tag	Type of Anomaly	Deg of Corrosion	Module	Level	Heat Map	Comments
Y	-	-	-	Deterioration	-	-	-	-	Cracking of concrete near point of entry

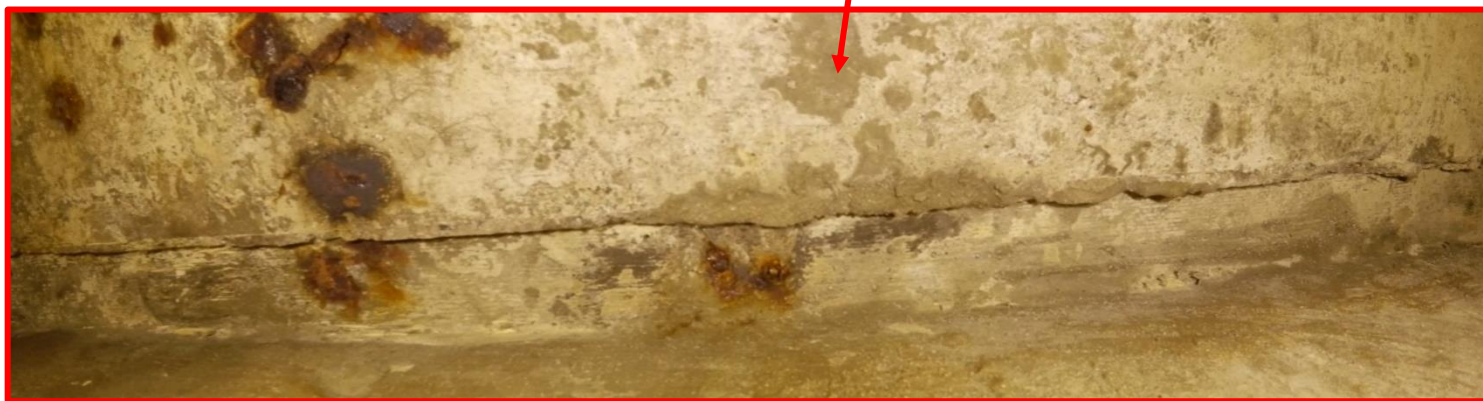
Anomaly (Y/N)	ID	Component	Component Tag	Type of Anomaly	Deg of Corrosion	Module	Level	Heat Map	Comments
Y	-	-	-	Crack	-	-	-	-	Cracking along west wall

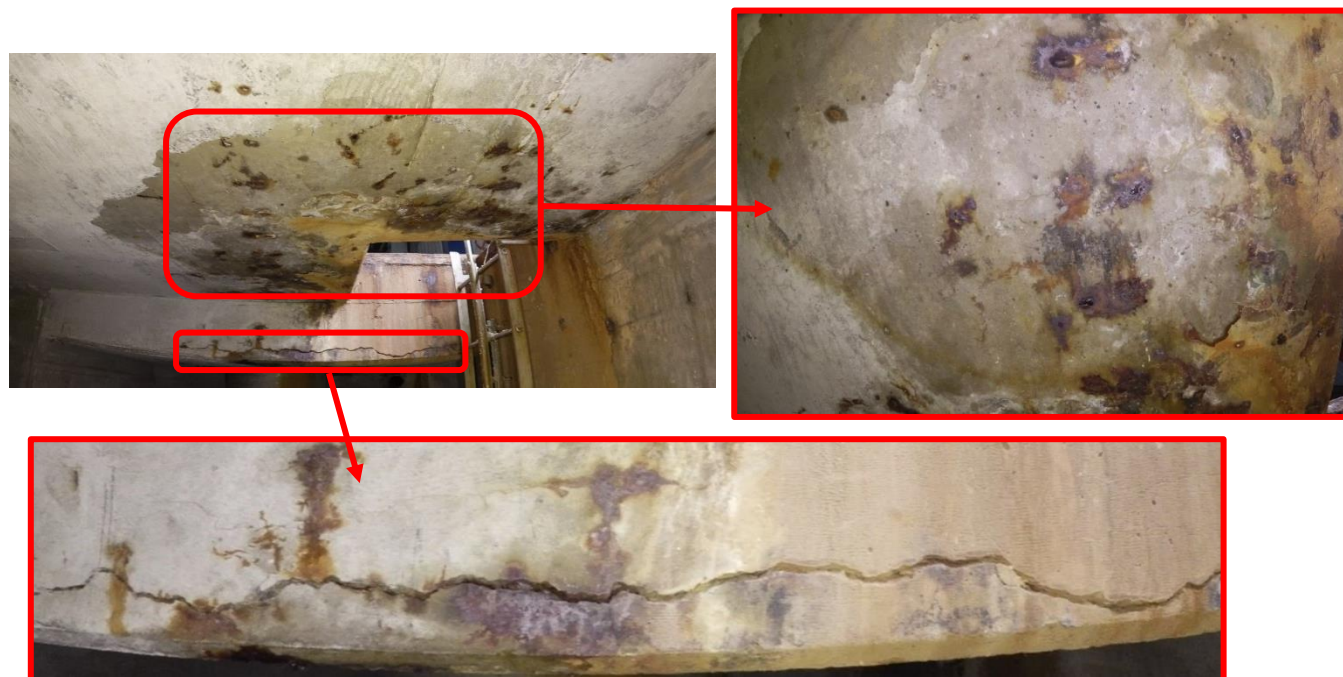
Anomaly (Y/N)	ID	Component	Component Tag	Type of Anomaly	Deg of Corrosion	Module	Level	Heat Map	Comments
Y	-	-	-	Crack	-	-	-	-	Large crack and deterioration of concrete at entry point

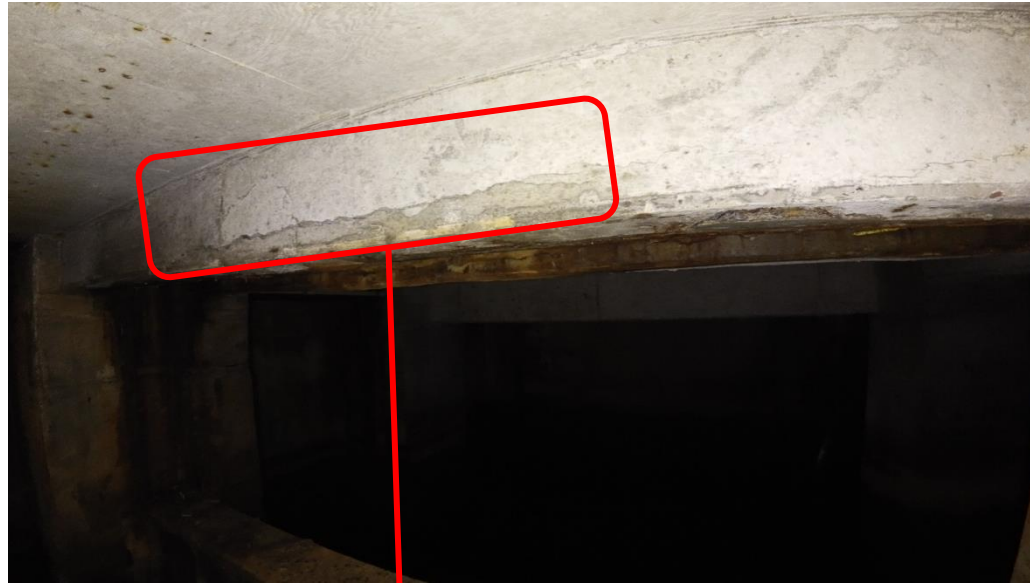
Anomaly (Y/N)	ID	Component	Component Tag	Type of Anomaly	Deg of Corrosion	Module	Level	Heat Map	Comments
Y	-	-	-	Crack	-	-	-	-	Cracking of concrete beam

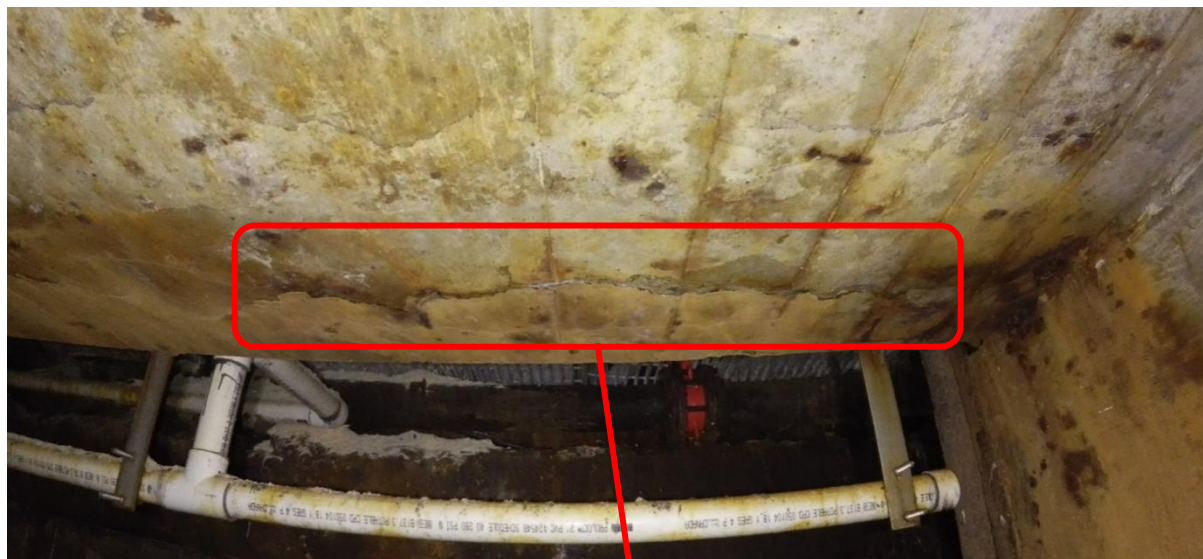
Anomaly (Y/N)	ID	Component	Component Tag	Type of Anomaly	Deg of Corrosion	Module	Level	Heat Map	Comments
Y	-	-	-	Deterioration of concrete	-	-	-	-	Concrete delamination

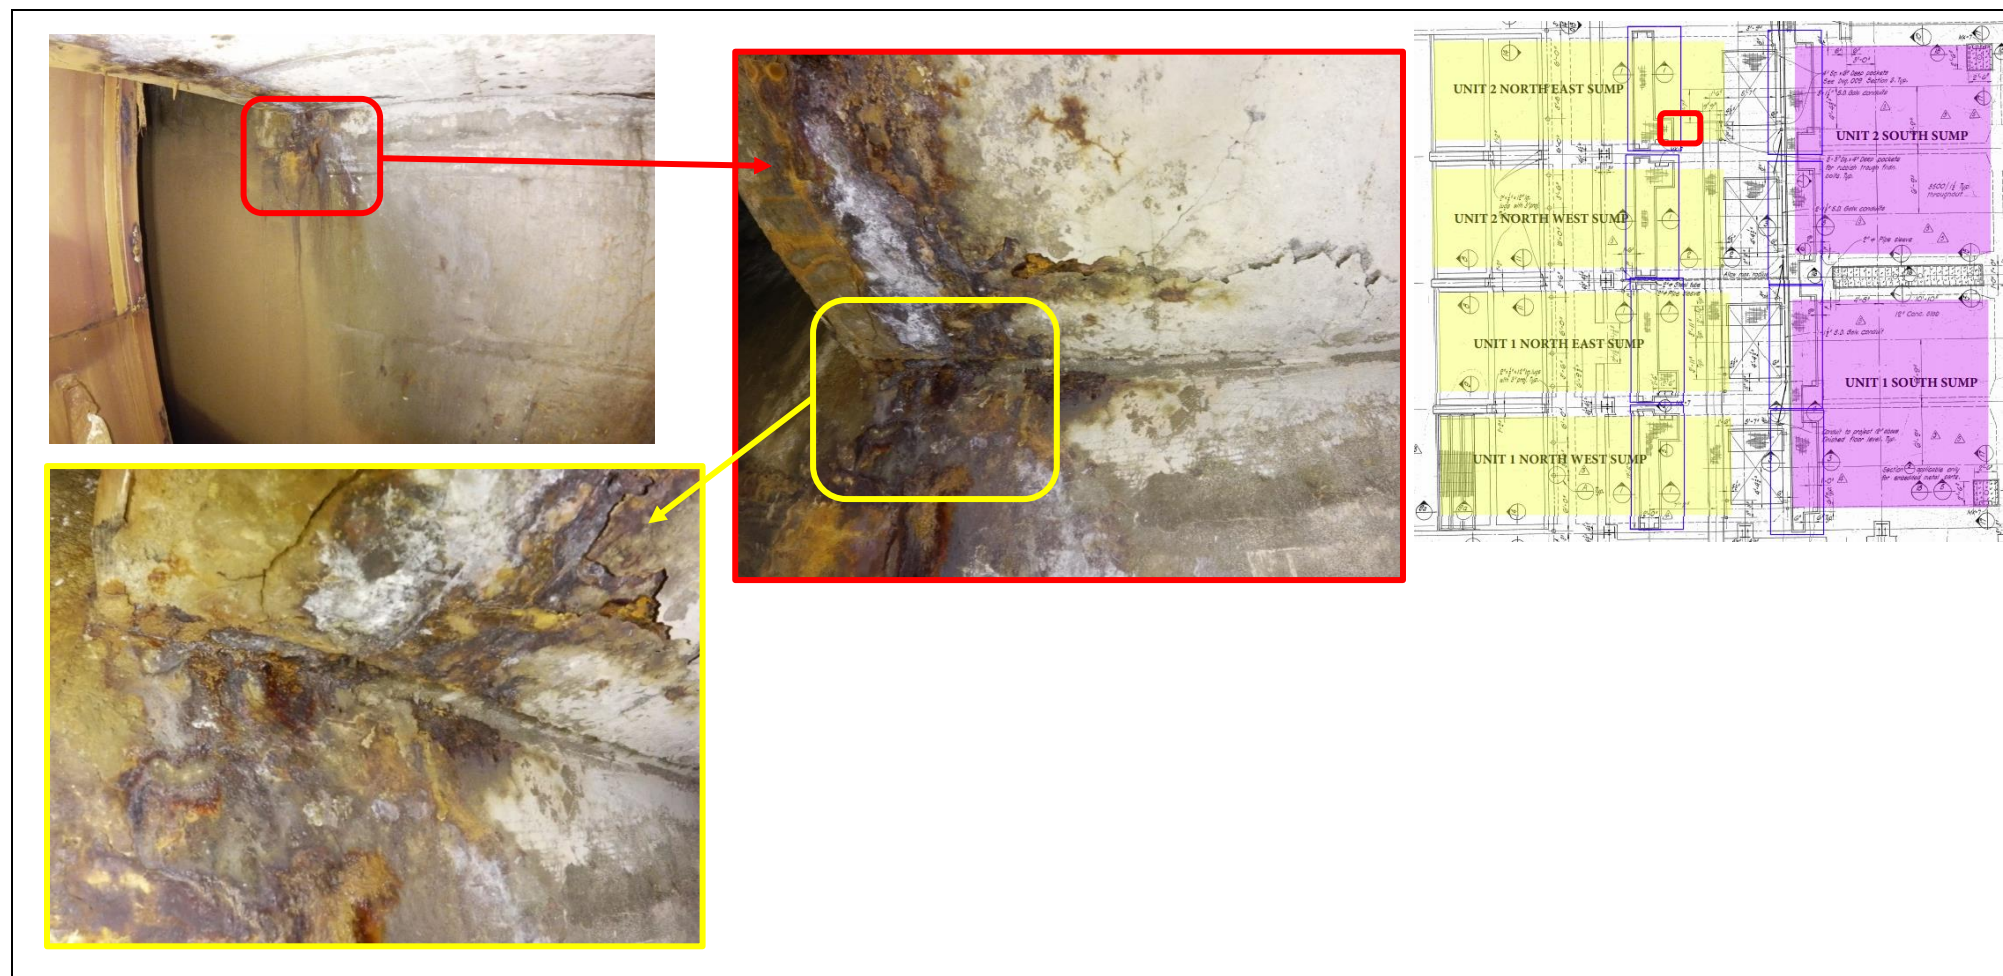
Anomaly (Y/N)	ID	Component	Component Tag	Type of Anomaly	Deg of Corrosion	Module	Level	Heat Map	Comments
Y	-	-	-	Deterioration of concrete	-	-	-	-	Delamination of concrete and corrosion of rebar

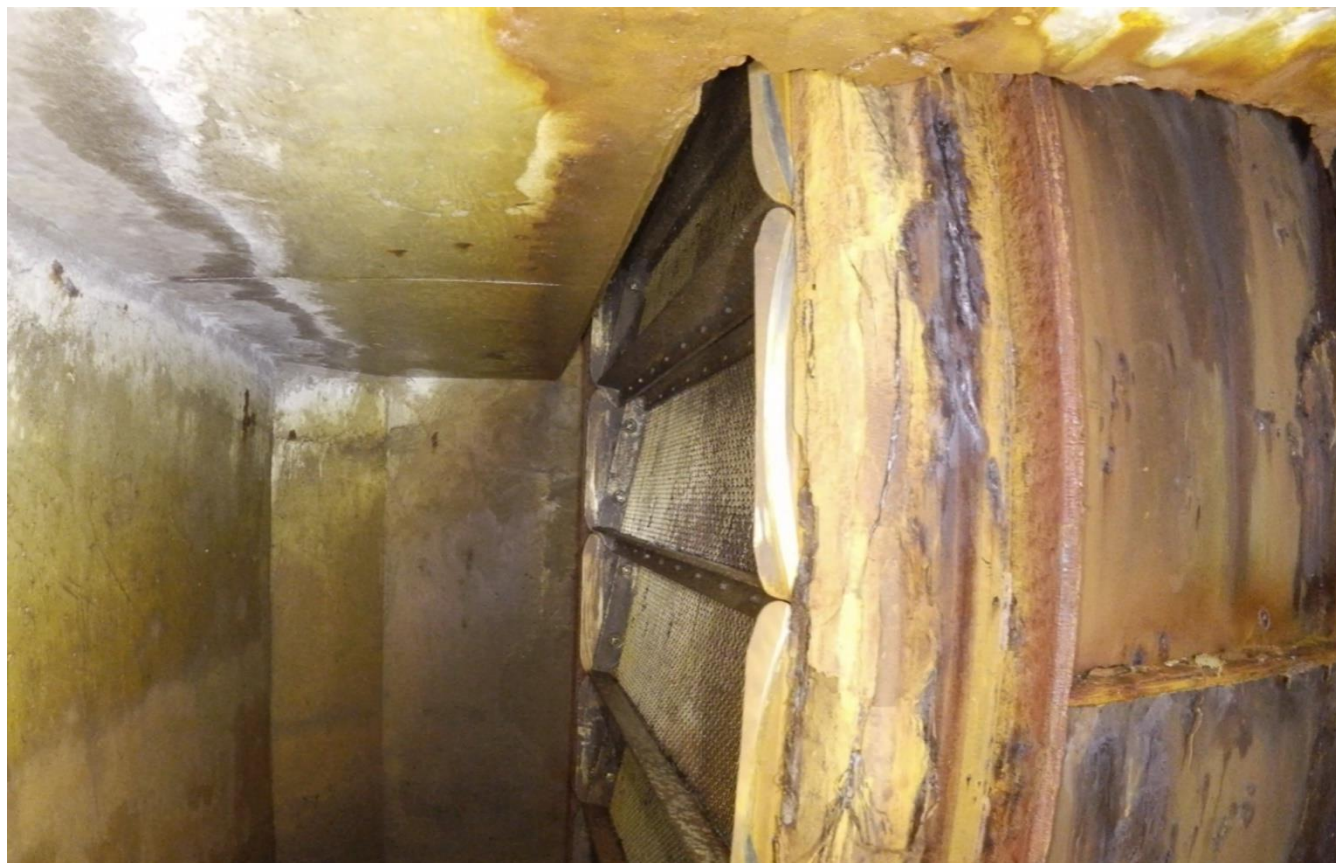
Anomaly (Y/N)	ID	Component	Component Tag	Type of Anomaly	Deg of Corrosion	Module	Level	Heat Map	Comments
Y	-	-	-	Deterioration of concrete	-	-	-	-	General overview of south end of sump, around the traveling screens. Noted throughout.

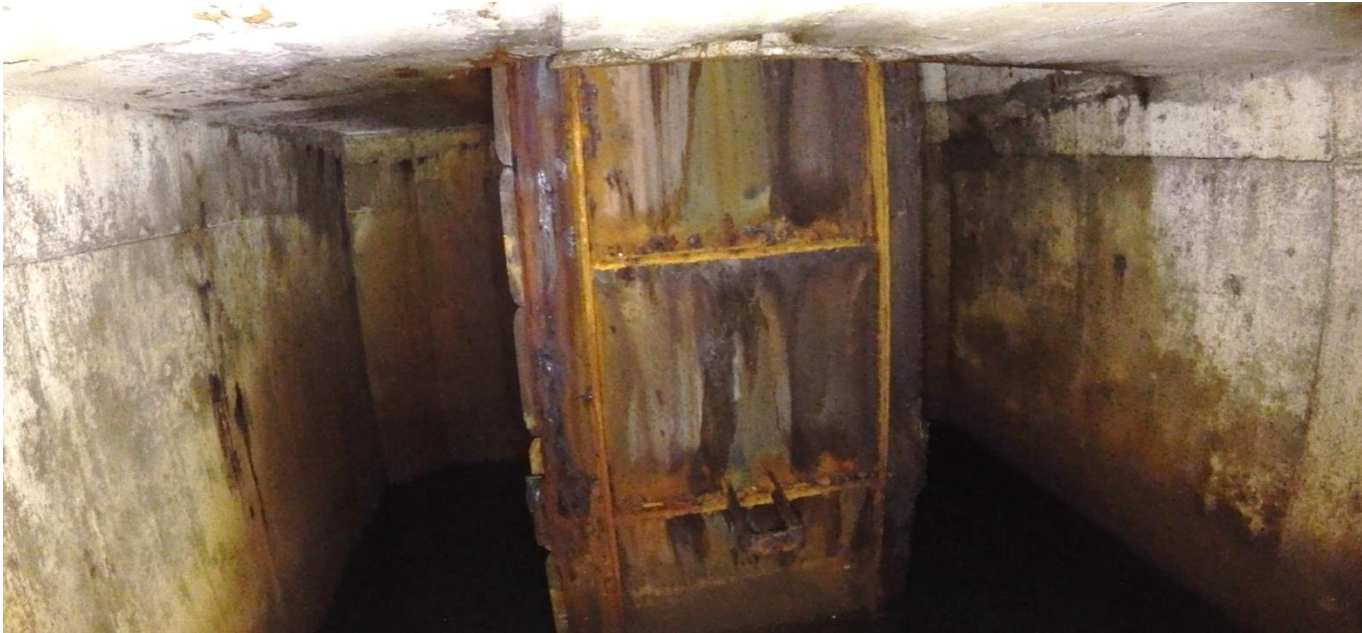
Anomaly (Y/N)	ID	Component	Component Tag	Type of Anomaly	Deg of Corrosion	Module	Level	Heat Map	Comments
Y	-	-	-	Deterioration of Concrete/corrosion	-	-	-	-	General overview of south end of sump Deterioration is present throughout and corrosion of steelwork, noted throughout.

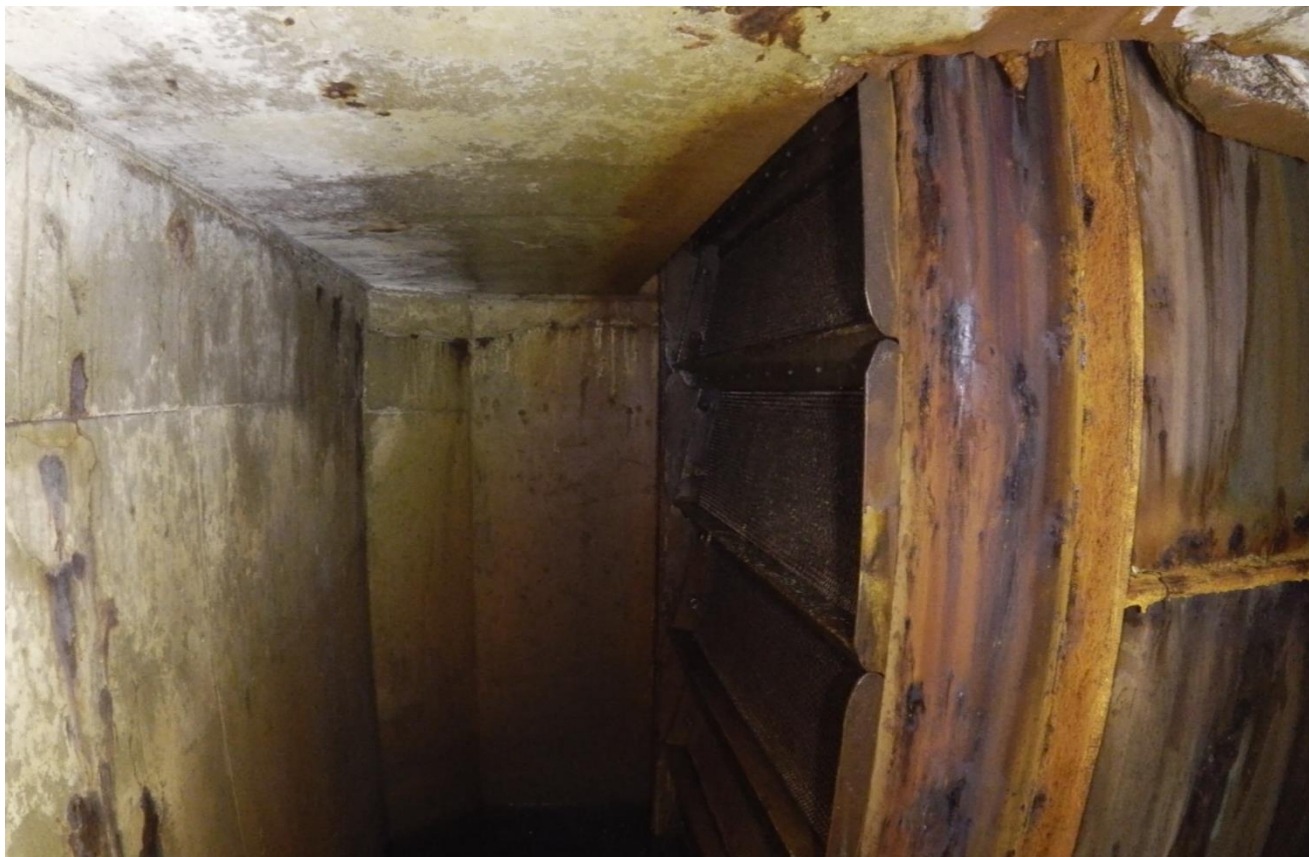
Anomaly (Y/N)	ID	Component	Component Tag	Type of Anomaly	Deg of Corrosion	Module	Level	Heat Map	Comments
Y	-	-	-	Deterioration / Corrosion	-	-	-	-	General overview of south end of sump Deterioration and corrosion noted around traveling screens.

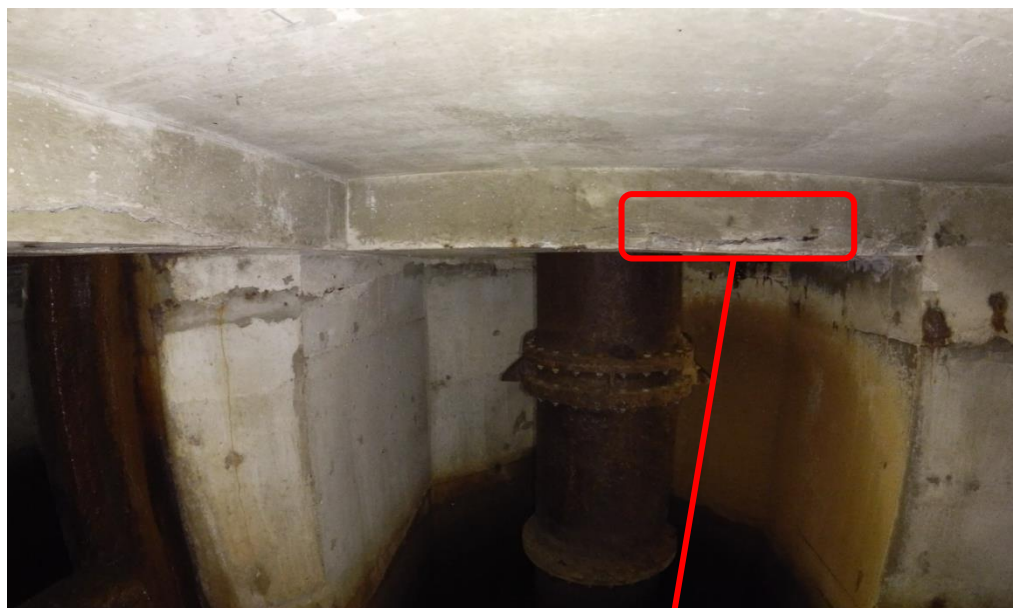
Anomaly (Y/N)	ID	Component	Component Tag	Type of Anomaly	Deg of Corrosion	Module	Level	Heat Map	Comments
Y	-	-	-	Crack	-	-	-	-	Substantial crack in concrete on the pump on the concrete cross member.

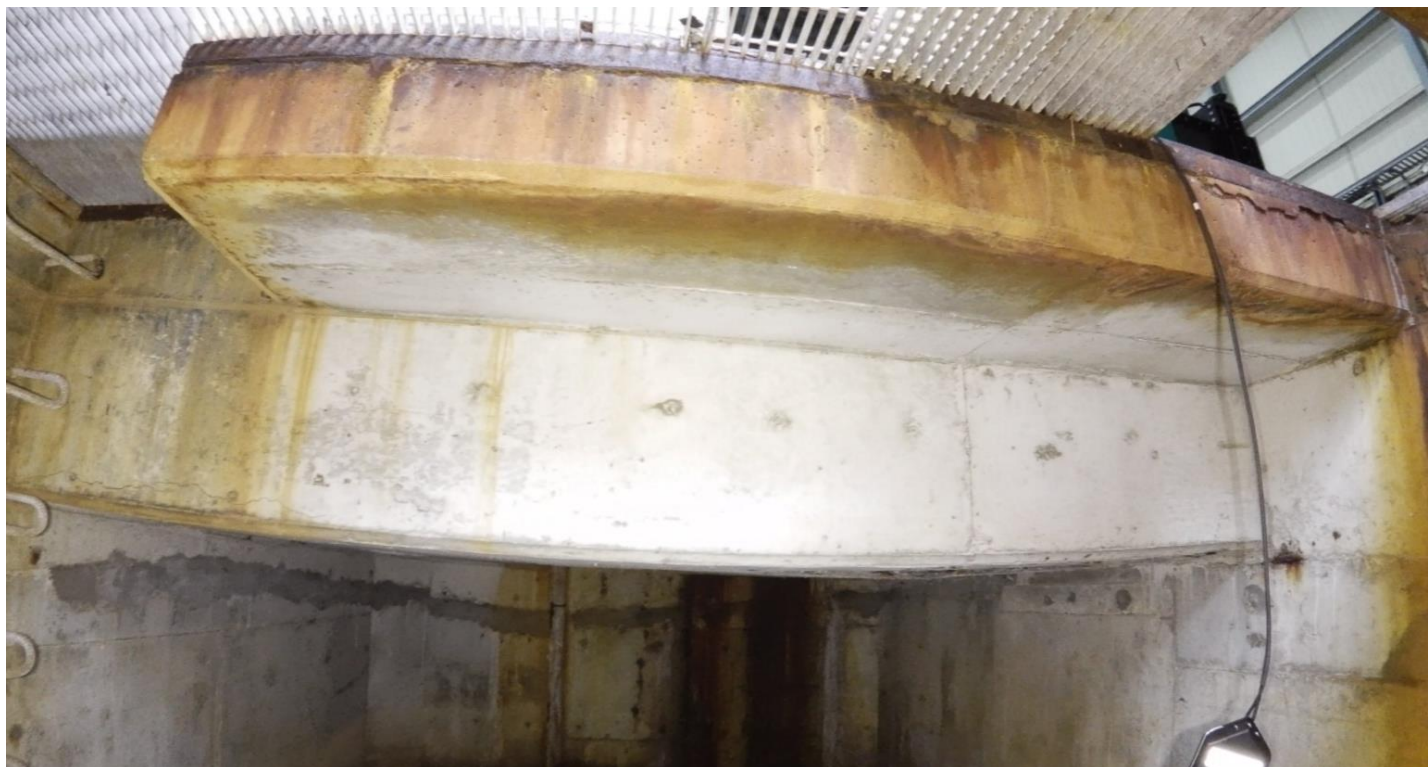
Anomaly (Y/N)	ID	Component	Component Tag	Type of Anomaly	Deg of Corrosion	Module	Level	Heat Map	Comments
Y	-	-	-	Deterioration of Concrete	-	-	-	-	Near entry point, deterioration noted around grating.

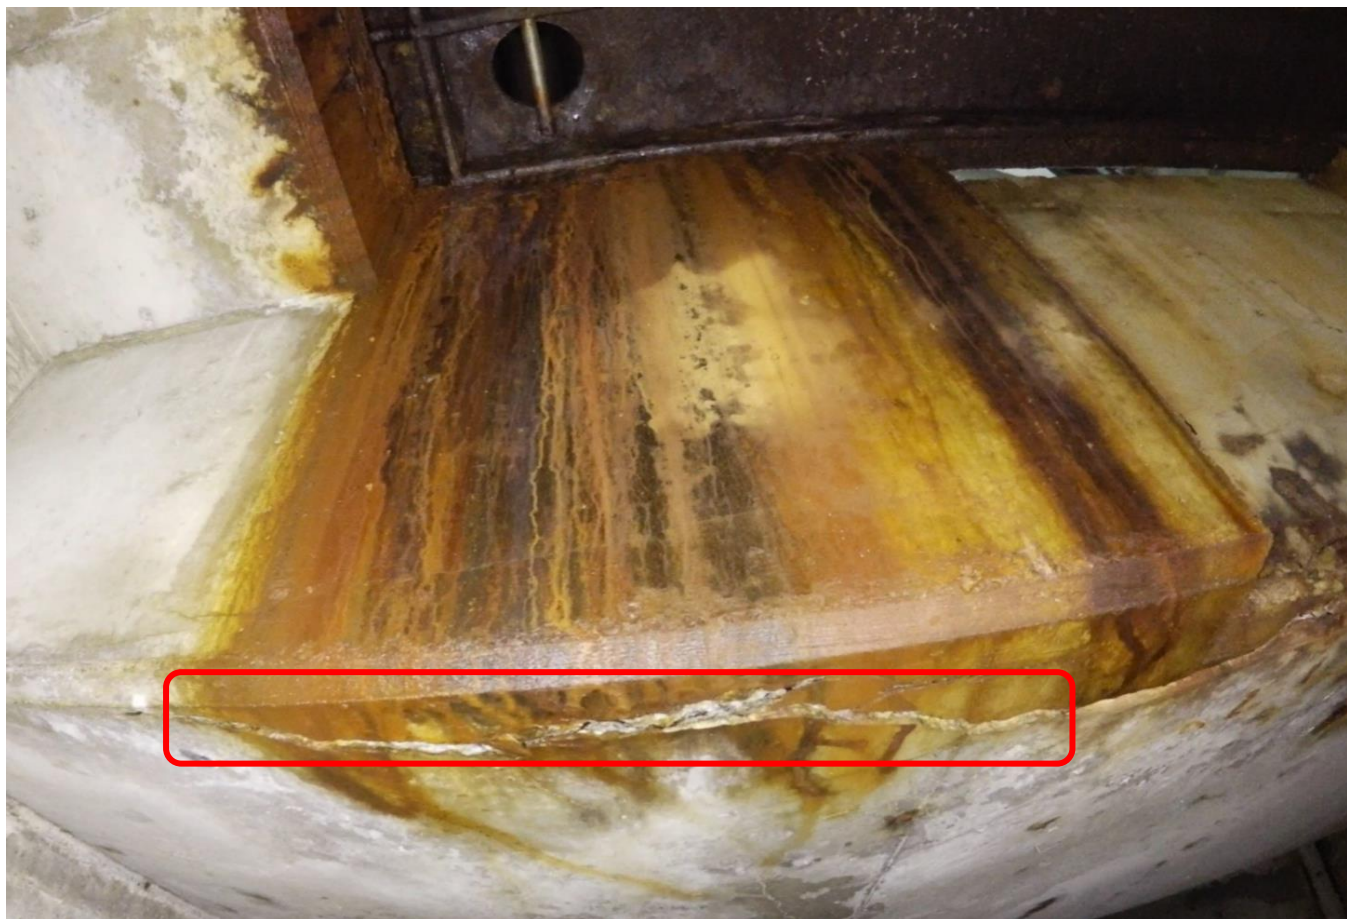
Anomaly (Y/N)	ID	Component	Component Tag	Type of Anomaly	Deg of Corrosion	Module	Level	Heat Map	Comments
Y	-	-	-	Deterioration / Crack	-	-	-	-	Deterioration of concrete around hatch, crack formed that can be seen highlighted

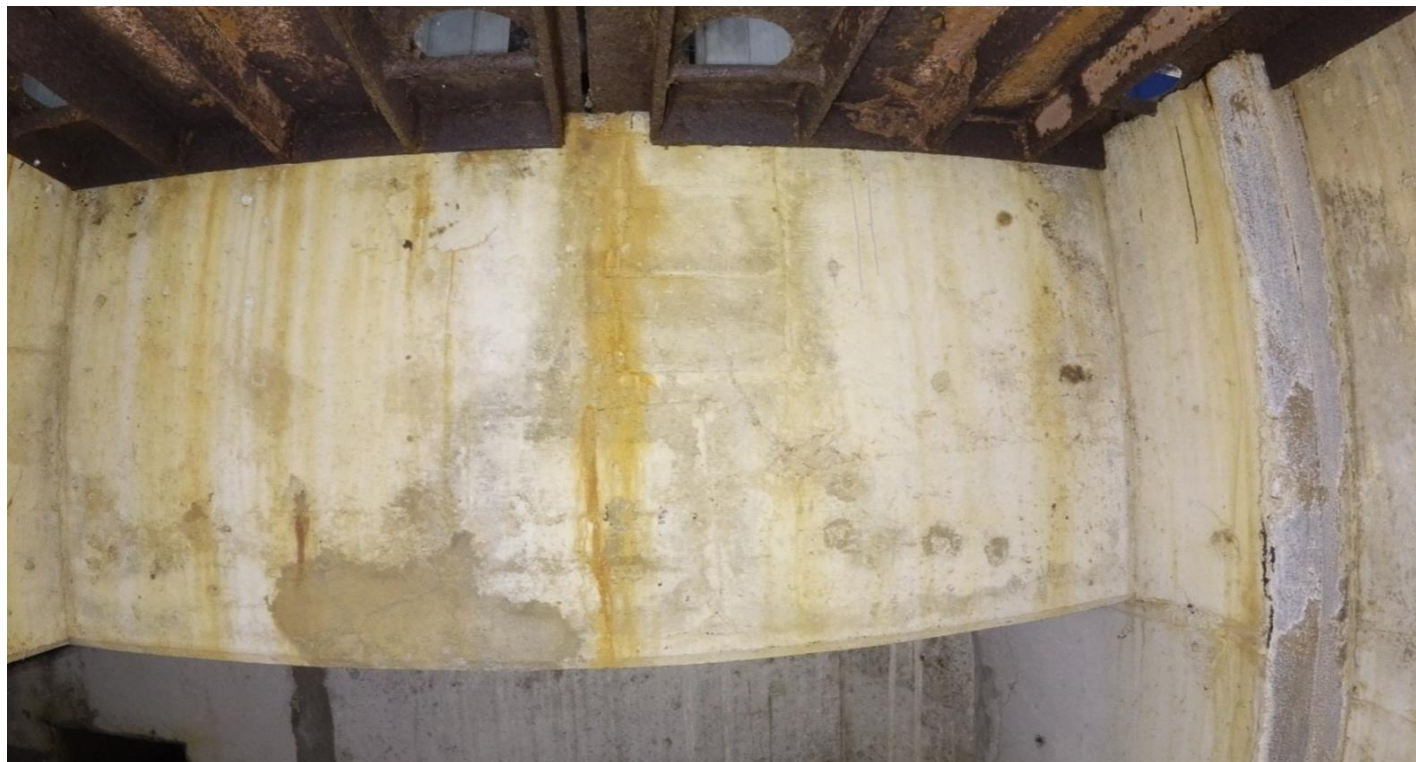
Anomaly (Y/N)	ID	Component	Component Tag	Type of Anomaly	Deg of Corrosion	Module	Level	Heat Map	Comments
Y	-	-	-	Minor spalling and deterioration	-	-	-	-	Minor spalling and deterioration occurring near south end looking north
