1 Q. Please provide a copy of equipment-related root cause or causal analyses reports
2 conducted over 2016-2018.

CRACK INVESTIGATION AND REPAIR REPORT

This report is intended to summarize the site inspection and repair recommendations of a crack that developed in Penstock No.1 at the Bat d'Espoir hydroelectric development owned and operated by Newfoundland and Labrador Hydro (NL Hydro).

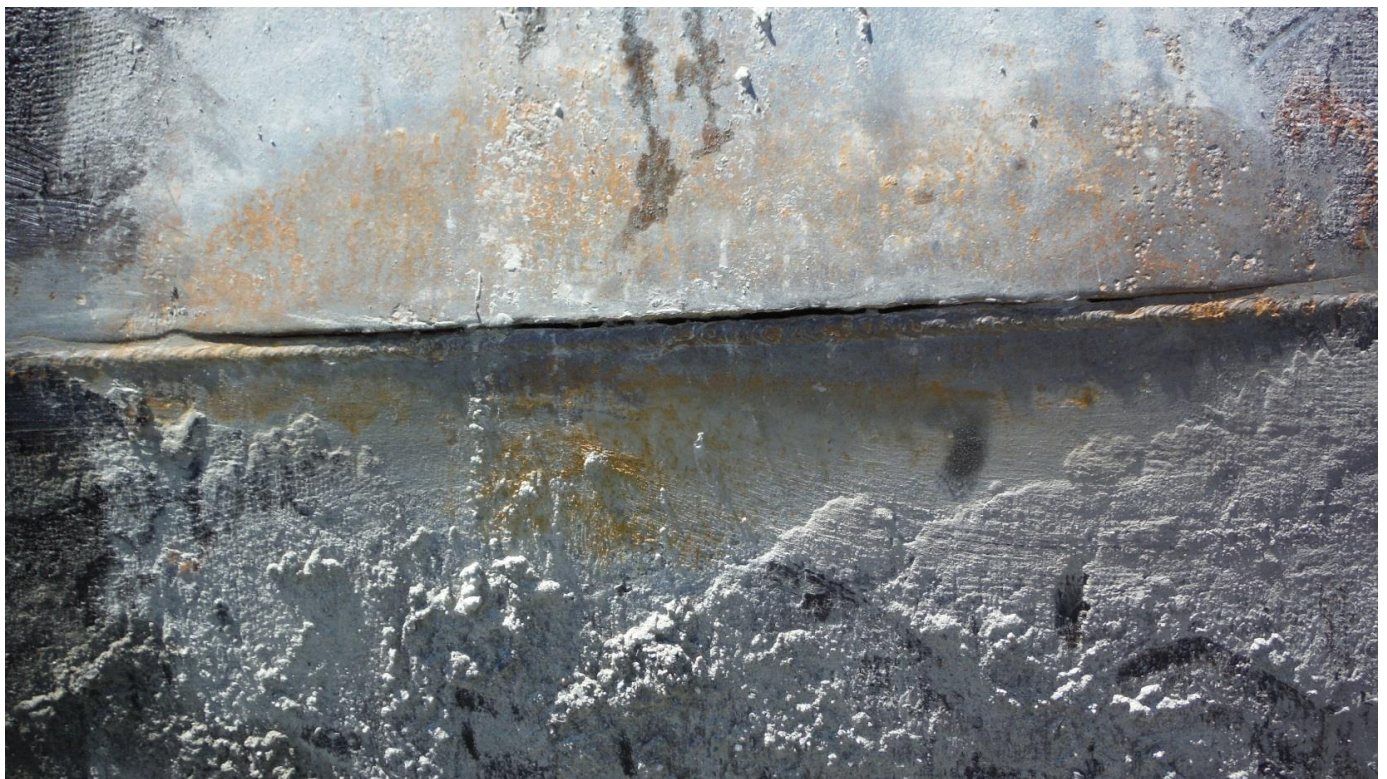
- The crack was observed to be in the base material (penstock plating) and not through the weld material (Photo 2). This cracked area is in what is considered the heat effected zone where the welding process heats the base material enough to alter the properties without melting it. This zone tends to be more brittle than the original base material.

PHOTO 2 – CRACK IN PENSTOCK PLATE ALONG LONGITUDINAL WELD

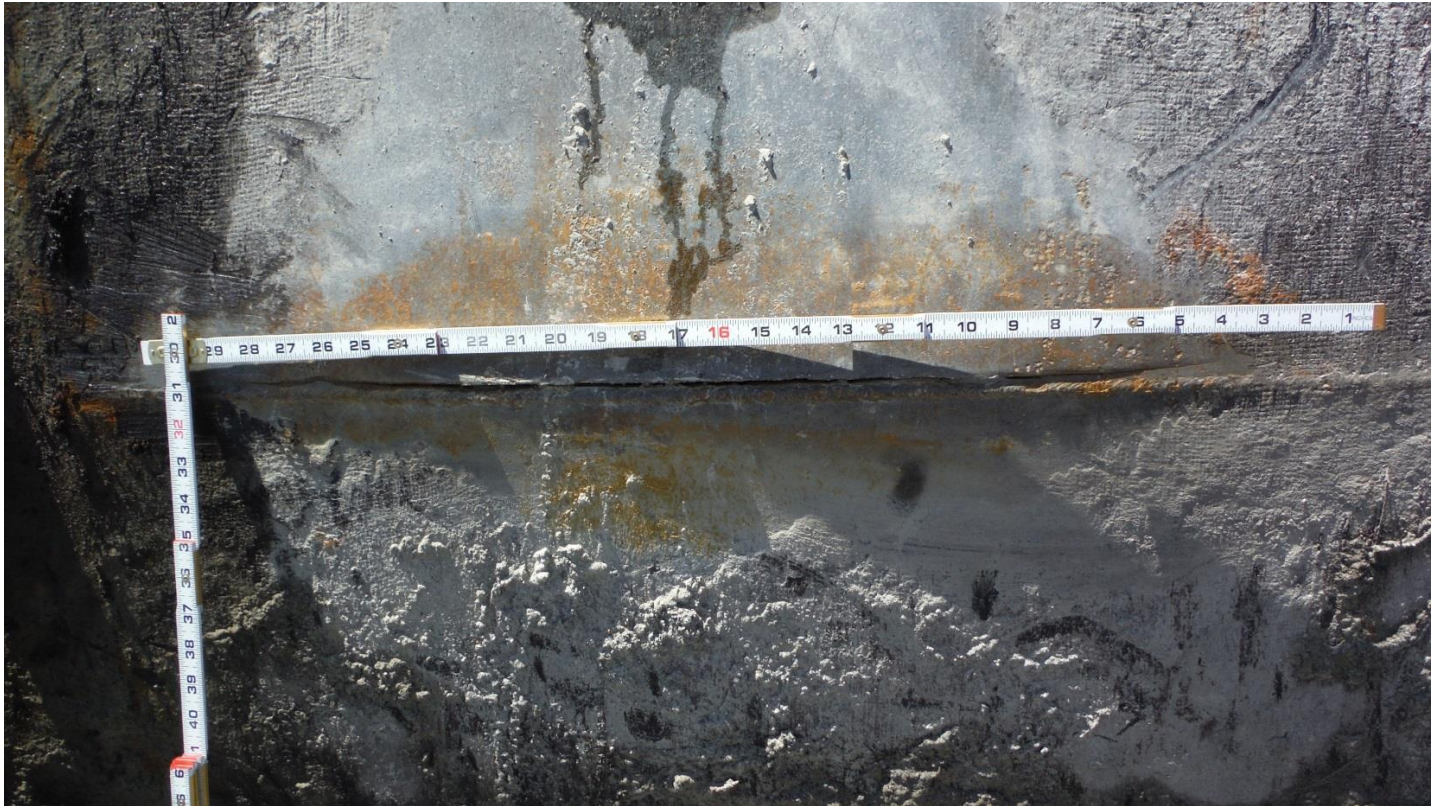
- The crack was located at Station 0+260 as measured from the intake (Photo 1) and was measured to be 24.5 inches long from what could be seen visually (Photo 3). Per Drawing F-106-C-7, this location approximately corresponds to Bend No. 3A.

PHOTO 3 – MEASURING VISIBLE LENGTH

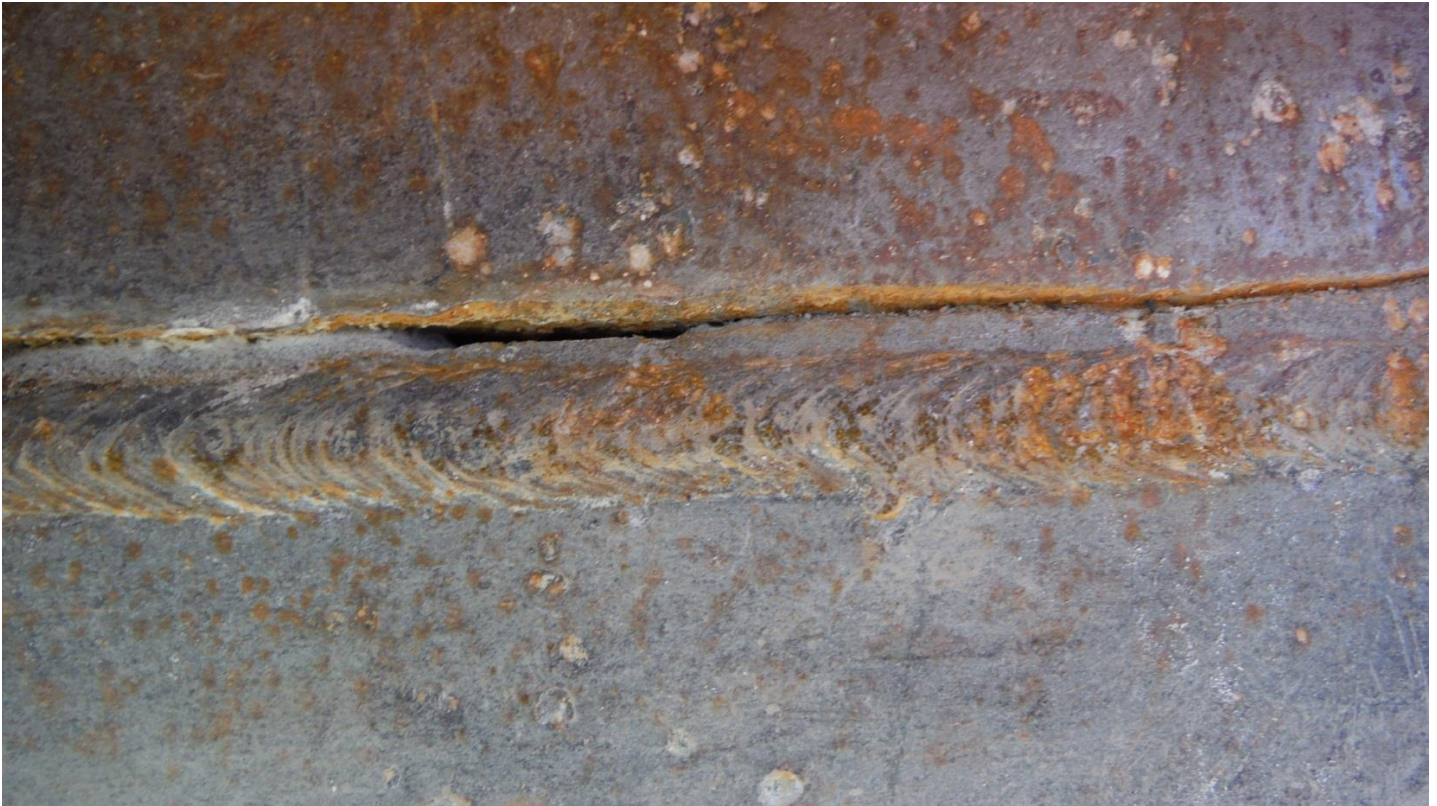
- Rust/corrosion was noted in the crack and was too mature to have developed since the leakage was first observed on May 21 (Photo 5). This indicates that a portion of the crack was initiated prior to the May 21 incident. The rust was light enough that it is likely less than 5 years old but certainly more than a few months.

PHOTO 5 – CLOSE-UP OF CRACK. NOTE CORROSION IN CRACK THAT APPEARS OLDER THAN ONE WEEK.

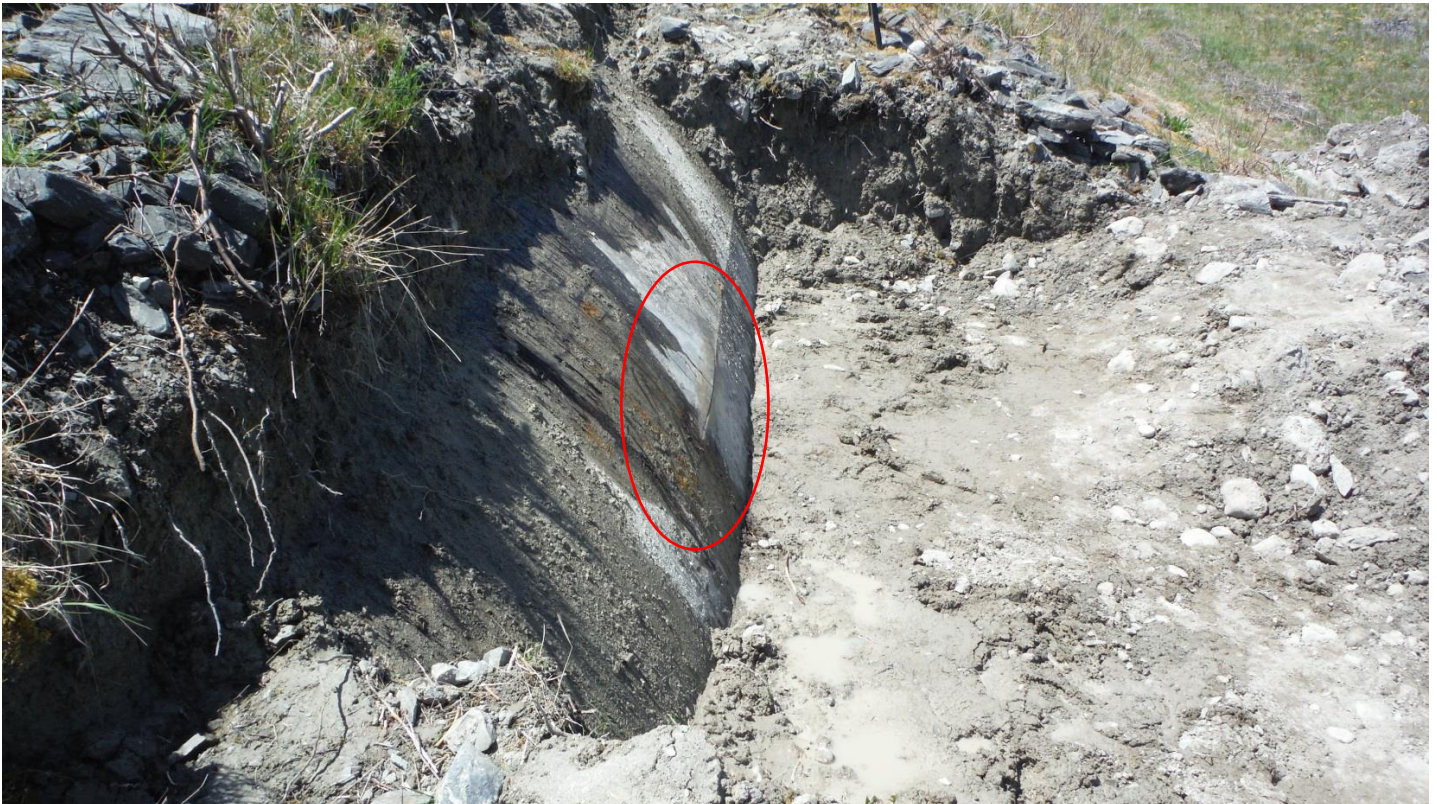
PHOTO 6 – LOOKING UPSTREAM ALONG CRACK LOCATION WITH BACKFILL REMOVED

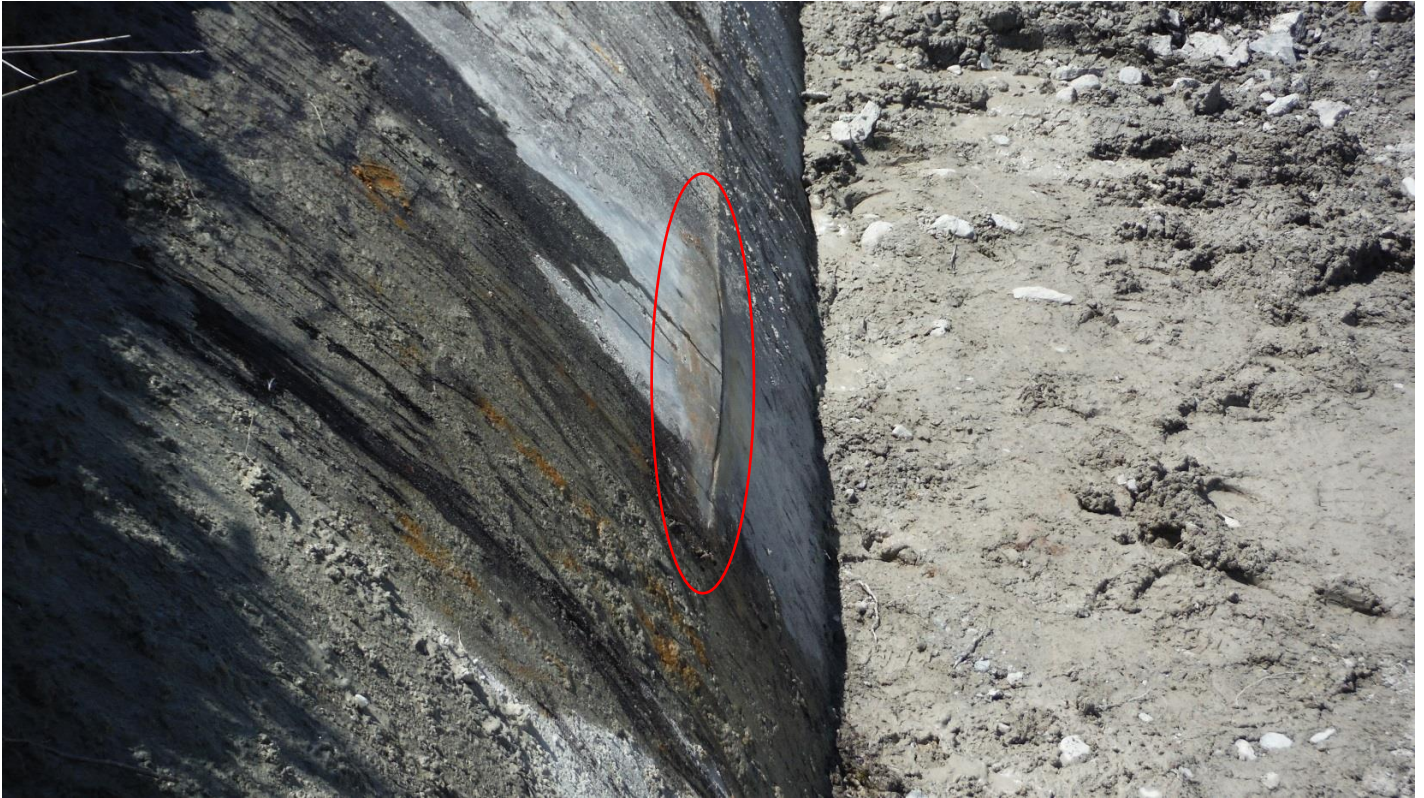
PHOTO 7 – LOOKING UPSTREAM FOR SIDE VIEW OF CRACK AND BULGE

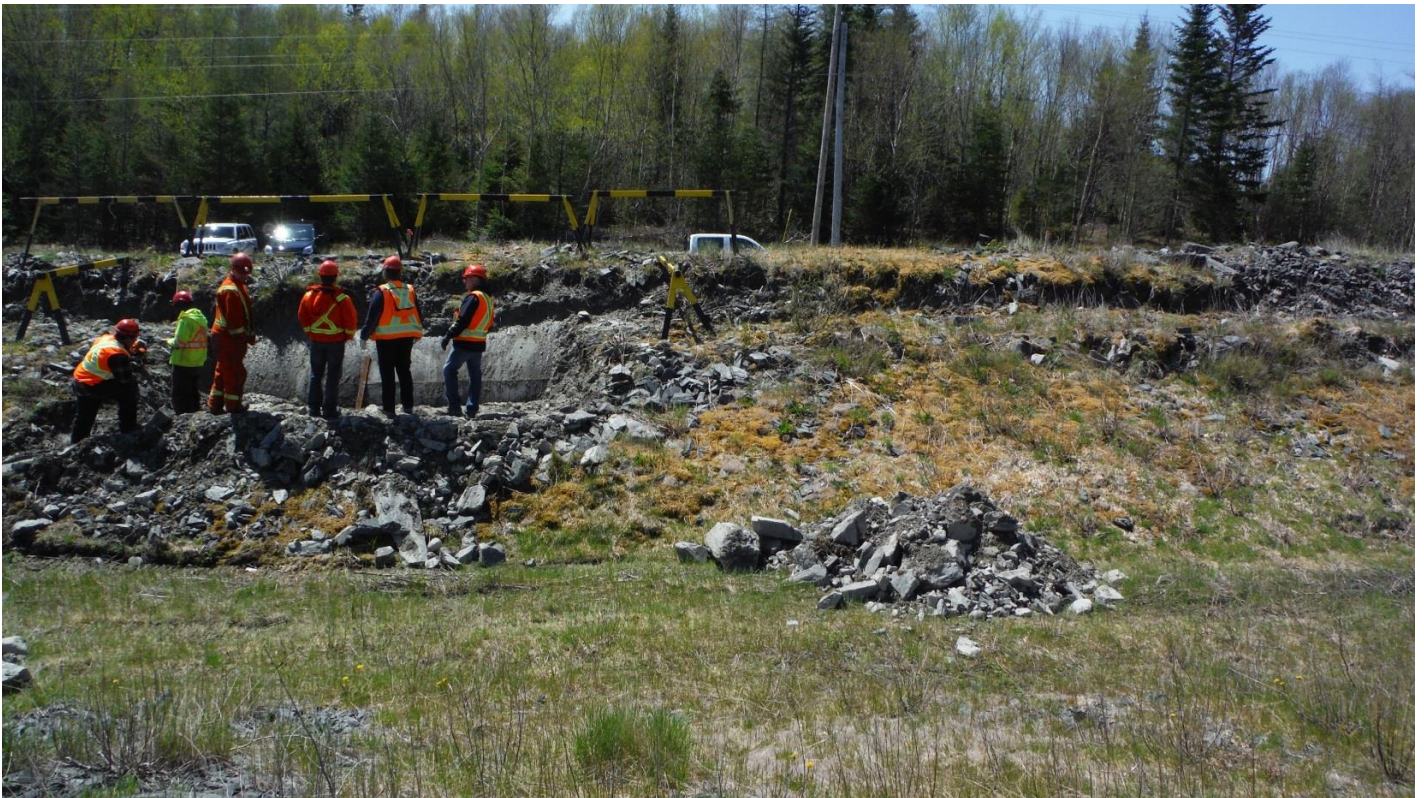
PHOTO 8 – LOOKING AT THE LEFT SIDE OF THE PENSTOCK IN AREA OF CRACK. NOTE SLUMPED BACKFILL

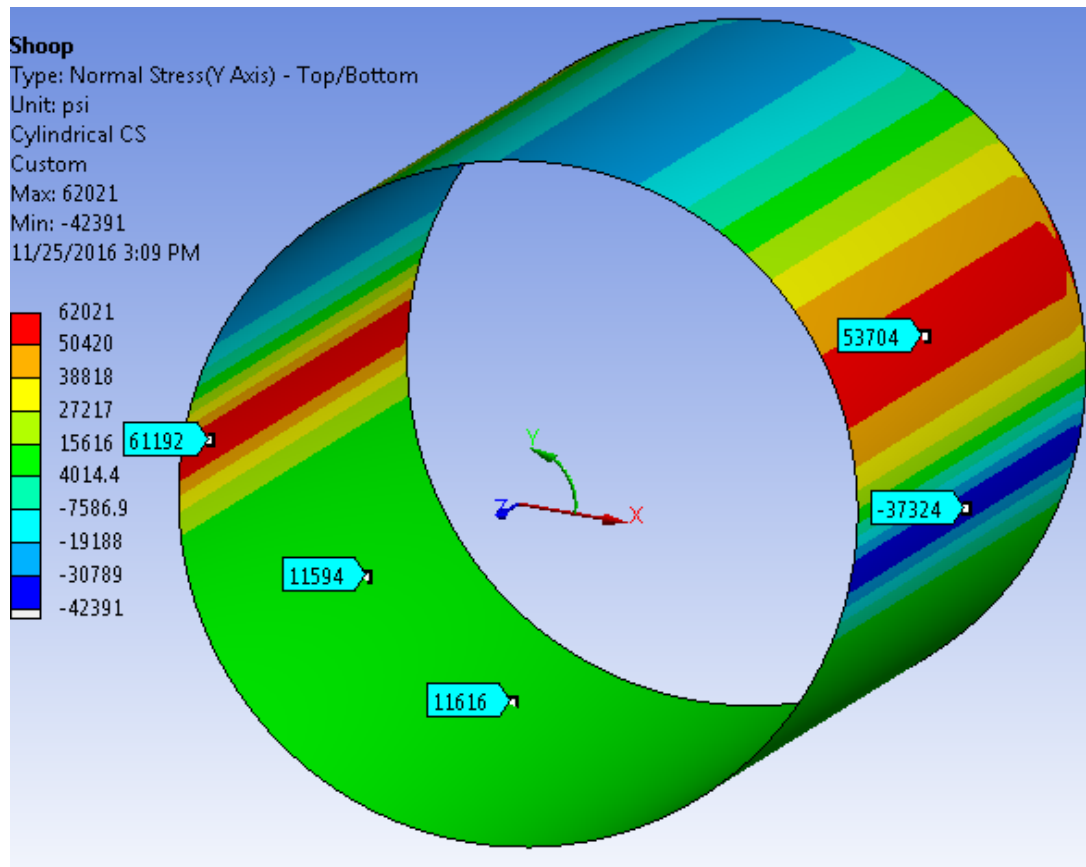
Figure 17: LS1 - Total hoop stress. Allowable for continuous plate $S_{a|A285I} = 30000 \cdot \text{psi}$. 100% overstress, more if longitudinal welded joint efficiency at 3 and 9 o'clock is taken into account.

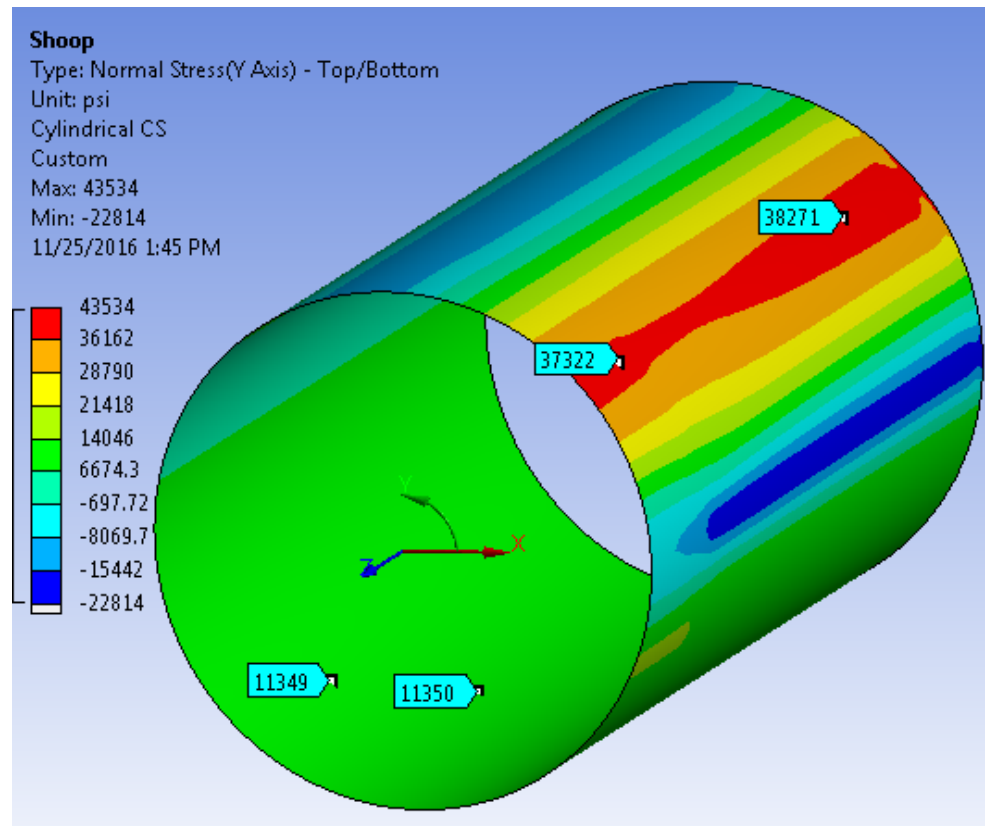
Figure 21: LS3 - Total hoop stress. Allowable for continuous plate $S_{A285I} = 30000 \cdot \text{psi}$. 45 % overstress, more if longitudinal welded joint efficiency at 3 o'clock is taken into account.

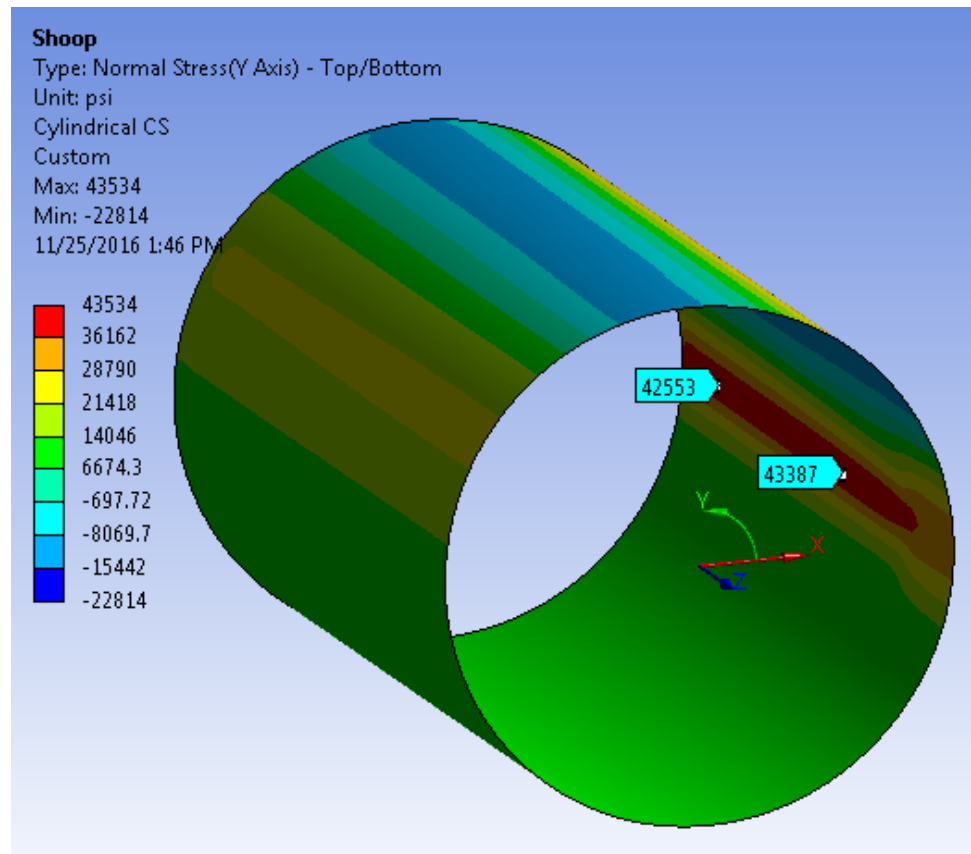
Figure 22: LS3 - Total hoop stress. Allowable for continuous plate $S_{aIA285I} = 30000 \cdot \text{psi}$. 45 % overstress, more if longitudinal welded joint efficiency at 3 o'clock is taken into account.

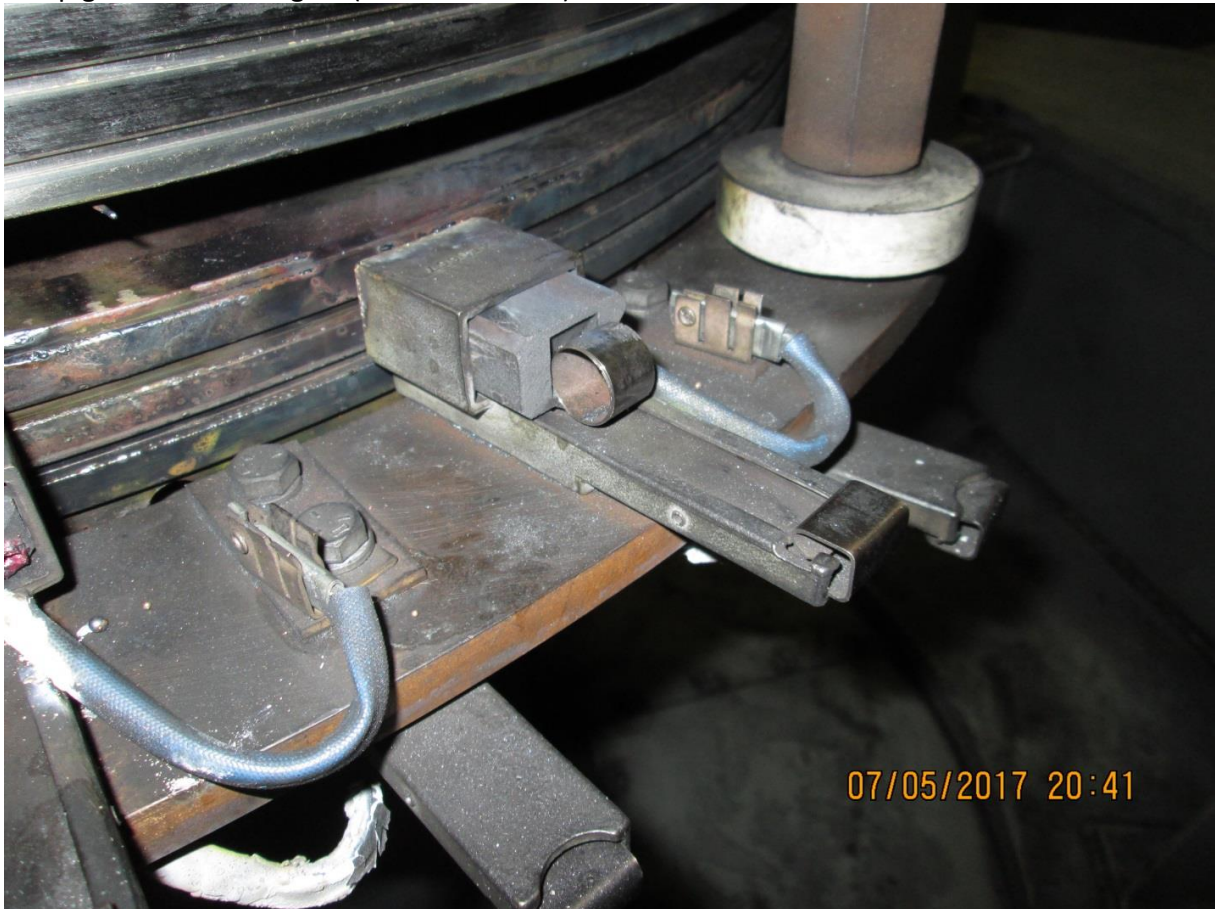
T2: The brush holder has some metal loss on the surface adjacent to the ring. The brush wear is a little below the threshold for replacement. The pigtail is melted off at the brush connection. (Picture 4)

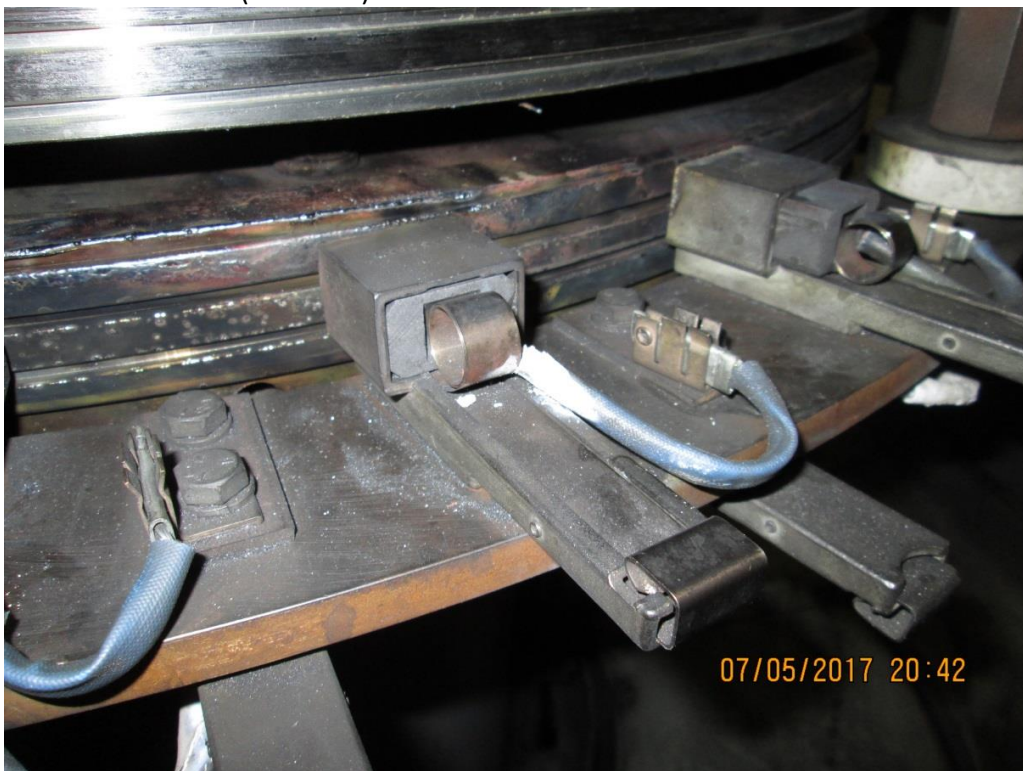
T3: The brush wear is at the threshold for replacement. The pigtail is melted off at the brush connection. (Picture 5)

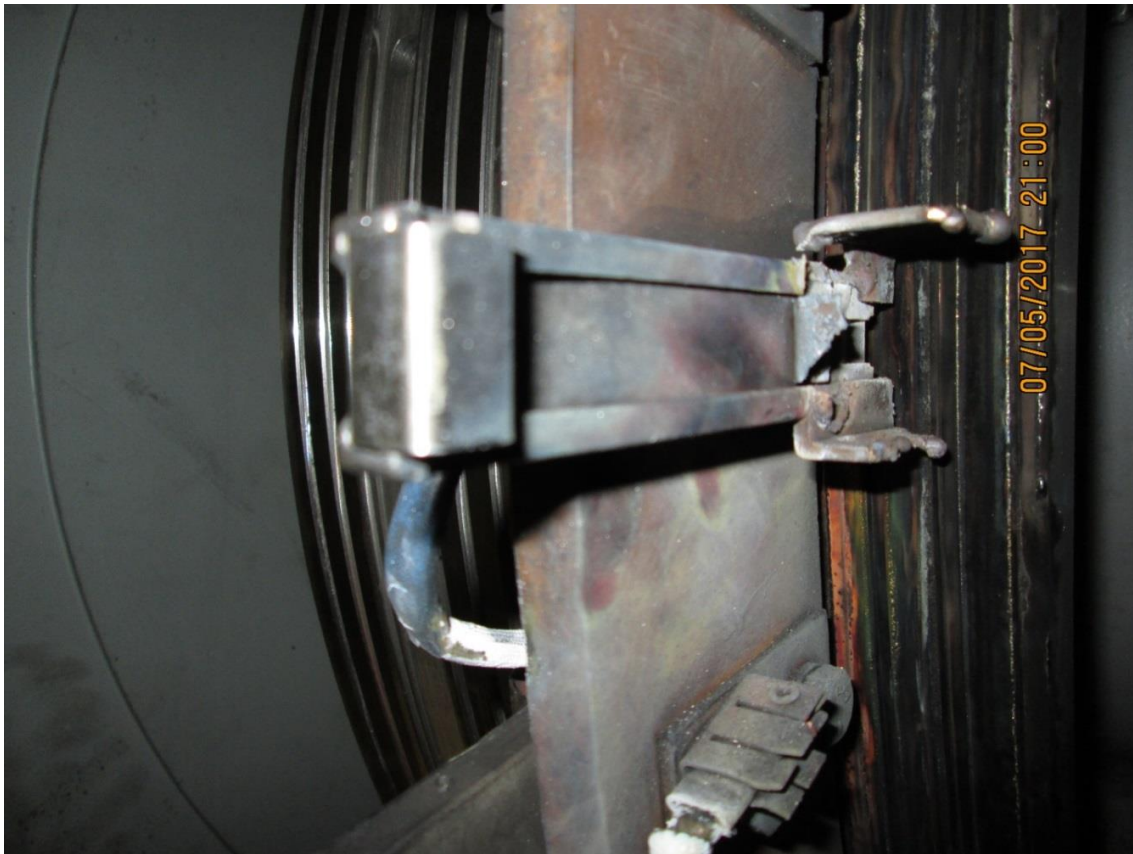
The insulator near the cable connection to the slip ring has splatter damage. (Picture 24)

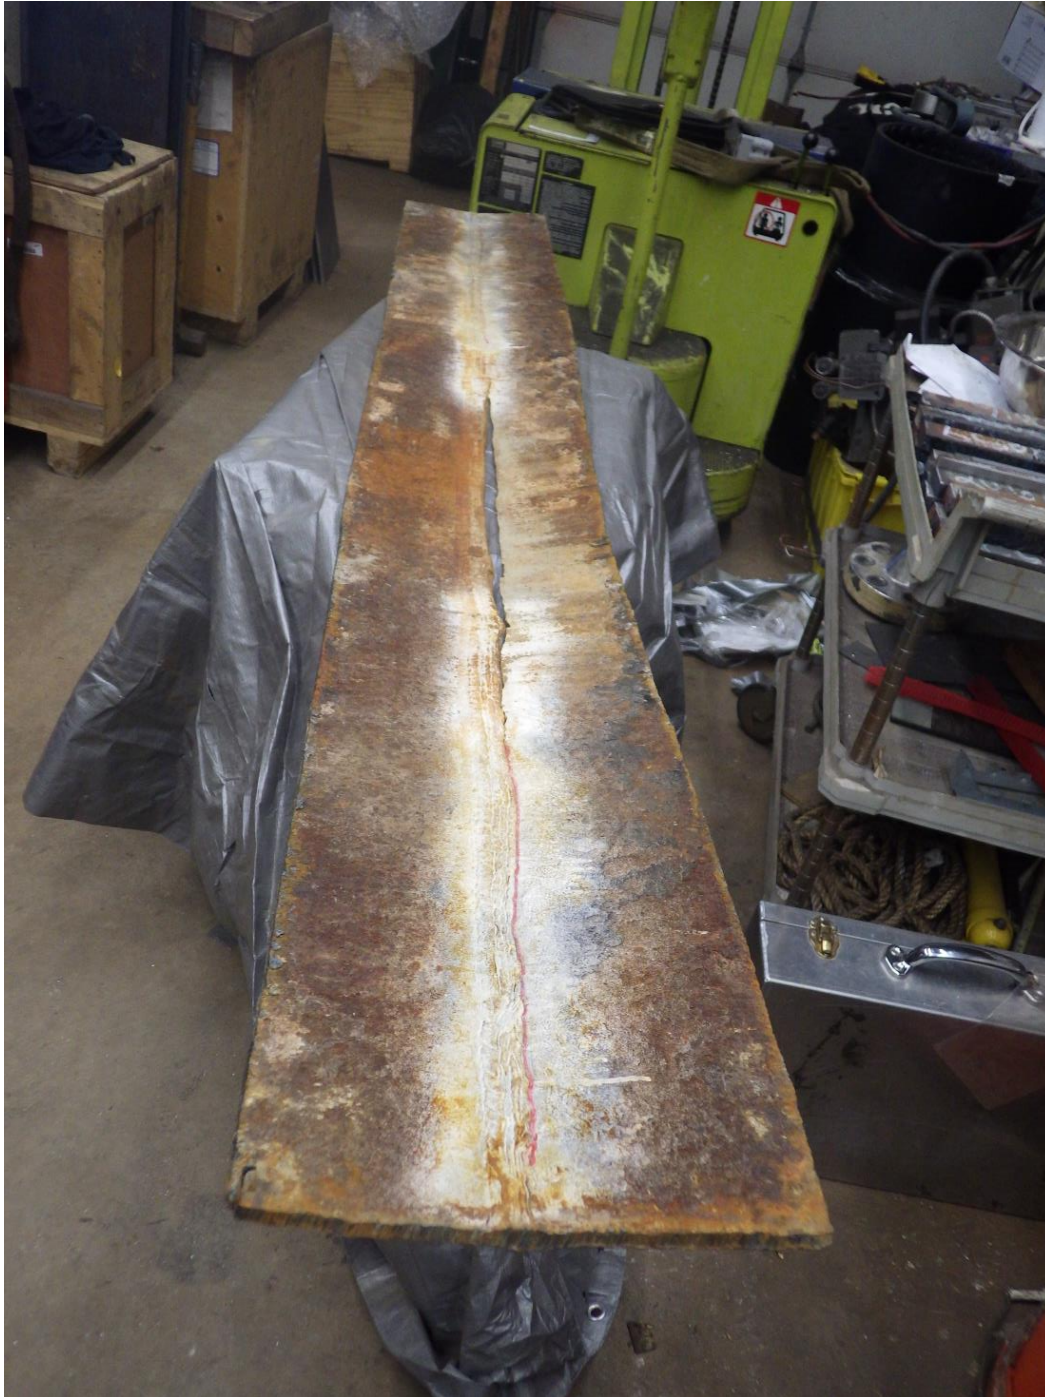
Figure 1 Failed Penstock plate as received

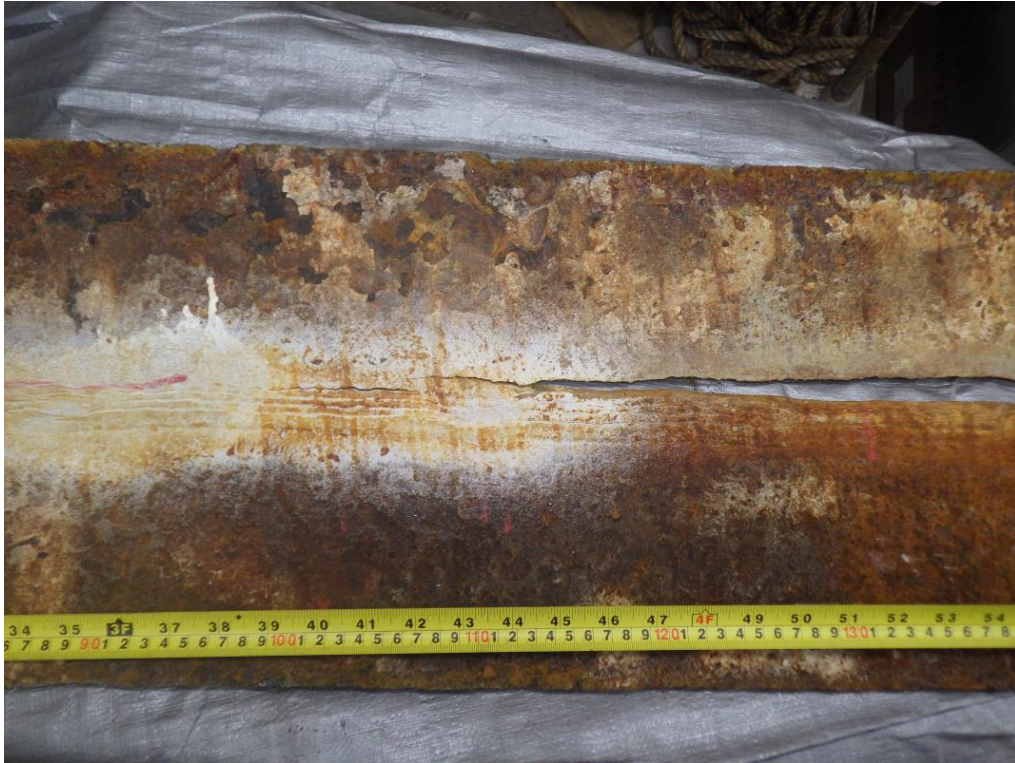
Figure 2 Penstock plate showing one end of the fracture near the 39 inch mark

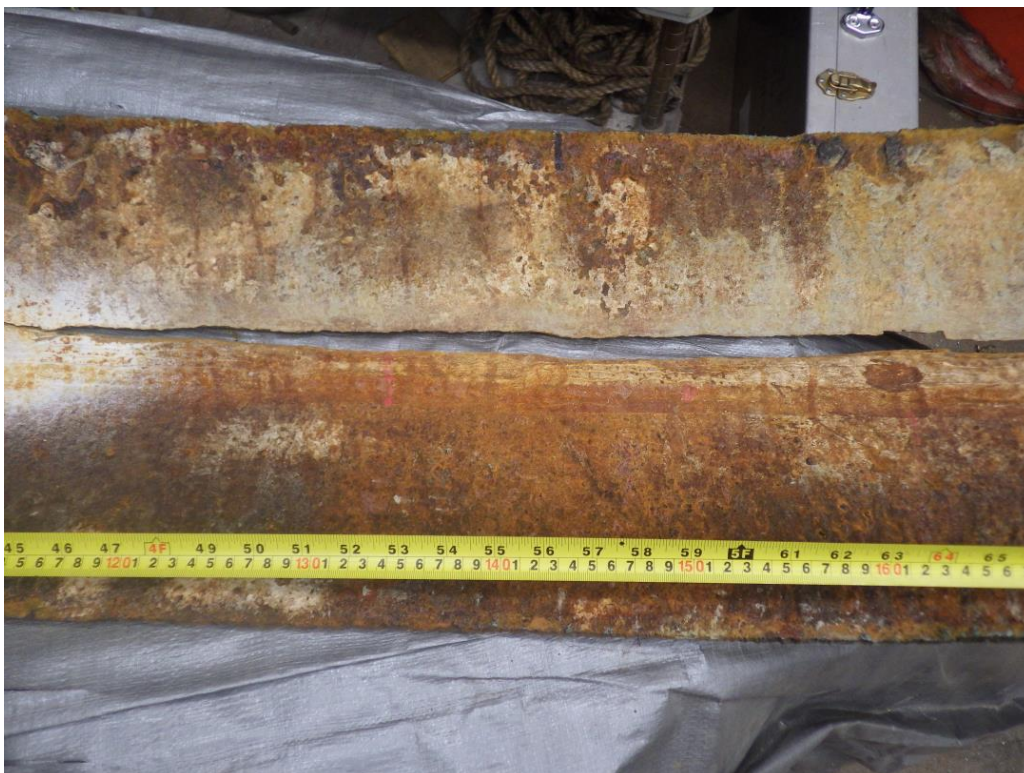
Figure 3 Crack in the plate from the 45 inch mark to the 65 inch mark

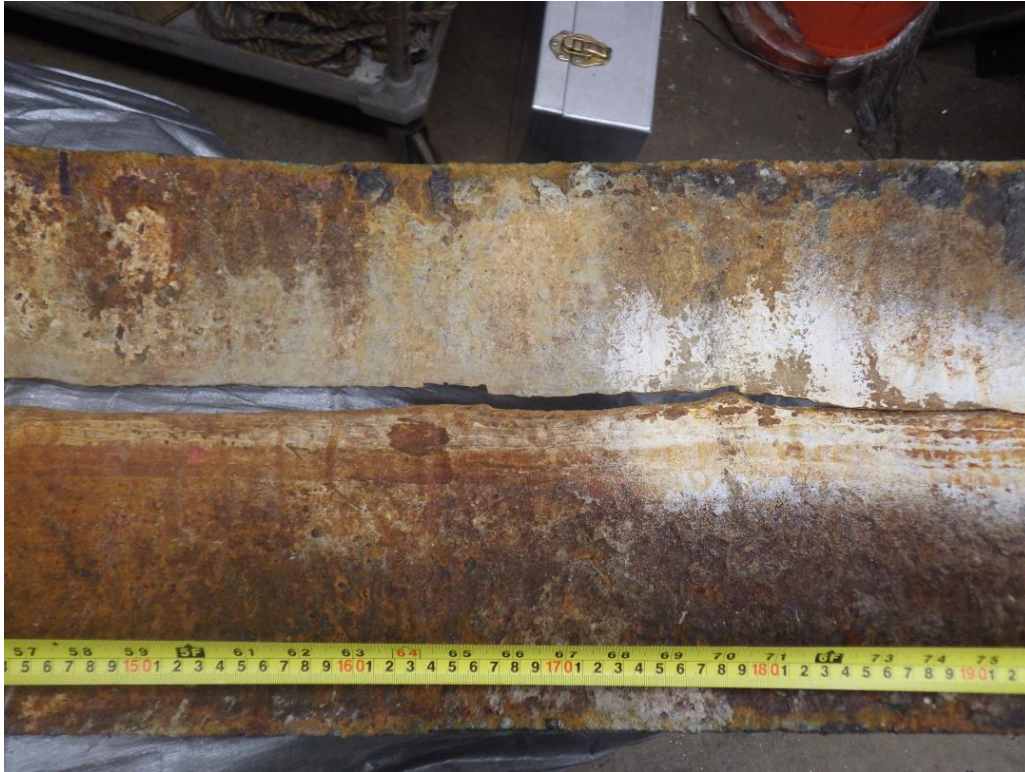
Figure 4 Crack in the plate from the 57 inch mark to the 75 inch mark

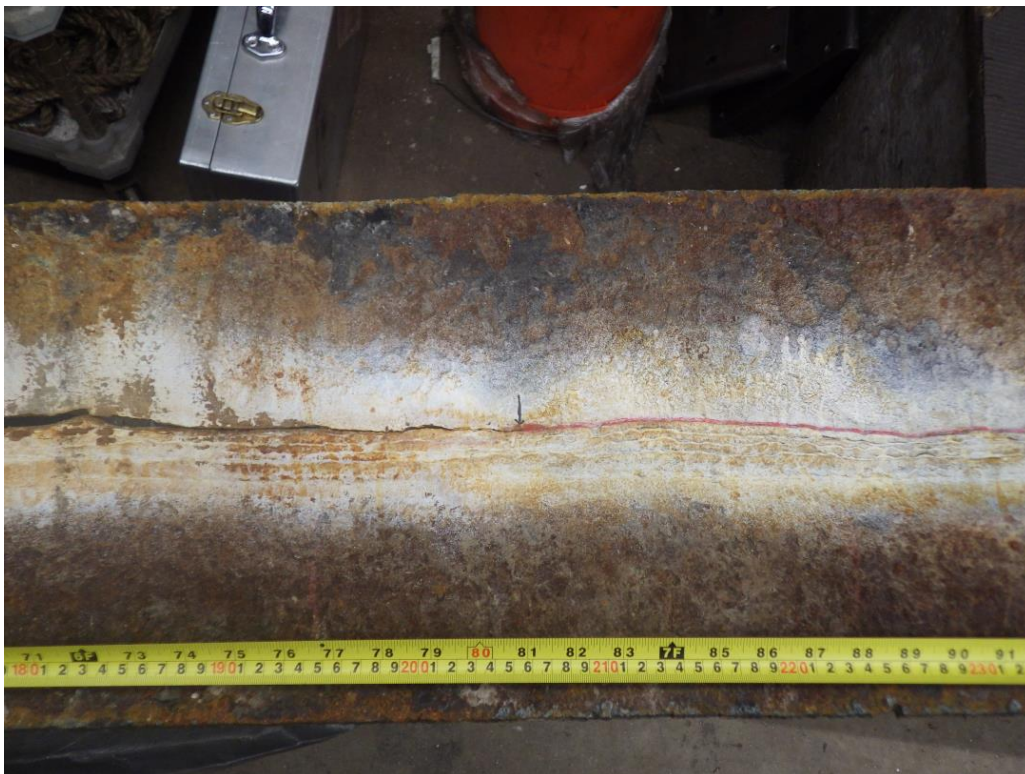
Figure 5 Crack in the plate from the 70 inch mark to the end of the crack near the 82 inch mark

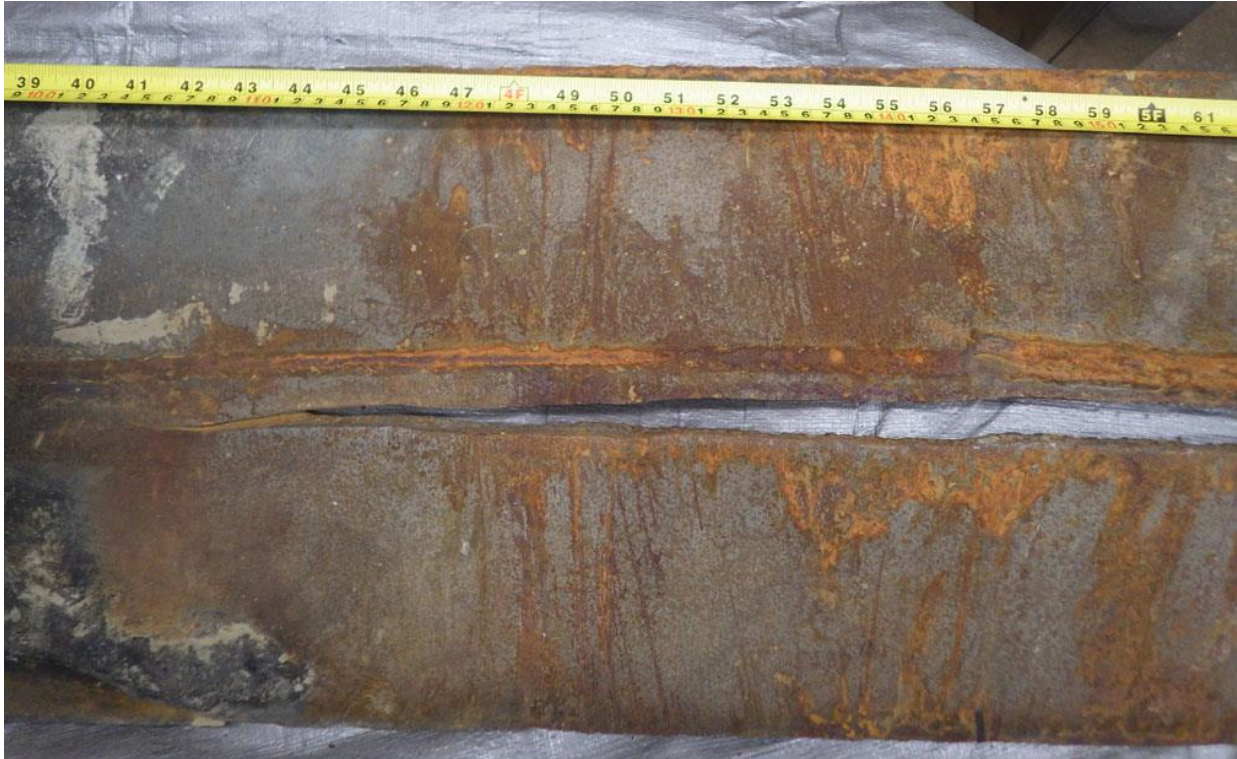
Figure 6 End of the crack on the outside of the Penstock showing the crack arrest in the base metal.

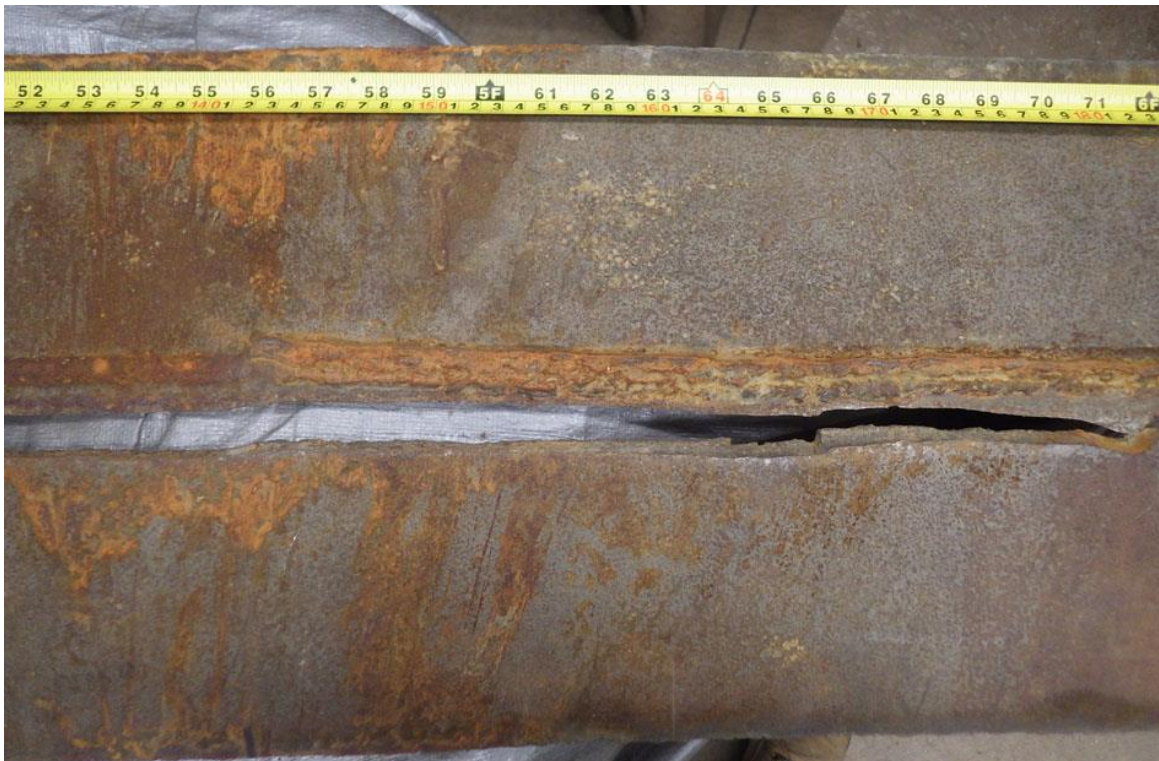
Figure 7 Crack section from the 52 inch mark to the 72 inch mark showing crack travel along the weld.

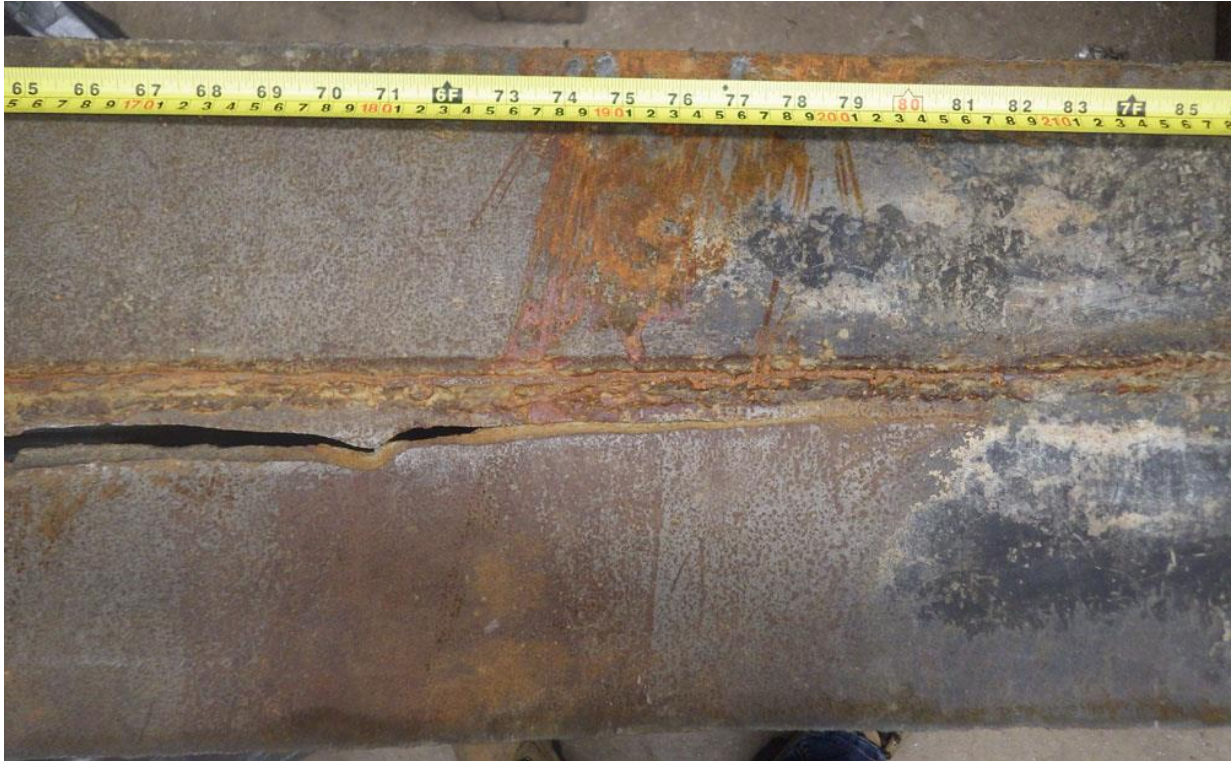
Figure 8 Penstock outside surface showing crack from 65 in. to 82 in.

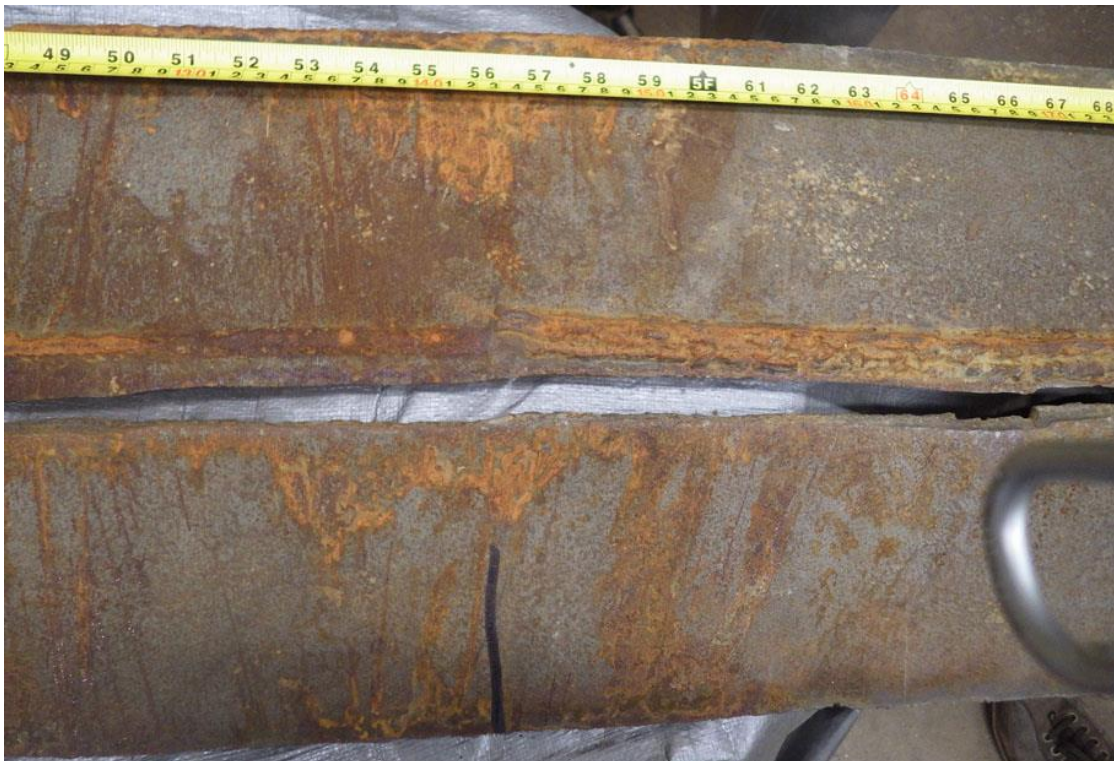
Figure 9 Crack near the transition of original weld and repair weld

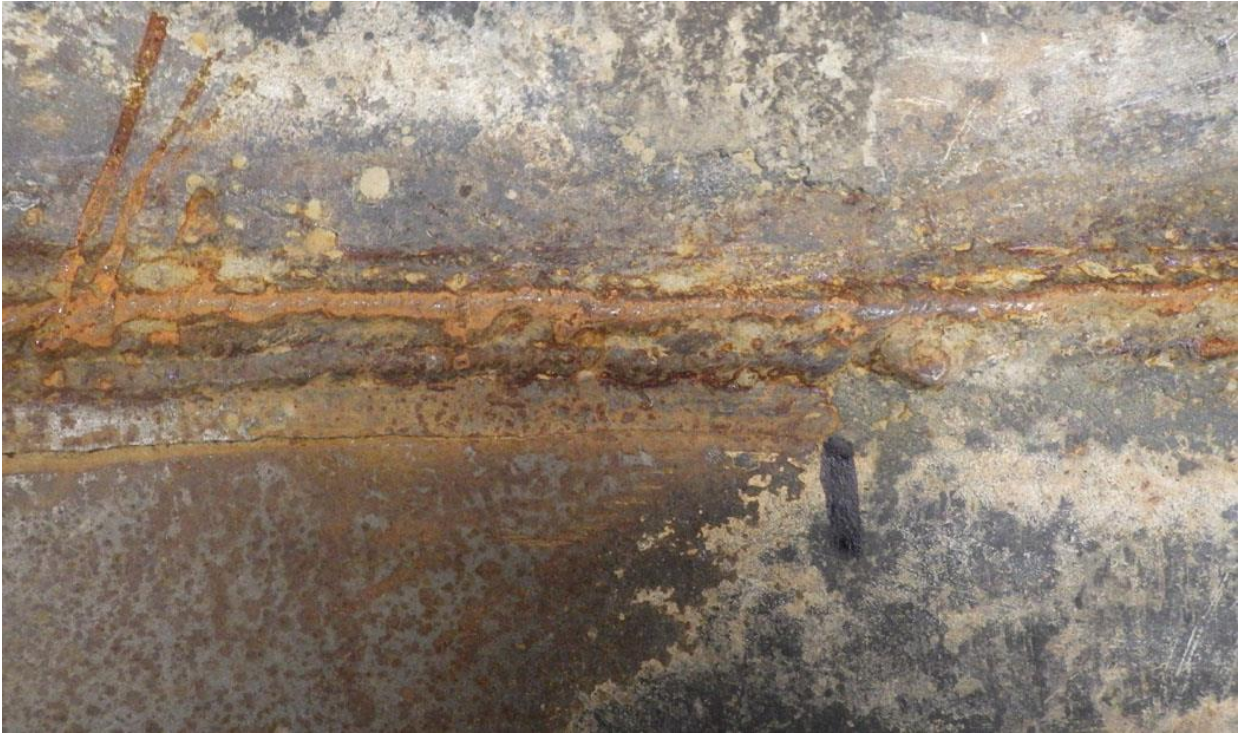
Figure 10 Crack arrest location in base metal offset from weld

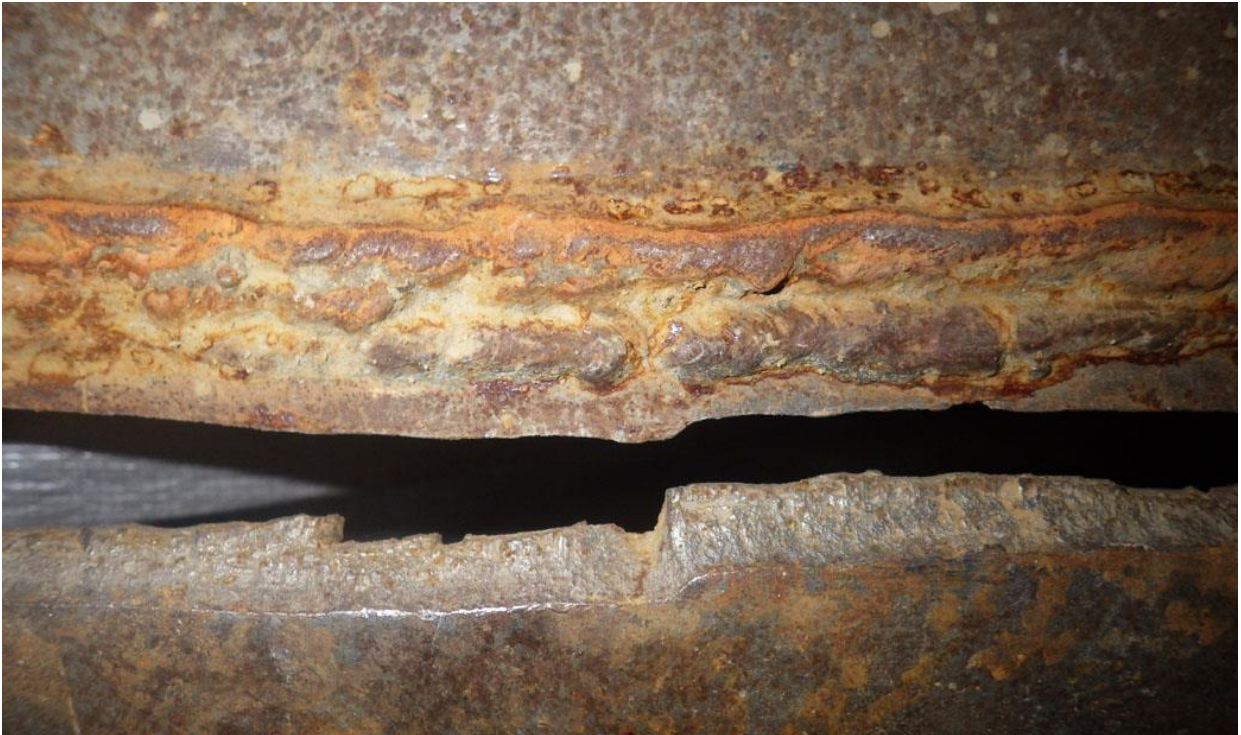
Figure 11 Feature at 65 in. location near edge of weld.
