1 Q. Please provide a copy of equipment-related root cause or causal analyses reports
2 conducted over 2016-2018.

CRACK INVESTIGATION AND REPAIR REPORT

This report is intended to summarize the site inspection and repair recommendations of a crack that developed in Penstock No.1 at the Bat d'Espoir hydroelectric development owned and operated by Newfoundland and Labrador Hydro (NL Hydro).

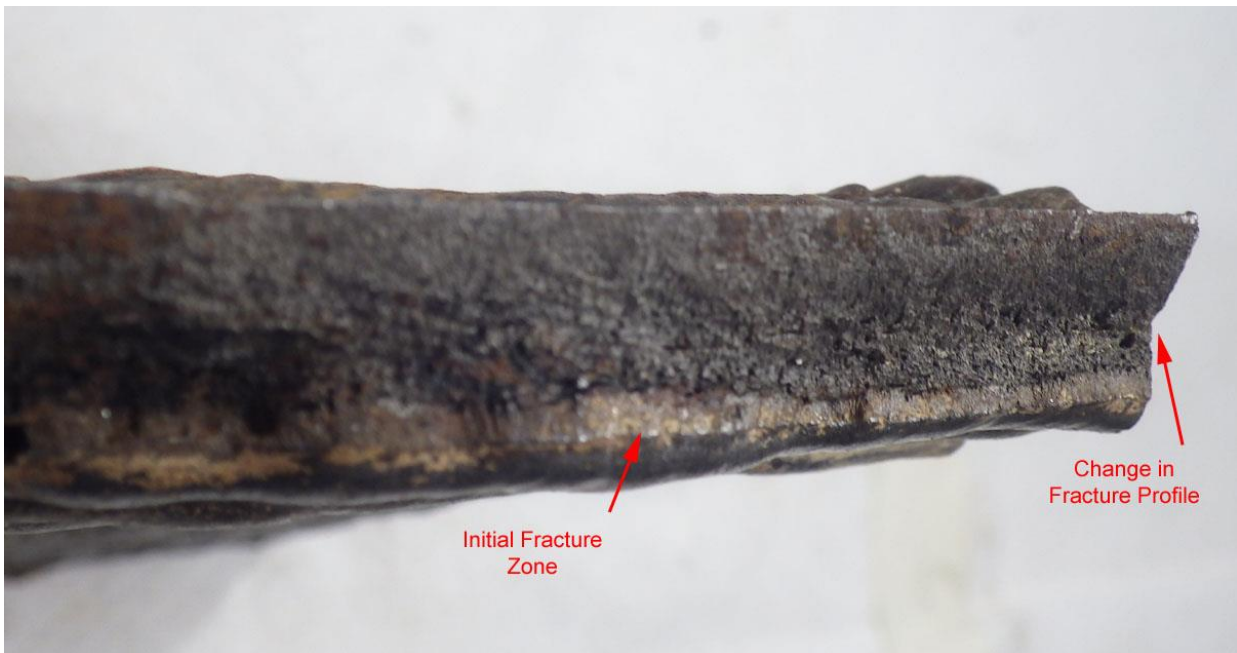
Figure 13 Photograph showing the fracture surface illustrating different fracture modes

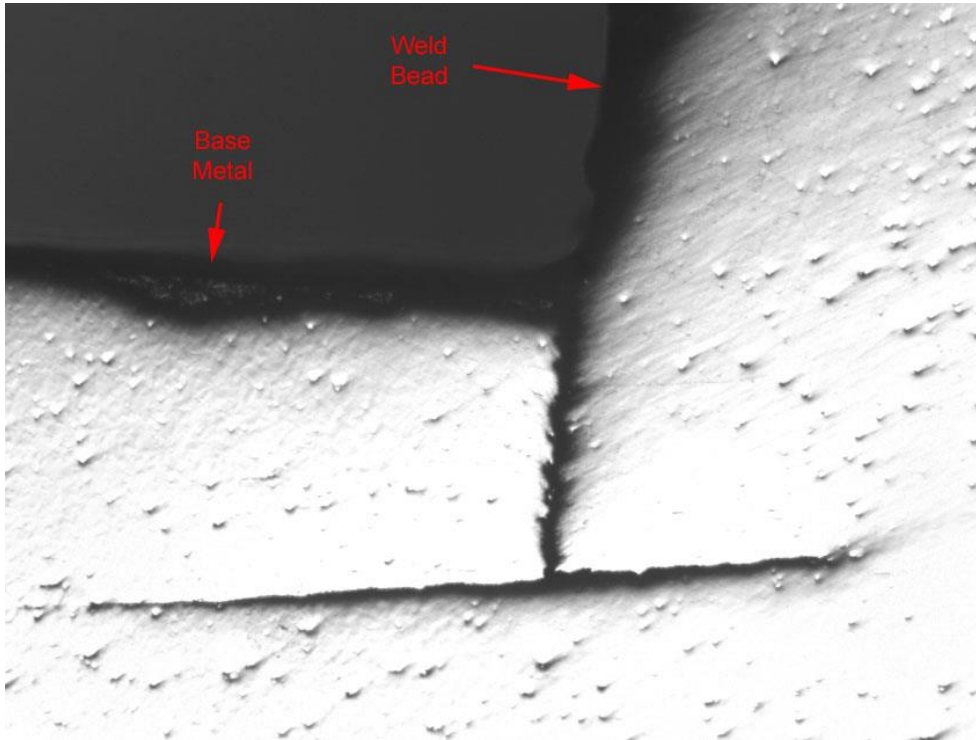
Figure 21 Photograph showing the crack in the M1 sample from near the 15in location

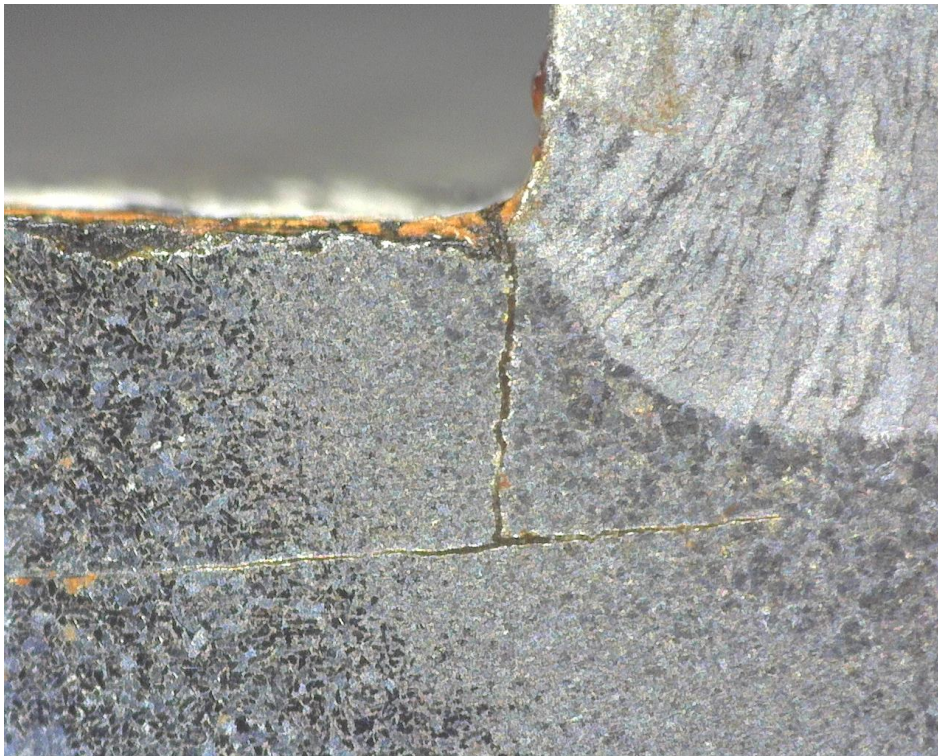
Figure 22 Photograph showing the crack in the M1 sample at the 15in location after etching

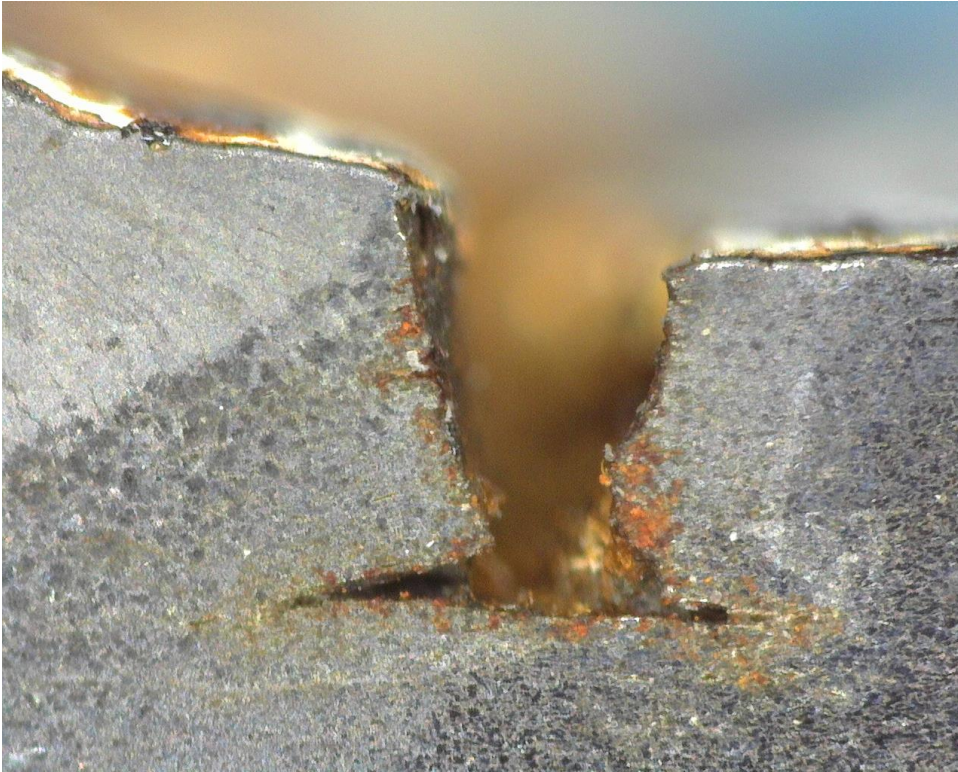
Figure 23 Photograph showing the crack in the M3 sample at the 42in location after etching

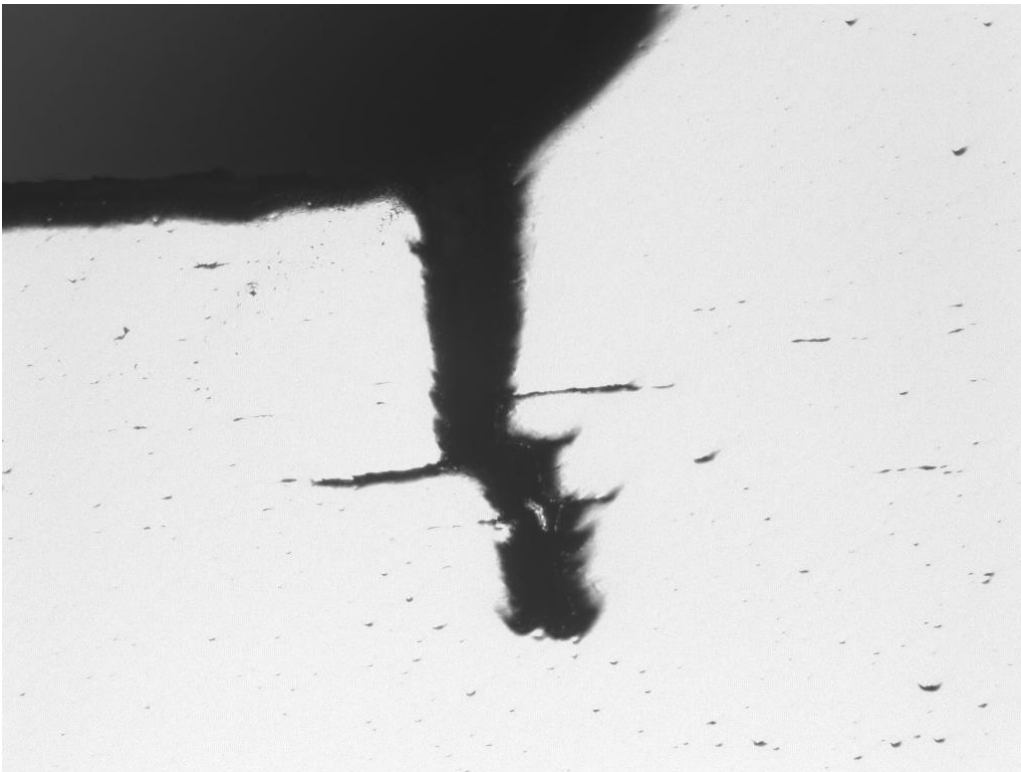
Figure 24 Photograph showing the crack in the M4B sample at the 86.5in location

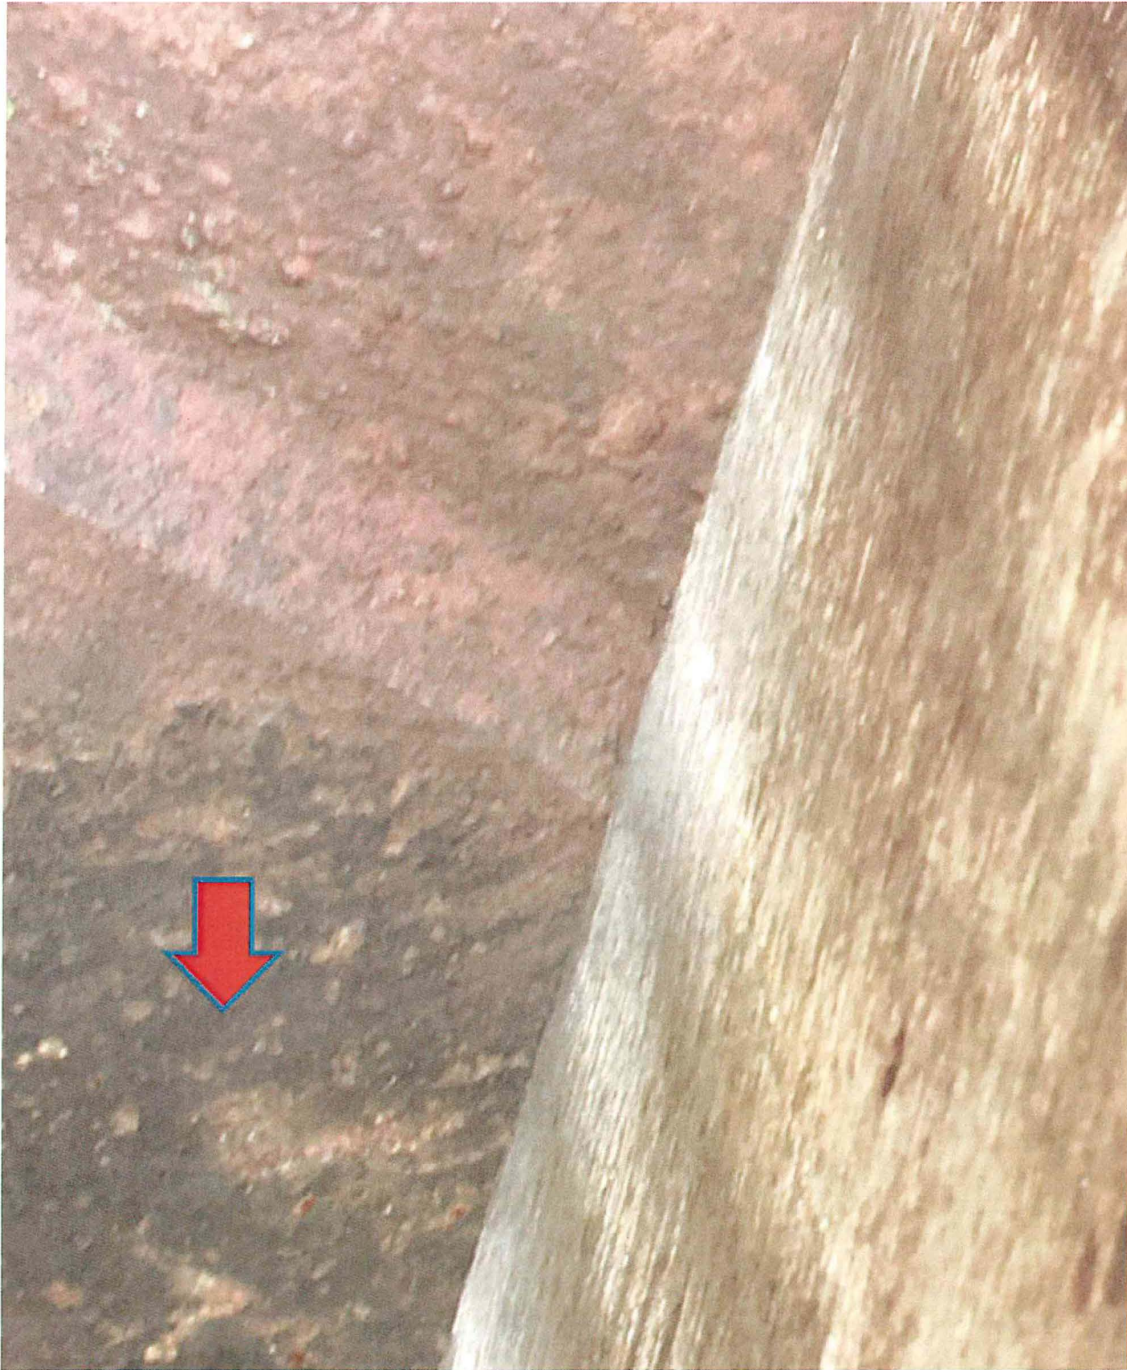
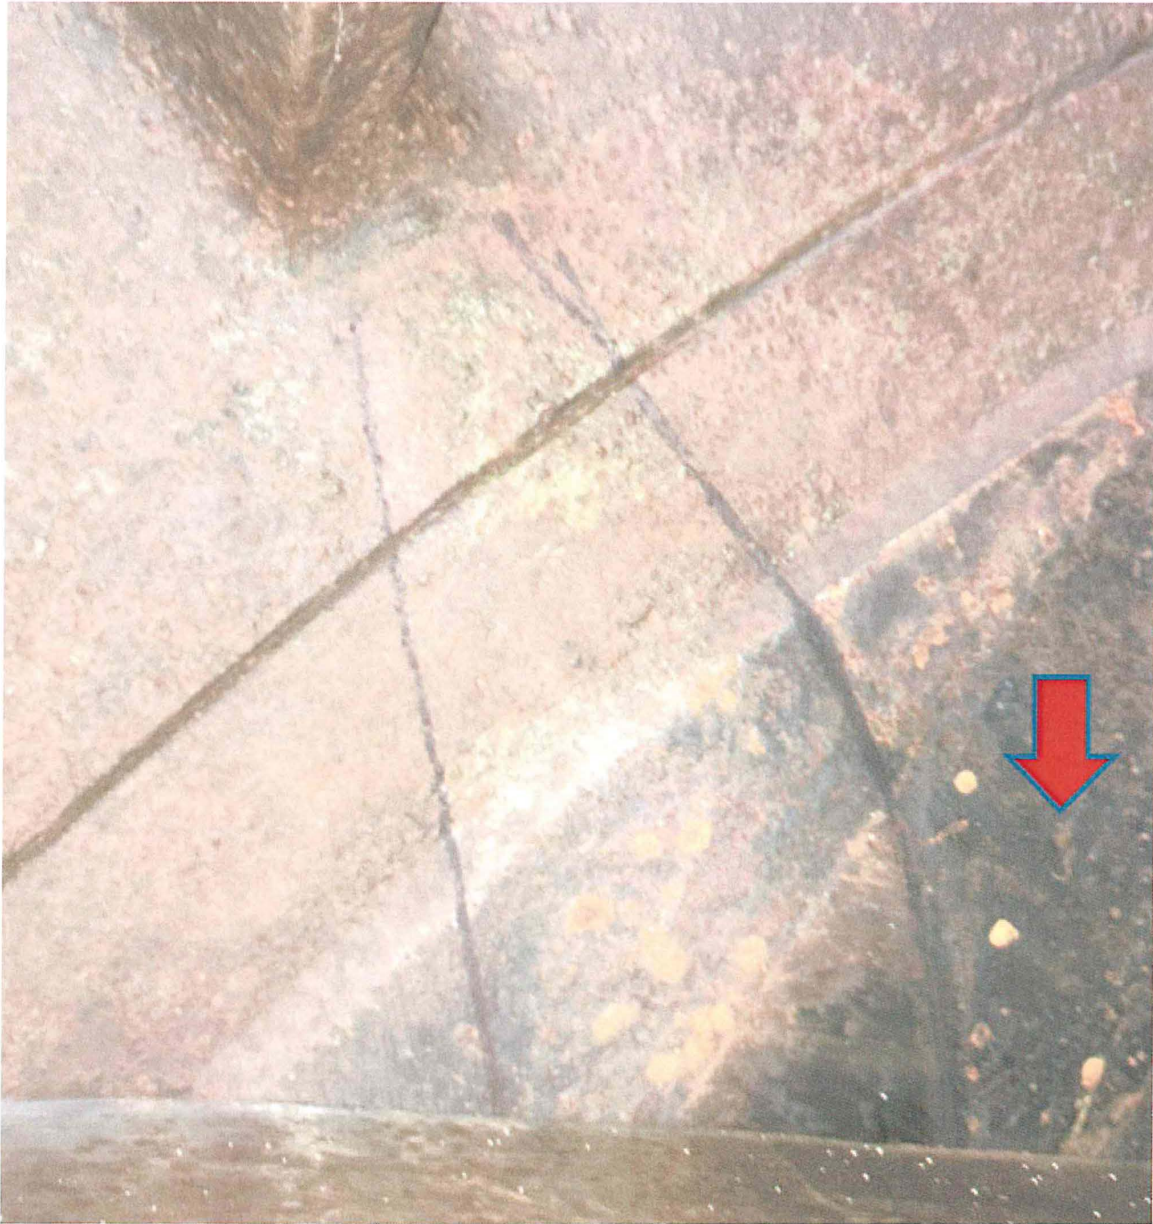
Gate Ring Clearances U2 Upstream & U2 Downstream –

Based on the design value of .019" each end, the as found clearances on both distributors are too tight for proper operation. In the photos below please note the buildup of scale on the wicket gate interface surfaces.

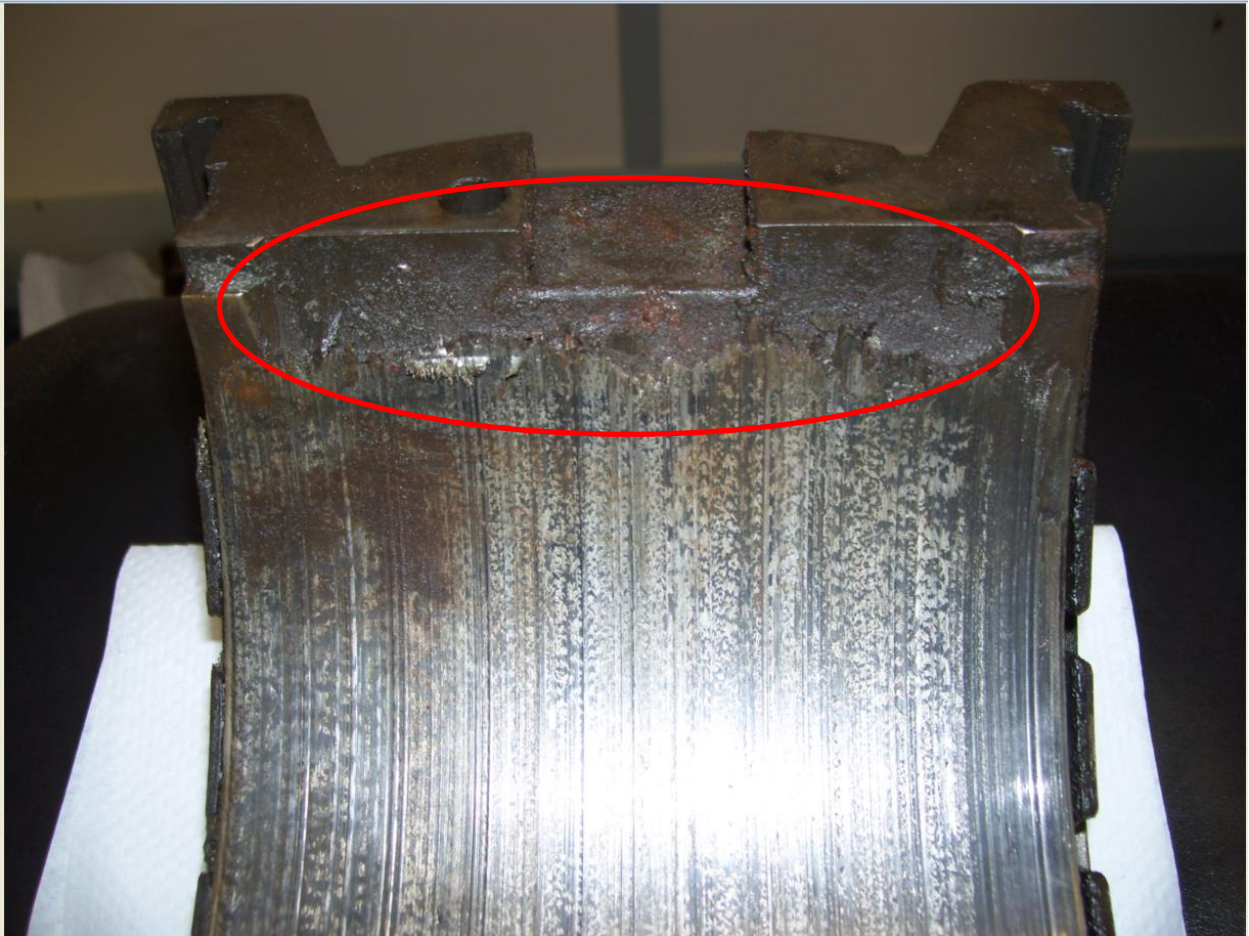
2.1.4 Loss of babbit at the leading edge of the bottom half of the bearing.

The loss of babbit at the leading edge of the bottom half indicates fatigue failure. Fatigue failure would begin as cracks at the leading edge of the bearing half and will progress to babbit loss. Fatigue failure is caused mainly due to cyclic loading. The bearing halves were never checked for cracks either by dye penetrant or ultrasonic examination during outages.
