Re: Application for Approval of Refurbishment of the Hardwoods Gas Turbine Alternator Exciter

End Bearing and the Purchase of an Exciter Bearing Liner and Thrust Pads

Restoration of Hardwoods Gas Turbine Capital Spares

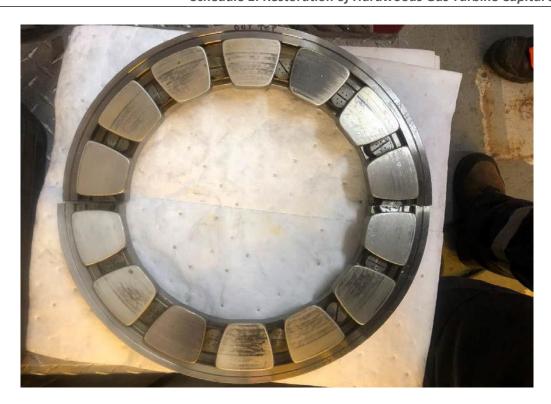
Figure 4: Exciter Bearing Thrust Ring B Side, as Found

- 28 the issues with placing End B in service. Upon exciter bearing disassembly, it was found that there was
- 29 no measureable clearance on either side of the thrust bearing. The thrust pads showed signs of wear

- 30 (Figures 4 and 5), but were determined suitable for further service.

- 1 Based on as found condition, the alternator exciter end bearing and the exciter bearing liner were
- 2 replaced with the available capital spares. Having been deemed suitable for service, the exciter bearing
- 3 thrust pads were polished and reinstalled. The exciter bearing journal² was also polished prior to
- 4 completing the reinstallation of the exciter bearing components. Dimensional checks were completed
- 5 on all bearing components to ensure conformance to OEM specifications prior to return to service.
- 6 Figures 6 through 8 are photos of the as installed condition of the new and polished bearing
- 7 components.

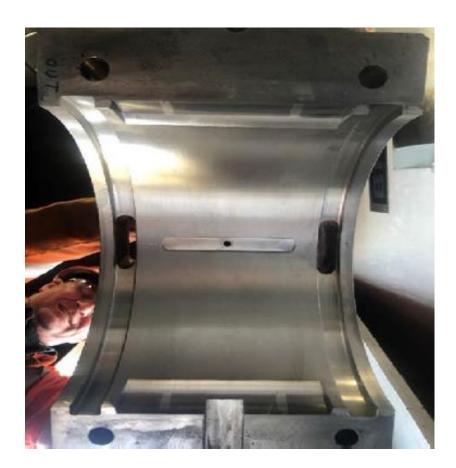
Figure 6: New Alternator Exciter End Bearing Lower Half Prior to Installation

- 3 Upon inspection of the alternator exciter end bearing, it also showed evidence of shaft contact. The
- 4 bearing, while still in serviceable condition, was replaced with the on-site spare to ensure the reliable
- 5 operation of the alternator going forward. This replacement requires the oversight of a Brush
- 6 representative and was therefore completed while the field service engineer was on site, avoiding the
- 7 requirement for a future site visit to complete this work.

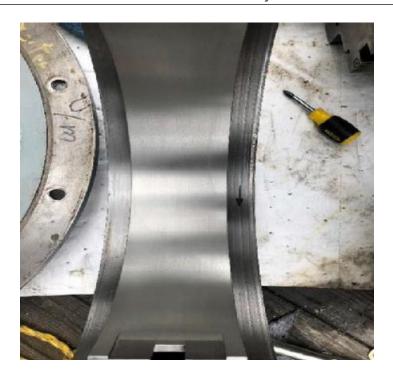
Figure 7: New Exciter Bearing Liner Lower Half Prior to Installation

- 1 Upon inspection of the exciter bearing, the lower half of the liner exhibited evidence of shaft touch and
- the liner top half had a small area of damage as well.

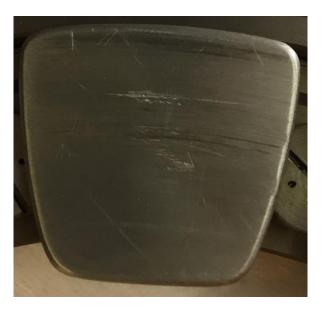
Figure 9: Thrust Pad Wear

- 27 to the unit and have been polished and returned to service on a number of occasions but have not been
- 28 replaced in the unit's 42 year service life to date. Their current condition, while deemed suitable for

- 29 further service, is not ideal. As can be seen in Figures 9 and 10, they are showing signs of significant
- 30 wear and may not be able to be returned to service if further issues arise. Generally, the thrust pads

- 1 have developed deep scratches and grooving over the years which cannot be removed as the babbitt
- 2 surface has been thinned over time through cleaning and polishing.

- 7 The detailed project scope includes the following:
 - 1) Purchase of a replacement exciter bearing liner;
- 9 2) Purchase of replacement thrust pads and miscellaneous materials required for thrust padinstallation; and
- 3) Refurbishment (re-babbiting) of the spare alternator exciter end bearing.
- 12 The project will be completed by Hydro personnel with technical support from the alternator OEM,
- Brush. Bearing liner and thrust pad supply will be by Brush and will be the specified components for this
- 14 alternator. Re-babbitting of the alternator exciter end bearing will also be performed by Brush to
- original equipment specifications. Table 4 provides the project estimate; Table 5 provides the expected
- 16 project schedule.
