Re: Application to Supply and Install Runner – Unit 2 – Cat Arm Hydroelectric Generating Station

AB25-0356 REV A - Cat Arm - Unit #1 old runner wear analysis

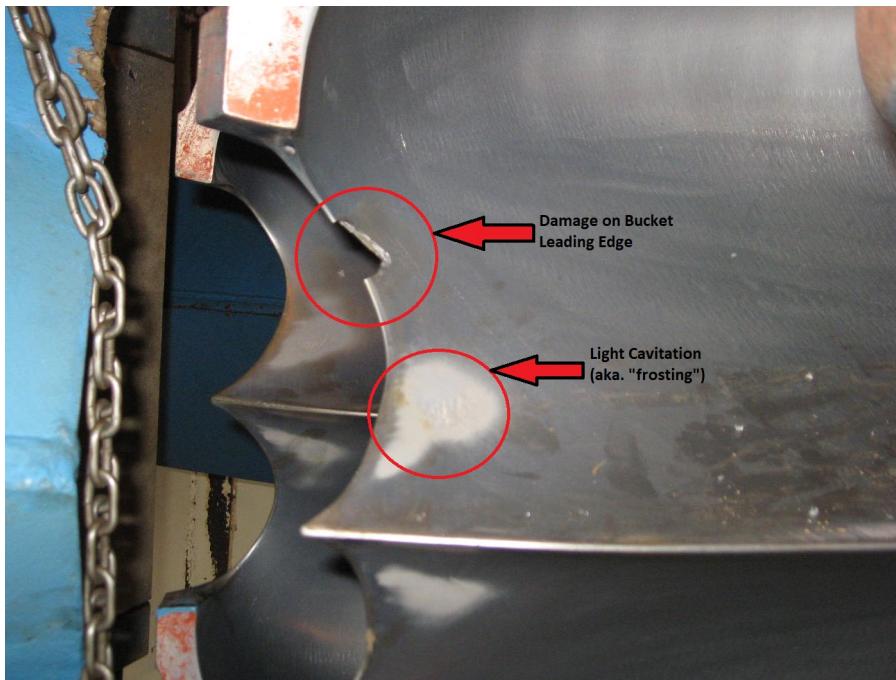
Figure 3: Cat Arm Unit 1 Pelton Runner Damage (2014)

1 In 2014, the Unit 1 runner experienced damage due to a broken piece on the leading edge of a bucket, as
2 shown in Figure 3. Subsequent inspections on Unit 1 and Unit 2 also noted early signs of cavitation on both
3 runners. Upon review, which included trending of key performance indicators, it was determined that both
4 the broken piece and light cavitation would not impact the operation of the units, and the runners could
5 safely be placed back into service. Hydro continued to monitor key indicators on the unit, such as vibration
6 and temperature, for any changes that may give early warning of issues for preventive intervention.

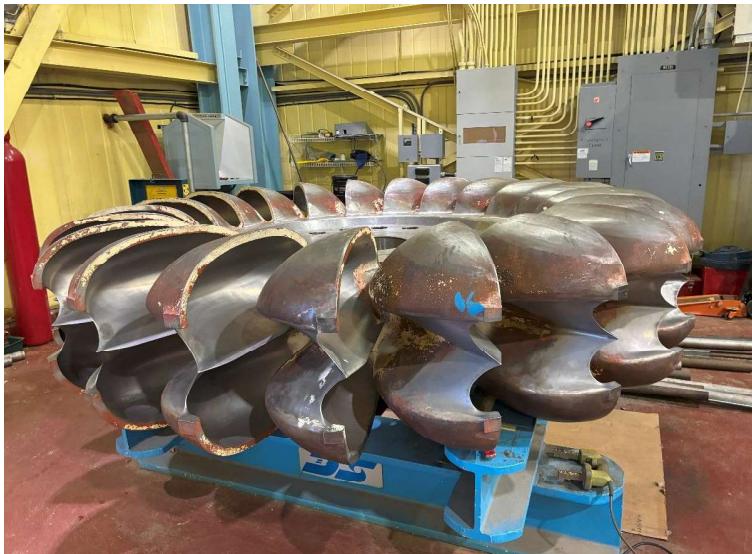
Visual inspection performed at 100% of runner on accessibles area.

Results : Cavitation were found on each bucket.

Weld spatter, arc strike, scratches were found on runner, see table next pages.

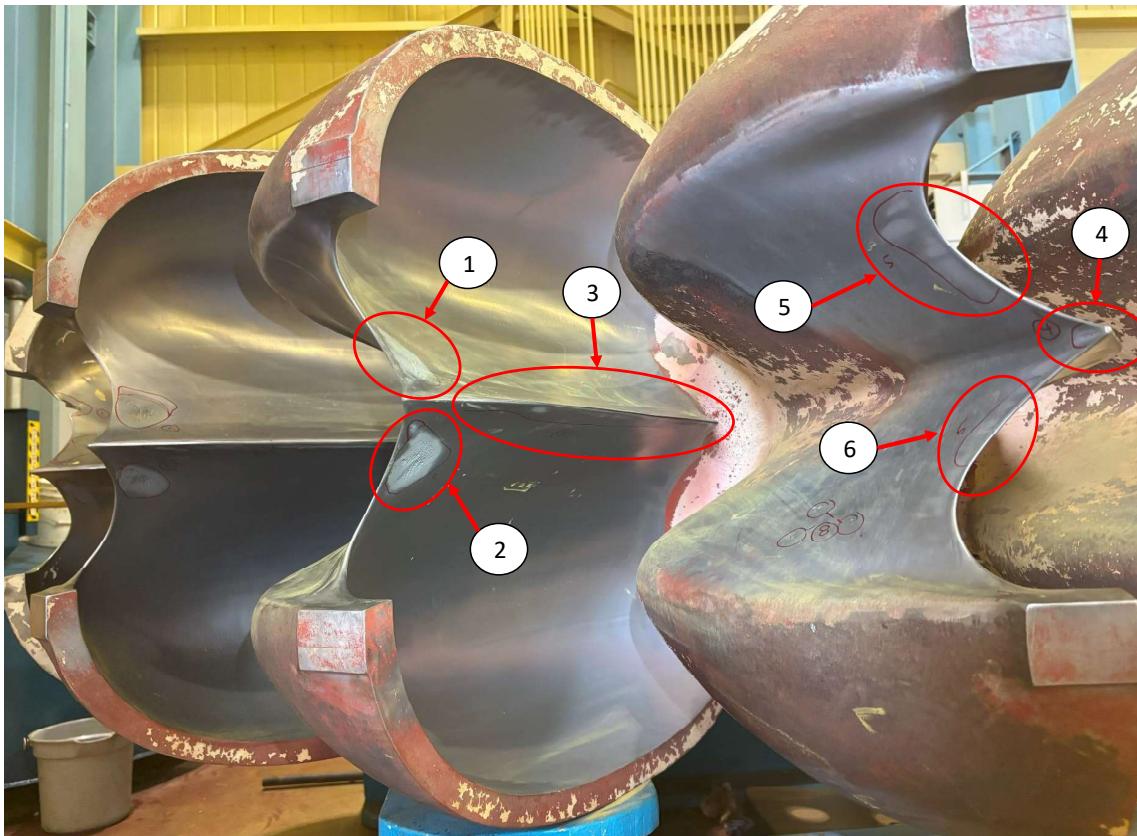
See the images of cavitation observed on the buckets. We have included some photos.

Cavitation found at same places on each bucket

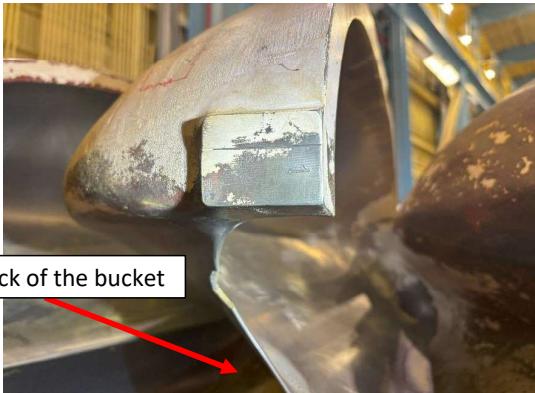
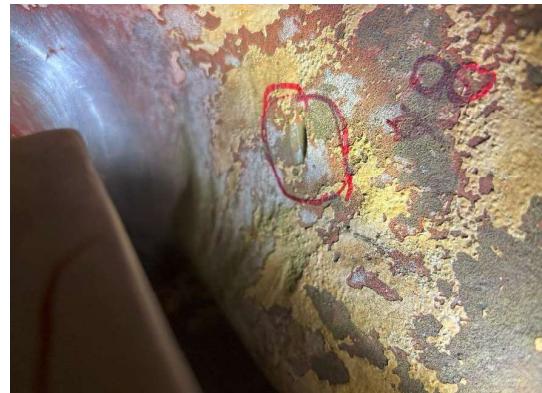
Bucket #1 ; Indication #8 in casting located in zone VII.

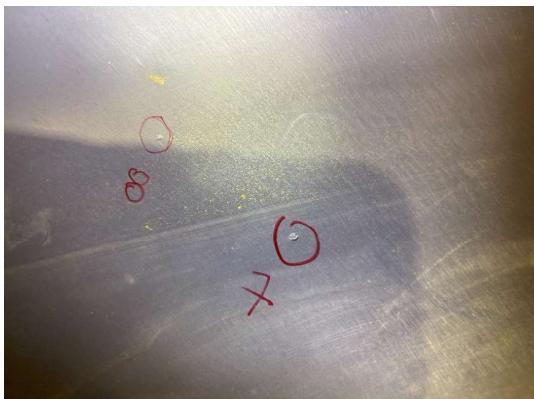
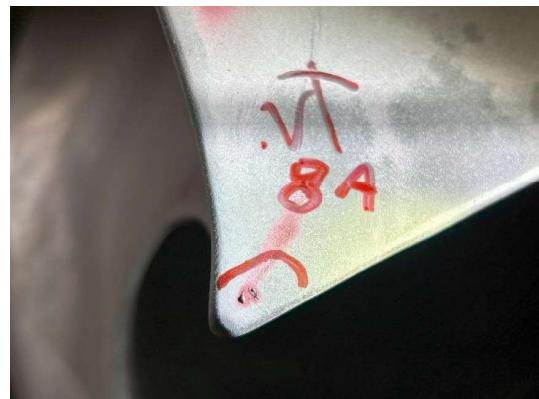
Bucket #8 : Indication #7, #8; damaged area on machined surface inside bucket.
Indication #8A; welding spatters.

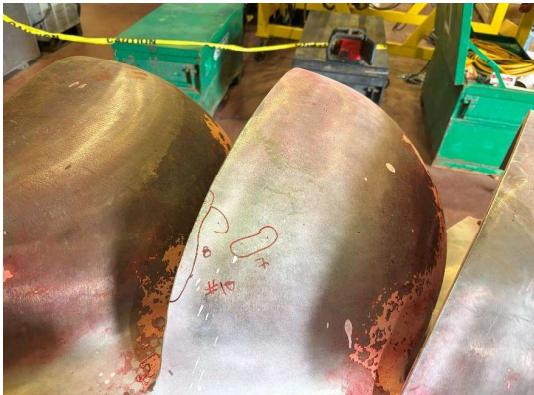
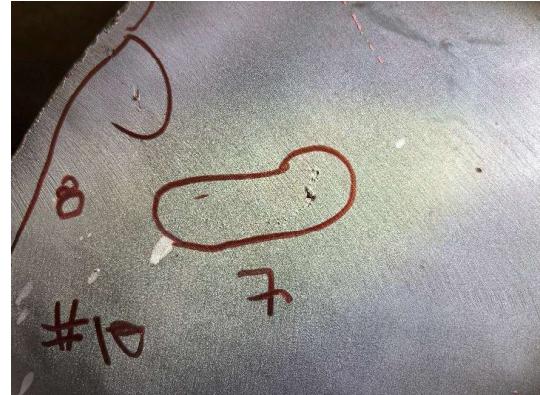
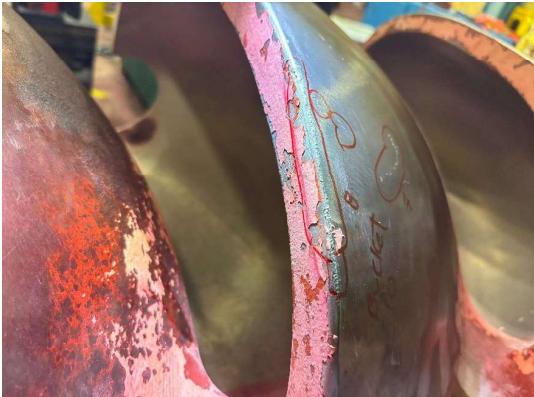
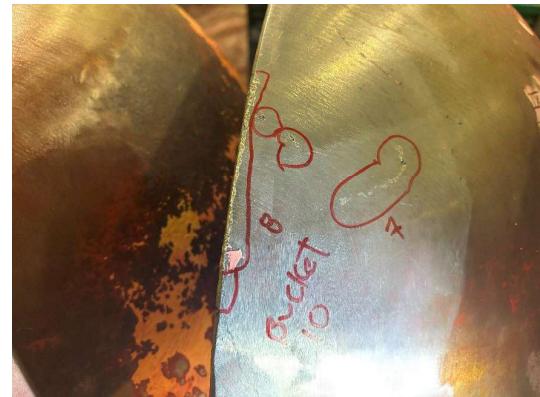
Bucket #10 ; Indication #7 ; arc strike

Indication #8 ; Edge of the bucket damaged.

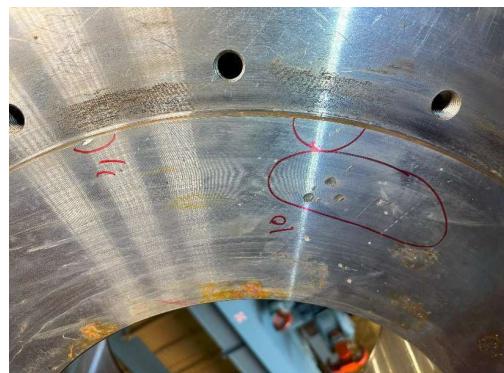
Pictures of indications found under the runner.

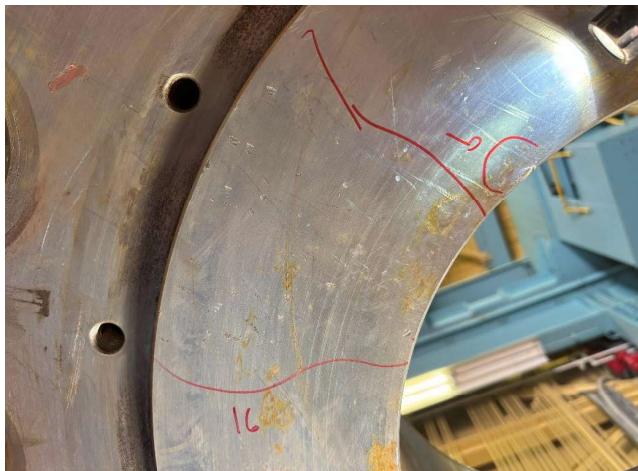
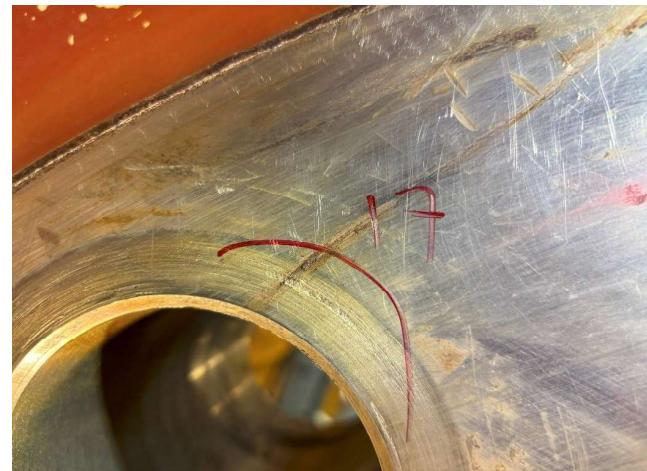
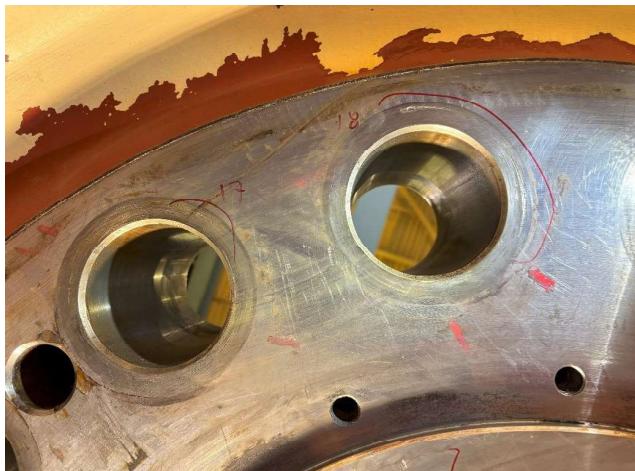
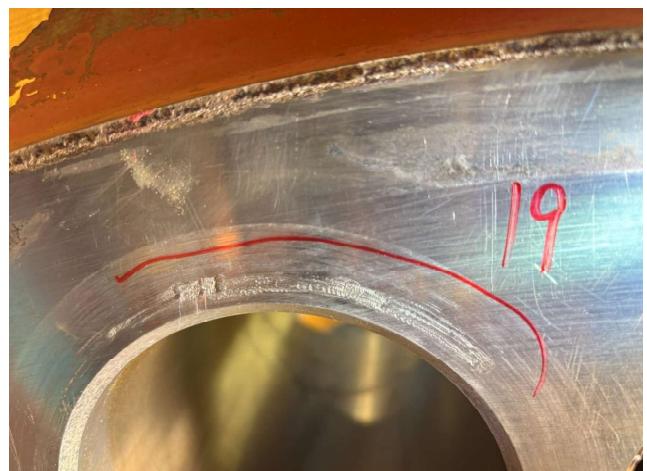
Pictures of indications found under the runner.

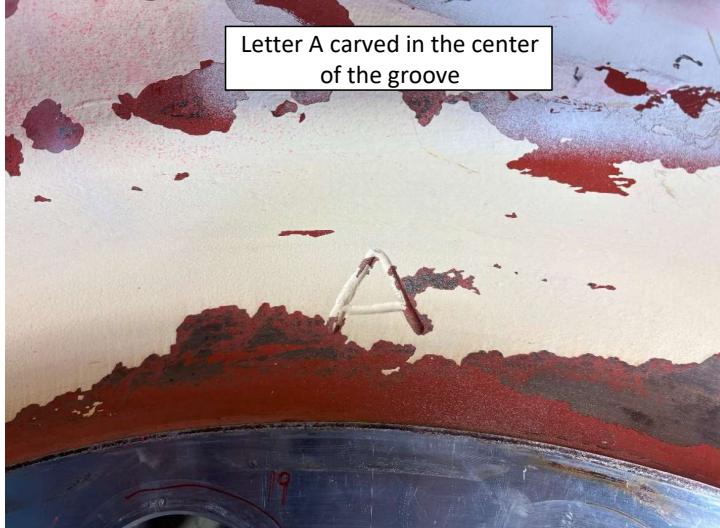
Pictures of indications found under the runner.

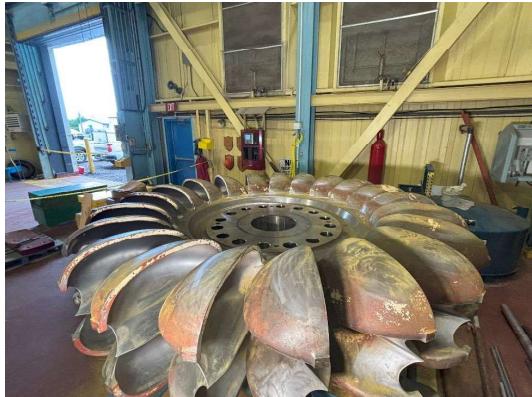
Magnetic particle inspection was carried out on 100% of the surface of runner in accessible area.

Paint present in certain places which may hide indications.

Results : 1 crack were found on bucket #1.

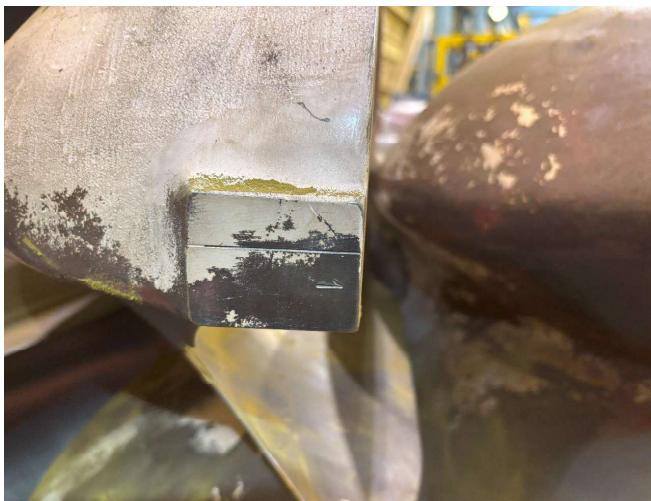
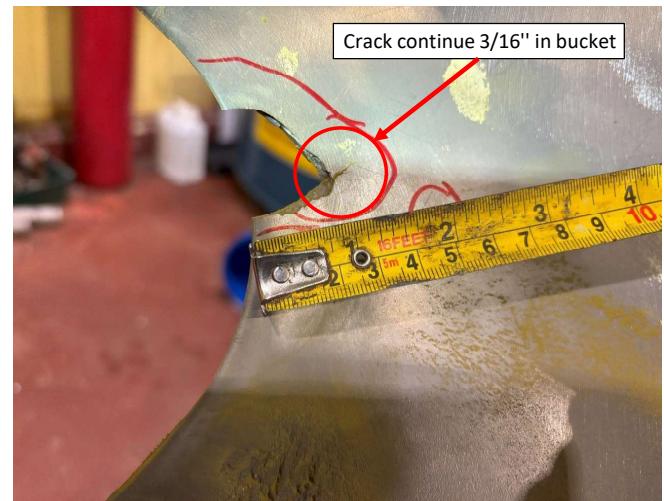
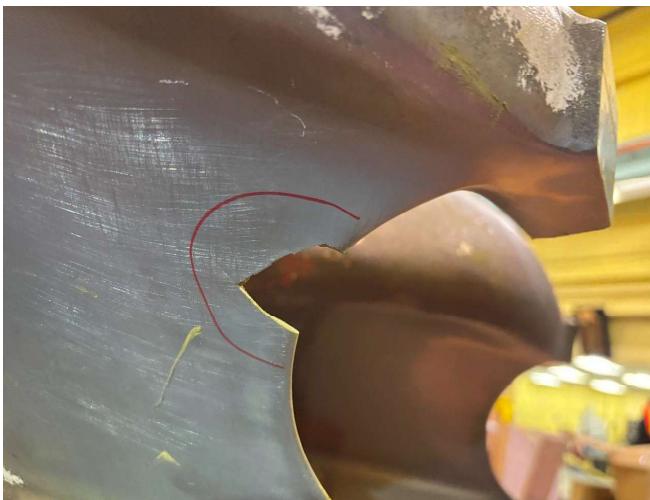
Pictures of defect found : Crack into bucket #1, zone #1 ; 1.25"x1"

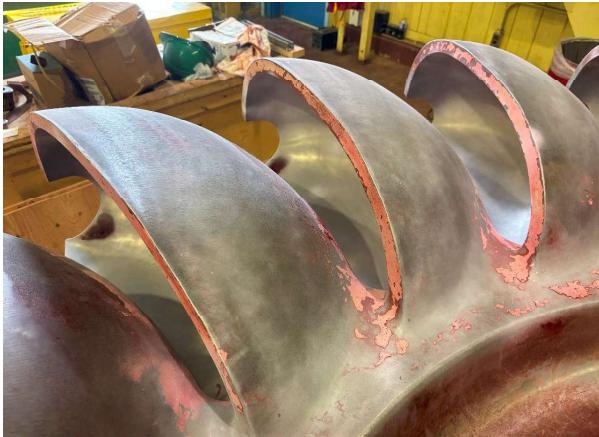
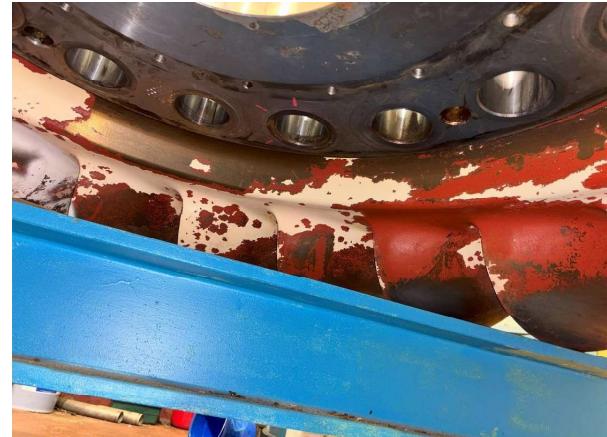
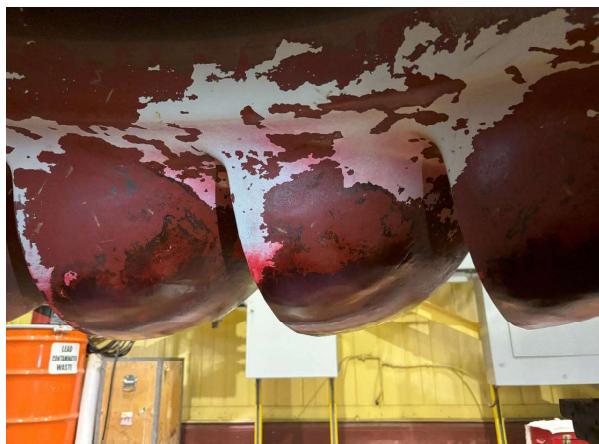
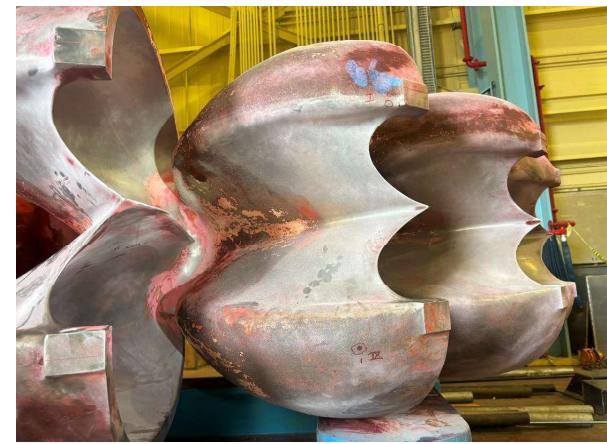
Liquid penetrant performed at 100% on the surfaces of the bucket on accessible areas.

Paint present in certain places, inspection cannot be carried out in these places.

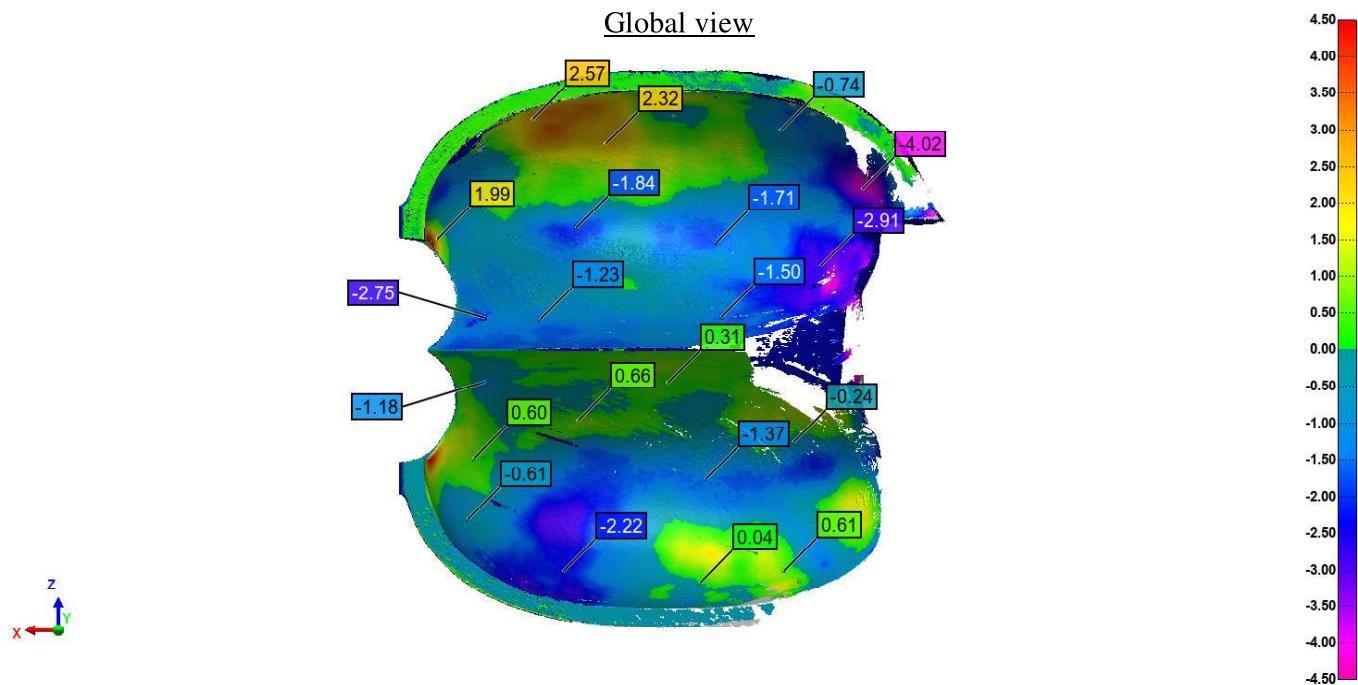
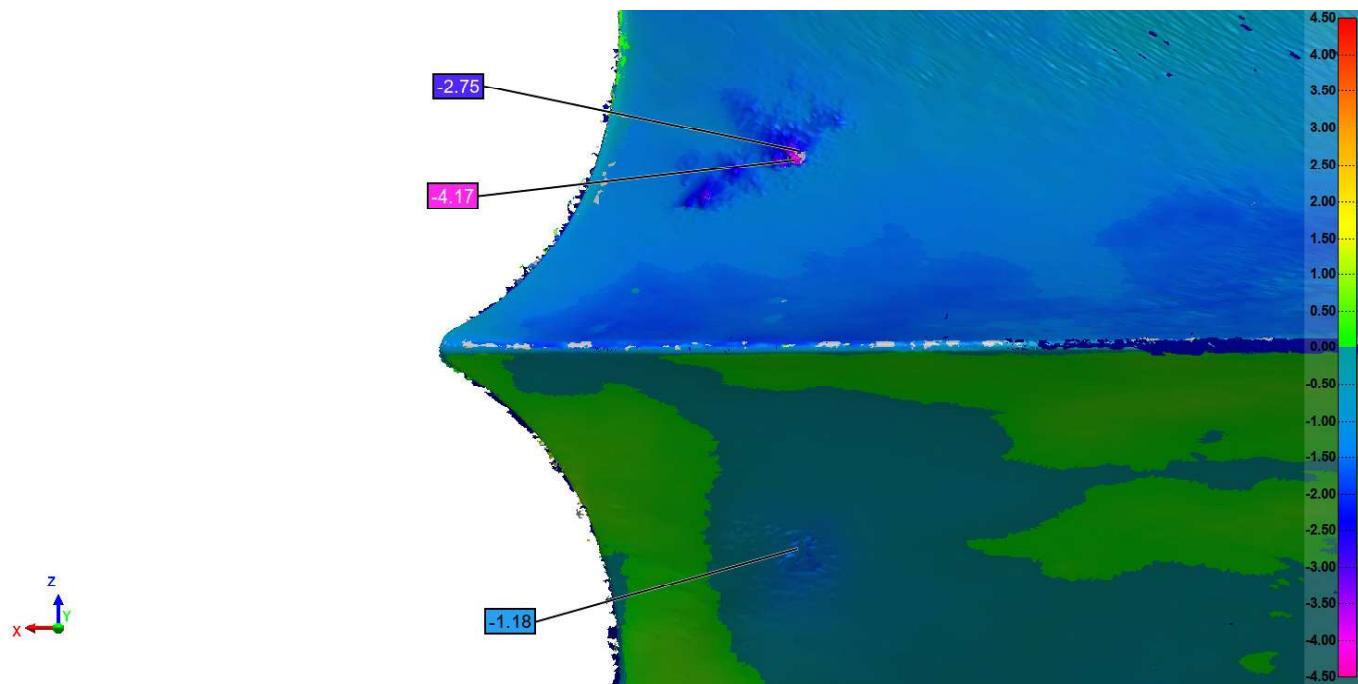
Bucket #5 - Wear colormaps

Zoom on cavitation area

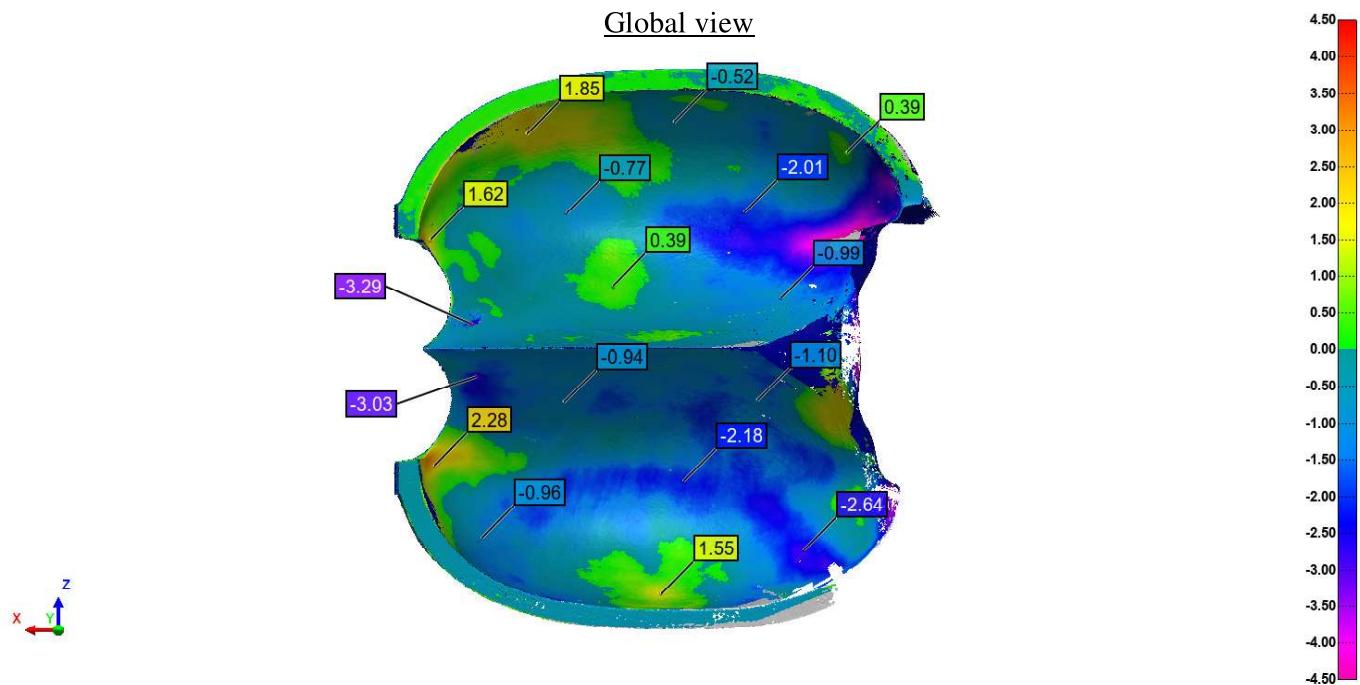
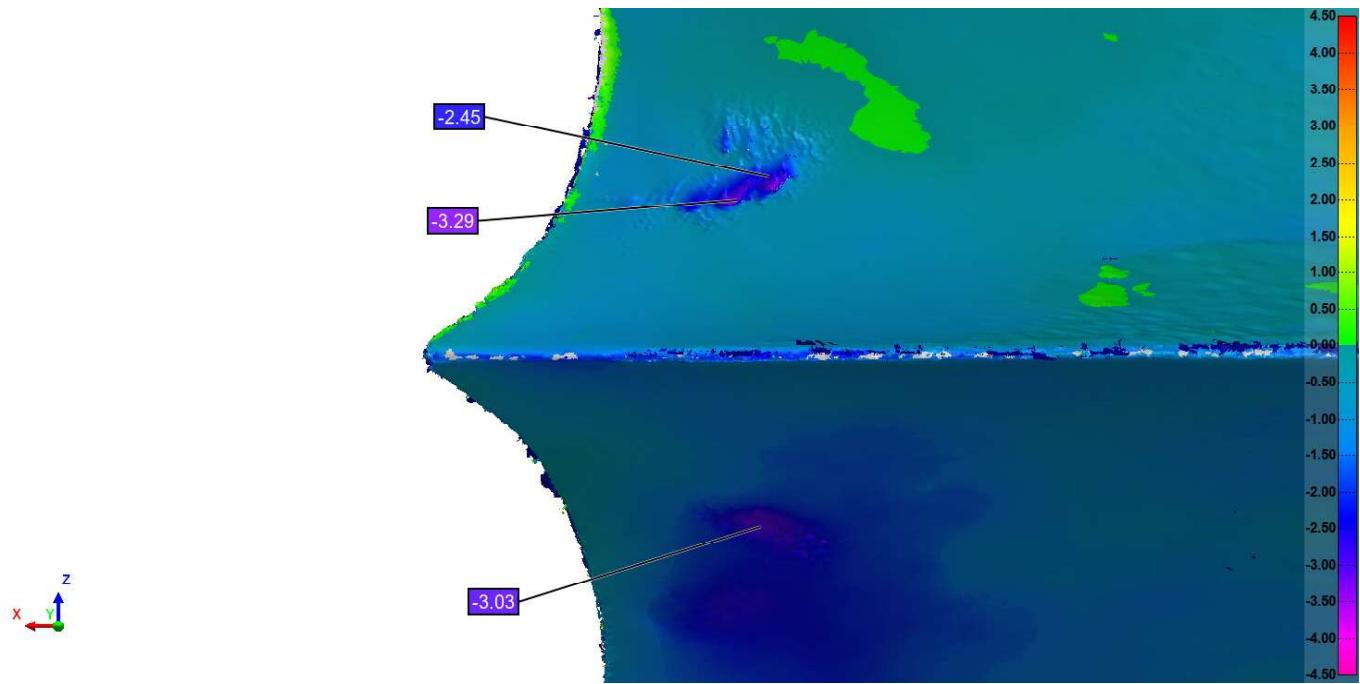
Bucket #10 - Wear colormaps

Zoom on cavitation area

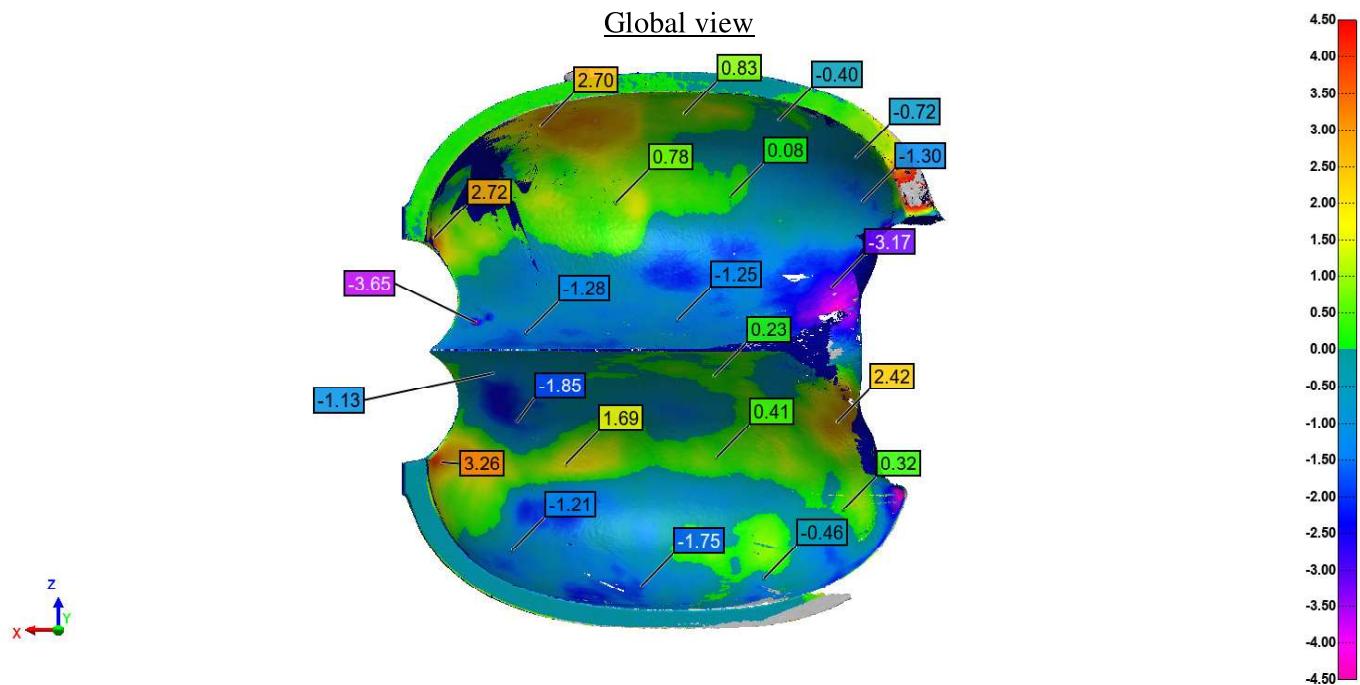
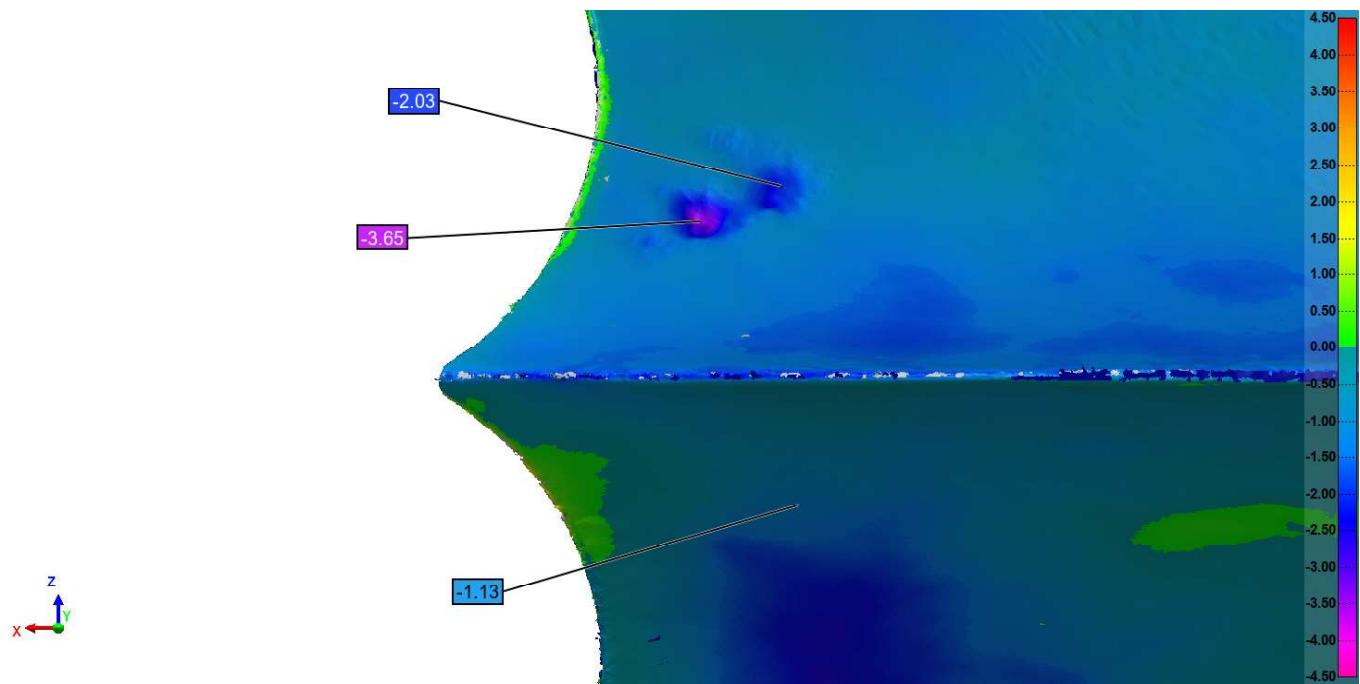
Bucket #12 - Wear colormaps

Zoom on cavitation area

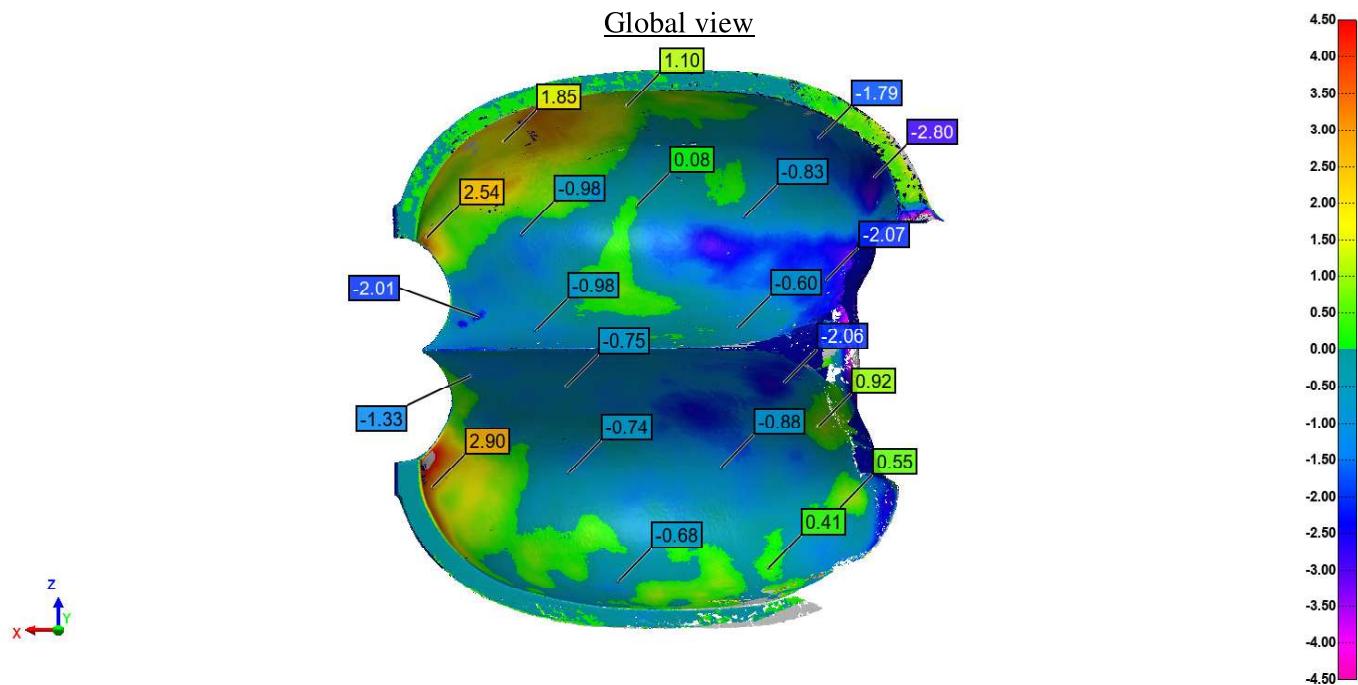
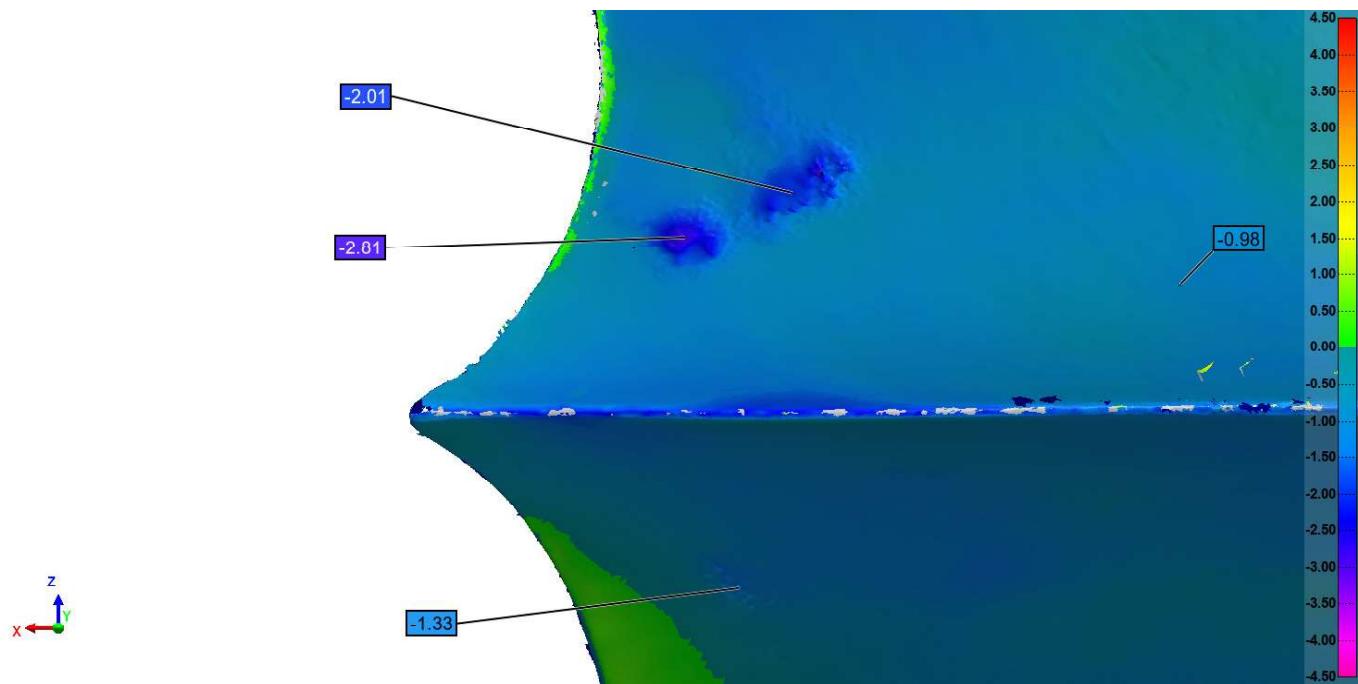
Bucket #13 - Wear colormaps

Zoom on cavitation area

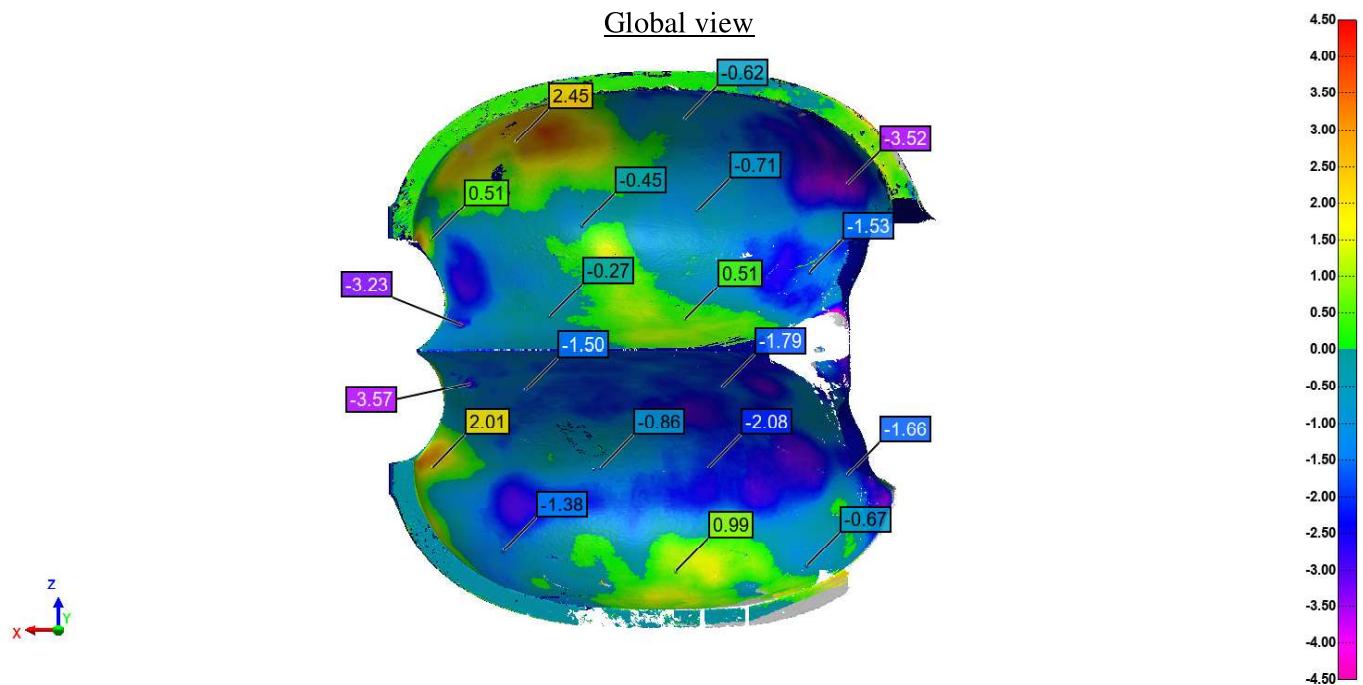
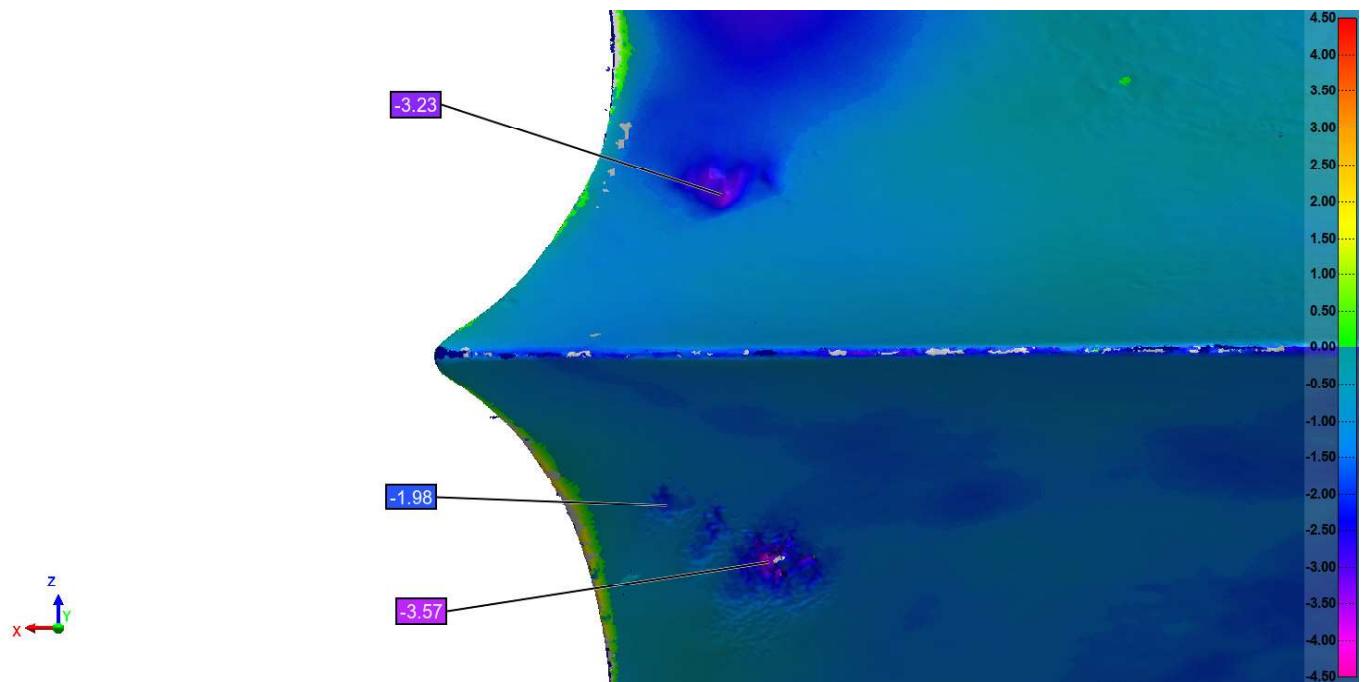
Bucket #14 - Wear colormaps

Zoom on cavitation area

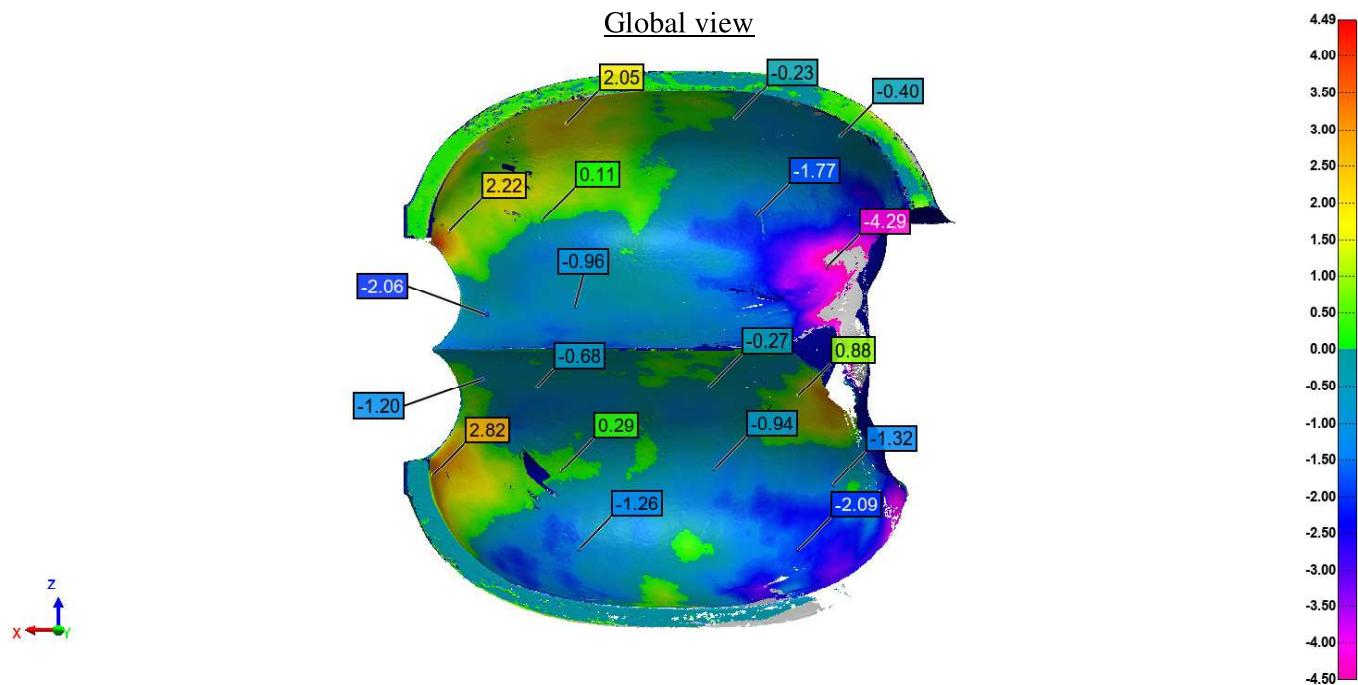
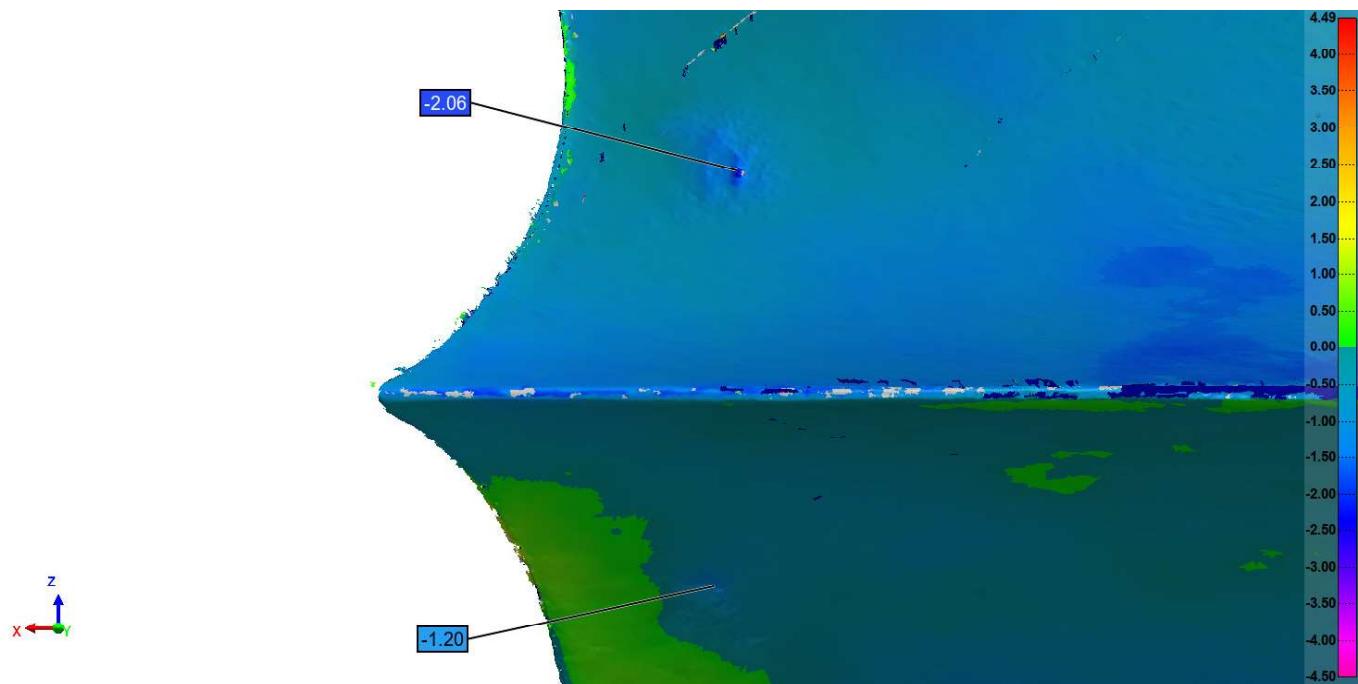
Bucket #16 - Wear colormaps

Zoom on cavitation area

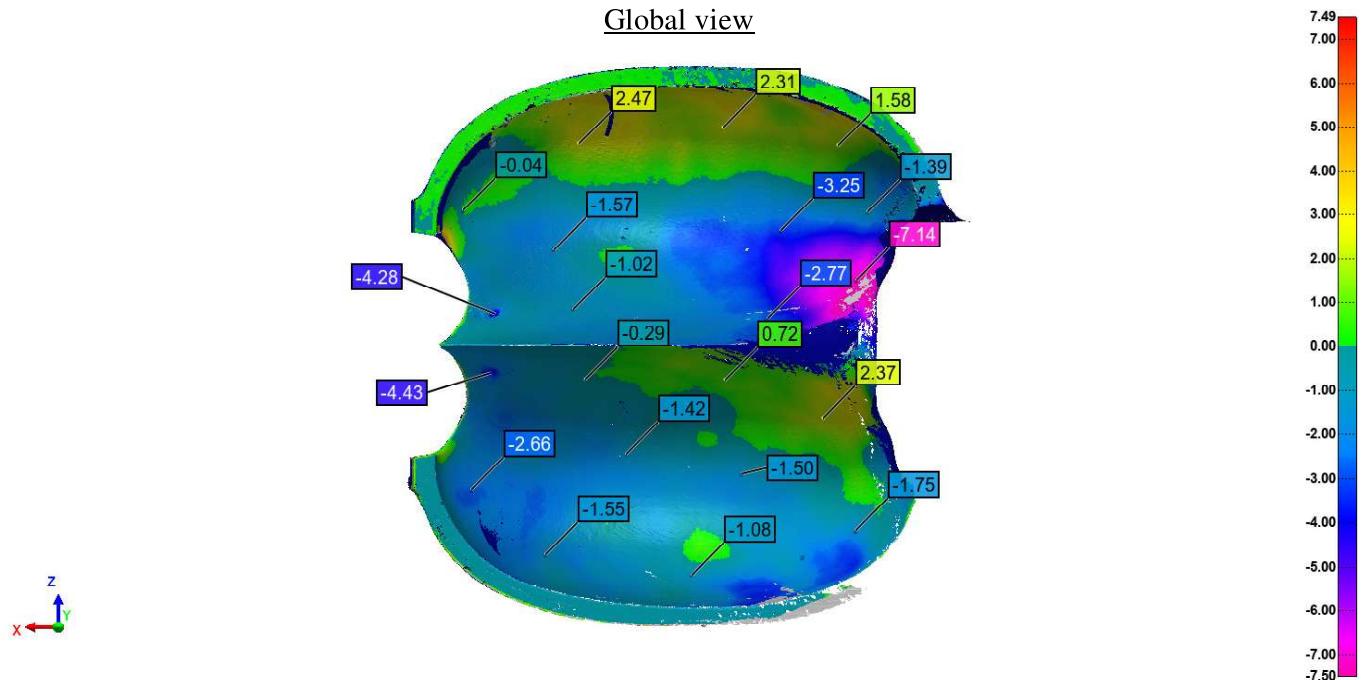
Bucket #17 - Wear colormaps

The color map range have been increased from $\pm 4.5\text{mm}$ to $\pm 7.5\text{mm}$ to reflect a worse wear
