**Re: Allowance for Unforeseen Items Account – Holyrood Thermal Generating Station Unit 3 Boiler Tube Failure – Final Report**

# **Holyrood Thermal Generating Station Unit 3 Boiler Tube Failure**

## **Final Report**

**December 21, 2021**

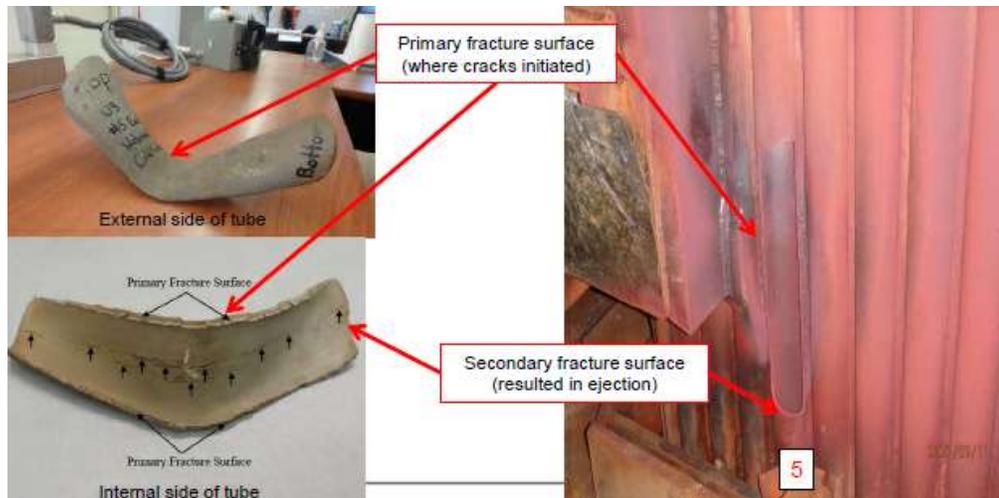
17 On September 11, 2021, while Hydro was in the process of returning Holyrood TGS Unit 3 to service  
18 following a planned maintenance outage, a rupture on boiler tube #5 occurred on the east waterwall of  
19 Unit 3 boiler. A section of the tube (approximately 13.5 inches tall by 3 inches wide) was ejected during  
20 the rupture resulting in the release of steam into the powerhouse. The rupture occurred on the side of  
21 the tube that is facing the boiler insulation and cladding (cold side) as shown in the picture in Figure 1;  
22 therefore, it is referred to as a cold side rupture.

**Figure 1: Boiler Tube #5 Rupture on the East Waterwall of Unit 3 Boiler**

1 The released high-pressure steam blew out a part of the insulation and cladding. A cold side rupture of  
2 this nature is a rare occurrence. This incident is only the second occurrence in the Unit 3 boiler's 40  
3 years of operation with the first occurring in 1993. A rupture of this nature has never occurred on Units  
4 1 and 2.

1 A section of the ruptured tube was sent to an engineering consultant (Wayland Engineering Ltd) for  
2 investigation and evaluation of the degradation mechanism. The physical, chemical, and metallurgical  
3 evidence indicated that the primary degradation mechanism responsible for this cold-side rupture is  
4 consistent with corrosion fatigue which initiated from the internal surface of the tube. Fatigue due to  
5 thermal cyclic loads causes cracks to develop and propagate over years of the tubes service life. These  
6 cracks grow to a critical size (length/depth) at which point the tube is no longer able to withstand the  
7 applied stresses due to thermal cyclic loading and internal steam pressure. Due to the nature of the  
8 corrosion fatigue failure mechanism and the risk of additional failures on the Unit 3 waterwall boiler  
9 tubes, Hydro initiated a level 2 condition assessment to ensure all waterwall tubes on all sides of the

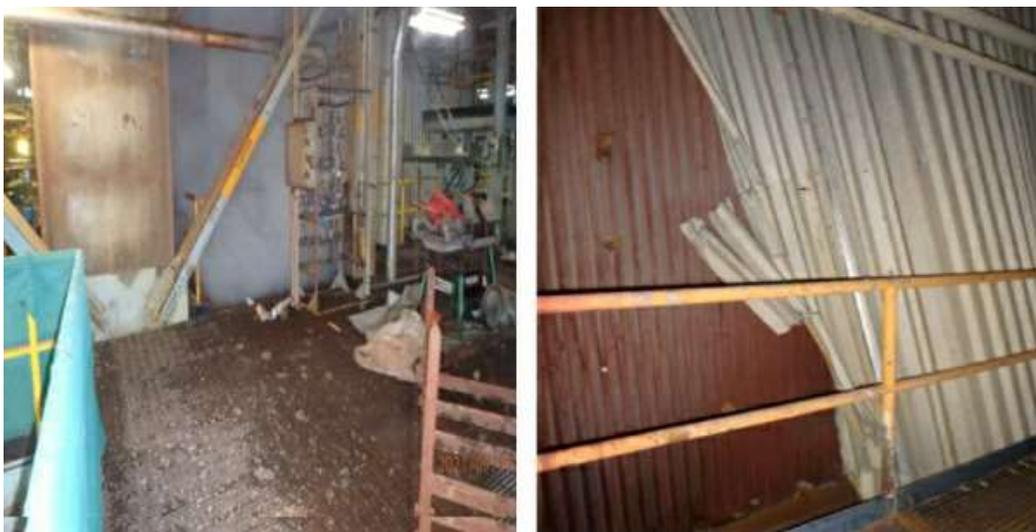
5 At the time of the rupture event, Unit 3 was in the process of increasing load from 30 MW up to 70 MW.  
6 The unit tripped and Holyrood TGS was safely evacuated. Figure 2 shows debris and steam on the floor  
7 and cladding damage on Unit 3 boiler as a result of the tube rupture. The incident was a high-potential  
8 near miss which did not result in any injuries.

**Figure 2: Debris, Released Steam and Cladding Damage on Unit 3 Boiler**

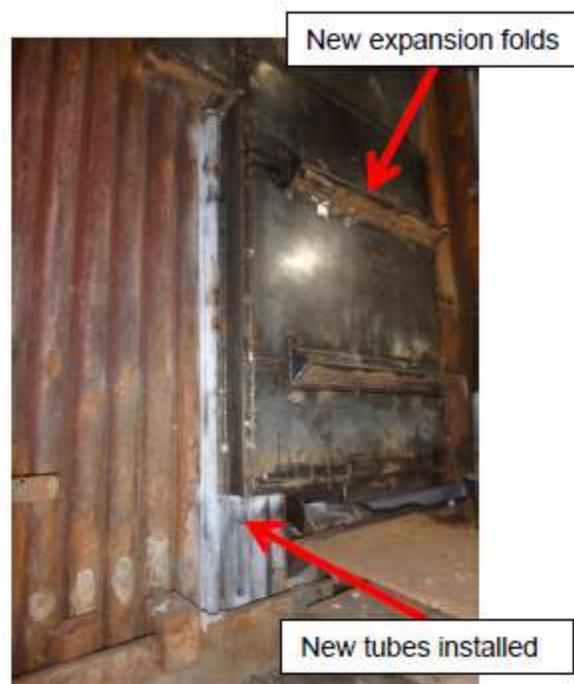
**Figure 3: New Expansion Folds in the Windbox**

10 In 2020, Hydro engaged B&W to perform an engineering study to mitigate thermal cyclic stresses. The  
11 study recommended tube replacements and installation of expansion folds in the windbox to reduce the  
12 loads on tubes attached to the windbox due to thermal expansion. The B&W study was completed near  
13 the end of 2020. During the 2021 outage, 12 tube replacements approximately 10 feet in length (6 at  
14 the South West and 6 at the South East corners of the windbox high stress areas) were completed along  
15 with the installation of expansion folds recommended in the B&W study (Figure 3).

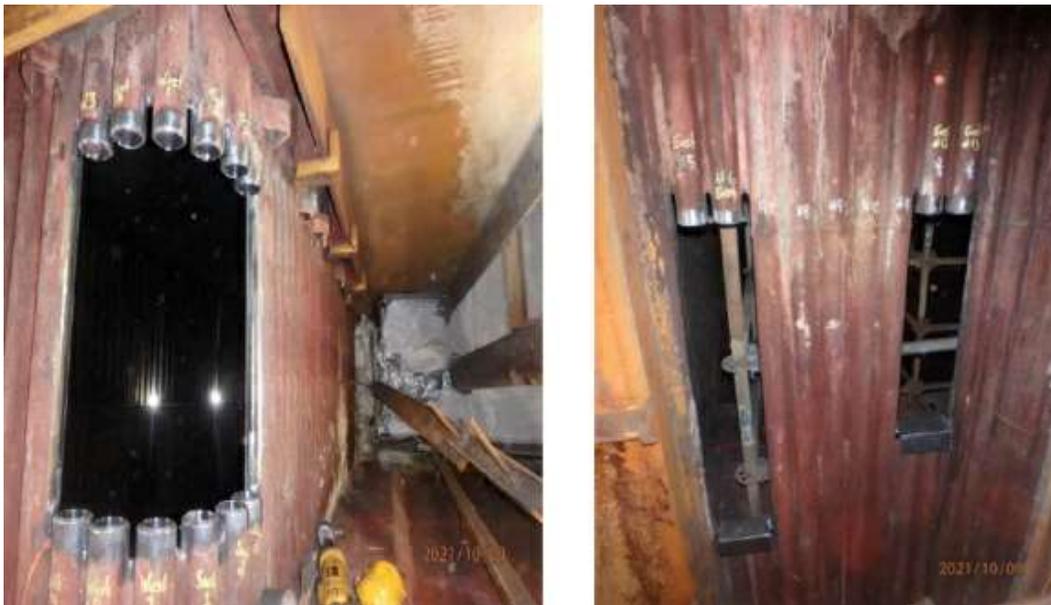
**Figure 4: Portion of Removed Waterwall Tube Section on Unit 3 Boiler**

7 To provide access to the inside of the waterwall tubes for inspection, 71 tube sections (totaling  
8 approximately 200 feet of tube) were removed to allow a specialized probe (custom made to fit for Unit  
9 3) to be inserted inside of at risk tubes to perform inspections (Figure 4).

1 the boiler waterwalls to provide access for inspection equipment were replaced by Hydro’s boiler  
 2 contractor, GE.
