Re: 2019 Failure of Bay d'Espoir Penstock 1 and Plan Regarding Penstock Life Extension

Bay d'Espoir Penstock No. 1 – 2019 Failure Investigation Report

Newfoundland and Labrador Hydro
Bay d'Espoir Penstock No. 1 – 2019 Failure Investigation Report

668998-0000-40ER-0001
Revision 00
March 19 2020

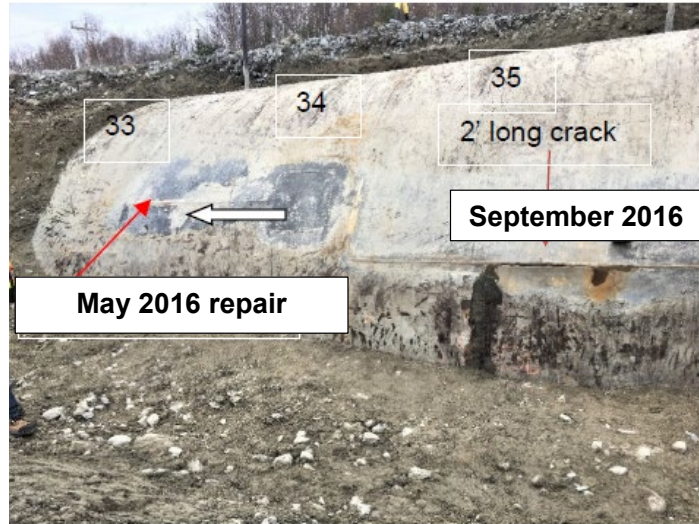
Figure 3-1: Penstock No. 1 - Failures occurred in 2016 (Ref. 3)

In May and September 2016, Penstock No 1 experienced two ruptures in Cans 96 and 95 respectively as shown in Figure 3-1 (Ref 3). These ruptures were repaired, and the penstock returned to service.

(Cans have been since renumbered, so Cans 34 and 35 are now Cans 96 and 95 respectively)

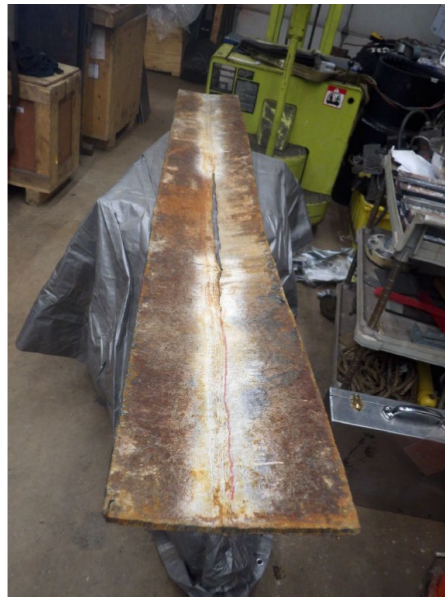
Figure 3-2: Penstock No. 1 - Failure occurred in 2017 (Ref. 3)

In November 2017, Penstock No 1 experienced a third rupture in Can 95 and in the same weld seam, adjacent to the crack that was repaired in September 2016. The failure consisted of a 2 foot long crack. The metallurgical analysis of the failed section confirmed that the 2017 rupture was initiated at the toe of the 2016 repair weld and then it propagated into the parent plate material in an orientation parallel to the weld. The material tests did not indicate any defects in plate material or the welds.

Significant weld degradation and cracking was uncovered in Penstock No. 1. Approximately 950m of welds were repaired as indicated in Figure 3-2. All repaired welds were inspected by Magnetic Test (MT) before the penstock was put back in service (Ref. 2). Note that MT of the repair welds could only reveal surface and subsurface defects. Volumetric defects are always detectable by Radiography (RT), however they are more expensive and require more organisation. Adoption of RT for all weld repairs may have added better assurance in the integrity to the repaired welds.

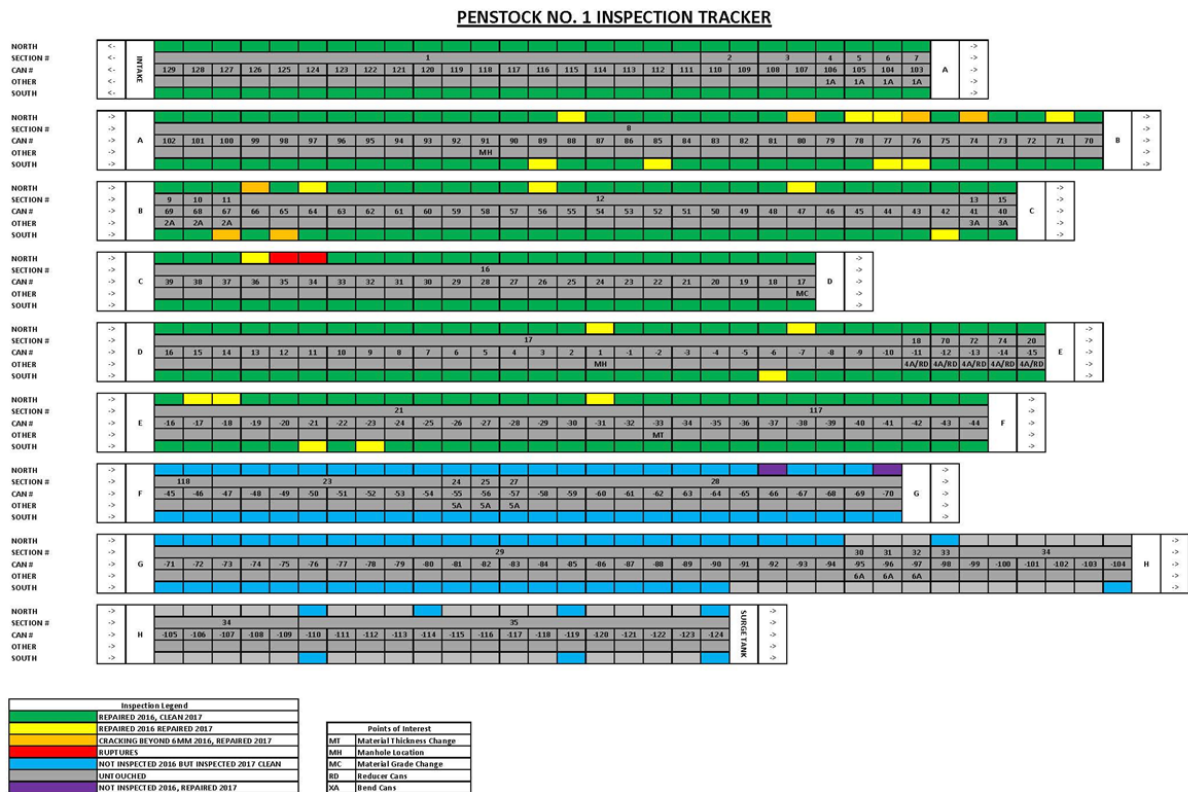
Figure 3-3: Penstock 1- Inspection Tracker (Ref. 2)

(Cans have since been renumbered, so Can 129 and -124 are now Cans 1 and 253 respectively)

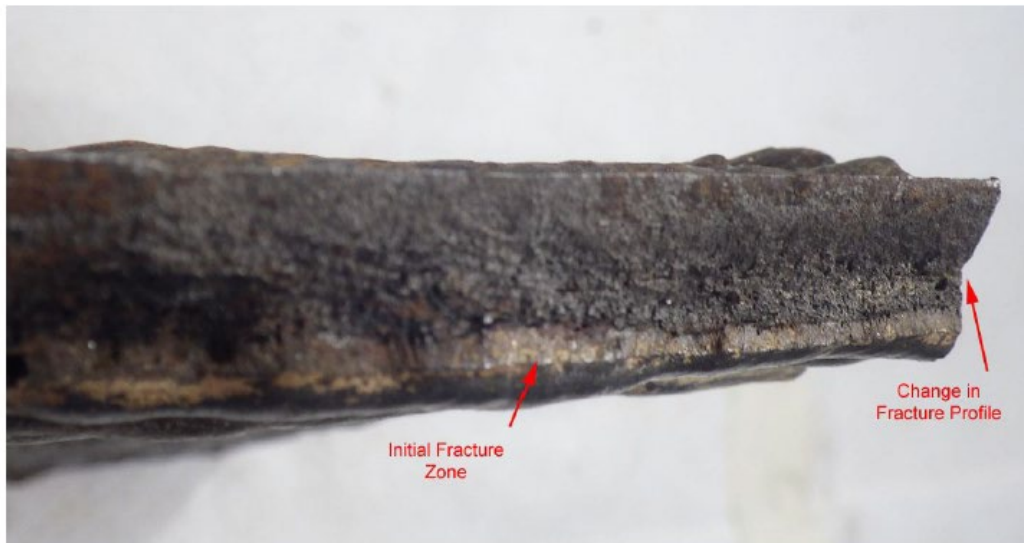
Figure 3-7: Crack propagation modes for 2017 Penstock 1 Failure (Ref. 3)

This failure is somewhat like typical fatigue failure. Initial fracture zone was smooth, followed by coarser fracture zones towards the end.

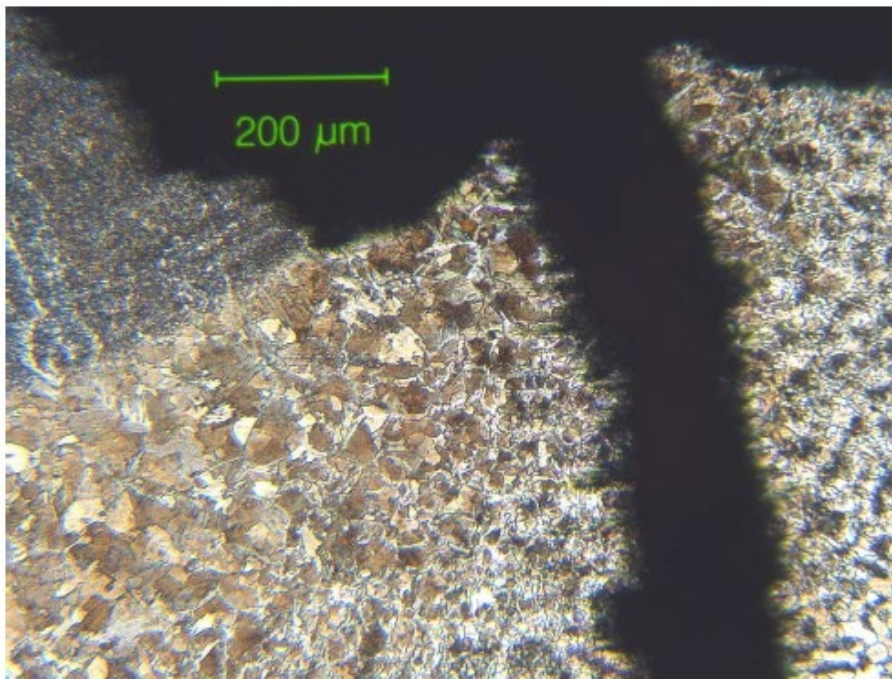
Figure 4-1: Photomicrograph of small crack outside of the weld region (RCP Report, see Appendix B)

- RPC Report stated: “The photomicrograph of the smaller crack just outside the weld region in the heat affected zone (HAZ) crack appears to have a wide mouth, which is usually seen with corrosion fatigue” (see FIGURE 4-1).
- The complementary RPC Report on water corrosive testing reported a Langelier Index of -4.06 which is an indicator that the water is acidic and corrosive which aggravates general corrosion on prolonged exposure such as experienced by Bay d'Espoir penstocks.

Photomicrograph of the smaller crack just outside the weld region in the heat-affected zone (HAZ). Crack appears to have a wide mouth, which is usually seen with corrosion fatigue. The weld metal and coarse grain HAZ are to the left side of the crack. (Original image is taken at 100X magnification.)

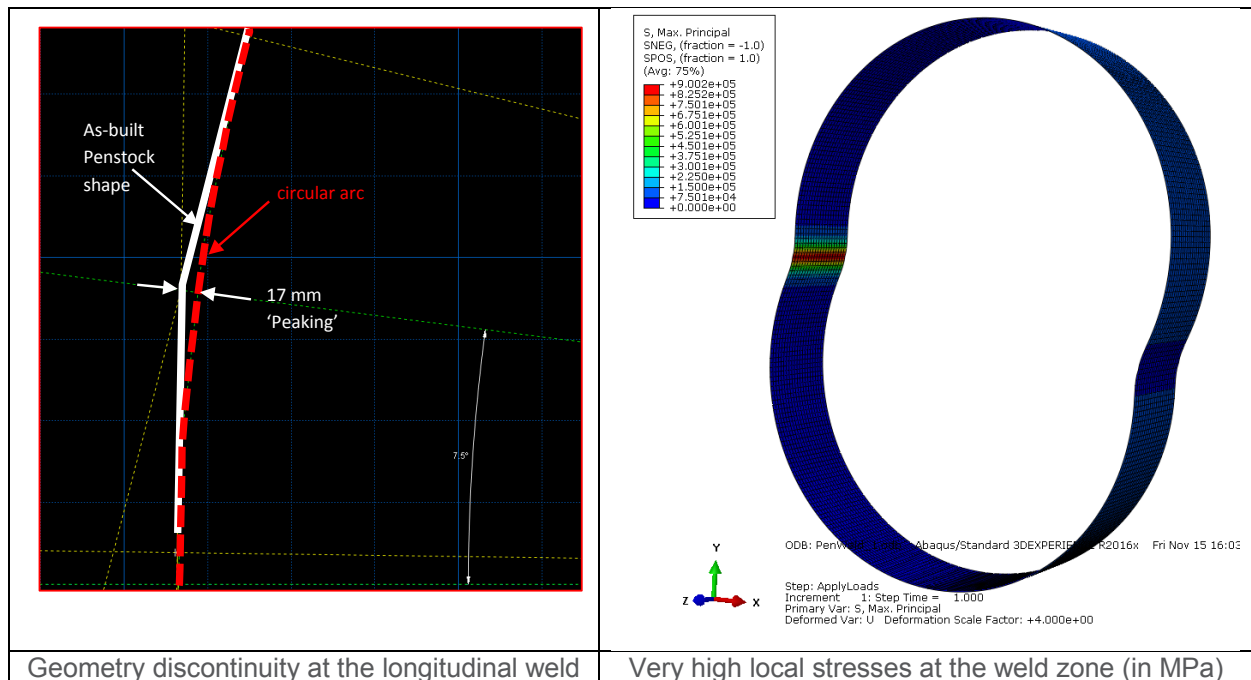
Figure 5-5: High local stresses induced by geometrical discontinuity e.g. peaking

(Note that in figure 5-5, the figure shows the penstock peaking in. In reality, It is not the case, we get this impression because the figure includes displacements and the displacements have been magnified by a factor of 100. At the peaking out location the displacement is inward and near but less than 17mm while else where the displacement is outward and small. It is the inclusion of the magnified displacements in the image that creates the distortion.)

It is our opinion that these high peak stresses are of concern for the performance of the Bay d'Espoir Penstock No. 1. This situation can lead to crack initiation in the base material or in the weld zone. Once small cracks are initiated, the fatigue cause by small cycling stresses during normal operation can propagate the crack and lead to the ruptures that have occurred in Penstock No. 1.

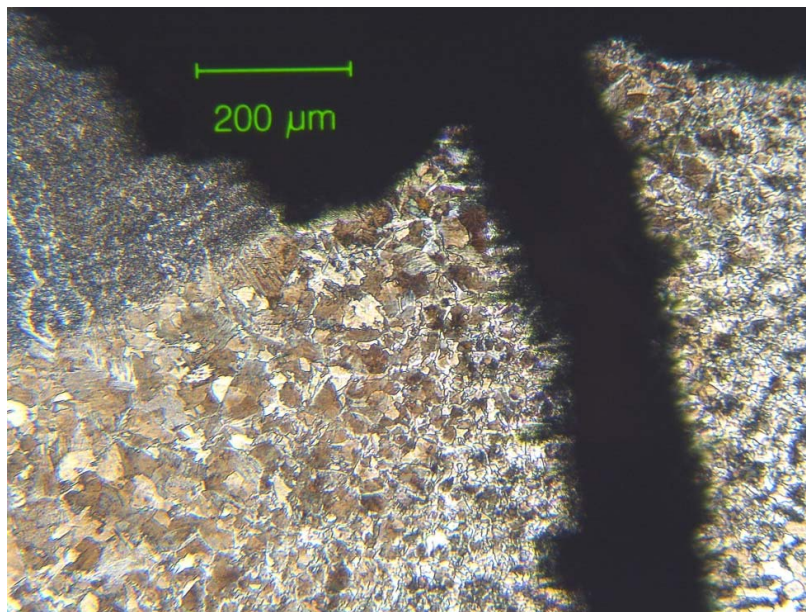
Figure 3 Photomicrograph of the smaller crack just outside the weld region in the heat-affected zone (HAZ). Crack appears to have a wide mouth, which is usually seen with corrosion fatigue. The weld metal and coarse grain HAZ are to the left side of the crack. (Original image is taken at 100X magnification.)

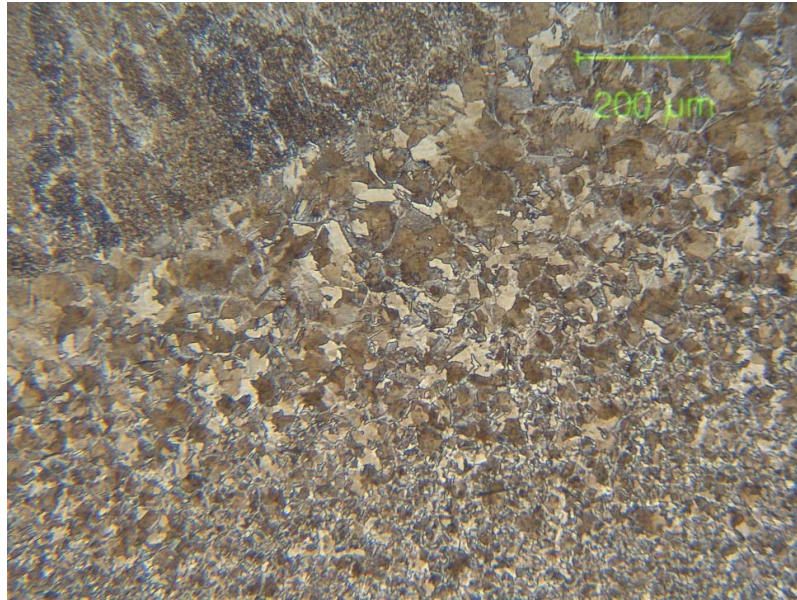
Figure 4 Photomicrograph of the heat-affected zone (HAZ) near the small crack (not shown). Note the weld metal (upper left corner), coarse grain region of the HAZ and the transformation to the small grain refinement region of the HAZ (lower right corner). (Original image is taken at 100X magnification.)

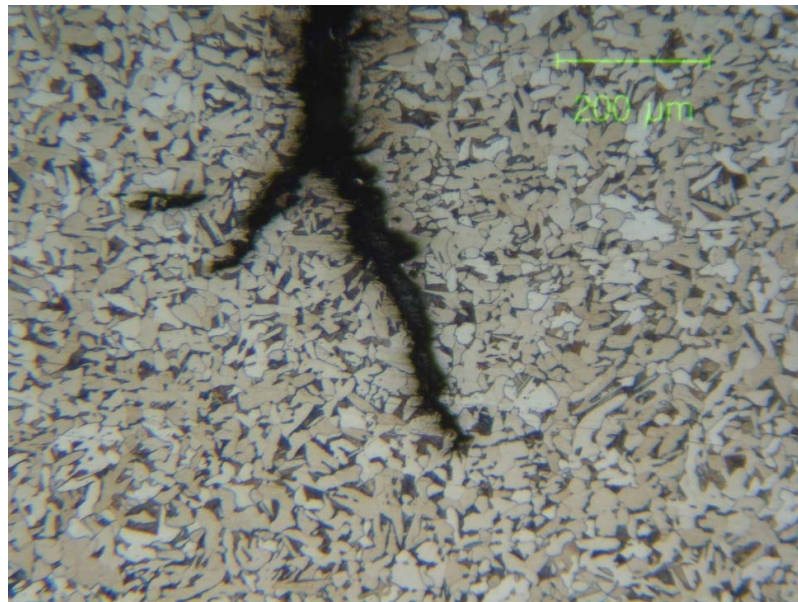
Figure 5 Photomicrograph of the tip of the smaller crack in base metal. Base metal has a typical ferrite and pearlite microstructure for carbon steels. (Original image is taken at 100X magnification.)

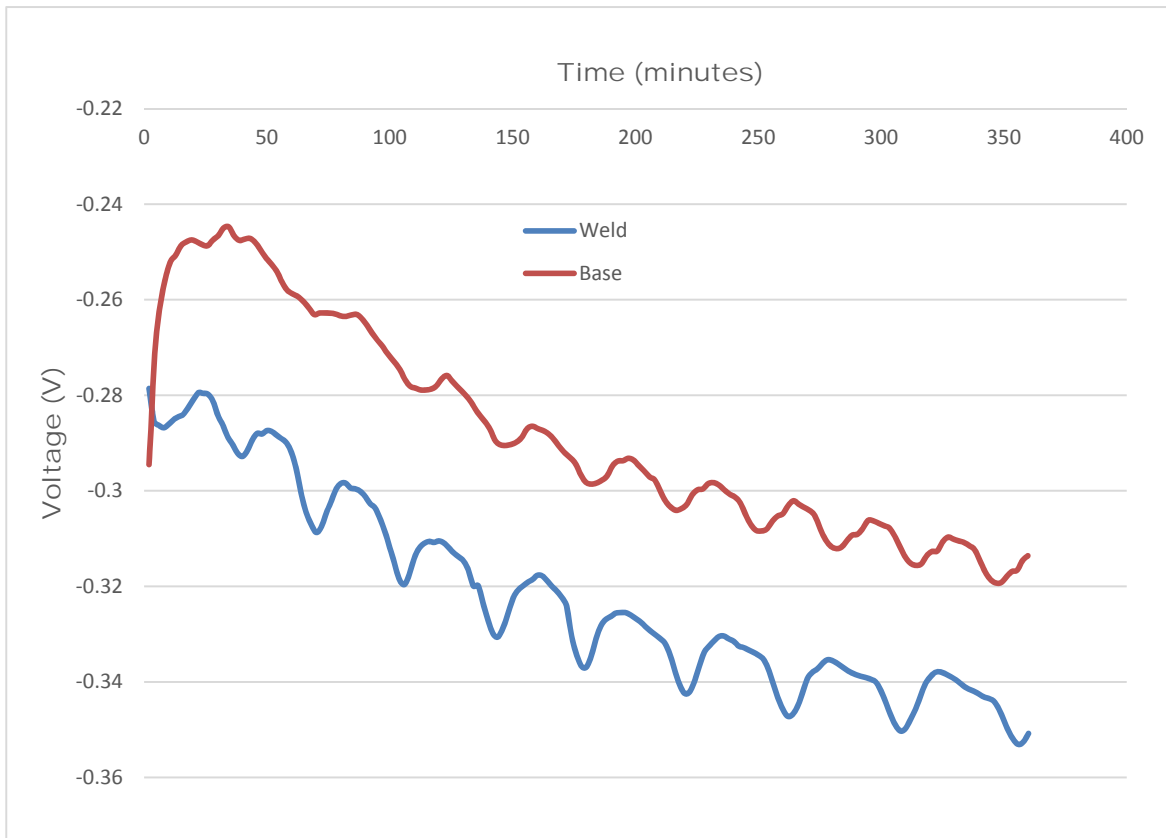
The samples were immersed in the electrolyte for a six-hour duration recording potential throughout the extent of testing. Figure 2 illustrates the samples condition at the conclusion to testing. Voltage readings were taken at two-minute intervals throughout the duration of testing, a comparative graph illustrates the potential generated during testing. The potential of both the weld metal and base metal were similar in the corrosive potential generated in the galvanic cell, with the weld metal being slightly more active.

Figure 3 Samples at Conclusion of Testing. Greater Potential (larger negative value) Implies Greater Corrosion Potential.
