Re: Transmission System and Terminal Station Asset Management Execution Report

A report to the Board of Commissioners of Public Utilities

Terminal Station Asset Management Overview

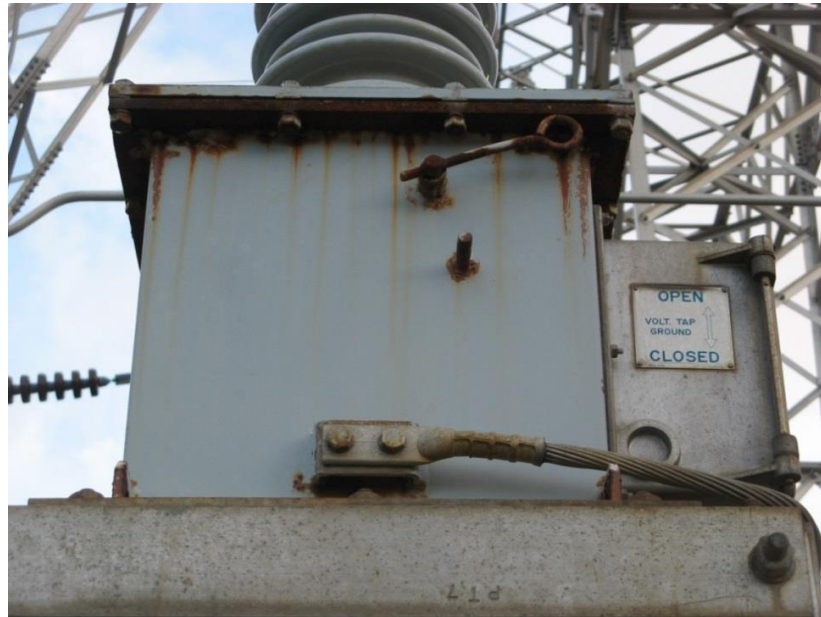
Figure 2: Rusting PT

4 Physical deterioration involves conditions such as oil leaks, rusting, or small chips and cracks in the
5 insulation. Figure 2 shows an example of rusting on a PT tank.

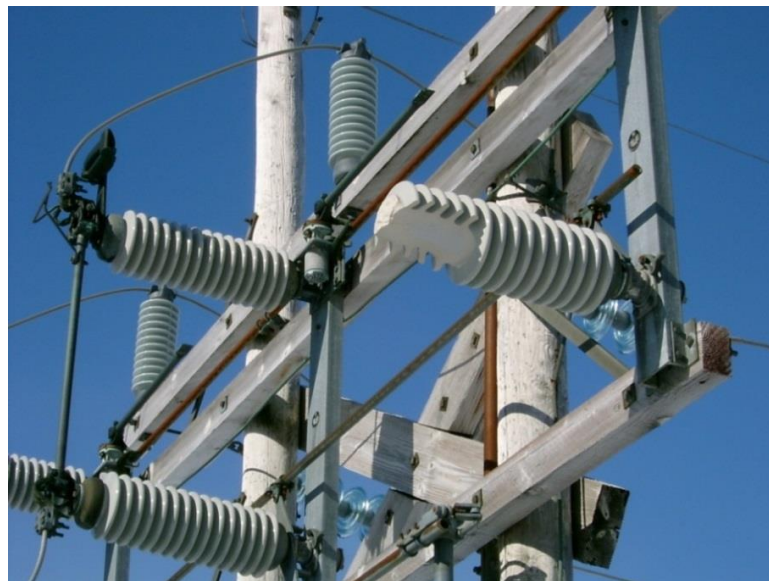
9 Figure 4 shows an example of a badly damaged disconnect switch.

Figure 4: Broken Insulator on 69 kV Disconnect Switch

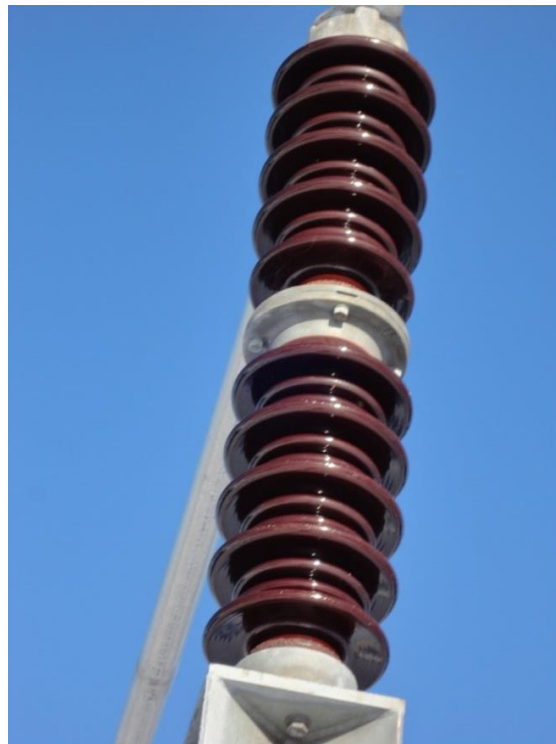
Figure 6: Multi-Cone Type Insulator Prone to Failure due to Cement Growth

1 For insulators using porcelain, cement is used in mating the porcelain and metal hardware. Some older
2 insulators have been damaged by a phenomenon known as cement growth. This is a common problem
3 in the utility industry. In such situations, water is absorbed into the concrete during freeze/thaw cycles,
4 causing swelling of the cement placing stress upon the porcelain. Over time, the increasing pressure
5 caused by cement growth will crack or break the porcelain resulting in insulator failure. In such
6 situations, porcelain may fall presenting a safety hazard to crews or damaging equipment below. Faults
7 resulting in outages to customers also often occur, when insulator failure leads to flash over. Some time
8 ago, insulator manufacturers identified and researched cement growth problems and have improved
9 their cement quality to eliminate this problem.

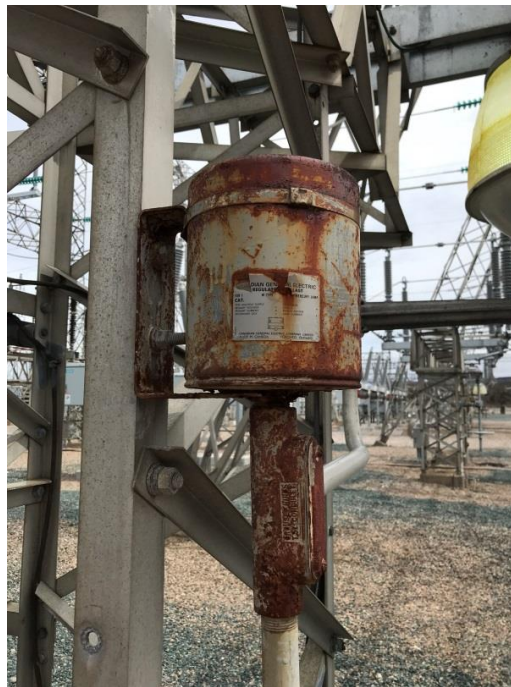
Figure 12: Corroded Ballast Requiring Replacement

- 5 Under this program, Hydro will replace deteriorated lighting systems as they become unable to provide
- 6 adequate illumination of the terminal station and have become obsolete or beyond repair. Hydro will
- 7 replace legacy lighting systems with modern, efficient lighting technologies whenever possible.

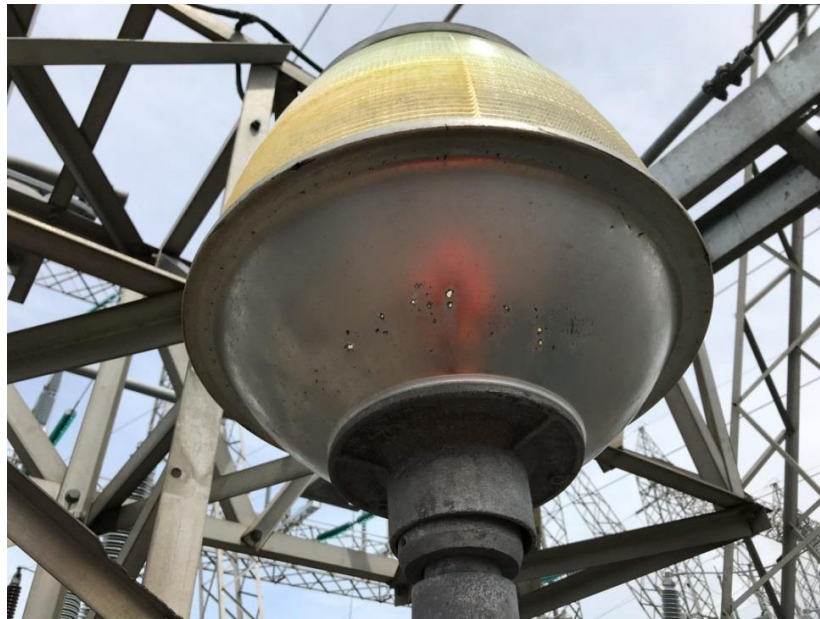
Figure 13: Light Fixture Showing Perforations due to Corrosion, Enabling Moisture Ingress

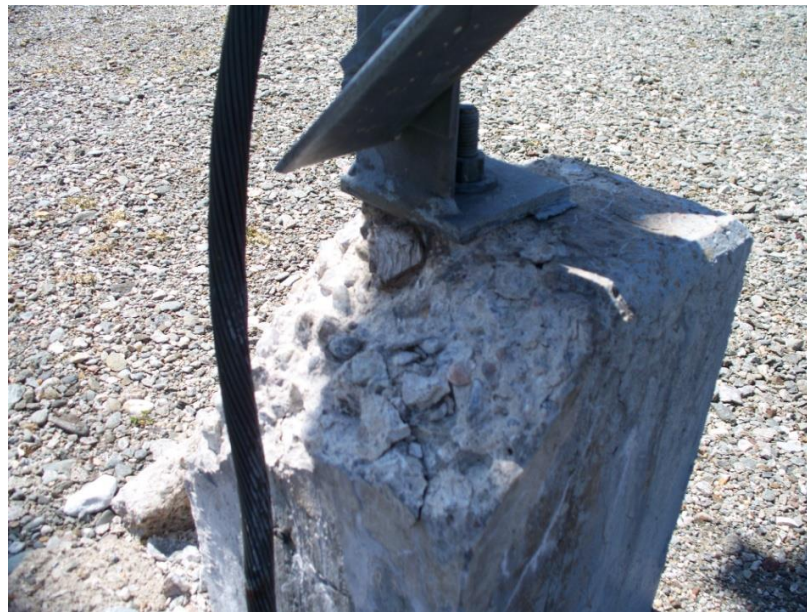
Figure 14: Structure B1T1 Bottom Brook Terminal Station

6 The service life of galvanized steel structures varies depending on the operating environment but can
7 exceed 100 years, outliving the foundations on which they are built. A number of the foundations in
8 Hydro terminal stations have deteriorated significantly due to repeated exposure to damaging
9 freeze/thaw cycles, weathering, and age, leading to concerns over their integrity. Examples of degraded
10 structure foundations are shown in Figure 14 and Figure 15.

1 To ensure foundations perform as per the original design intent, severely deteriorated concrete
2 foundations must be refurbished or replaced. Failure to complete repairs could result in a catastrophic
3 failure, causing outages or personal injury. Hydro has carried out engineering inspections of all 230 kV
4 stations and identified foundations requiring repairs. Additionally, Hydro performs visual inspections of
5 foundations every 120 days during regular terminal station inspections. Foundations identified for repair
6 are addressed under this program.

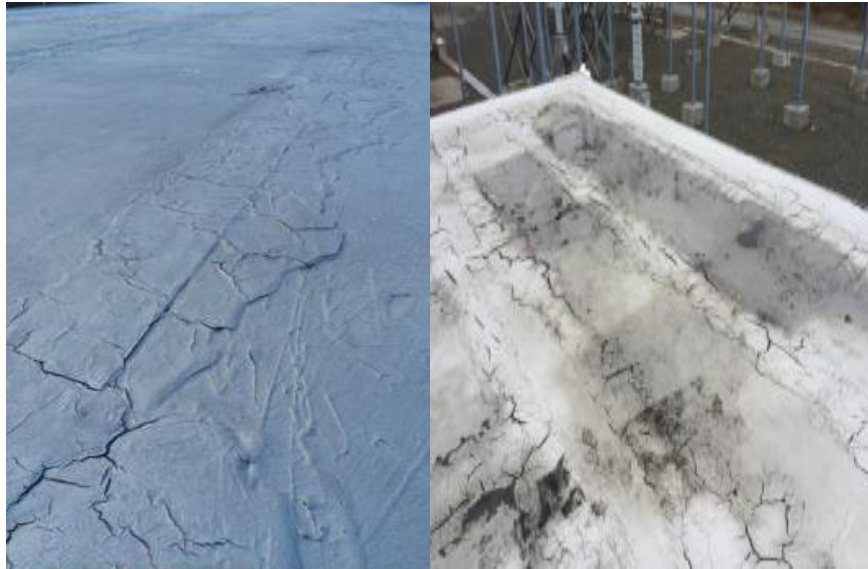
Figure 16: Terminal Station Control Buildings (Come by Chance and Sunnyside) Showing Cracking and Deterioration of the Roof Membrane System

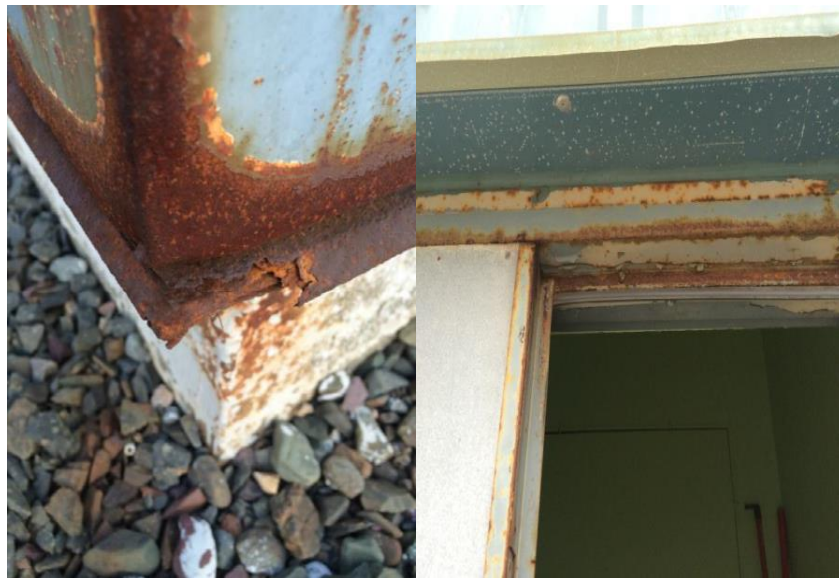
Figure 17: Building Exterior Cladding and Exterior Doorways Displaying Severe Rusting and Deterioration
