NEWFOUNDLAND AND LABRADOR  
**BOARD OF COMMISSIONERS OF PUBLIC UTILITIES**  
120 Torbay Road, P.O. Box 21040, St. John's, Newfoundland and Labrador, Canada, A1A 5B2

2015-07-06

**Newfoundland and Labrador Hydro**

**The Liberty Consulting Group**

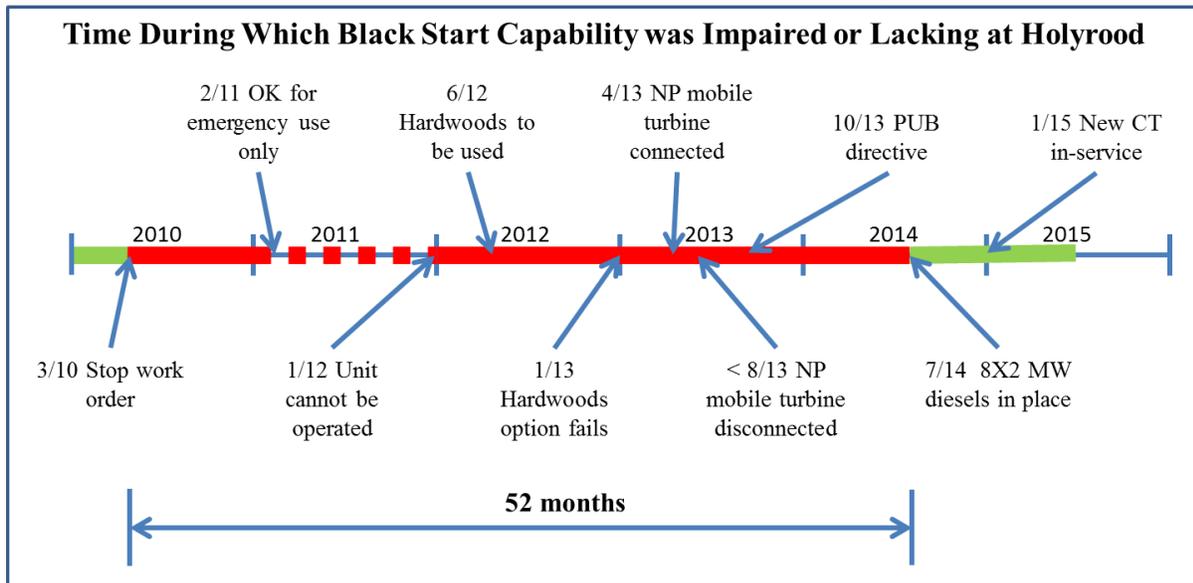
**Illustration 10.1: Black Start Chronology**

The next illustration shows the periods during which Holyrood lacked or had only impaired black start capability prior to completing installation of the eight diesel generators. The illustration shows how long it took Hydro to succeed in providing black start capability that could work.

Hydro has stated that it believes that the winter of 2010-2011 comprises the only time when it lacked black start capability at Holyrood. Hydro has also stated that:

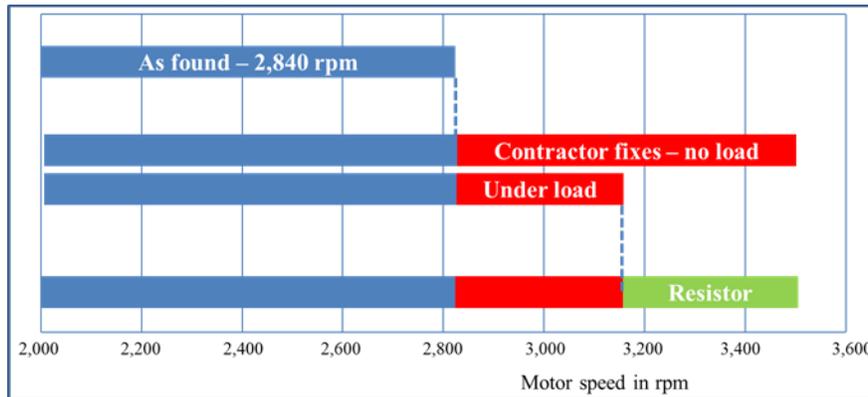
**Diagram 11.1: Evolution of Motor Repairs**

In an effort to determine the cause of the motor’s inadequacy, Hydro sent it to a contractor for testing. The contractor also could not attain a speed of more than about 2,800 rpm. Further testing found that: (a) the motor’s brush boxes were offset, and (b) the motor’s neutral plane was misaligned. The accompanying insert explains how such flaws affected the motor. After the contractor corrected both items, the motor was able to reach its rated speed of 3,500 rpm under no load conditions. After its return to the Plant, Hydro connected the motor to the pump, but it again was unable to come to speed, reaching only about 3,100 rpm. Subsequent adjustment of a resistor setting allowed the motor successfully to reach rated speed under load. The next diagram illustrates this evolution.

The root cause analysis addressed the source of these problems, which appear about equally responsible for the motor’s failure to perform. The root cause analysis attributed the misalignments to quality issues at a maintenance vendor, indicating that the resistor setting “was moved.” Hydro has stated that the maintenance vendor operated under a standard that required speed testing of the motor before its return. Hydro also states that the vendor did perform the required testing. However, neither Hydro nor the vendor provided documentation sufficient to verify the conduct of speed testing. Hydro recently submitted a copy of the vendor’s invoice, which under the description of the work, included the following notation:<sup>71</sup>

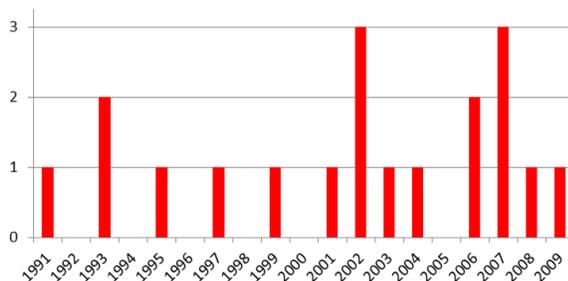
**Chart 13.1: Reported Fires at Isolated System Plants**

In 2011, Hydro commissioned a study by an external consultant to revisit its approach of not providing fire suppression for such systems.<sup>92</sup> That study produced a risk matrix and plan for a long term effort to phase in fire suppression systems at the isolated plants. The study noted, as the next chart illustrates, a significant number of fires (19) at isolated systems since 1991.

Moreover, the study cited the possibility of others that may have gone unreported.<sup>93</sup> A rate of roughly one fire per year, with some producing catastrophic damage, would suggest that revisiting the fire suppression study was overdue. Hydro’s root cause analysis of a 2008 event appears to have triggered the outside study. It is not clear why it came three years later. Liberty believes that it would have been appropriate for Hydro to have addressed the frequent rate of fires earlier. Its isolated systems had experienced 10 fires in the six-year period (2002-07) preceding the 2008 event that led to the 2011 study.
