# Bay d'Espoir Penstock 1 Life Extension Project Update

Period Ended August 31, 2025

A report to the Board of Commissioners of Public Utilities

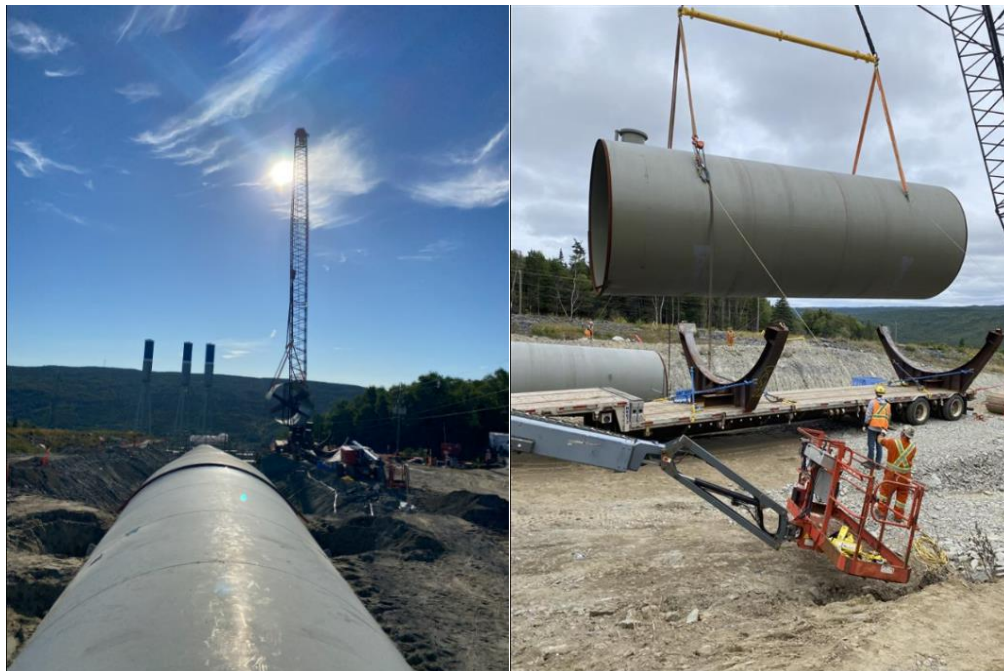
**Figure 1: Placement of Can 21 and 22**

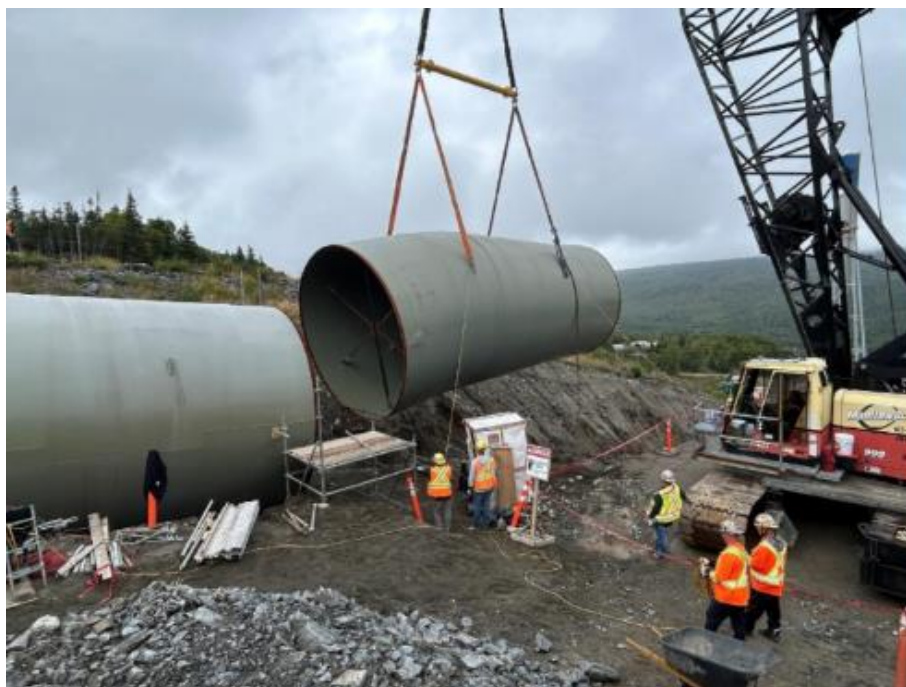
**Figure 2: Placement of Can 25**

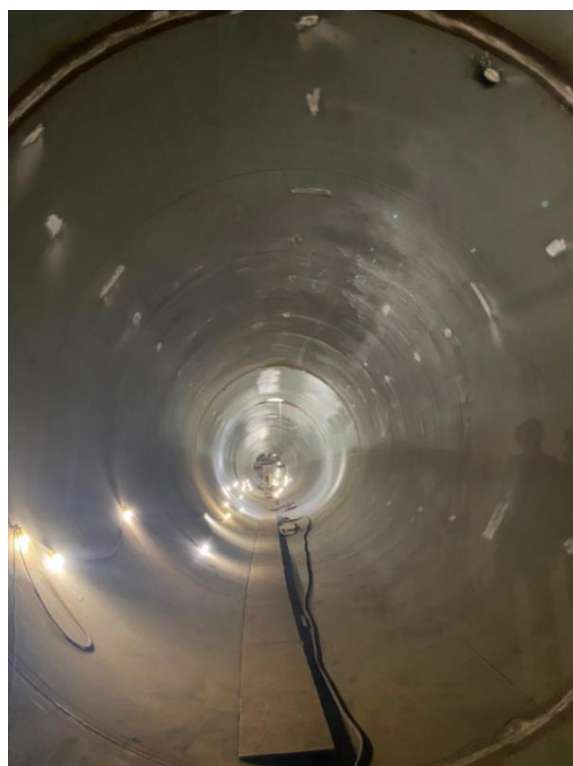
**Figure 3: Internal Bracing Removed in New Cans**

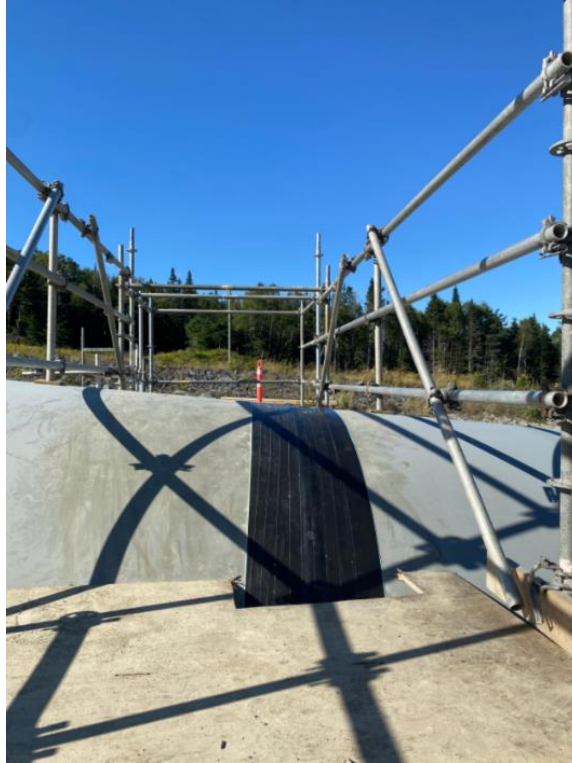
**Figure 4: Exterior Coating Wrap on Cans 18–19**

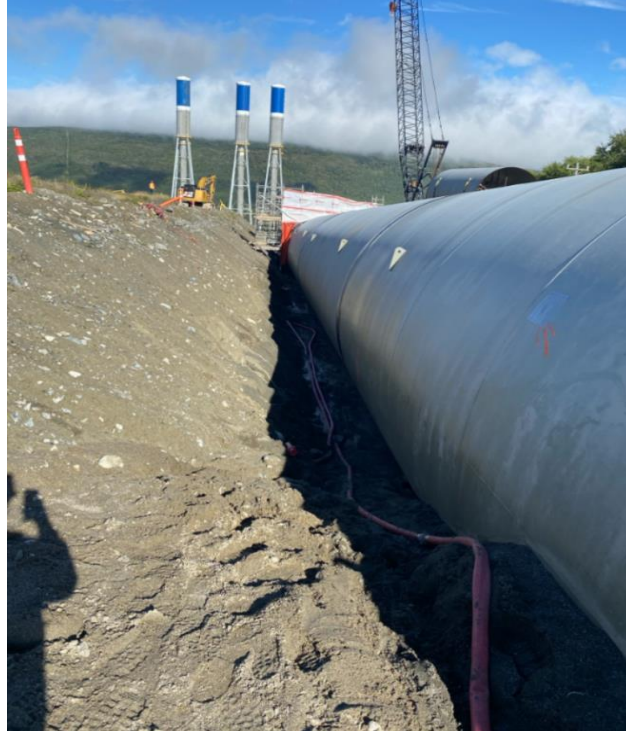
**Figure 5: Placement of Bedding Sand to Springline  
Near Cans 18–21**

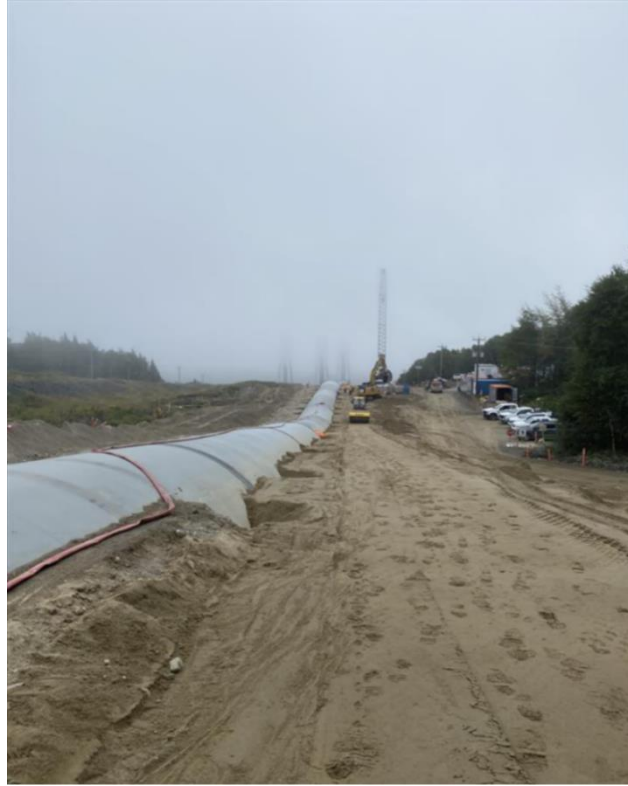
**Figure 6: Placing Common Backfill on the South Side of Penstock**
