AND IN THE MATTER OF an Application by Newfoundland and Labrador Hydro pursuant to Subsection 41(3) of the *Act*, for the approval of the purchase of replacement equipment resulting from the Sunnyside T1 Transformer Failure.

Replacement of Equipment Resulting From Sunnyside T1 Transformer Failure

Newfoundland and Labrador Hydro

June 2014

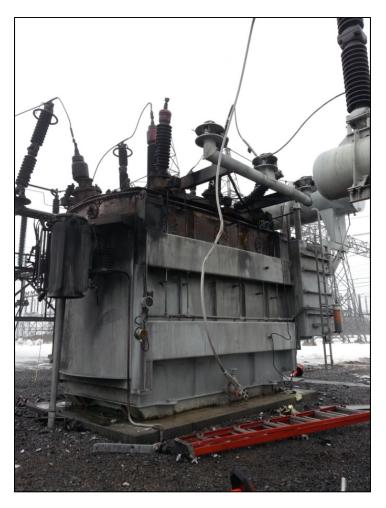
- 10 Power transformers are a critical component of the power system. At generating stations
- transformers are referred to as step up transformers. These transformers step up the
- 12 voltage for power transmission from the generation source voltage to the line voltage. A
- 13 higher transmission voltage yields a lower transmission current and lower transmission line
- losses. At a terminal station or a substation, step down power transformers are used to
- 15 convert the voltage down to an intermediate or a distribution voltage level suitable for
- delivery to end users. Figure 2 shows a picture of the failed 75/100/125 MVA, 230/138 kV
- power transformer T1 at Sunnyside Terminal Station. As a result of the fire in the Sunnyside
- 18 T1 transformer, it has been damaged beyond repair and needs to be replaced.

Figure 2: Sunnyside T1 Transformer

- 3 An internal inspection of the Sunnyside T1 transformer has verified that this transformer
- 4 has received significant damage and cannot be returned to service. Based on the availability
- of a 75/100/125 MVA, 230/138 kV autotransformer by September of 2014, Hydro has
- 6 determined that the best option is to purchase and install a new transformer in 2014 to
- 7 replace the failed Sunnyside T1 transformer. This would return the Sunnyside Terminal
- 8 Station to a status that meets the transmission planning criteria with respect to transformer
- 9 capacity in the Stony Brook Sunnyside 138 kV loop.

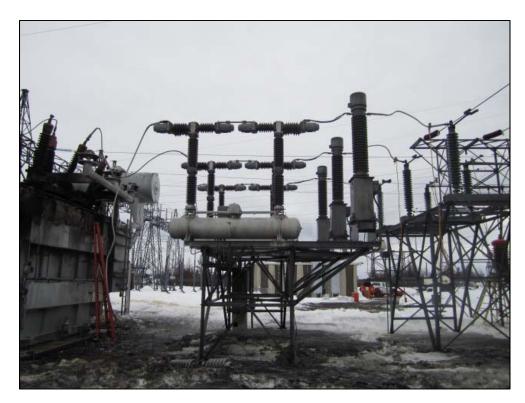
Circuit breakers are a critical component of the power system. Located in a terminal station or substation, each circuit breaker performs switching actions to complete, maintain, and interrupt current flow under normal or fault conditions. The reliable operation of all circuit breakers through their fast response and complete interruption of current flow is essential to protect the power system and to maintain the stability of the system. The existing 138 kV breaker (B2T1) for the T1 transformer was damaged as a result of its proximity to the T1 fire and is in need of replacement. Figure 3 shows a picture of B2T1 at the Sunnyside Terminal Station.

Figure 3: Sunnyside 138 kV B2T1 Breaker

- 12 This project is justified on the requirement to replace failing or deteriorated infrastructure
- in order for Hydro to provide safe, reliable electrical service. Because of the proximity of the
- 14 138 kV breaker B2T1 to the fire on Sunnyside T1 transformer, the breaker has sustained
- damage that could lead to a premature failure if it is returned to service. Breaker B2T1 has
- been in service for 43 years and is approaching its end of life. Hydro's current long term
- 17 plan for the replacement/overhaul of circuit breakers had the 138 kV breaker B2T1
- scheduled for overhaul in 2014. Due to the proximity of this breaker to the fire and to
- 19 ensure safe and reliable delivery of power to customers, it is recommended that the 138 kV
- 20 breaker B2T1 be replaced in 2014.

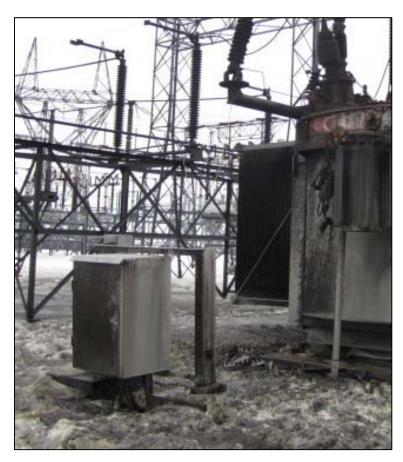
The manual transfer switch transfers the supply of electrical power from a normal electrical supply to a secondary or emergency electrical supply when the normal supply becomes unavailable. The Sunnyside Terminal Station transfer switch is connected to the tertiary windings of the T1 and T4 transformers. The existing station service transfer switch for the Sunnyside Terminal Station was damaged as a result of its proximity to the T1 fire and is in need of replacement. Figure 7 shows a picture of the station service transfer switch at the Sunnyside Terminal Station.

Figure 7: Sunnyside Station Service Transfer Switch

An alternate station service power supply is essential at the Sunnyside Terminal Station to ensure that auxiliary systems such as battery chargers and compressed air systems are operating in the event that they are called upon and to allow for routine maintenance to be performed on equipment. Due to the close proximity of the existing station service transfer switch to the T1 transformer, it has sustained damage that could lead to its failure if not replaced. In addition, the close proximity of the existing transfer switch to the T1 transformer resulted in the inability to restore station service in an expedient manner during the events on January 4, 2014. The replacement of the existing station service transfer switch will provide a reliable redundant power supply for the station and ensure the safe delivery of power to customers. Based on the recommendations of Hydro's investigation "Review of Supply Disruptions and Rotating Outages: January 2-8, 2014" it is
