**Re: Rigolet Diesel Engine Failure**  
**Allowance for Unforeseen Items Final Report**

# Rigolet Diesel Engine Failure Final Report

March 25, 2019

*A Report to the Board of Commissioners of Public Utilities*

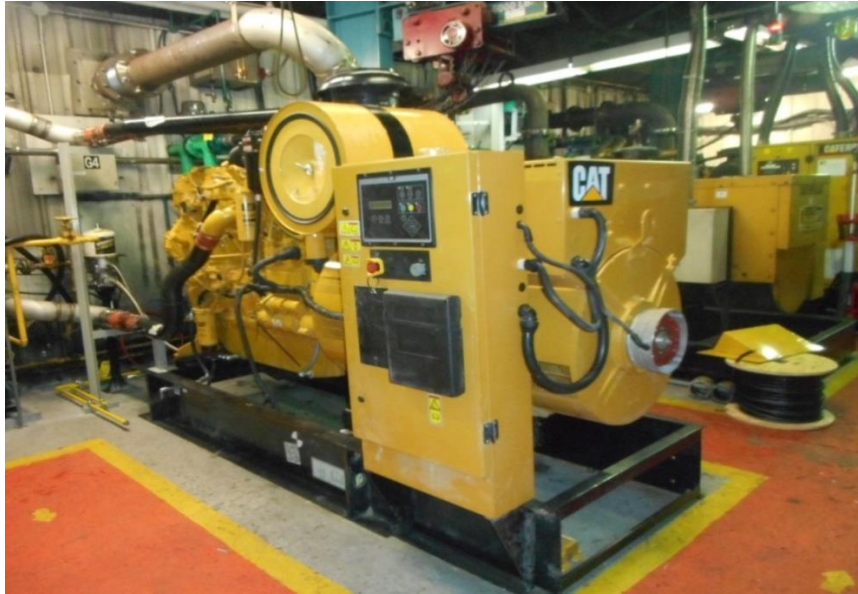
**Figure 1: Unit 2101 Installed in place of Unit 2051**

- 1        5) Movement of Unit 2101 components into the plant and reassembly of Unit 2101 to
- 2            prepare for installation;
- 3
- 4        6) Installation of Unit 2101 in the previous location of Unit 2051;
- 5
- 6        7) Connection of exhaust, coolant lines, fuel lines, electrical cabling, and controls;
- 7
- 8        8) Installation of aftercooler outside the plant for Unit 2101; and
- 9
- 10       9) Commissioning of Unit 2101 with assistance from Toromont Cat technicians.

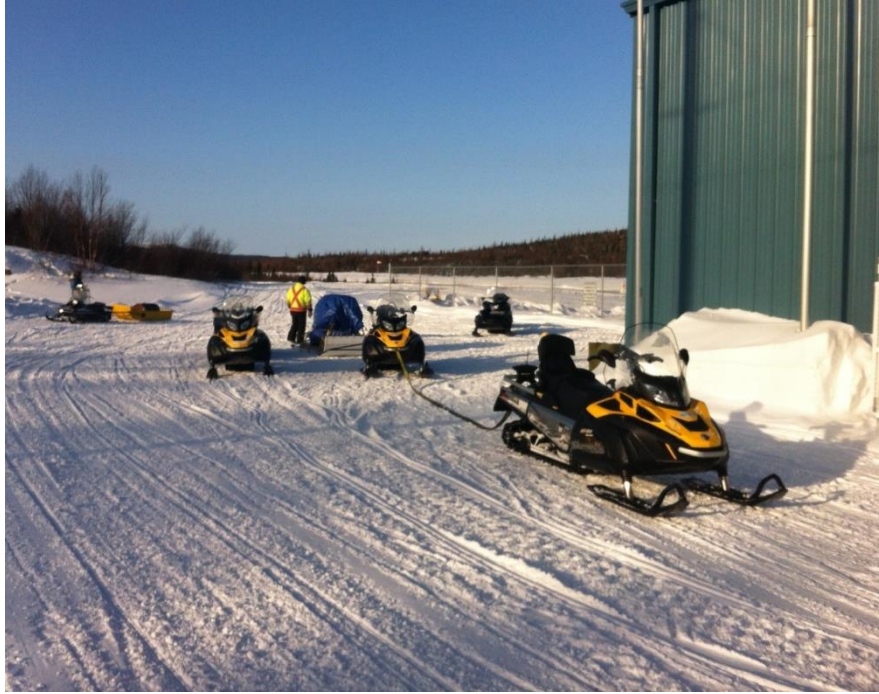
**Photo 1: New Engine on Sled Leaving Rigolet Airport Being Towed by Skidoo to the Plant**

- 17 1) Removal of the failed Unit 2051 from the plant to make room for the new unit (“Unit  
18 2101”);
- 19
- 20 2) Disassembly of Unit 2101 into four pieces (engine, generator, aftercooler, and skid) to  
21 allow transport on a Twin Otter aircraft;
- 22
- 23 3) Transportation of the components of Unit 2101 to Rigolet (four separate flights from the  
24 Goose Bay Airport to the Rigolet Airport);
- 25
- 26 4) Unloading of the components of Unit 2101 from the aircraft at the Rigolet Airport and  
27 towing to the plant by snowmobile;

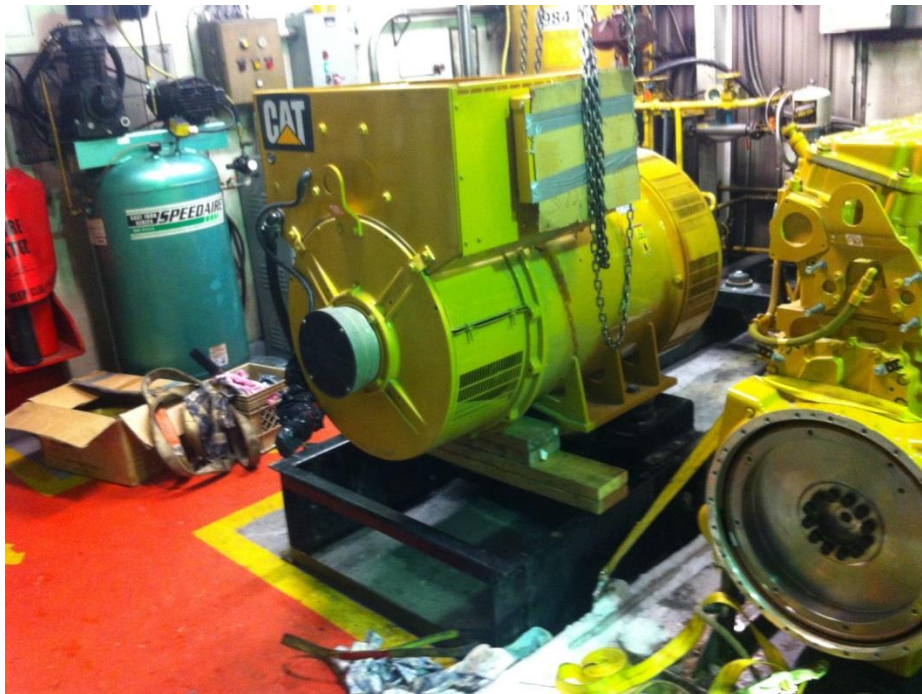
**Photo 2: The New Generator (Left) and the New Engine (Right) Inside the Rigolet Plant**

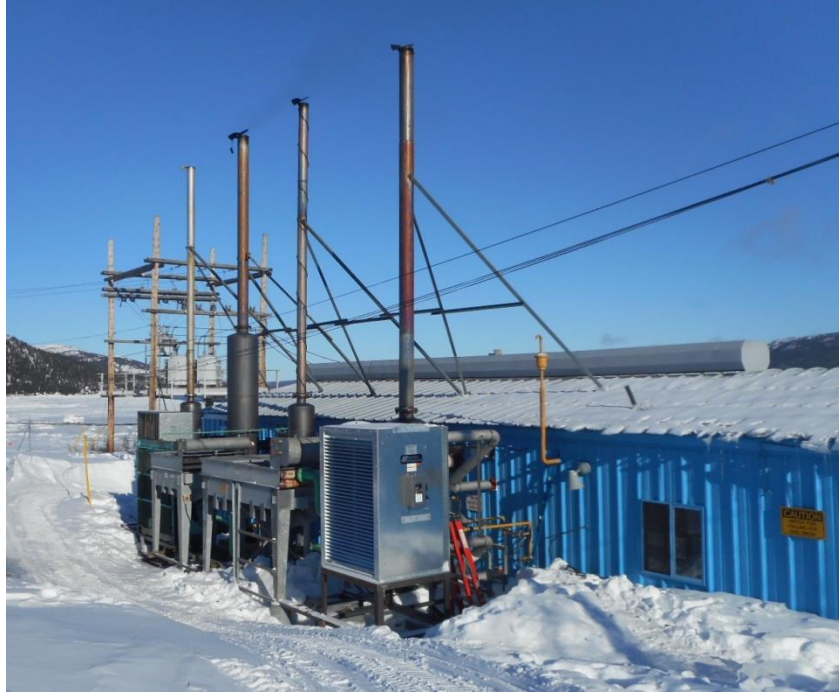
**Photo 3: New Aftercooler Installed Outside the Rigolet Plant**

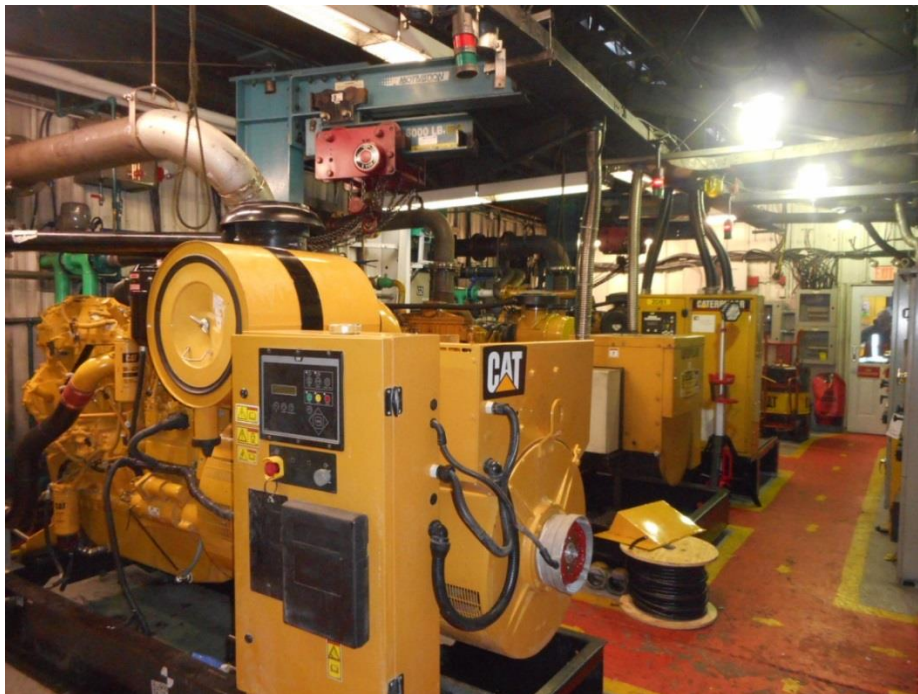
**Photo 4: Unit 2101 Installed (Nearest Unit)**
