Holyrood Thermal Generating Station (Holyrood) Condition Assessment & Life Extension Study, - Final Report

Holyrood Thermal Generating Station
Condition Assessment & Life Extension Study

January 28, 2011

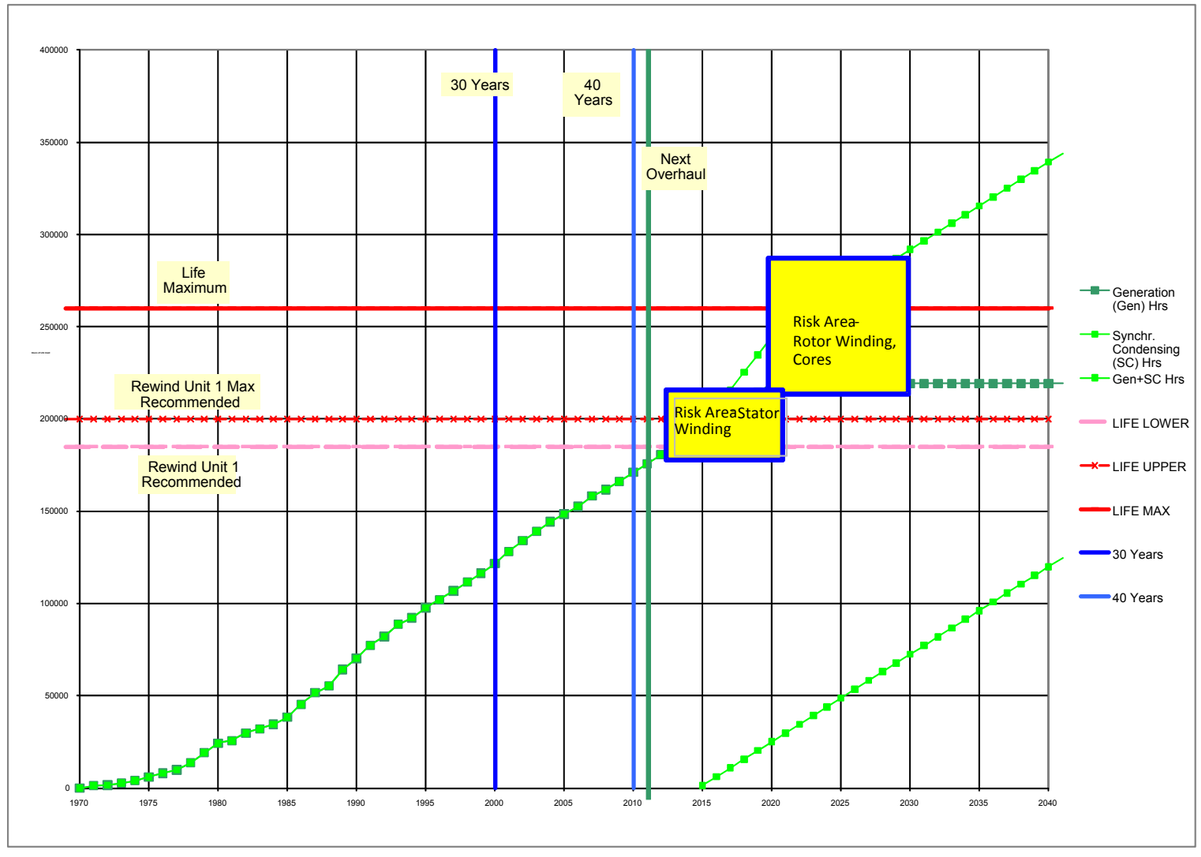
FIGURE 8-2 LIFE CYCLE CURVE – UNIT 1 GENERATOR

The generator figure below shows the operating hours as an electricity generator, in synchronous condensing mode (beginning in 2015), as well as the sum of the two. Only one set of curves is required, given that the major elements of the generator (stator and rotor windings and core) and much of the hydrogen system are the same age. The new parts of the hydrogen system are not identified due to their shorter time in-service. One vertical line illustrates the timing of the next generator overhaul in 2012. The lowest two horizontal lines represent the ranges of expected generator life for Holyrood Unit 1 based on current and historical information and expert opinion. The “Rewind Unit 1 Recommended” line is based on the recommended estimated remaining reliable stator winding life of five years at current generation levels. The two upper lines also represent an assessment of a longer 10 + year of the lower reliability, higher failure risk, remaining life of the rotor winding as well as a maximum 20 years likely for the stator and rotor cores.

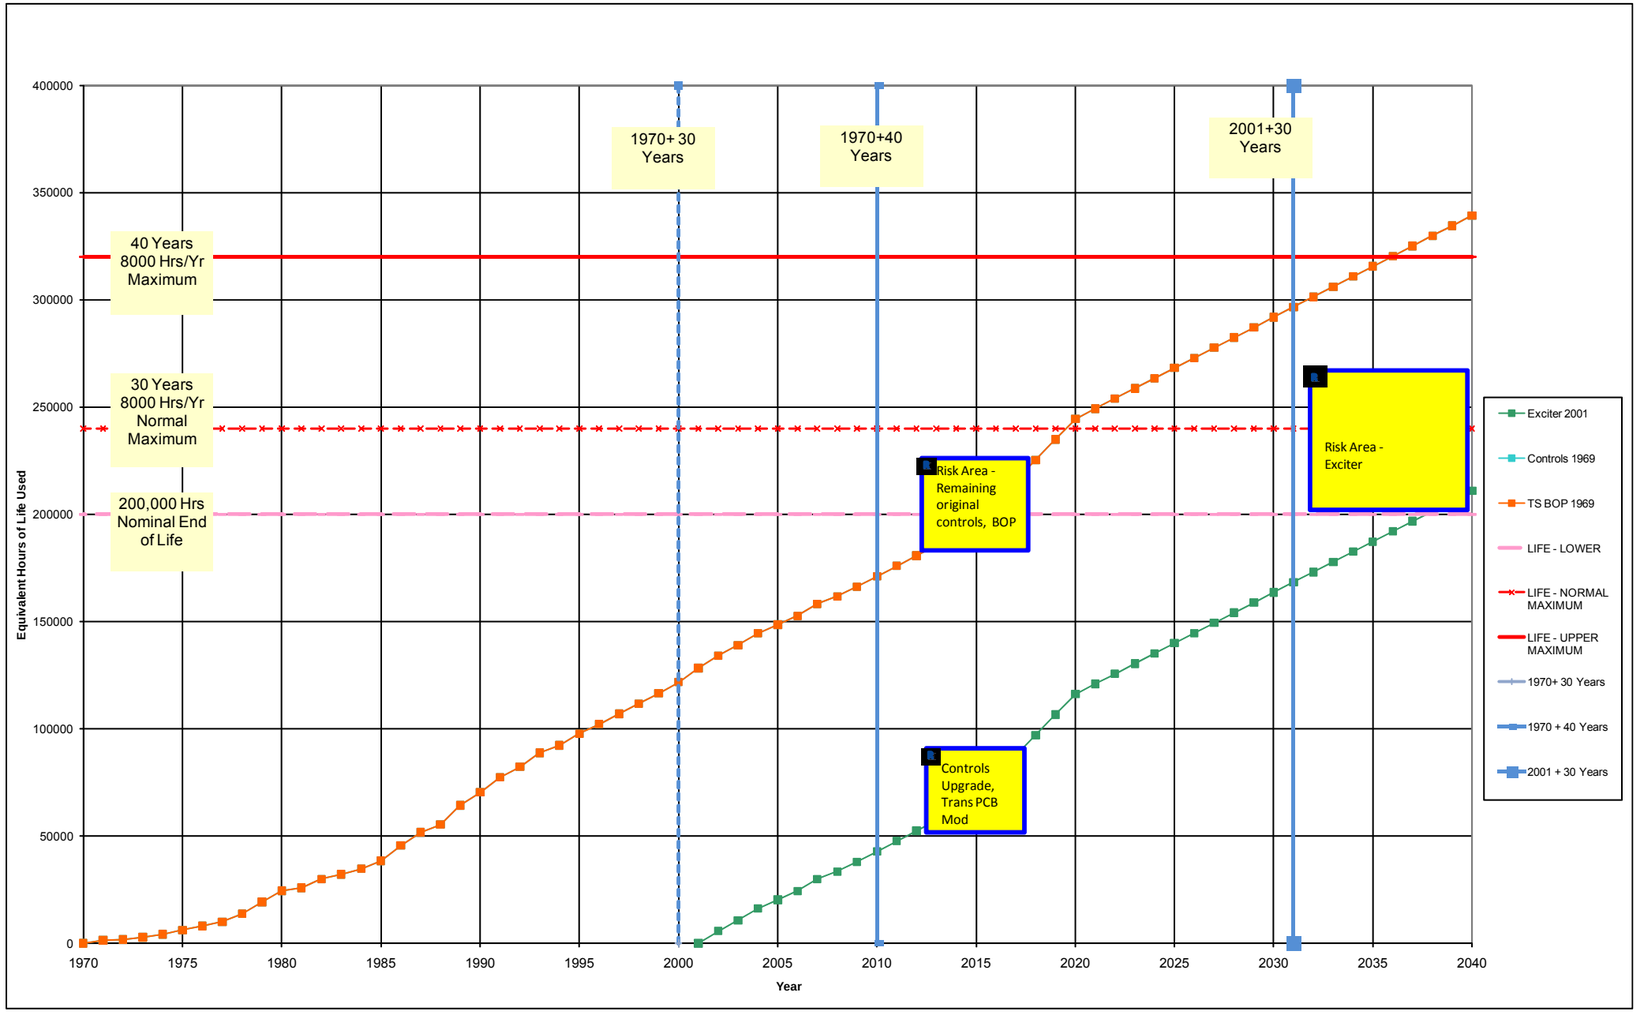
FIGURE 8-3 LIFE CYCLE CURVE – UNIT 1 GENERATOR - EXCITER

The exciter figure shows only the total operating hours as an electricity generator plus in synchronous condensing mode (beginning in 2015). It has two curves for any remaining original equipment as well as for the upgrades to the system made in 2001.

The curves indicate that the remaining life (RL) of the Unit 1 generator exceeds the desired life (DL) which is the lesser of the time to its next major planned overhaul/inspection (2012) or to the desired End of Life (EOL) date of 2041. Thus no specific dedicated Level 2 is required, but sufficient inspection and testing will be required in the 2012 overhaul to demonstrate the ability to meet the 2041 EOL date. The exciter should for the most part be able to meet an EOL of 2020, and with periodic refurbishment may meet 2041.The highlighted nearer term risk areas include the stator winding, exciter controls (upgrade only), the rectifying transformer, and some original BOP components. These systems are candidates for replacement or refurbishment – addressed in later sections. The curve also suggests that a nine year time between generator overhauls is impractical at this time in the generator's life and should be a six year cycle.

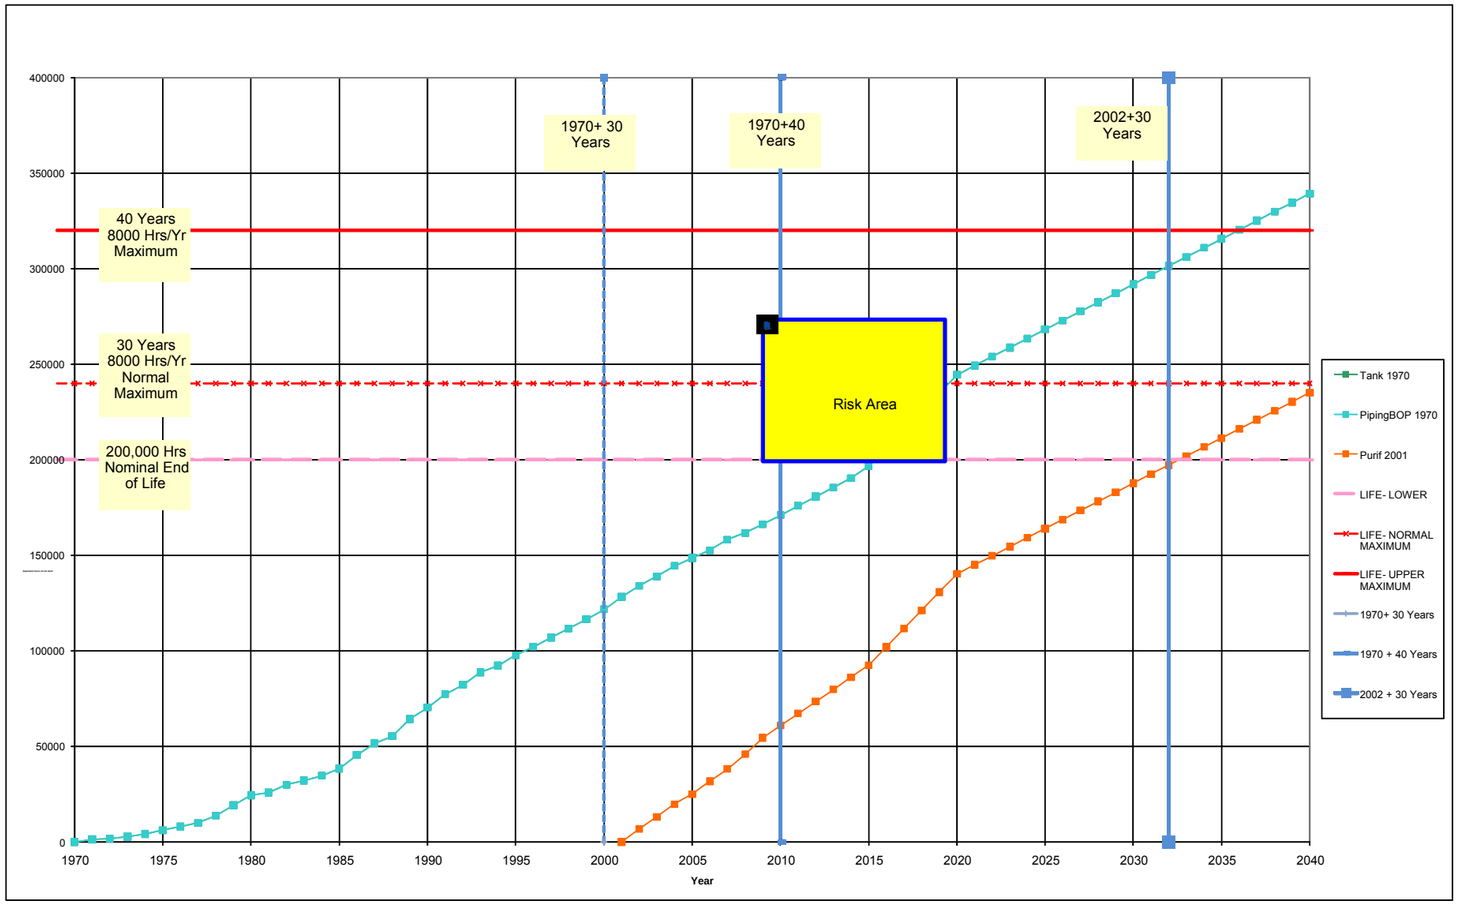
FIGURE 8-4 LIFE CYCLE CURVE – UNIT 1 GENERATOR LUBE OIL SYSTEM

Figure 8-4 below illustrates the life cycle curve for the Unit 1 generator lube oil system. Two curves are required given that the upgraded purification system entered service in 2001, while other major elements of the lube oil system are largely of the same age. There is insufficient information to develop specific accurate curves for the storage tank, and coolers. Further detailed examination during the 2012 turbine overhaul should provide the basis going forward. The life curve is a plot of current and projected operating hours (generation plus synchronous condensing model on the y-axis versus calendar year on the x-axis. Vertical lines represent bands of nominal years of normal base loaded life (typically 200,000 operating hours, thirty years and 200,000 to 240,000 operating hours, and forty years, and 280,000 to 320,000 operating hours). Horizontal lines represent the ranges of equipment life based on current and historical information and expert opinion. The risk area box provides an indication of the timing of potential issues either from an age or equivalent operating hours view.

The curves indicate that the remaining life (RL) of the Unit 1 generator lube oil system exceeds the desired life (DL) which is the lesser of the time to its next major planned overhaul/inspection (2012) or to the desired end of life (EOL) date of 2041. Thus no specific dedicated Level 2 is required of the system as a whole, but sufficient inspection and testing will be required in 2012 steam turbine generator overhaul to demonstrate the ability to meet the EOL date. The exception is the storage tank for which information was considered inadequate to form a firm conclusion and level 2 testing is recommended in 2011, albeit of a modest level and lower priority. The figure's highlighted risk areas is primarily operating hours driven and likely to shift further out in time after the 2012 turbine generator overhaul. The 2012 overhaul/inspection is a fundamental element in changing the current assessment.

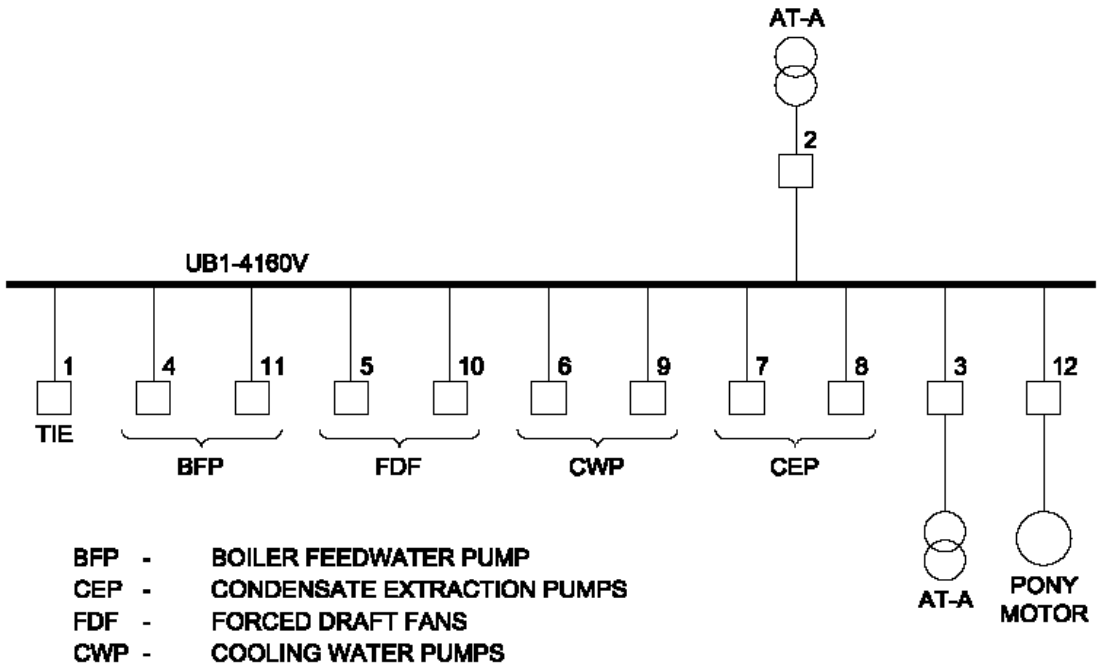
FIGURE 8-5 UNIT 1 UB1 SWITCHGEAR

Unit Board UB1 (4160V) was manufactured by ITE and installed in 1968. The 4160V switchgear, utilizes original draw-out power, air-magnetic breakers, Type 5HK, 1200A and 2000A. All protection, synch, and control relays are original CGE electro-mechanical. Schweitzer 701, Motor Protection Relaying is used on U1 Circulating Water Pumps and North and South Condensate Extraction Pumps. All other loads utilize the original P&B Golds relays.

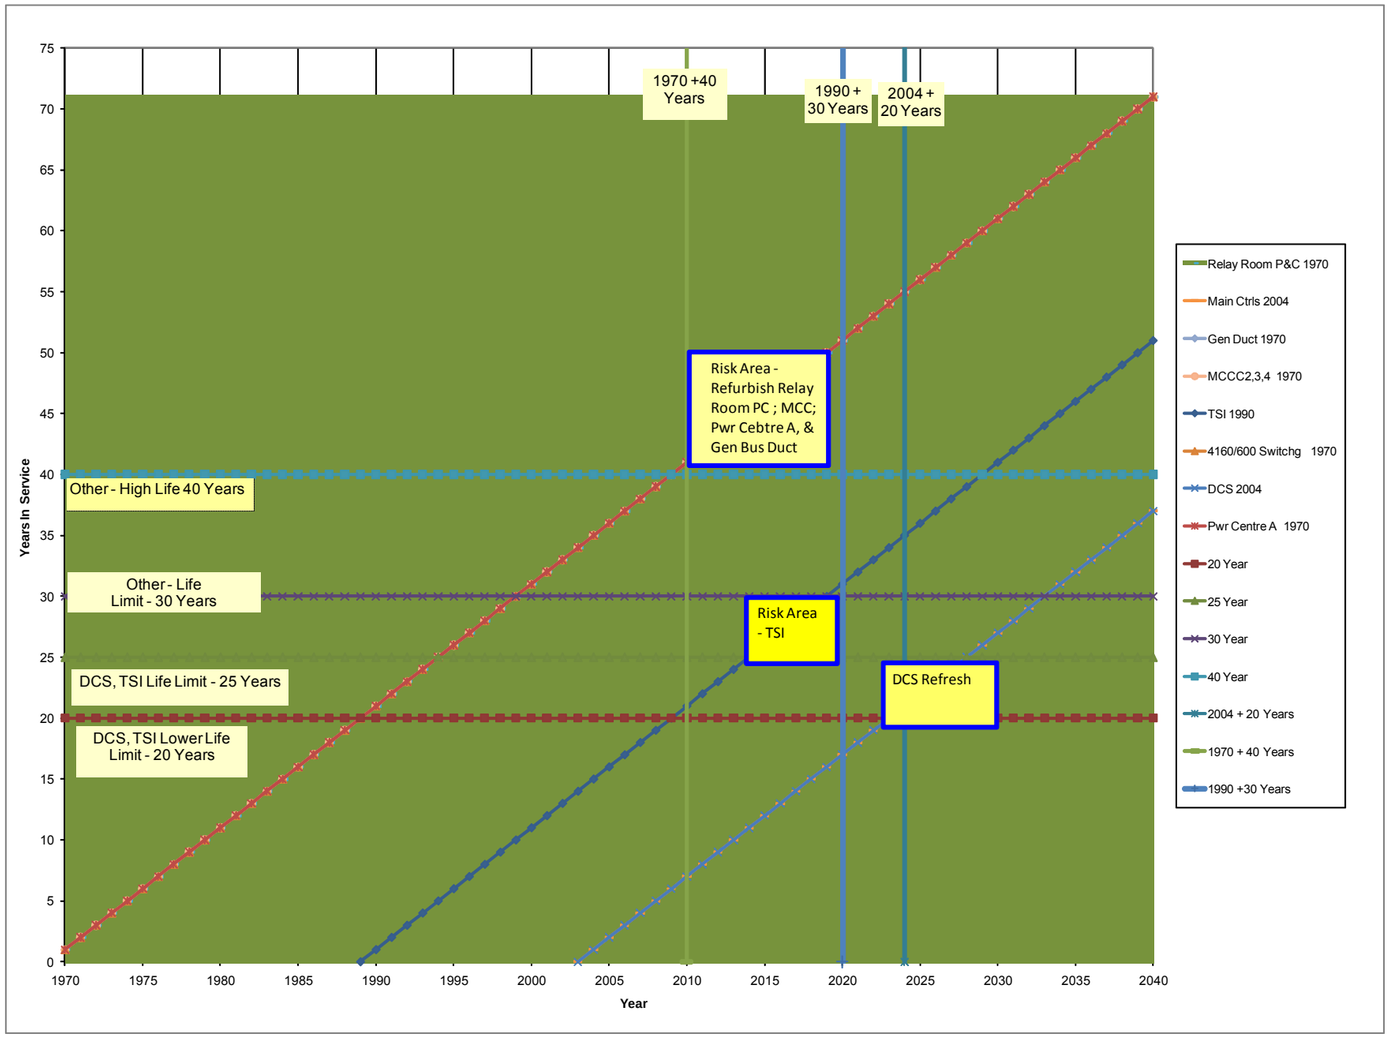
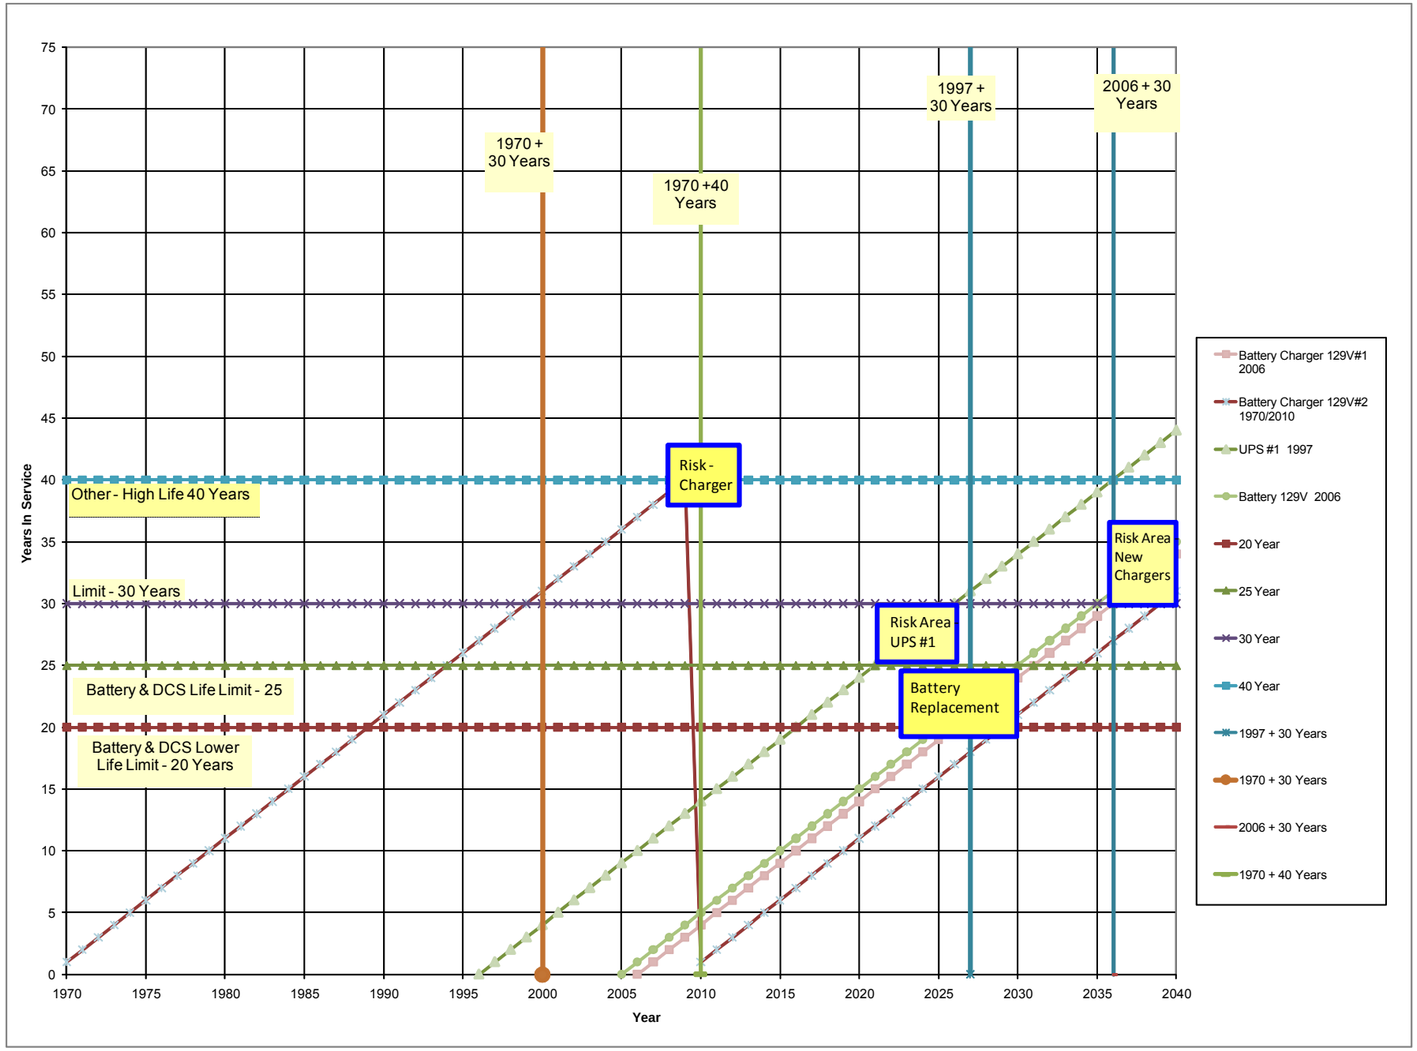
Figures 8-6 and 8-7 below, illustrate the life cycle curves for the Unit 1 electrical and control systems associated with generators. Several curves are required to represent the various elements. They have been broken into two parts – the electrical and control systems (MCC's, relays, breakers, TSI, DCS) and those primarily associated with batteries and chargers. The curves are plots of current and projected years in service on the y-axis versus calendar year on the x-axis. Age in-service due to either aging or obsolescence is more an issue than unit operating hours. Vertical lines represent bands of nominal years of in-service life for different in service dates. Horizontal lines represent the ranges of equipment life based on current and historical information and expert opinion. The risk area boxes provide an indication of the timing of potential issues either from an age or equivalent operating hours view.

The curves indicate that the remaining life (RL) of much of the equipment does not exceed the desired life (DL) for generation of 2020 and for synchronous condensing of 2041, without extensive refurbishment or replacement. This is well illustrated by the highlighted risk areas which highlights that many original MCC's and relays as well as the TSI are in need or replacement or extensive refurbishment in the very near term. The risk figures also illustrate that most of the rest of the equipment (DCS, batteries, and chargers) will require replacement or refurbishment in the 2020+ period.

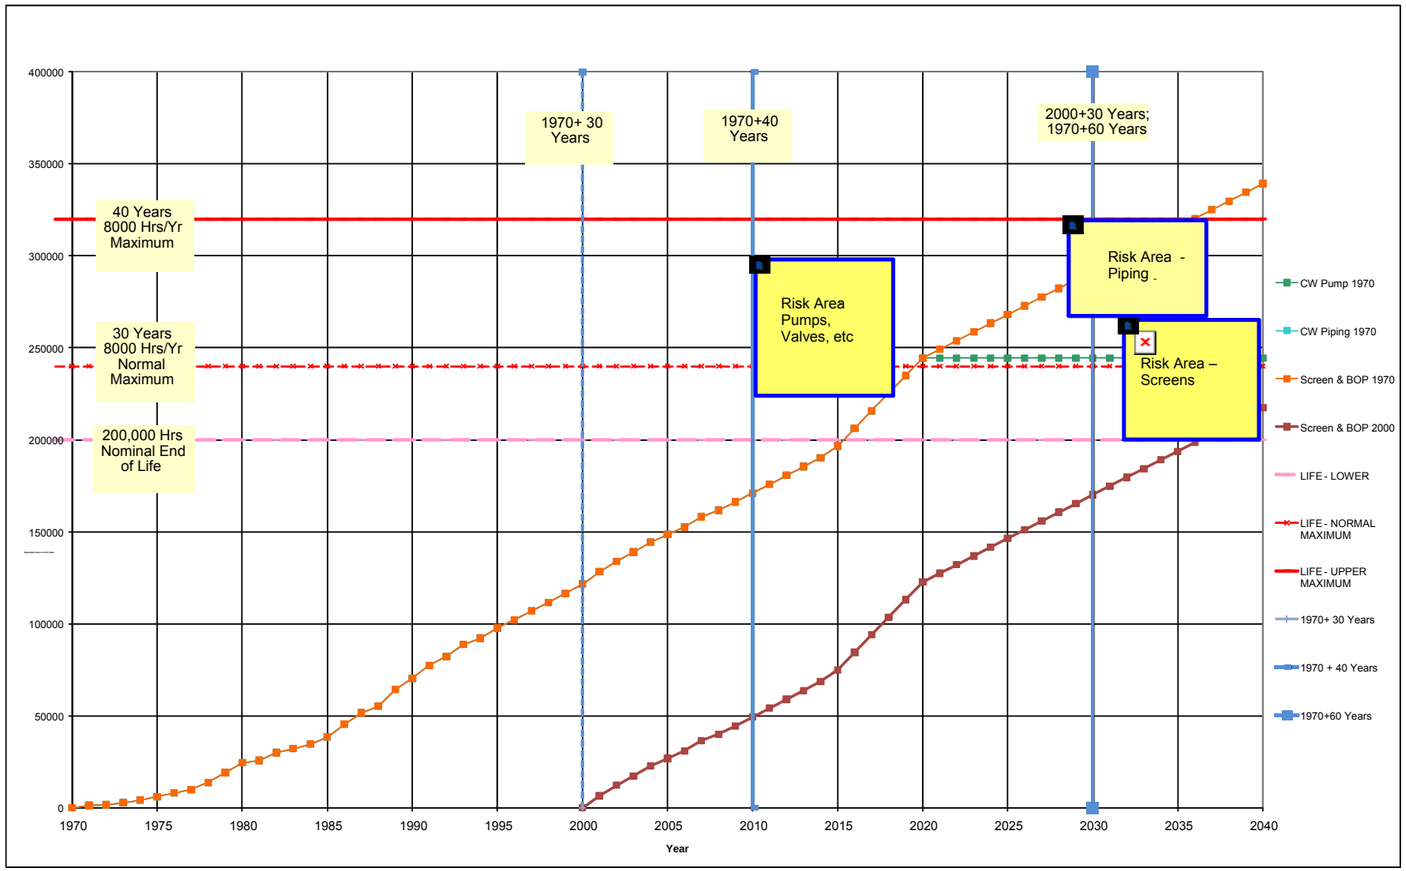
FIGURE 8-9 LIFE CYCLE CURVE – UNIT 1 COOLING WATER SYSTEMS ASSOCIATED WITH GENERATORS

Figure 8-9 below, illustrates the life cycle curves for the major elements of the Unit 1 cooling water systems associated with generators. The life curves are plots of current and projected operating hours (generation plus synchronous condensing mode) on the y-axis versus calendar year on the x-axis. The figure has vertical lines representing differing representative nominal age limits for various components. It has horizontal lines that represent a range of practical equivalent base loaded operating hour life limits. Data specific to the intake and outfall structures were not sufficient to include them at this time, but they are not expected to be an issue (perhaps the condition of some operational equipment such as stoplogs or their supports). Data specific to the pumps and motors for the general service cooling water and the turbine generator cooling water are also not presented as they are relatively new and/or modest equipment elements. The risk area boxes provide an indication of the timing of potential issues either from an age or equivalent operating hours view.

The curve indicates that the remaining life (RL) of most elements of the Unit 1 cooling water systems associated with generators is sufficient to reach the end date of 2020 for generation, but not necessarily the 2041 end date for synchronous condensing. The CW pumps and associated equipment are the primary nearer term issues highlighted by the risk boxes. The actual end date and remaining life will become clearer through the series of ongoing routine inspections that forms part of the plant's PM program and the Level 2 inspections recommended in the report. Curves for the intake and outfall structures and associated sub-components should be added subsequent to the undertaking of a Level 2 inspection.

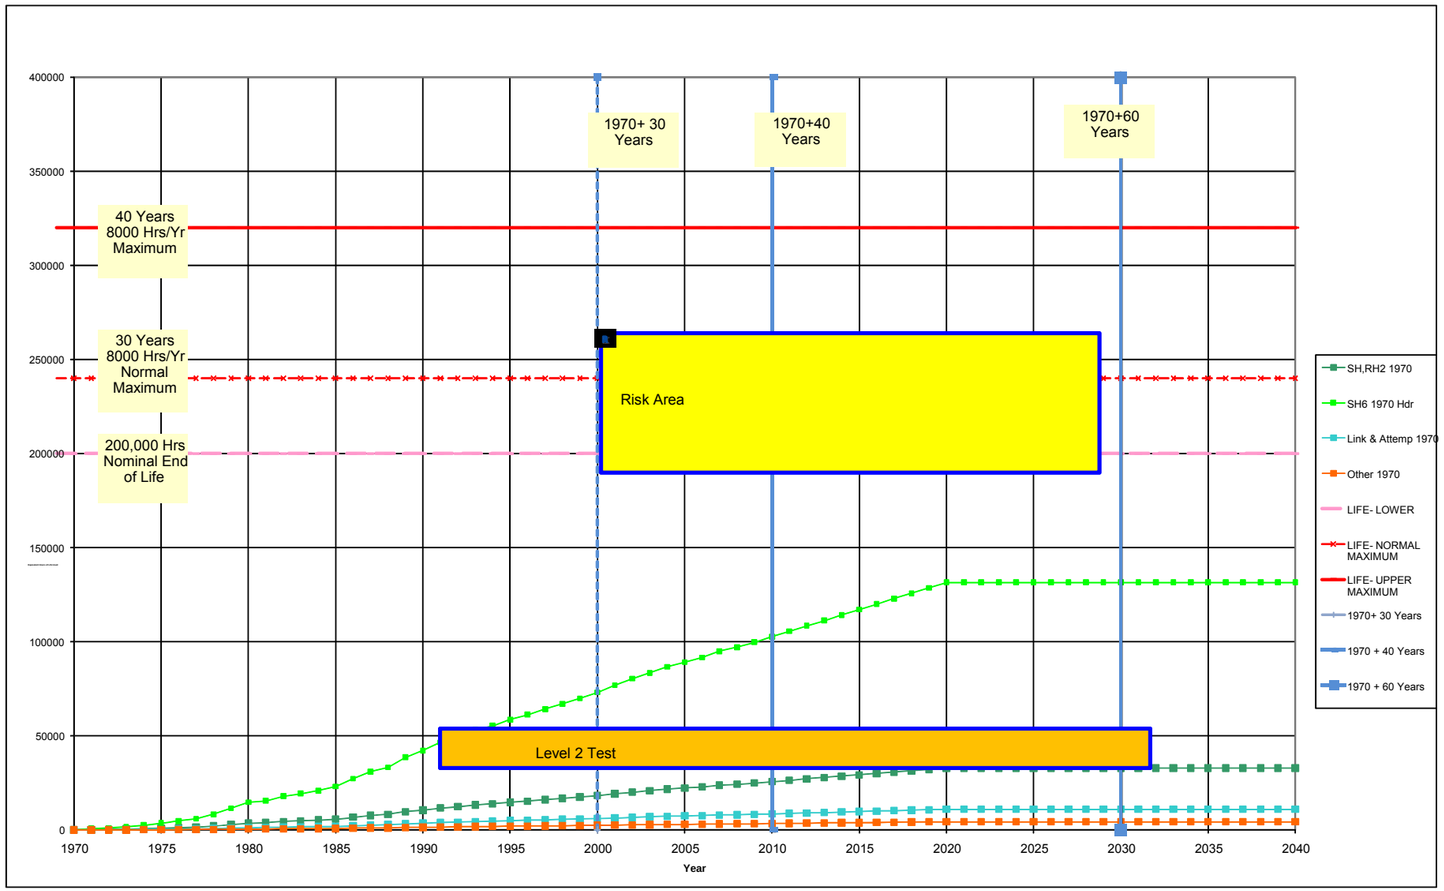
FIGURE 8-10 LIFE CYCLE CURVE –UNIT 1 BOILER SYSTEM (BOILER HEADERS AND COMPONENTS OUTSIDE THE FLUE GAS PATH)

The boiler headers and components are subject primarily to time spent under the effects of steam pressure and temperature. Their equivalent expended life presented in figure below is primarily related to the material properties and the steam conditions. As a result, several curves are required to represent the range of the various elements of the system. Details are included in Appendix 30. The life curves are plots on the y-axis of current and projected consumed equivalent life hours based on the theoretical metallurgical assessments. This differs from other sections that use nominal operating hours of usage on the y-axis versus calendar year on the x-axis. The figure has several vertical lines representing differing representative nominal age limits for various components. It also has several horizontal lines that represent a range of practical equipment equivalent base loaded operating hour life limits. The figure also includes two highlighted boxes. The risk box is representative of typical life expectations. The second identified as the “Level 2 Test” box identifies where EPRI recommends an initial Level 2 analyses or equivalent for these sorts of components (consumed life = 10% of expected or design life).

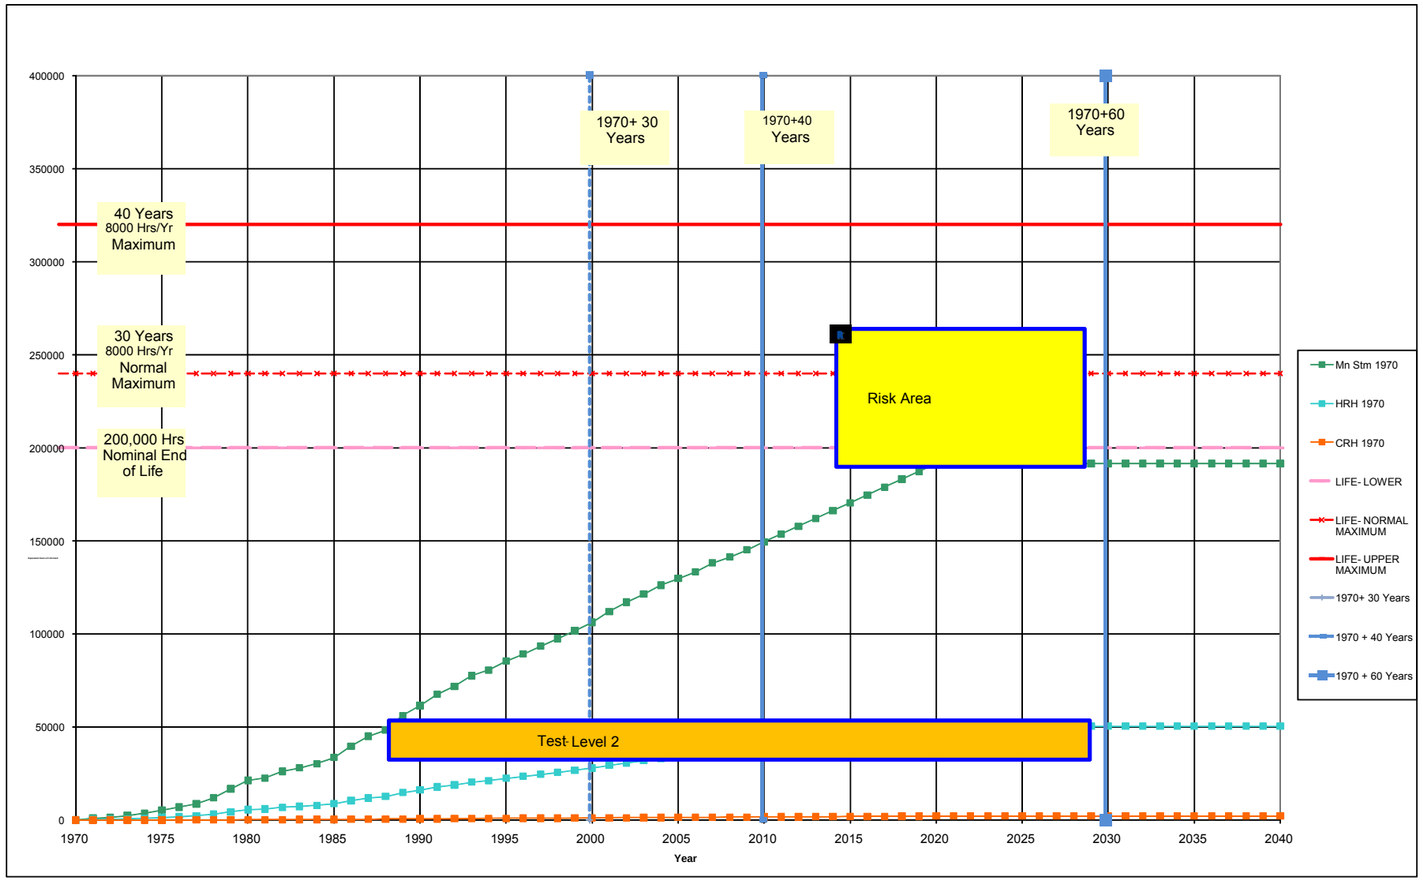
FIGURE 8-11 LIFE CYCLE CURVE –UNIT 1 BOILER SYSTEM (HIGH PRESSURE AND TEMPERATURE STEAM LINES)

Three curves represent the high pressure, high temperature steam lines (main steam, hot reheat, and cold reheat). Their life expenditure (illustrated in figure below) is primarily related to the time spent under the effects of steam pressure and temperature, similar to the boiler headers, and to the material properties of the steam lines. Details are included in Appendix 33.The life curves are plots on the y-axis of current and projected “consumed equivalent life hours” based on the theoretical metallurgical assessments. The figure has three vertical lines representing differing representative nominal age limits. It also has several horizontal lines that represent a range of practical equipment equivalent base loaded operating hour life limits. The figure also included two highlighted boxes. The risk box is representative of typical life expectations. The second identified as the “Level 2 Test” box identifies where an initial Level 2 analyses or equivalent is likely required (consumed life = 10% of expected life).

The high pressure steam line life curves indicate that the remaining life (RL) of the Unit 1 steam lines and their associated components are expected to exceed the desired life (DL) which is the generation end of life in 2020. Nevertheless, it also identifies that both the main steam and hot reheat steam lines exceed EPRI’s 10% consumed life guide for a Level 2 inspection of these systems. Given that they have not been tested for some time, this is considered appropriate at this time.

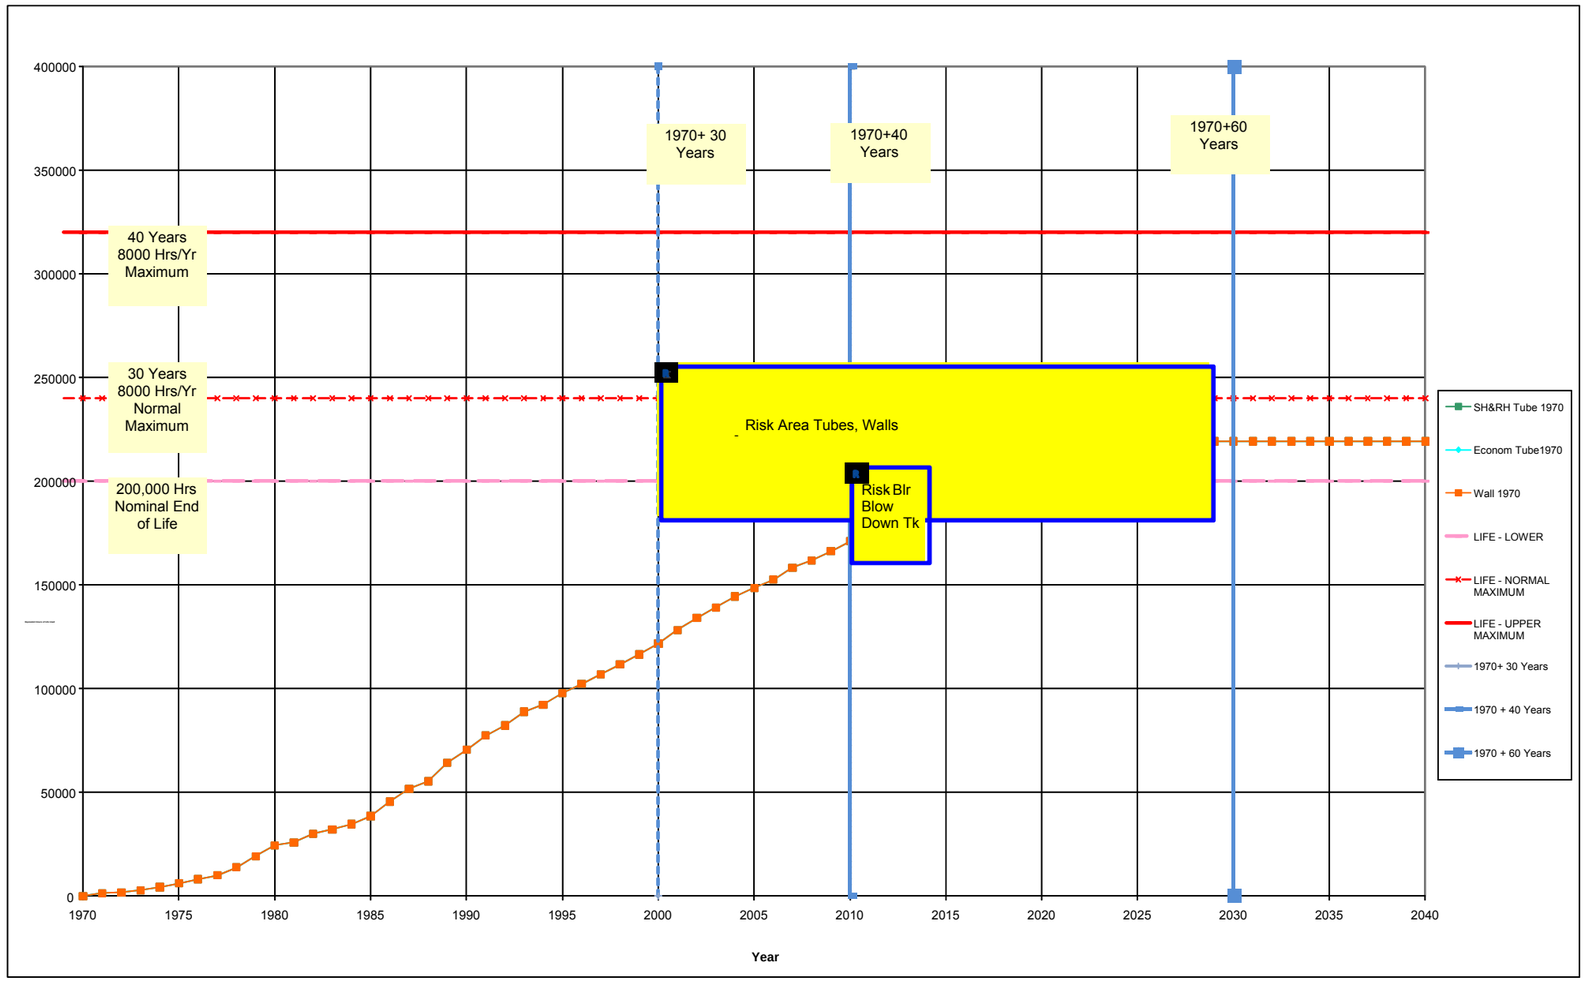
FIGURE 8-12 LIFE CYCLE CURVE –UNIT 1 BOILER SYSTEM (TUBES EXPOSED TO THE COMBUSTION PROCESS, BOILER BLOWDOWN)

A single life cycle curve is presented beginning with the in-service date of the unit. It is meant to represent initial design goals, using nominally operating hours. It was considered impractical to accurately document or reasonably present in one curve the many changes that have occurred, and are likely to continue to occur going forward due to legacy impacts. It is shows the current status of the boiler blowdown tank, which is both a life issue and a safety issue. It uses nominal operating hours as opposed to metallurgical equivalent hours in the two previous boiler curves as a more appropriate way of expressing its normal lifetime.

The curve indicates that the boiler tubes within the furnace envelope would have been expected to be seeing some end of life component concerns with original equipment. Nevertheless, it is more likely legacy impacts that will have greater effects on component replacements and refurbishments going forward to 2020. With ongoing inspections and refurbishments, 2020 is achievable with good reliability with the new fuel. It also shows that the boiler blowdown tank should be replaced.

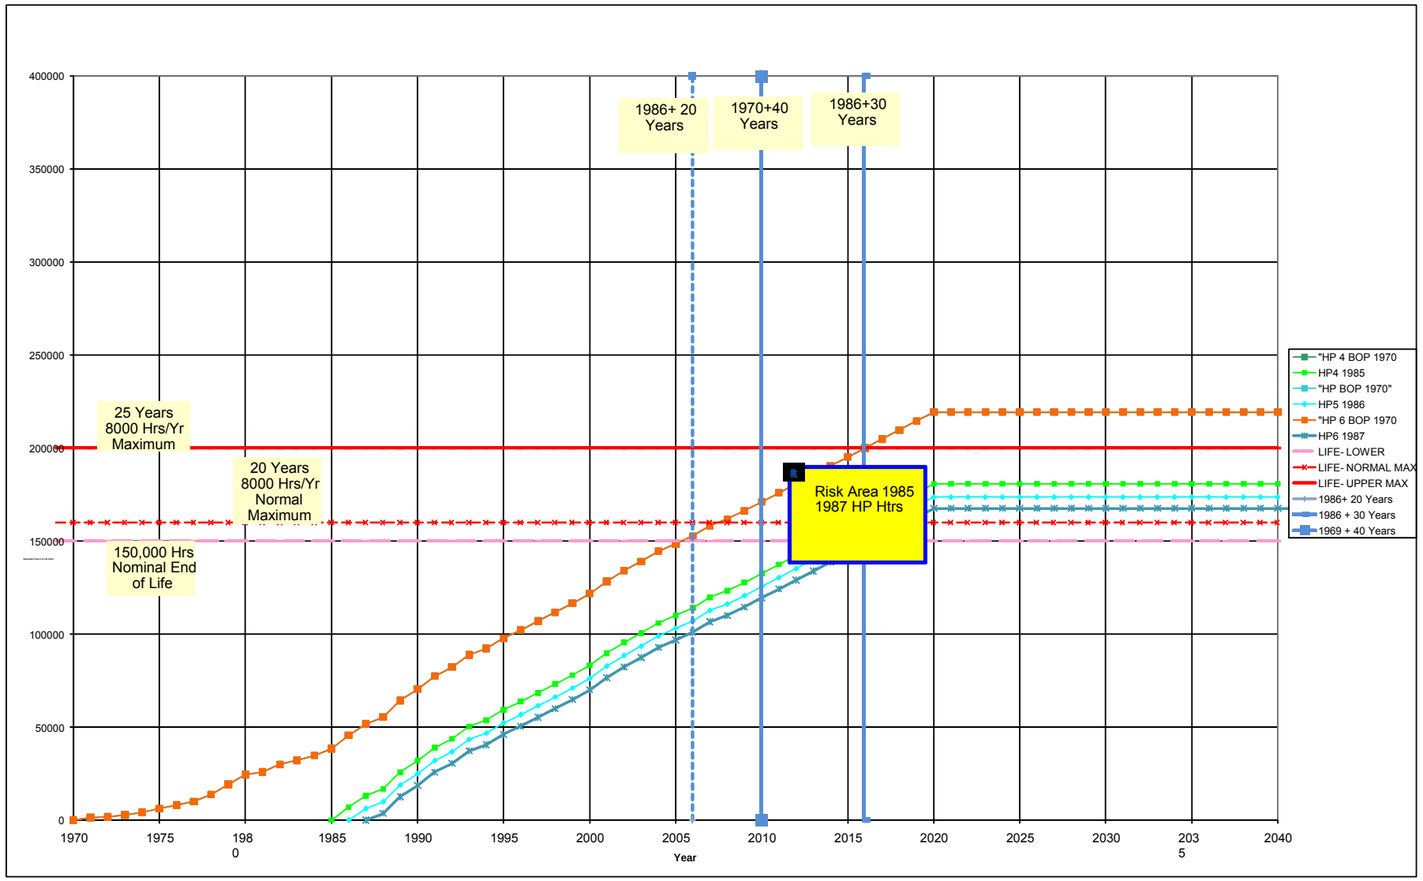
FIGURE 8-13 LIFE CYCLE CURVE – UNIT 1 FEEDWATER SYSTEM - HP FEEDWATER HEAT EXCHANGERS

For the Unit 1 feedwater system HP heat exchangers, individual curves represent the three heat exchangers and components, as well as a curve to represent any balance of plant that is original equipment.

The curves indicate that the remaining life (RL) of the Unit 1 HP heat exchangers (and the associated feedwater systems) may be able to reach the desired life (DL) 2020 end date for generation. Nevertheless, given that no detailed NDE information has been obtained on the HP heat exchangers for some time, a detailed Level 2 inspection is recommended for 2012.

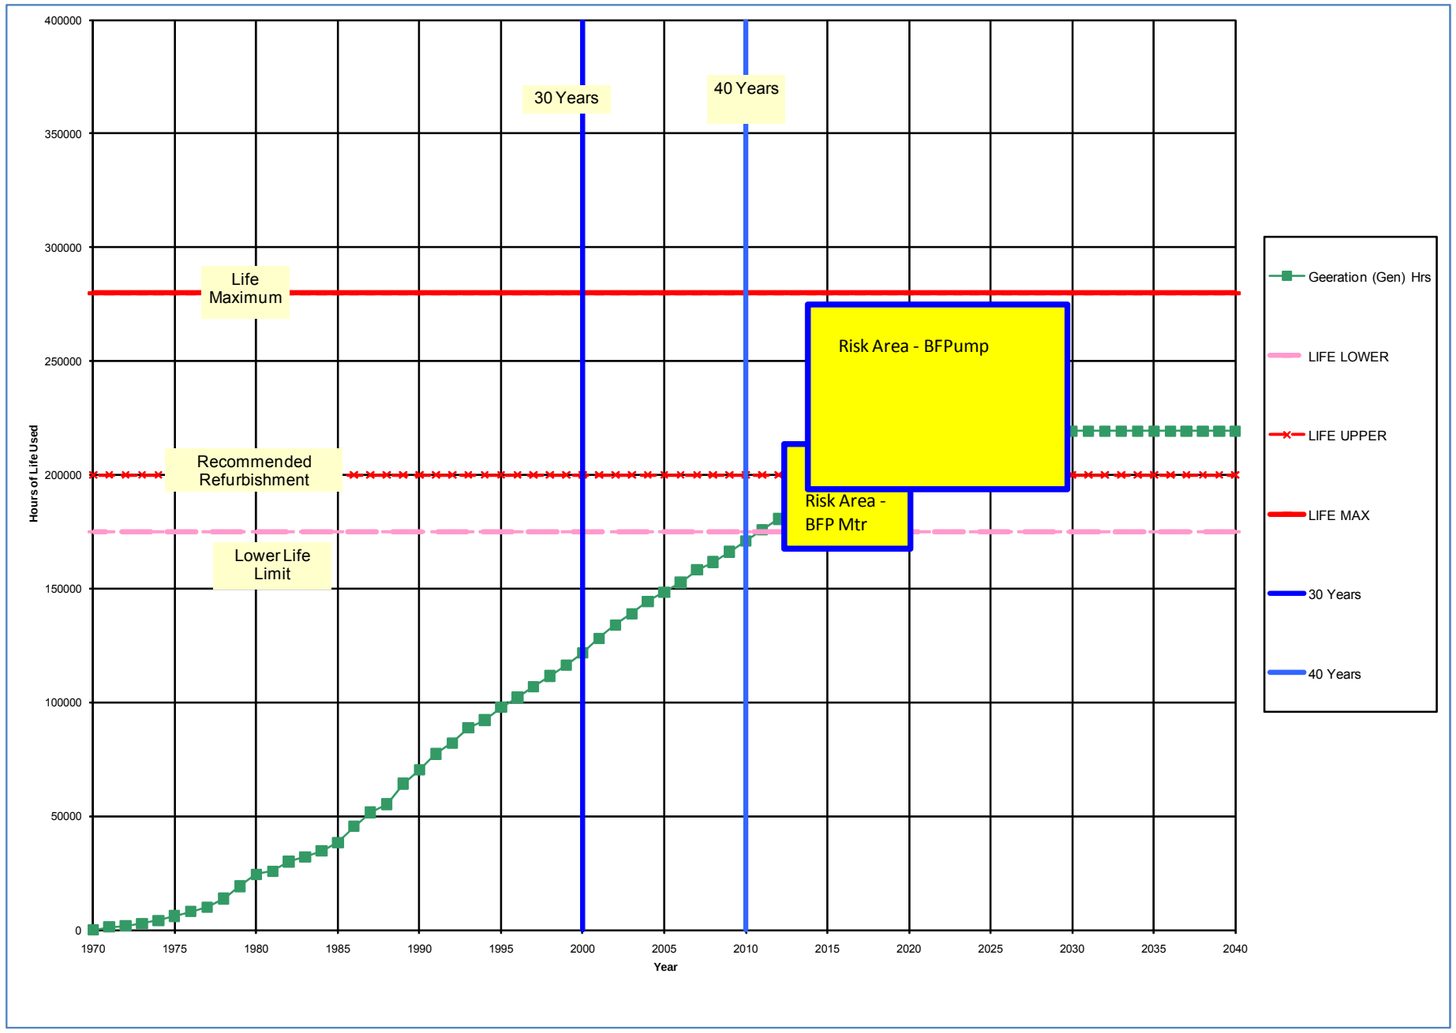
FIGURE 8-14 LIFE CYCLE CURVE – UNIT 1 FEEDWATER SYSTEM - HP BOILER FEED PUMPS

For the Unit 1 Boiler Feed Pumps, a single curve represents each of the two boiler feed pumps dating back to their original installation. While indicative of expected life with good maintenance practice, the pumps have been and continue to be refurbished on a six year cycle using a spare pump section. Their actual condition is therefore substantially better than might otherwise be expected.

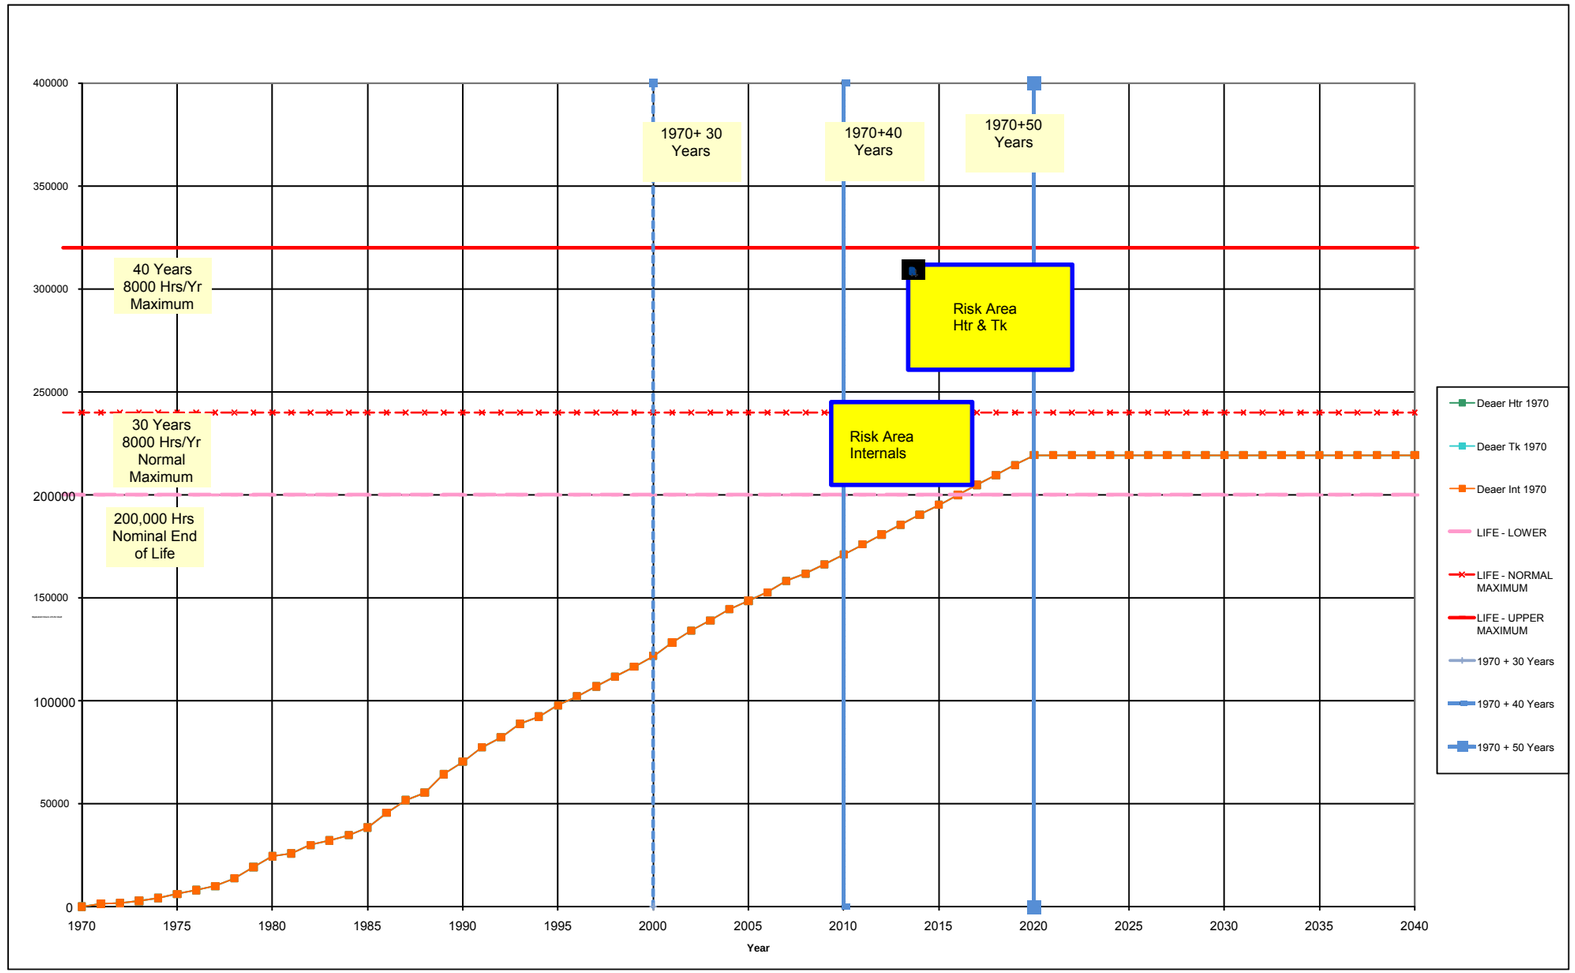
FIGURE 8-15 LIFE CYCLE CURVE – UNIT 1 FEEDWATER SYSTEM - DEAERATOR

Figure 8-15 below illustrates the life cycle curve for the Unit 1 Unit 1 feedwater system – deaerator. One curve is used as the major elements of the deaerator are largely of the same age and condition. The life curve is a plot of current and projected operating hours in generation mode only on the y-axis versus calendar year on the x-axis. The figure has several vertical lines representing differing representative nominal age limits for various components. It also has several horizontal lines that represent a range of practical equipment equivalent base loaded operating hour life limits. The risk area boxes provide an indication of the timing of potential issues either from an age or equivalent operating hours view.

The curve indicates that the remaining life (RL) of the Unit 1 feedwater system - deaerator exceeds the desired life (DL) which is end date for generation of 2020, with the potential though unlikely exception of some deaerator internals. The plant inspections form an excellent base of condition information supporting the ability of the deaerator as a whole to meet the EOL date. There is however insufficient detailed inspection information of some of the difficult to reach internals to fully assess their condition. A detailed Level 2 inspection in 2012 is recommended to provide information for that assessment.

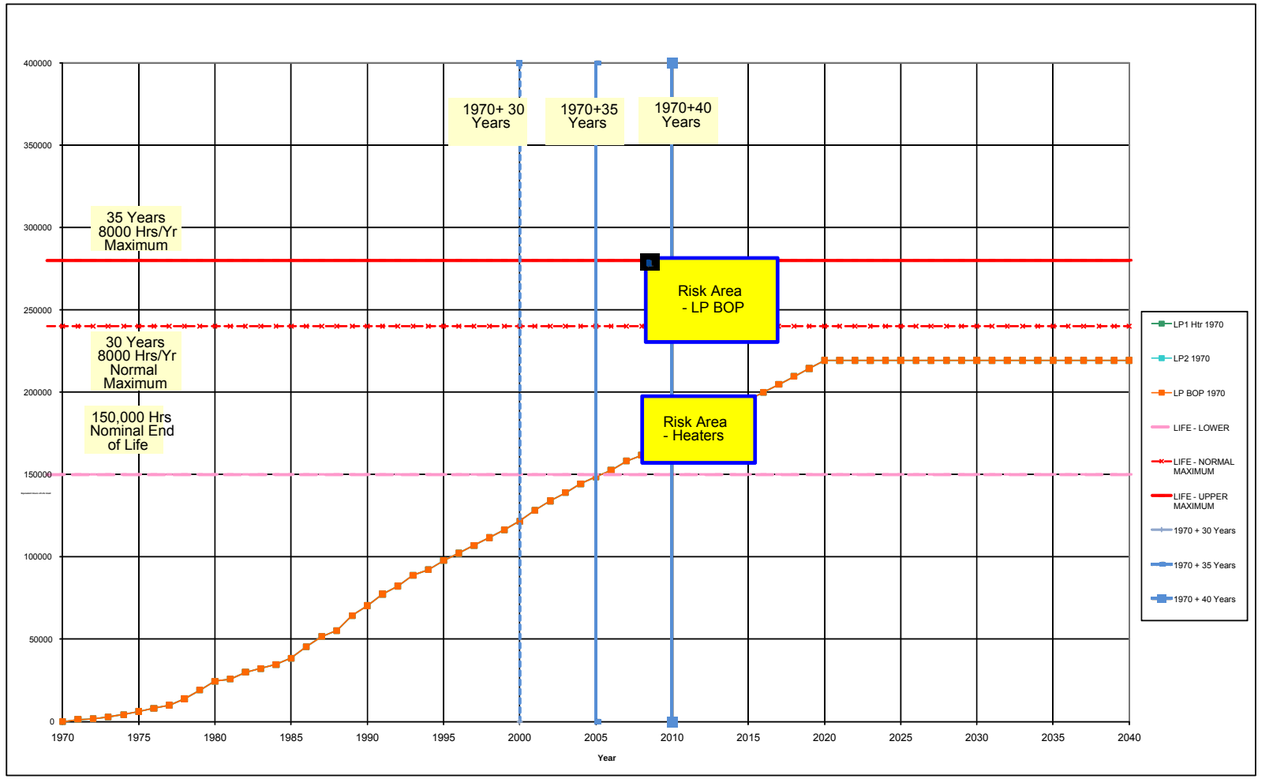
FIGURE 8-16 LIFE CYCLE CURVE – UNIT 1 FEEDWATER SYSTEM - LP FEEDWATER HEAT EXCHANGERS

The curves indicate that the remaining life (RL) of the feedwater system LP heat exchangers may not be able to reach the desired life (DL) 2020 end date for generation. Given that no detailed NDE information has been obtained on the LP heat exchangers, a detailed Level 2 inspection is recommended for 2011.
