Holyrood Thermal Generating Station (Holyrood) Condition Assessment & Life Extension Study, - Final Report

Holyrood Thermal Generating Station
Condition Assessment & Life Extension Study

January 28, 2011

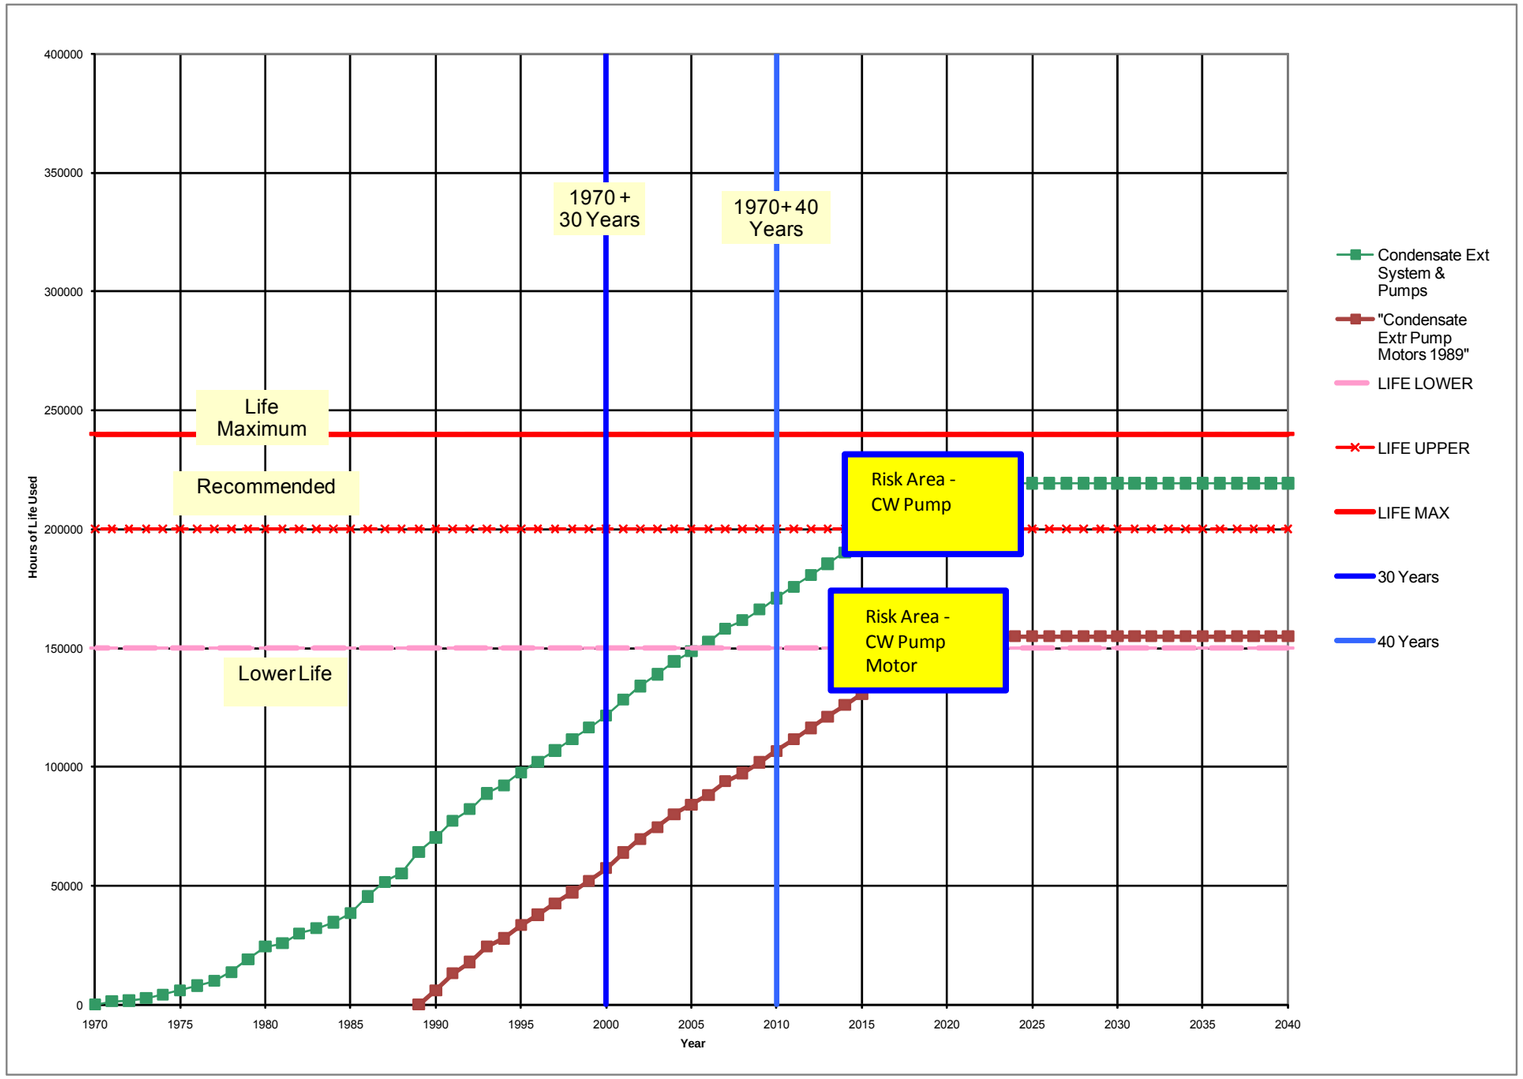
FIGURE 8-17 LIFE CYCLE CURVE – UNIT 1 FEEDWATER SYSTEM – CONDENSATE EXTRACTION PUMPS AND MOTORS

The curves indicate that the remaining life (RL) of the condenser condensate extraction pumps and motors can likely be able to reach the desired life (DL) 2020 end date for generation. The condensate extraction pump motors are expected however to be entering a period of higher unreliability.

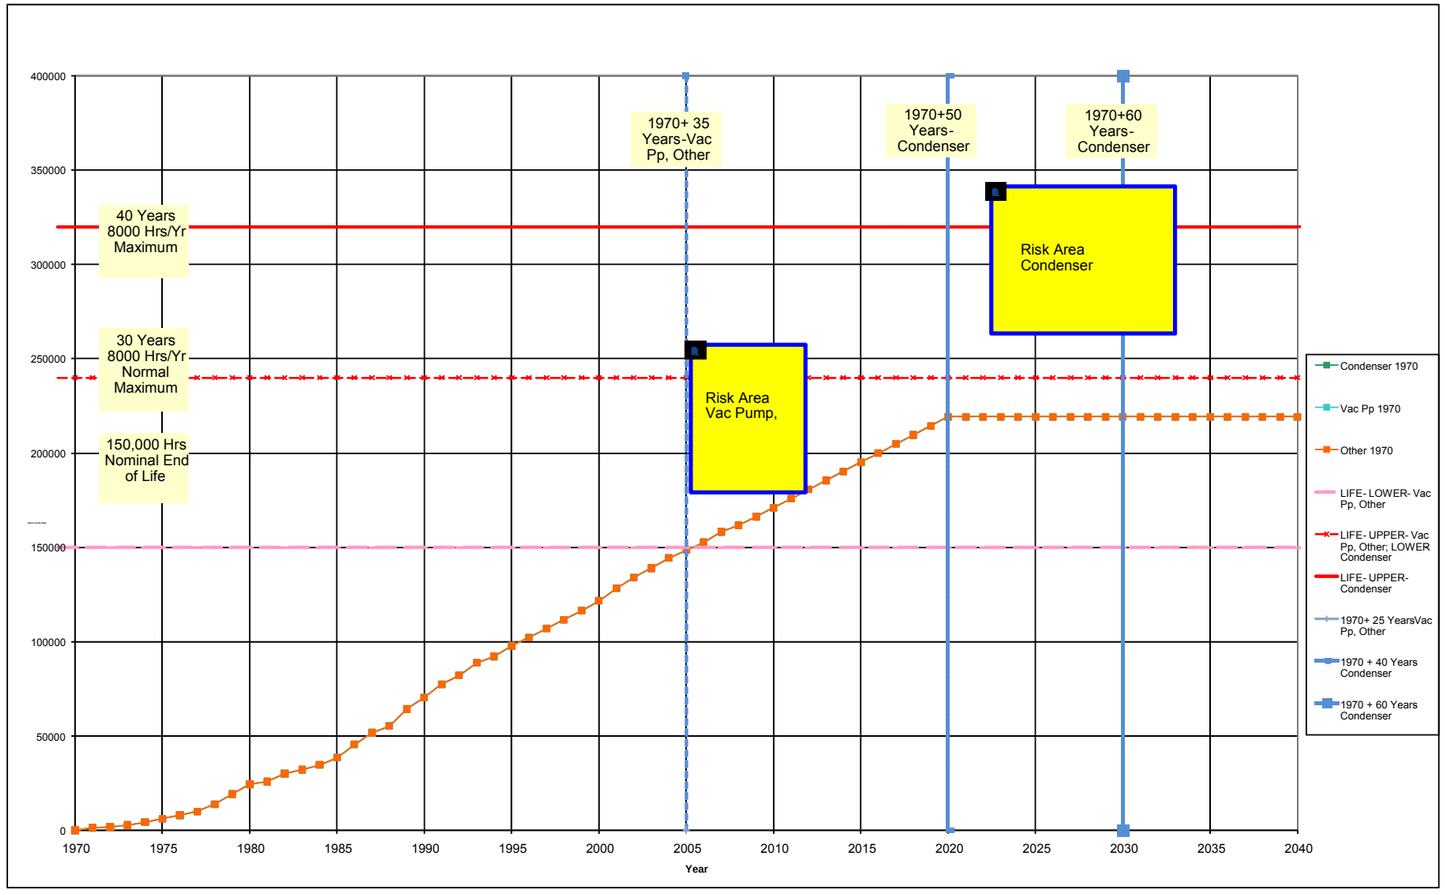
FIGURE 8-18 LIFE CYCLE CURVE – UNIT 1 CONDENSER

The curves indicate that the remaining life (RL) of the Unit 1 condenser can easily reach the desired life (DL) 2020 end date for generation. The exception to this, as illustrated by the risk boxes, is the vacuum pumps. These are original equipment, and likely at or near end of life.

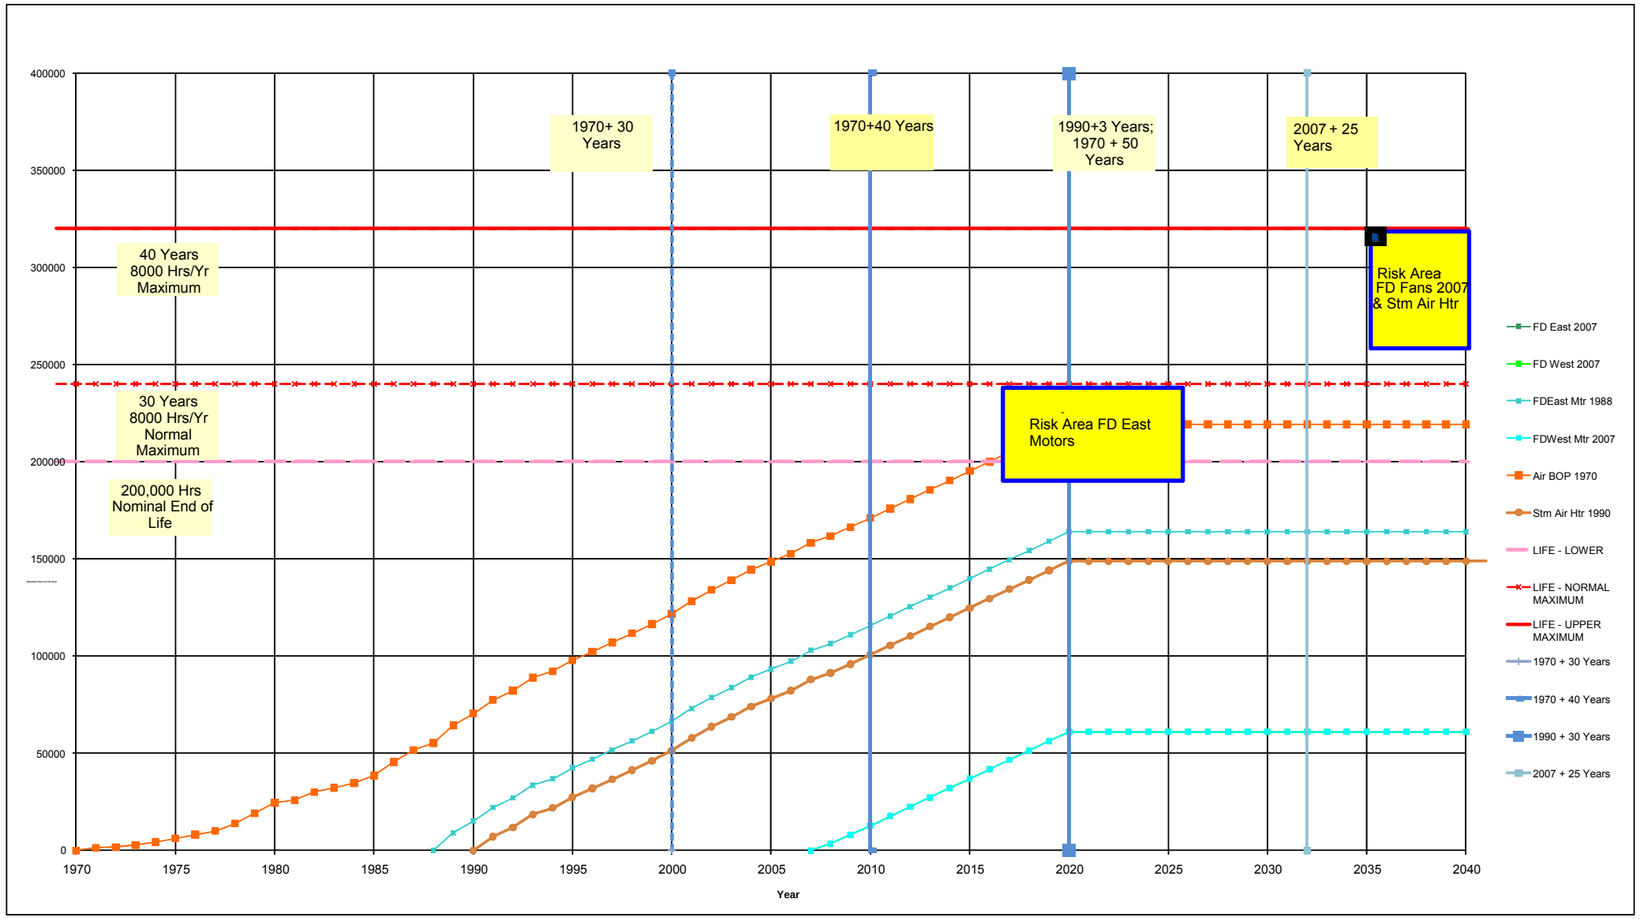
FIGURE 8-19 LIFE CYCLE CURVE – UNIT 1 FD FANS (AND SYSTEM)

The curves indicate that the remaining life (RL) of the Unit 1 FD fans (and system) is expected to meet or exceed the desired life (DL) 2020 end date for generation. The age of the large 4 kV motors makes them a logical cost-effective candidate for sparing to ensure reliability, although plant testing/monitoring programs are effectively monitoring their status.

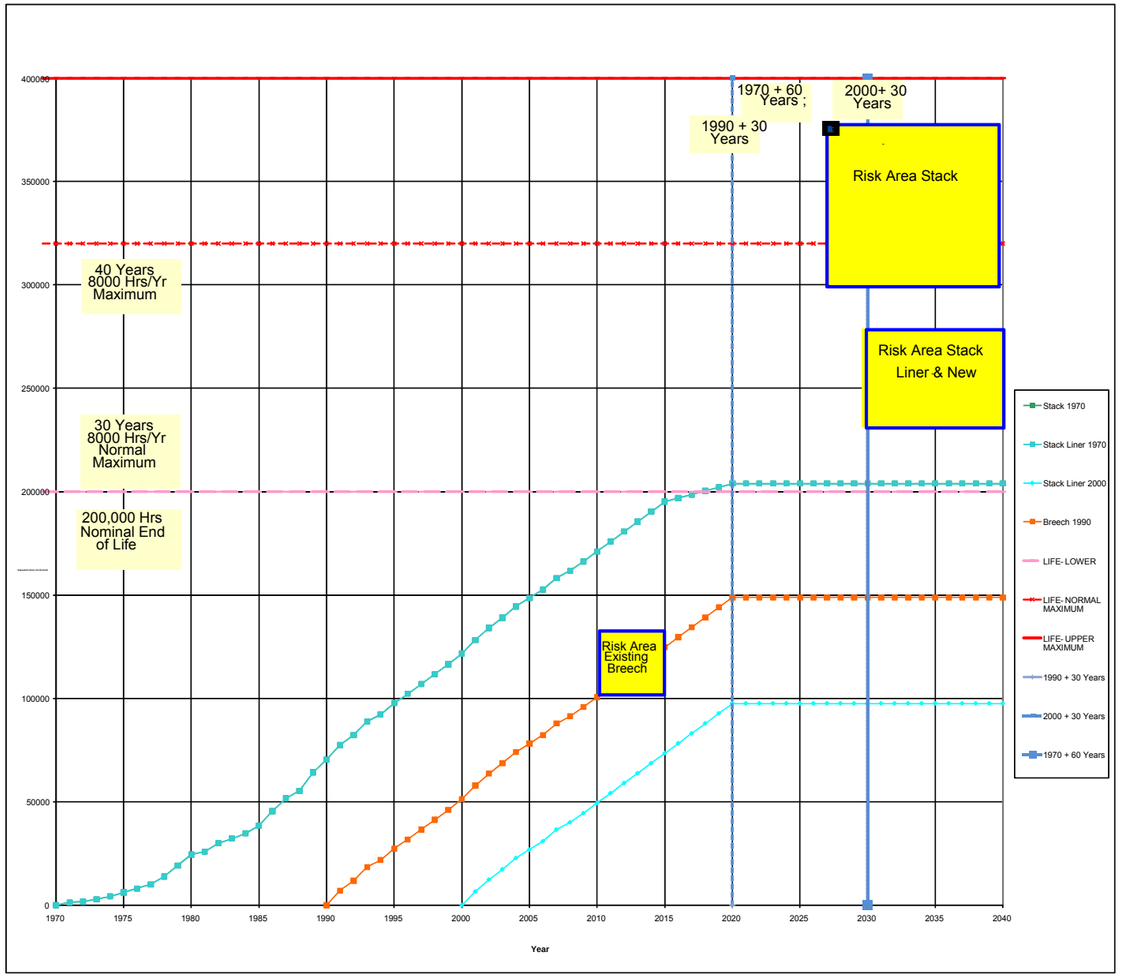
FIGURE 8-20 LIFE CYCLE CURVE – UNIT 1 STACK AND BREECHING

The curves indicate that the remaining life (RL) of the Unit 1 stack is may be able to reach the desired life (DL) 2020 end date for generation, as well as the end date of 2040 for synchronous condensing/plant life. It does show that the stack breeching is in need of immediate repair. The breeching requirement is not a normal life issue, but one of poor design. Other elements can achieve the 2020 end date for generation with the ongoing plant maintenance program.

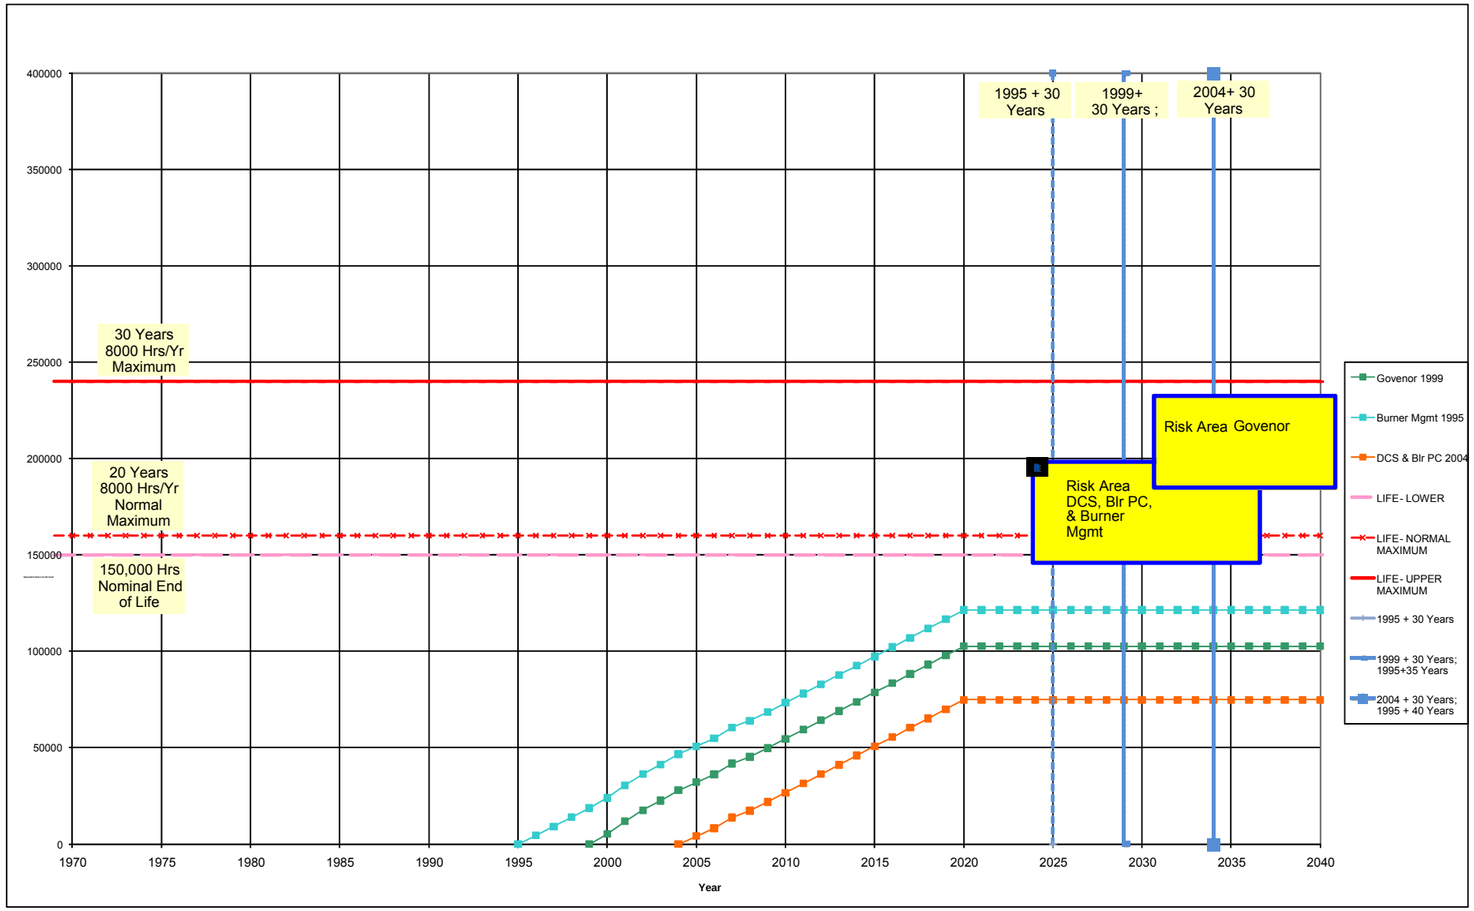
FIGURE 8-21 LIFE CYCLE CURVE – UNIT 1 ELECTRICAL AND CONTROL SYSTEMS (INCLUDING DCS) ASSOCIATED WITH STEAM SYSTEMS

The curves indicate that the remaining life (RL) of the Unit 1 control systems (including DCS) associated with steam systems can readily reach the desired life (DL) 2020 end date for generation, provided regular inspection and service as per the station PM plan is maintained. The electrical systems, particularly breakers and motor controls are addressed in more detail as part of Section 8.1.3. It is clear that in order to meet the end date for generation service, some components must be replaced, or in some cases refurbished.

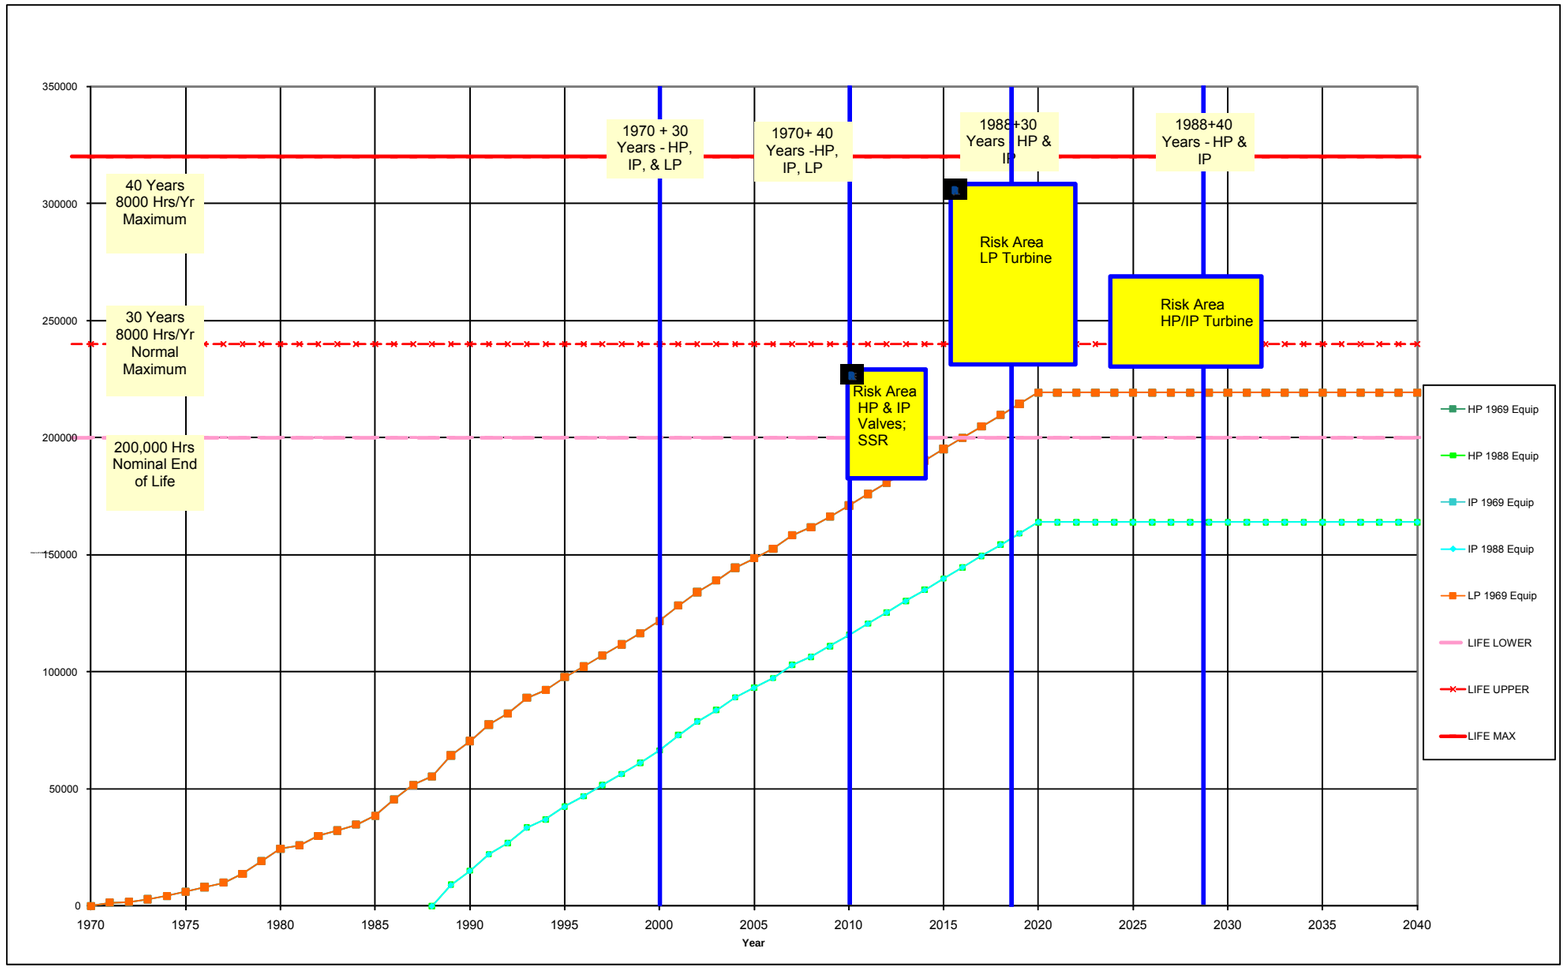
FIGURE 8-22 LIFE CYCLE CURVE – UNIT 1 STEAM TURBINE

The curves indicate that the remaining life (RL) of the various elements of the Unit 1 steam turbine exceeds the desired life (DL) which is the lesser of the time to its next major planned overhaul/inspection (2012) or to the desired End of Life (EOL) date of 2020. In fact the 2020 end date should be readily achievable. Hence, no specific dedicated Level 2 is required, but sufficient inspection and testing will be required in the 2012 overhaul to confirm the ability to meet the 2020 EOL date. The exceptions to that are the HP and IP valves which continue to have reliability and life issues, the steam seal regulator, as well potentially as high temperature stud bolts. It is clear that the current inspection schedule seems suitable.

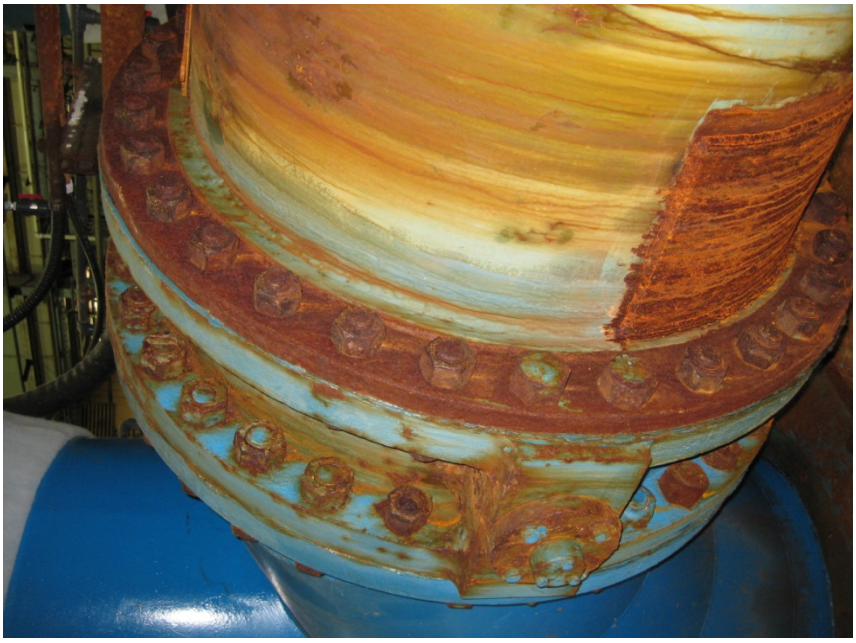
According to station staff, the steel piping at the inlet and outlet between the condenser and the underground concrete pipes has been replaced but the date was unknown. Some patching is evident on some units.

FIGURE 8-25 CIRCULATING WATER PIPE PATCH

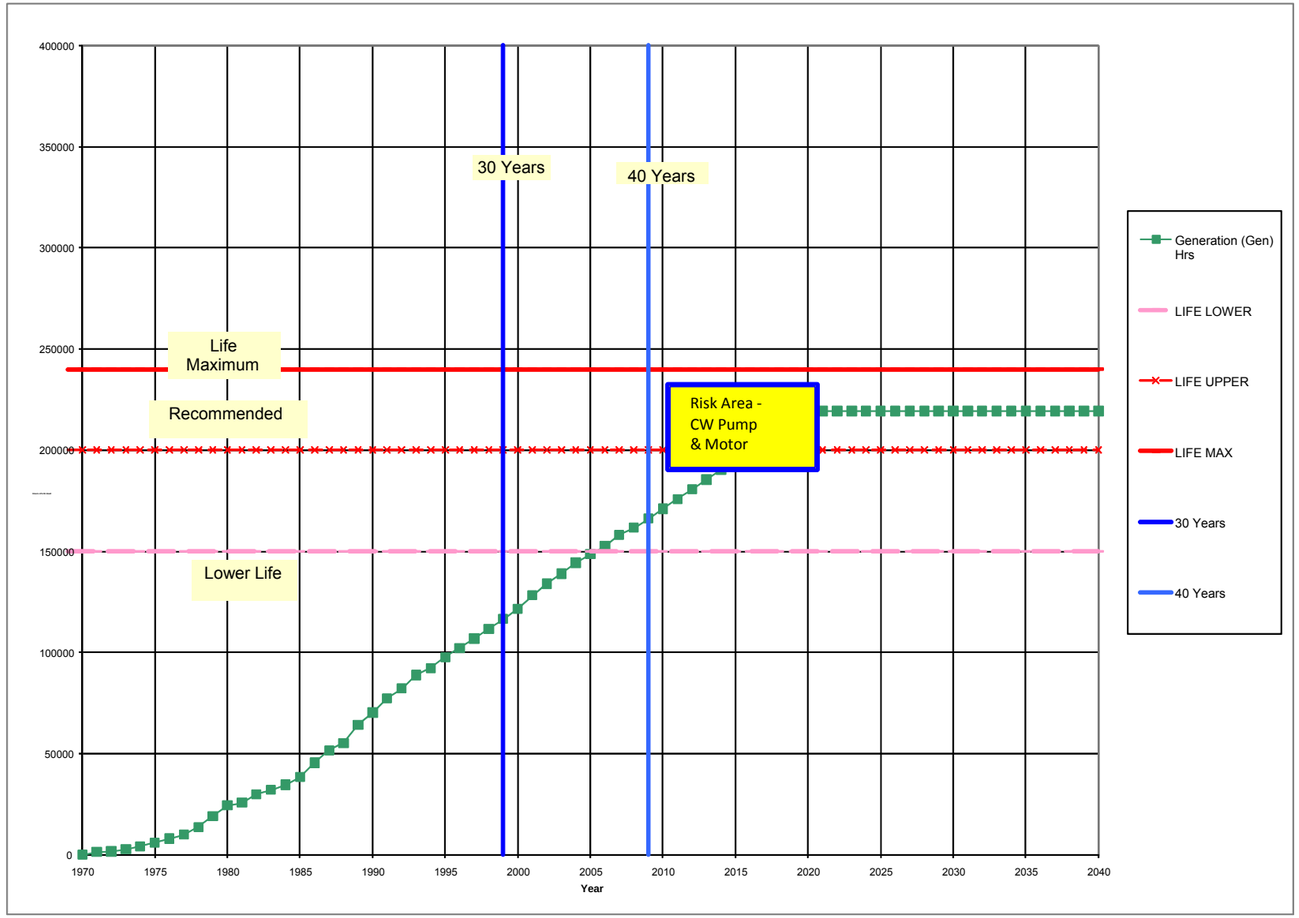
FIGURE 8-26 LIFE CYCLE CURVE – UNIT 1 COOLING WATER SYSTEM ASSOCIATED WITH STEAM SYSTEMS

The curves indicate that the remaining life (RL) of the Unit 1 cooling water system - associated with steam systems can likely reach the end date for generation of 2020, but with some reliability risk, particularly as it pertains to the 4 kV motor. It is recommended that a spare motor shared between units would be a reasonable precaution. Corrosion of the steel pipe, valves, and fittings was also evident suggesting that some maintenance on these issues is required.

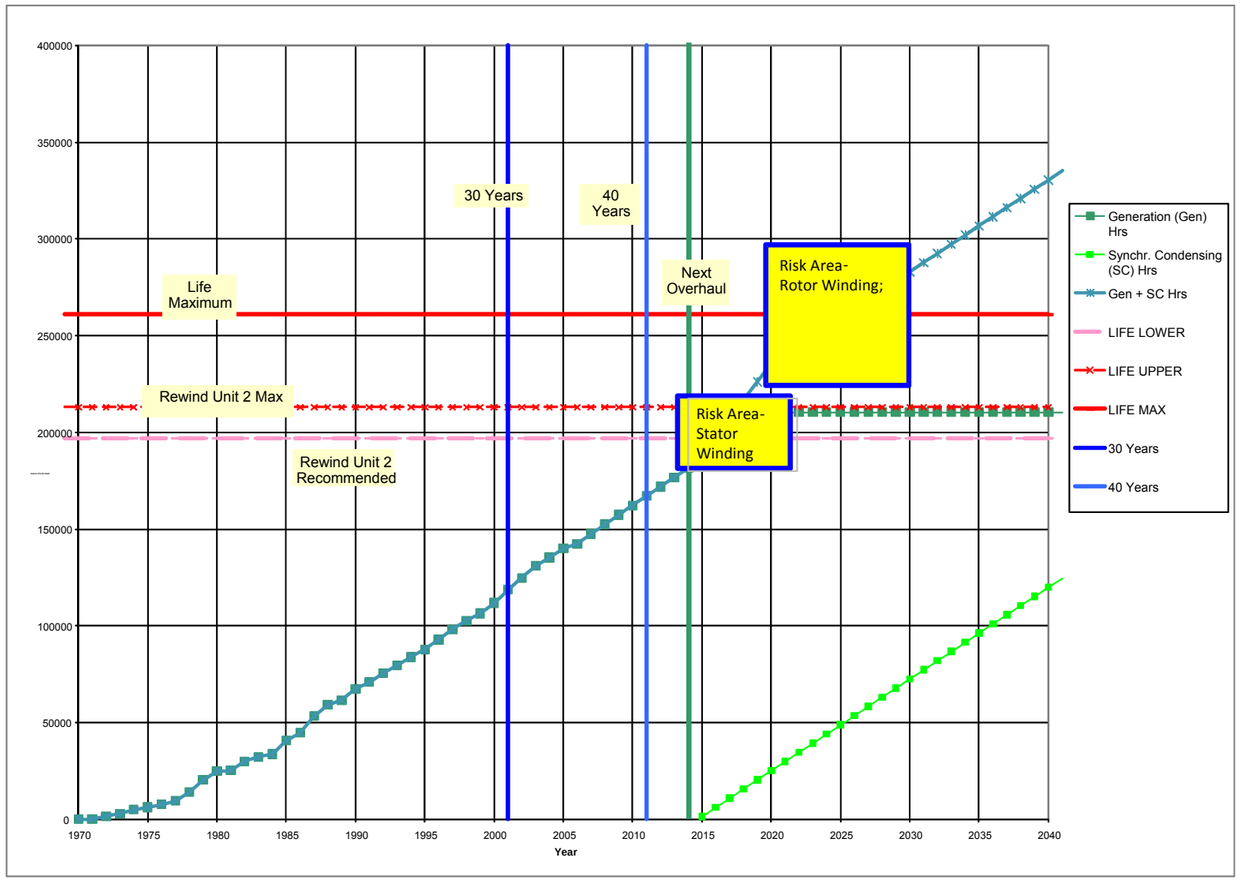
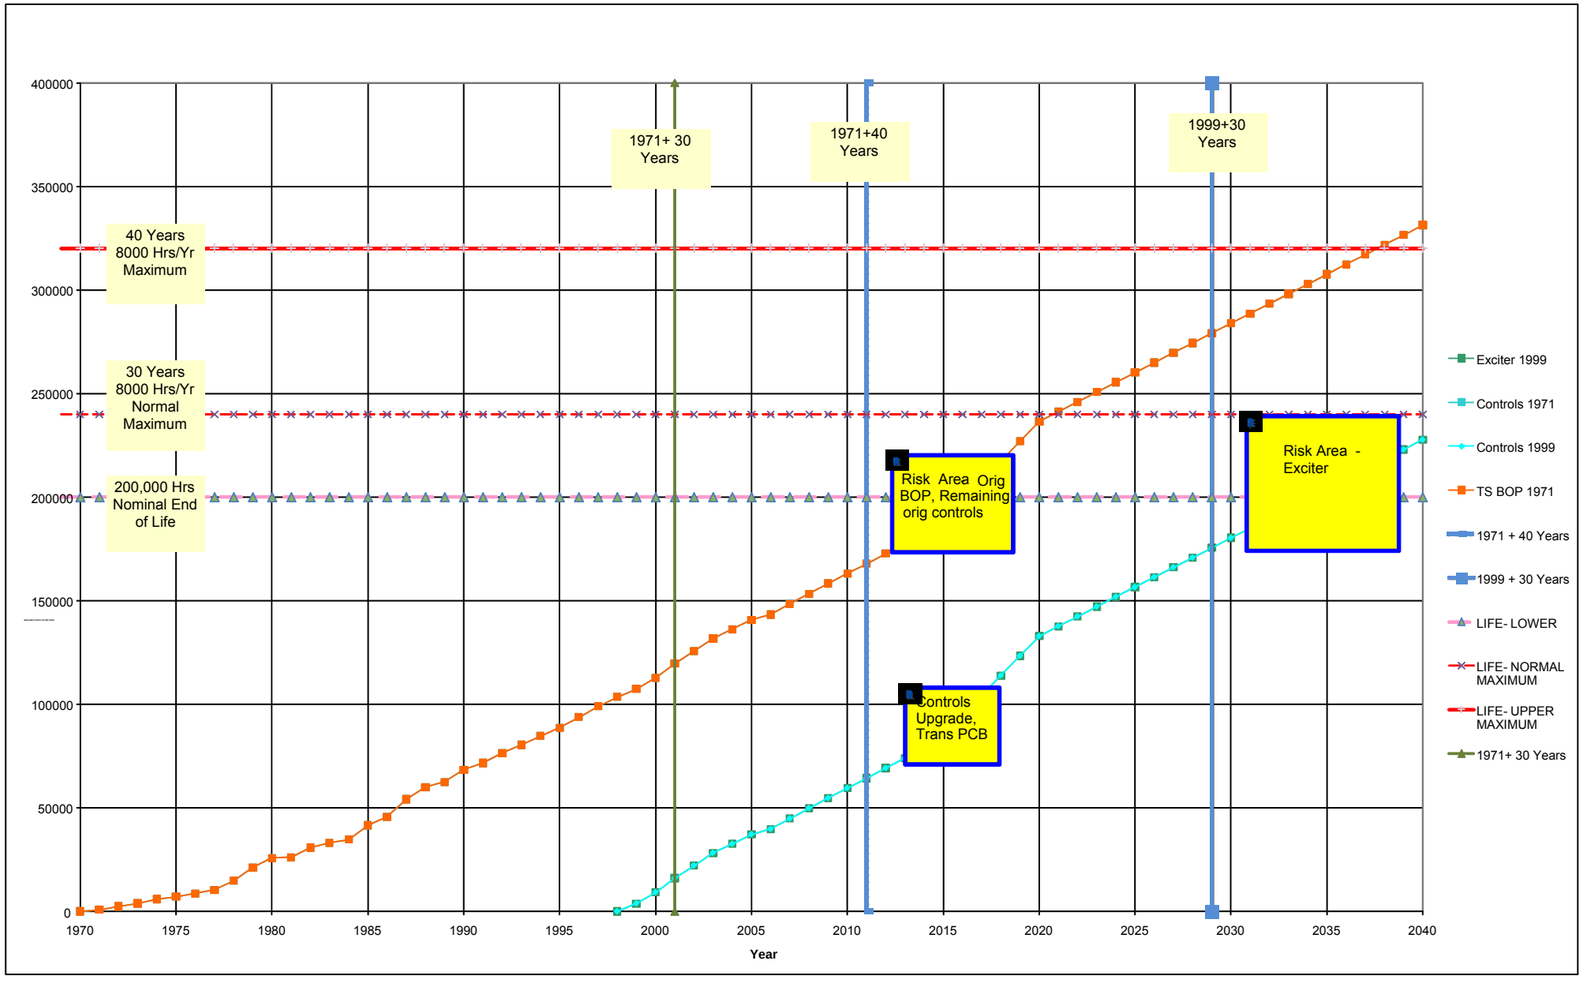
FIGURE 9-2 LIFE CYCLE CURVE – UNIT 2 GENERATOR

FIGURE 9-3 LIFE CYCLE CURVE – UNIT 2 GENERATOR - EXCITER

The curves indicate that the remaining life (RL) of the Unit 2 generator exceeds the desired life (DL) which is the lesser of the time to its next major planned overhaul/inspection (2014) or to the desired End of Life (EOL) date of 2041. No specific dedicated Level 2 is required, but sufficient inspection and testing will be required in the 2014 overhaul to demonstrate the ability to meet the 2041 EOL date. The exciter should for the most part be able to meet an EOL of 2020, and with periodic refurbishment may meet 2041.The highlighted nearer term risk areas include the stator winding, exciter controls (upgrade only), the rectifying transformer, and some original BOP components. These systems are candidates for replacement or refurbishment – addressed in later sections. The curve also suggests that a nine year time between generator overhauls is impractical at this time in the generator's life and should be a six year cycle.

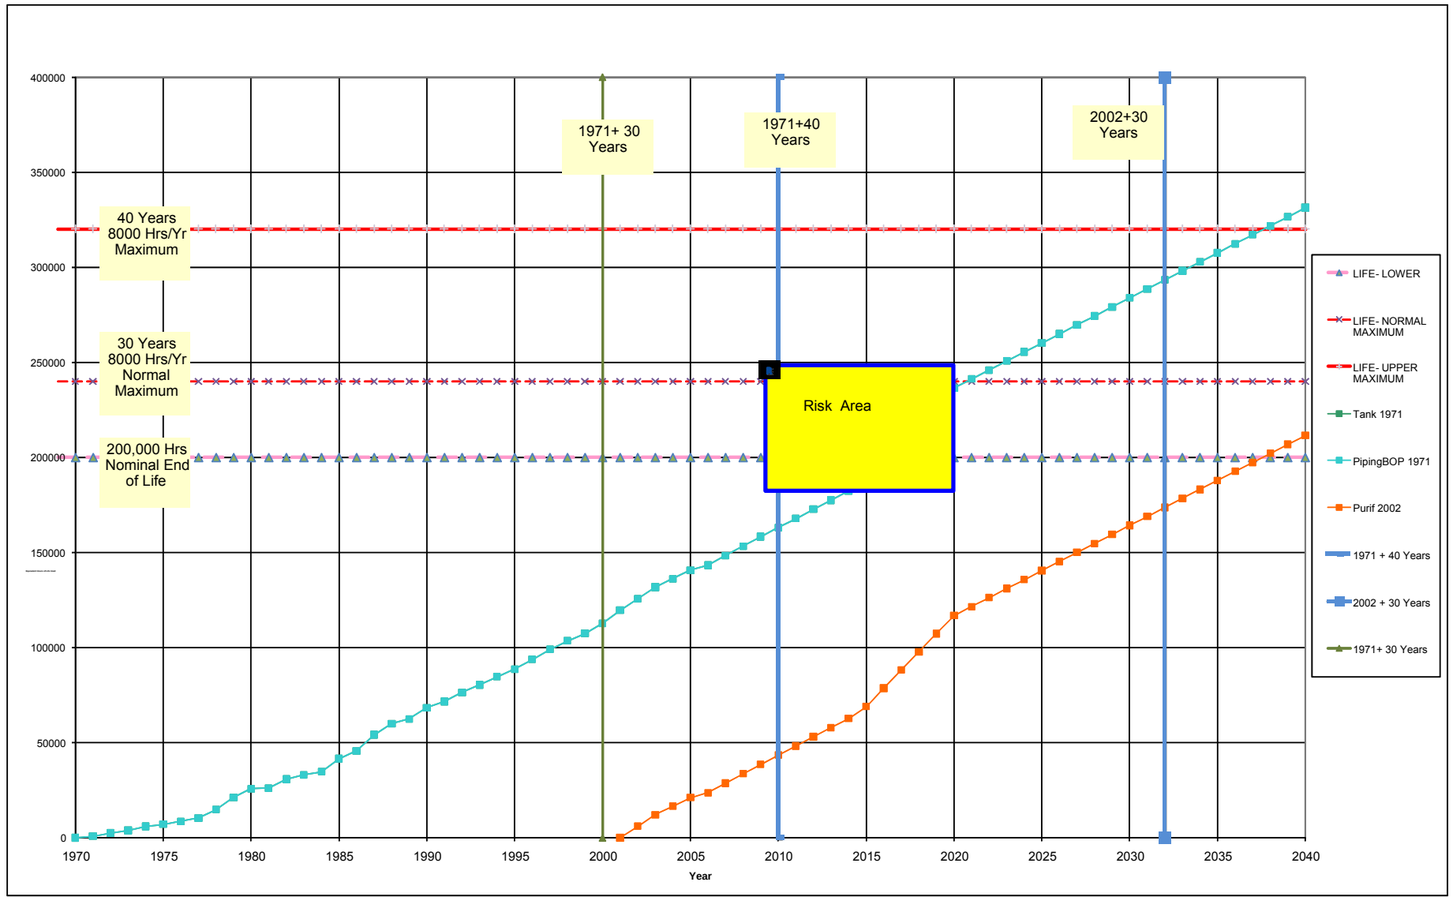
FIGURE 9-4 LIFE CYCLE CURVE – UNIT 2 GENERATOR LUBE OIL SYSTEM

The curves indicate that the remaining life (RL) of the Unit 2 generator lube oil system exceeds the desired life (DL) which is the lesser of the time to its next major planned overhaul/inspection (2014) or to the desired End of Life (EOL) date of 2041. Hence, no specific dedicated Level 2 is required of the system as a whole, but sufficient inspection and testing will be required in 2014 steam turbine generator overhaul to demonstrate the ability to meet the EOL date. The exception is the storage tank for which information was considered inadequate to form a firm conclusion and level 2 testing is recommended in 2011. The figure's highlighted risk areas is primarily operating hours driven and likely to shift further out in time after the 2014 turbine generator overhaul. The 2014 overhaul/inspection is a fundamental element in changing the current assessment.

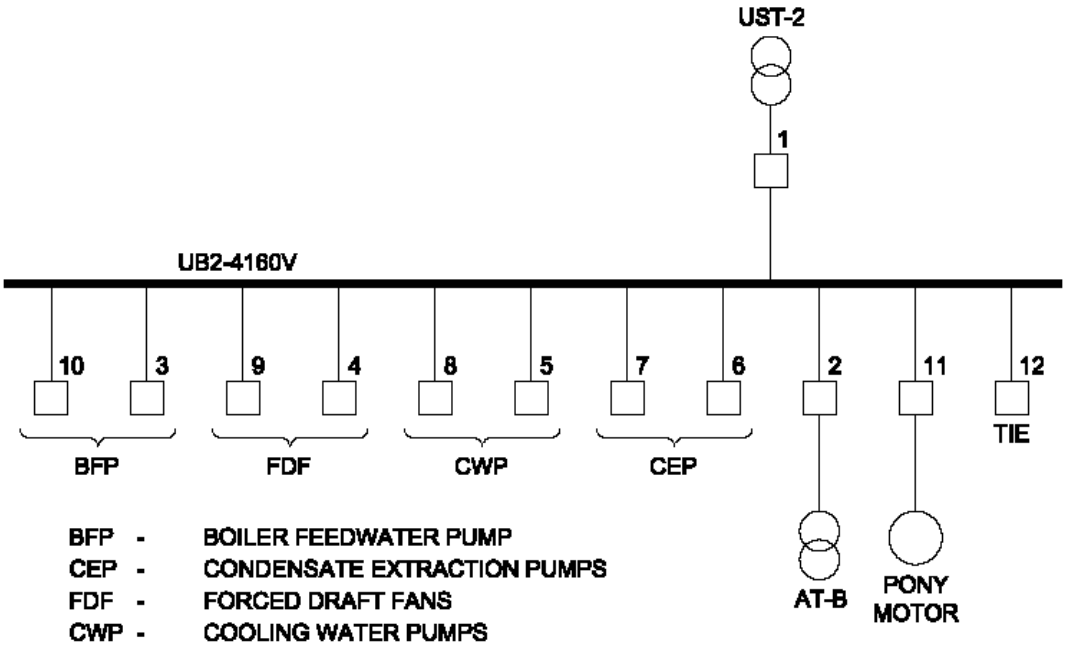
FIGURE 9-5 UB2 SWITCHGEAR

Unit Board UB2 (4160V) was manufactured by ITE and installed in 1968. The 4160V switchgear, utilizes original draw-out power breakers, Type 5HK, 1200A and 2000A. All protection, synch, and control relays are original CGE electro-mechanical. Schweitzer 701, Motor Protection Relays have been added to some feeders. All other loads utilize original P&B Golds' relays.

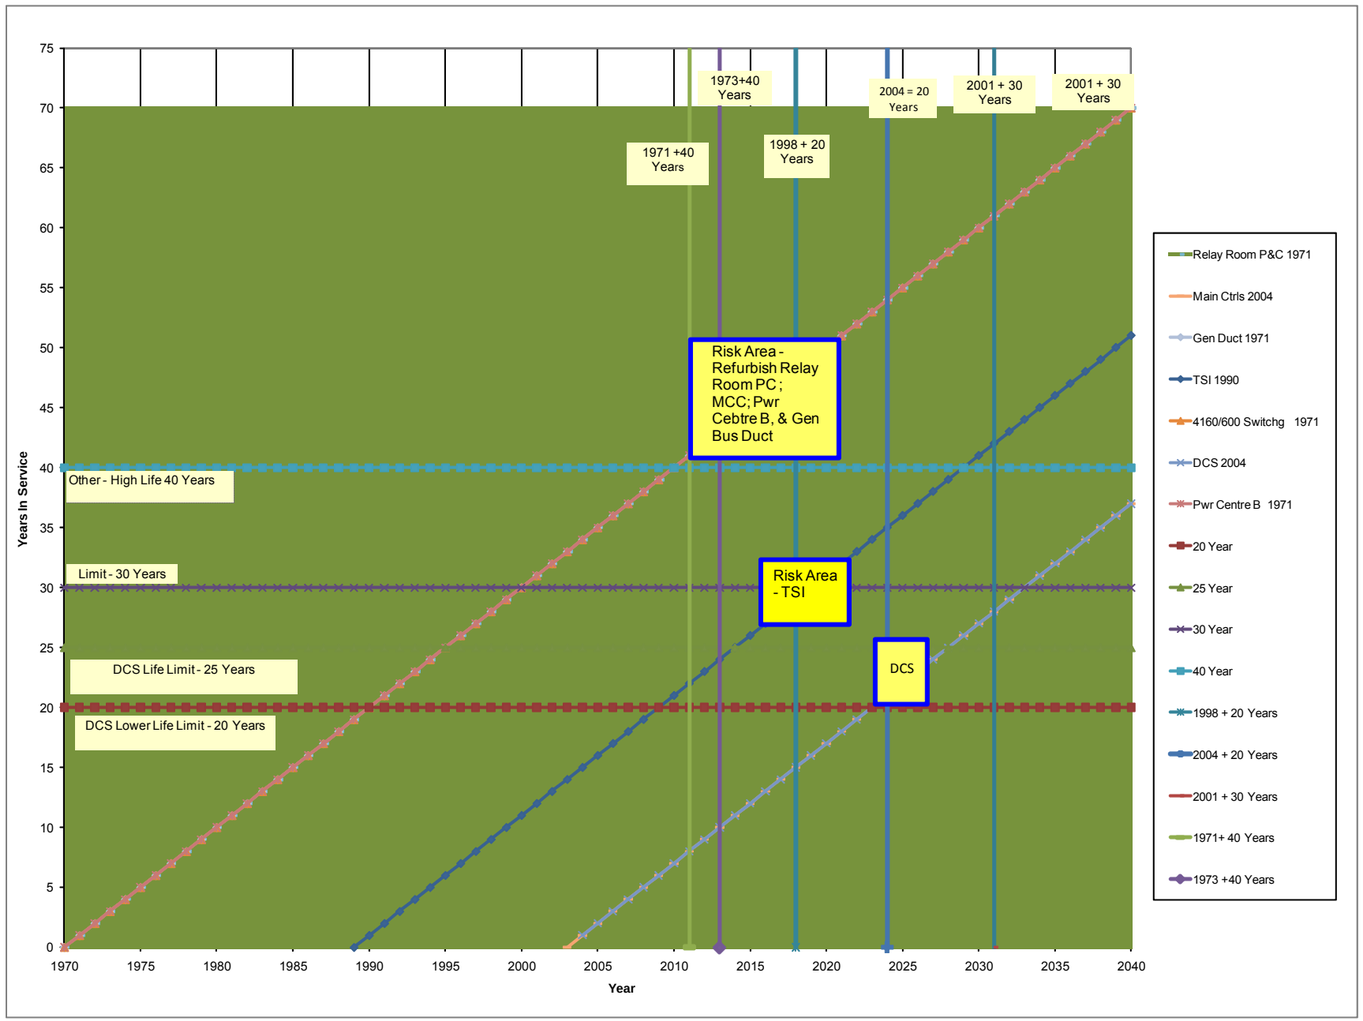
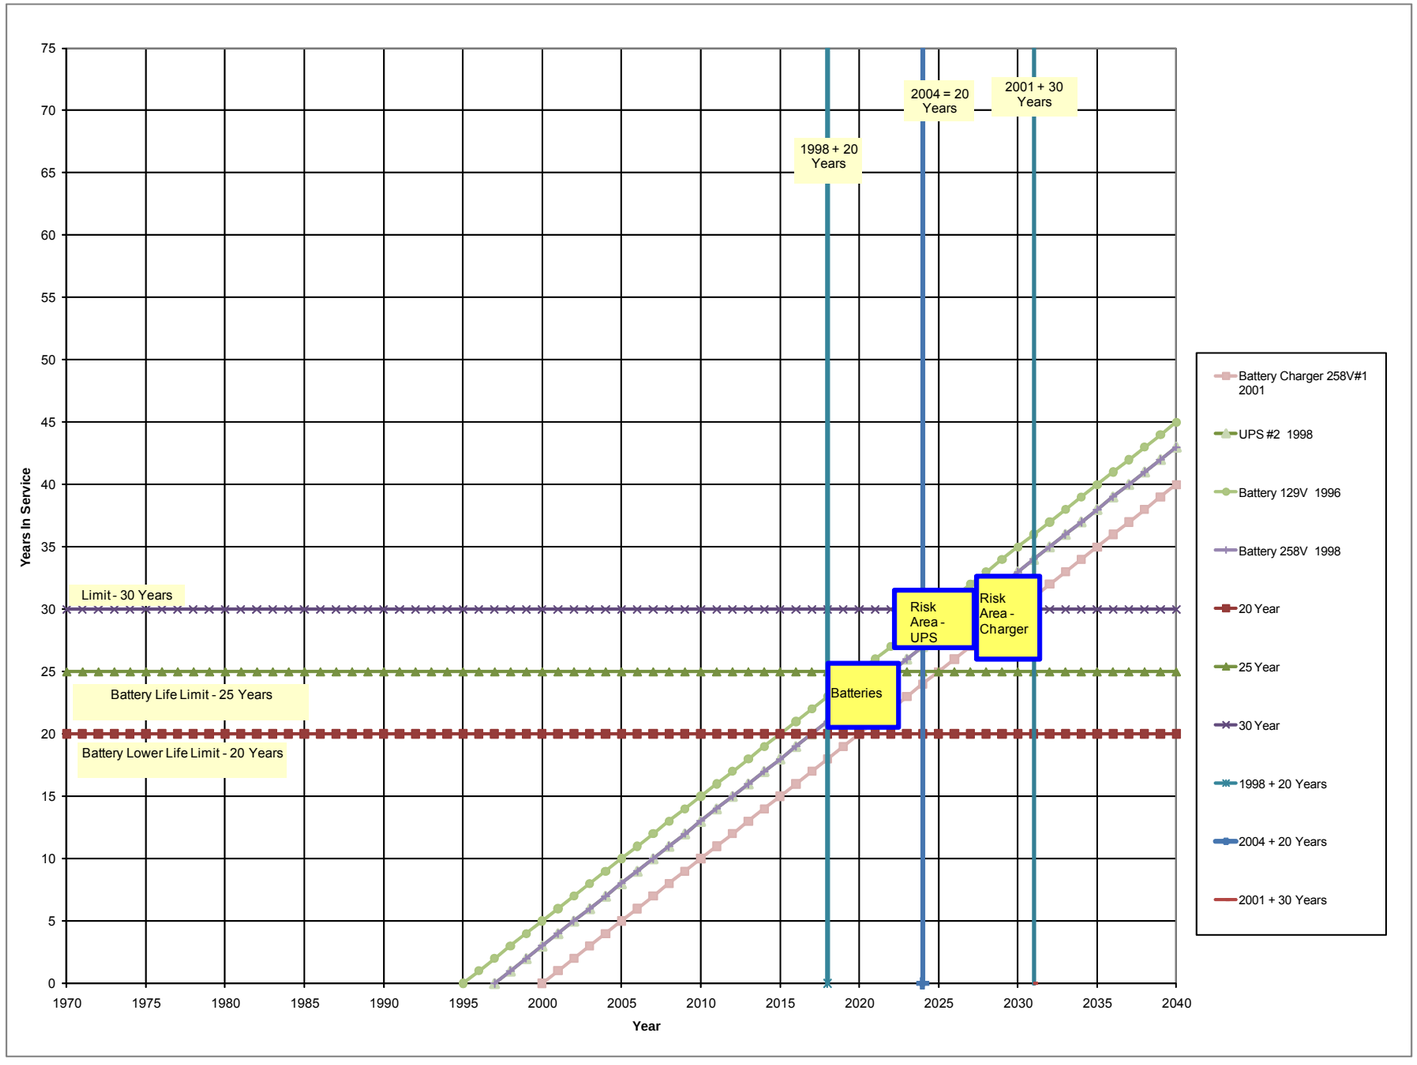
FIGURE 9-6 LIFE CYCLE CURVE – UNIT 2 ELECTRICAL AND CONTROL SYSTEMS ASSOCIATED WITH GENERATORS (MCC'S, RELAYS, BREAKERS, TSI, DCS)

FIGURE 9-7 LIFE CYCLE CURVE – UNIT 2 ELECTRICAL AND CONTROL SYSTEMS ASSOCIATED WITH GENERATORS (BATTERIES AND CHARGERS)

The curves indicate that the remaining life (RL) of much of the equipment does not exceed the desired life (DL) for generation of 2020 and for synchronous condensing of 2041, without extensive refurbishment or replacement. This is well illustrated by the highlighted risk areas which highlights that many original MCC's and relays as well as the TSI are in need or replacement or extensive refurbishment in the very near term. The risk figures also illustrate that most of the rest of the equipment (DCS, batteries, and chargers) will require replacement or refurbishment in the 2020+ period.

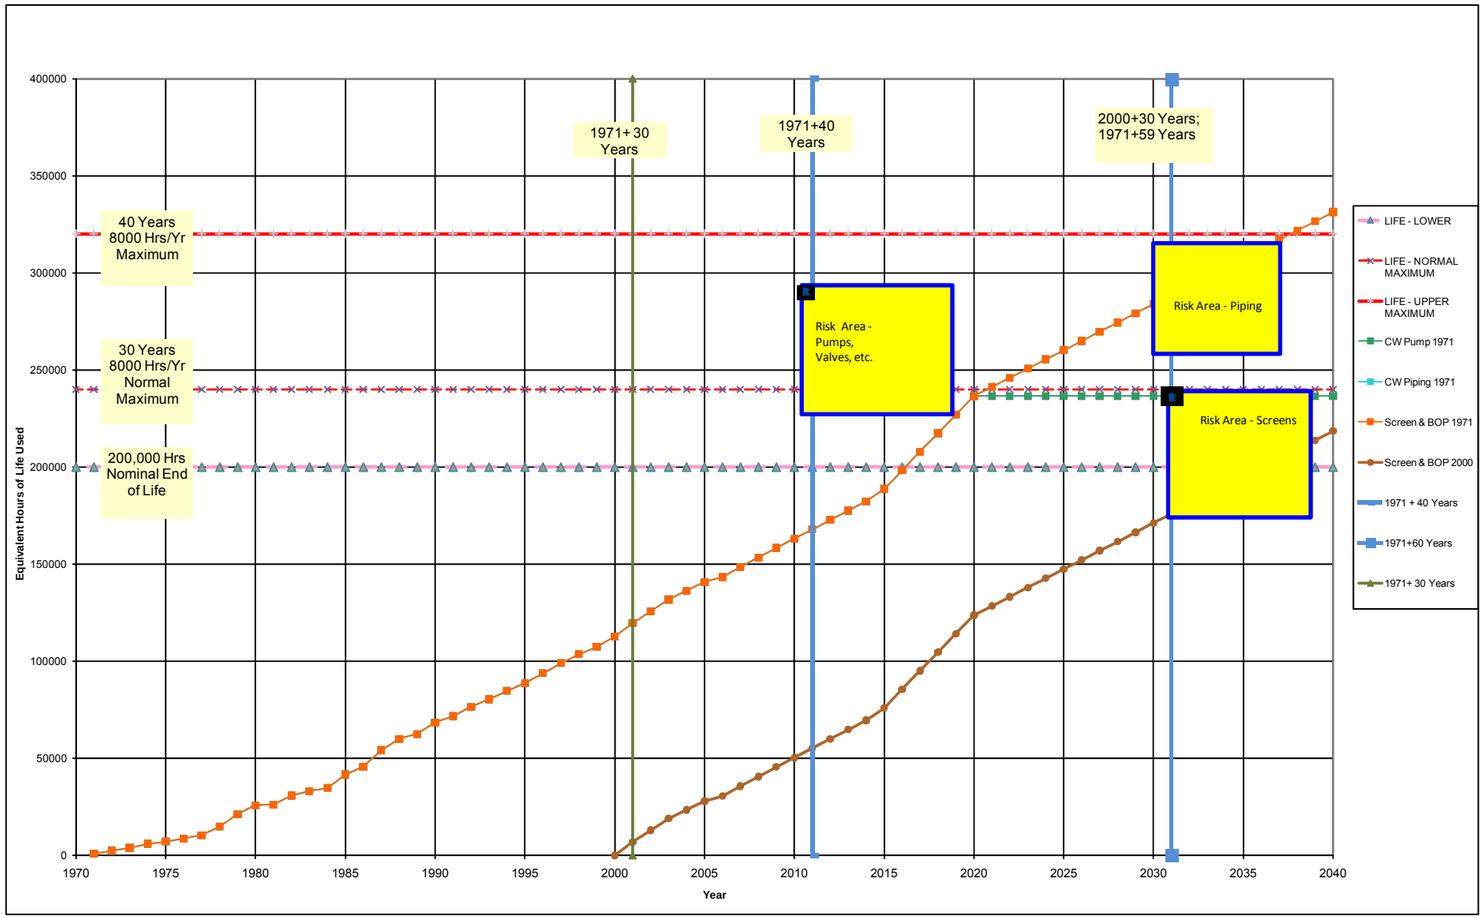
FIGURE 9-9 LIFE CYCLE CURVE – UNIT 2 COOLING WATER SYSTEMS ASSOCIATED WITH GENERATORS

The curve indicates that the remaining life (RL) of most elements of the Unit 2 cooling water systems associated with generators is sufficient to reach the end date of 2020 for generation, but not necessarily the 2041 desired life (DL) end date for synchronous condensing. The CW pumps and associated equipment are the primary nearer term issues highlighted by the risk boxes. The actual end date and remaining life will become clearer through the series of ongoing routine inspections that forms part of the plant's PM program and the Level 2 inspections recommended in the report. The intake and outfall structures and associated sub-components should be added as a result of a Level 2 inspection.

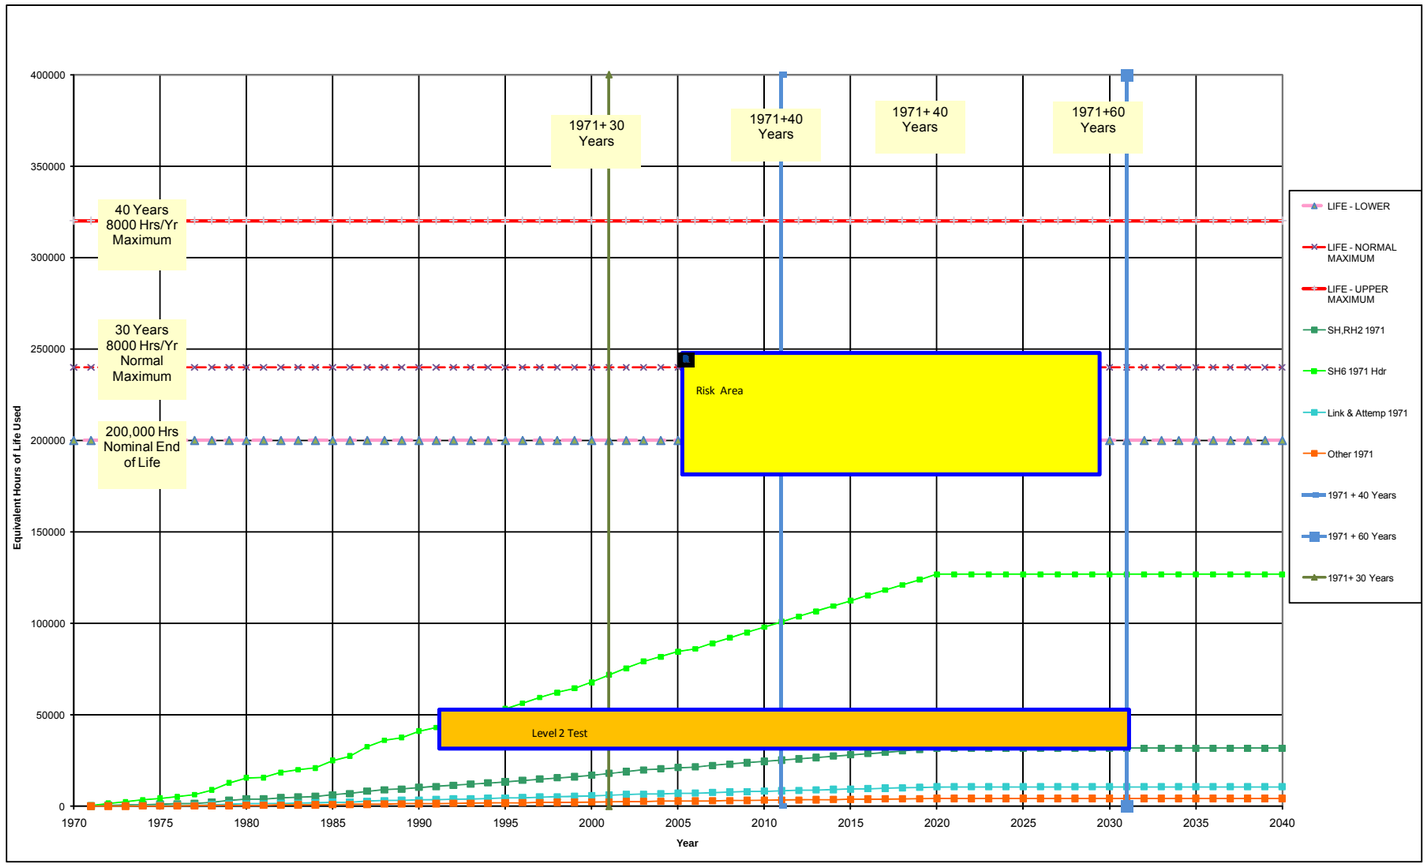
FIGURE 9-10 LIFE CYCLE CURVE – UNIT 2 BOILER SYSTEM – BOILER HEADERS

The header life curves indicate that the remaining life (RL) of the Unit 2 boiler headers and associated components is expected to exceed the desired life (DL) which is the generation end of life in 2020. Nevertheless, it also identifies that some of higher temperature components should undergo a Level 2 inspection (identified later in this section of the report) if not already planned or undertaken.
