Holyrood Thermal Generating Station (Holyrood) Condition Assessment & Life Extension Study, - Final Report

Holyrood Thermal Generating Station
Condition Assessment & Life Extension Study

January 28, 2011

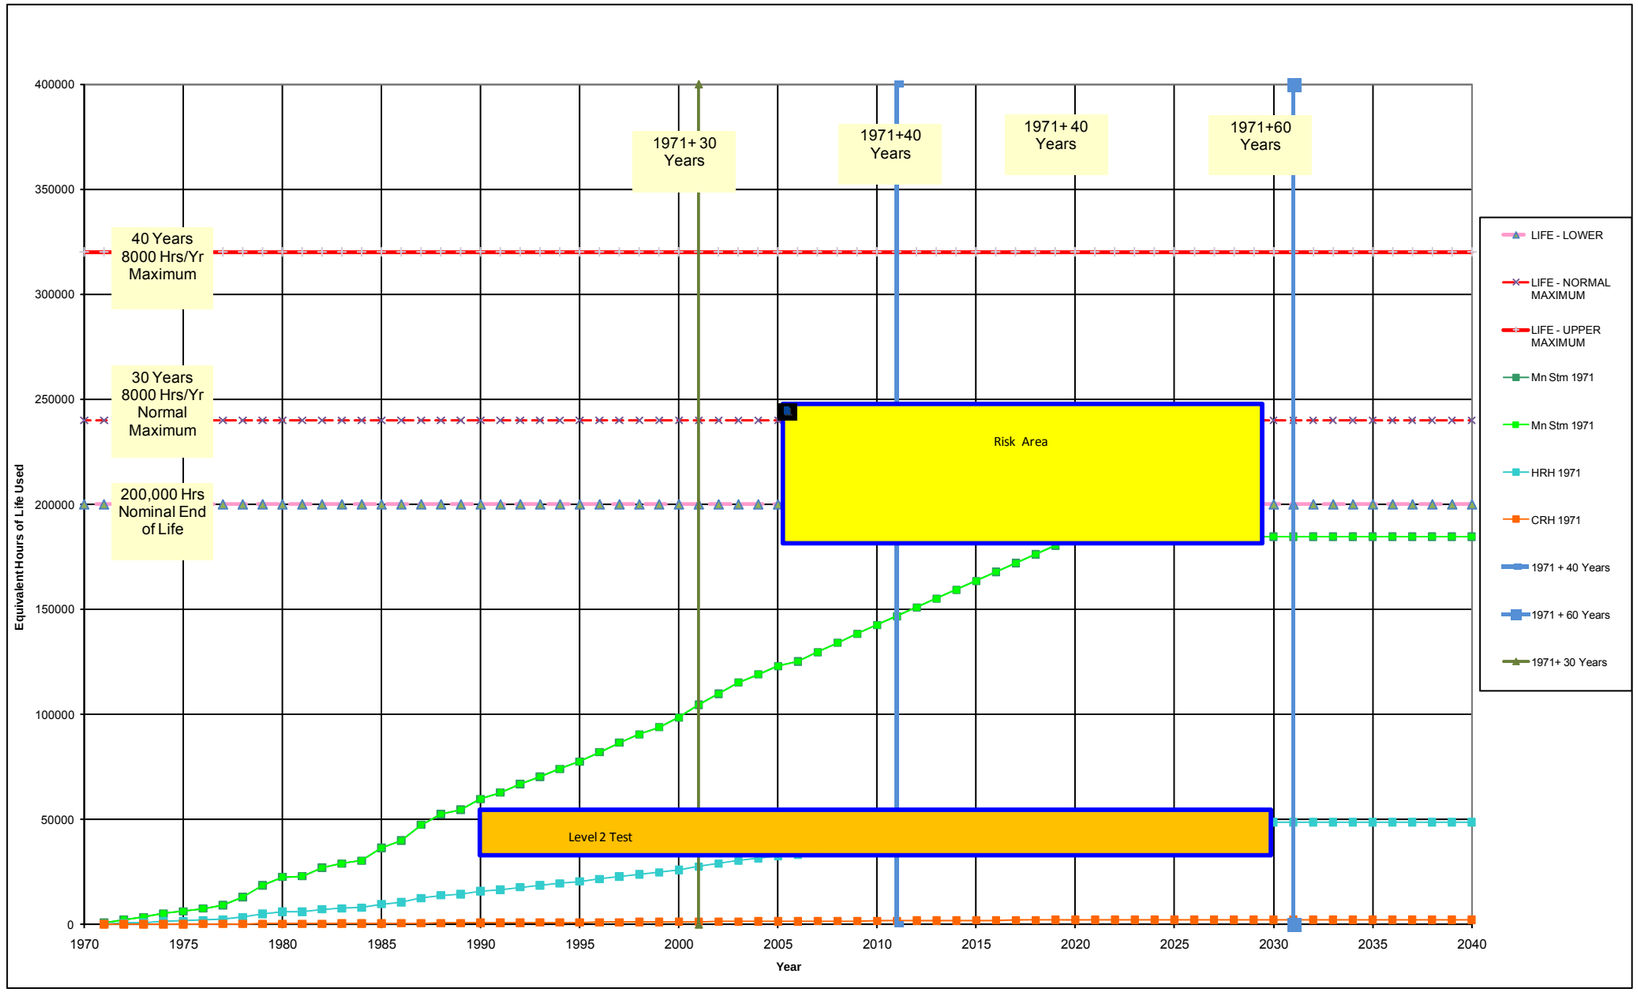
FIGURE 9-11 LIFE CYCLE CURVE – UNIT 2 BOILER SYSTEM – HIGH PRESSURE AND TEMPERATURE STEAM LINES

The high pressure steam line life curves indicate that the remaining life (RL) of the Unit 2 steam lines and their associated components are expected to exceed the desired life (DL) which is the generation end of life in 2020. Nevertheless it also identifies that both the main steam and hot reheat steam lines exceed EPRI’s 10% consumed life guide for a Level 2 inspection of these systems. Given that they have not been tested for some time, this is considered appropriate at this time.

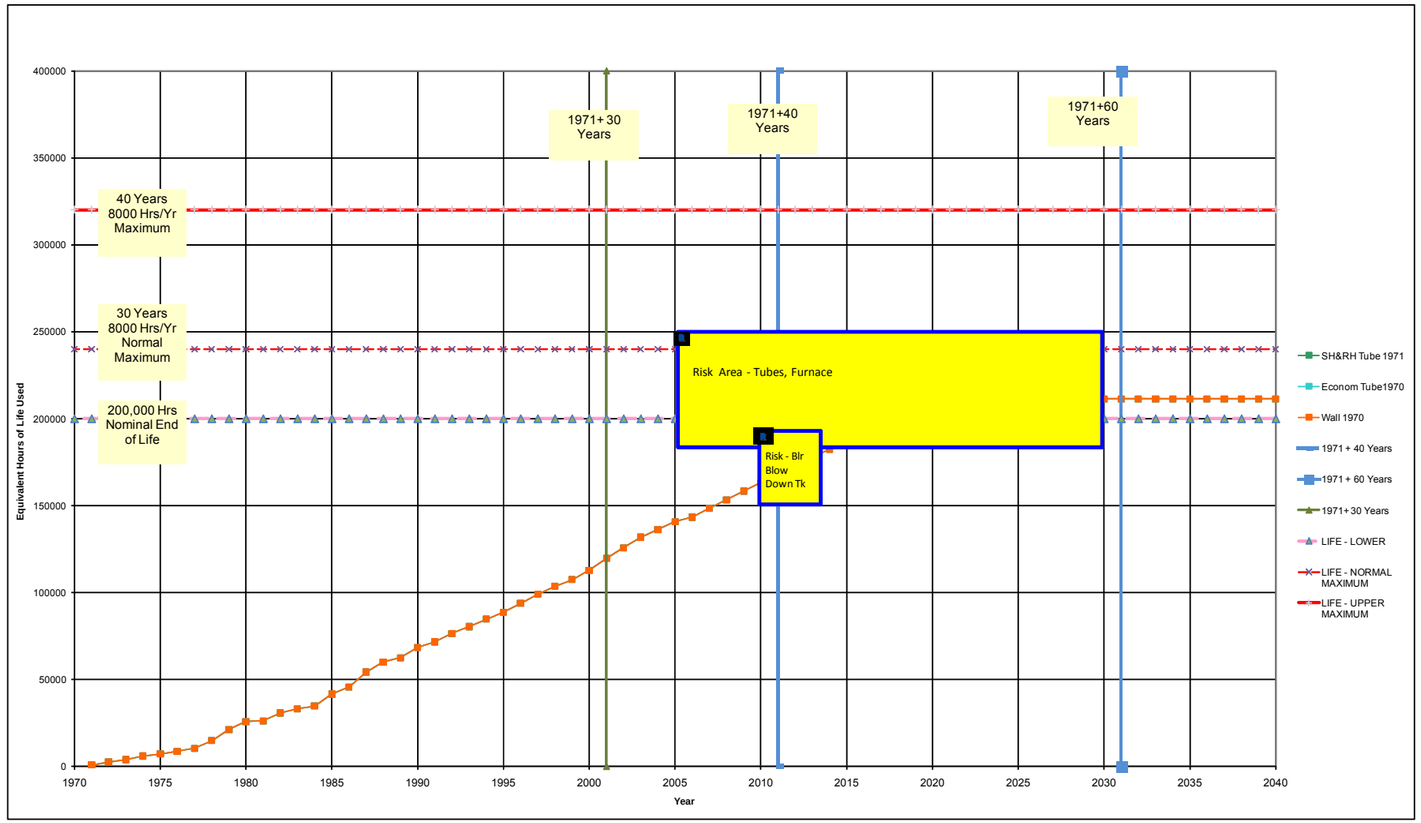
FIGURE 9-12 LIFE CYCLE CURVE – UNIT 2 BOILER SYSTEM (TUBES EXPOSED TO THE COMBUSTION PROCESS, BOILER BLOWDOWN)

The curve indicates that the boiler tubes within the furnace envelope would have been expected to be seeing some end of life component concerns with original equipment. Nevertheless, it is more likely legacy impacts that will have greater effects on component replacements and refurbishments going forward to 2020. With ongoing inspections and refurbishments, 2020 is achievable with good reliability with the new fuel. It also shows that the boiler blowdown tank should be replaced.

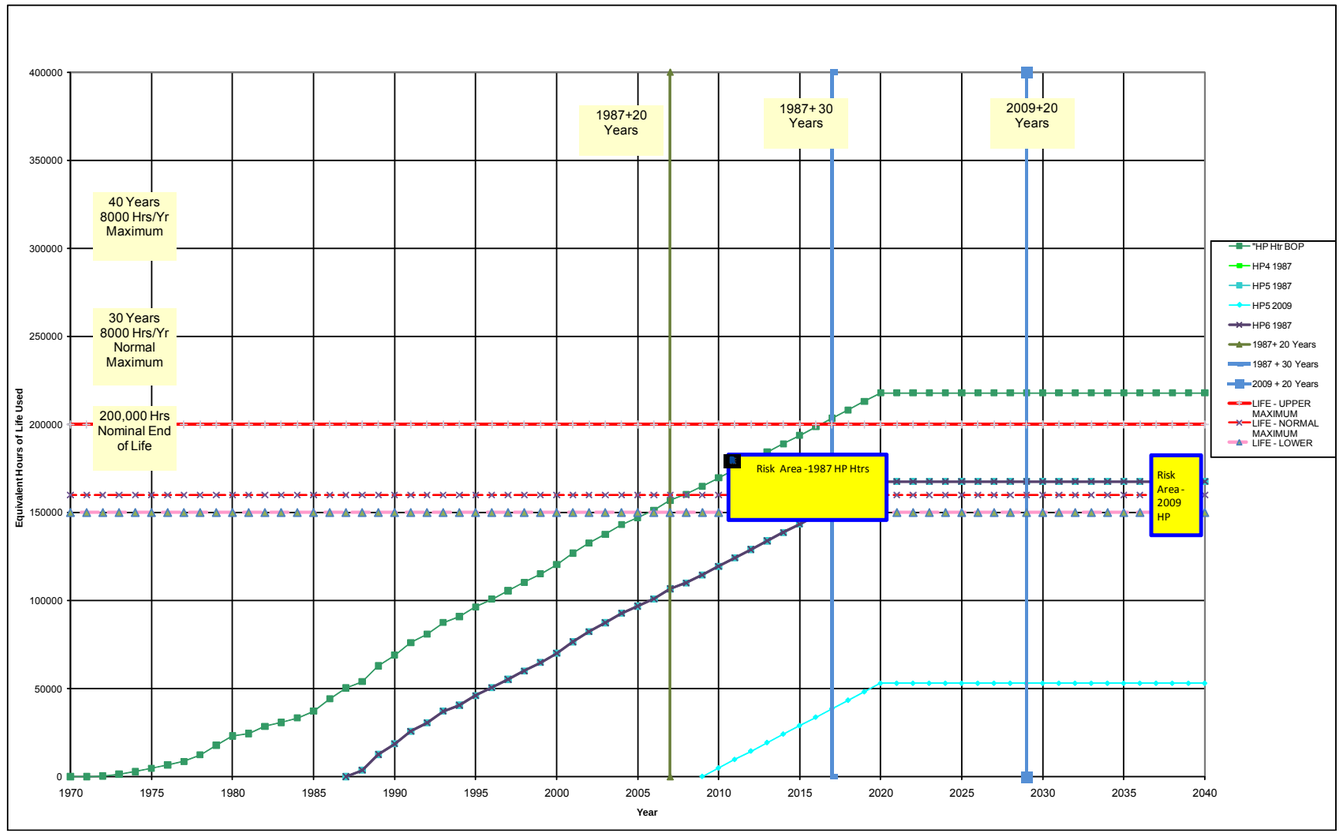
FIGURE 9-13 LIFE CYCLE CURVE – UNIT 2 FEEDWATER SYSTEM - HP FEEDWATER HEAT EXCHANGERS -

The curves indicate that the remaining life (RL) of the Unit 2 HP feedwater heat exchangers (and the associated feedwater systems) may be able to reach the desired life (DL) 2020 end date for generation. Nevertheless, given that no detailed NDE information has been obtained on the HP heat exchangers for some time, a detailed Level 2 inspection is recommended for 2013.

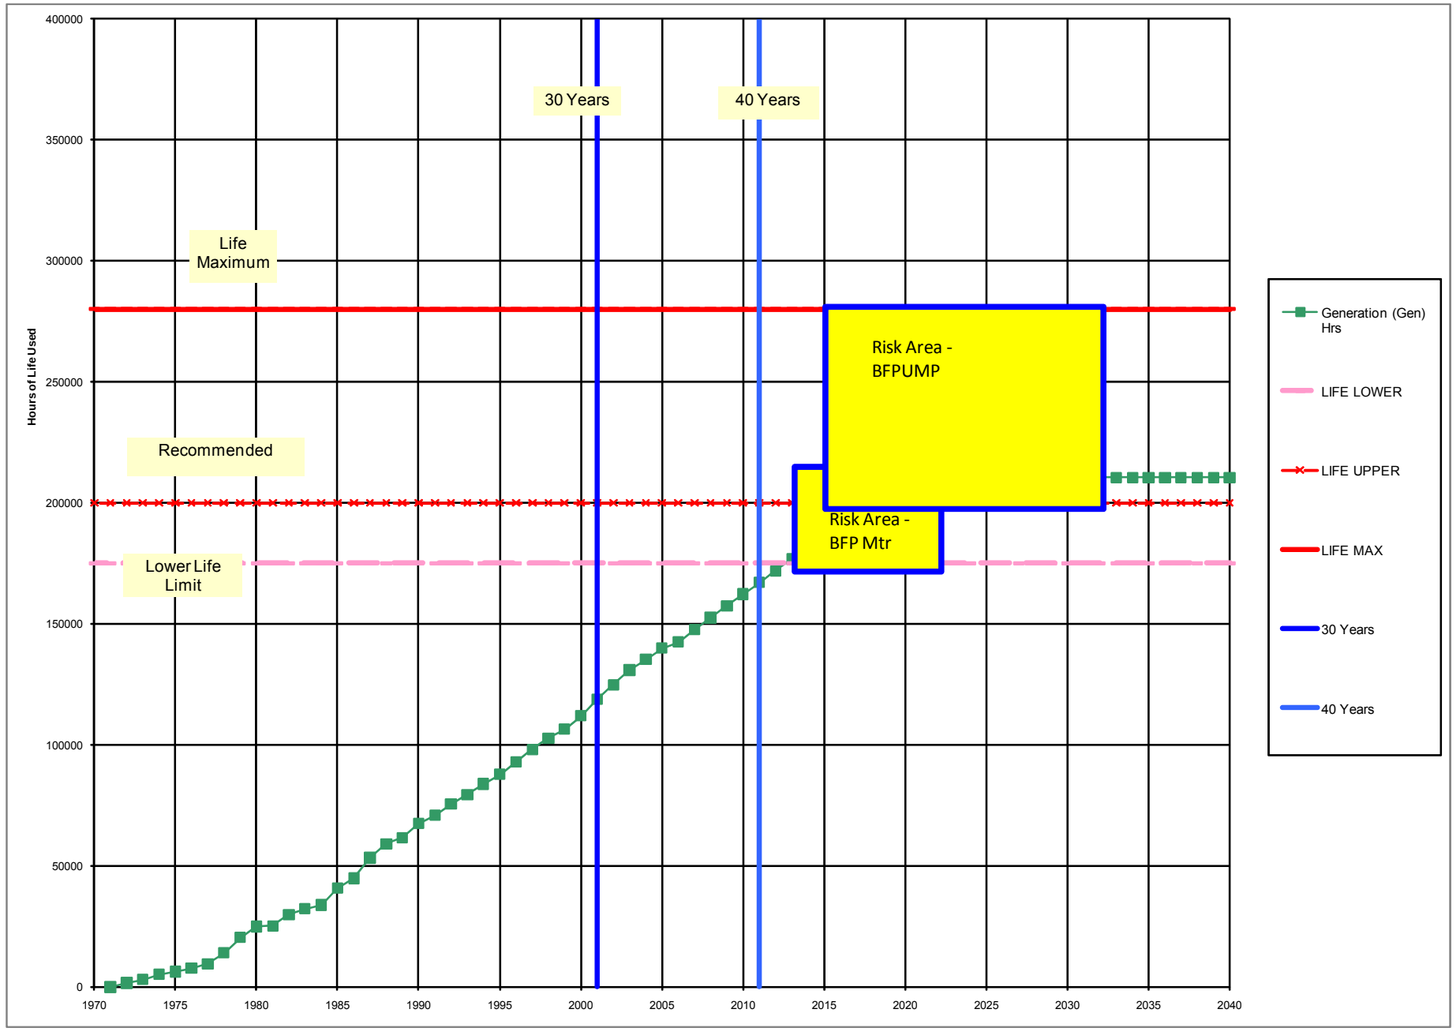
FIGURE 9-14 LIFE CYCLE CURVE – UNIT 2 FEEDWATER SYSTEM - BOILER FEED PUMPS

The curve indicates that the remaining life (RL) of the Unit 2 HP boiler feed pumps is likely able to reach desired end date which is the 2020 end date for generation. Given their six year refurbishment cycle and a spare pump section, they are expected to continue to perform reliably well past the 2020 end date for generation. The BFP motors are approaching older age and entering areas where reliability and unexpected failure may become more an issue than expected life.

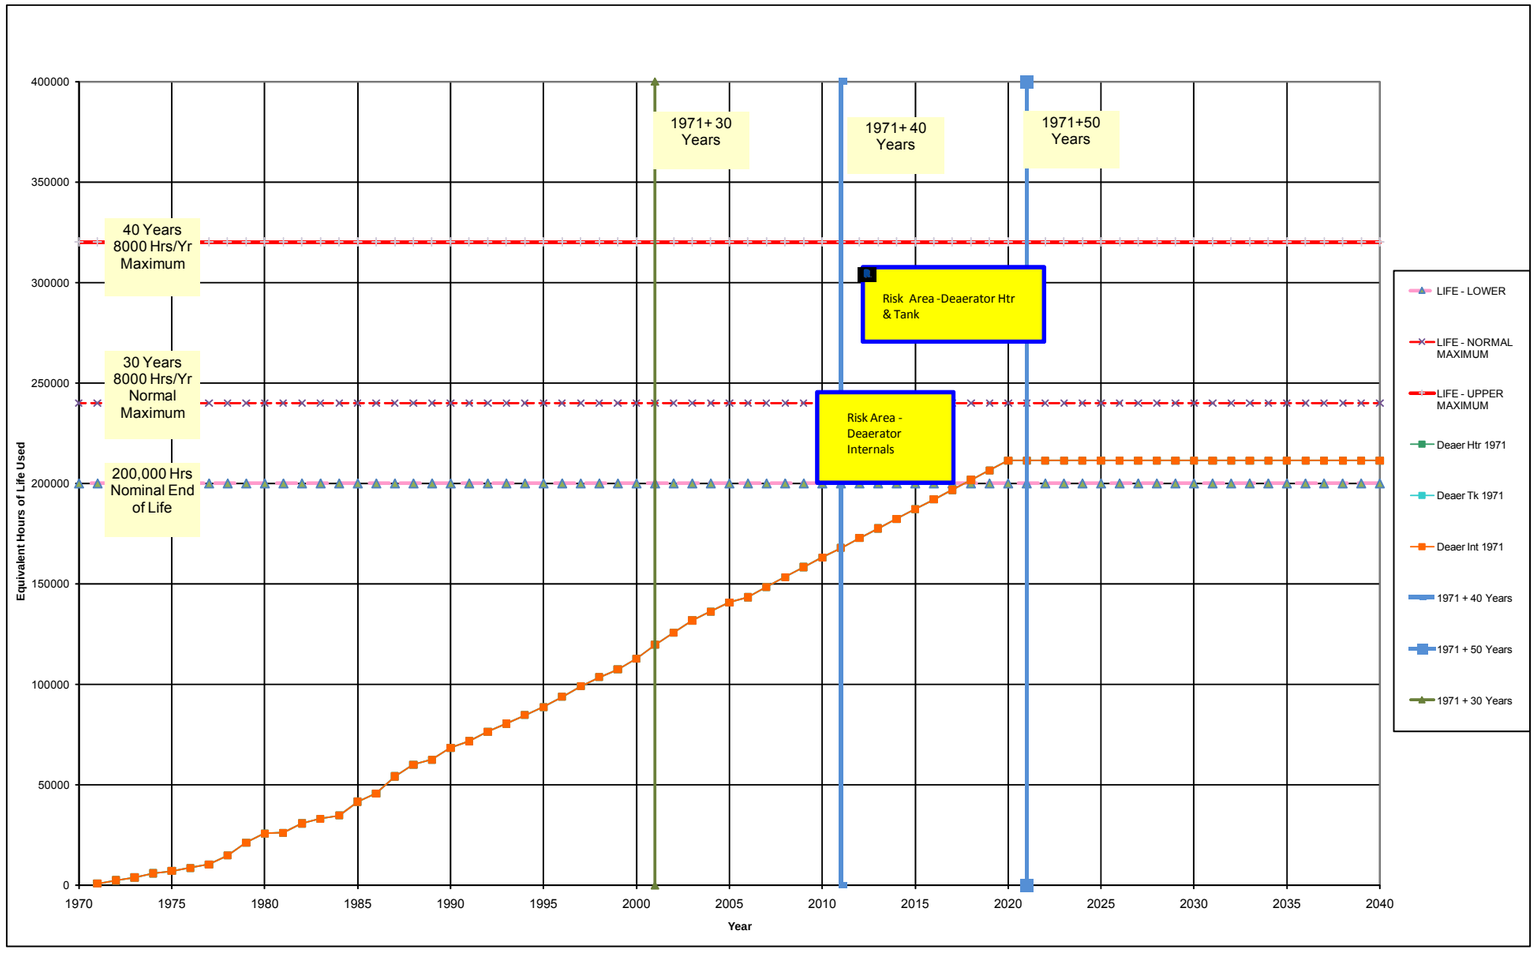
FIGURE 9-15 LIFE CYCLE CURVE – UNIT 2 FEEDWATER SYSTEM - DEAERATOR

The curve indicates that the remaining life (RL) of the Unit 2 feedwater system - deaerator exceeds the desired life (DL) which is end date for generation of 2020, with the potential though unlikely exception of some deaerator internals. The plant inspections form an excellent base of condition information supporting the ability of the deaerator as a whole to meet the EOL date. There is however insufficient detailed inspection information of some of the difficult to reach internals to fully assess their condition. A detailed Level 2 inspection in 2013 is recommended to provide information for that assessment.

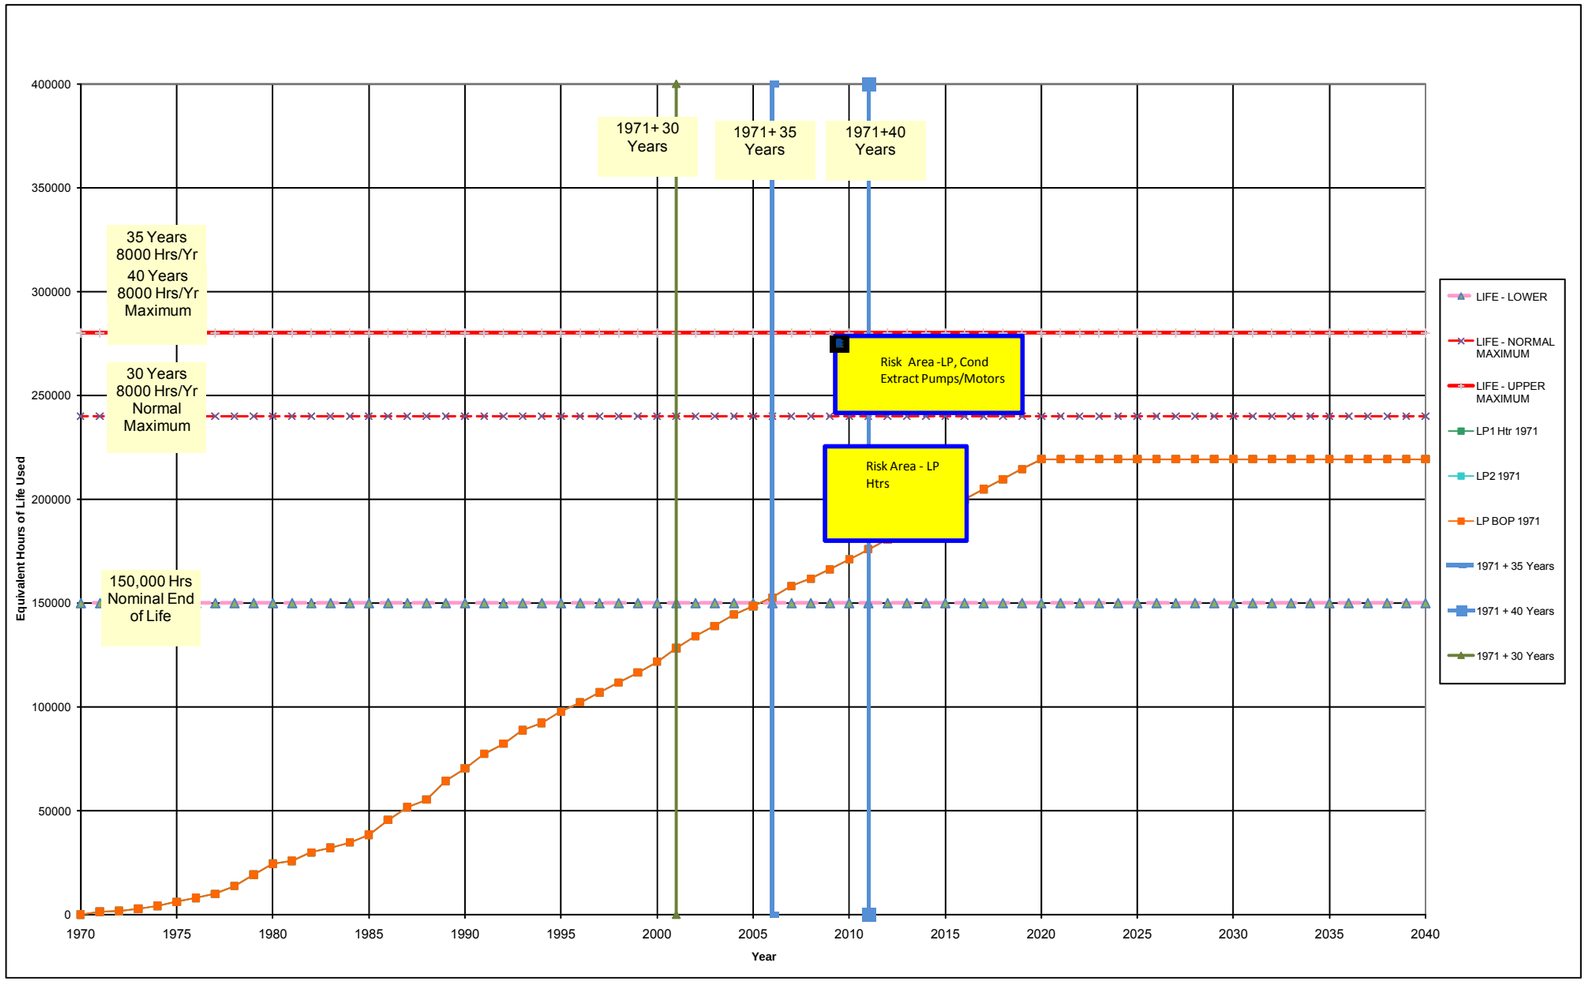
FIGURE 9-16 LIFE CYCLE CURVE – UNIT 2 FEEDWATER SYSTEM - LP FEEDWATER HEAT EXCHANGERS

The curve indicates that the remaining life (RL) of the Unit 2 feedwater system - LP heat exchangers may not be able to reach the desired life (DL) 2020 end date for generation. Given that no detailed NDE information has been obtained on the LP heat exchangers, a detailed Level 2 inspection is recommended for 2011.

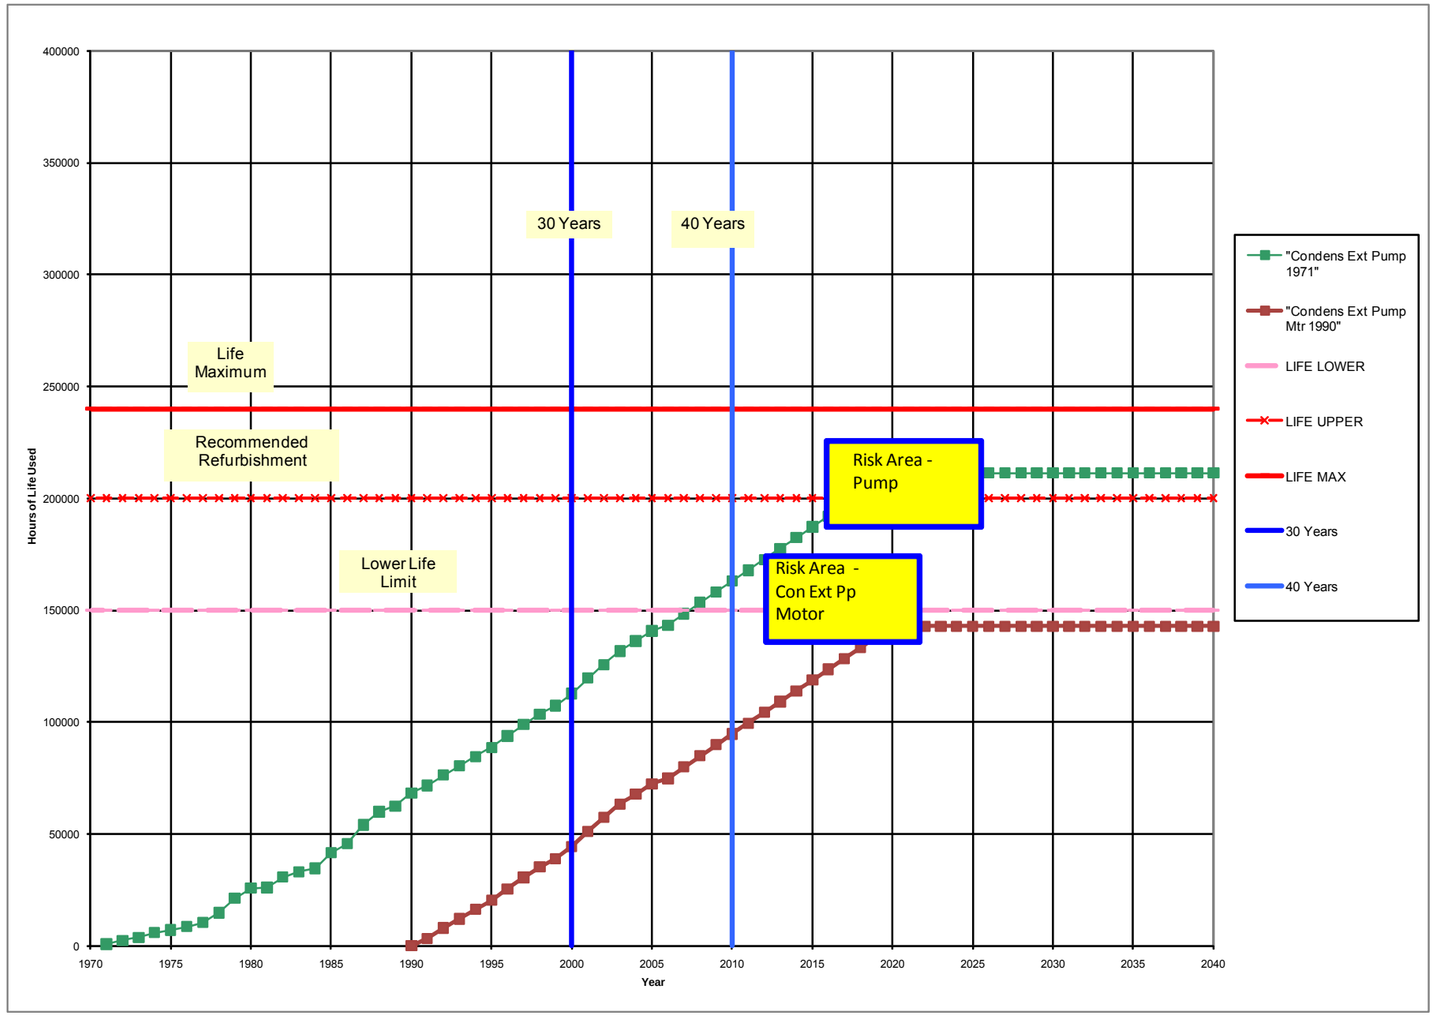
FIGURE 9-17 LIFE CYCLE CURVE – UNIT 2 CONDENSATE EXTRACTION SYSTEM

The curves indicate that the remaining life (RL) of the condenser condensate extraction pumps and motors can likely be able to reach the desired life (DL) 2020 end date for generation. The condensate extraction pump motors are expected however to be entering a period of higher unreliability.

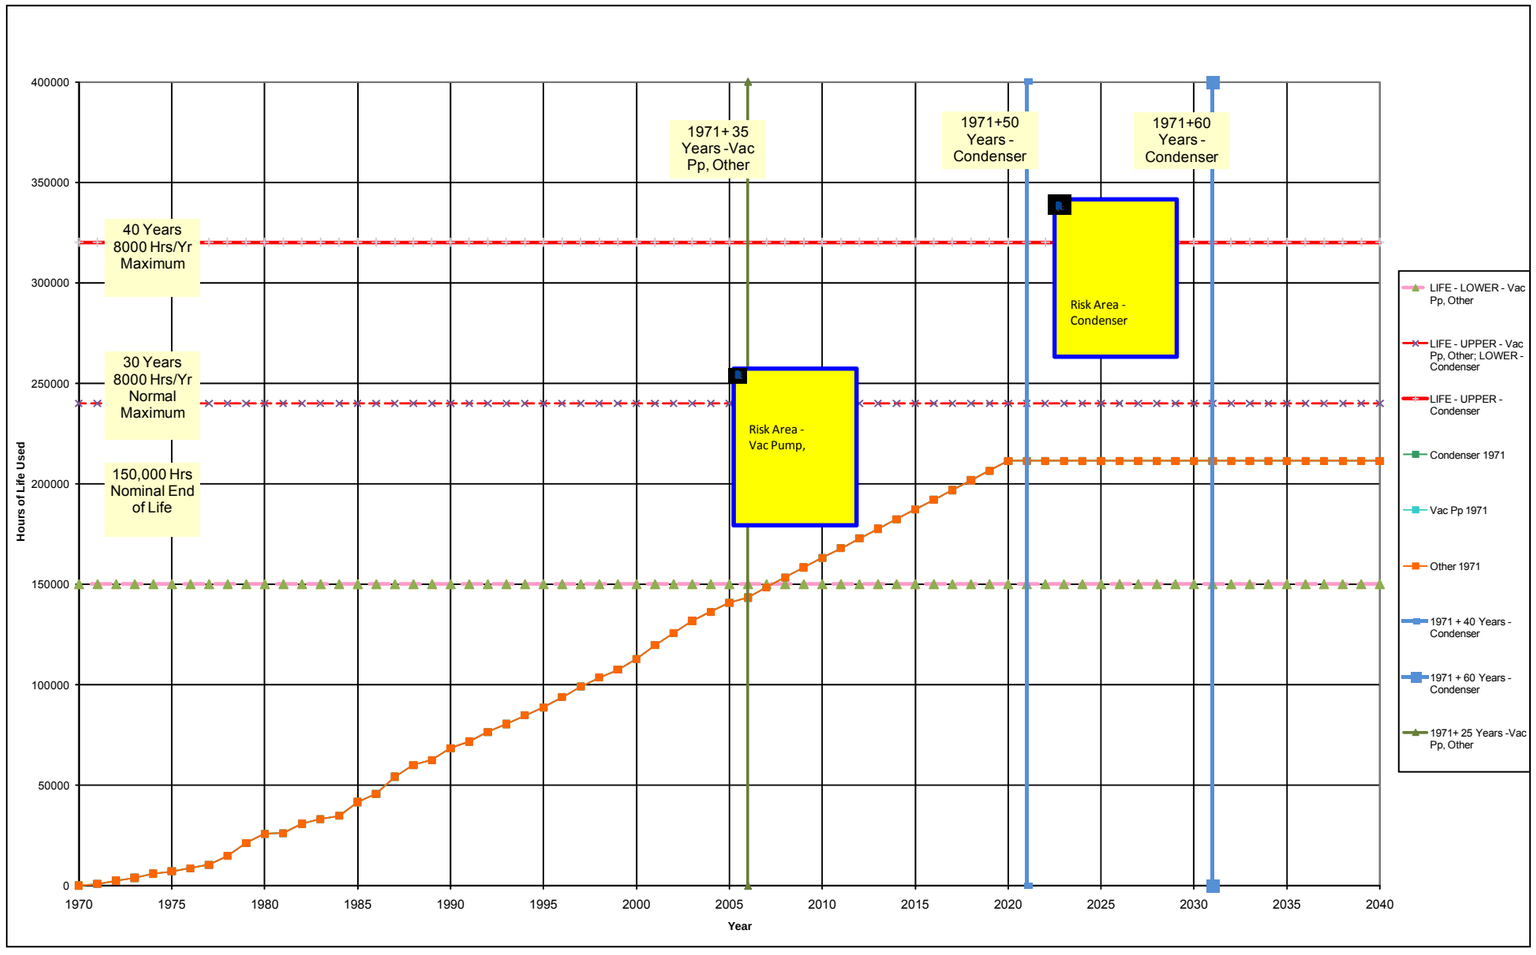
FIGURE 9-18 LIFE CYCLE CURVE – UNIT 2 CONDENSER

The curves indicate that the remaining life (RL) of the Unit 2 condenser can easily reach the desired life (DL) 2020 end date for generation. The exception to this, as illustrated by the risk boxes, is the vacuum pumps. These are original equipment, and likely at or near end of life.

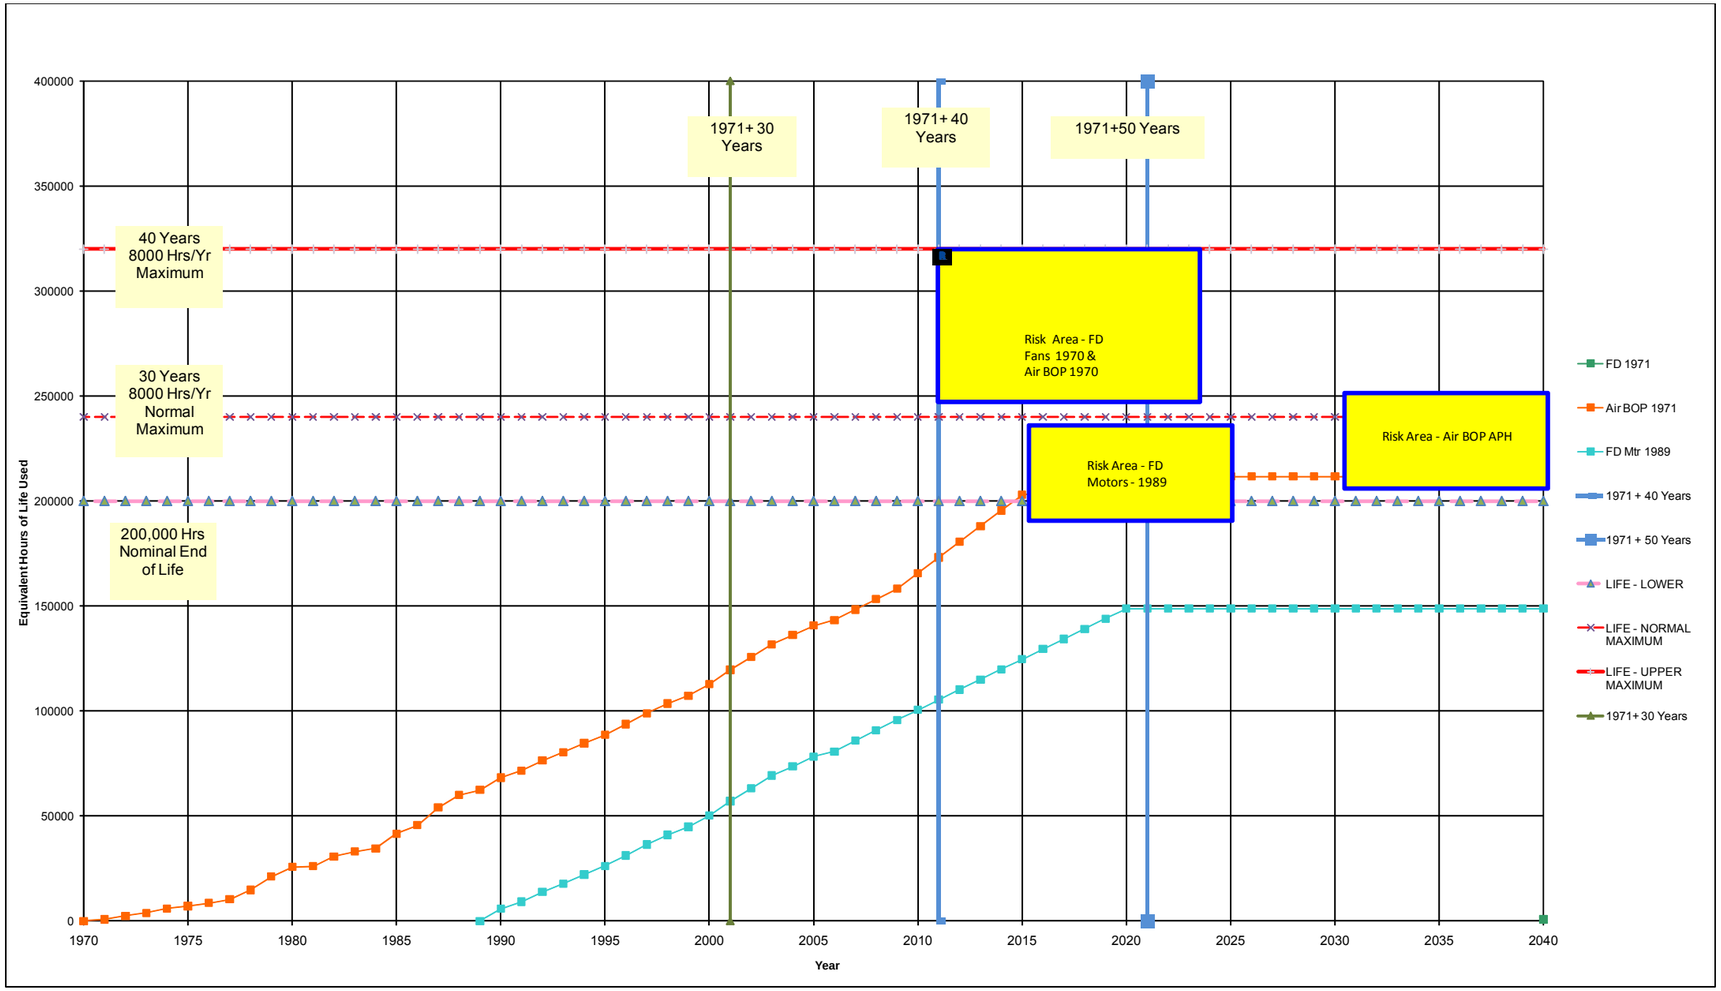
FIGURE 9-19 LIFE CYCLE CURVE – UNIT 2 FD FANS (AND SYSTEM)

The curves indicate that the remaining life (RL) of the Unit 2 FD fans (and system) is expected to meet or exceed the desired life (DL) 2020 end date for generation. The age of the large 4 kV motors makes them a logical cost-effective candidate for sparing to ensure reliability, although plant testing/monitoring programs are effectively monitoring their status.

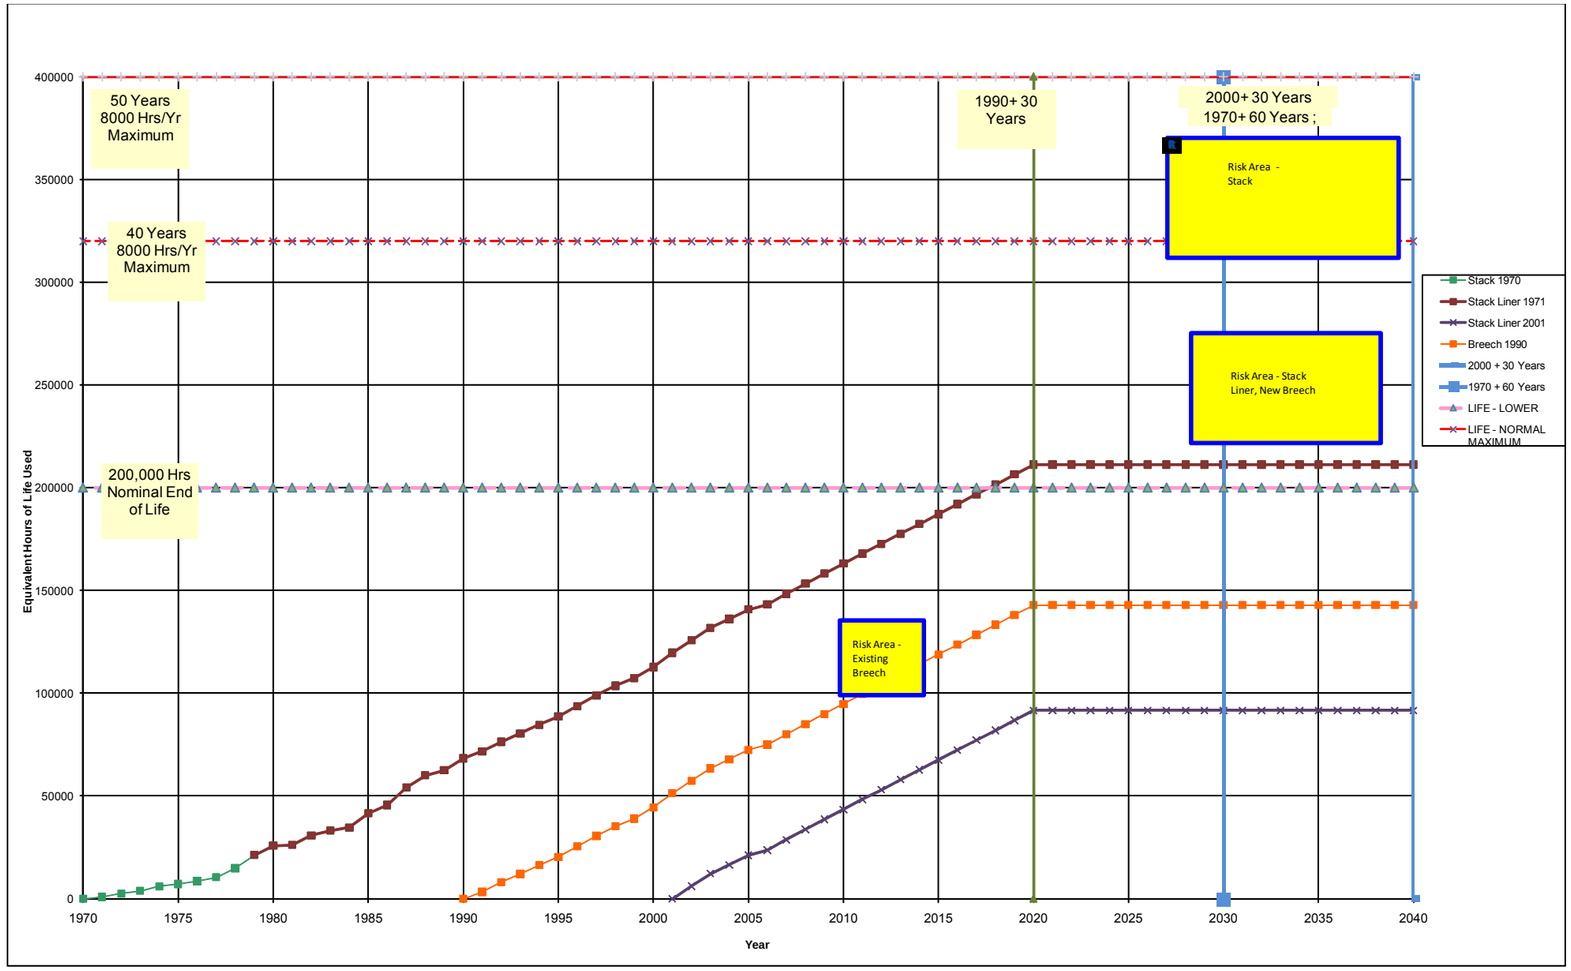
FIGURE 9-20 LIFE CYCLE CURVE – UNIT 2 STACK AND BREECHING

The curves indicate that the remaining life (RL) of the Unit 2 stack is able to reach the desired life (DL) 2020 end date for generation, as well as the end date of 2040 for synchronous condensing/plant life. It does show that the stack breeching is in need of immediate repair. The breeching requirement is not a normal life issue, but one of poor design. Other elements can achieve the 2020 end date for generation with the ongoing plant maintenance program.

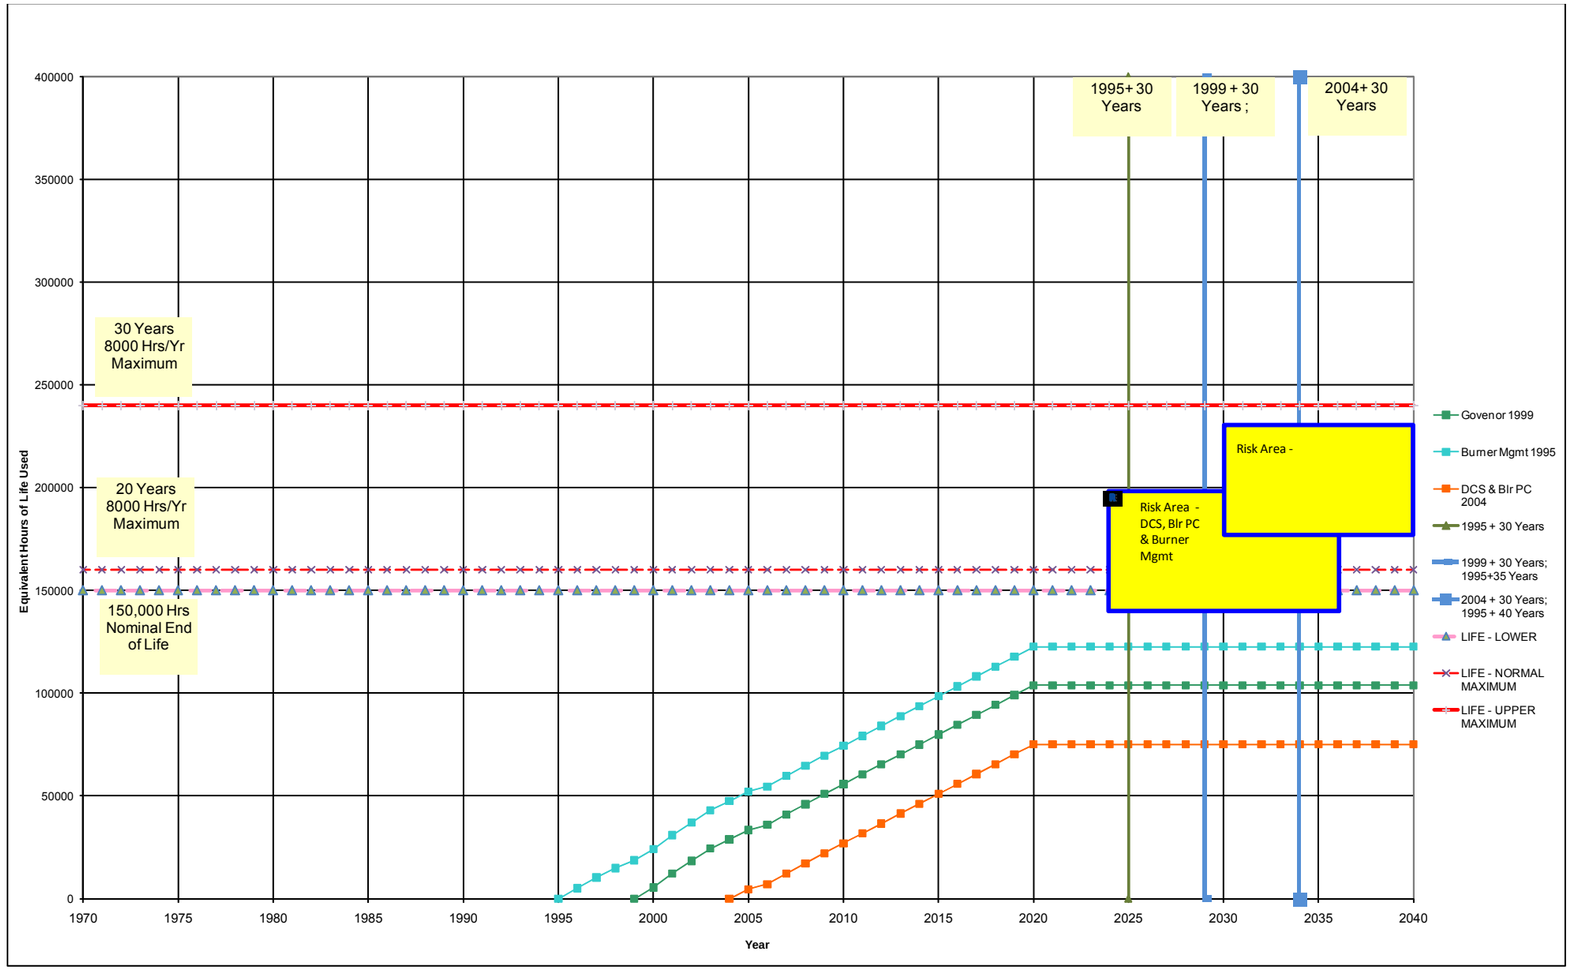
FIGURE 9-21 LIFE CYCLE CURVE – UNIT 2 ELECTRICAL AND CONTROL SYSTEMS (INCLUDING DCS) ASSOCIATED WITH STEAM SYSTEMS

The curves indicate that the remaining life (RL) of the Unit 2 control systems (including DCS) associated with steam systems can readily reach the desired life (DL) 2020 end date for generation, provided regular inspection and service per the station PM plan is maintained. The electrical systems, particularly breakers and motor controls are addressed in more detail as part of Section 9.1.3. It is clear that in order to meet the end date for generation service, some of these systems must be replaced or in some cases refurbished.

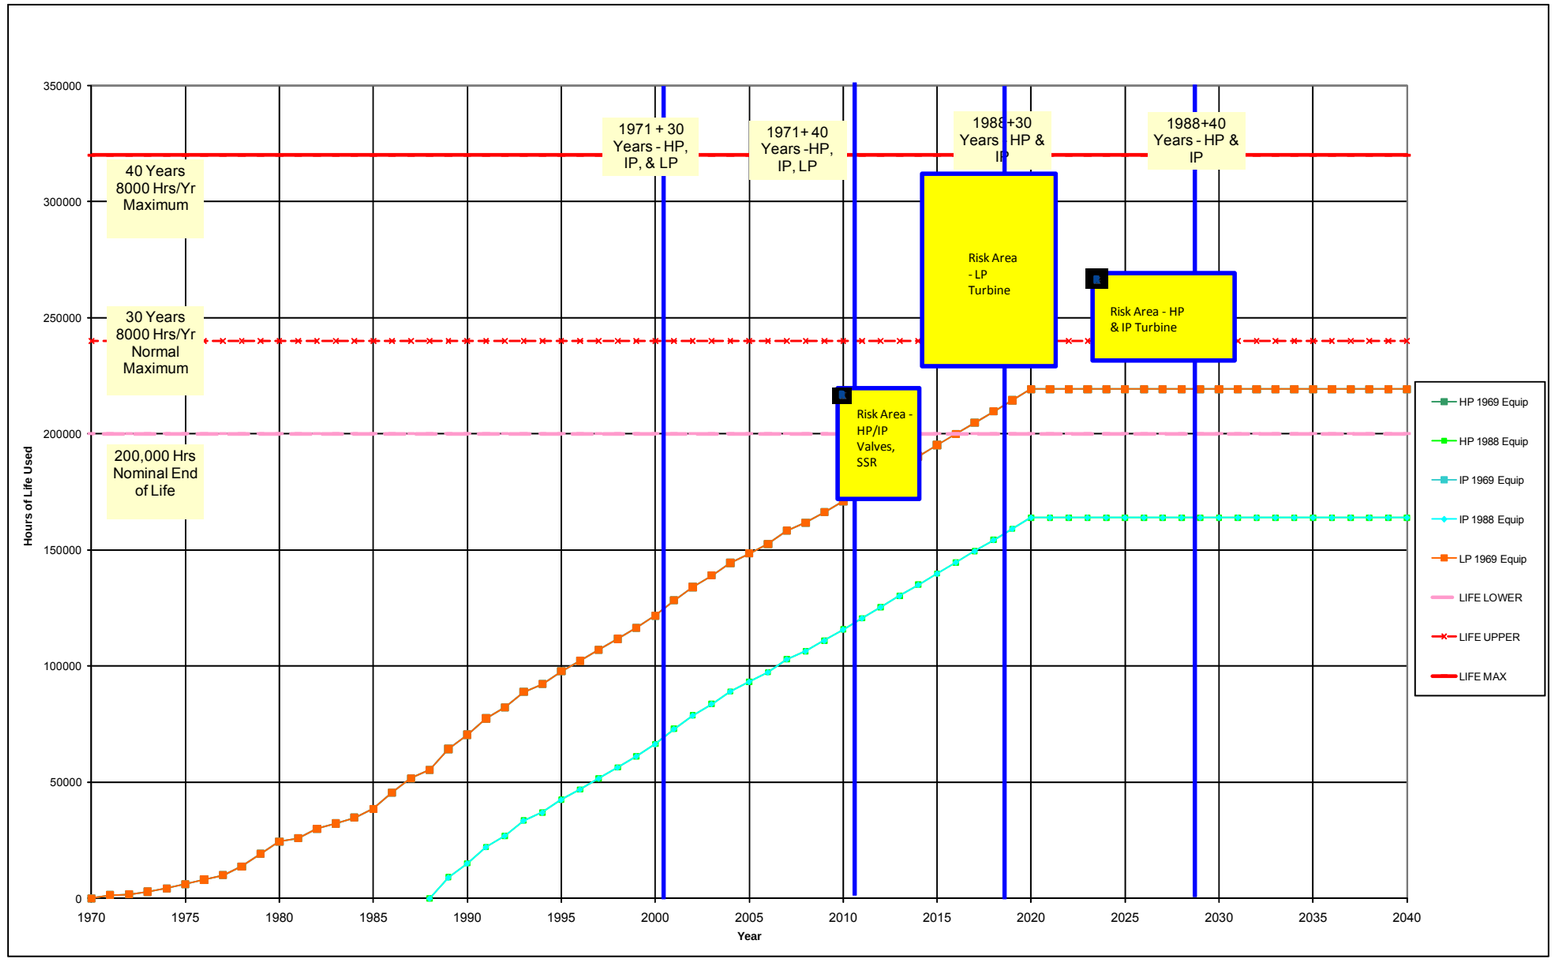
FIGURE 9-22 LIFE CYCLE CURVE – UNIT 2 STEAM TURBINE

The curves indicate that the remaining life (RL) of the various elements of the Unit 2 steam turbine exceeds the desired life (DL) which is the lesser of the time to its next major planned overhaul/inspection (2014) or to the desired End of Life (EOL) date of 2020. In fact, the 2020 end date should be readily achievable. Hence, no specific dedicated Level 2 is required, but sufficient inspection and testing will be required in the 2014 overhaul to confirm the ability to meet the 2020 EOL date. The exception to that are the HP and IP valves which continue to have reliability and life issues, the steam seal regulator, as well potentially as high temperature stud bolts. It is clear that the current inspection schedule seems suitable.

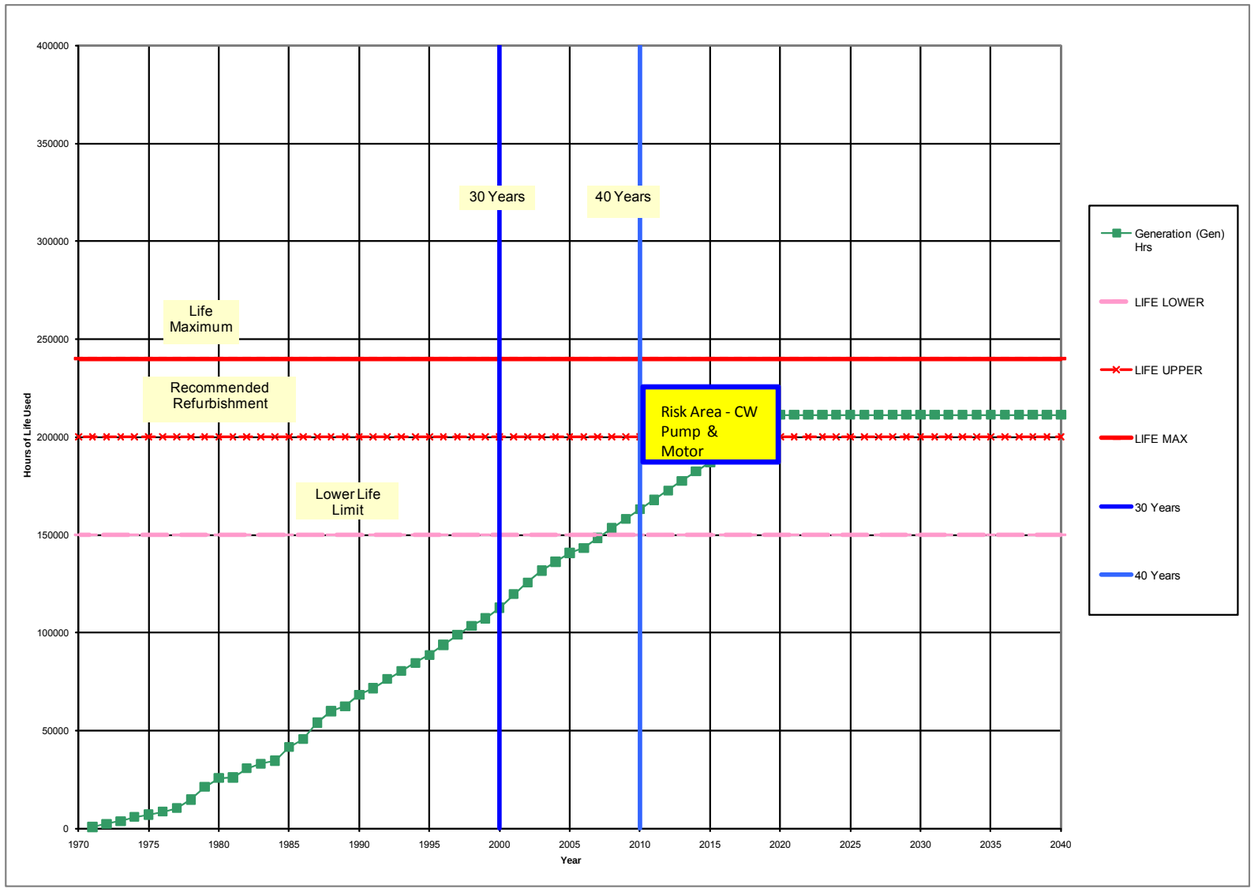
FIGURE 9-26 LIFE CYCLE CURVE – UNIT 2 COOLING WATER SYSTEM - ASSOCIATED WITH STEAM SYSTEMS

The curves indicate that the remaining life (RL) of the Unit 2 cooling water system - associated with steam systems can likely reach the desired life (DL) end date for generation of 2020, but with some reliability risk, particularly as it pertains to the 4 kV motors. It is recommended that a spare motor shared between units would be a reasonable precaution. Corrosion of the steel pipe, valves, and fittings was also evident suggesting that some maintenance on these issues is required.

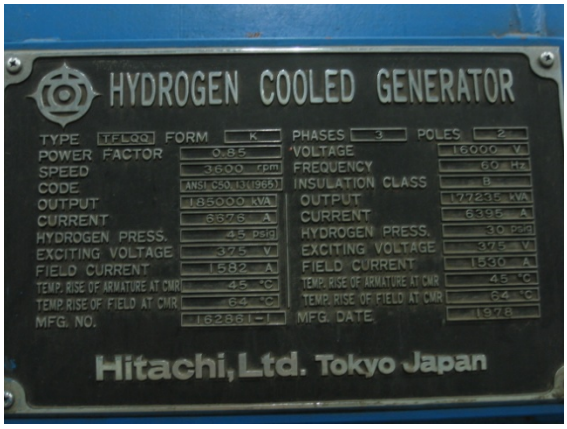
FIGURE 10-1 UNIT 3 GENERATOR

The Unit 3 generator and its auxiliary systems are in reasonably good condition for their age.

- Stator Core: satisfactory, based on EI-cid test results;
- Stator Windings: satisfactory after 29 years, but the re-wedged bars are likely to loosen again;
- Rotor forging: Not known - no NDE checks have been done for 14 years or more. (concerns are based on design details);
- Field winding: satisfactory, per CGE report 2001, (there are some concerns, based on experience with similar Hitachi and GE generators in Canada); and

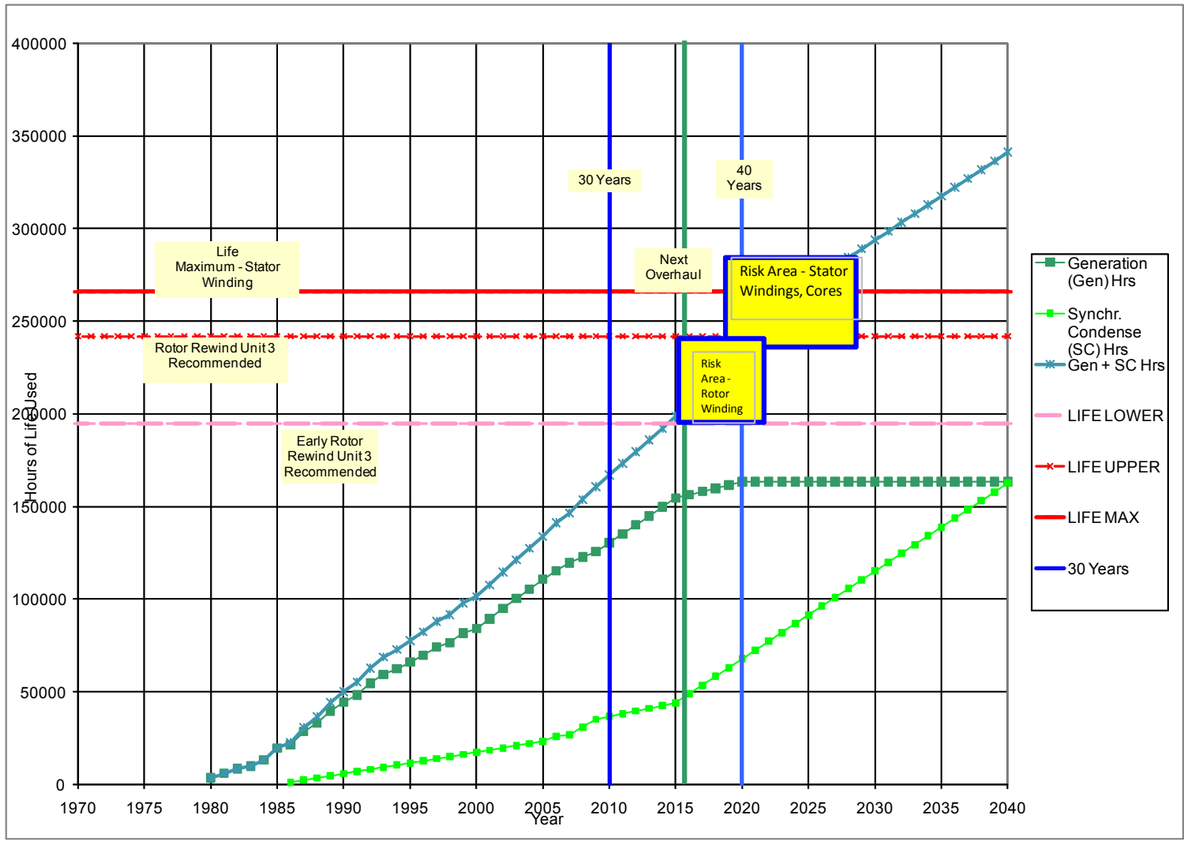
FIGURE 10-4 LIFE CYCLE CURVE – UNIT 3 GENERATOR

The generator figure below shows the operating hours as an electricity generator, in synchronous condensing mode, as well as the sum of the two. Only one set of curves is required, given that the major elements of the generator (stator and rotor windings and core) and the hydrogen system are the same age. One vertical line illustrates the timing of the next generator overhaul in 2016. The lowest two horizontal lines represent the ranges of expected generator life (primarily the rotor winding) for Holyrood Unit 3 based on current and historical information and expert opinion. The “Early Rotor Rewind Unit 3 Recommended” line is based on an estimated minimum remaining reliable rotor winding life of seven years at current generation levels. The other two represent longer rotor winding lives that may be achievable with decreasing reliability and higher failure risk, as well as a maximum 20 years likely for the stator and rotor cores.

The “Rewind Unit 3 Recommended” line is based on the estimated remaining reliable rotor and stator winding life of five years at current generation levels. The other two represent longer lives that may be achievable with decreasing reliability and higher failure risk. The two upper lines also represent a longer assessment of the remaining life of the rotor winding and maximum 20 years likely for the stator and rotor cores. The same curves apply as no major changes in equipment have taken place to date.

The curves indicate that the remaining life (RL) of the Unit 3 generator exceeds the desired life (DL) of 2016, which is the lesser of the time to its next major planned overhaul/inspection (2016) or to the desired End of Life (EOL) date of 2041. Thus no specific dedicated Level 2 is required, but sufficient inspection and testing will be required in the 2016 overhaul to assess key issues with the rotor windings, rotor core, and stator windings. The primary issue will be whether a rotor rewind is necessary in or about 2020. The remaining life (RL) of the Unit 3 generator exciter does not exceed the desired life (DL) and in fact has exceeded its normal expected life and should be replaced as soon as practical to meet the desired life of 2041.The highlighted near term risk areas include the rotor winding, exciter, the rectifying transformer, and BOP equipment. The curve also suggests that a nine year time between generator overhauls is impractical at this time in the generator's life and should be a six year cycle.
