Holyrood Thermal Generating Station (Holyrood) Condition Assessment & Life Extension Study, - Final Report

Holyrood Thermal Generating Station
Condition Assessment & Life Extension Study

January 28, 2011

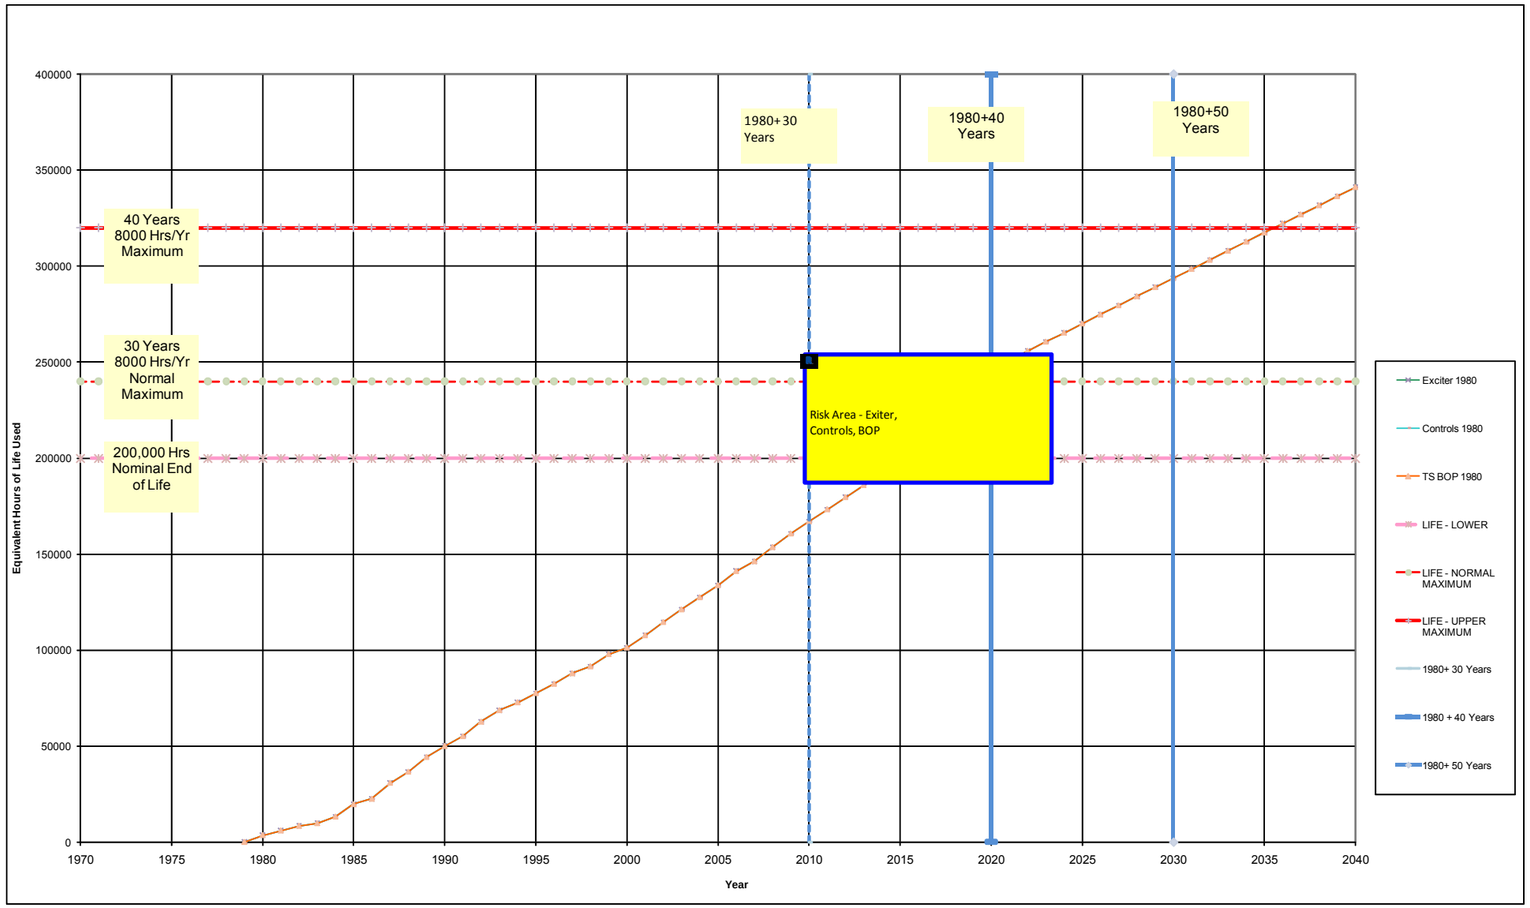
FIGURE 10-5 LIFE CYCLE CURVE – UNIT 3 GENERATOR - EXCITER

The exciter figure shows only the total operating hours as an electricity generator plus in synchronous condensing mode. It has one curve for the original equipment

The curves indicate that the remaining life (RL) of the Unit 3 generator exceeds the desired life (DL) of 2016, which is the lesser of the time to its next major planned overhaul/inspection (2016) or to the desired End of Life (EOL) date of 2041. Thus no specific dedicated Level 2 is required, but sufficient inspection and testing will be required in the 2016 overhaul to assess key issues with the rotor windings, rotor core, and stator windings. The primary issue will be whether a rotor rewind is necessary in or about 2020. The remaining life (RL) of the Unit 3 generator exciter does not exceed the desired life (DL) and in fact has exceeded its normal expected life and should be replaced as soon as practical to meet the desired life of 2041.The highlighted near term risk areas include the rotor winding, exciter, the rectifying transformer, and BOP equipment. The curve also suggests that a nine year time between generator overhauls is impractical at this time in the generator's life and should be a six year cycle.

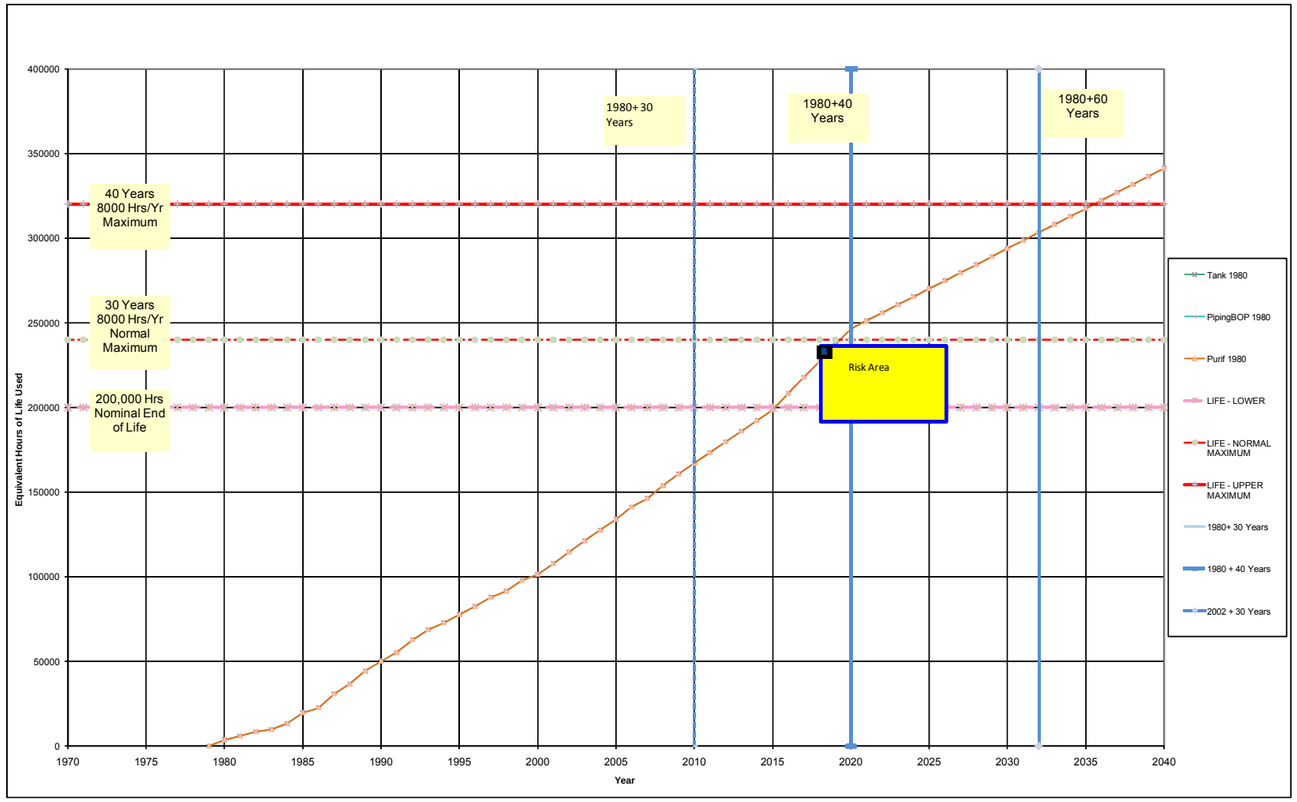
FIGURE 10-6 LIFE CYCLE CURVE – UNIT 3 GENERATOR LUBE OIL SYSTEM

Figure 10-6 below illustrates the life cycle curve for the Unit 3 generator lube oil system. One curve is required, given that the major elements of the lube oil system are approximately the same age. There is insufficient information to develop specific accurate curves for the storage tank. Further detailed examination during the 2016 turbine overhaul should provide the basis going forward. The life curve is a plot of current and projected operating hours (generation plus synchronous condensing mode0 on the y-axis versus calendar year on the x-axis. Vertical lines represent bands of nominal years of normal base loaded life (typically 200,000 operating hours, thirty years and 200,000 to 240,000 operating hours, and forty years, and 280,000 to 320,000 operating hours). Horizontal lines represent the ranges of equipment life based on current and historical information and expert opinion. The risk area box provides an indication of the timing of potential issues either from an age or equivalent operating hours view.

The curves indicate that the remaining life (RL) of the Unit 3 generator lube oil system exceeds the desired life (DL) which is the lesser of the time to its next major planned overhaul/inspection (2016) or to the desired End of Life (EOL) date of 2041. Thus no specific dedicated Level 2 is required of the system as a whole, but sufficient inspection and testing will be required in 2013 steam turbine valve overhaul or the 2016 steam turbine generator overhaul to demonstrate the ability to meet the EOL date. The exception is the storage tank for which information was considered inadequate to form a firm conclusion and level 2 testing is recommended in 2011. The figure's highlighted risk areas is primarily operating hours driven and likely to shift further out in time after the 2016 turbine generator overhaul. The 2013 steam turbine valve overhaul and the 2016 overhaul/inspection are fundamental elements in changing the current assessment.

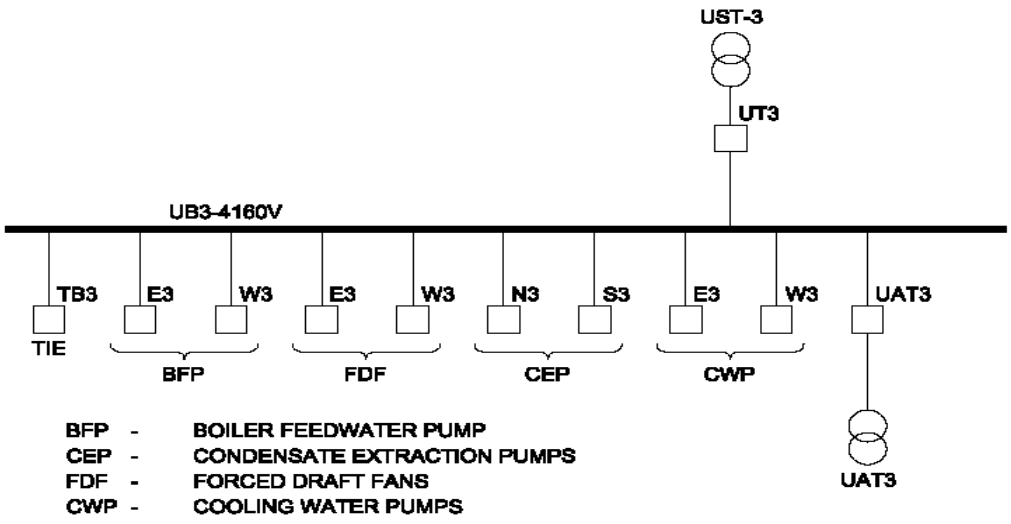
FIGURE 10-7 UB3 SWITCHGEAR

The 4160V switchgear, utilizes original draw-out ITE type 5HK power breakers. Protection, synch, and control relays are original CGE electro-mechanical. All feeders have Schweitzer.

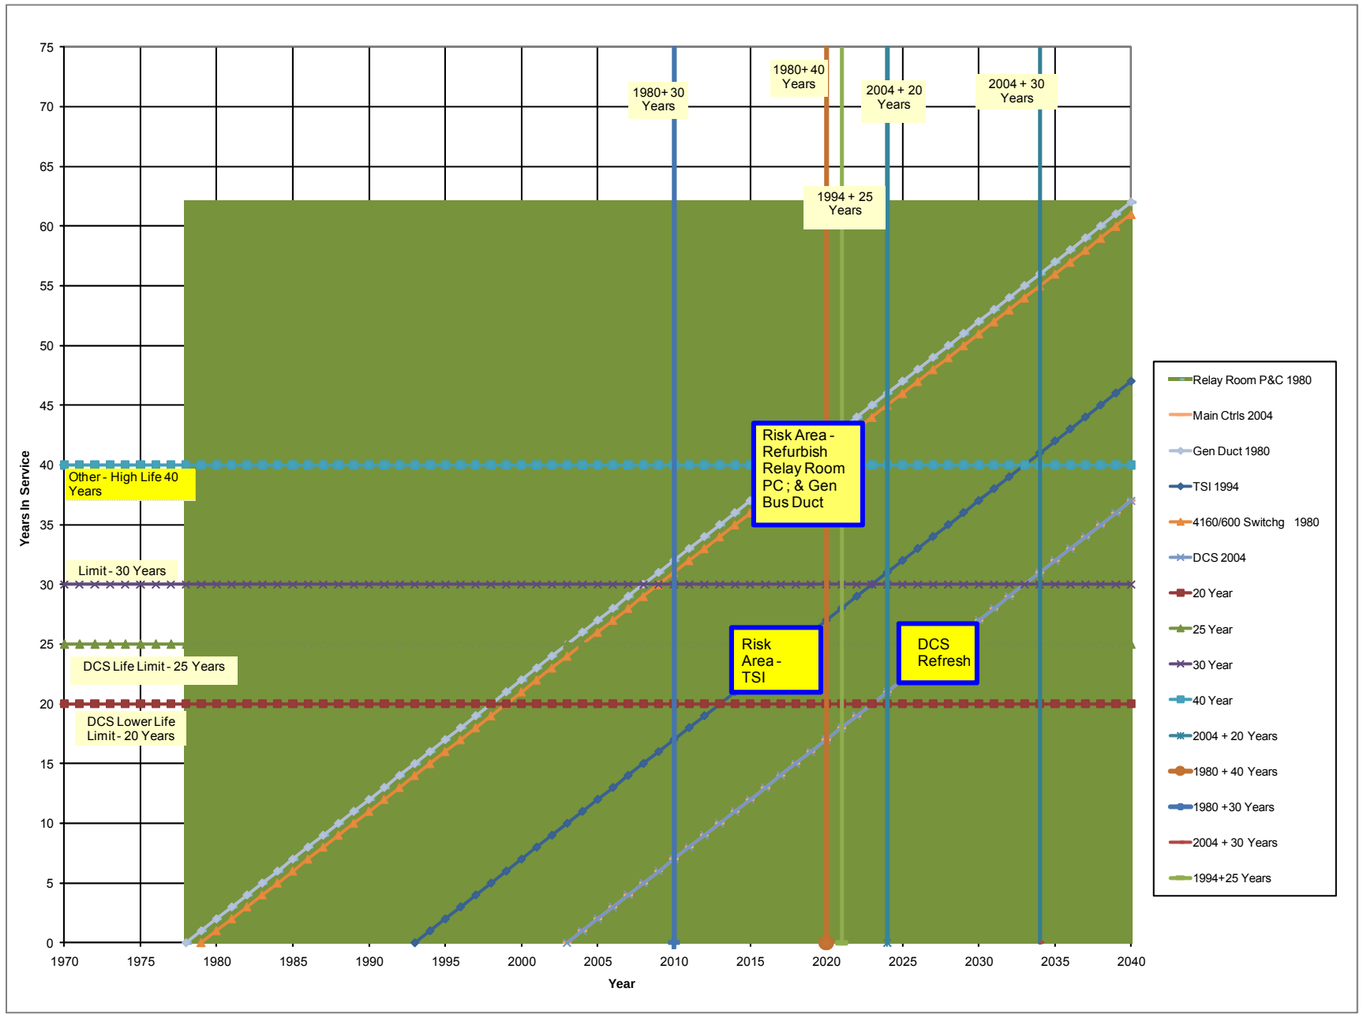
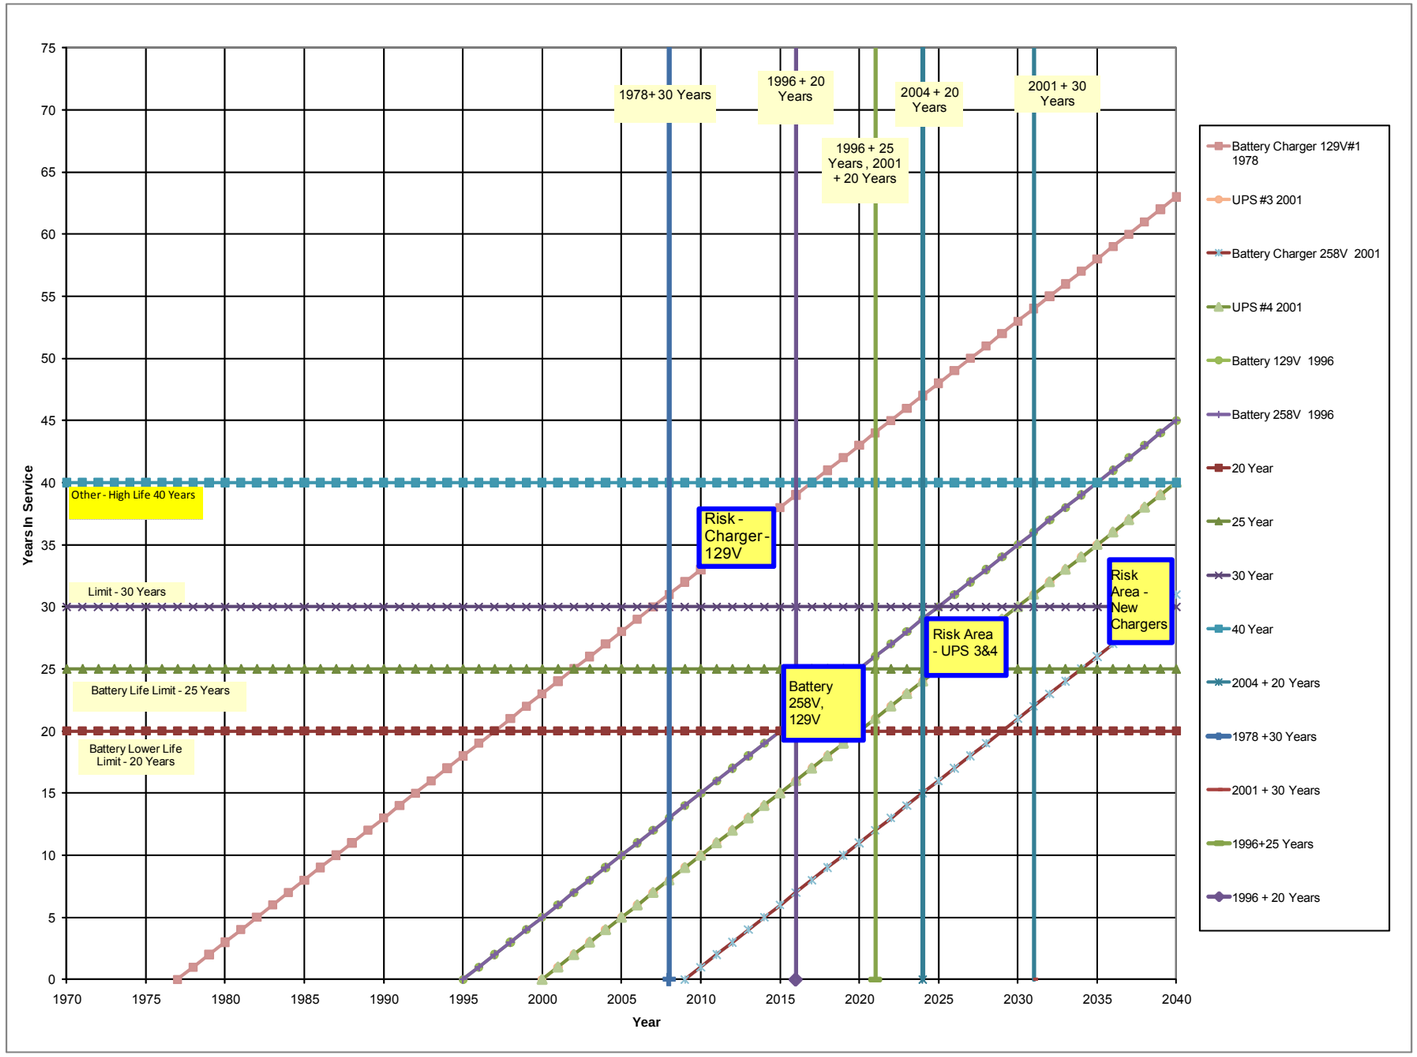
Figures 10-9 and 10-10 below illustrate the life cycle curve for the Unit 3 electrical and control system associated with the Unit 3 generators. Several curves are required to represent the various elements. They have been broken into two parts – the electrical and control systems (MCC's, relays, breakers, TSI, DCS) and those primarily associated with batteries and chargers. The curves are plots of current and projected years in service on the y-axis versus calendar year on the x-axis. Age in-service due to either aging or obsolescence is more an issue than unit operating hours. Vertical lines represent bands of nominal years of in-service life for different in service dates. Horizontal lines represent the ranges of equipment life based on current and historical information and expert opinion. The risk area boxes provide an indication of the timing of potential issues either from an age or equivalent operating hours view.

The curves indicate that the remaining life (RL) of much of the equipment does not exceed the desired life (DL) for generation of 2020 and for synchronous condensing of 2041, without extensive refurbishment or replacement. This is well illustrated by the highlighted risk areas which highlights that many original MCC's and relays as well as the TSI are in need or replacement or extensive refurbishment in the very near term. The risk figures also illustrate that some equipment (DCS, batteries, and chargers) will require replacement or refurbishment in the 2020+ period.

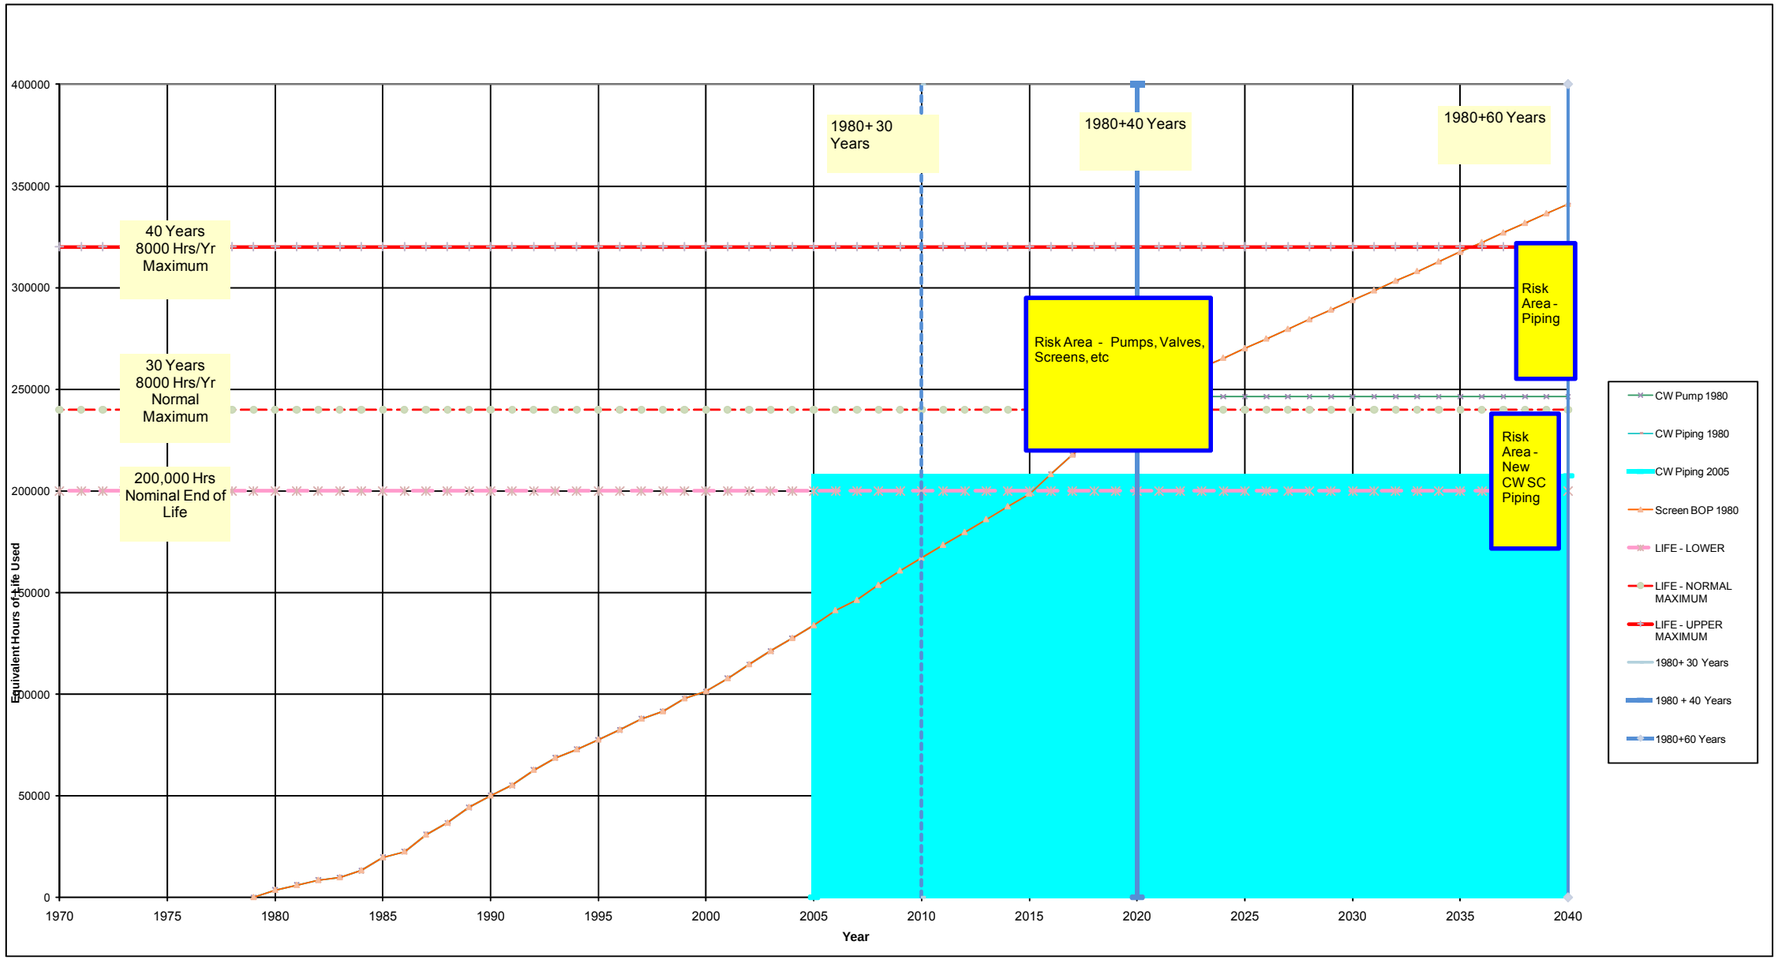
FIGURE 10-12 LIFE CYCLE CURVE – UNIT 3 WATER SYSTEMS ASSOCIATED WITH GENERATORS

Figure 10-12 below illustrates the life cycle curve for the various elements of the Unit 3 CW systems associated with generators. The life curves are plots of current and projected operating hours (generation plus synchronous condensing mode) on the y-axis versus calendar year on the x-axis. The figure has vertical lines representing differing representative nominal age limits for various components. It has horizontal lines that represent a range of practical equivalent base loaded operating hour life limits. Data specific to the intake and outfall structures were not sufficient to include them, but they are not expected to be an issue (perhaps the condition of some operational equipment such as stoplogs or their supports). Data specific to the pumps and motors for the general service cooling water and the turbine generator cooling water are also not presented as they are relatively new and/or modest equipment elements. The risk area boxes provide an indication of the timing of potential issues either from an age or equivalent operating hours view.

The curve indicates that the remaining life (RL) of most elements of the Unit 3 cooling water systems associated with generators is sufficient to reach the end date of 2020 for generation, but not the 2041 desired life (DL) end date for synchronous condensing. The CW pumps and associated equipment are the primary nearer term issues highlighted by the risk boxes. The actual end date and remaining life will become clearer through the series of ongoing routine inspections that forms part of the plant's PM program and the Level 2 inspections recommended in the report. The intake and outfall structures and associated sub-components should be added as a result of a Level 2 inspection.

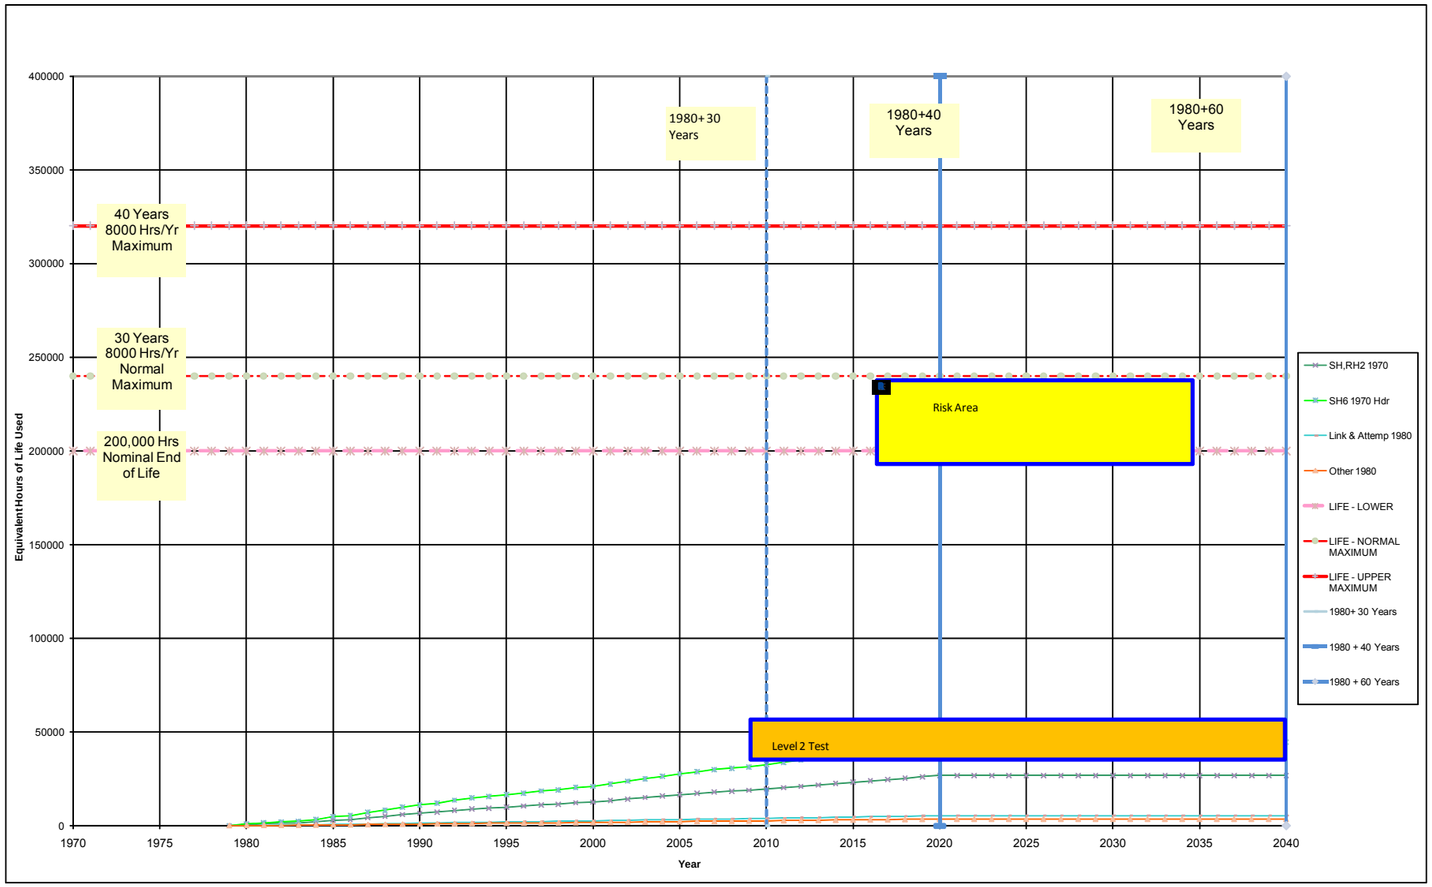
FIGURE 10-13 LIFE CYCLE CURVE – UNIT 3 BOILERS (HEADERS AND COMPONENTS)

The boiler headers and components are subject primarily to time spent under the effects of steam pressure and temperature. Their equivalent expended life presented in figure below is primarily related to the material properties and the steam conditions. As a result several curves are required to represent the range of the various elements of the system. Details are included in Appendix 30. The life curves are plots on the y-axis of current and projected consumed equivalent life hours based on the theoretical metallurgical assessments. This differs from other sections that use nominal operating hours of usage on the y-axis versus calendar year on the x-axis. The figure has several vertical lines representing differing representative nominal age limits for various components. It also has several horizontal lines that represent a range of practical equipment equivalent base loaded operating hour life limits. The figure also included two highlighted boxes. The risk box is representative of typical life expectations. The second identified as the “Level 2 Test” box identifies where EPRI recommends an initial Level 2 analyses or equivalent for these sorts of components (consumed life = 10% of expected or design life).

The header life curves indicate that the remaining life (RL) of the Unit 3 boiler headers and associated components is expected to exceed the desired life (DL) which is the generation end of life in 2020. Nevertheless, it also identifies that some of higher temperature components should undergo a Level 2 inspection (identified later in this section of the report) if not already planned or undertaken.

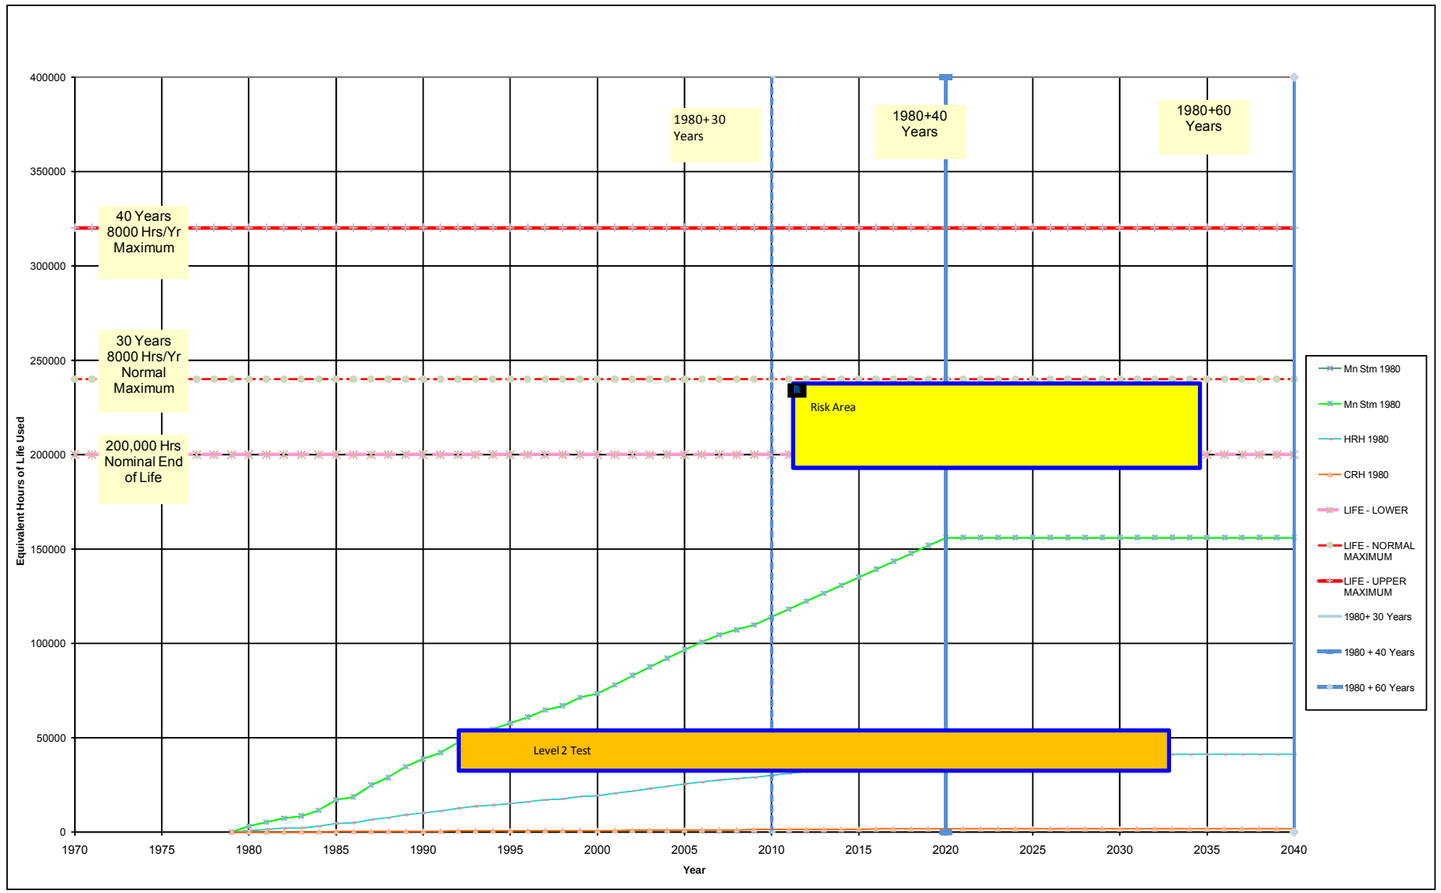
FIGURE 10-14 LIFE CYCLE CURVE – UNIT 3 BOILERS (HIGH PRESSURE AND TEMPERATURE STEAM LINES)

Three curves represent the high pressure, high temperature steam lines (main steam, hot reheat, and cold reheat). Their life expenditure (illustrated in figure below) is primarily related to the time spent under the effects of steam pressure and temperature (similar to the boiler headers) and to the material properties of the steam lines. Details are included in Appendix 33. The life curves are plots on the y-axis of current and projected "consumed equivalent life hours" based on the theoretical metallurgical assessments. The figure has three vertical lines representing differing representative nominal age limits. It also has several horizontal lines that represent a range of practical equipment equivalent base loaded operating hour life limits. The figure also included two highlighted boxes. The risk box is representative of typical life expectations. The second identified as the "Level 2 Test" box identifies where an initial Level 2 analyses or equivalent is likely required (consumed life = 10% of expected life).

The high pressure steam line life curves indicate that the remaining life (RL) of the Unit 3 steam lines and their associated components are expected to exceed the desired life (DL) which is the generation end of life in 2020. Nevertheless it also identifies that both the main steam and hot reheat steam lines exceed EPRI's 10% consumed life guide for a Level 2 inspection of these systems. Given that they have not been tested for some time, this is considered appropriate at this time.

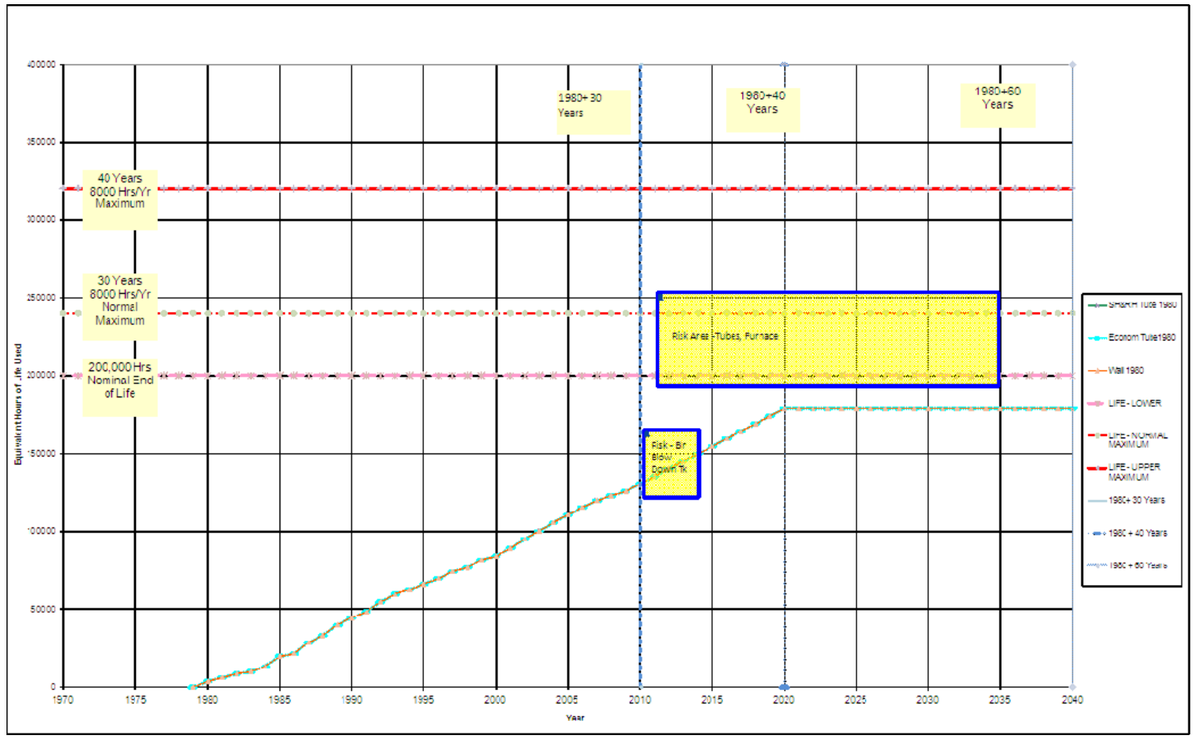
FIGURE 10-15 LIFE CYCLE CURVE – UNIT 3 BOILER SYSTEM (TUBES EXPOSED TO THE COMBUSTION PROCESS)

A single life cycle curve is presented beginning with the in-service date of the unit. It is meant to represent initial design goals, using nominally operating hours. It was considered impractical to accurately document or reasonably present in one curve the many changes that have occurred, and are likely to continue to occur going forward due to legacy impacts. It is shows the current status of the boiler blowdown tank, which is both a life issue and a safety issue. It uses nominal operating hours as opposed to metallurgical equivalent hours in the two previous boiler curves as a more appropriate way of expressing its normal lifetime.

The curve indicates that the boiler tubes within the furnace envelope would have been expected to be seeing some end of life component concerns with original equipment. Nevertheless, it is more likely legacy impacts that will have greater effects on component replacements and refurbishments going forward to 2020. With ongoing inspections and refurbishments, 2020 is achievable with good reliability with the new fuel. It also shows that the boiler blowdown tank should be replaced.

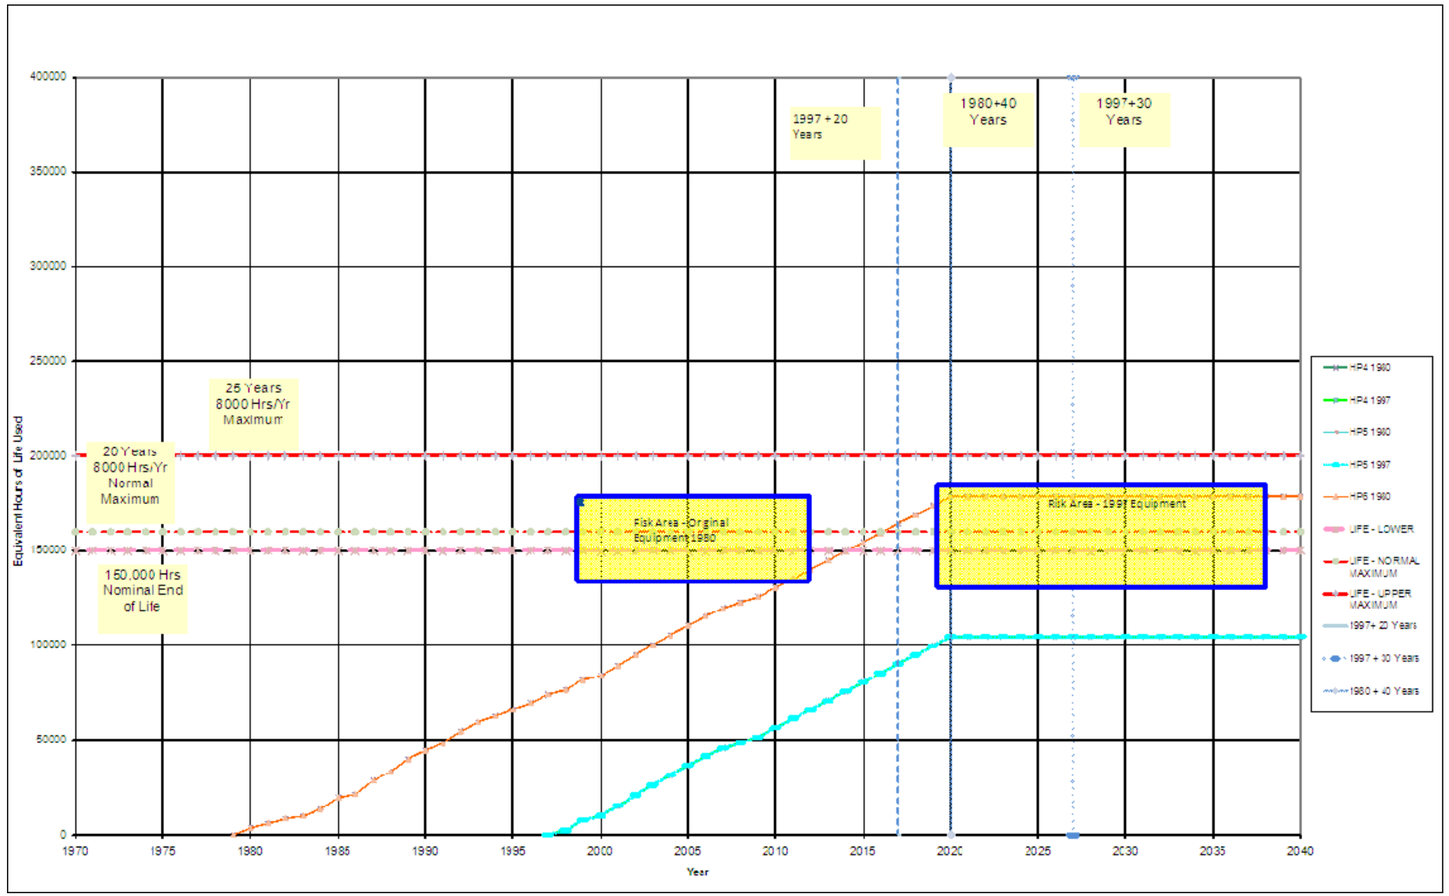
FIGURE 10-16 LIFE CYCLE CURVE – UNIT 3 FEED WATER SYSTEM HP HEAT EXCHANGERS

For the HP heat exchangers, curves represent the three heat exchangers and components, as well as a curve to represent any balance of plant that is original equipment.

The curves indicate that the remaining life (RL) of the Unit 3 HP heat exchangers (and the associated feedwater systems) may be able to reach the desired life (DL) 2020 end date for generation. Nevertheless, given that no detailed NDE information has been obtained on the HP heat exchangers for some time, a detailed Level 2 inspection is recommended for 2014.

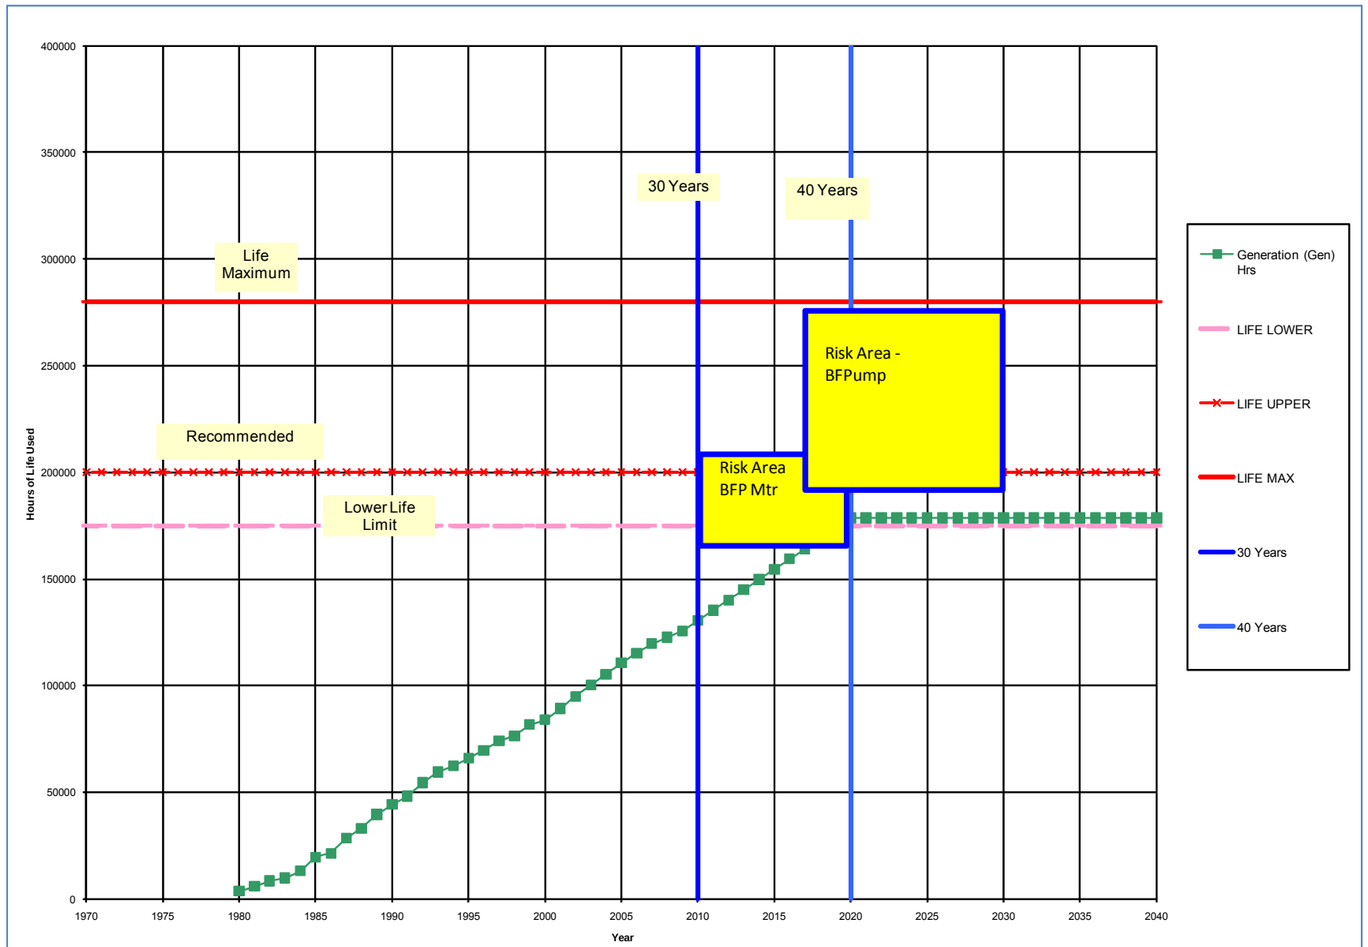
FIGURE 10-17 LIFE CYCLE CURVE – UNIT 3 FEEDWATER SYSTEM - BOILER FEED PUMPS

For the Unit 3 boiler feed pumps, a single curve represents each of the two boiler feed pumps dating back to their original installation. While indicative of expected life with good maintenance practice, the pumps have been and continue to be refurbished on a six year cycle using a spare pump section. Their actual condition is therefore substantially better than might otherwise be expected.

The curve indicates that the remaining life (RL) of the Unit 3 HP boiler feed pumps is likely able to reach desired end date which is the 2020 end date for generation. Given their six year refurbishment cycle and a spare pump section, they are expected to continue to perform reliably well past the 2020 end date for generation. The BFP motors are approaching older age and entering areas where reliability and unexpected failure may become more an issue than expected life.

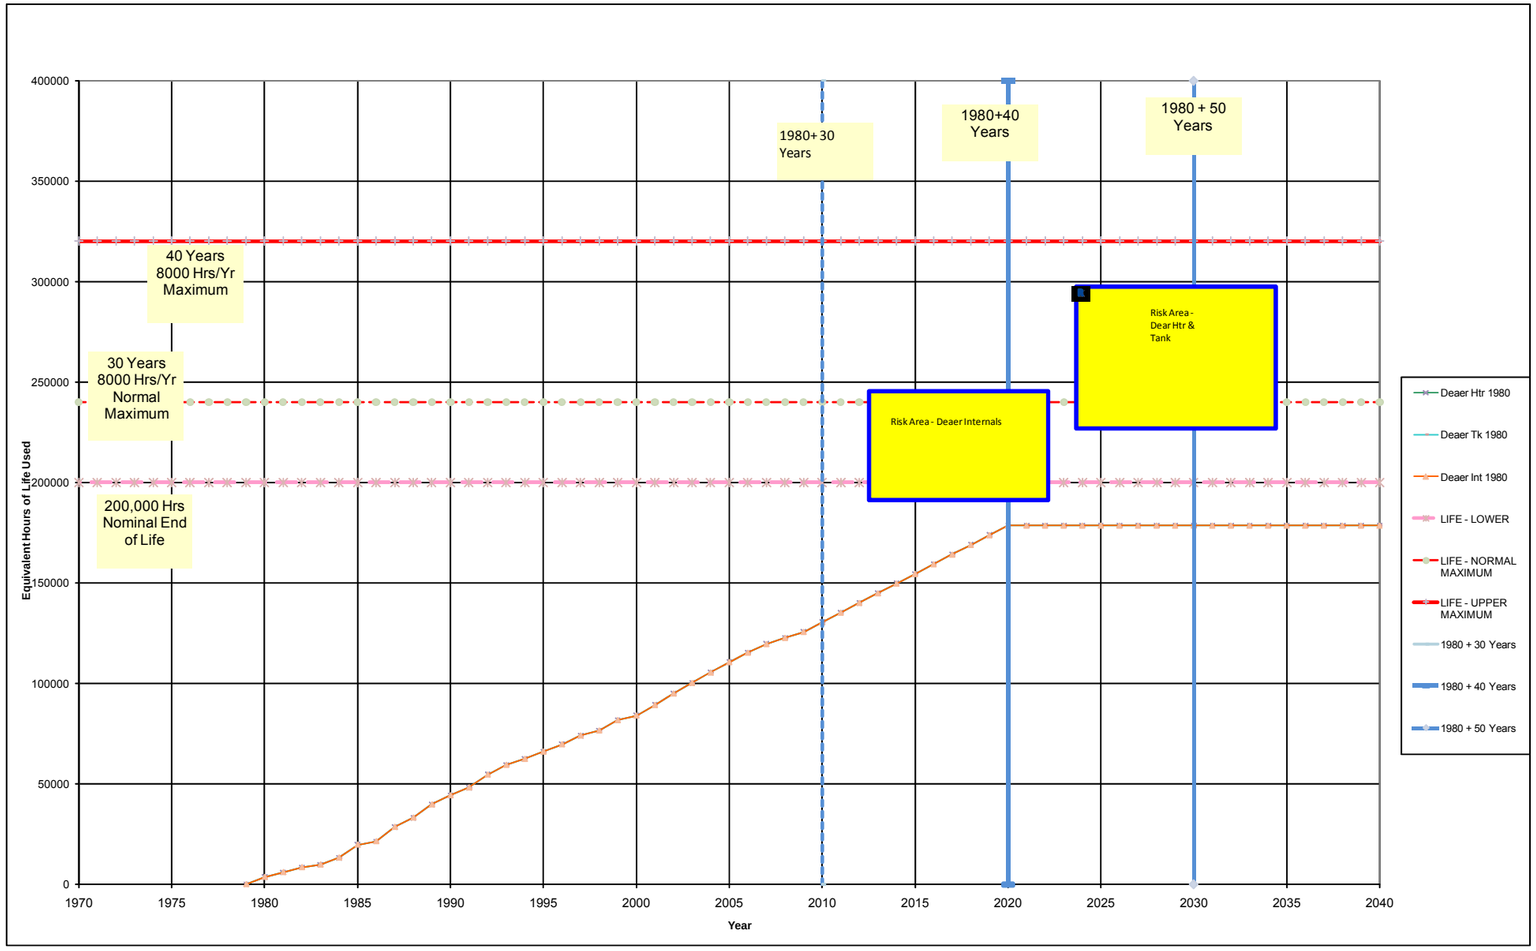
FIGURE 10-18 LIFE CYCLE CURVE – UNIT 3 FEEDWATER SYSTEM - DEAERATOR

The life cycle curve for the Unit 3 feedwater system – deaerator is illustrated below. Only one curve is used as the major elements of the deaerator are approximately of the same age and condition. The life curve is a plot of current and projected operating hours of usage on the y-axis versus calendar year on the x-axis. The figure has several vertical lines representing differing representative nominal age limits for various components. It also has several horizontal lines that represent a range of practical equipment equivalent base loaded operating hour life limits. The risk area boxes provide an indication of the timing of potential issues either from an age or equivalent operating hours view.

The curve indicates that the remaining life (RL) of the Unit 3 feedwater system - deaerator exceeds the desired life (DL) which is end date for generation of 2020, with the potential though unlikely exception of some deaerator internals. The plant inspections form an excellent base of condition information supporting the ability of the deaerator as a whole to meet the EOL date. However, there is insufficient detailed inspection information of some of the internals that are difficult to access in order to fully assess their condition. A detailed Level 2 inspection is recommended in 2014.

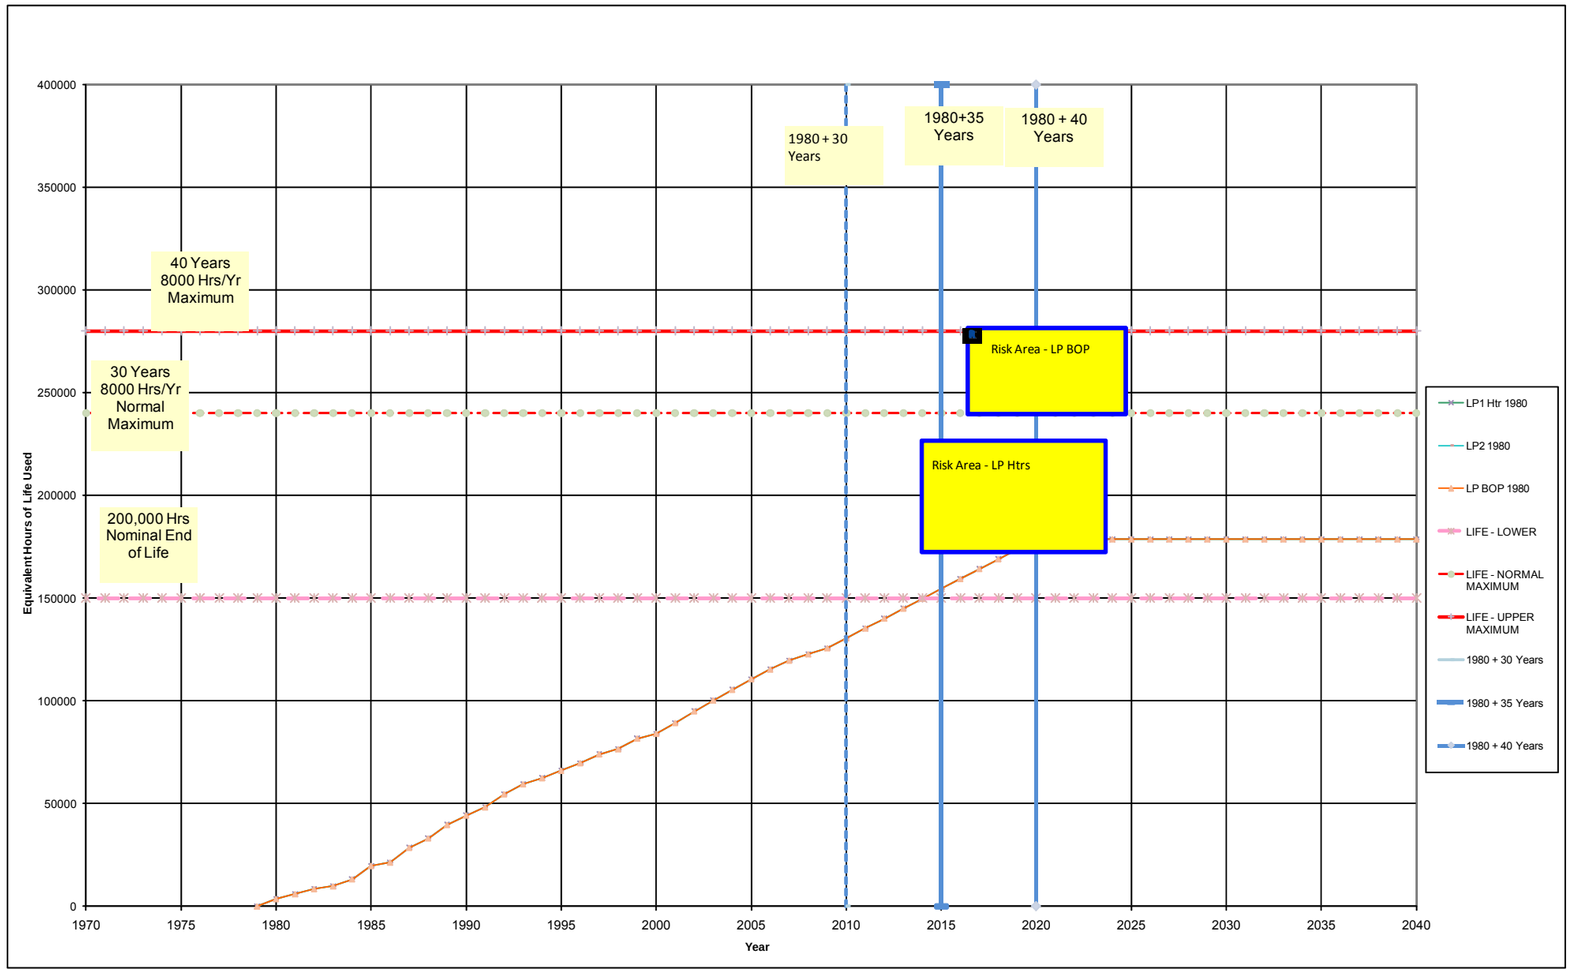
FIGURE 10-19 LIFE CYCLE CURVE – UNIT 3 FEEDWATER SYSTEM - LOW PRESSURE FEEDWATER HEAT EXCHANGERS

The life cycle curve for the Unit 3 feedwater system - low pressure feedwater heat exchangers is illustrated below. One curve represents both low pressure heat exchangers which are original equipment. The life curve is a plot of current and projected operating hours (generation mode only) on the y-axis versus calendar year on the x-axis. The figure has several vertical lines representing differing representative nominal age limits for various components. It also has several horizontal lines that represent a range of practical equipment equivalent base loaded operating hour life limits. The risk area boxes provide an indication of the timing of potential issues either from an age or equivalent operating hours view.

The curve indicates that the remaining life (RL) of the Unit 3 feed water system LP heat exchangers may not be able to reach the desired life (DL) 2020 end date for generation. Given that no detailed NDE information has been obtained on the LP heat exchangers, a detailed Level 2 inspection is recommended for 2011.

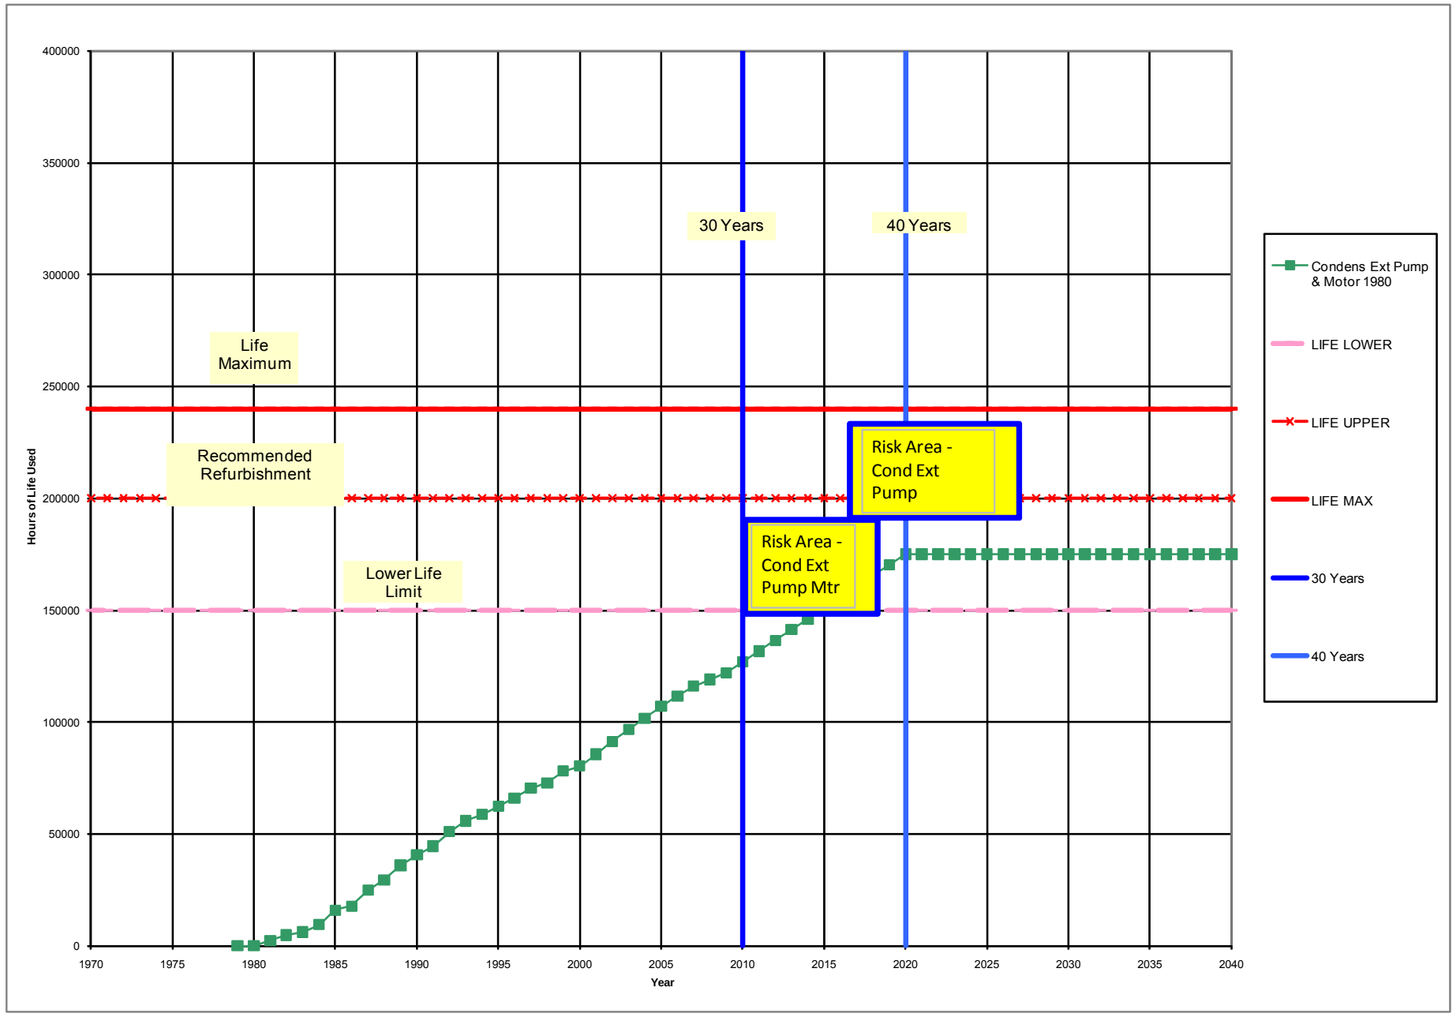
FIGURE 10-20 LIFE CYCLE CURVE – UNIT 3 FEEDWATER SYSTEM - CONDENSATE EXTRACTION SYSTEM

The life cycle curve for the Unit 3 condensate extraction pumps and motors is illustrated below. One curve is used to represent the pumps and motors as they are all original equipment. The life curve is a plot of current and projected operating hours (generation mode only) on the y-axis versus calendar year on the x-axis. The figure has two vertical lines representing differing representative nominal age limits. It also has several horizontal lines that represent a range of practical equipment equivalent base loaded operating hour life limits. The risk area boxes provide an indication of the timing of potential issues either from an age or equivalent operating hours view.

The curves indicate that the remaining life (RL) of the condenser condensate extraction pumps and motors can likely be able to reach the desired life (DL) 2020 end date for generation. The condensate extraction pump motors are expected however to be entering a period of higher unreliability.
