Holyrood Thermal Generating Station (Holyrood) Condition Assessment & Life Extension Study, - Final Report

Holyrood Thermal Generating Station
Condition Assessment & Life Extension Study

January 28, 2011

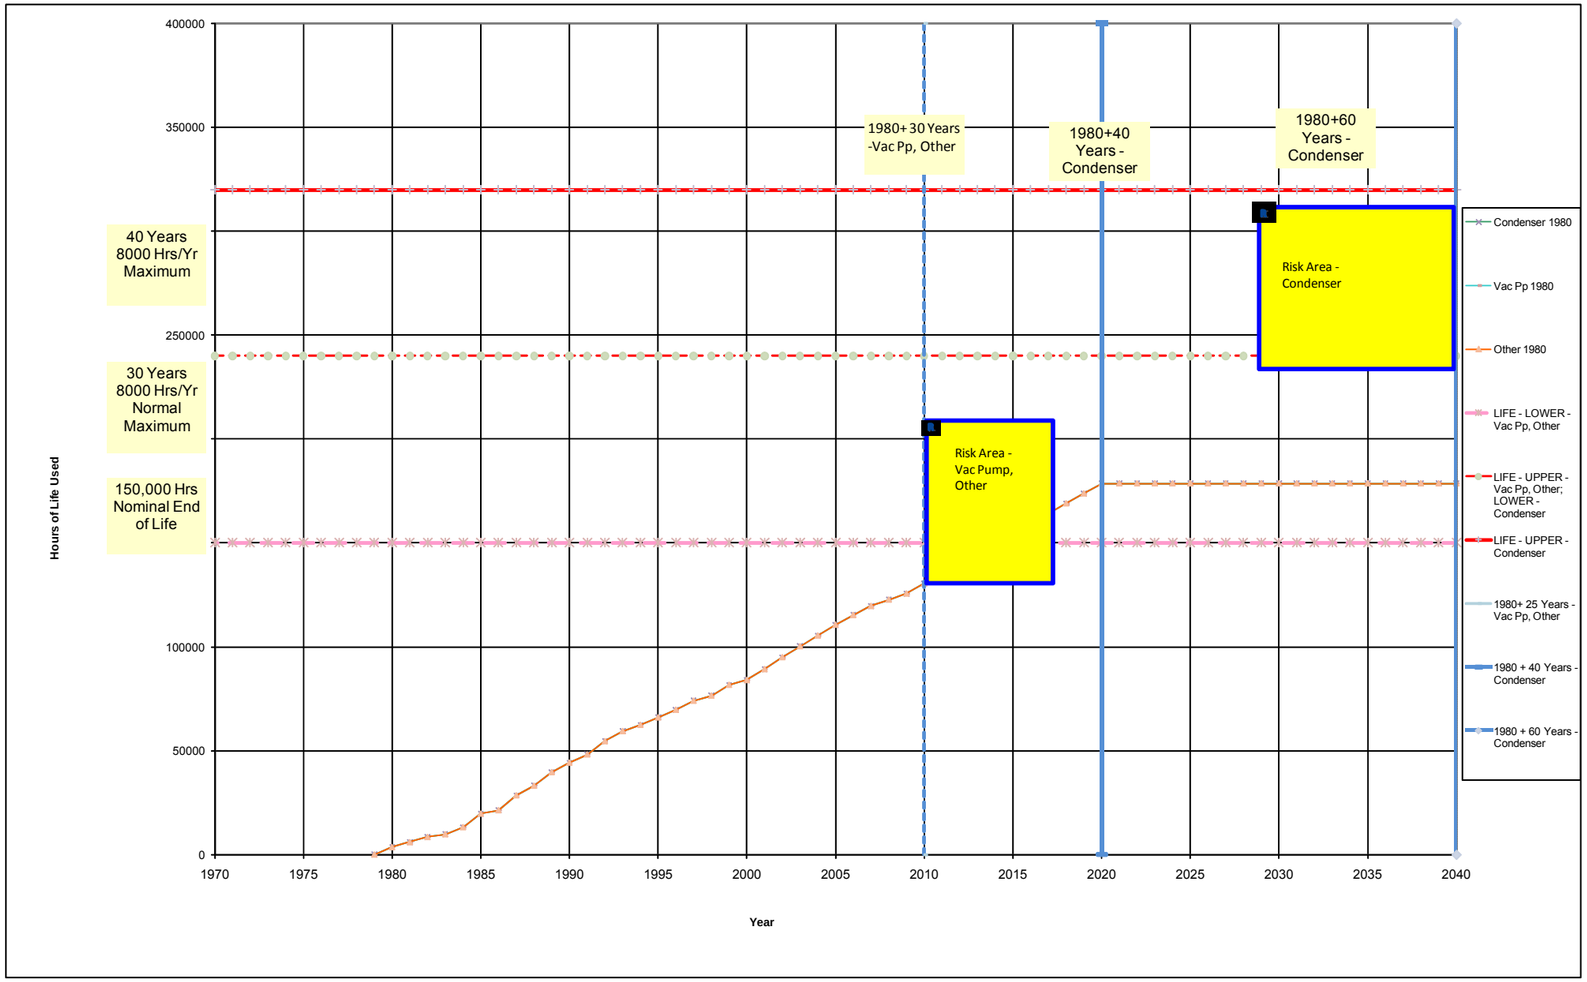
FIGURE 10-21 LIFE CYCLE CURVE – UNIT 3 CONDENSER

With the exception of the vacuum pumps, the curves indicate that the remaining life (RL) of the Unit 3 condenser can easily reach the desired life (DL) 2020 end date for generation. Additional information at the 2013 and 2016 turbine inspections should further confirm the condition. The equipment is original and is likely at or near end of life.

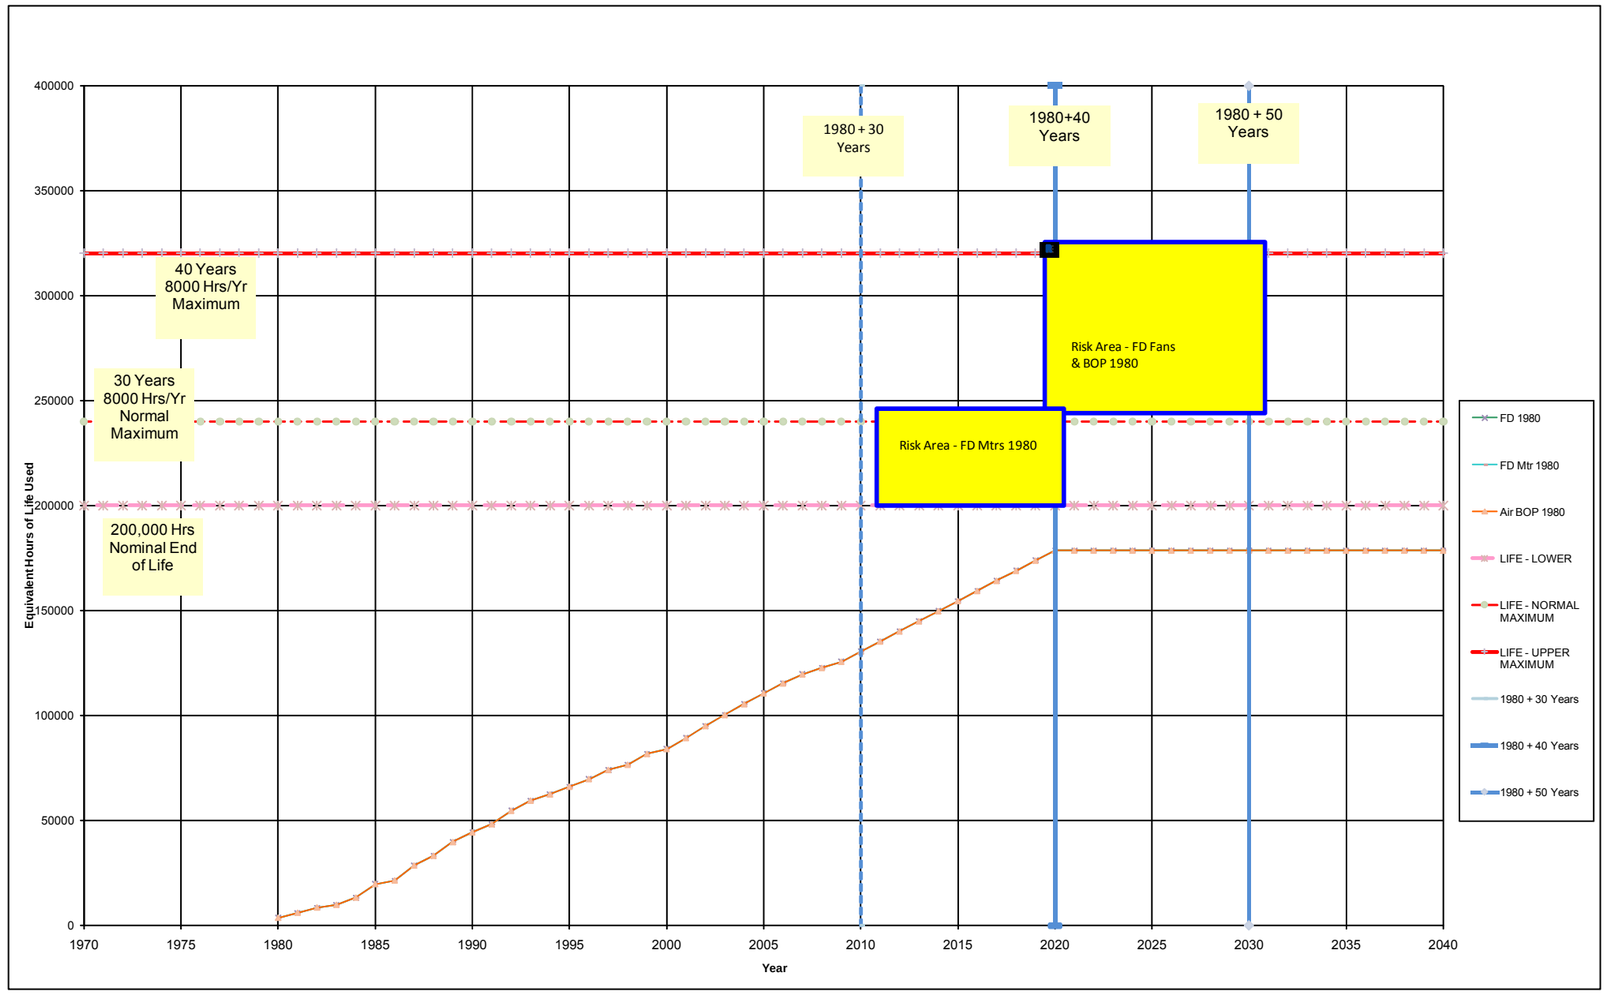
FIGURE 10-22 LIFE CYCLE CURVE – UNIT 3 FD FANS (AND SYSTEM)

The curves indicate that the remaining life (RL) of the Unit 3 FD fans (and system) are likely able to meet or exceed the desired life (DL) 2020 end date for generation. The age of the large 4 kV motors makes them a logical cost-effective candidate for sparing to ensure reliability, although plant testing/monitoring programs are effectively monitoring their status.

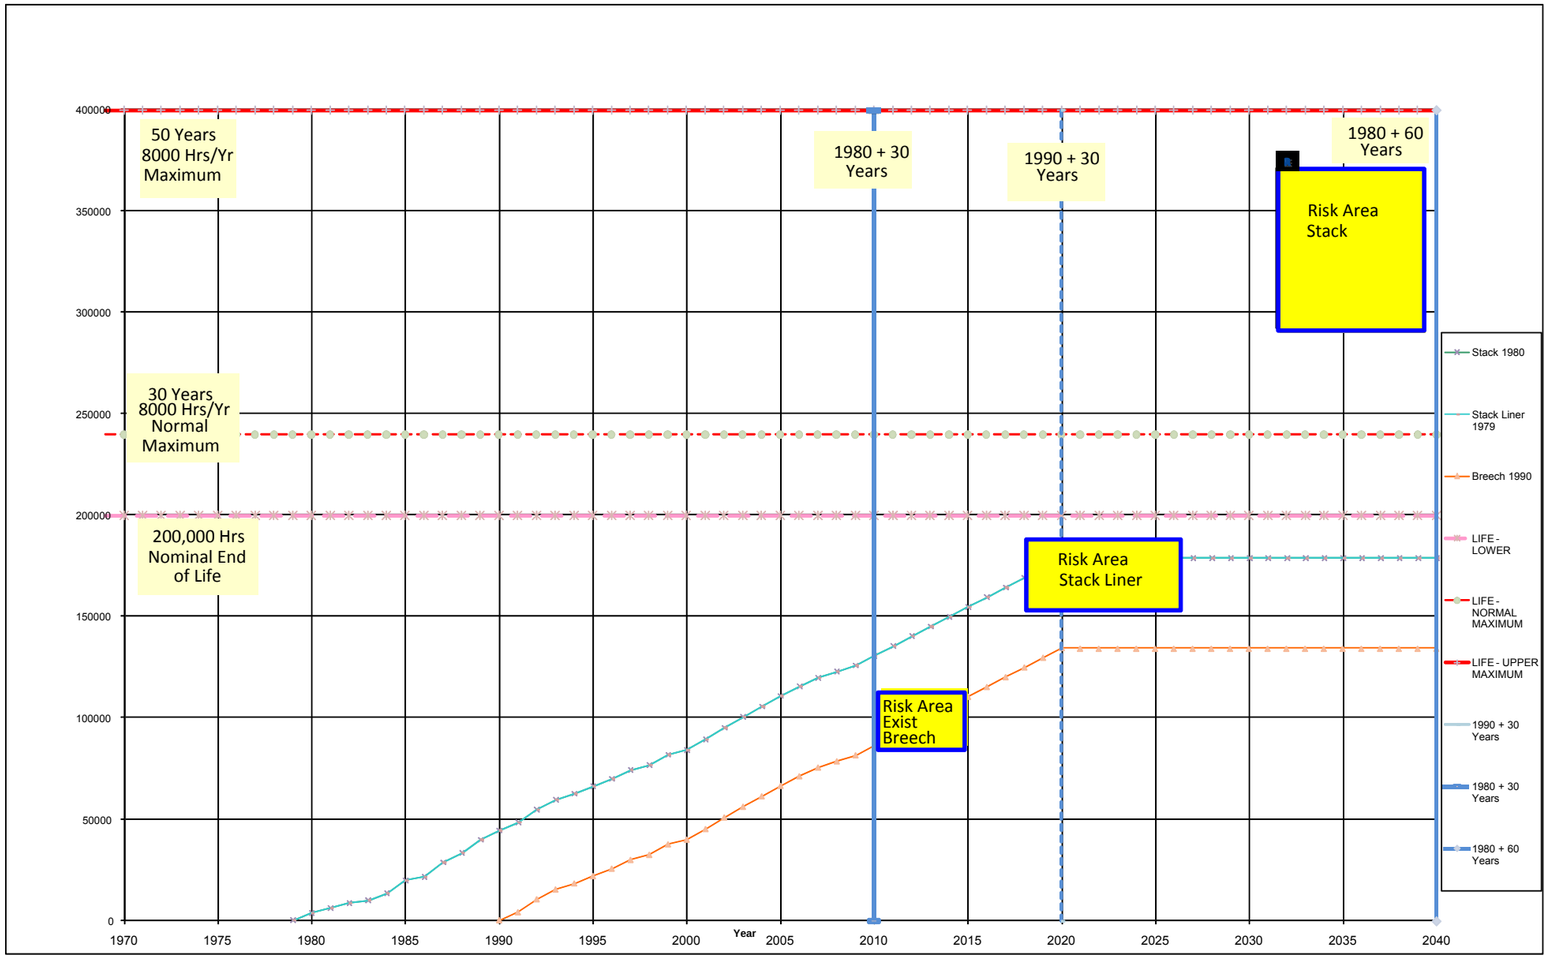
FIGURE 10-23 LIFE CYCLE CURVE – UNIT 3 STACKS AND BREECHING

The curves indicate that the remaining life (RL) of the Unit 3 stack is able to reach the desired life (DL) 2020 end date for generation, as well as the end date of 2041 for synchronous condensing/plant life. It does show that the stack breeching is in need of immediate repair. The breeching requirement is not a normal life issue, but one of design. Other elements can achieve the 2020 end date for generation with the ongoing plant maintenance program.

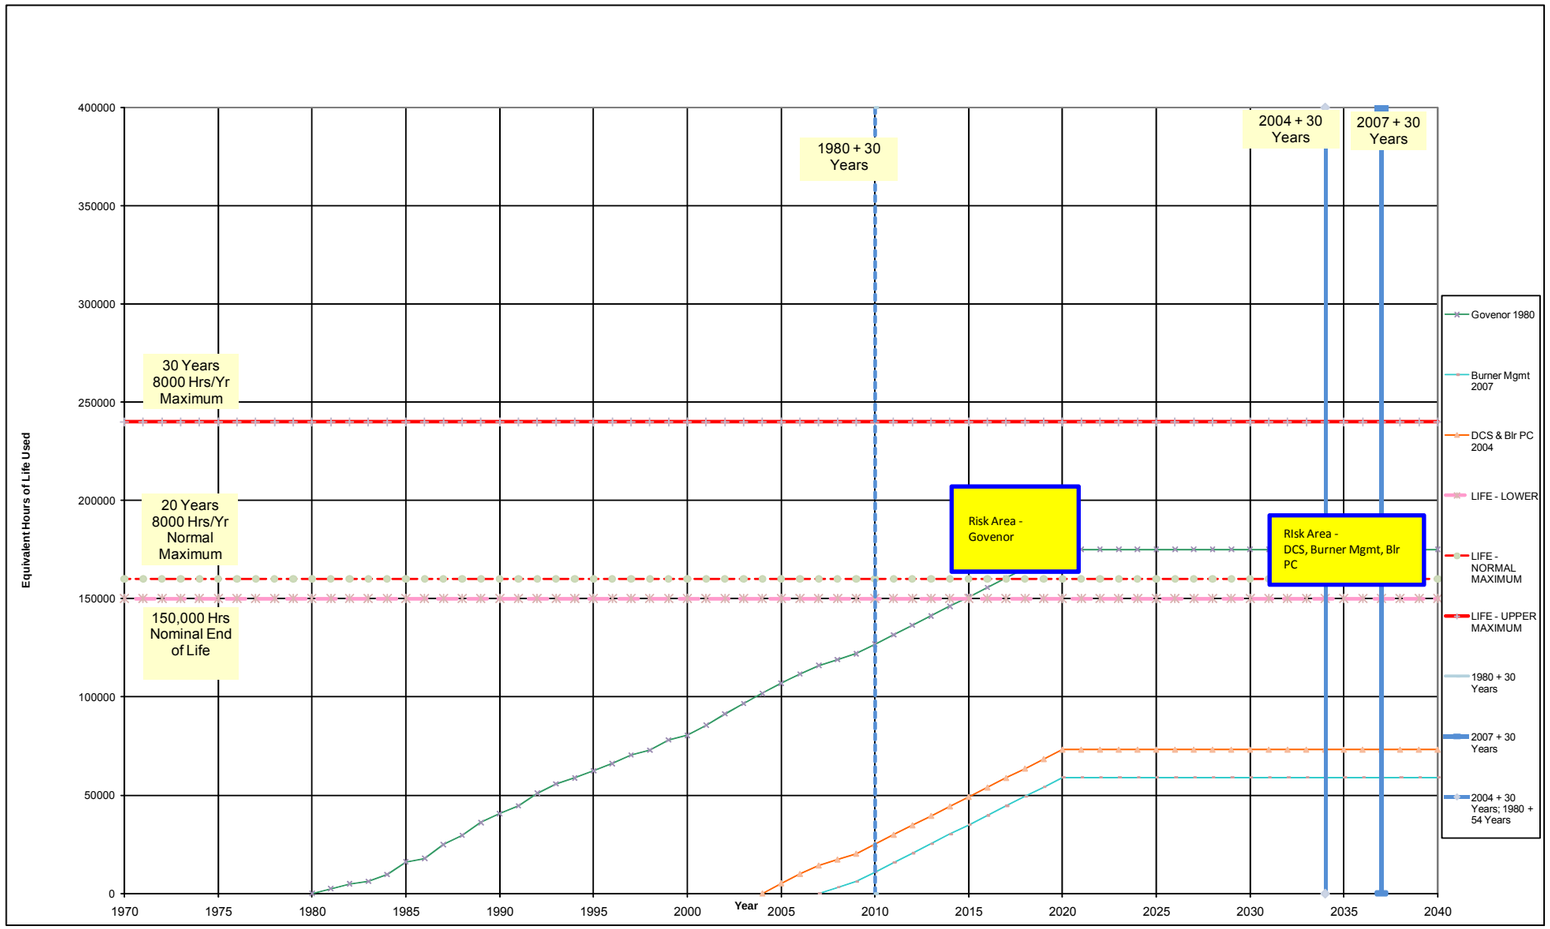
FIGURE 10-24 LIFE CYCLE CURVE – UNIT 3 ELECTRICAL AND CONTROL SYSTEMS (INCLUDING DCS) ASSOCIATED WITH STEAM SYSTEMS

The curves indicate that the remaining life (RL) of the Unit 3 control systems (including DCS) associated with steam systems can readily reach the desired life (DL) 2020 end date for generation, provided regular inspection and service per the station PM plan is maintained. The electrical systems, particularly breakers and motor controls are addressed in more detail as part of Section 10.1.3. It is clear that in order to meet the end date for generation service, some of these components must be replaced or in some cases refurbished.

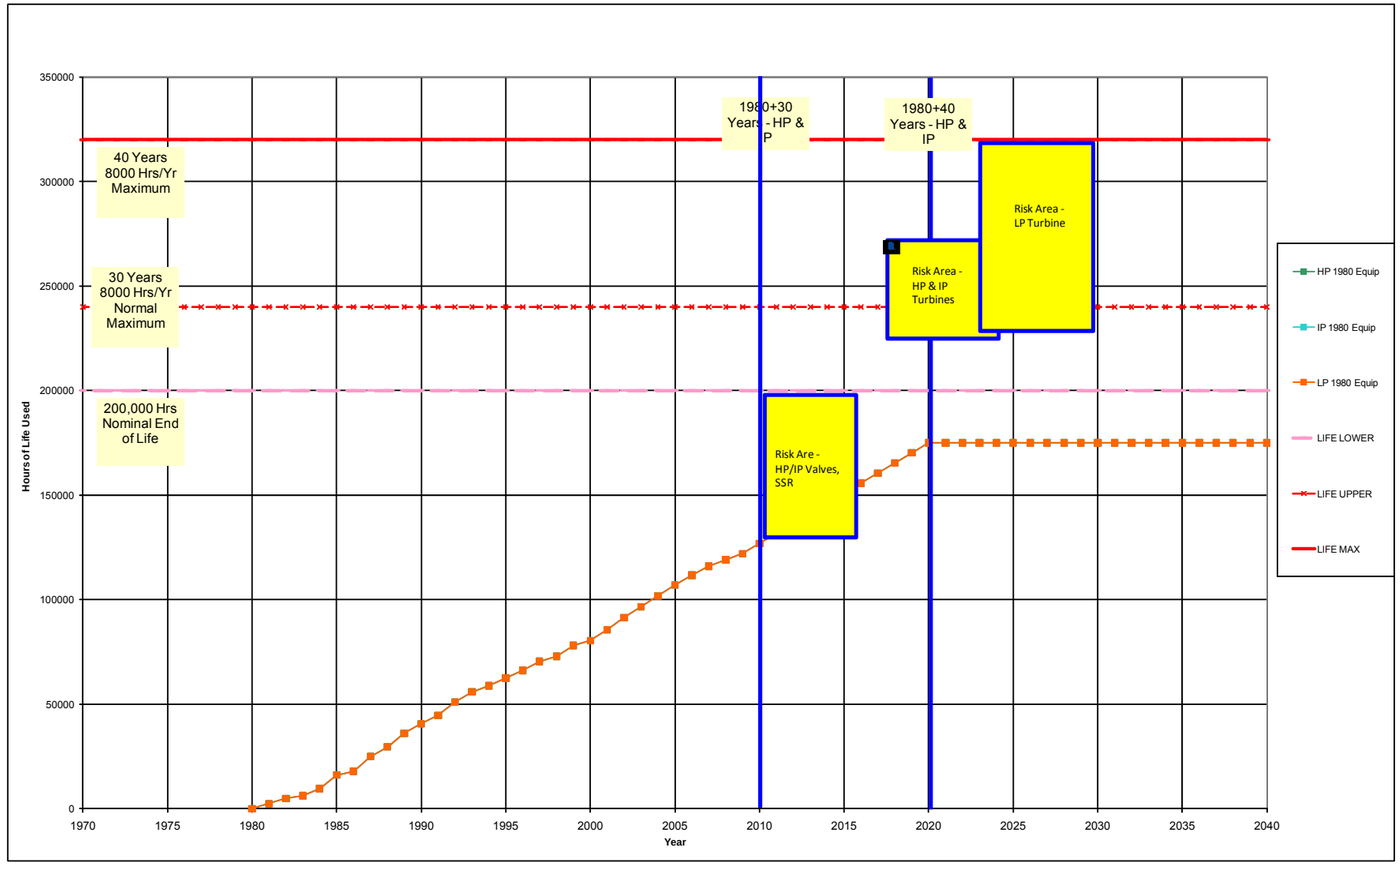
FIGURE 10-25 LIFE CYCLE CURVE – UNIT 3 STEAM TURBINE

The curves indicate that the remaining life (RL) of the various elements of the Unit 3 steam turbine exceeds the desired life (DL) which is the lesser of the time to its next major planned overhaul/inspection (2016) or to the desired End of Life (EOL) date of 2020. In fact the 2020 end date should be readily achievable. No specific dedicated Level 2 is required, but sufficient inspection and testing will be required in the 2016 overhaul to confirm the ability to meet the 2020 EOL date. The exception to this is the SSR and the high temperature stud bolts. It is clear that the current inspection schedule seems suitable.

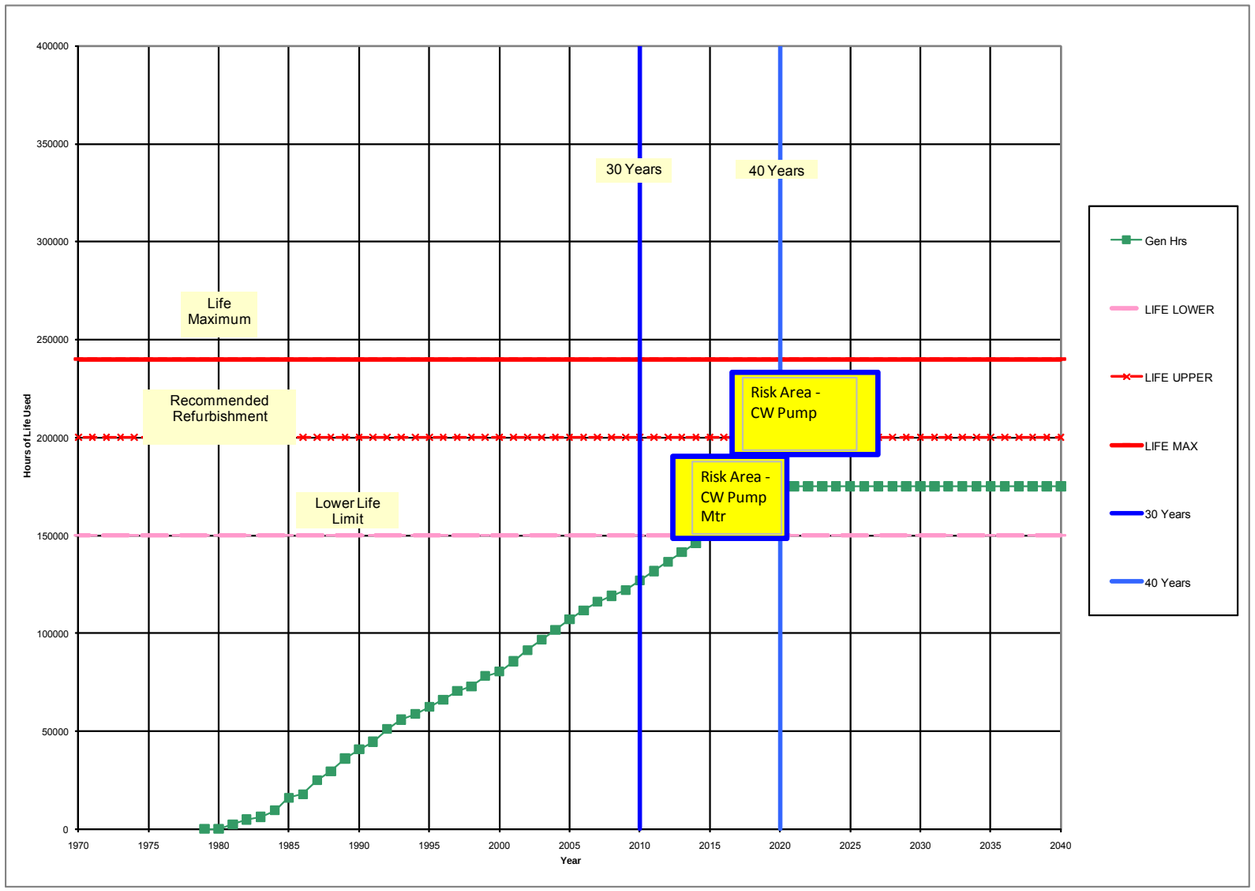
FIGURE 10-29 LIFE CYCLE CURVE – COOLING WATER SYSTEM - ASSOCIATED WITH STEAM SYSTEMS

The curves indicate that the remaining life (RL) of the Unit 3 cooling water system - associated with steam systems can likely reach the desired life (DL) end date for generation of 2020, but with some reliability risk, particularly as it pertains to the 4 kV motors. It is recommended that a spare motor shared between units would be a reasonable precaution. Corrosion of the steel pipe, valves, and fittings was also evident suggesting that some maintenance on these issues is required.

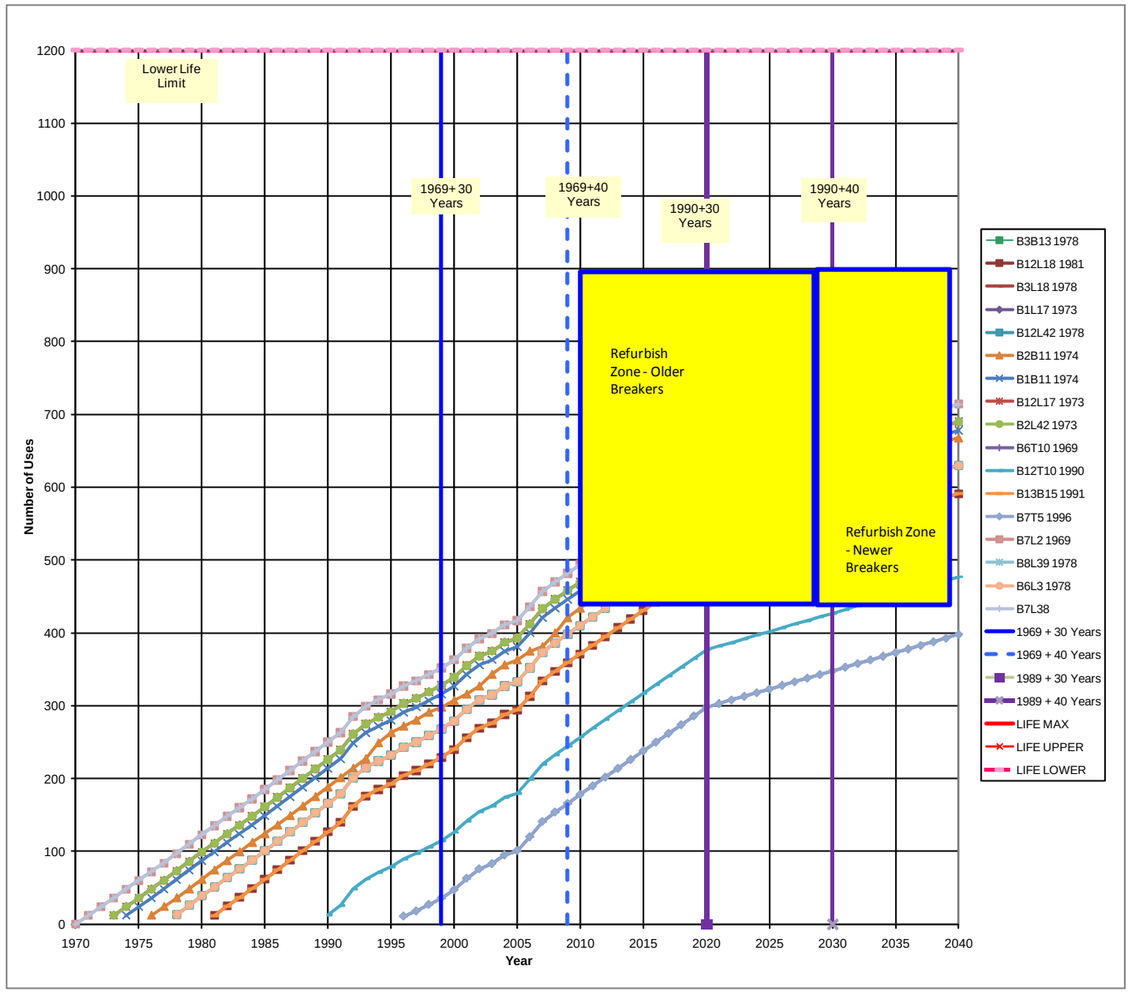
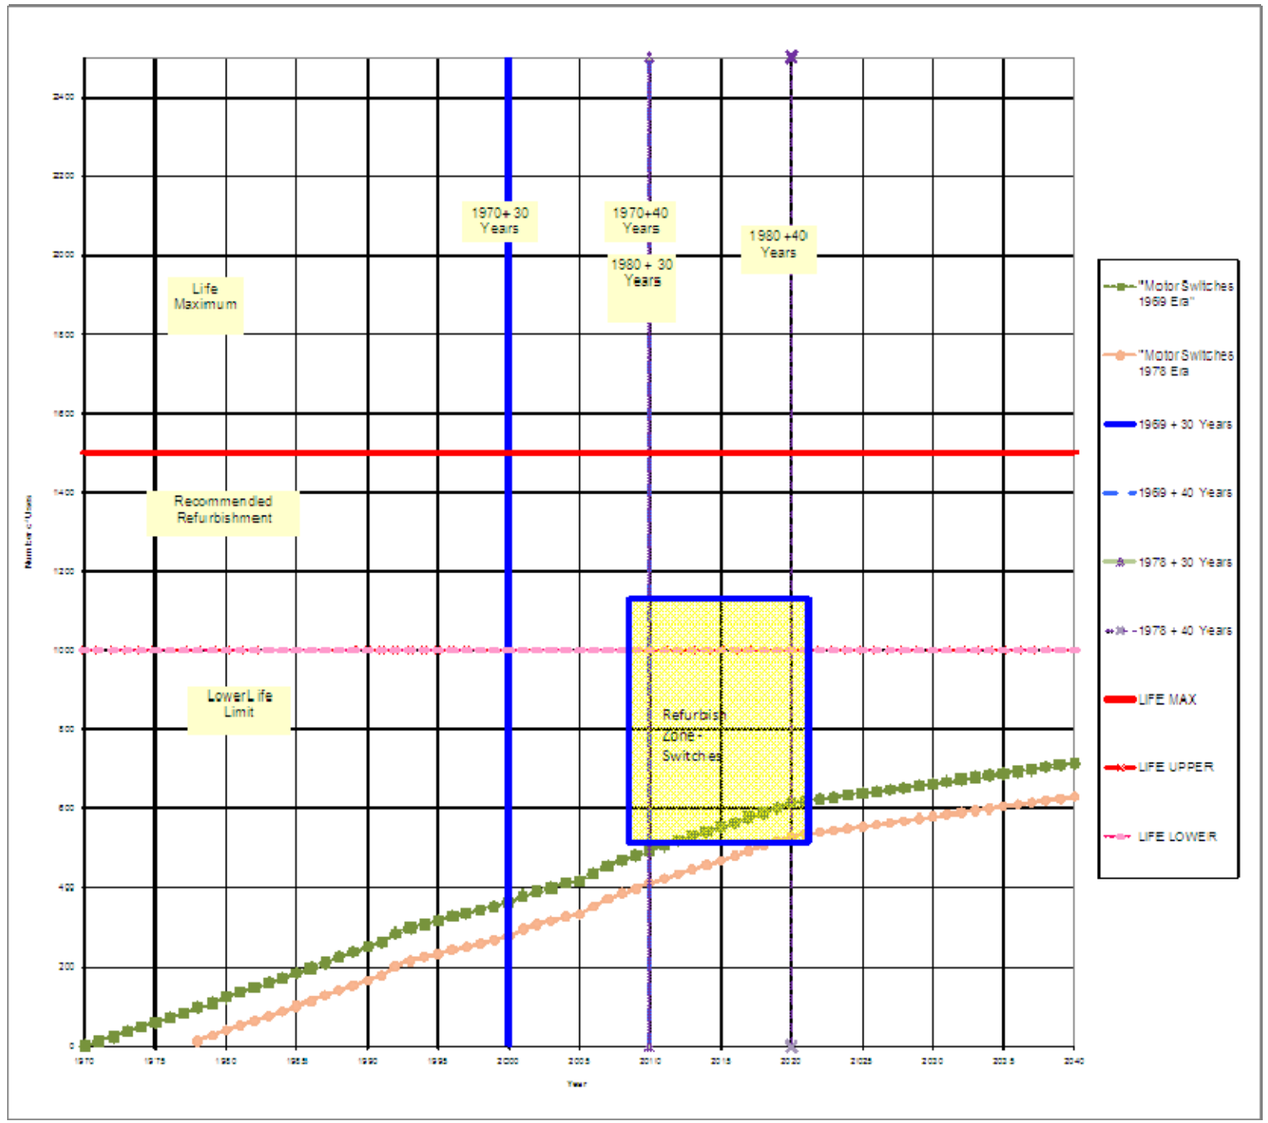
FIGURE 11-2 LIFE CYCLE CURVE – SWITCHYARD SWITCHGEAR - BREAKERS

FIGURE 11-3 LIFE CYCLE CURVE – SWITCHYARD SWITCHGEAR - MOTORIZED DISCONNECTS AND SWITCHES

The curves indicate that the remaining life (RL) of the switchyard switchgear exceeds the end date for generation of 2020, but not the desired life (DL) of 2041 (at the end of synchronous condensing life) without refurbishment and/or replacement. The equipment has reached an age where reliability is a concern, particularly where system interruptions or lightning storm impacts play a role. Given the critical nature of the station and its switchyard to the supply of the mainland, a pro-active program of testing and refurbishment is a priority.

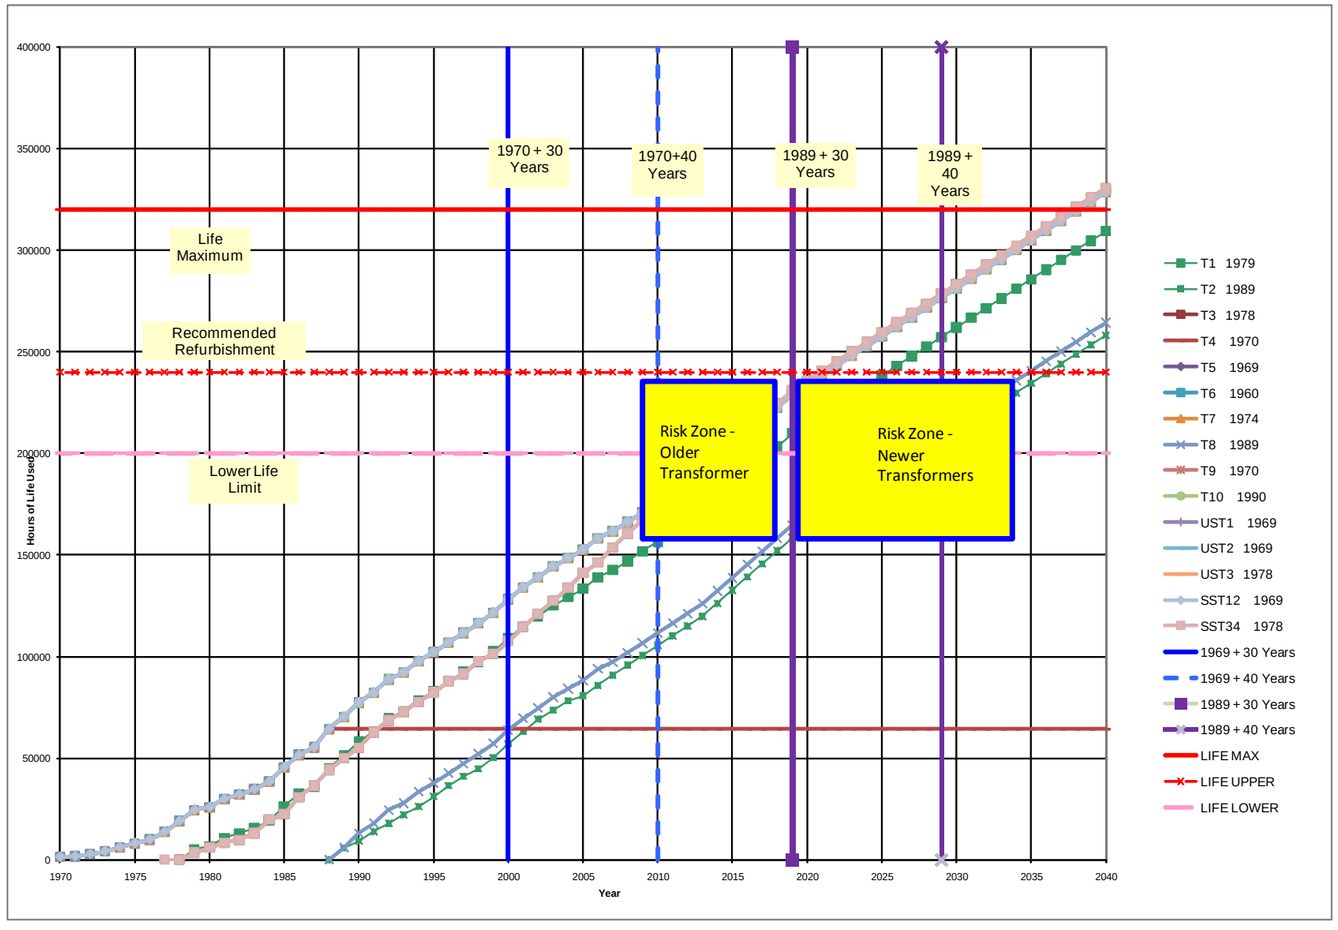
FIGURE 11-7 LIFE CYCLE CURVE – TRANSFORMERS

The curves indicate that the older transformers are in a critical period in their life where their reliability decreases and their likely susceptibility to system distance effects is higher. The remaining life (RL) of the transformers exceeds the end date for generation of 2020, but may not exceed the desired life (DL) of 2041 (at the end of synchronous condensing life) without refurbishment and/or replacement. The equipment has reached an age where reliability is a concern, particularly where system interruptions or lightning storm impacts play a role. Given the critical nature of the station and its switchyard to the supply of the mainland, a pro-active program of testing and refurbishment is a priority.

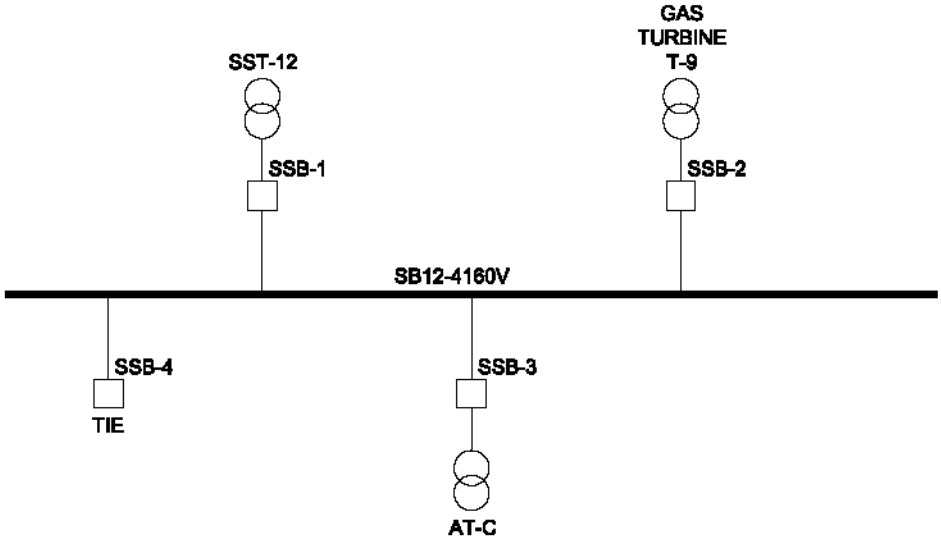
FIGURE 11-8 SB12 SWITCHGEAR

Station Board SB12 (4160V) was manufactured by ITE and installed in 1968. The 4160V switchgear utilizes original ITE type 5HK draw-out power breakers, 1200A and 2000A. Some feeders have Schweitzer 701 motor protection relays added. All other loads utilize original P&B Golds relays. All power breakers are original. All protection, synch, and control relays are original CGE electro-mechanical.

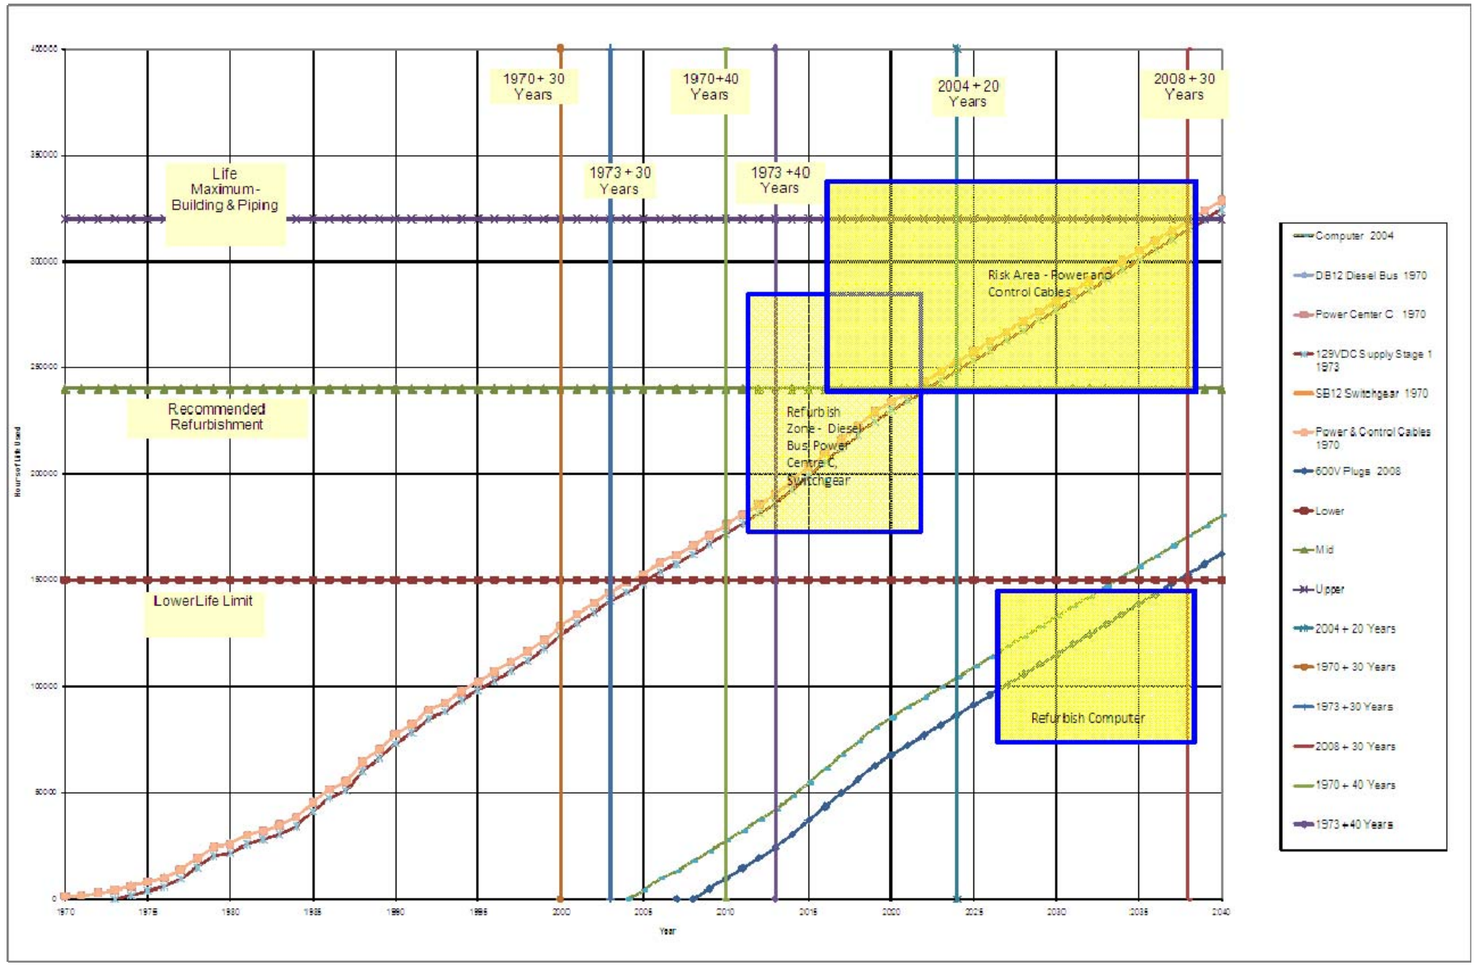
FIGURE 11-9 LIFE CYCLE CURVE – COMMON ELECTRICAL AND CONTROL ASSETS

The curves indicate that the remaining life (RL) of most of the common electrical and control assets exceeds the end date for generation of 2020, but not the desired life (DL) which is the end date for synchronous condensing of 2041. Further, any older switchgear such as breakers or motor control centres will need to be replaced (some possibly refurbished) within the next five years or risk increasing rates of failure.

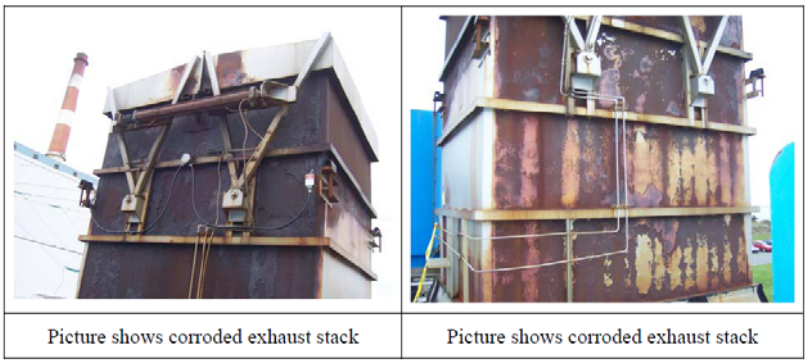
Picture shows corroded exhaust stack	Picture shows corroded exhaust stack

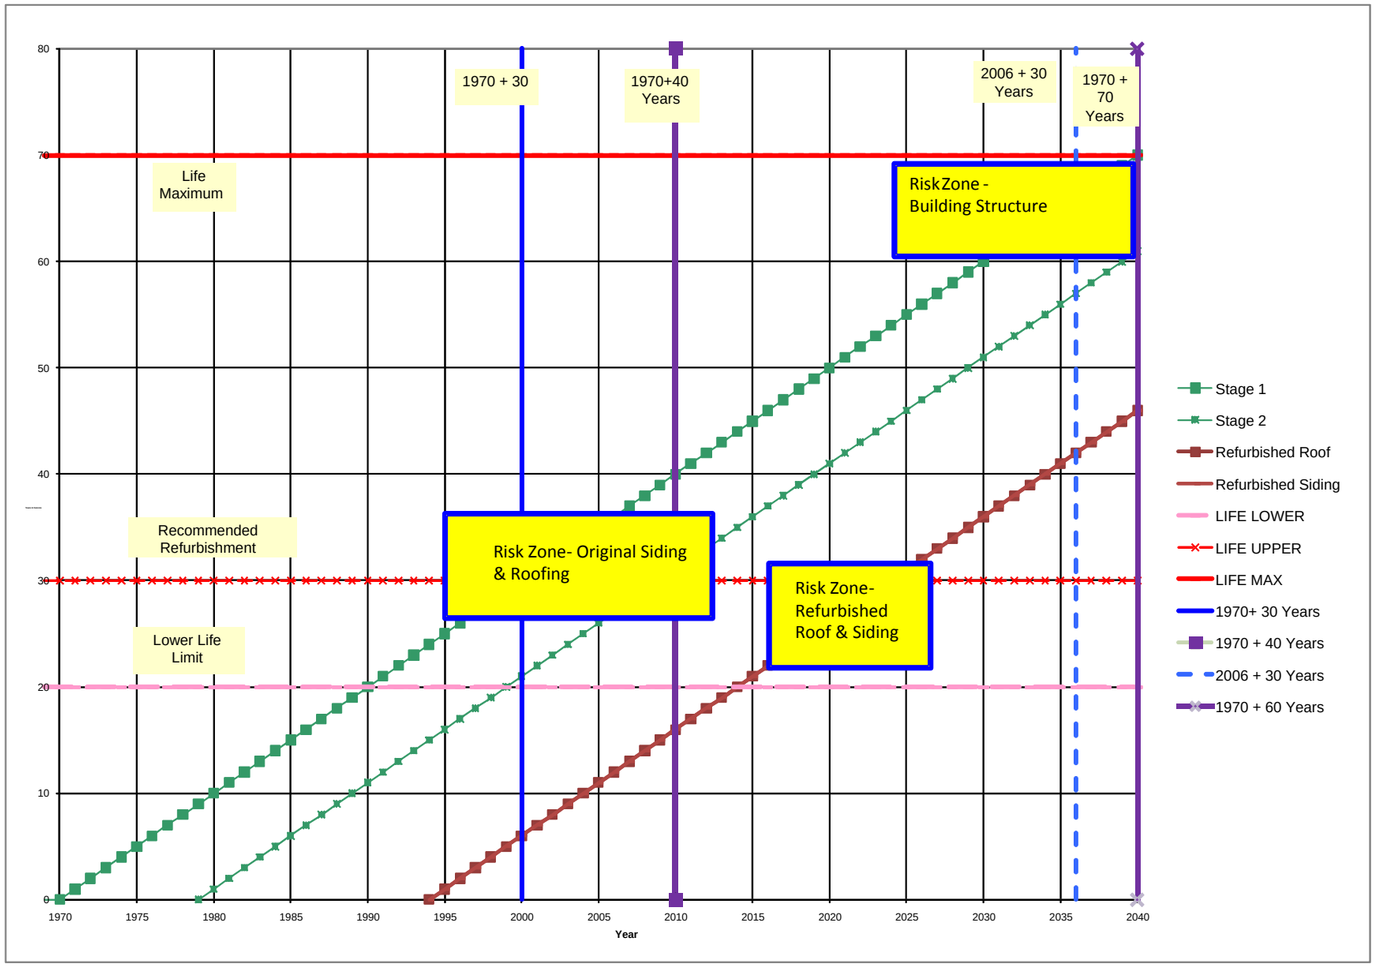
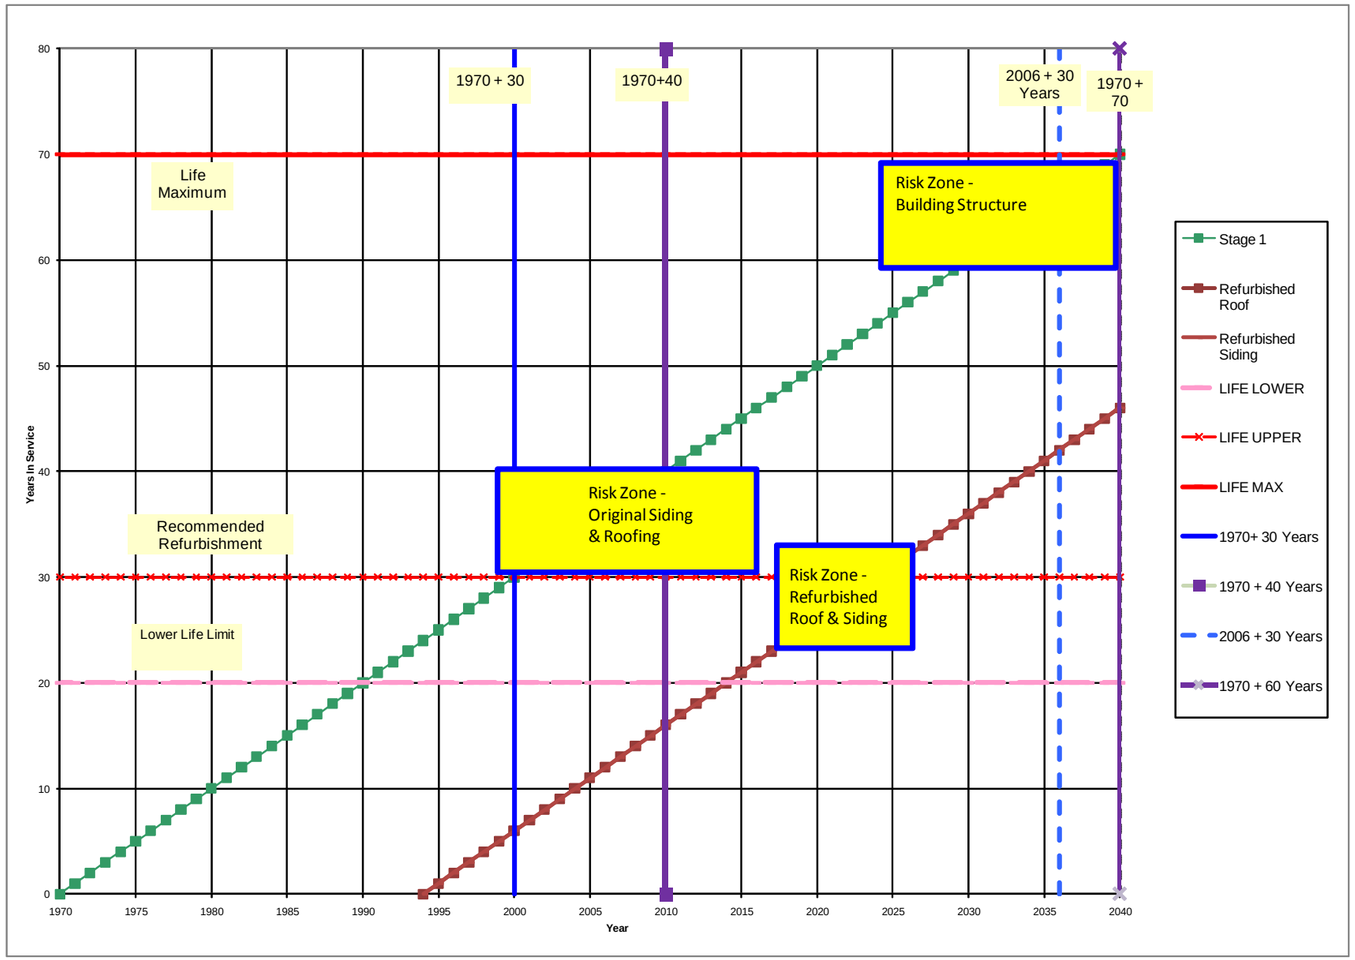
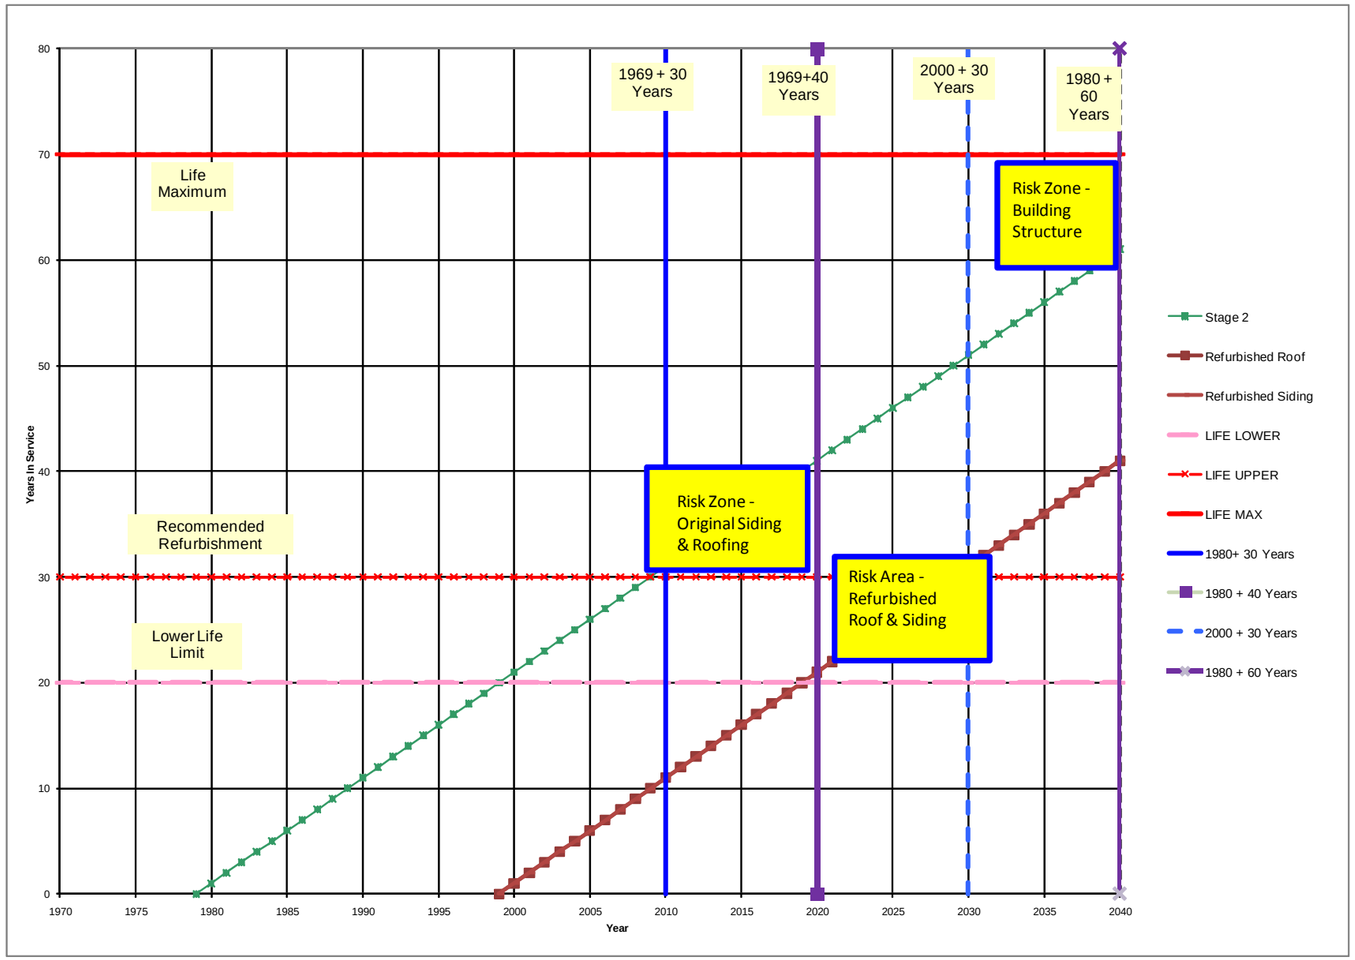
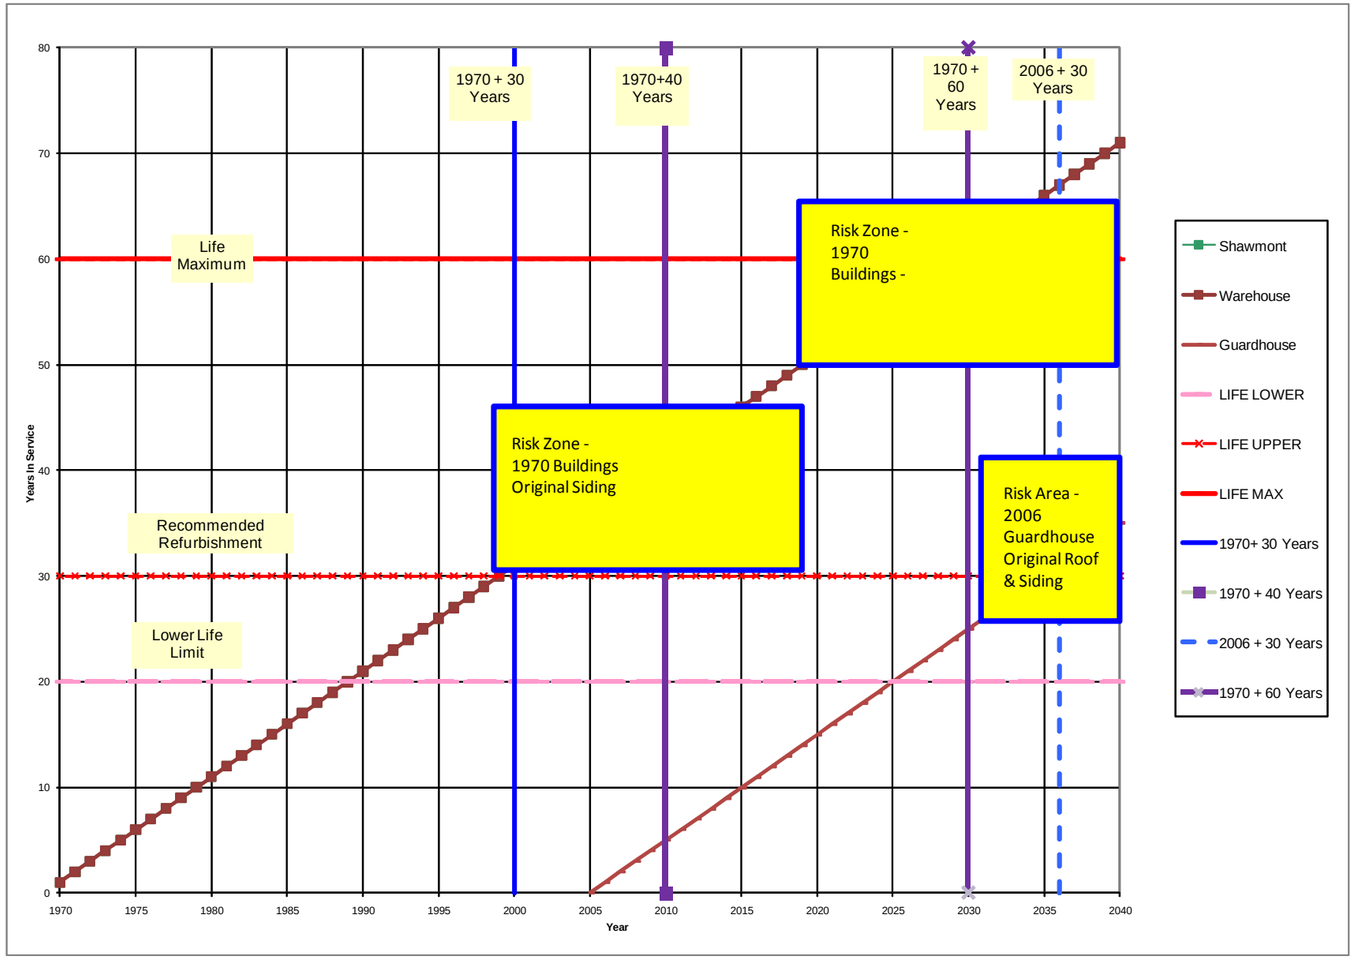
FIGURE 11-11 LIFE CYCLE CURVE - BUILDINGS AND BUILDING M AND E SYSTEM (POWERHOUSE)

FIGURE 11-12 LIFE CYCLE CURVE - BUILDINGS AND BUILDING M AND E SYSTEM (STAGE 1 PUMPHOUSE)

FIGURE 11-13 LIFE CYCLE CURVE - BUILDINGS AND BUILDING M AND E SYSTEM (STAGE 2 PUMPHOUSE)

FIGURE 11-14 LIFE CYCLE CURVE – BUILDINGS AND BUILDING M AND E SYSTEM (PERIPHERAL BUILDINGS)

The curves indicate that the remaining life (RL) of most buildings exceeds the generation end date of 2020 and likely the desired life (DL) which is the end date for synchronous generation of 2041. The implementation of a roofing and siding refurbishment program will be necessary between the 2015 to 2025 period, and later for newer buildings or parts of buildings (WTP, guardhouse). The basic structure of most buildings is considered sound, but with limited data available. The primary M and E system of concern (not shown) are the powerhouse house elevators which are likely nearing the end of their reliable service life and should have a major refurbishment or be replaced. Cranes are an issue to continue regular testing, but no specific life issues were identified. Other aspects such as HVAC also will come into play (i.e. condenser vacuum venting, upper roof vent wind protection) in the short term, but nothing major beyond these in the immediate future.

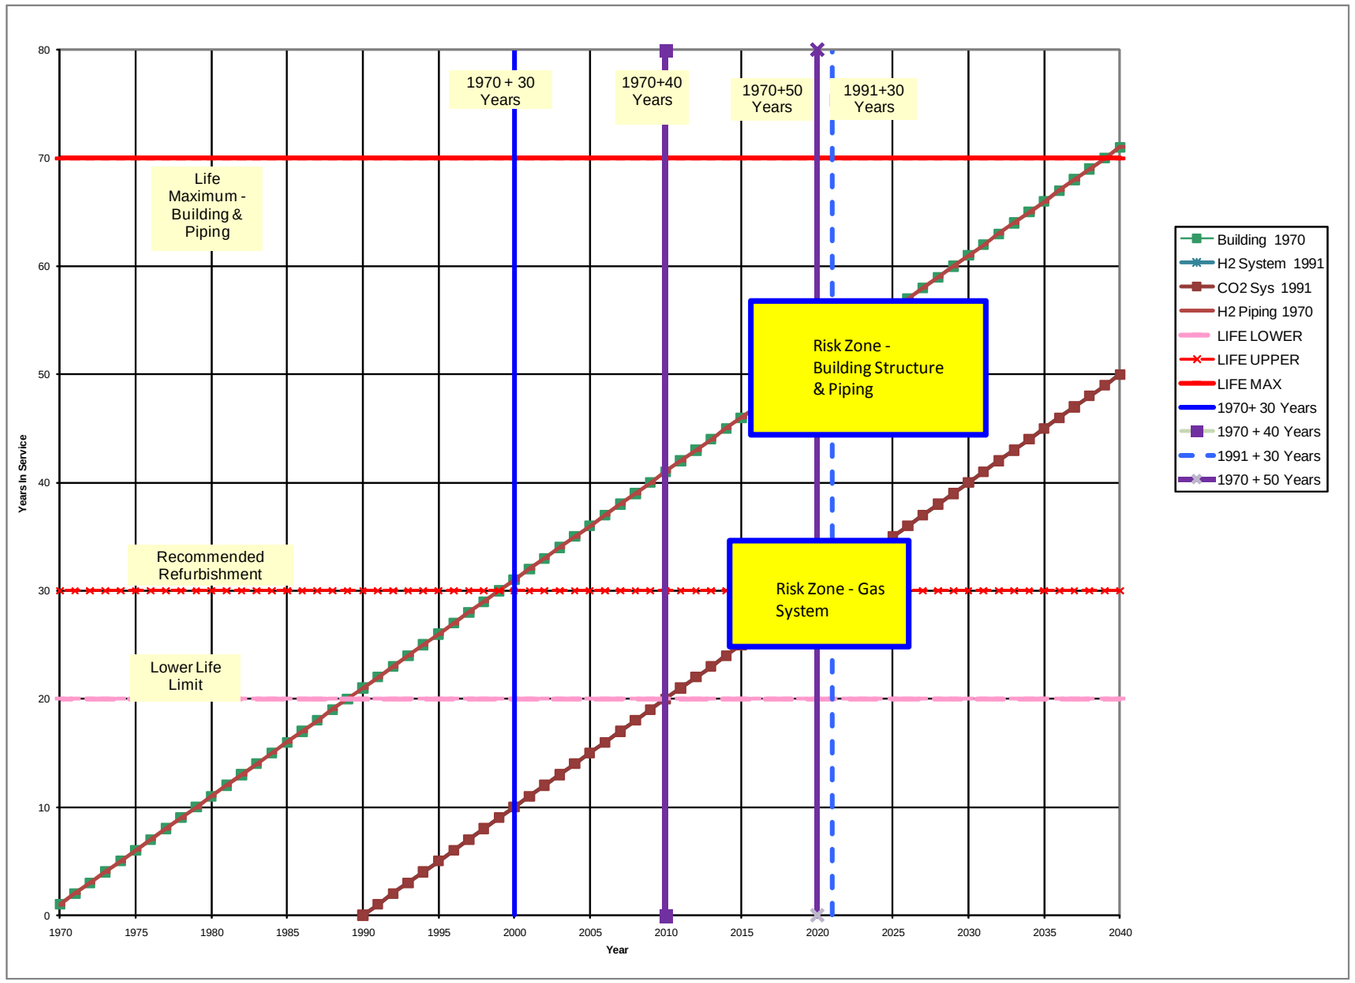
FIGURE 11-19 LIFE CYCLE CURVE – HYDROGEN, NITROGEN, AND CARBON DIOXIDE SUPPLY SYSTEMS

The curves indicates the remaining life (RL) of the hydrogen, nitrogen, and carbon dioxide supply systems exceeds the end date for generation of 2020 but not likely the desired life (DL) which is the end date for synchronous generation of 2041. It is clear that the system generally has considerable technical life remaining. Three concerns not reflected are i) the condition of the distribution piping for which no test information was reviewed, ii) the restricted supply capability of the carbon dioxide delivery system; and iii) the limited supply infrastructure for hydrogen on the mainland.
