Holyrood Thermal Generating Station (Holyrood) Condition Assessment & Life Extension Study, - Final Report

Holyrood Thermal Generating Station
Condition Assessment & Life Extension Study

January 28, 2011

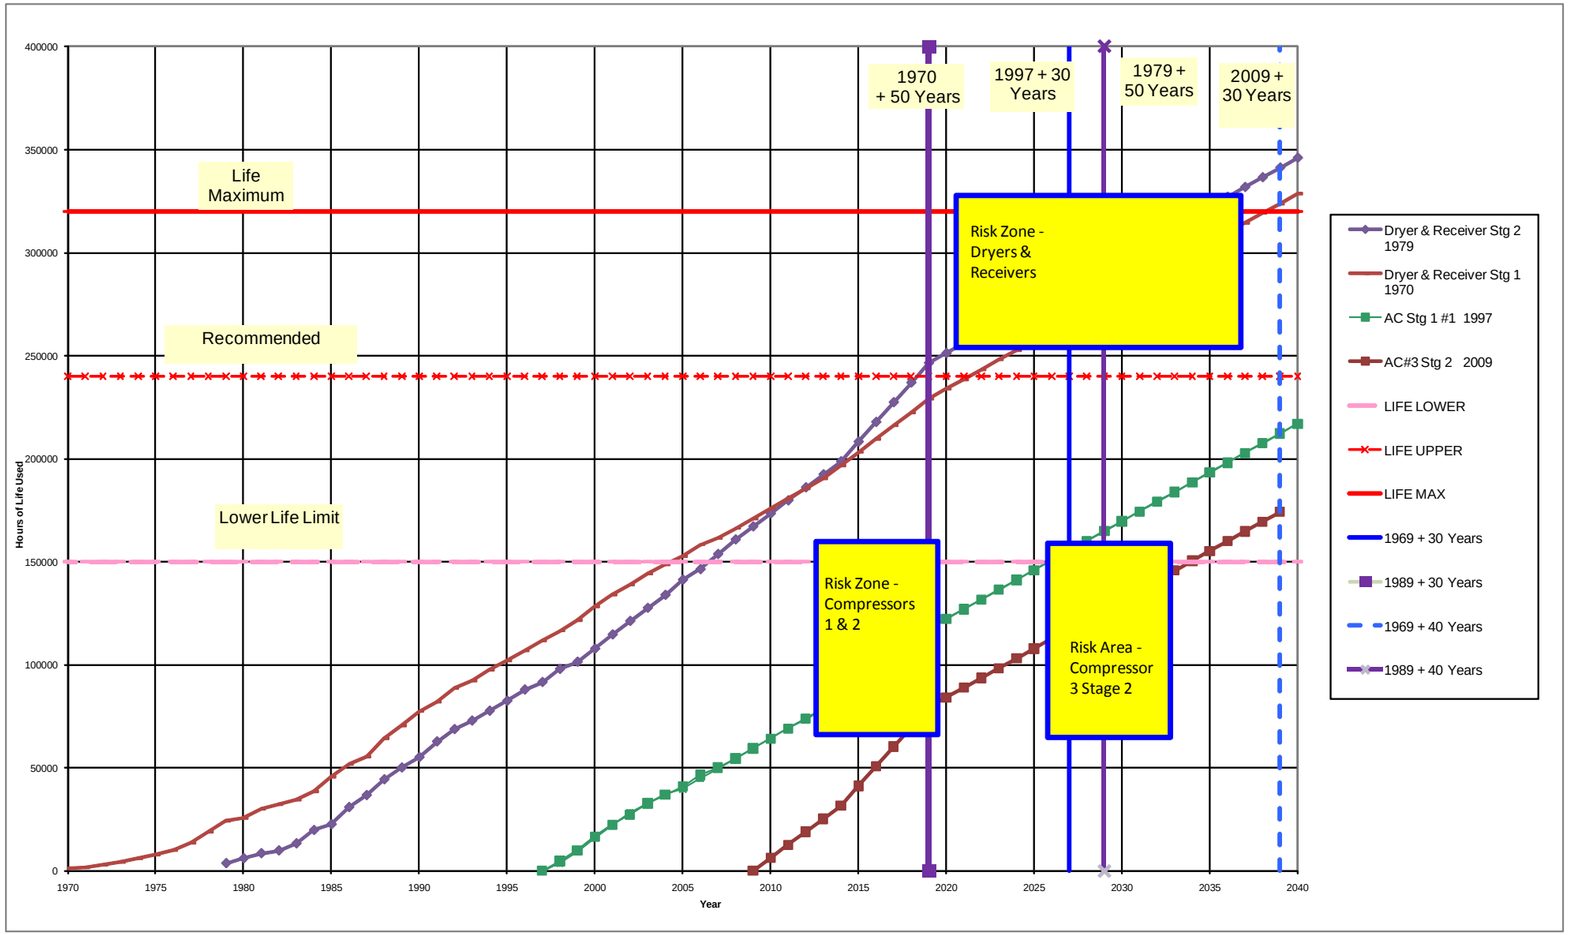
FIGURE 11-21 LIFE CYCLE CURVE – COMPRESSED AIR

The curves indicate that the remaining life (RL) of the compressed air system exceeds the end date for generation of 2020, but maybe not the desired life (DL) of 2041 (at the end of synchronous condensing life) without refurbishment and/or replacement. The exception is the current stage 1 compressors which are in need of replacement in the next few years and the newer Stage 2 compressors which will likely need replacement in the period after 2020.

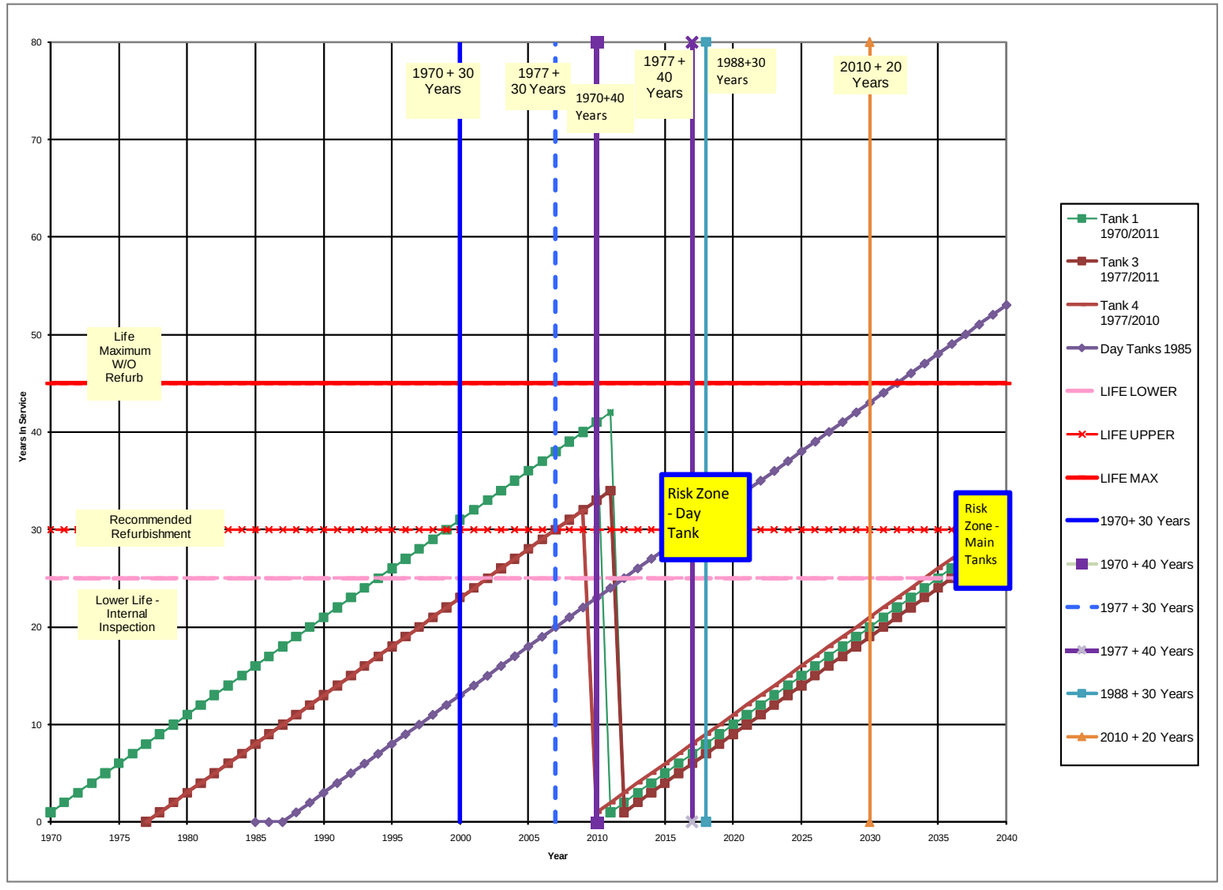
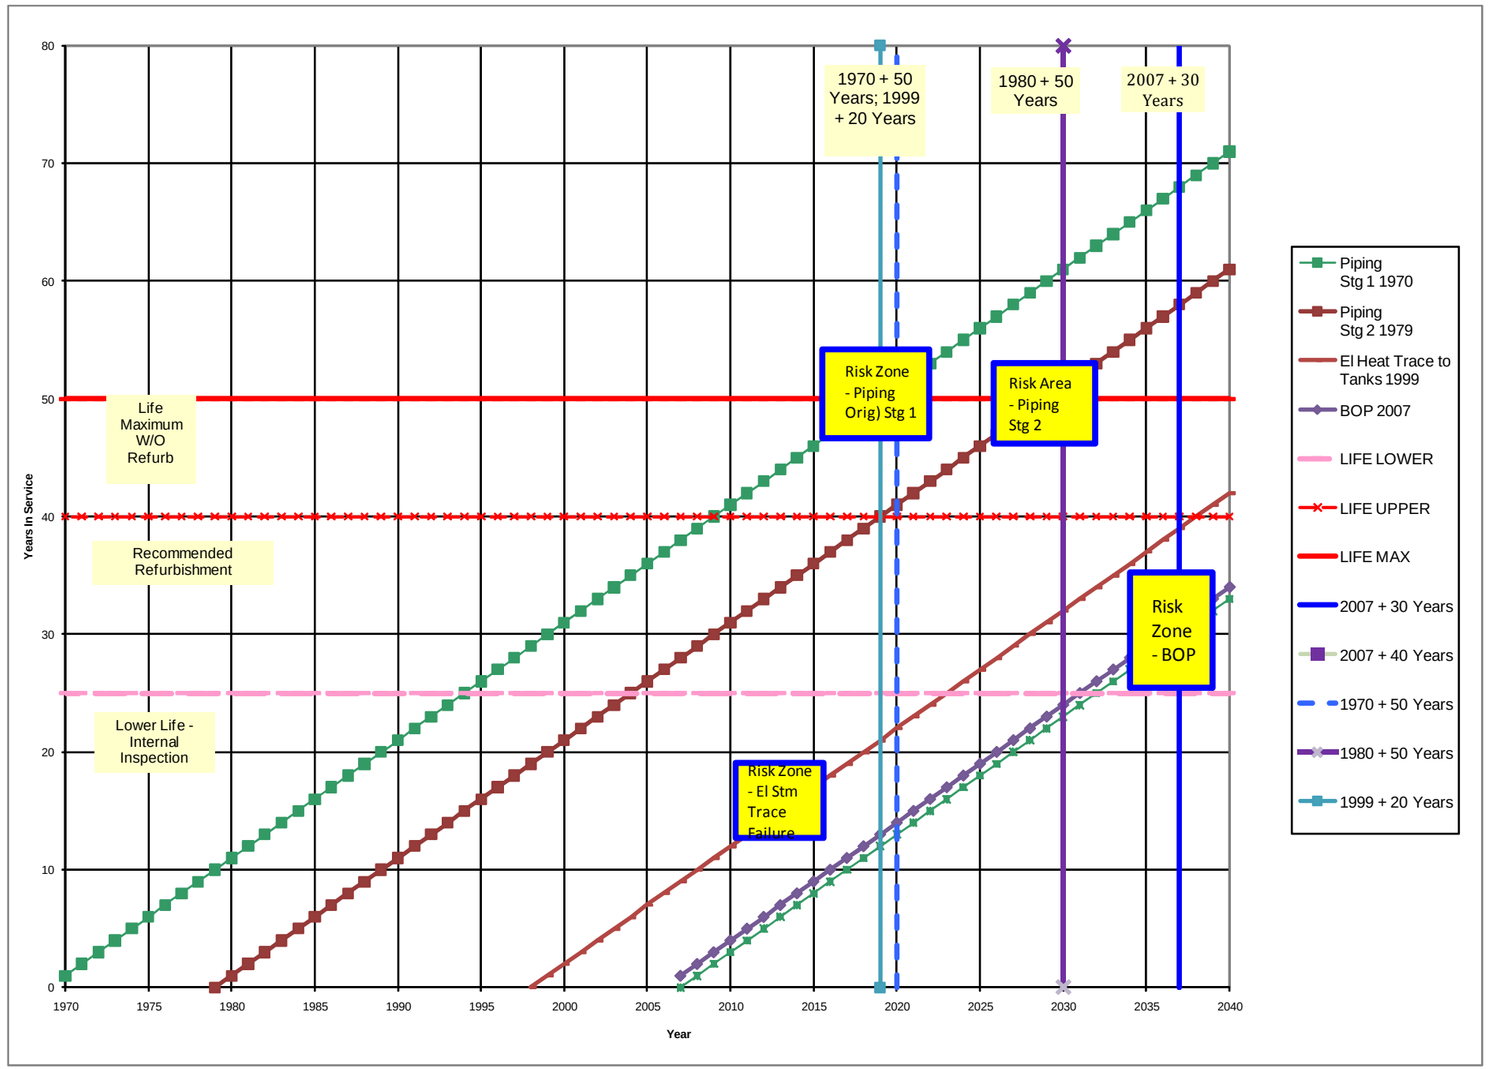
FIGURE 11-27 LIFE CYCLE CURVE – FUEL SYSTEMS (LIGHT AND HEAVY OIL TANKS)

FIGURE 11-28 LIFE CYCLE CURVE – FUEL SYSTEMS (LIGHT AND HEAVY OIL - BOP)

The curves indicate that the remaining life (RL) of the light oil and heavy oil tanks can reach the desired life (DL) of the end date for generation of 2020 once the current heavy oil tank refurbishment is completed. It does identify a need for the heavy oil day tank to be inspected and refurbished in the near future. It also identified the immediate and critical problem of the electric heat tracing on the oil delivery line to the heavy oil tank farm.

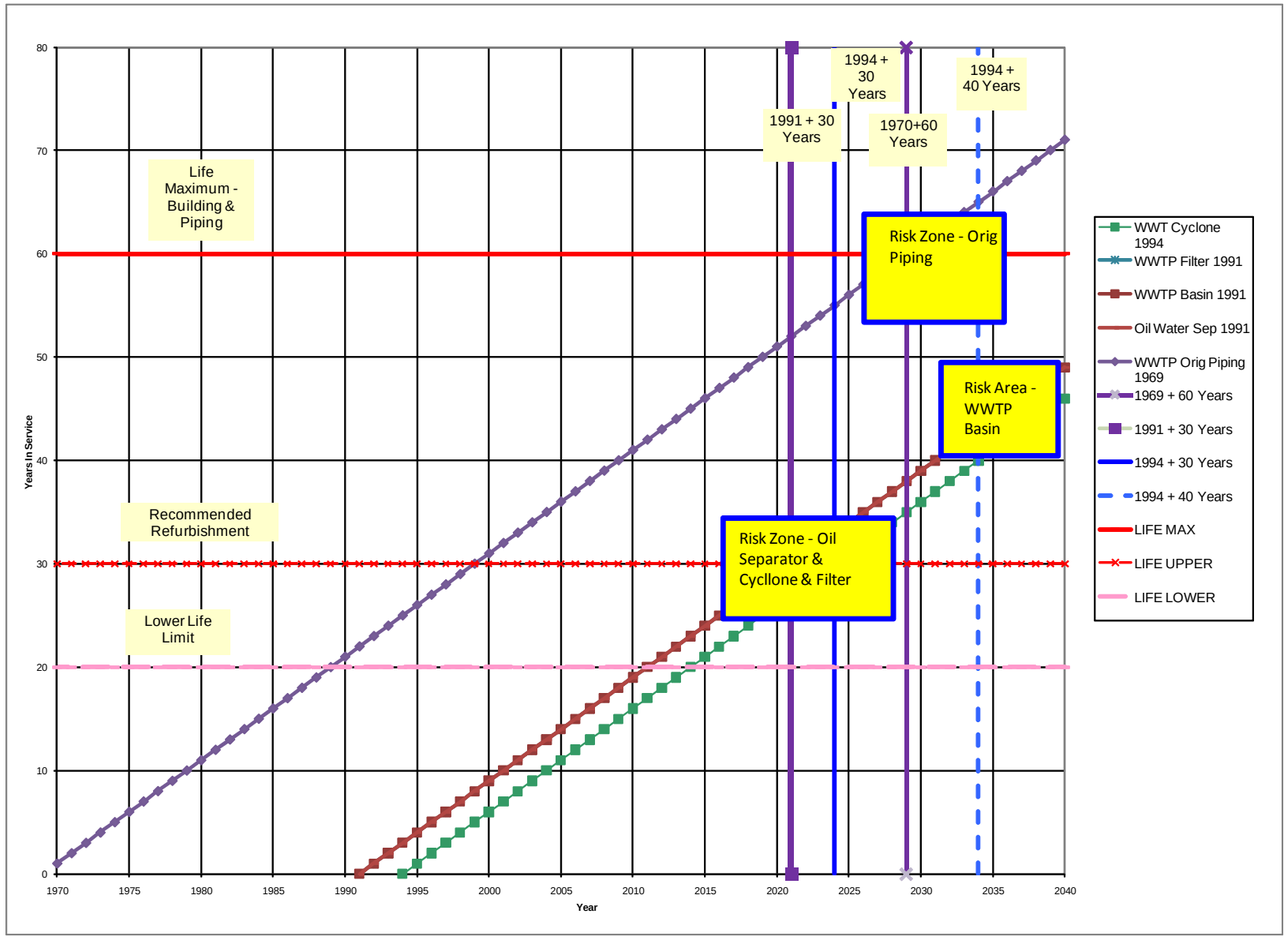
FIGURE 11-29 LIFE CYCLE CURVE – WASTE WATER TREATMENT PLANT (WWTP)

The curves indicate that the remaining life (RL) of most of the waste water treatment plant (WWTP) system exceeds the desired life (DL) which is the end date for generation of 2020. The exception is the WWTP basin building which requires refurbishment/replacement. The dates for the oil separation and piping and basin tanks are subject to inspection information required.

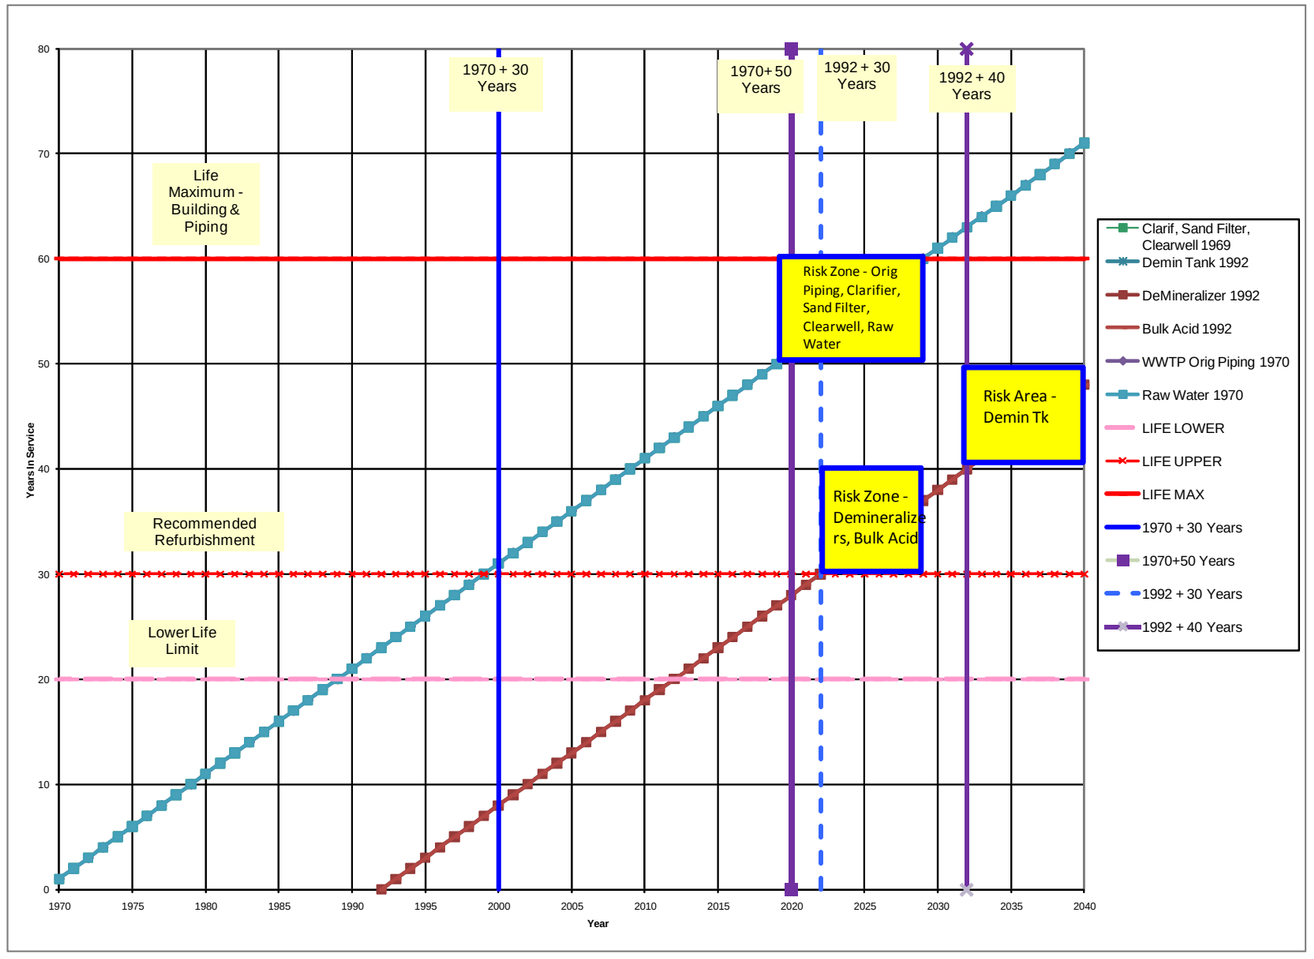
FIGURE 11-33 LIFE CYCLE CURVE – WATER TREATMENT PLANT (WTP) SYSTEM

The curves indicate that the remaining life (RL) of the water treatment plant (WTP) system exceeds the desired life (DL) which is the end date for generation of 2020. This is dependent on the condition primarily of the original equipment. Given they represent a single contingency failure mode, an assessment of their condition is critical to firming this assessment. Similarly, their importance as a single contingency failure mode makes an understanding of the condition of the raw water line from the storage pond and the dam at the storage pond a critical task.

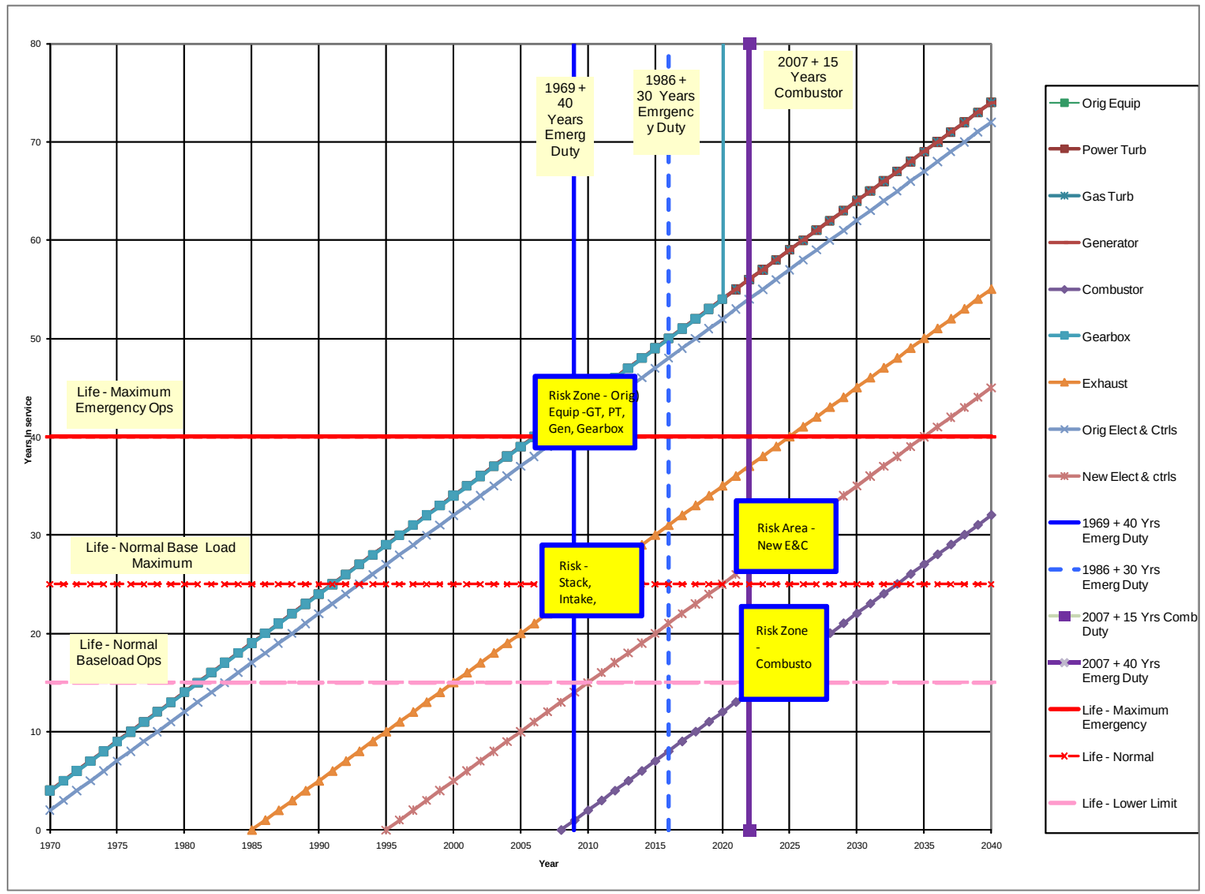
FIGURE 11-39 LIFE CYCLE CURVE – GAS TURBINE GENSET (PHYSICAL AGE BASIS)

The curves, as well as the condition assessment, indicate the unit is in need of a significant and immediate overhaul and refurbishment or replacement. Its remaining life (RL) is less than the desired life (DL) which is 2020. The importance of a near term overhaul or replacement is highlighted by the critical system role that the unit needs to play in black starting the Holyrood units in the event of a system failure. The stack is physically in need of refurbishment or replacement. The intake likely needs a better filter media. The fuel system and coolers need repairs and better ambient protection. The gearbox seals continue to be an issue and a fire safety hazard. The gas turbine has not been overhauled for a considerable period, and recent inspections as well as the life cycle curve for a marine environment suggest that this necessary.

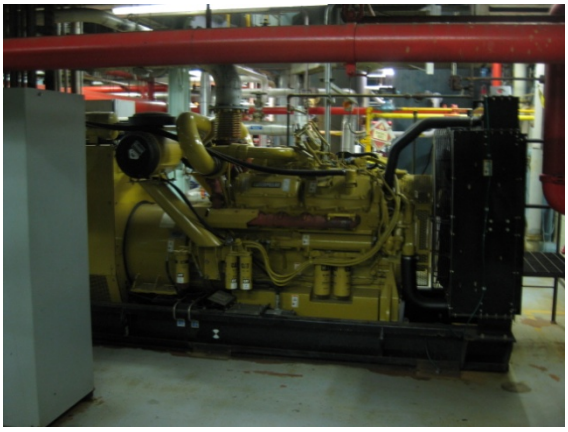
The Stage 2 emergency diesel was installed in 1980. It is at the end of its normal useful life. It should be replaced between 2012 and 2015 and would then be expected to last to 2041.

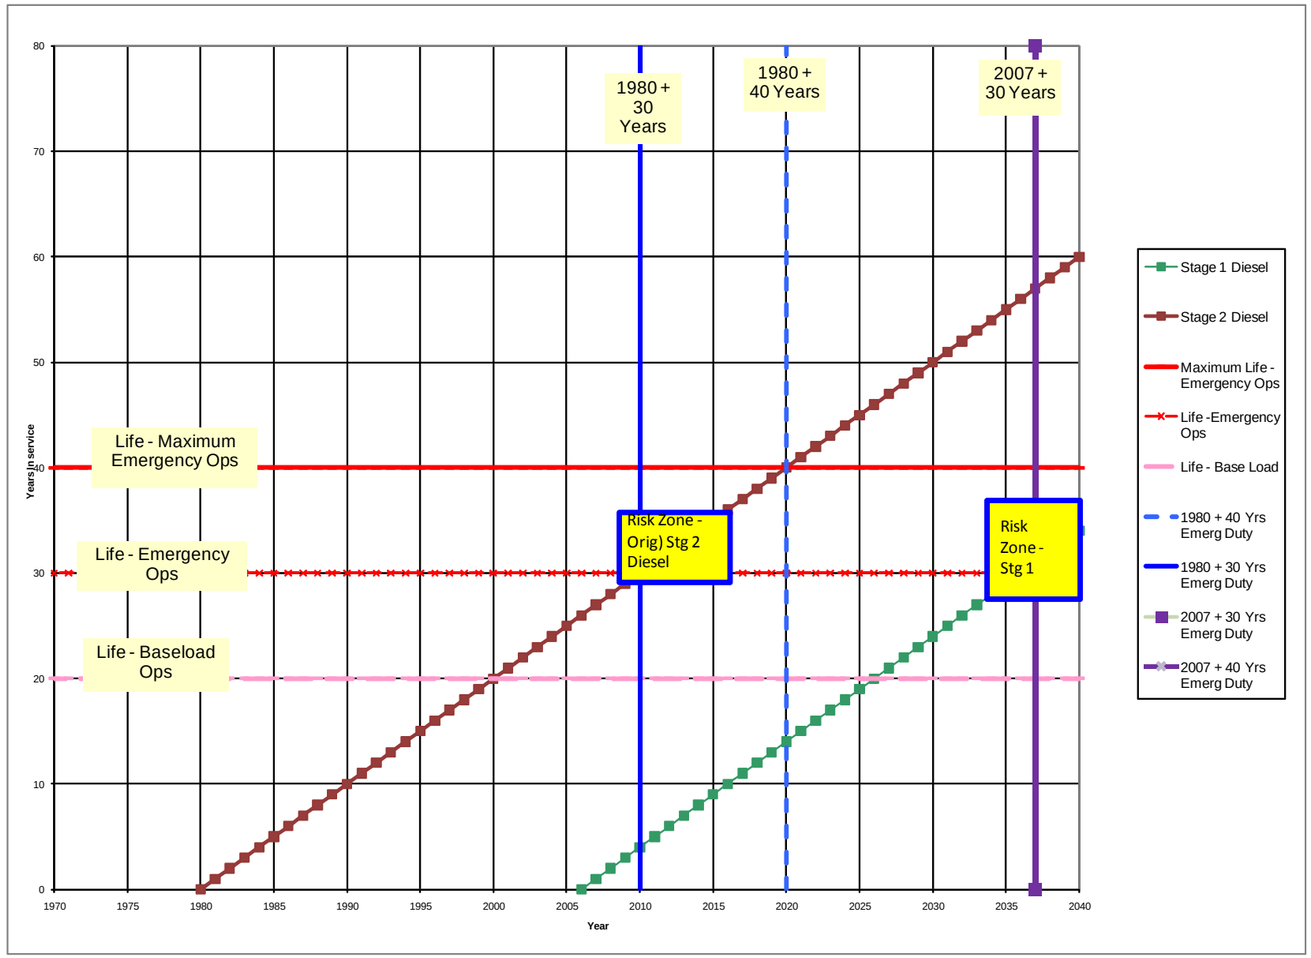
FIGURE 11-42 LIFE CYCLE CURVE – DIESEL GENSETS

The curves indicate that the remaining life (RL) of the newer Stage 1 diesel genset exceeds the end date for generation of 2020, and likely the desired life (DL) of 2041 (at the end of synchronous condensing life). It also indicates that the original Stage 2 diesel genset is at or very near its end of life and should be replaced. Given the critical role these units play in emergency safe shutdown, the replacement should be a high priority.
