REPORT NO. 5467-08-4

NEWFOUNDLAND POWER CO.

GAS PATH INSPECTION OF GRAND BANK  
MOD POD 25 POWER TURBINE  
FOR CONTINUED OPERATION  
AT 20 MW AND UNDER

July 29, 2001

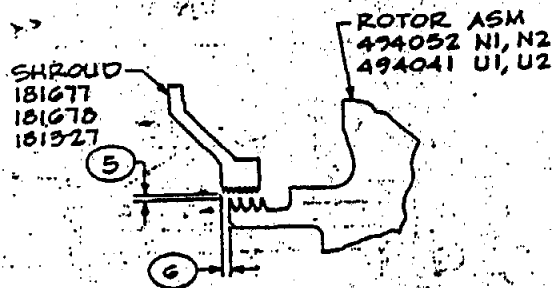
FRONT ROTOR SEAL CLEARANCE

Rev	Fit Number	Description	Max/Min	Max/Min	TMR		TMR	
			B/P Fit	Serv Fit	LN	RH	LH	RH
1	5	First stage turbine rotor disk to labyrinth seal (.015 Min. at Bottom) Rad. Gap diameter difference + shroud ID - rotor labyrinth OD = .140 (Serv Fit) (.110 (B/P Fit))	0 ± .01	0 ± .01	.087		.087	
	6	Labyrinth seal to first stage turbine rotor disk front axial overlap	.137 .000	.137 .000	+.020			
	7	First stage turbine rotor disk to front air seal Radial gap	.115 .090L	.125 .090L				
	8	First stage turbine rotor disk to rear air seal Radial gap	.115 .090L	.160 .080L				
	30	First stage turbine rotor disk front to front air seal overlap	.298 .113	.435 .113				
	31	First stage turbine rotor disk rear to air seal overlap	.273 .094	.280 .030
