**Newfoundland Power
2004 Capital Budget Application
Filing Contents**

**Volume I
Application, Schedules and Prefiled Evidence**

**Volume II
Expenditure Details, Reports and Studies**

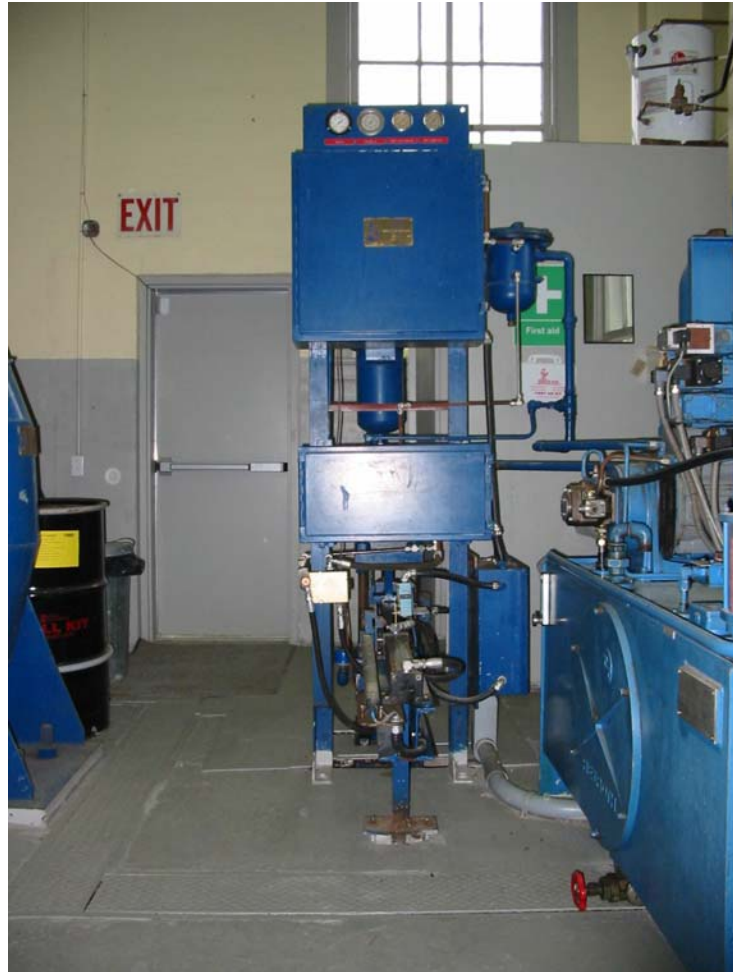
Pressure Relief Valve

Interfacing with the PRV tracking system has increased the PLC hardware requirements of both the programming effort and the necessary

processing power of the PLC. To ensure the long term reliability of the system it is felt that integrating the control of the PRV into the PLC ladder logic improves control and protection for both the PRV and the penstock.

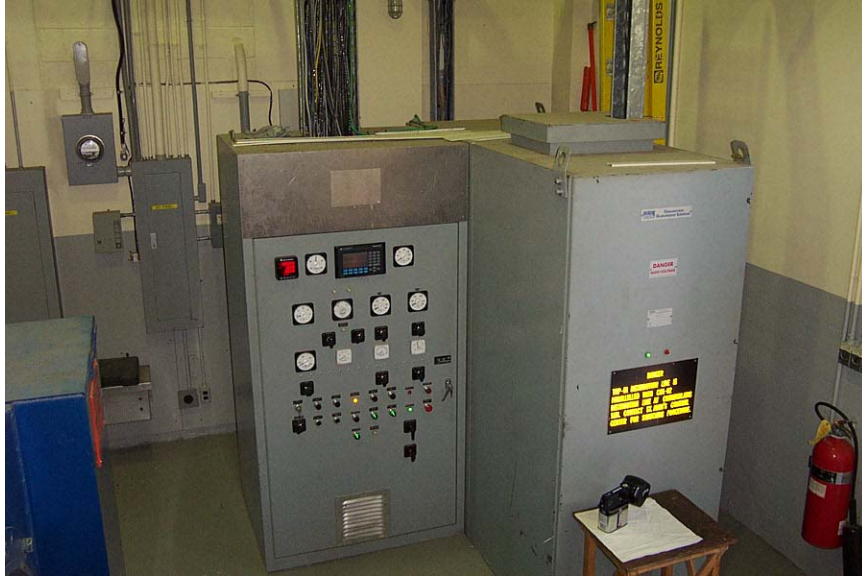
Unit Control Panel and Generator Breaker

To provide the necessary space for a governor PLC, it will be necessary to replace an existing equipment enclosure with an enclosure that also includes the governor function.

The replacement of the sequencing logic and associated controls presents an opportunity to combine both the governing function and the protection and control function into a single enclosure.

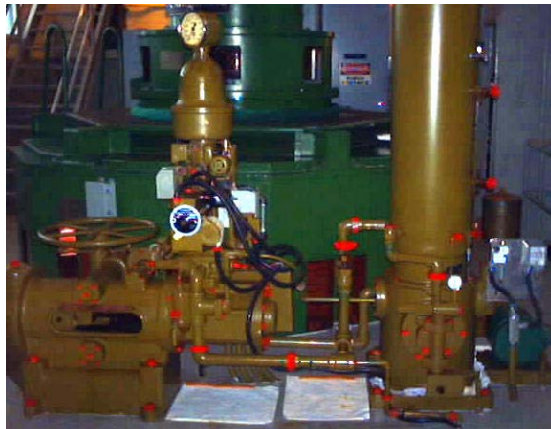
Woodward Governor

Recent experience indicates that the existing governor speed droop is inaccurate and it is no longer able to properly regulate frequency when operating isolated from the provincial power grid. Frequent adjustments are required and, as a result, there are concerns with the quality of power provided to customers when supplying local load. The Woodward governor is original to the plant and is difficult to maintain. The manufacturer is no longer able to provide replacement parts and has limited their support to system upgrades and retrofits. As a result, replacement parts are machined locally and do not meet the tolerances of the original specifications. In addition, the pressurized oil system employed by this governor exposes the plant to the risk of oil release into the tailrace.

There are two options for replacing the original governor. The mechanical governing head can be replaced with an electronic upgrade from the original manufacturer. The hydraulic system would undergo replacement of some parts no longer available and refurbishment of the power piston. The second option is to replace the Woodward system entirely with an all-electric solution, thereby reducing the use of oil at the facility. One significant technical issue to overcome is related to the fact that the existing Woodward governor is mechanically linked to a pressure relief valve. Both solutions have a similar cost, and the final decision as to which option should be implemented will be determined during the detailed engineering design stage. An additional benefit resulting from the implementation of either of these solutions is the provision of spare parts that will be used to maintain similar units still in service.

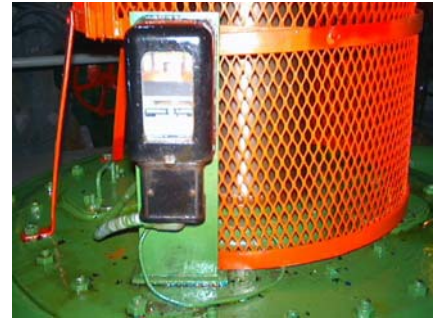
Automating the valves and flow meter in the bearing cooling water system through the UCP will enhance mechanical protection for the turbine and generator. Cooling will be provided only when required to maintain constant bearing temperature.

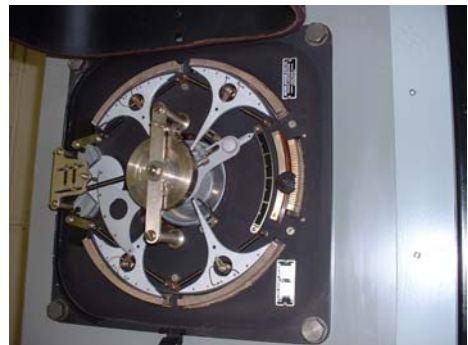
The excitation system is in good condition, with the exception of the antiquated voltage regulator. The unit control panel will be supplied with a digital voltage regulator to interface with the exciter. Consideration should be given for a brushless exciter if savings in maintenance costs can be demonstrated.

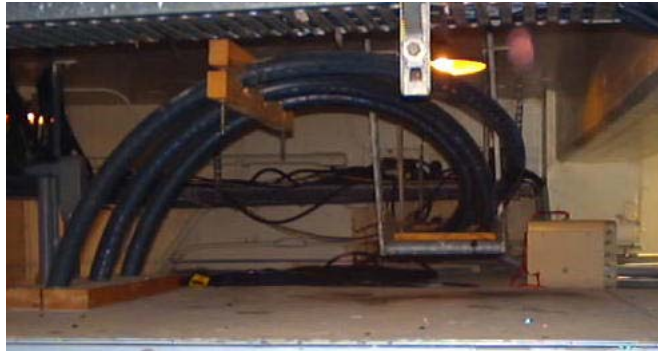
The power cables were replaced in March 2000. The power cables will remain in service and be connected to a new generator breaker. The bus connection between the generator output terminals and the power cables will need to be modified to accept a new generator breaker. The existing PTs and CTs will be replaced with the new switchgear.

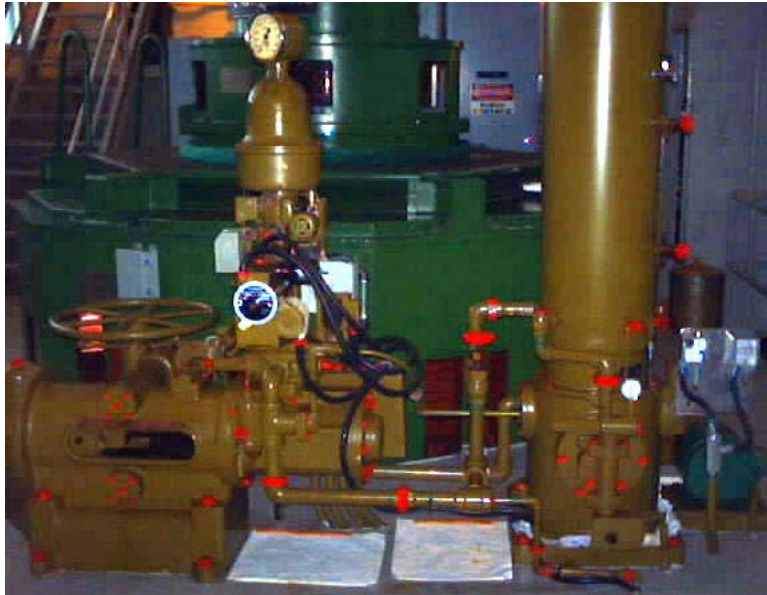
The existing Woodward governor is mechanically linked to a pressure relief valve. This will impact design solutions for a governor replacement.

Options for governor replacement include a Woodward 505H upgrade (including power piston overhaul) or a new hydraulic replacement, along with the all electric solutions employed recently at Newfoundland Power.

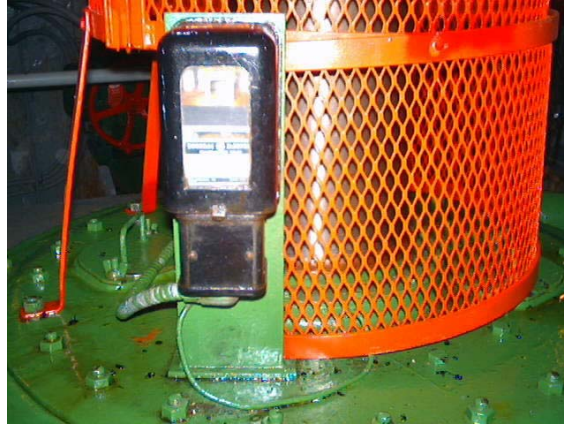
The existing bearings require water-cooling to ensure safe operating temperatures are maintained. There are valves and piping in place, however there is no automated control of these valves at present. Automating the bearing cooling system will ensure that problems are detected before damage is done to the bearings or shaft, thereby eliminating costly future repairs.

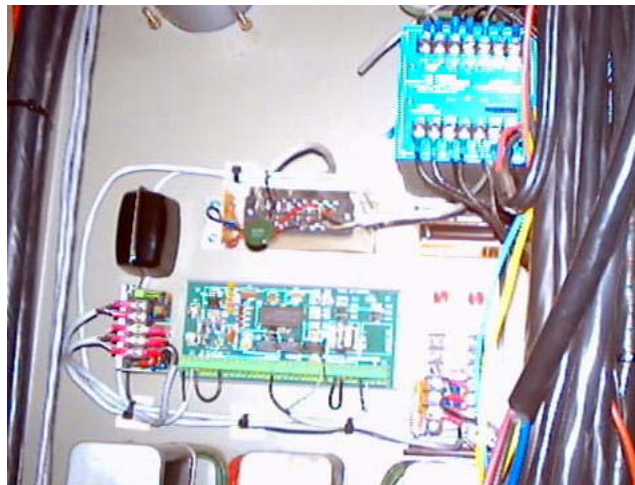
The existing water level probe and transducer are the older vintage Intertechnology equipment. The equipment is manufacturer discontinued and spare parts are no longer available. This equipment should be replaced with a new 4 to 20-milliamp water level transmitter and interfaced with the unit control PLC.

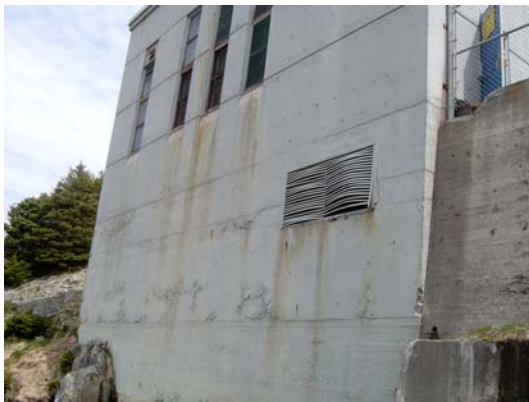
View of Back of Powerhouse

The powerhouse is in good condition. The exterior of the building and roof appear to be satisfactory. Some concrete repairs are required in the tailrace area at the water line. This area is susceptible to salt water spray and numerous freeze thaw cycles.

Concrete rehabilitation is required in the tailrace area in the vicinity of the water line. The damage is caused by salt-water spray and the freeze thaw cycles experienced in the ocean environment.

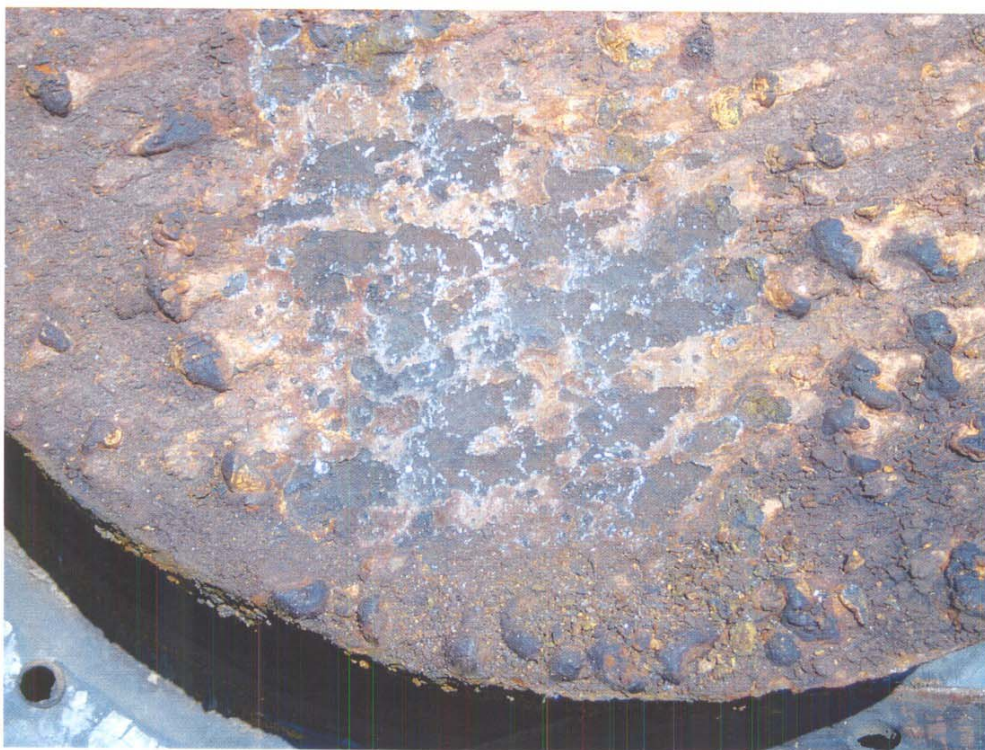
Pitting on Inside Surface of Manhole Cover

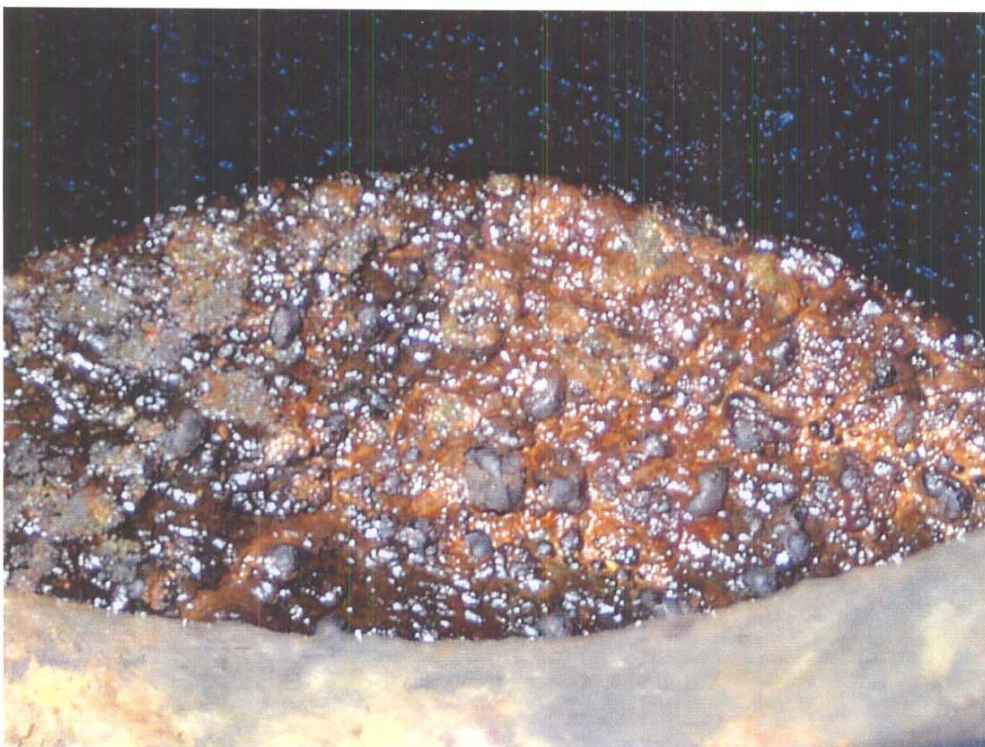
Growth on Internal Surface of Penstock
