**Re: Newfoundland Power's 2007 Capital Budget Application**

Prepared by:  
Gary L. Murray, P.Eng.

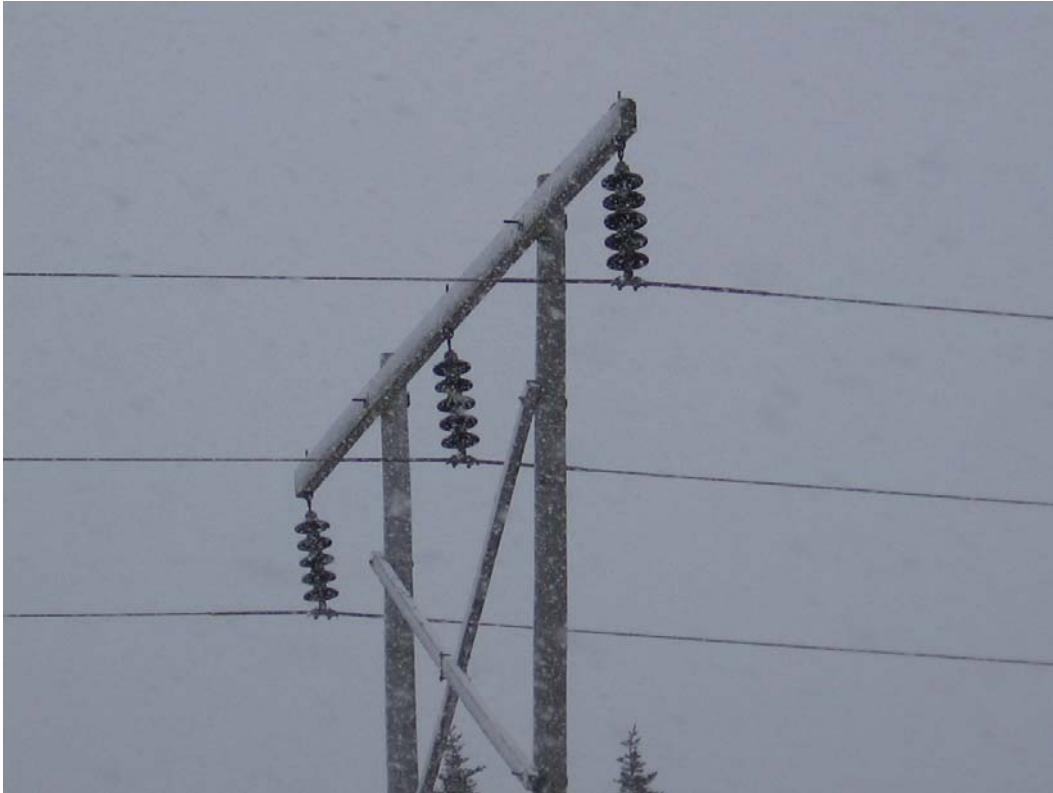
**Figure 12 - Old Insulators 20L**

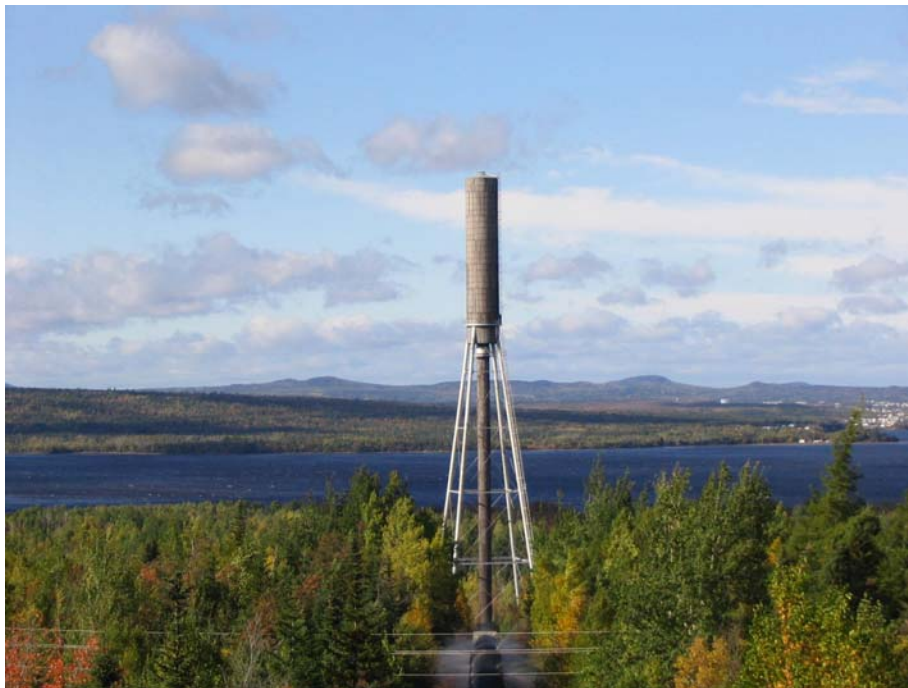
**Figure 6: View of Surge Tank**

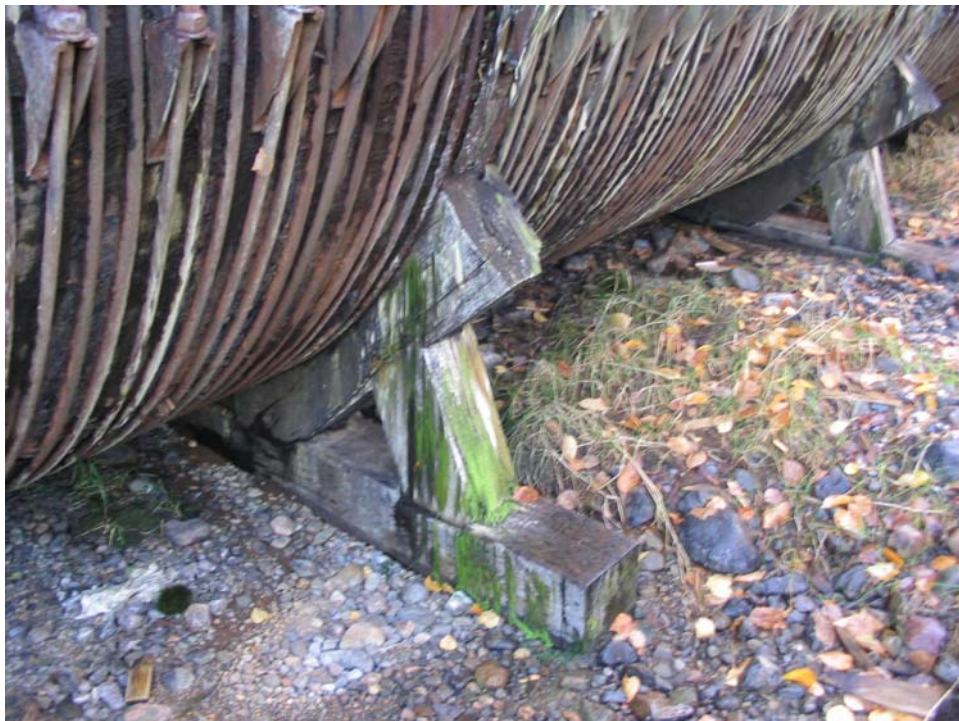
**Figure 11: Settlement of Penstock Supports**

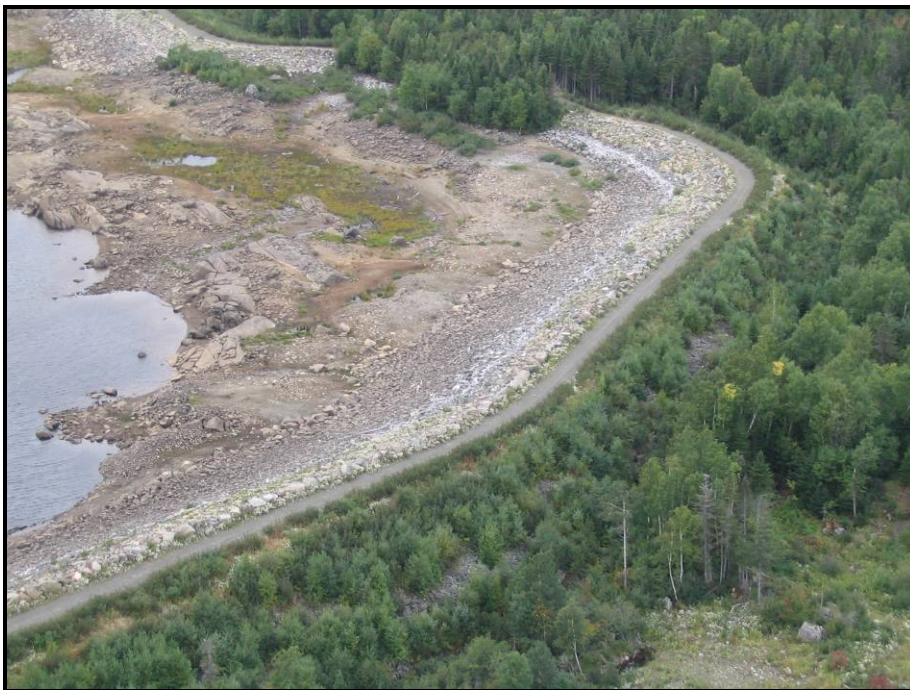
The upstream face of the dam is in good condition. The riprap is well graded with no indication of movement of the material. No unusual conditions were observed at the abutments. There was a good transition from the embankment sections to the abutments. The crest of the dam is in good condition. At the time of inspection there was no evidence of overtopping or damage observed due to vehicular traffic.

**Figure 4: Rattling Lake Dam (Note excessive vegetation on downstream face)**

To minimize the amount of vegetation growth on the downstream face of the dam it is recommended the downstream face be re-graded and rockfill be placed over the entire length of the dam.

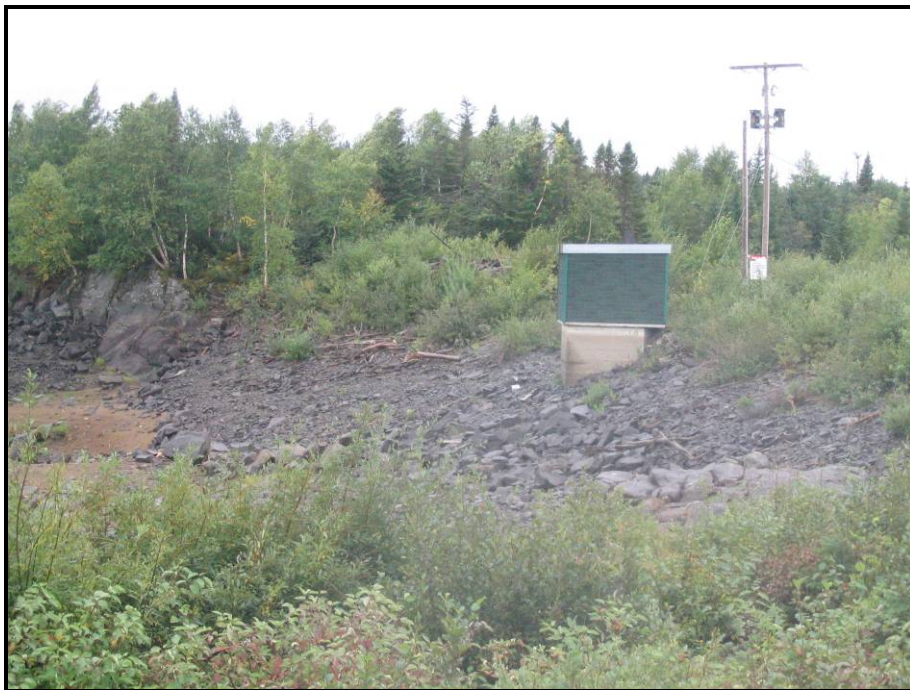
The riprap on the upstream face of the dam is sparse throughout most sections. Some sliding of rockfill into the approach channel was observed. No unusual conditions were observed at the abutments and the crest of the dam appears to be in good condition. No seepage was observed, potentially due to low reservoir levels.

**Figure 8: Amy's Lake Dam (Upstream Face)**

Riprap refurbishment is required on the upstream face of the dam. To prevent sliding of rockfill into the approach channel, it is recommended that the intake be raised by either extending the concrete wing wall or placing large boulders along the channels edge. Furthermore, to minimize vegetation growth, it is recommended that the downstream slope be re-graded and rockfill be placed along the entire length of the dam.

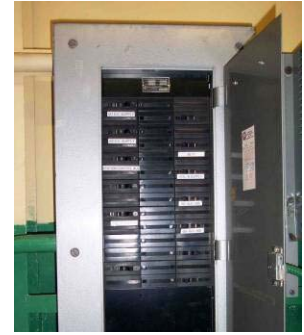
The DC distribution panel (figure 2) is original to the plant and has no spare breaker positions for additional circuits. Additional breaker positions will be required to accommodate the various electronic components to be included in the governor and unit control panels. Additional DC circuits are also required for the motor actuators associated with the new valves to be installed as part of the plant mechanical upgrade. Due to its age, and lack of spare capacity it is recommended that the DC distribution panel be replaced.

**Figure 2 - DC Distribution**

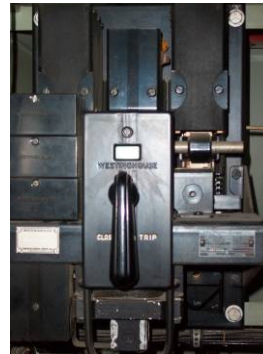
The Field Breakers (figure 6) on both units are original to the 1958 installation, are obsolete and lack a sufficient number of auxiliary contacts required by the PLC control system being installed. New field breakers will be installed in the new switchgear lineup. The power cables from the exciters to the generators via the field breaker are also original to the plant and will be replaced as they are at the end of their service life.

Figure 6 - Field Breaker

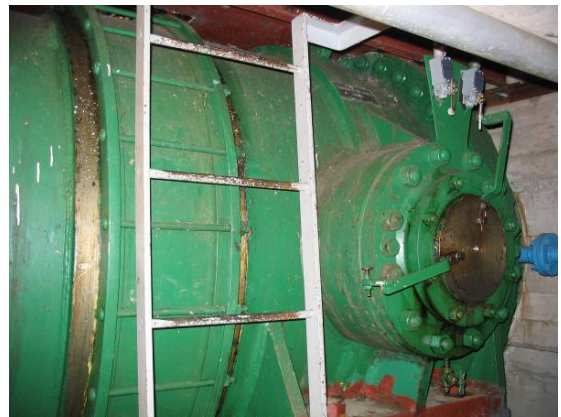
The existing main inlet valves have experienced leaks and related problems. Attempts were made to mitigate these issues however none resulted in long term success. The valves currently leak and make it unsafe to access the scroll case without having to dewater the penstock.

**Figure 1- Main Valve**

During the site visit, a series of pressure and load rejection tests were carried out. These tests were conducted to determine the pressure differential across the butterfly valves. The maximum pressure loss across each valve was measured to be approximately 3 psi. This pressure loss is approximately three times that which would be typical of a modern butterfly valve. Assuming an annual plant production of 76 GWh after plant refurbishment and a cost of energy of \$0.07/kwh, the replacement costs were justifiable.

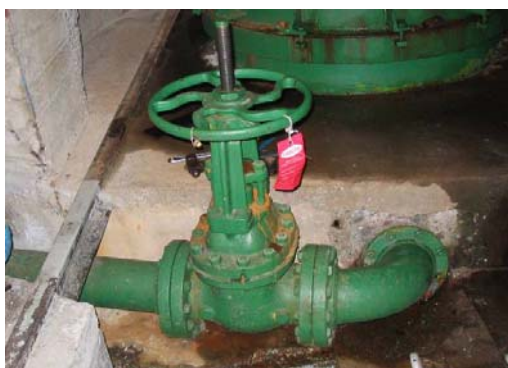
Each system has a 6 inch manual drain valve (figure 2) and a 6 inch manual bypass gate valve (figure 3). All valves are original equipment with the exception of the water actuated bypass valve on unit no. 2 which was replaced in 2001 and is in good condition.

**Figure 2 - Drain Valve**

Based on age and anticipated service life, the manually operated bypass and drain valves will be replaced.

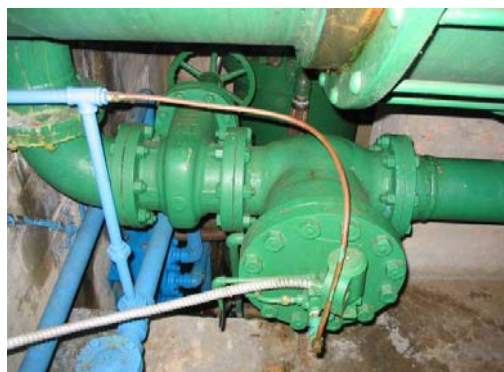
**Figure 3 - Bypass Valve**

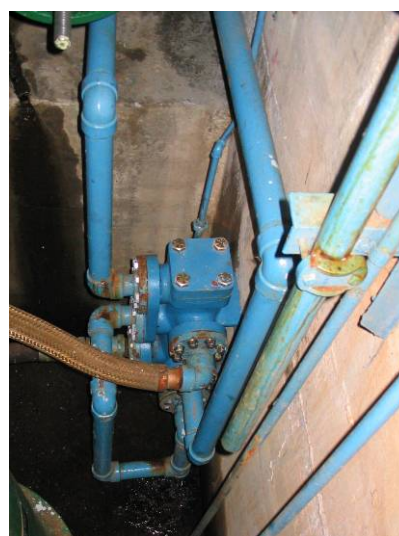
The existing butterfly and bypass valves for each unit are water actuated via a 2 inch 5-way control valve as shown in figure 4. Both 5-way control valves were refurbished in 2004 however, the original piping remains. Manual operation of the valves was at one time possible by means of a hand pump circuit and auxiliary water supply, but this system is no longer functional.

**Figure 4 - Valve Actuator**

This system will be decommissioned and the valve actuators replaced with 125 VDC electric actuators.

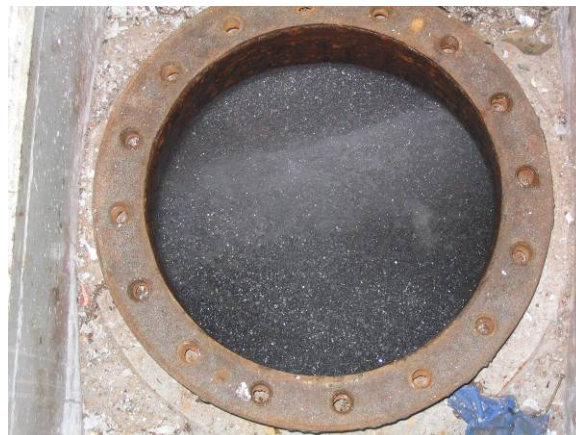
During the site visit, it was difficult to conduct an internal inspection of the turbines because of the excessive leakage past the two main inlet butterfly valves. On both units, when the scroll case access hatch was opened (figure 7), the field of view was clouded by the significant spray of water originating around the butterfly valve disc. To mitigate this problem the drain valve was opened and a plywood barricade was placed downstream of the butterfly and drain valves. Even with this barricade in place, there was still a considerable amount of water interfering with the inspection.

Figure 7 – Scroll Case Access Hatch

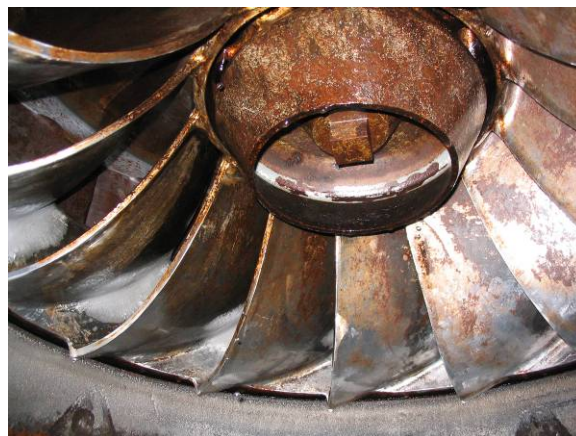
In 1986, the unit no. 2 turbine runner was replaced with a new Allis-Chalmers runner. The runner is currently in good condition (figure 9). There is some evidence of minor cavitation in essentially the same location on each of the blades. There is no cause for concern at this time.

All wicket gates, but one, are in good condition. Like on unit no. 1, this gate is located near the 2<sup>nd</sup> and 3<sup>rd</sup> stay vanes, counting from the area near the scroll case access hatch. These gates will be repaired as a temporary measure until the unit is overhauled in 2013.

Figure 9 – Turbine Blades Unit 2

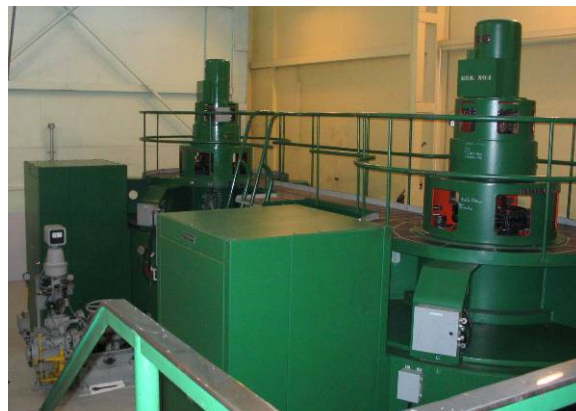
Figure 11 – Generator Gallery

The generator stator on unit no. 1 was rewound in 2004 and the exciter received a minor overhaul that included cleaning and painting. In addition new leads, brackets, and insulators were installed on the exciter. Electrically the exciter's test results were good.

During the rewind project, the braking system was overhauled and air lines were replaced with all new flexible high pressure lines, the brake cylinders were overhauled, and all new brake pads were installed.

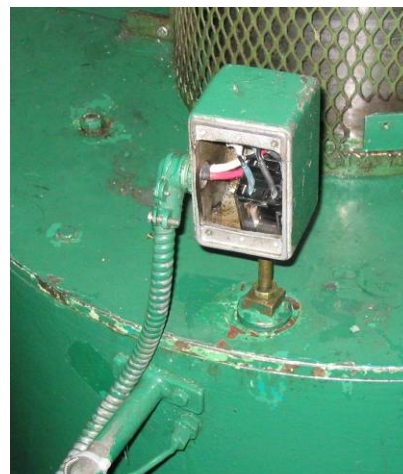
Figure 12 – Bearing Oil Level Switch

The existing oil level switches on the bearings (figure 12) provide alarm contacts only. These will be replaced with new sensors that are also capable of transmitting an analog signal to the unit PLC.

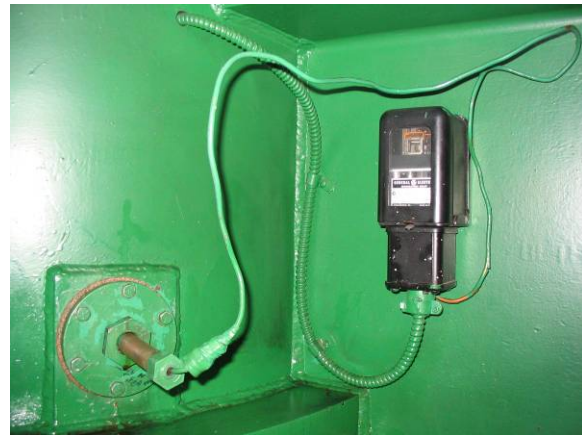
Figure 13 – Bearing Temperature Switch

The temperature of each bearing shell is measured with a capillary tube temperature thermal bulb (figure 13). These will be replaced since they are contact only and there is no analog signal which can be transmitted to the PLC.

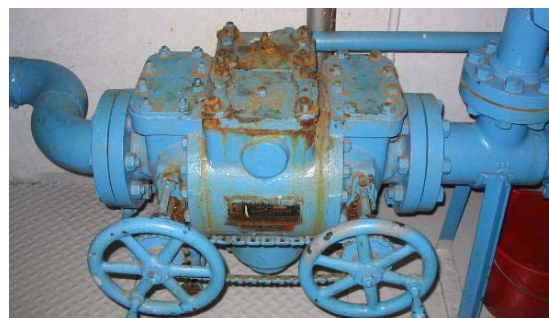
**Figure 14 – Twin Strainer**

The existing twin strainer (figure 14) is original 1958 vintage equipment and has caused problems in recent years. It supplies both bearing cooling water systems as well as other water systems that are no longer in use.

To clean the existing strainer, as is periodically required, both hydro units must be shut down. This strainer will be replaced.

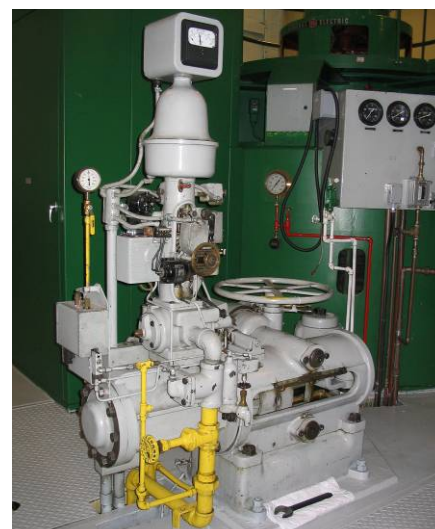
**Figure 16 – Woodward Governor**

Mechanically, both Woodward governors (figure 16) at Rattling Brook are in good condition and have operated reliably. Despite the fact that Woodward no longer supports its product to any great extent, parts, service, and training are now available from non-OEM providers.

The governors at Rattling Brook will be mechanically overhauled as part of the upgrades recommended in the Electrical Equipment Assessment Report. The functionality of the governors in terms of unit control capabilities is also found in this report.

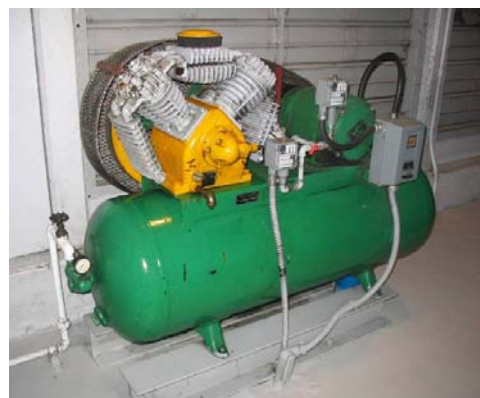
**Figure 17 – Air Compressor**

The central air compressor supplies the braking system on each unit as well as the actuators for the air intake and recirculation operable dampers. This compressor (figure 17) is original 1958 vintage equipment and will be replaced.

Upgrades will also be completed on the entire compressed air system, which is also original equipment. This includes replacement of the piping, valves, regulator, filters, separators, gauges, and related equipment.

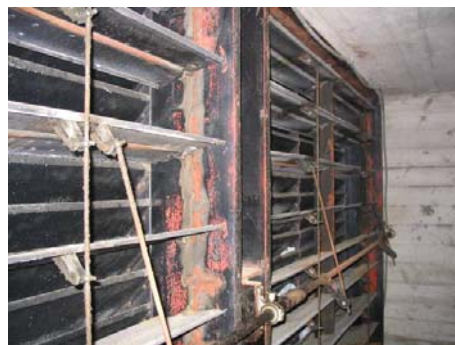
Figure 18– Air Inlet Dampers

The six air inlet dampers (figure 18) each have 9 inch horizontal, parallel blades in a 6 inch deep frame. The inside of each frame opening measures approximately 80½ inches long by 66 inches high. These dampers are badly corroded and require replacement.

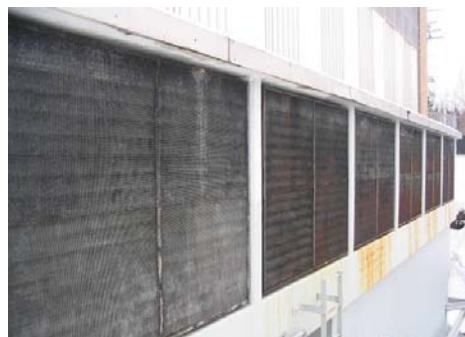
Figure 19 – Exterior Louvers

The six fixed louvers (figure 19) are located immediately outside air inlet dampers within the same building openings. As such, the overall dimensions of each louver match that of the air inlet dampers. Each louver has 9 inch horizontal, parallel blades in a 6 inch deep frame. The louvers also have an exterior bird screen with ¼ inch openings. This equipment is badly corroded and requires replacement.
