Root Cause Analysis Report

Bay d'Espoir Penstock No. 1 Refurbishment

H352666-00000-220-066-0002

March 17, 2017

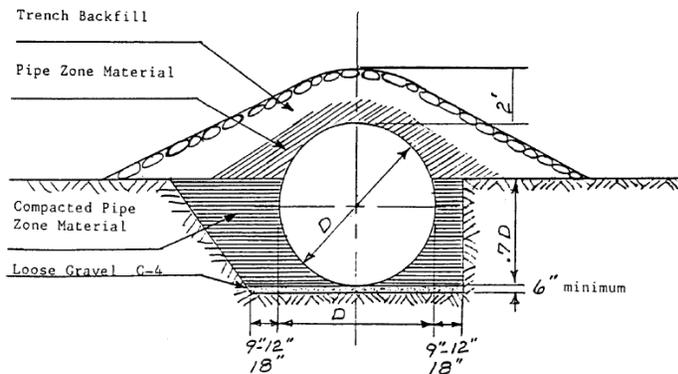
Figure 3-9: Typical Half Trench

Current reference material shows typical half trench buried penstock cover details (Buried Steel Penstocks – Steel Plate Engineering Data –Volume 4) of 2 ft minimum of cover and can be seen below:

When analyzing the backfill it was determined that backfill is structurally integral to the penstock and provides needed support along the center line. In the area where the penstock cracks occurred, the depth of backfill is less than 2 ft and some sliding and sloughing of the backfill has occurred. This has been shown to increase the stress level by approximately 100% in the area of longitudinal welds locations. Refer to the finite element stress analysis completed for the backfilling of the excavated areas in Appendix G.

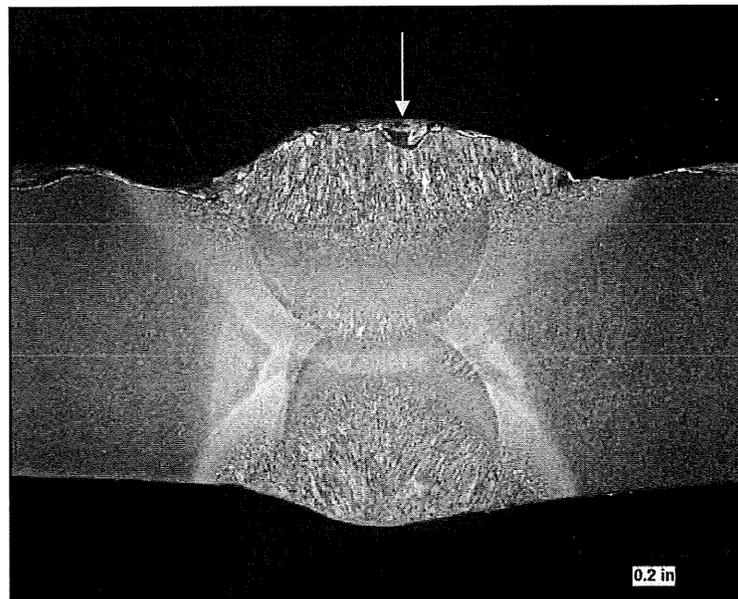
Specimen examined at 4X, photo shown at approximately 4X
Etched in 2% Nital

Figure 2: Photomicrograph of the Section 1, which had discontinuities at both toes (red arrows) and porosity (yellow arrow) on the face on one side of the weld.

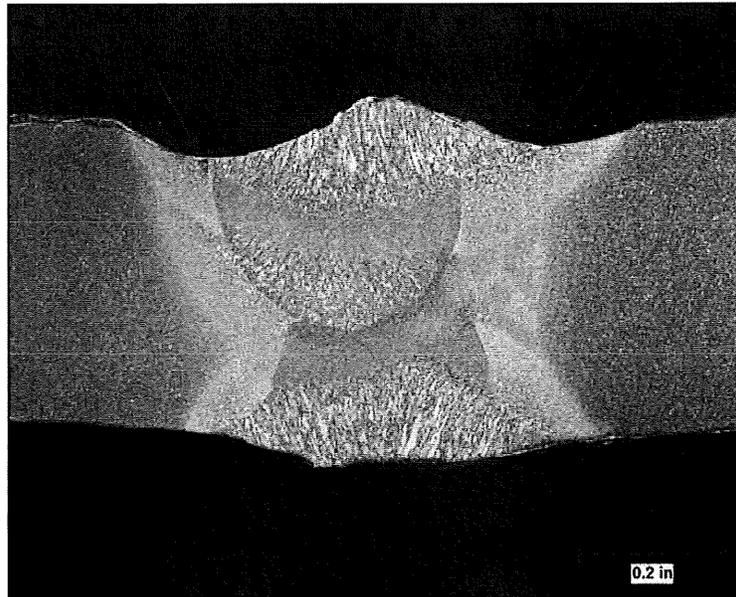
Figure 4: Photomicrograph of the Section 2, which had discontinuities at both toes (red arrows) on one side of the weld.

Section 2: Examination of the specimen showed that the weld had discontinuities at both toes on one side of the weld (refer to Figure 4). At higher magnification, the discontinuities at the toes of the weld were revealed to be cracks propagating along the fusion line of the weld (refer to Figure 5). The weld appeared to have no porosity, undercut or inclusions, and there was complete penetration and complete fusion observed throughout the weld.

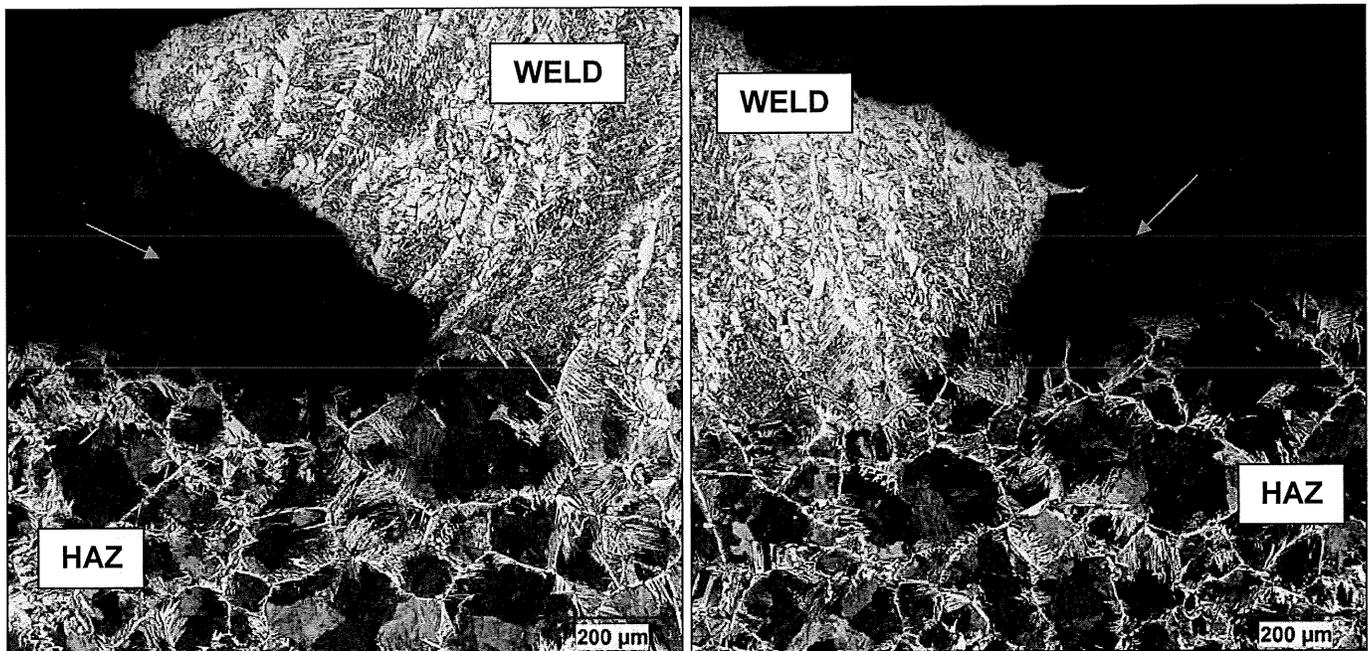
Figure 1: Photomicrographs of the Section 1 weld coupon at the “FL” locations. Transgranular cracks (red arrows) propagated through the HAZ of the weld from cavities located at the both toes on the face of the weld. Both cavities were filled with corrosion product (green arrows). The HAZ microstructure at the toe of the weld consisted of relatively coarse-grained pearlite with intergranular ferrite. The weld microstructure consisted of columnar ferrite and pearlite.

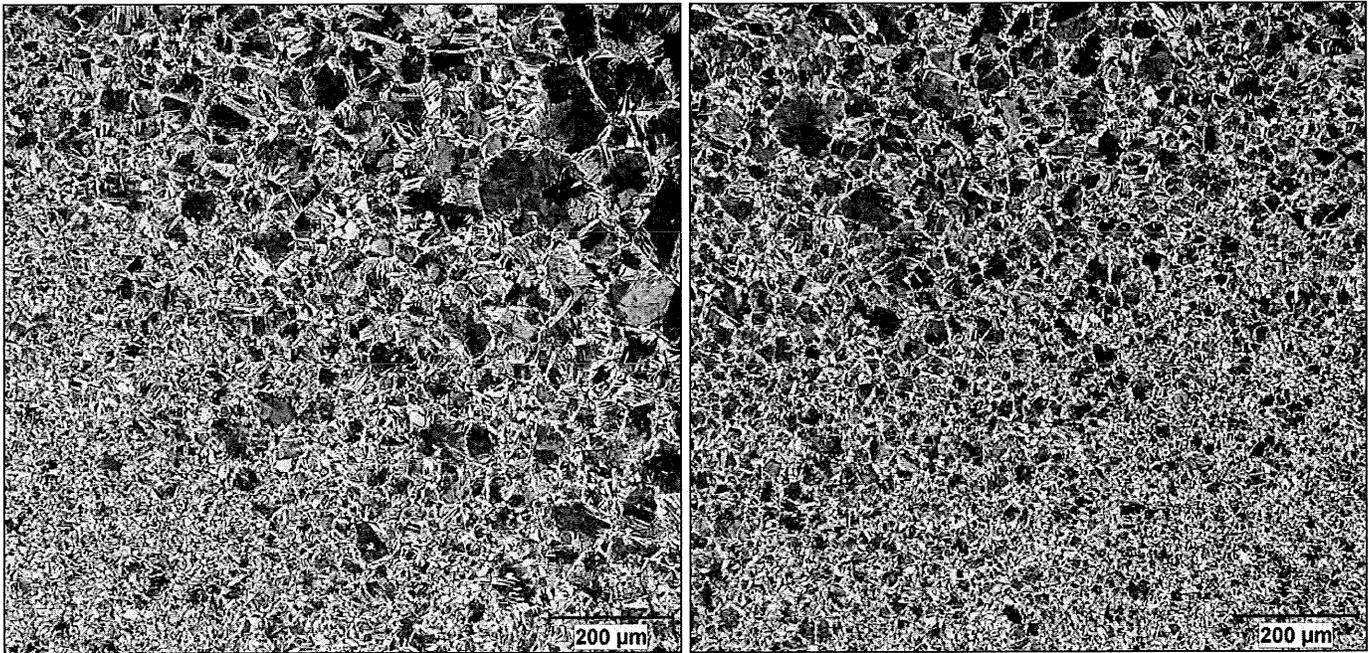
Figure 2: Photomicrographs of the Section 1 weld coupon at the "FL +1" locations, where the HAZ microstructure was a heterogeneous mixture of ferrite and pearlite, with a more refined grain size.

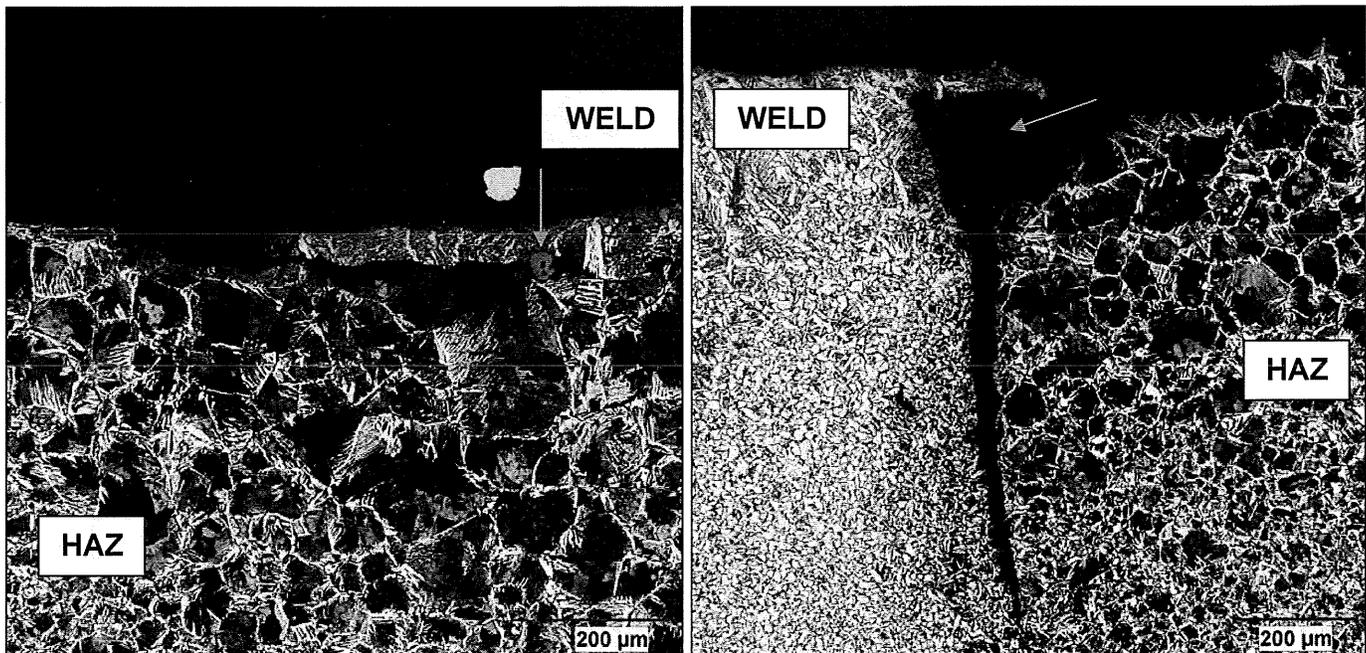
Figure 3: Photomicrographs of the Section 2 weld coupon at the “FL” locations. Transgranular cracks (red arrows) propagated through the HAZ of the weld from a cavity located at one toe on the face of the weld (right), and from an overlap at the other toe on the face of the weld (left). The cavity was filled with corrosion product (green arrow, right). An inclusion was observed within the overlap (green arrow, left). The HAZ microstructure at the toe of the weld consisted of relatively coarse-grained pearlite with intergranular ferrite. The weld microstructure consisted of columnar ferrite and pearlite.

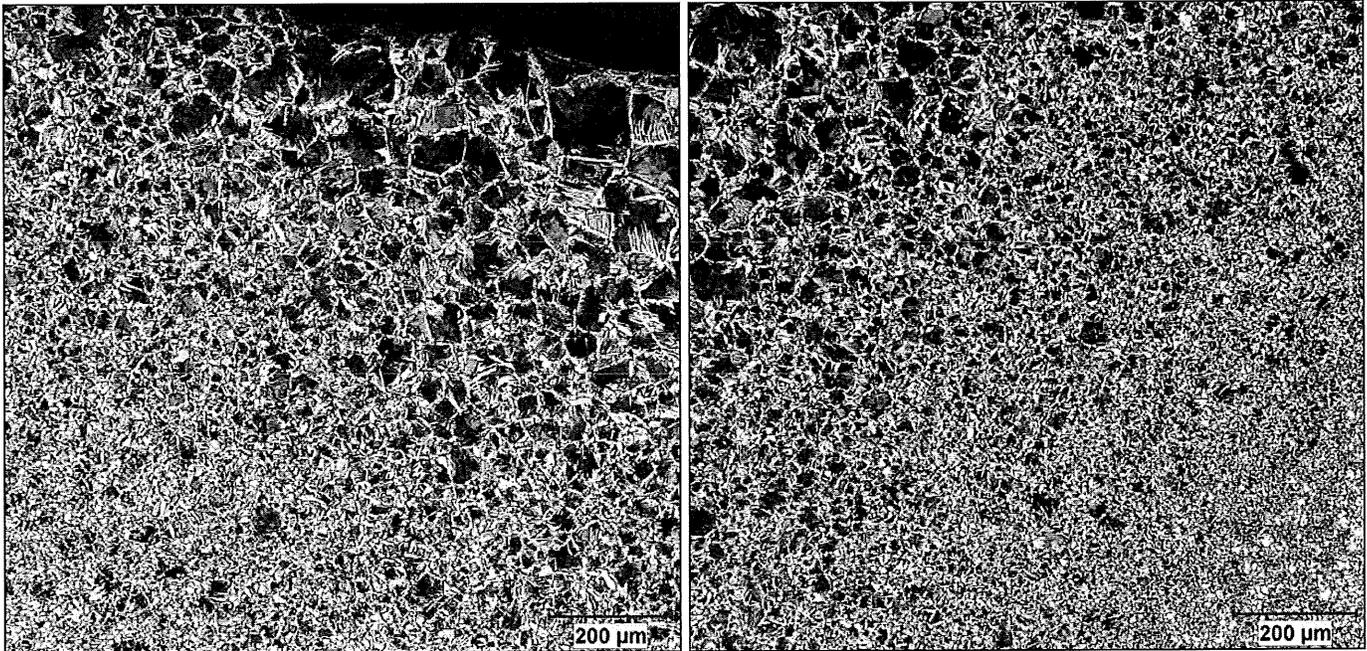
Figure 4: Photomicrographs of the Section 2 weld coupon at the "FL +1" locations, where the HAZ microstructure was a heterogeneous mixture of ferrite and pearlite, with a more refined grain size.

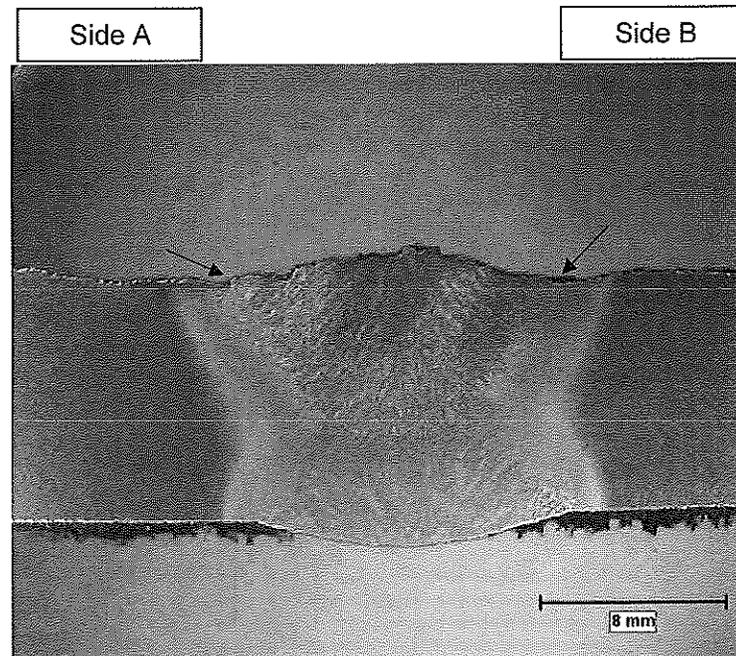
Figure 2: Photomicrograph of the Section 1, showing the pitting along the surface within the HAZ/at the weld toes along the inside diameter.

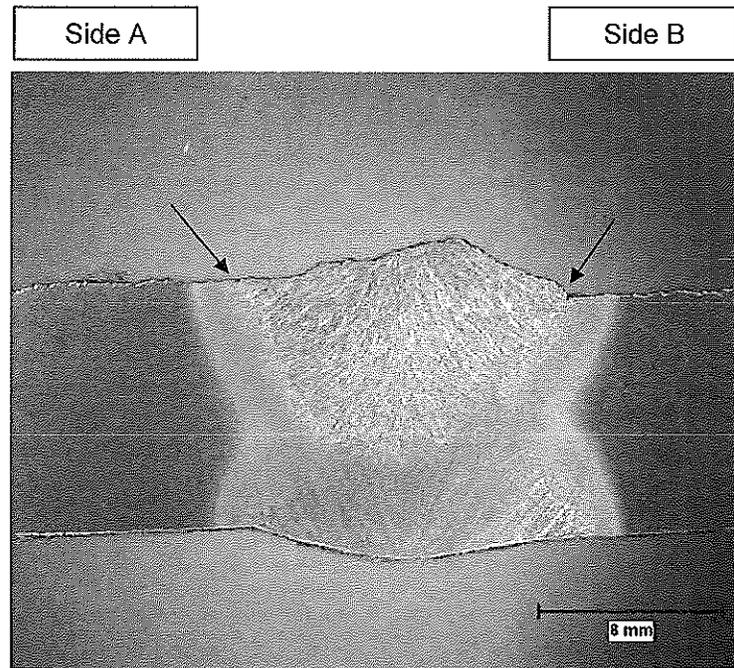
Figure 3: Photomicrograph of the Section 2, showing the pitting along the surface within the HAZ/at the weld toes along the inside diameter.

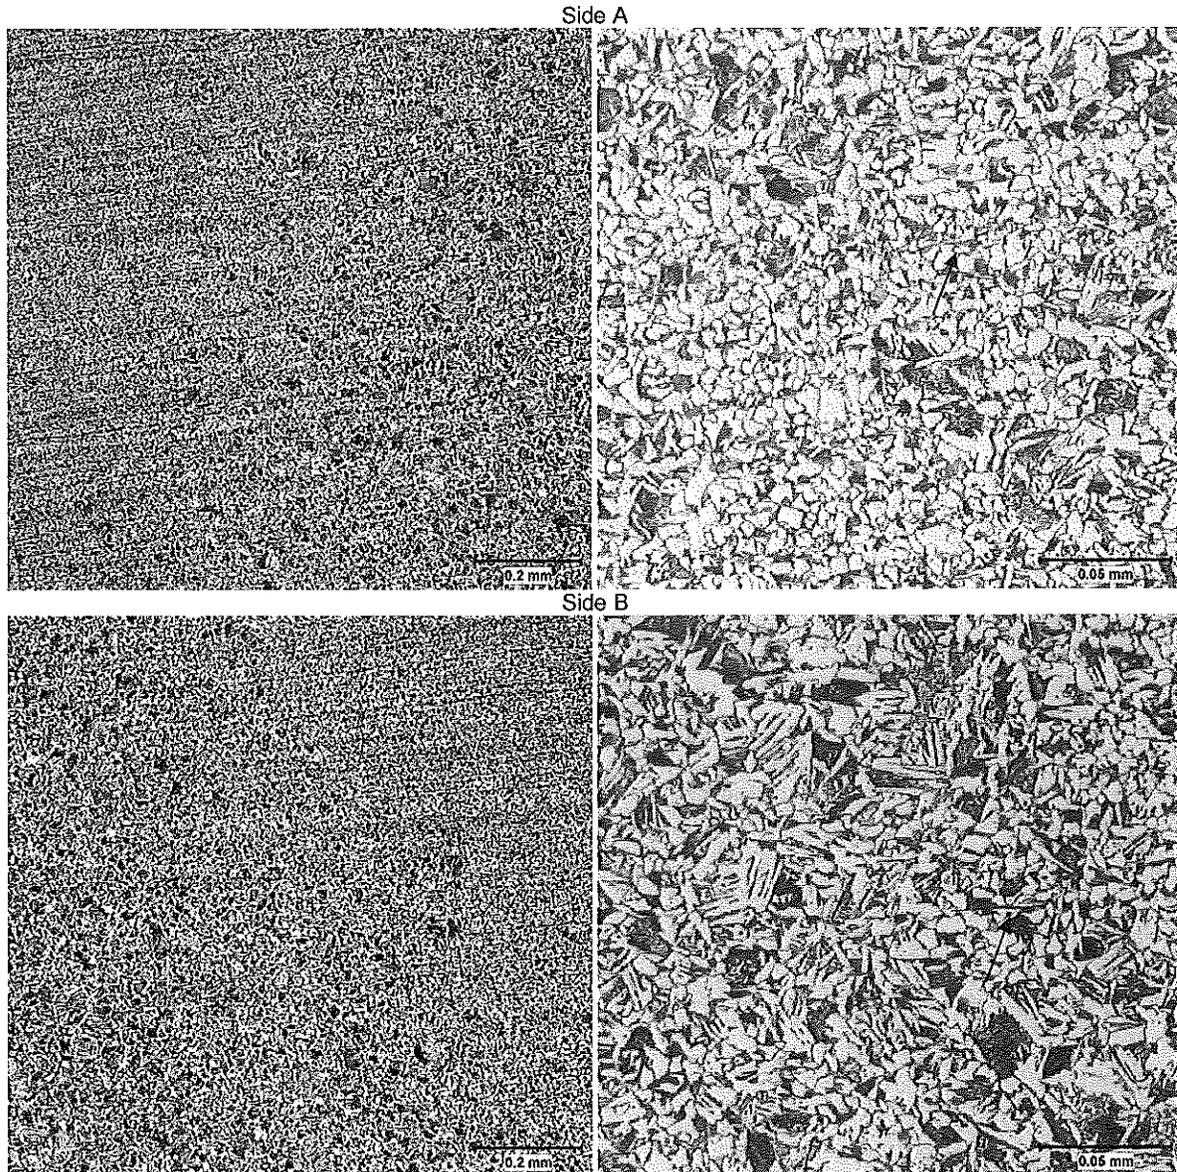
Figure 6: Photomicrographs of the Section 1 "Side A" and "Side B" weld coupon at the "FL +1" locations; where the HAZ microstructure showed a fairly uniform mixture of ferrite and pearlite, with a more refined grain size. At a higher magnification some sulphide inclusions were observed (refer to red arrows).

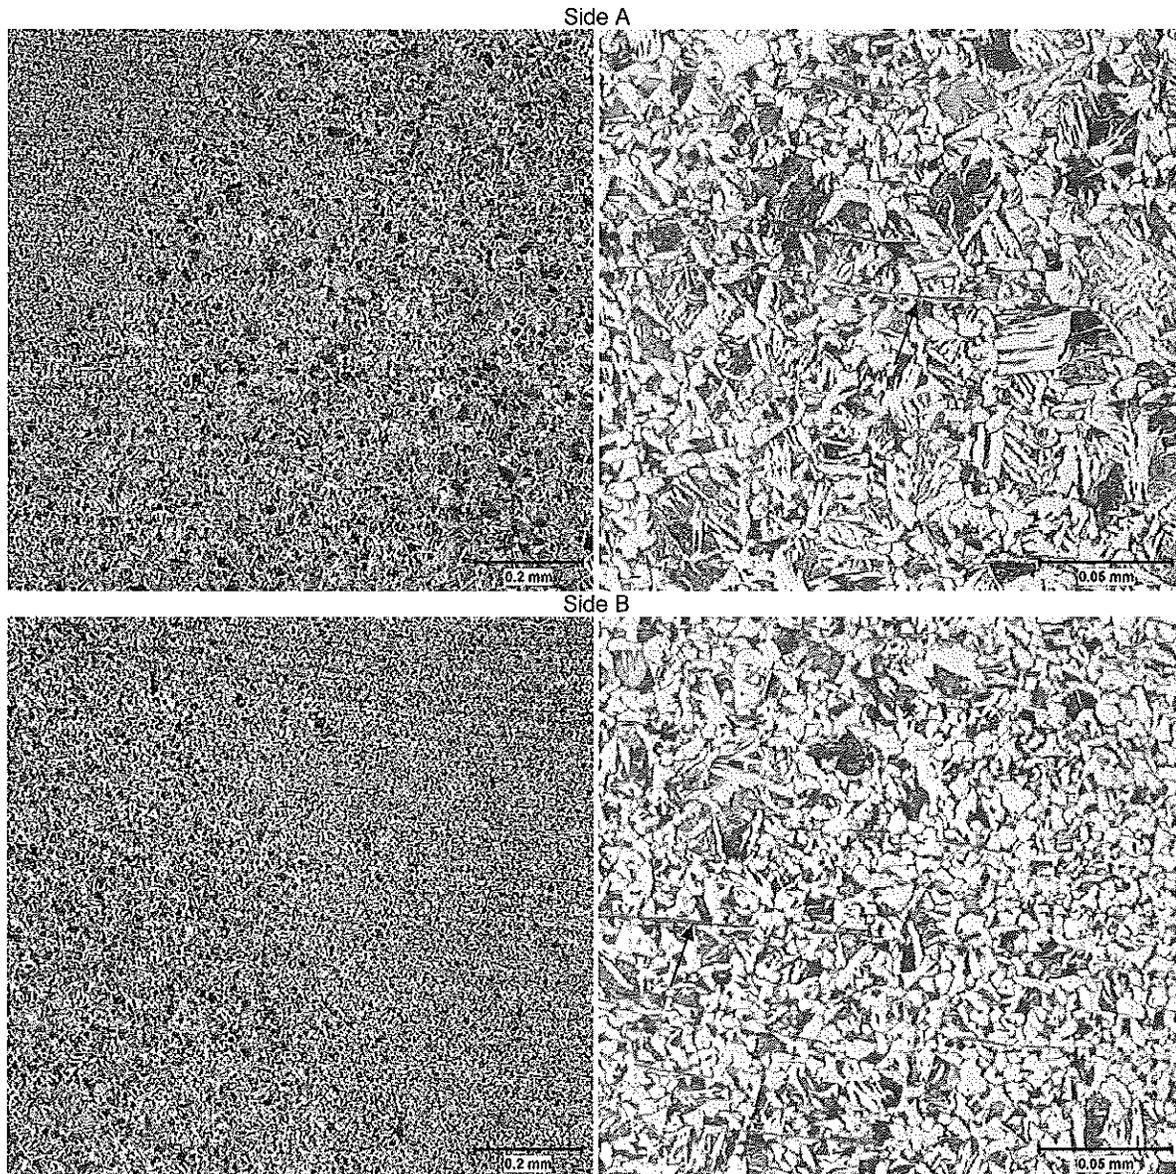
Figure 9: Photomicrographs of the Section 2 "Side A" and "Side B" weld coupon at the "FL +1" locations; where the HAZ microstructure showed a fairly uniform mixture of ferrite and pearlite, with a more refined grain size. At a higher magnification some sulphide inclusions were observed (refer to red arrows).

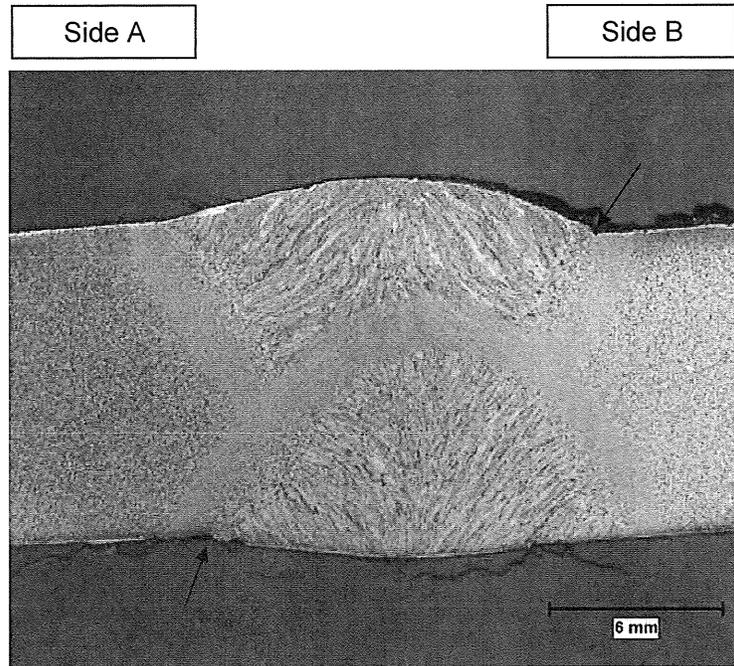
Figure 3: Photomicrograph of the Section 2, showing the pitting along the surface within the HAZ/at the weld toes.

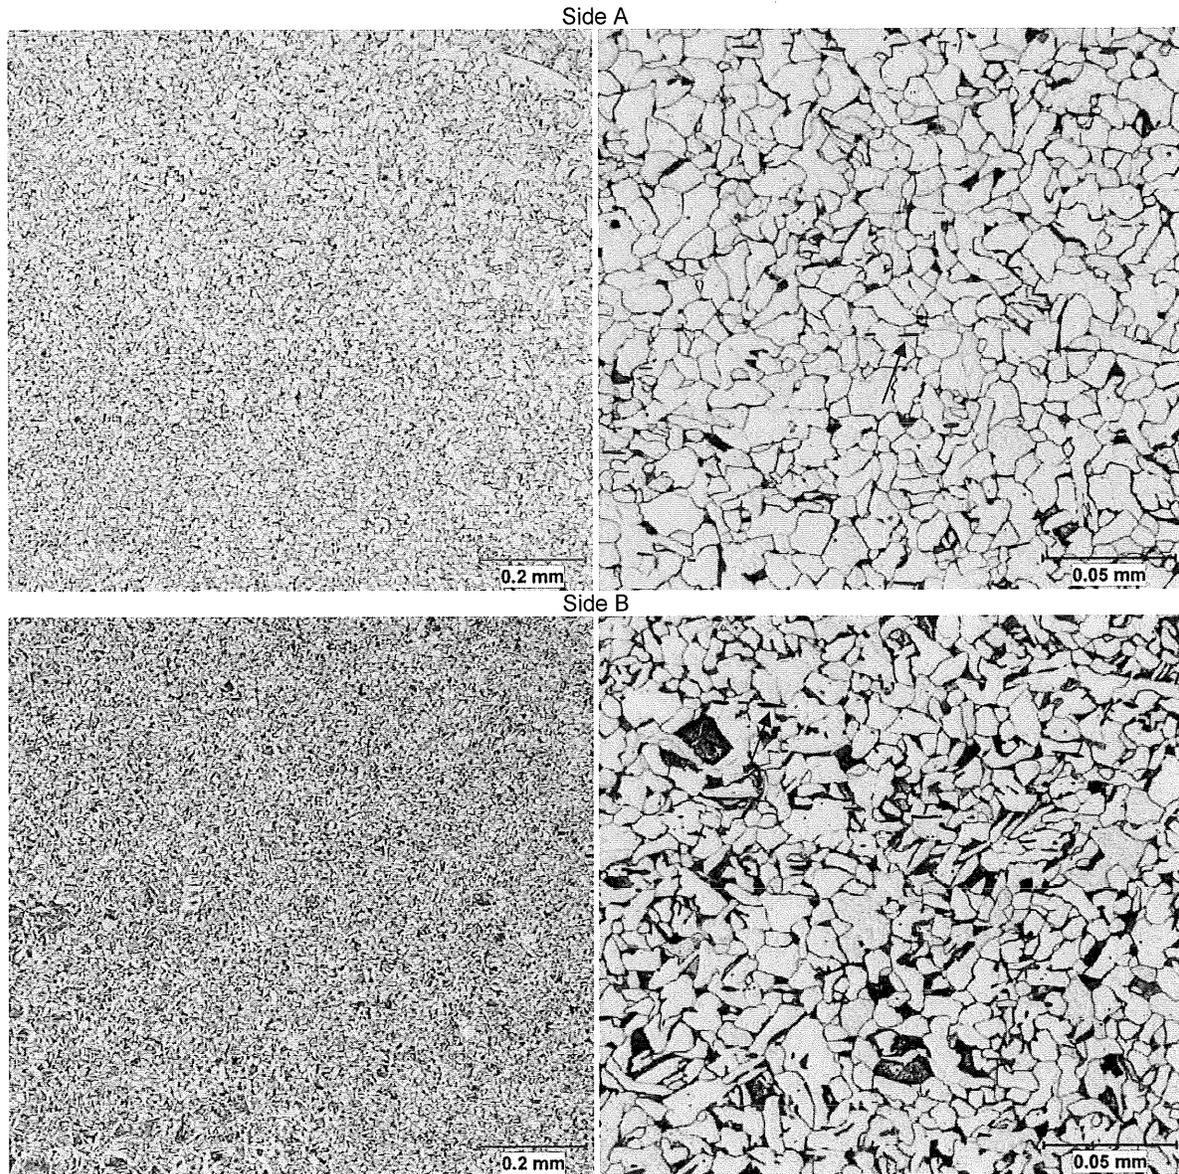
Figure 6: Photomicrographs of the Section 1 "Side A" and "Side B" weld coupon at the "FL +1" locations; where the HAZ microstructure showed a fairly uniform mixture of ferrite and pearlite, with a more refined grain size. At a higher magnification some sulphide inclusions were observed (refer to red arrows).

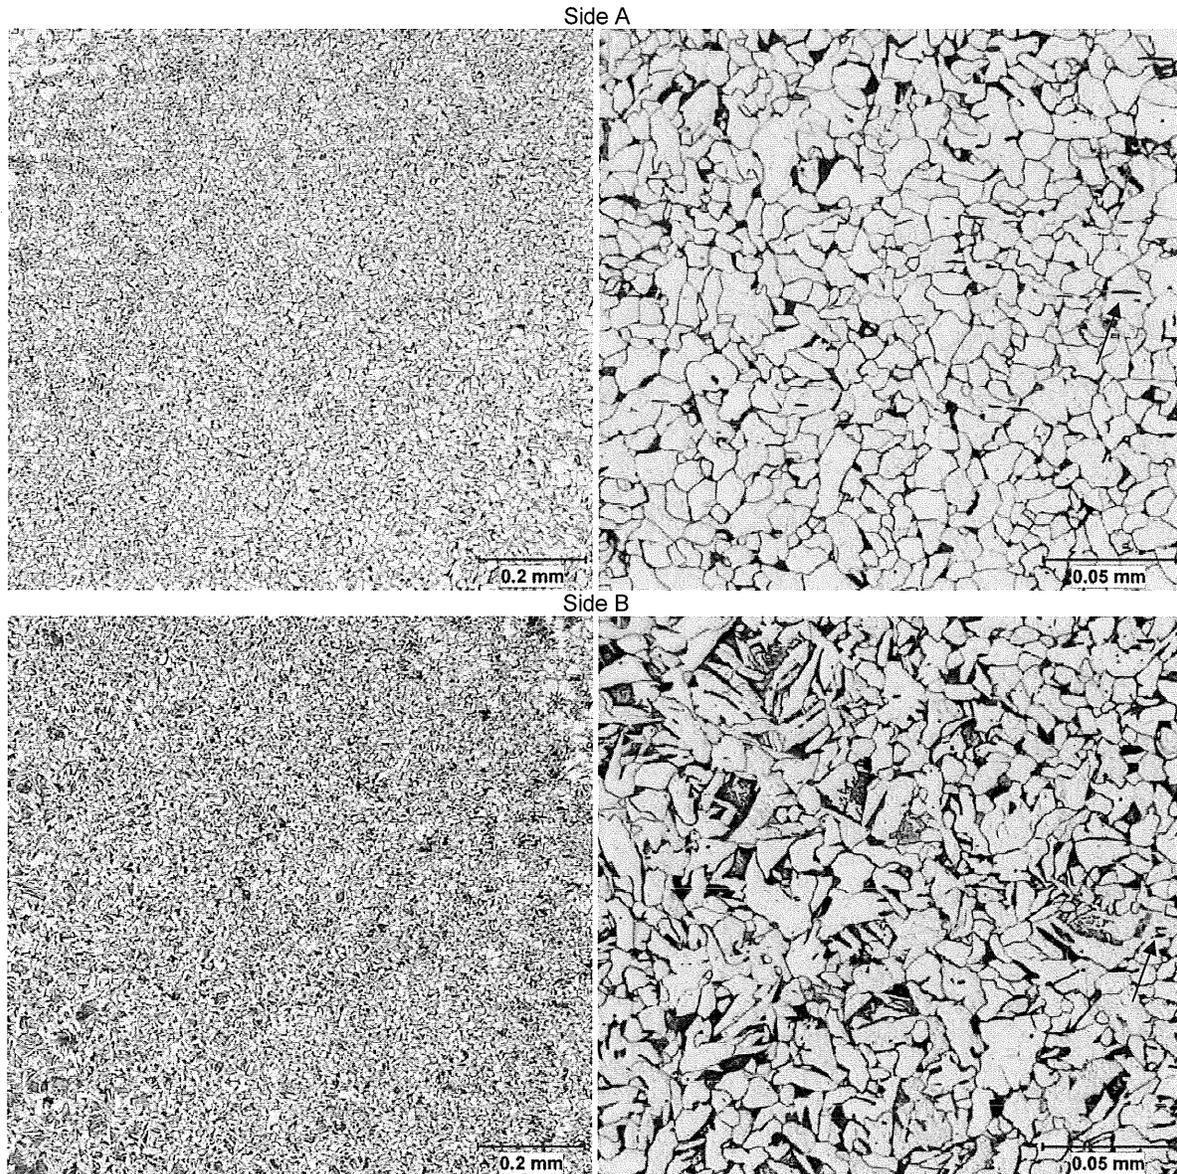
Figure 9: Photomicrographs of the Section 2 "Side A" and "Side B" weld coupon at the "FL +1" locations; where the HAZ microstructure showed a fairly uniform mixture of ferrite and pearlite, with a more refined grain size. At a higher magnification some sulphide inclusions were observed (refer to red arrows).

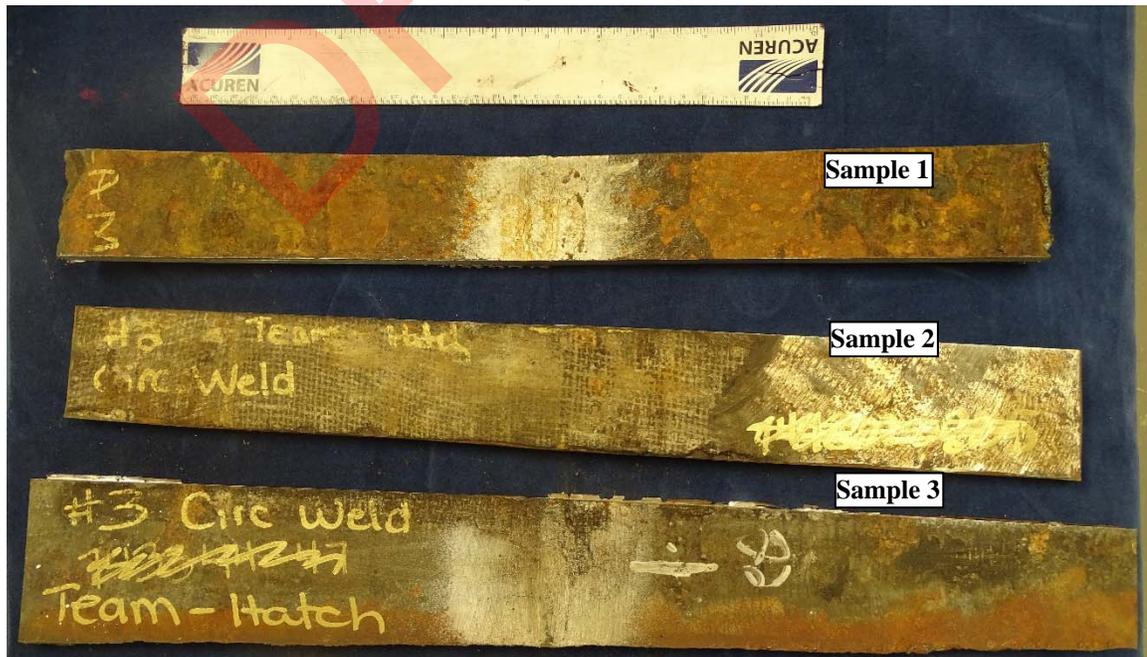
Figure 1 illustrates the as-received samples. In Sample 1, the weld is along the longitudinal direction of the tank, while in Samples 2 and 3, the weld is along the circumferential direction of the tank. Table 1 lists the chemical composition of the base metal and the electrode used for the welding process.

Figure 1. Low magnification morphology of HAZ-Metal couple sample 1.

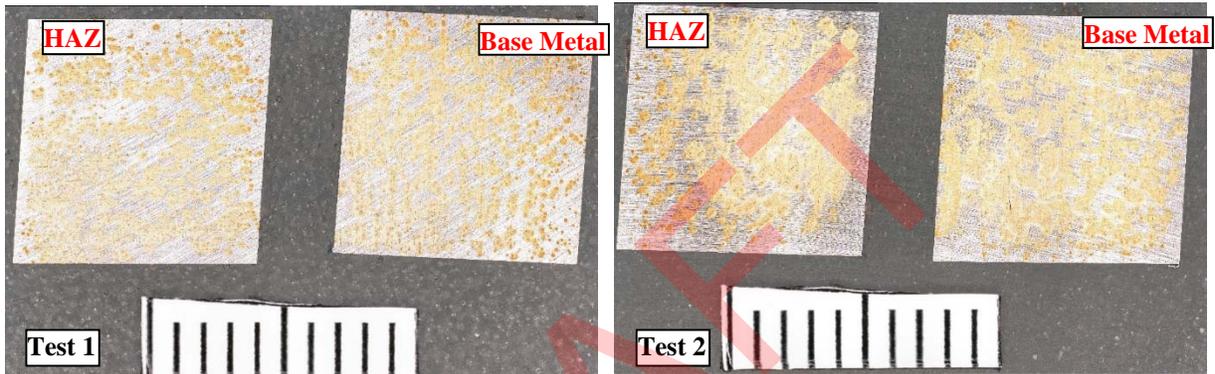
Figure 5 suggests that both HAZ and BM were corroded in both tests. For WELD/BM couple, both parts were corroded in both tests as shown in Figure 6. Figure 7 depicts that both WELD and HAZ regions were corroded in both tests. In total, it appears that none of the three regions is protected against one another, and pitting corrosion is a major feature on the surfaces of all samples.

Figure 5. Low magnification morphology of HAZ-Metal couple Sample 2.

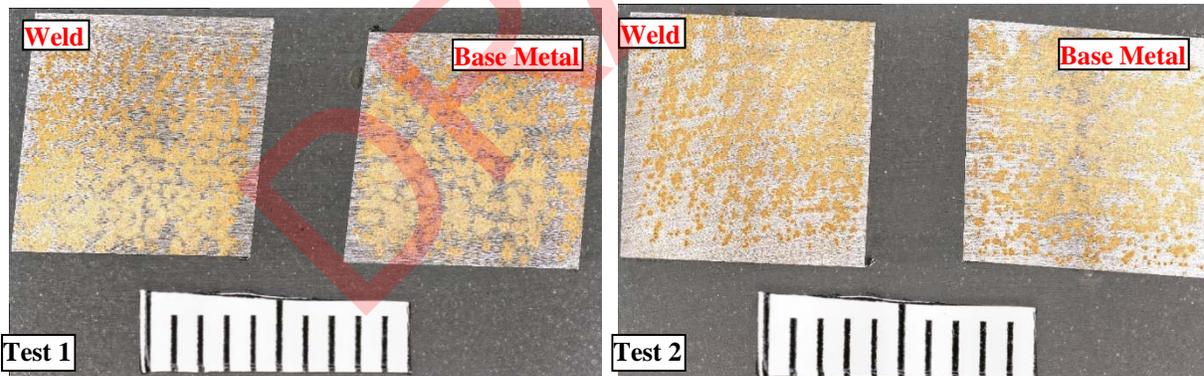
Figure 6. Low magnification morphology of Weld-Metal couple Sample 2.

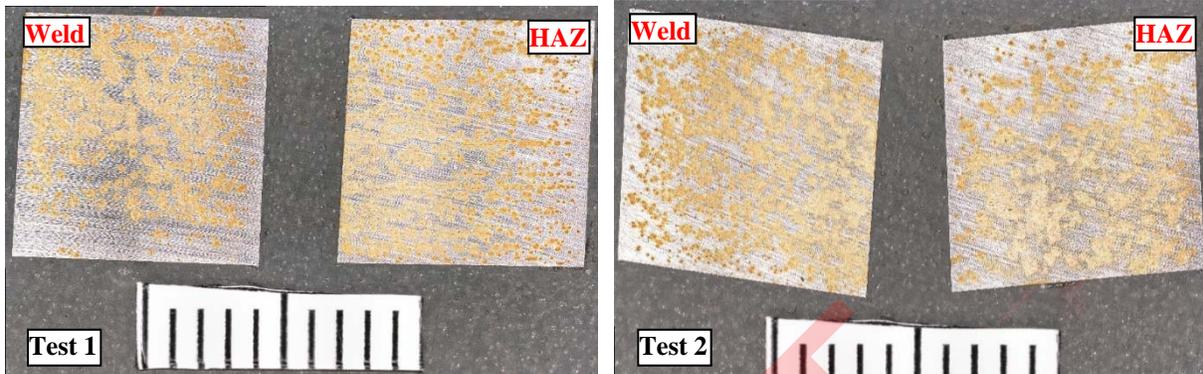
Figure 7. Low magnification morphology of Weld-HAZ couple Sample 2.

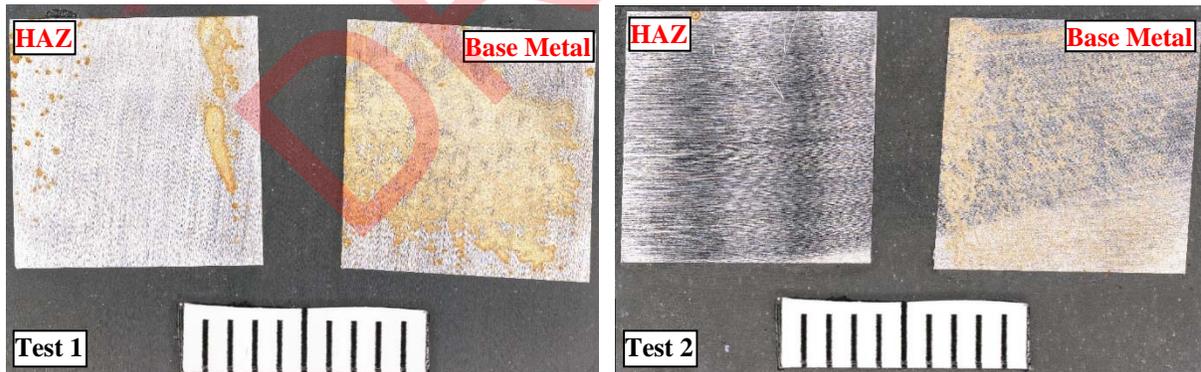
From Figure 8, it appears that HAZ was protected against BM in HAZ/BM galvanic couple. As for WELD/BM couple (Figure 9), both parts were corroded in test 1. In the second test, WELD is corroded, while BM is slightly corroded. As shown in Figure 10, in WELD/HAZ couple, the first test shows HAZ is corroded and WELD is protected, while in the second test, Weld is also corroded similar to HAZ.

Figure 8. Low magnification morphology of HAZ-Metal couple Sample 3.

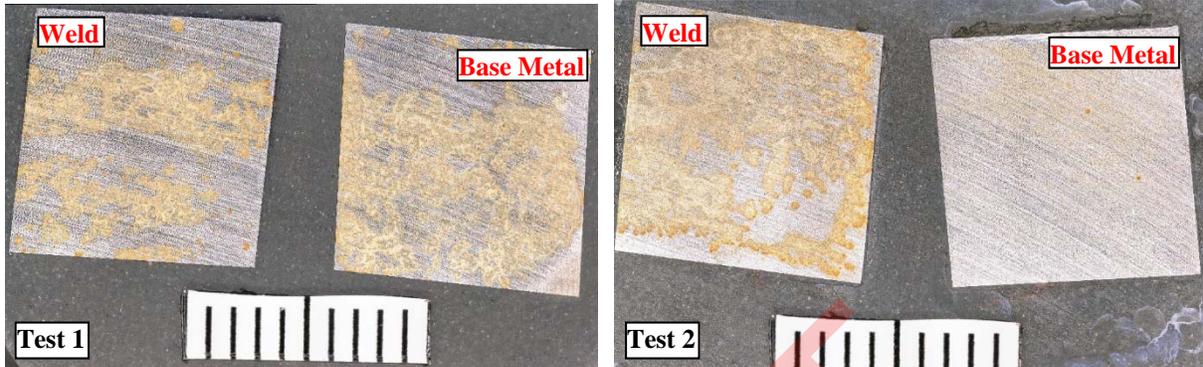
Figure 9. Low magnification morphology of Weld-Metal couple Sample 3.

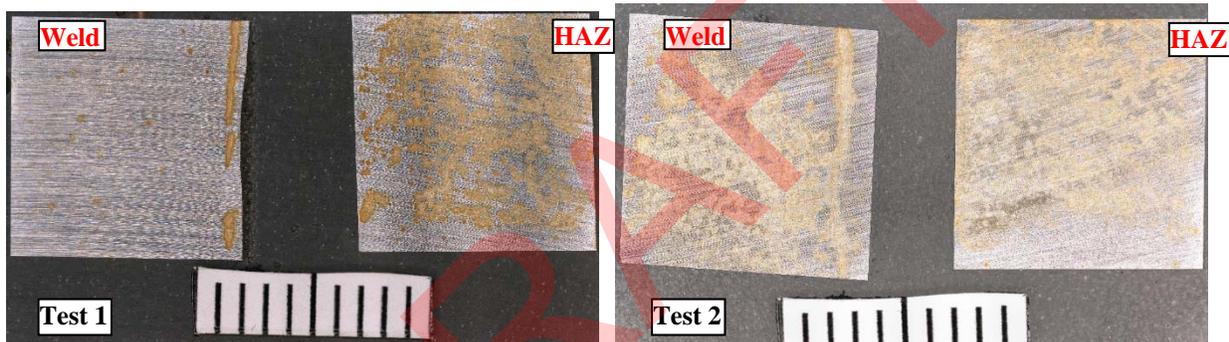
In General, it seems that apart from general corrosion of different parts of the weld joint, there is a possibility that HAZ could suffer from galvanic corrosion against WELD.

Figure 10. Low magnification morphology of Weld-HAZ couple Sample 3.

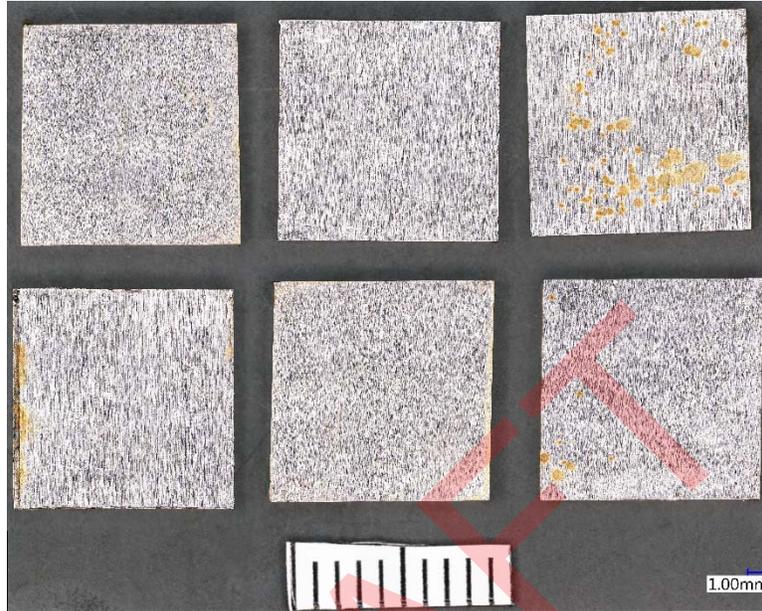
As it can be observed in Figure 11, samples show no significant corrosion after one hour of exposure to similar solution used for galvanic test. This indicates the severity of galvanic corrosion for this design.

Figure 11. Low magnification morphology of all reference samples after normal corrosion.

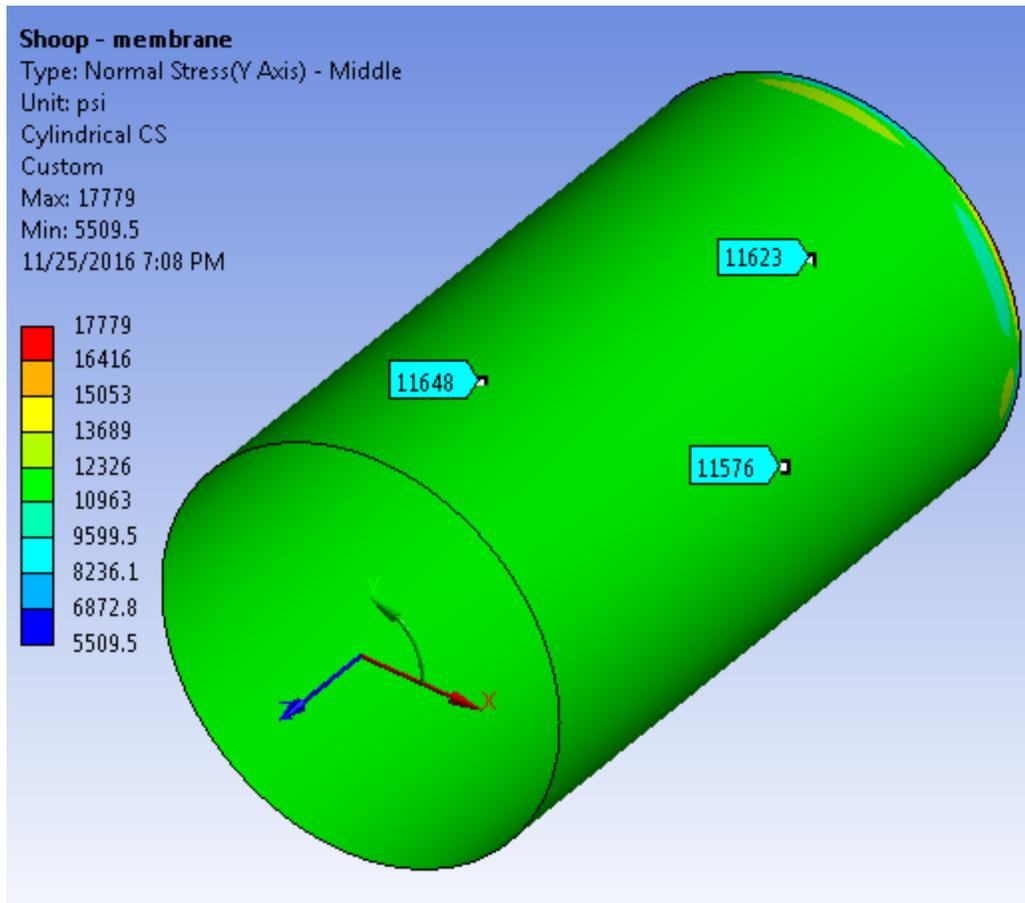
Figure 16: LS1 - Membrane hoop stress. Allowable for continuous plate $S_{pA285} = 20000 \cdot \text{psi}$. Ignore minor spikes at the boundary. No overstress.

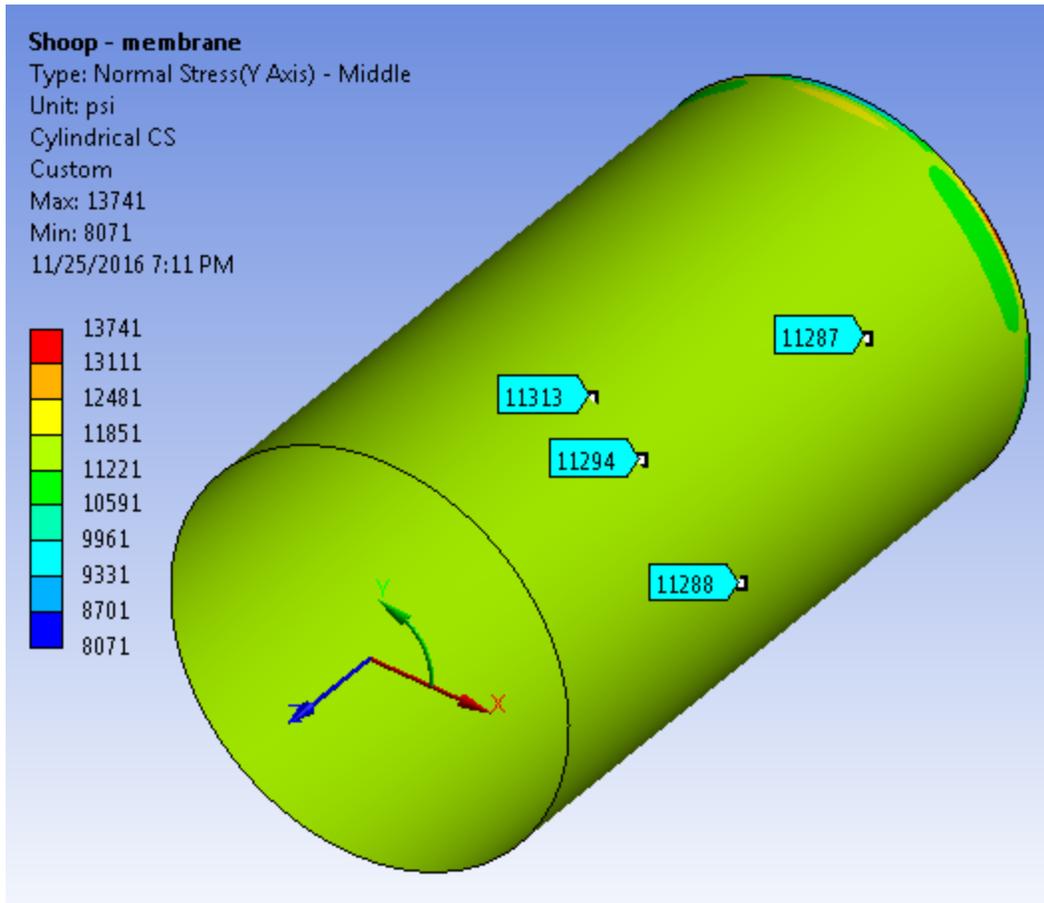
Figure 18: LS2 - Membrane hoop stress. Allowable for continuous plate $S_{pA285} = 20000$ ·psi. Ignore minor spikes at the boundary. No overstress.

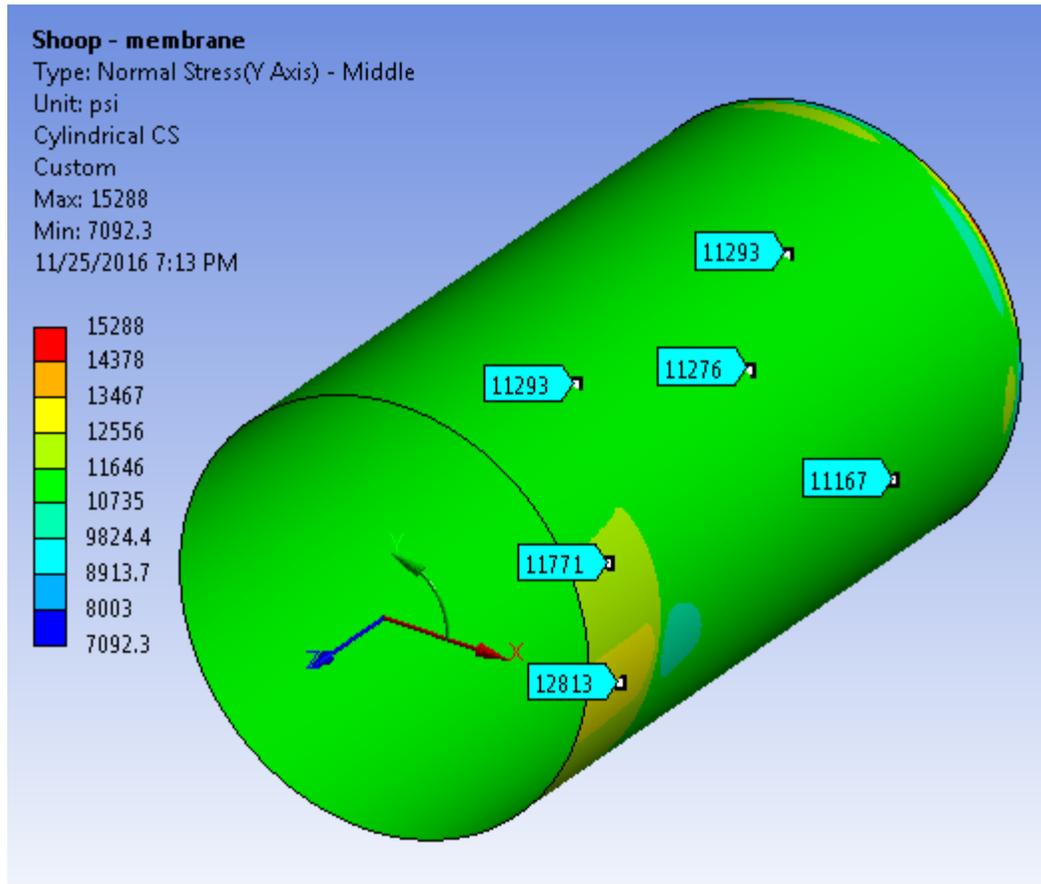
Figure 20: LS3 - Membrane hoop stress. Allowable for continuous plate $S_{pA285} = 20000 \cdot \text{psi}$. Ignore minor spikes at the boundary. No overstress.

Soil cover on top of the penstock plays an important role in reducing the stresses caused by the water + steel weight. Excavation causes 100% hoop stress increase (from 22,000psi to 43,500 psi) at 3 o'clock. It is recommended to restore the excavated sections to their original state (as per Ref 5) prior to filling the penstock. It is recommended to construct a more comprehensive FE model taking into account soil-steel frictions to study the influence of the soil cover at the top half of the pipe on the stresses in the 17ft diameter penstock sections.
