Re: An Application by Newfoundland and Labrador Hydro (Hydro) for approval of Reliability Improvements at the Holyrood Thermal Generating Station.

2017 Reliability Improvements Holyrood Thermal Generating Station

April 17, 2017

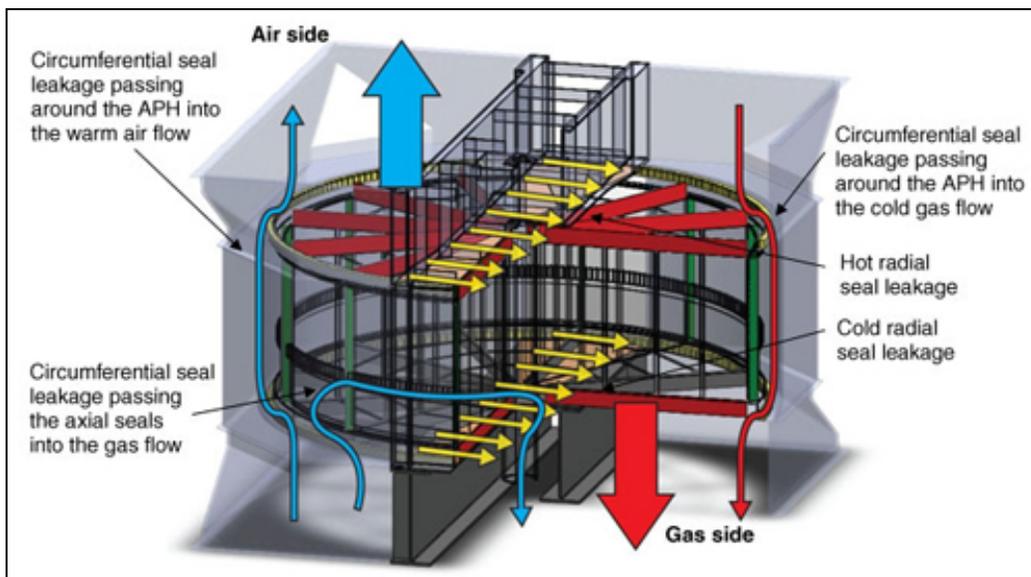
Figure 12: Boiler Air Heater

13 The four main components of each generating unit are the boiler, steam turbine, generator and
14 transformer. The main components of a boiler are forced draft fans, fuel combustion system,
15 air heaters, ductwork, water wall tubes, boiler drum, superheater, reheater, and economizer. A
16 cross section of the boiler air heater is shown in Figure 12.

1 The primary function of the boiler air heater is to recover heat from the flue gas to heat the
2 incoming boiler combustion air for improved efficiency. There are two (2) air heaters per boiler.
3 Each air heater contains a cylindrical rotor that turns slowly on a vertical axis. The rotor is
4 equipped with two layers of baskets or heating elements. The rotor passes through the flue gas
5 duct and through the incoming combustion air duct and the baskets pick up heat from the flue
6 gas and transfer this heat to the combustion air. Sector plates separate the gas and air ducts.
7 Seals on the rotor minimize the amount of air or gas that bypasses the rotor and also minimizes
8 the amount of air that leaks directly across the air heater, bypassing the boiler completely. Air
9 heater leakage, largely due to long term erosion and corrosion of the sector plates, has been
10 confirmed to be a significant problem and a major contributor to the de-ratings of Units 1 and

14
15 To correct this air leakage, it is necessary to install liners on the sector plates and replace the
16 rotor seals. A cross section of a boiler air heater is shown in Figure 12. There was insufficient
17 time in 2016 to action the work that was identified by Howden.

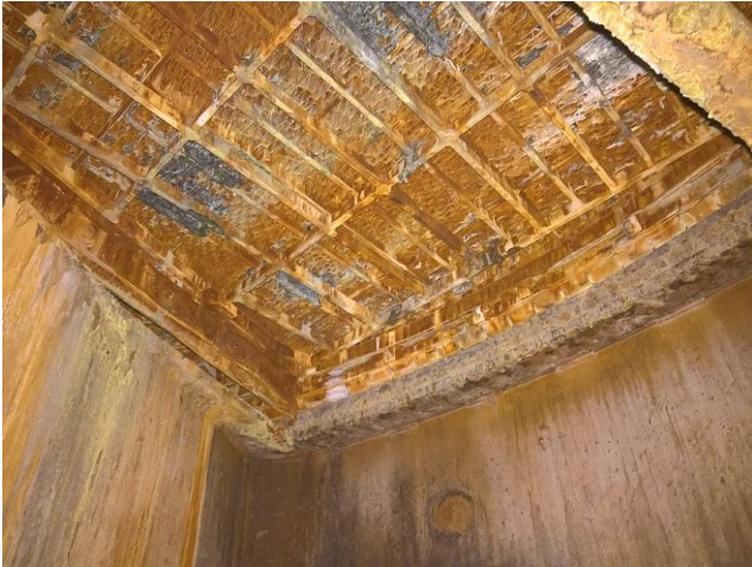
The internal inspection began with the hot end sides of both units. Assisting with the inspection was [REDACTED], Field Service Engineer with B&W. First impressions of the rotor structure showed that the unit is in good condition as far as structural integrity. No stay plate weld cracks were found. Hardware fasteners were in good condition with the exception of the mounting angles for the circumferential seals. These use square headed bolts for holding the backing bar to the seal and approximately 4 were found missing. Previous repairs here were noticed and appeared to be serviceable and holding.

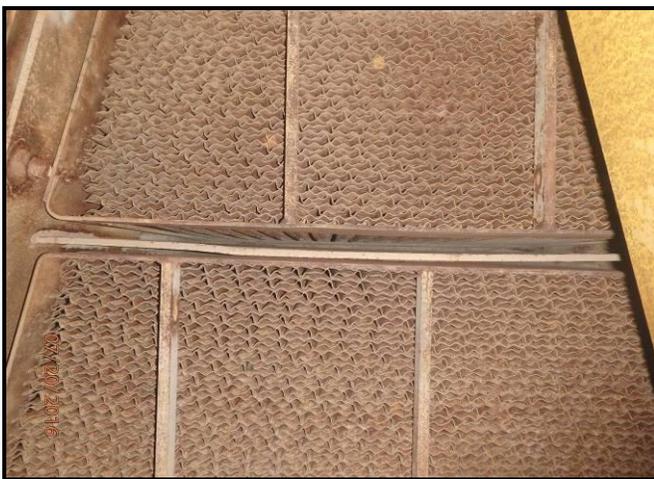
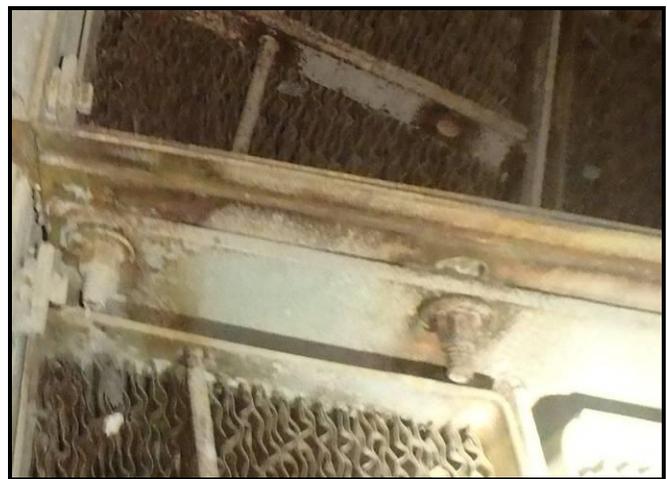
- The East and West APH's have 2 rows of baskets. The HE overall basket depth is ■ and CE basket overall depth is ■. They have been recently replaced within the past 4 years. The CE grating and support bars are in good serviceable condition.
- There are gaps between the HE baskets to stay plates and baskets to diaphragms.
Recommend: Gaps larger than a ■ should be covered with a sealing strip to maintain flow thru the basket elements.

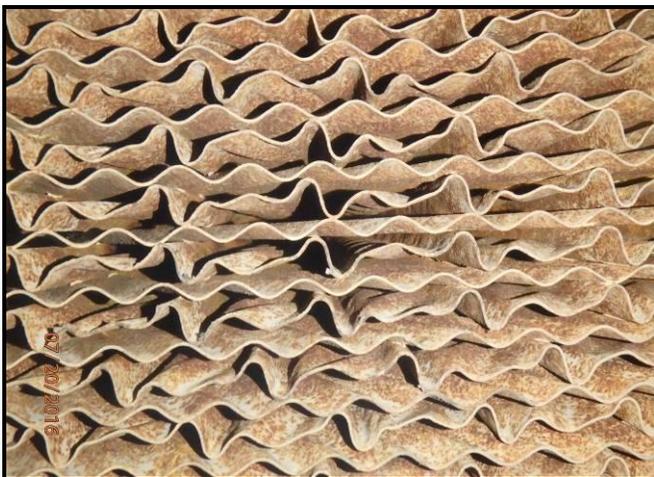
Hot end elements

- The HE and CE element appear to be good serviceable condition. No signs of severe pluggage. No signs of thinning or fracturing. With the soot blowers lance tubes being replace this outage this will aid in keeping the CE basket element in good condition.

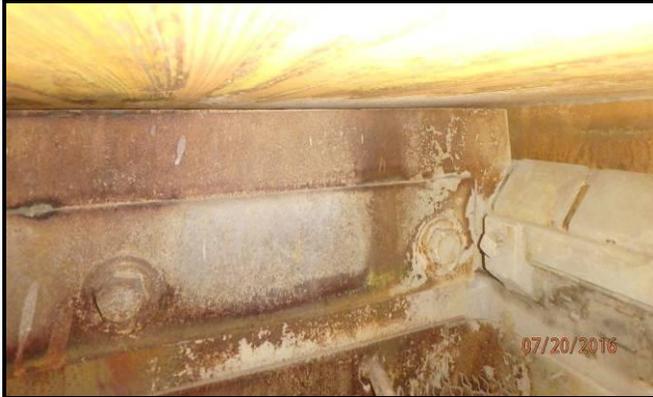
HE Air to Gas

- The East and West APH's HE sector plates are in good serviceable condition. There are signs of minor wear grooves.

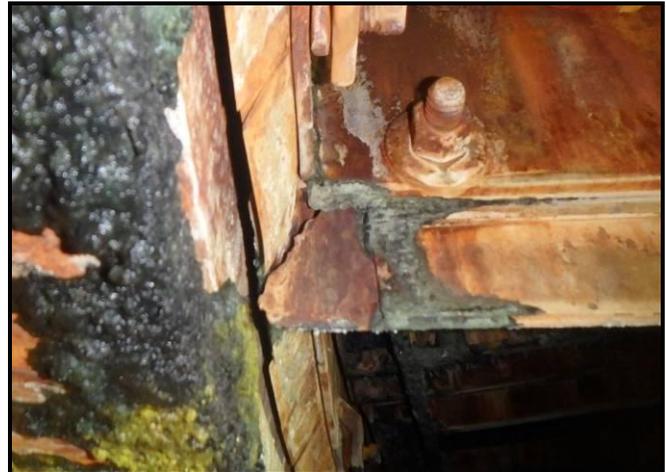
Gas CE Circ seal ring no wear

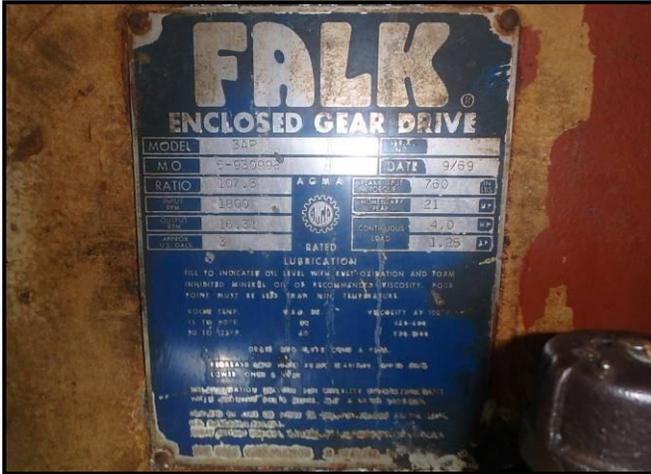
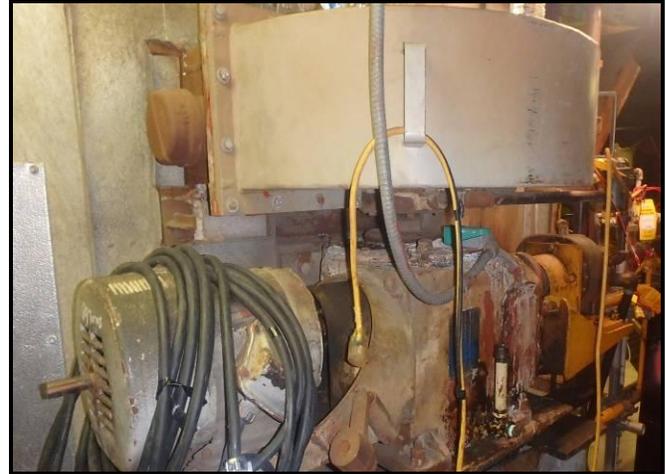
- The East and West drive unit has a Falk gear drive model [REDACTED] AP with a gear ratio of [REDACTED]. With one auxiliary air motor per APH. The units have new pinion gear shrouds installed and were not removed during this visit. Therefore no pin rack to pinion gear throat clearances were taken. The oil levels are very low and this was brought to the site contacts attention.
- The West APH was not available to rotate because of the top guide bearing was removed.
- The East APH was rotated by means of an Aluminum bar because the drive motor was removed and sent out to have the shaft keyway repaired.
- The up shaft positive air supply shaft seal appears to be good on the West APH and the EAST APH seal will need attention during the next scheduled outage.

Leaking seal

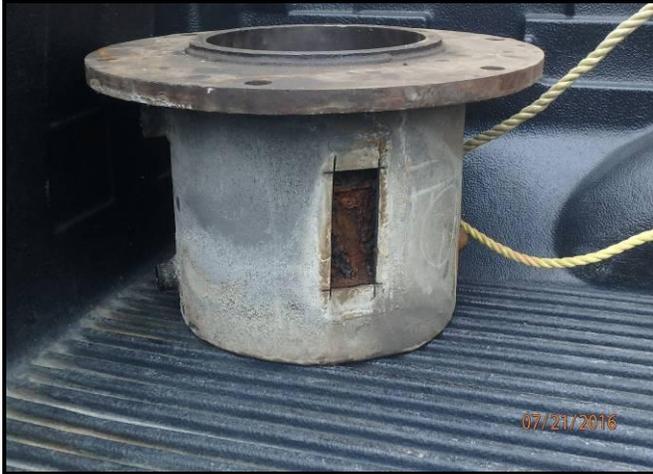
Access port for cleaning

- The top guide bearings annually have the bearing housing removed to clean out scale and debris from the cooling jacket to prevent overheating during normal operating conditions. The East was removed and replaced with the spare to perform a rotor level check. The debris and scale gets cleaned out and they perform a pressure test annually to ensure there are no leaks.

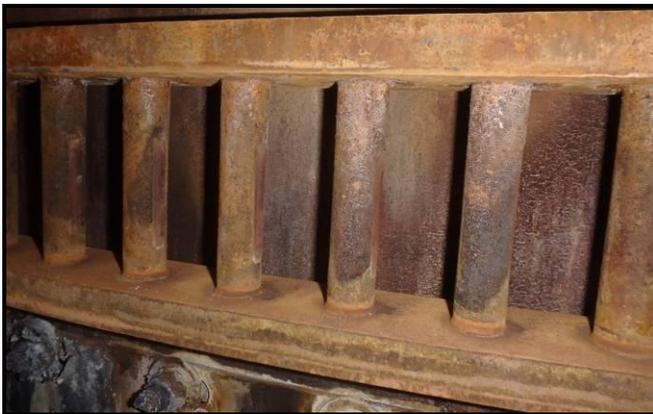
- The Pin Rack has normal wear on the contact surfaces. The pin rack to pinion gear clearance was not measured at this time.
