**Re: Approval of Capital Expenditures Supplemental to Newfoundland Power Inc.'s  
(the "Company") 2018 Capital Budget Application – Duffy Place Roof Replacement**

**Duffy Place Roof Replacement**

**July 2018**

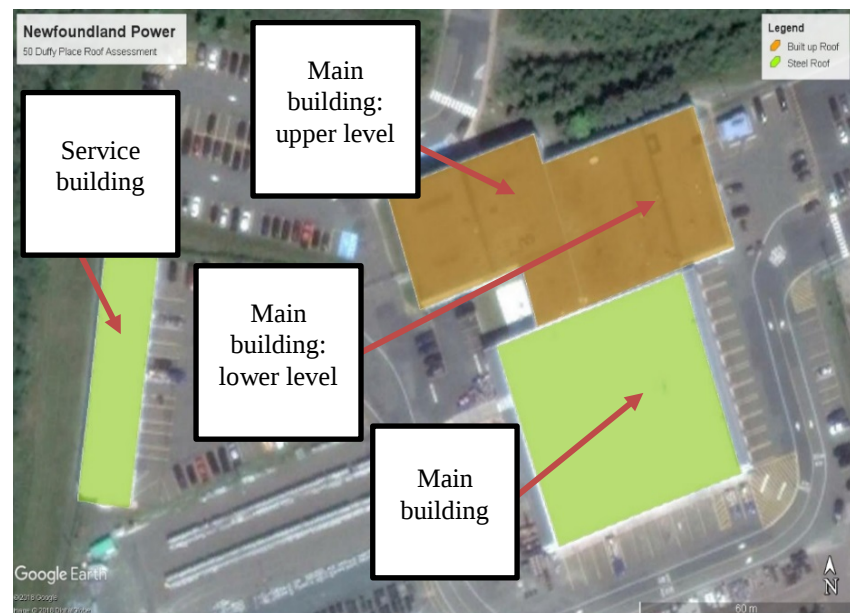
**Figure 1 – Duffy Place Regional Building**

The office space on the north side of the main building is covered by a dual level roof. The upper level roof is approximately 1,455 m<sup>2</sup> and covers the customer contact center, meeting spaces and various office space. The lower level roof is approximately 1,576 m<sup>2</sup> and covers training rooms, the meter shop, the telecommunications shop, the backup control center and the production center.

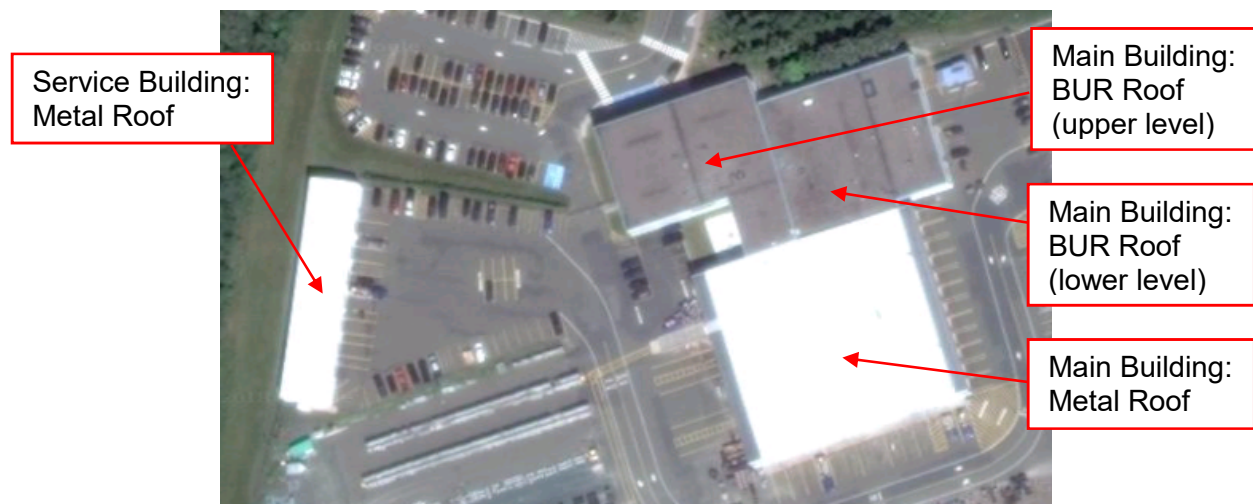
Figure 1 – Aerial site plan of 50 Duffy Place (courtesy of Google Maps)

There are two buildings associated with the NP facility located at 50 Duffy Place; the Main Building and the Service Building (Figure 1). The Main Building is comprised of two roofing assemblies; a flat built-up roofing (BUR) over two levels and a pitched metal roof. The Service Building has a pitched metal roof only. All roofs are known to be original to the building's construction (1988). We understand there has been on-going water infiltration associated with the various roofing assemblies on both buildings with the BUR being the most severe (Figure 2). Recent repairs (i.e., roof patches with modified bitumen roofing membrane and drain replacement) have been made to the BUR in an attempt to stop the persistent leaks but mostly unsuccessful.
