# **2010 CAPITAL BUDGET APPLICATION**

## PLANT LIFE EXTENSION UPGRADES

### Hardwoods Gas Turbine

June 2009

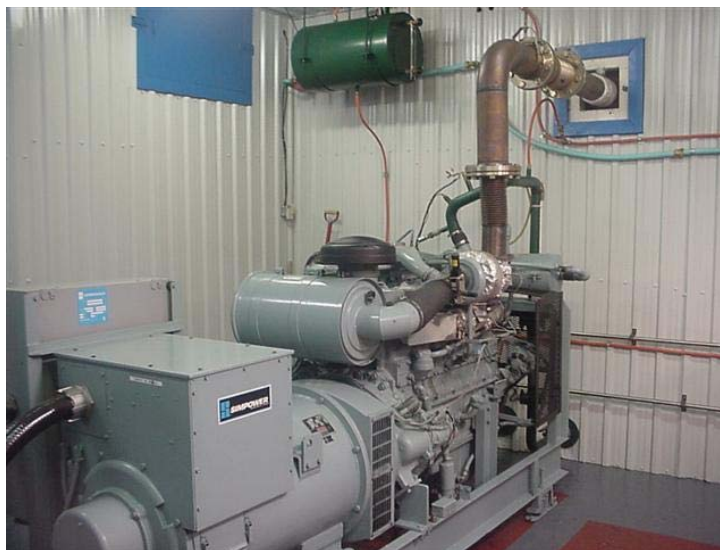
**Figure 2 Diesel Unit 566**

Generating Unit 566 (Figure 2) is a 200 kW Mitsubishi model 6D22-TCS generating unit manufactured in 1996. The engine on this unit will be replaced with a complete new engine (model 6D24-TC). A complete set of critical spares will be also be purchased for emergency parts replacement. All other equipment can be reused.

The engine block on Unit 566 is pitted and requires replacement; however, a replacement block is not available. Pitting of the block causes a loss of integrity of sealing surfaces and promotes further erosion. It eventually allows transfer of coolant to the cylinders and the escape of hot exhaust gases around sealing surfaces. Loss of cylinder sealing is a failure condition under which an engine should not be operated or else more serious damage may occur. Unit 566 would normally be overhauled complete with a new engine block. As stated, a replacement block is not available.

The vendor for Mitsubishi equipment recommends replacement of the engine on Unit 566

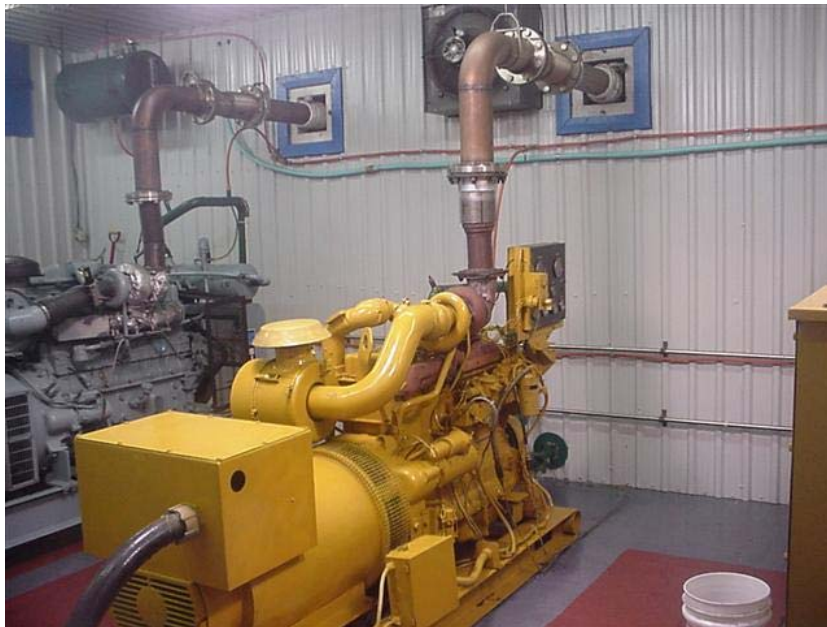
**Figure 3 Diesel Unit 2001**

Generating Unit 2001 (Figure 3) is a 136 kW Caterpillar model D3306 generating unit manufactured in 1981 which will be replaced with a 150 kW generating unit for improved dispatch flexibility. The unit replacement will include the installation of a new control panel meeting Hydro's current design standard. The existing exhaust stack and sound attenuated radiator will be reused.

Generating unit 2001 is 28 years old and has had four rebuilds. Under normal use, an overhaul will last for five to seven years (20,000 hours). In general, Hydro's prime power generating units do not exceed 30 years of service.

Unit 2001 has had four overhauls since installation. The last overhaul was at 60,000 hours and the unit currently has 81,343 hours of operating time. This unit requires overhaul or replacement.

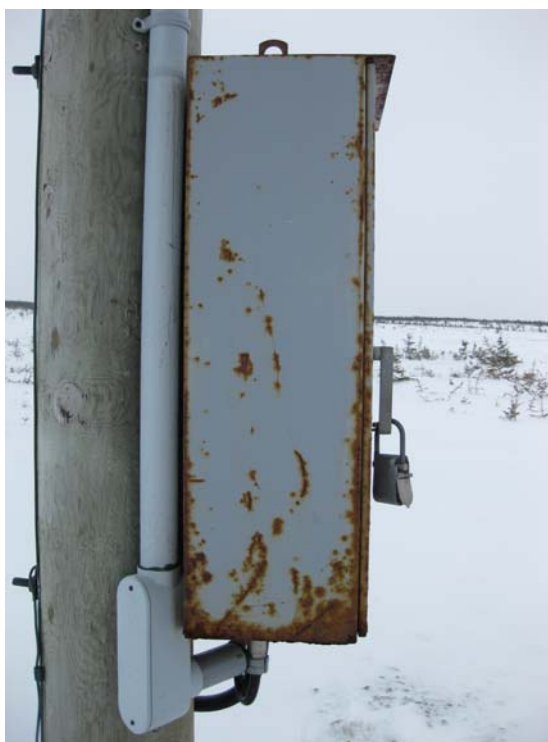
**Figure 1: Shoal Cove N Recloser Control Cabinet**

This project is to replace aging and weathered distribution recloser control panels on distribution feeders to ensure fault protection reliability is not compromised. Photos of a severely rusted recloser control panel are shown in Figures 1 and 2.
