1 Q. Please provide a copy of the 2011 AMEC Consulting report on the condition  
2 assessment of the Holyrood Gas Turbine.

Holyrood Thermal Generating Station (Holyrood) Gas Turbine Condition Assessment & Options Study –  
Final Report

### Gas Turbine Condition Assessment & Options Study

December 19, 2011

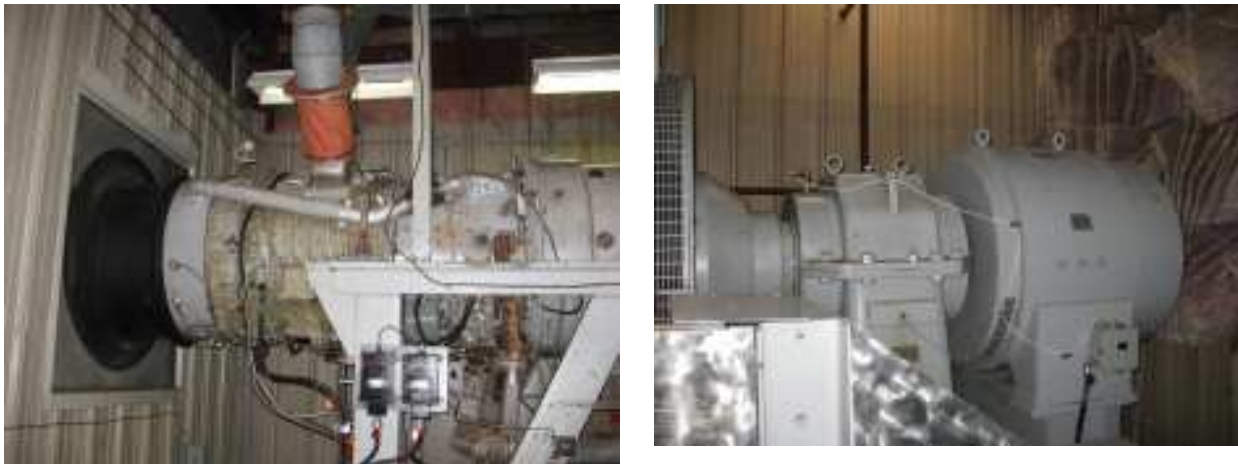
**FIGURE 2-1 GTG GAS ENGINE & GENERATOR**

The exhaust casing (volute) is a welded fabrication divided along the horizontal centreline. It turns the combustion gasses transversely to the machine and vertically upwards to the exhaust silencer.

The exhaust stack is constructed of heavy gauge steel plate with light gauge steel cladding on the exterior. The exterior cladding of the lower half of the exhaust stack is constructed of heavy gauge steel plate. This stack was replaced during the 1986 major upgrade. The snow doors on the exhaust stacks are pneumatically actuated and were a new addition in 1986 to reduce corrosion of the volute and power turbine from infiltration of snow and rain water which promoted corrosion within the unit. New limit switches installed on the doors in 2009 indicate the position (opened or closed) of each door at the control station.
