1 Q. In response to CA-NLH-017 Hydro stated that:

- 1. January 11, 2013 Power System Outage Report**
- 2. Remedial Actions from the January 11, 2013 System Events**

**Unit 1 Failure – Holyrood  
Life Safety Review  
SWOP # 2013000599  
January 11, 2013**

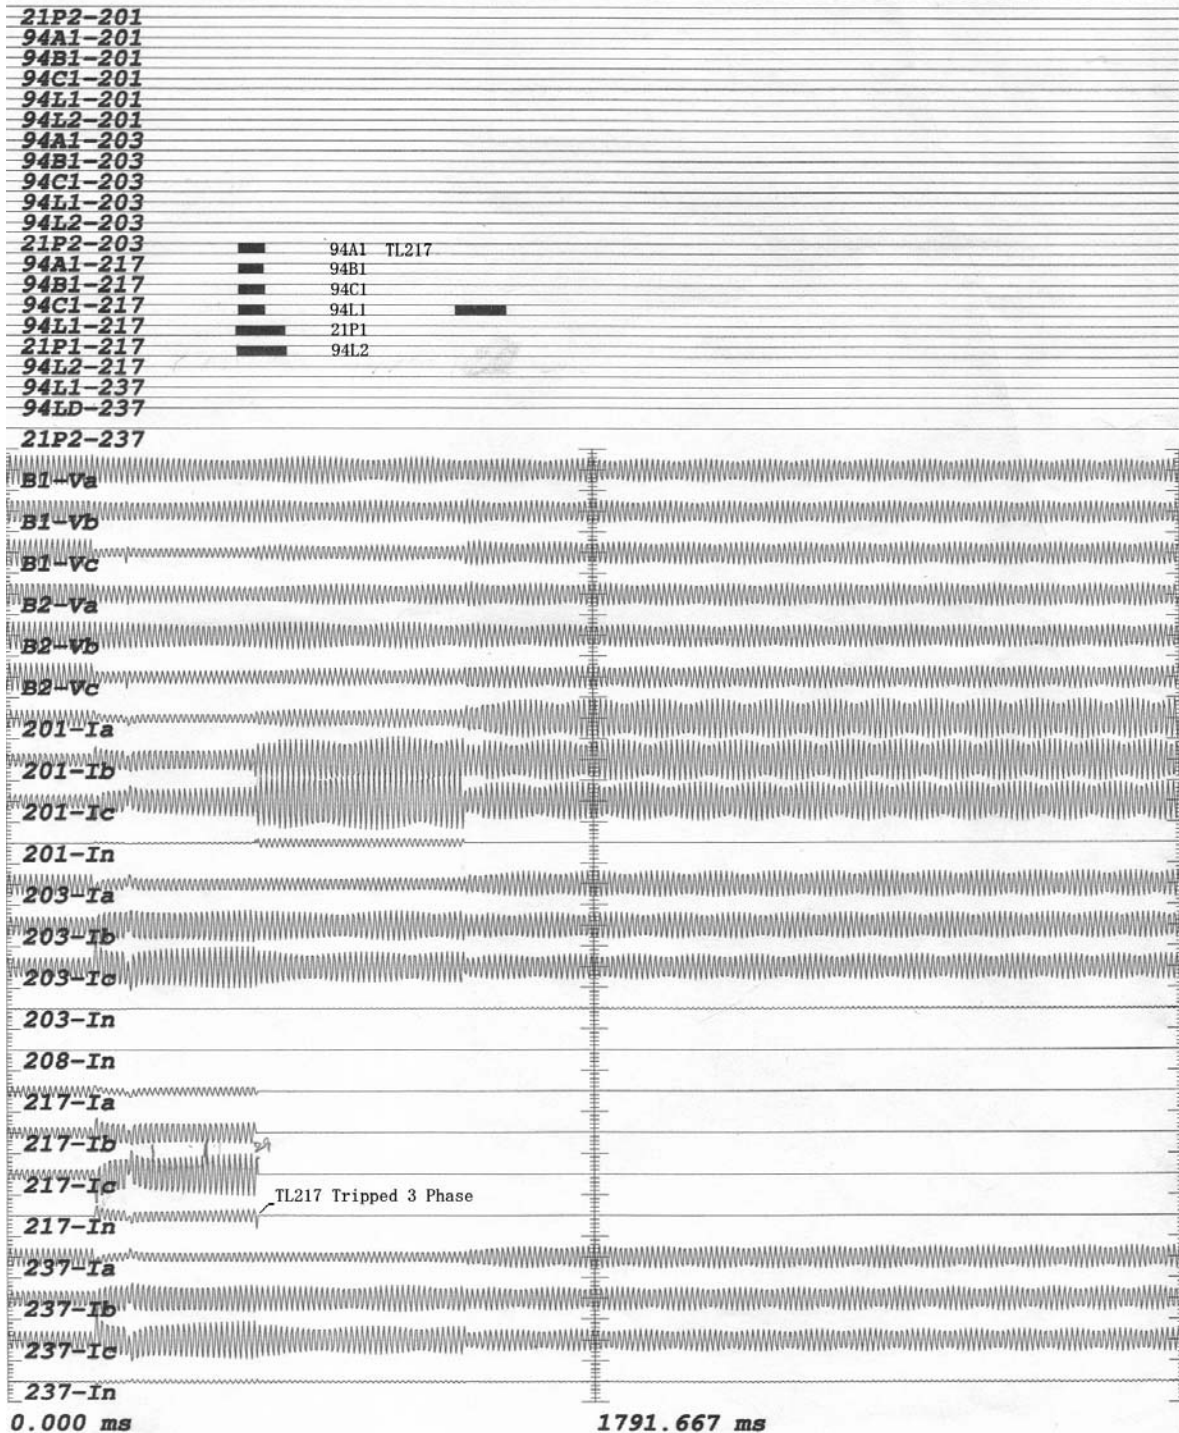
Figure 2-3: Western Avalon DFR Trace at 0642 Hours during B1L17 Fault

Figure 2-3 shows the Western Avalon DFR trace and the tripping of TL217 in 30 cycles via the Zone 2 time delayed ground distance protection, and indicates that both P1 and P2 protections operated correctly. After 64 cycles the fault migrated from where it started on the breaker

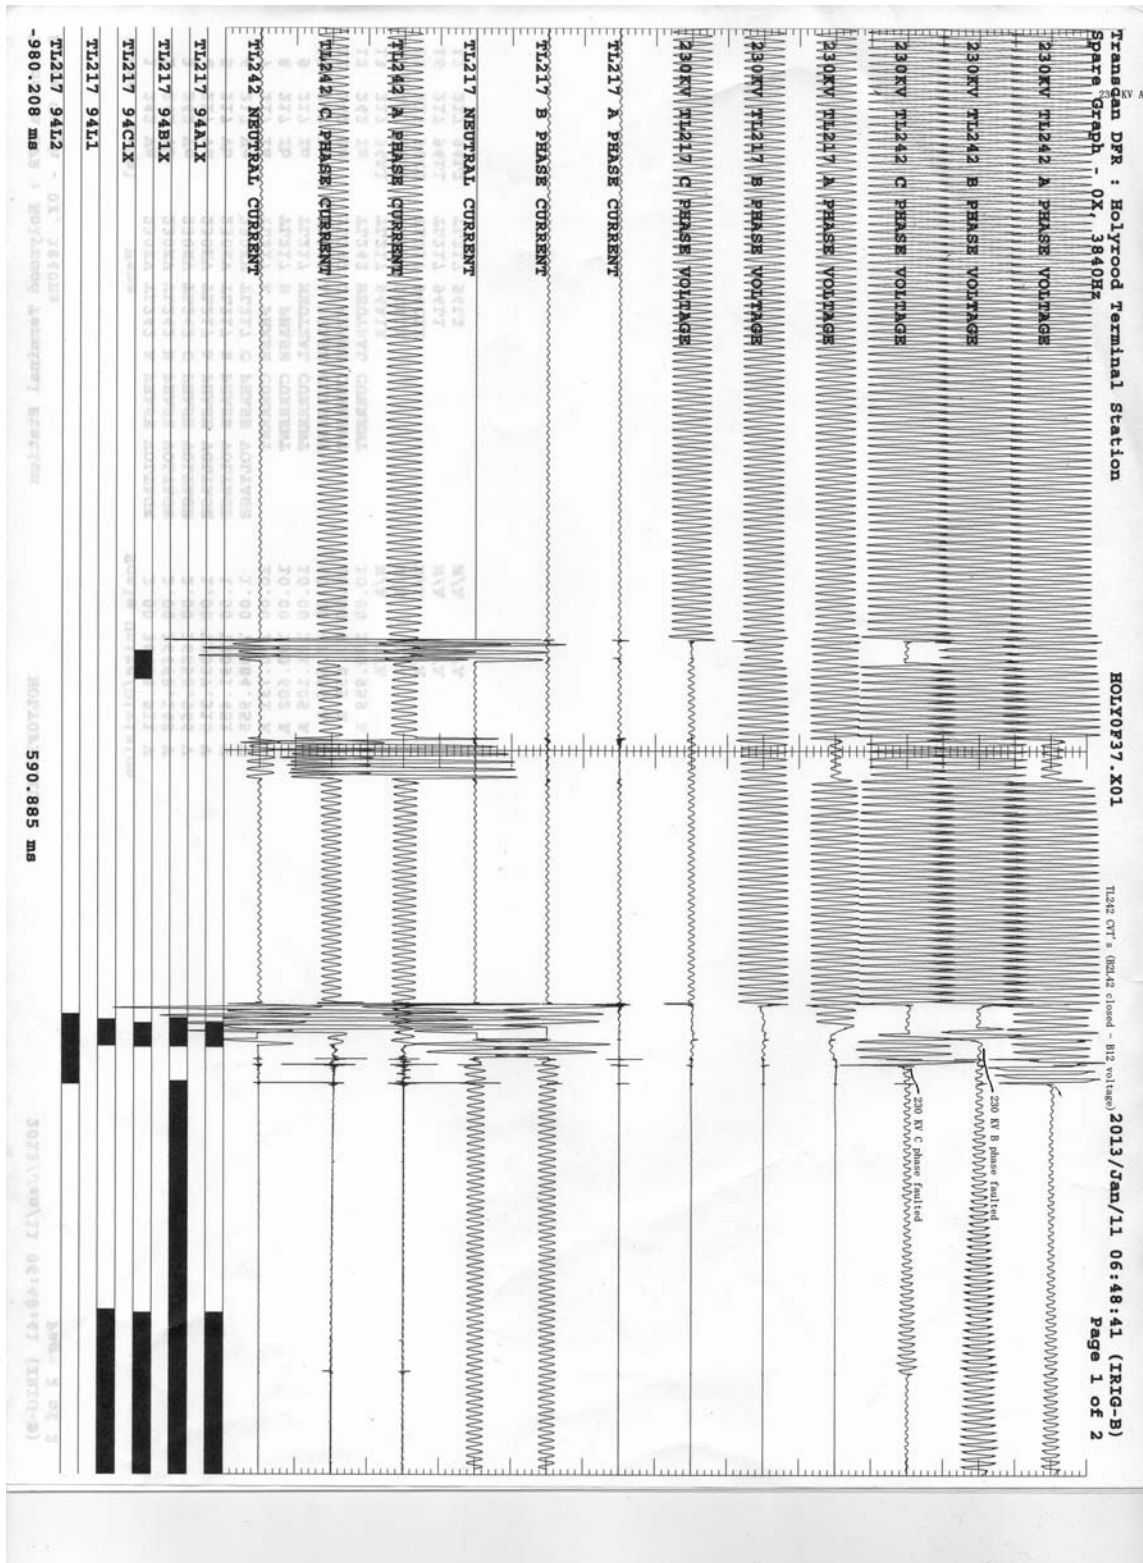
Figure 2-7: Holyrood DFR Trace at 0648 Hours Faults Showing TL242 CVT Voltages

230 KV in the vicinity of B12 causing a B-C ground fault. Figure 2-7 shows a current of approximately 230 A in the B12L17 CT supplied from the 66 KV into the B-C-ground fault. This figure also shows the TL242 CVT's voltages, connected to B12 via line breaker B12L42, collapsing when B and C phases faulted. This was followed by A phase flashing over approximately 2 cycles later. Figure 2-8 is a blow-up, showing voltages at the TL242 CVTs and the TL217 B phase current. All three phases were faulted.

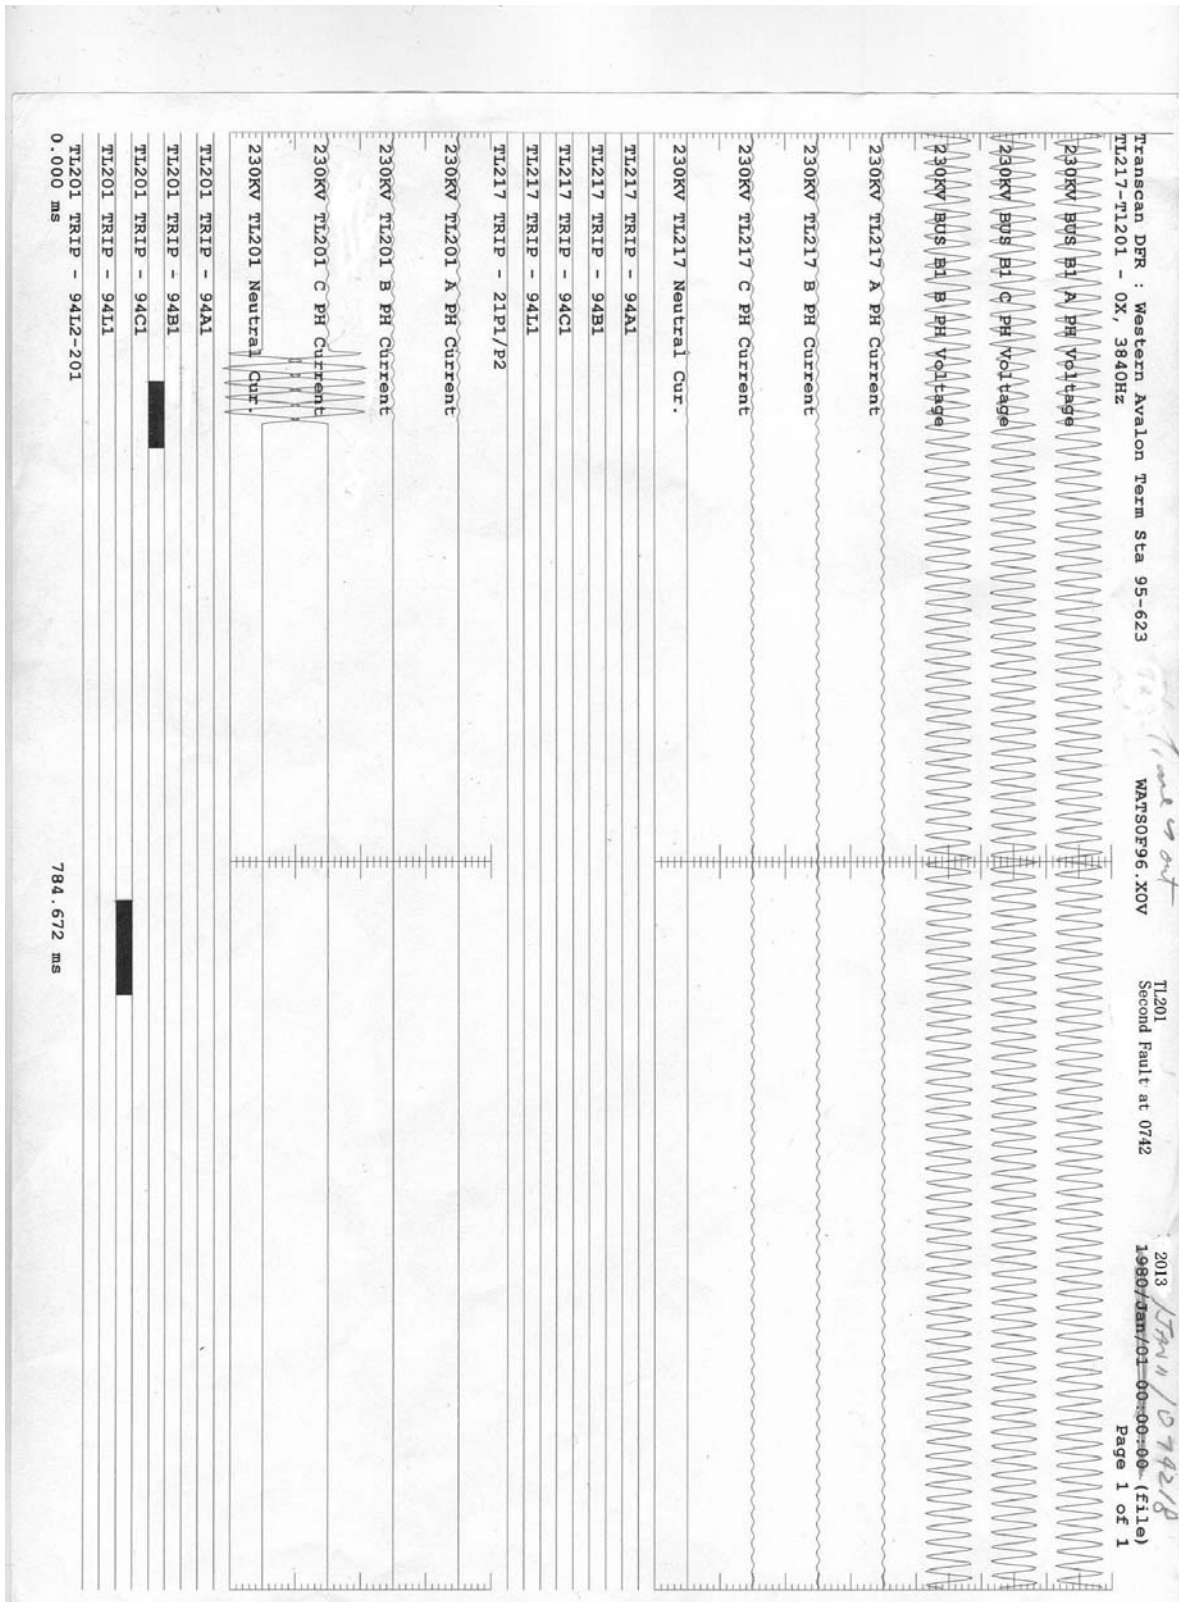
Figure 2-11: Western Avalon DFR at 0742 Hours Showing Second Fault to TL201

Prior to this event, all three units at Holyrood were offline, the 230 and 138 KV busses at Holyrood were de-energized with busses B12, B15 and B8 locked out and the Avalon Peninsula load, east of the Western Avalon (WAV) terminal station, was being supplied by TL201 with some local Newfoundland Power generation suspected to be still in service. As illustrated in the fault trace, Figure 2-10, a line to ground (C phase) fault developed on TL201 at 0742 hours. The line tripped C phase in four cycles at the Western Avalon end on P1 (Optimho protection only), followed by C phase at Hardwoods in seven cycles on both P1 & P2 protections and finally A and B phases at Hardwoods in 8 cycles on P1 protection only, eventually resulting in a 3 phase trip of the line. The trip of TL201 resulted in outages to the major load centers east of Western Avalon. At 41 cycles TL201 successfully reclosed at the Western Avalon end but faulted C phase

and tripped again approximately 2 seconds later, see Figure 2-11. The line fault was later revealed to be related to a jumper issue at Structure 210 located 49.9 km from WAV.

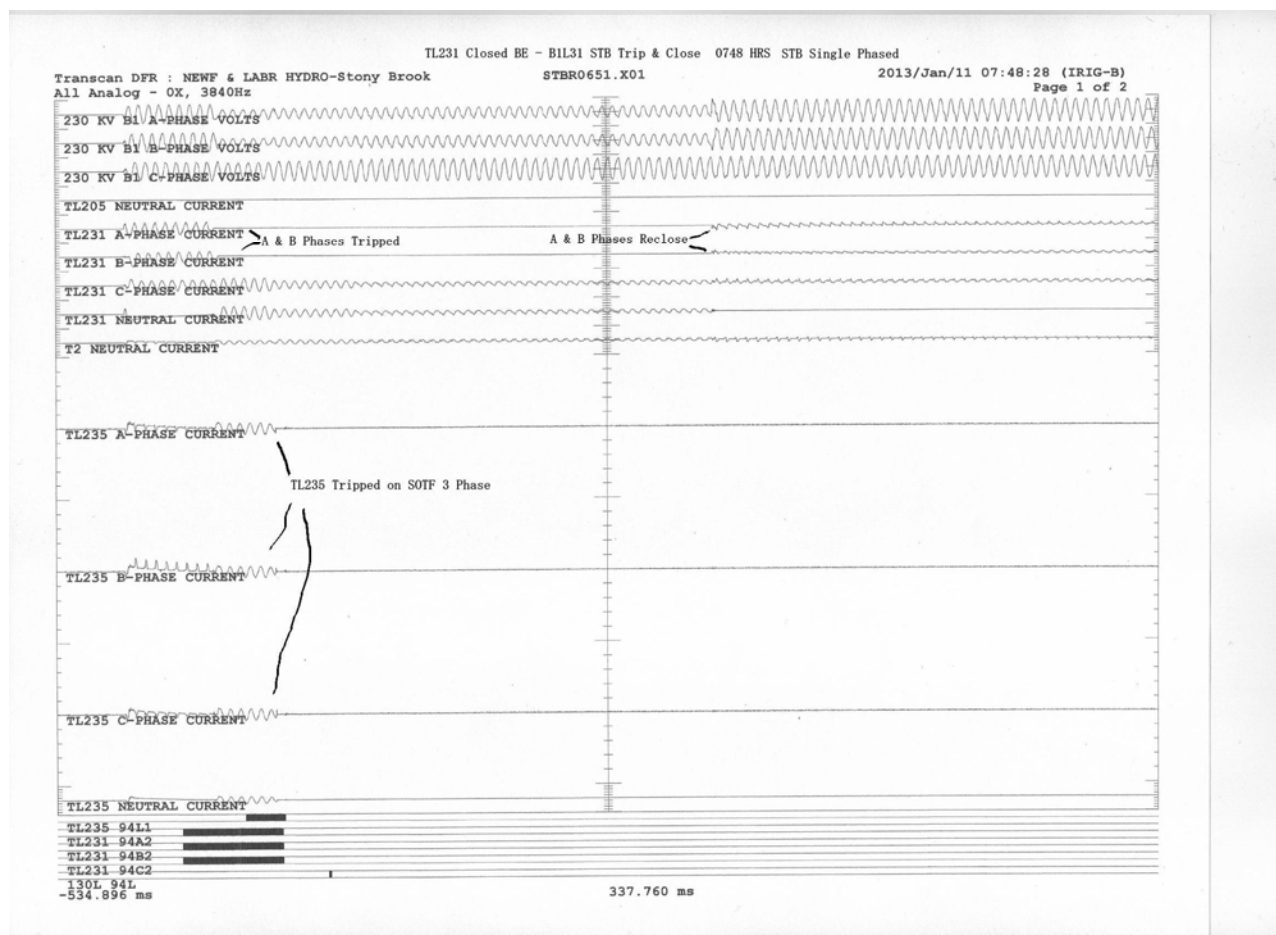
**Figure 3-1: Stony Brook DFR Trace at 0748 Hours Showing STB B1L31 Trip/Close**

- At 0748 hours, when TL231 was closed at BDE to re-energize STB, the P2 protection (Schweitzer distance) operated on TL231 at STB sending a three phase trip signal to the breaker B1L31 (L05L31 was already tripped from the incident at 0742 hours). With reference to previous Figure 3-1, B1L31 tripped only on two phases - A and B. The 230 KV bus at STB remained energized via C phase only for approximately 47 cycles until the A and B phases reclosed. C phase failed to open due to problems with the C phase breaker circuit. During later testing, the C phase trip coil circuit was showing open (no continuity) initially, but after several breaker operations it was shown to be closed or continuous. The non-continuity issue is believed to have cleared during the 'wiping' of the C phase auxiliary contact during the operational testing. This contact is in series with the trip coil of the breaker. Also revealed during testing was that C phase failed to open via the trip relay signals and instead tripped on phase disagreement protection.

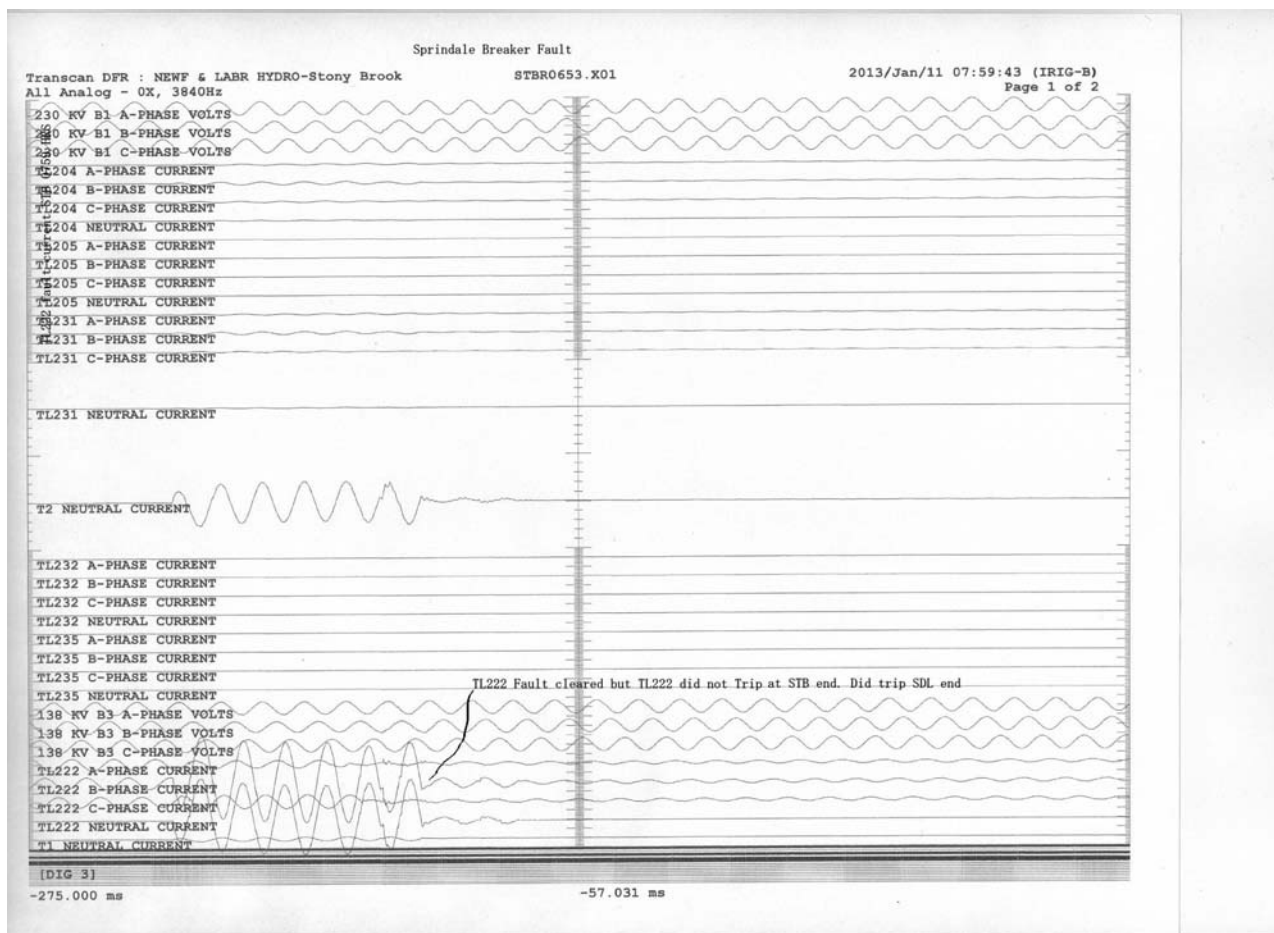
Figure 3-2: Stony Brook Trace at 0759 Hours Showing SPL Breaker B1L22 Fault

Just prior to 0800 hours, the breaker B1L22 was closed at Springdale (through the synchrocheck relay). This restored the 138 KV loop and the Bay d'Espoir and Hinds Lake plants were tied together for approximately three seconds before an internal problem in the breaker B1L22 at Springdale caused a fault and the breaker tripped again, clearing the fault with no clearing required at the remote Stony Brook end.

- At 0759 hours when TL222 from Stony Brook to Springdale was closed at Springdale, momentarily connecting the BDE system to the HLK system for approximately three seconds, the LPRO2100 protection at SPL operated due to a fault. The breaker B1L22 at SPL tripped but the breaker on TL222 at STB, B3L22, did not trip nor did the line protection at STB operate. However, the fault cleared in six cycles with the opening of the SPL B1L22 breaker. The fault can be seen on the STB DFR trace in Figure 3-2, previously referenced. Based on this information and the LPRO relay report at Springdale which operated and tripped, the fault was predicted to be in the SPL B1L22 breaker and most likely related to resistors, based on an experience in the past with this type of oil circuit breaker (138 KV GE KSO). The resistors were suspected to have been damaged during the closing motion and fallen off, faulting inside the tank with the fault clearing on opening. Subsequent detanking of the breaker and checks confirmed the presence of damaged resistors which were indeed found at the bottom of the tank.

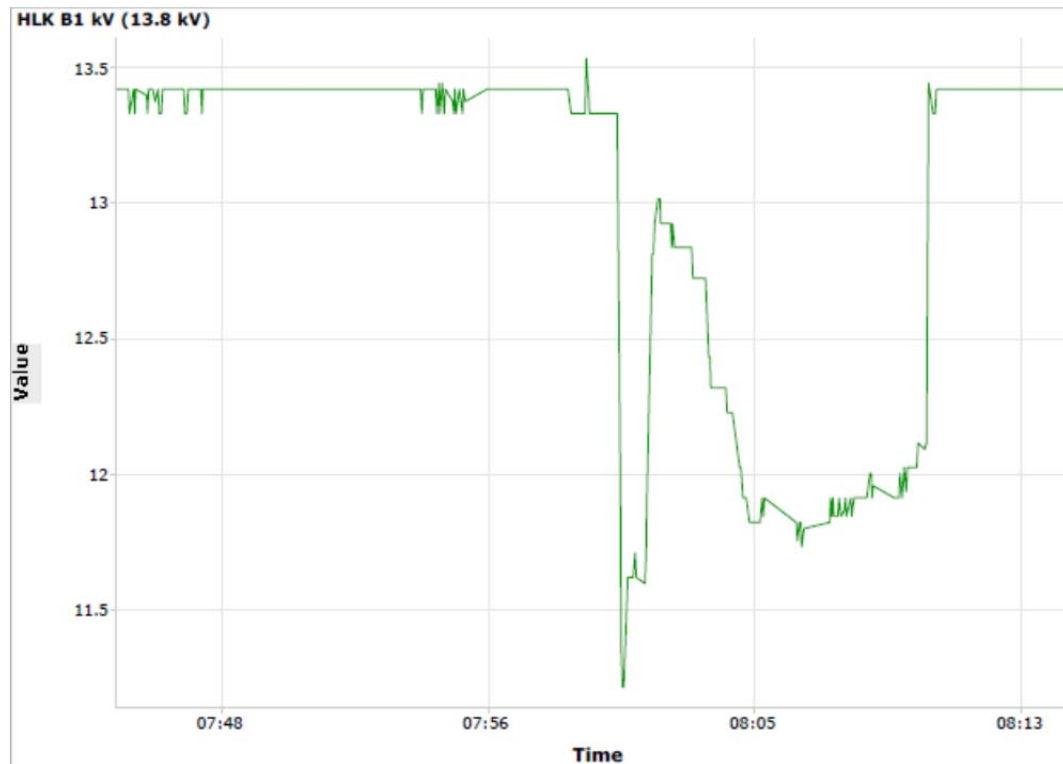
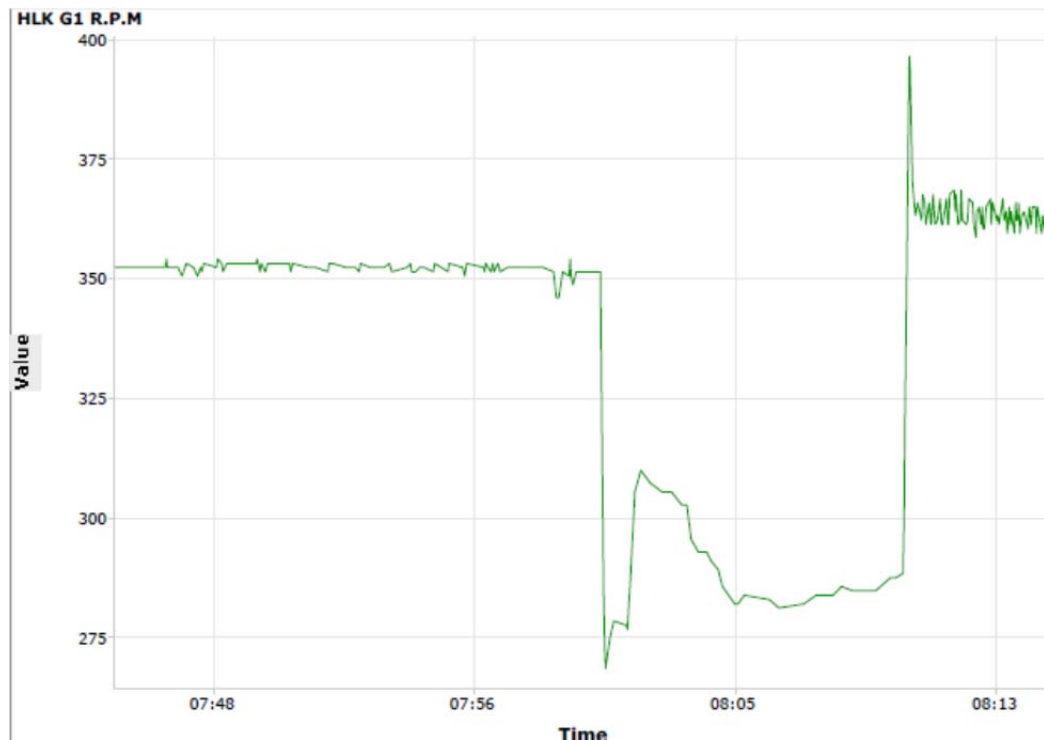
Figure 3-9a: Hinds Lake Terminal Voltage from 0745 to 0815 Hours

The overexcitation was mitigated somewhat by the operation of the Hinds Lake exciter volts per hertz monitor which functioned to keep this ratio within limits at the Hinds Lake unit. This protects the unit by decreasing the terminal voltage of the machine when the frequency decreased, as is evident in Figure 3-9 (a and b) which indicate the frequency and voltage at the unit at this time. The ratio of volts per hertz is being controlled at a maximum of approximately 1.07.

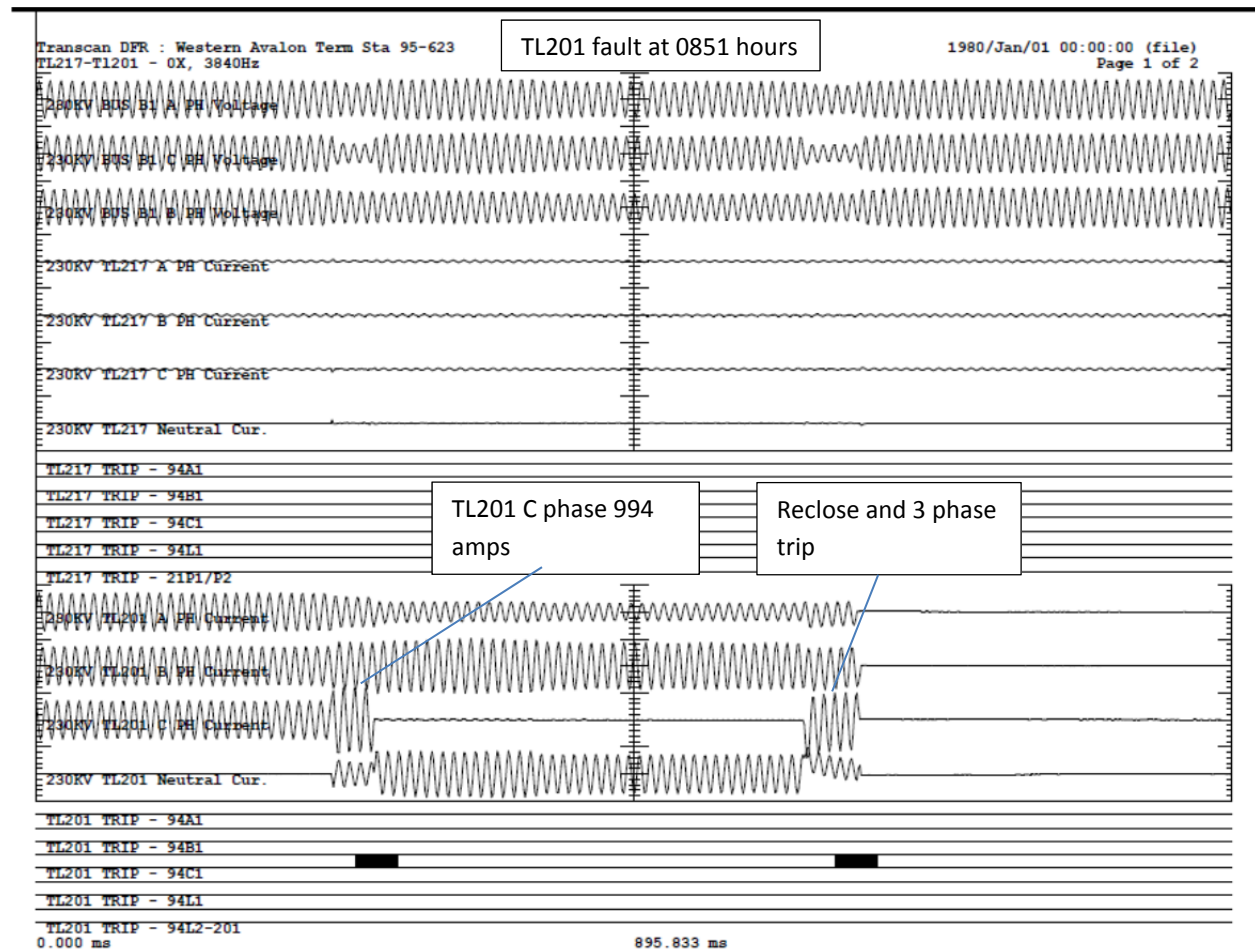
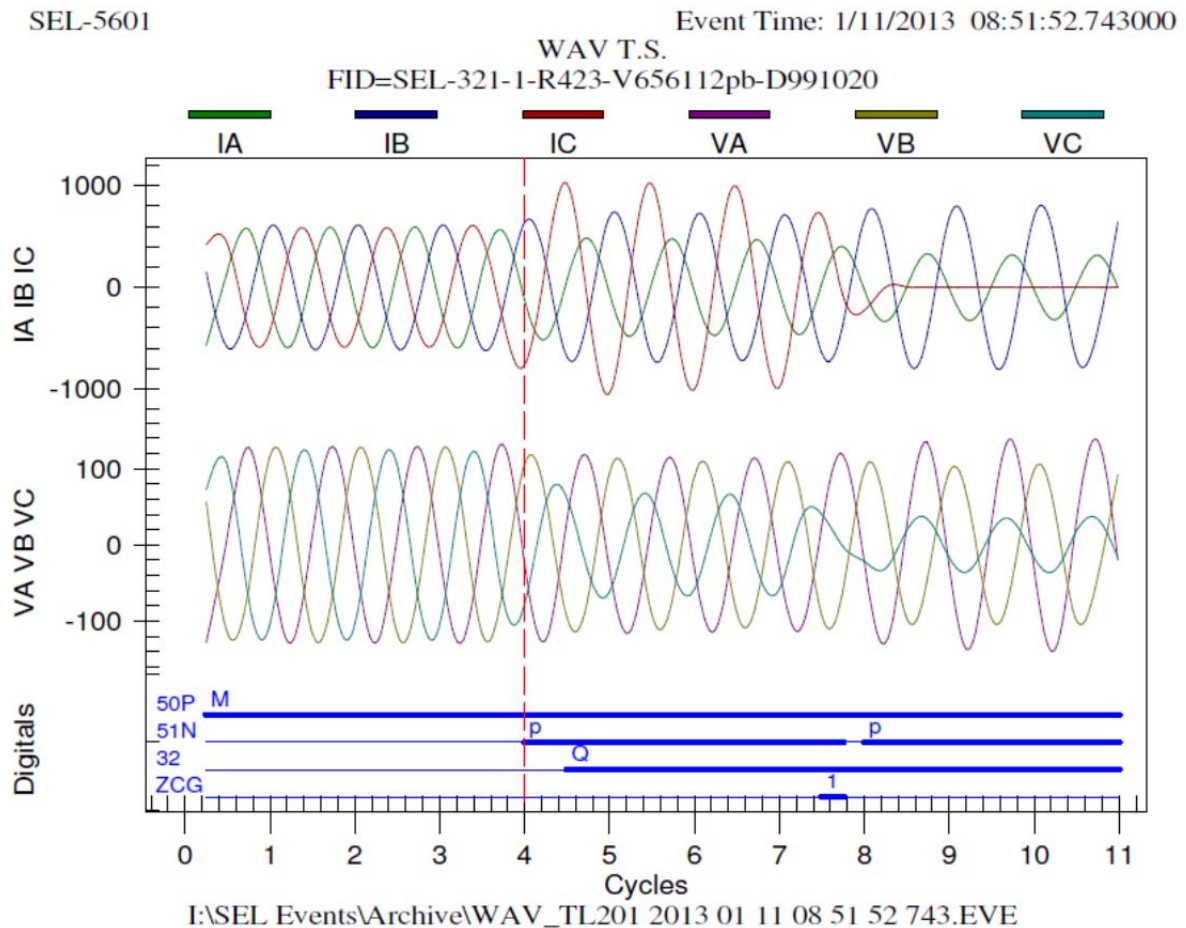
Figure 3-10: Western Avalon DFR Trace at 0851 Hours Showing TL201 Fault and Trip

- At 0851 hours TL201 faulted C phase again due to the jumper issue. Based on the Western Avalon DFR trace and the SEL 321 report, Figures 3 -10 and 3-11 respectively, the fault resistance was in the 100 ohm range and higher. The Schweitzer P2 Zone 1 marginally operated to see the fault as indicated by the momentary pickup in Figure 3-11. Neither of the Hardwoods protections, P1 nor P2, operated to clear the fault because of the high resistance value. It is thought that the Western Avalon end operated due to the effect of the load which assisted in the tripping at this end but did not at the Hardwoods end. The fault was cleared with the three phase trip of the Western Avalon end as the line was being operated radially at the time.

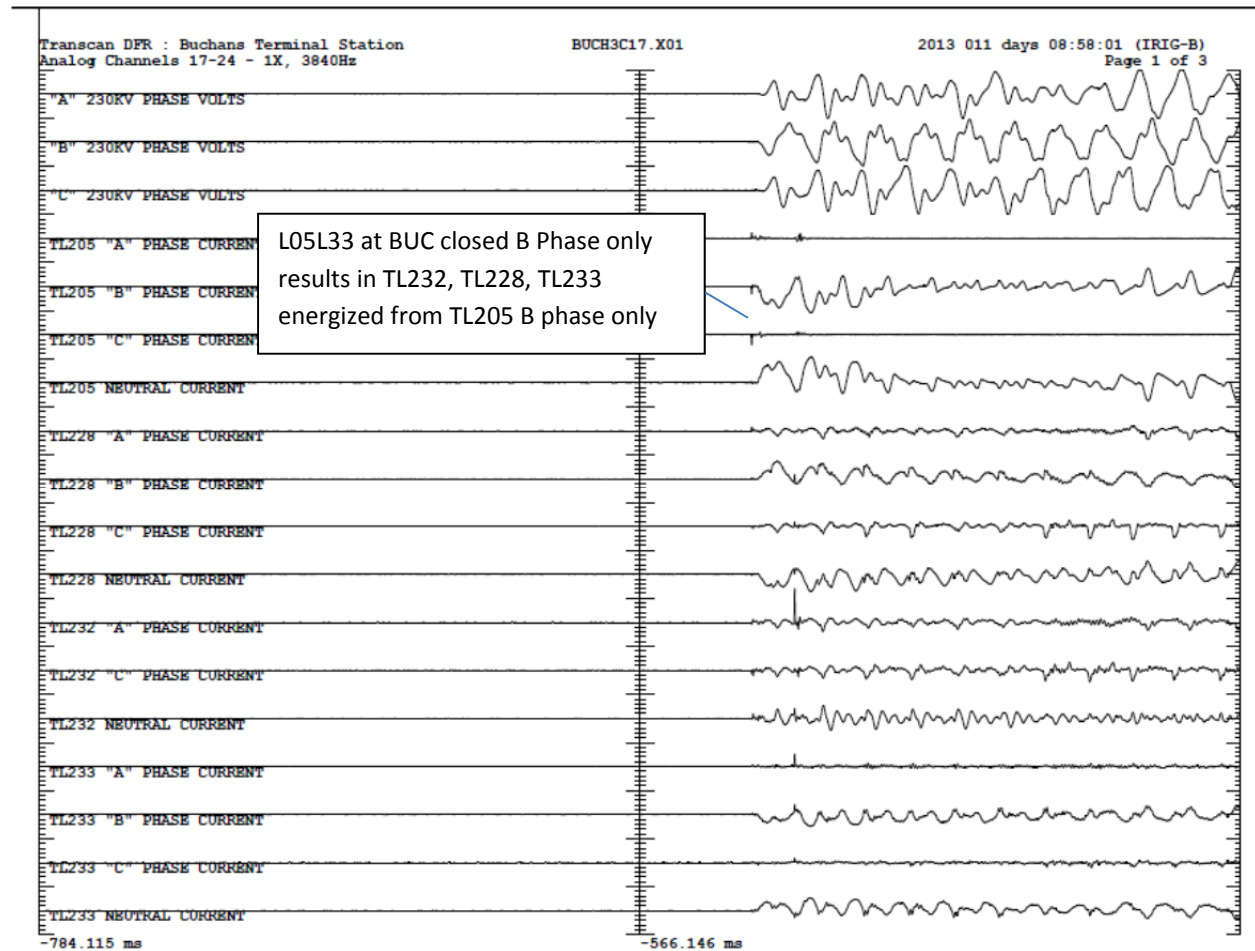
Figure 3-12: Buchans DFR Trace at 0858 Hours Showing the Start of Single Phasing

At 0858 hours breaker L05L31 at Stony Brook was closed by the ECC, energizing TL205 and also energizing, single phase through L05L33 (B phase), Buchans lines TL228, TL232, TL233 and the Bottom Brook terminal station (see Figure 3-12). Also energized at this time (single phase) were the 230 KV busses at Massey Drive via transmission line TL211. At this point loads were energized at Bottom Brook via the 138 KV bus and lines TL214 (supplying the Doyles and Port Aux Basques area) and TL250 (supplying the Burgeo area). No loads were single phased or energized at Buchans nor Massey Drive as they were isolated due to the lockout of Buchans T1 and the open 66 KV breakers at Massey Drive. Very high voltages were experienced on the 230 KV system due to the single phasing condition (see Figure 3-13). Voltages measured on the Bottom Brook DFR were 222 KV line to ground on B phase.

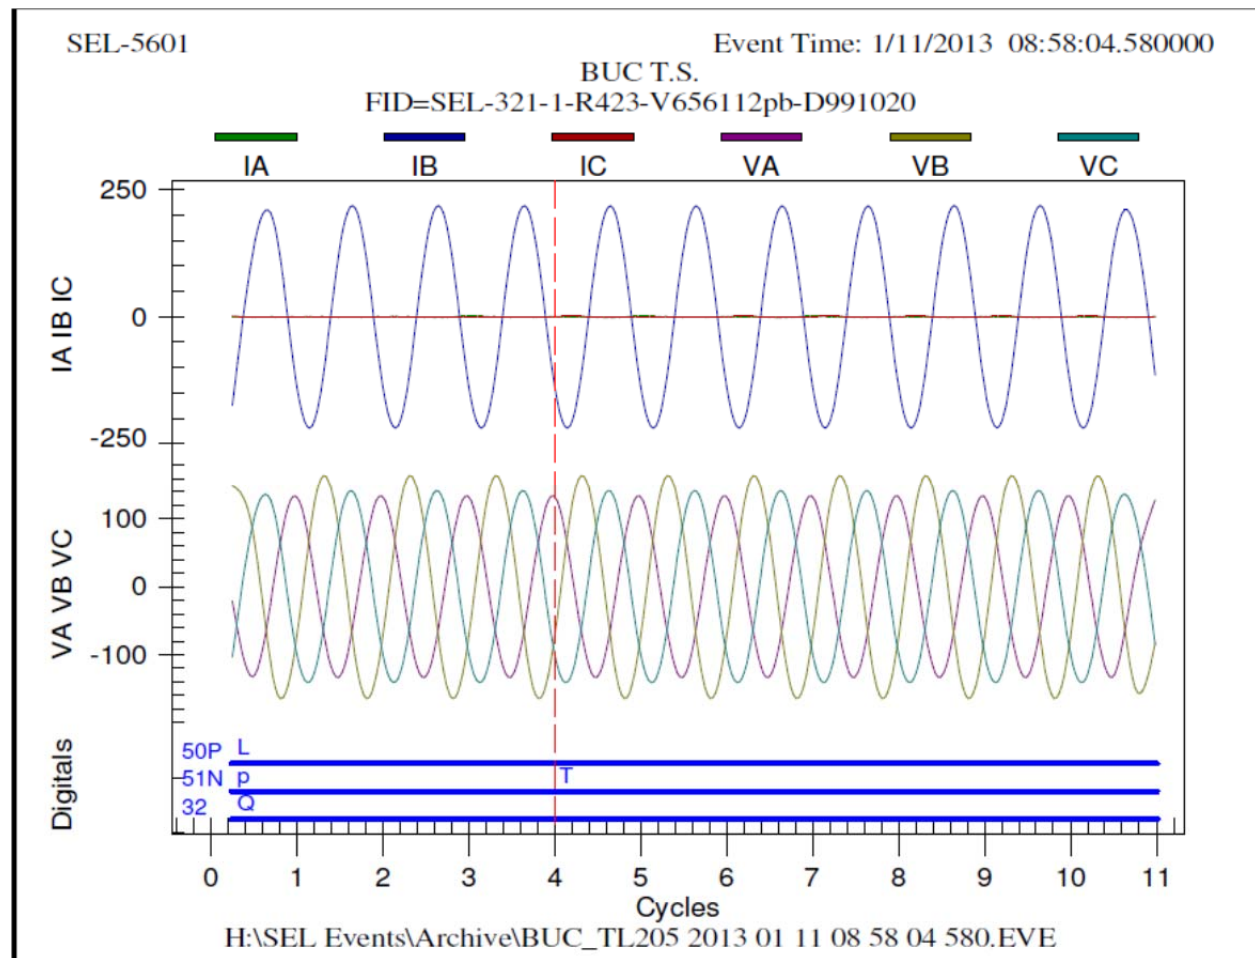
Figure 3-14: Buchans TL205 SEL Relay Report at 0858 Hours – 51N Operation

After approximately four seconds, Buchans line TL205's P2 (Schweitzer) ground overcurrent (51N) protection operated (Figure 3-14), sending trip signals to breaker B1L05 which was already open and L05L33. The B phase of breaker L05L33 still did not trip.

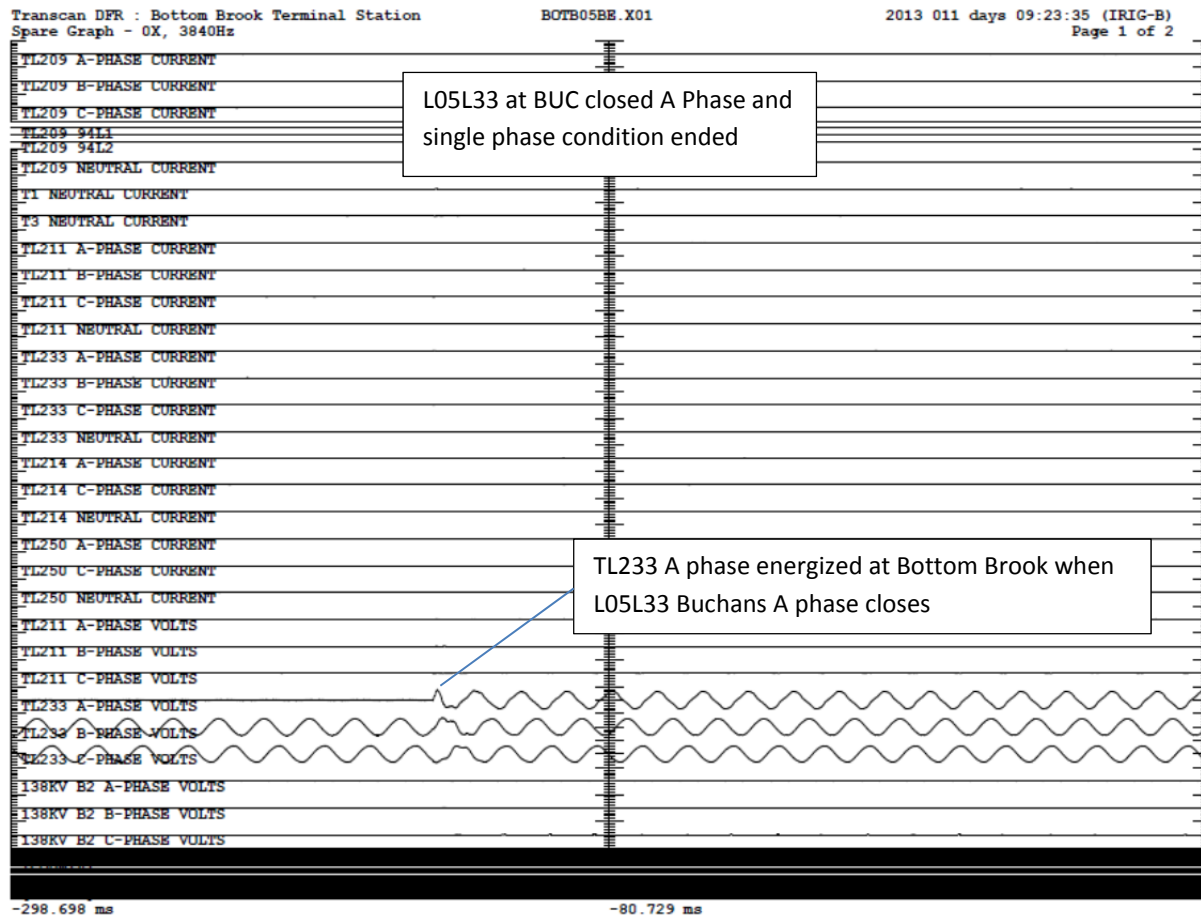
Figure 3-15: Bottom Brook DFR Trace at 0923 Hours Showing BUC L05L33 Closed Three Phase

At 09:22:58 C phase of Buchans breaker L05L33 closed and 09:23:34 there was a closure of A phase (see Figure 3-15), most likely due to loss of air, ending the single phasing condition and energizing TL233 on all three phases. This closing now permitted the ECC to begin a more normal restoration of the West Coast system.

- Further investigation and testing should be performed on Buchans breaker L05L33 to ensure that the failure to trip B phase, failure to trip on disagreement, and the

subsequent closure on loss of air is more completely understood, with repairs as required.

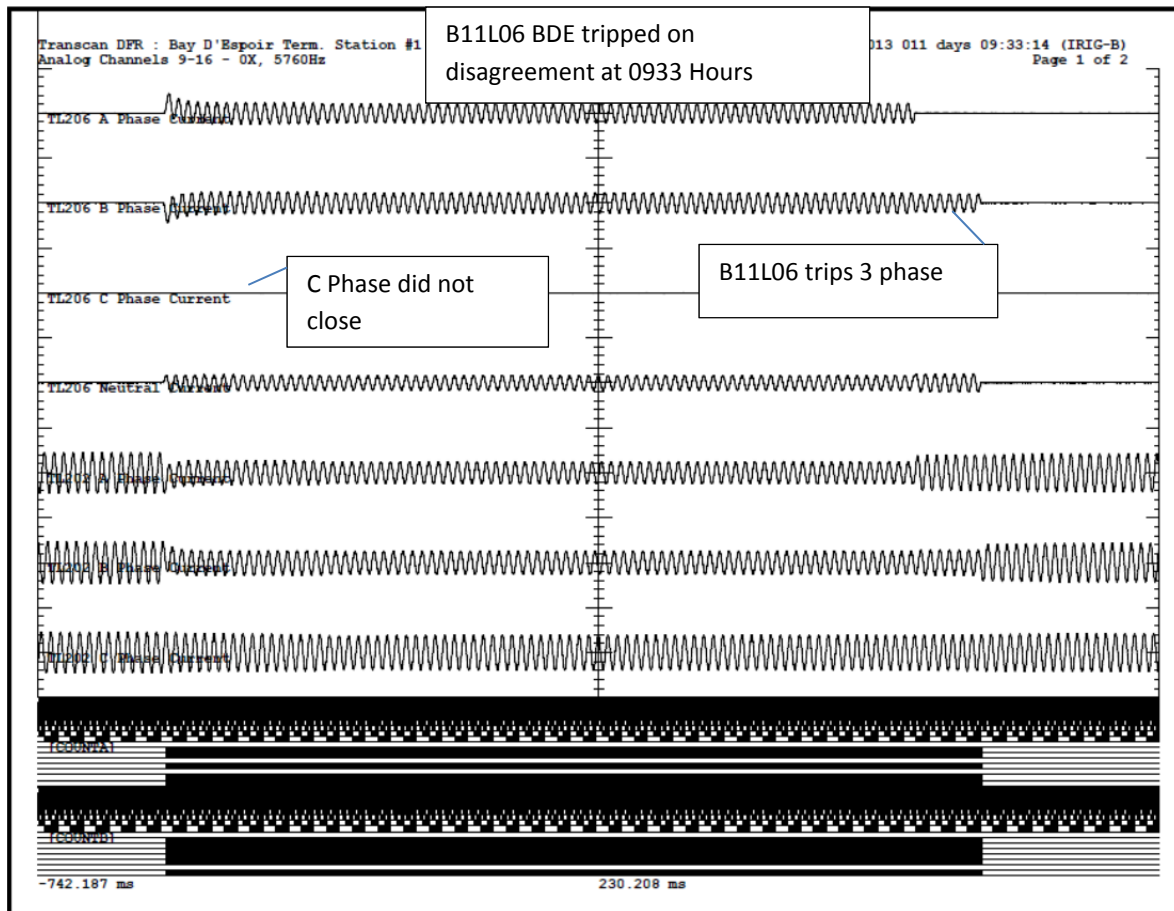
**Figure 3-16: Bay d'Espoir DFR Trace at 0933 Hours Showing TL206 Close and Trip**

- At 0933 hours breaker B11L06 at Bay d’Espoir was closed by the ECC putting line TL206 in-service. It was already closed at the Sunnyside end. The breaker closed on A and C phases only and tripped 85 cycles later most likely on pneumatic disagreement, see Figure 3-16. Come by Chance capacitor banks C1 and C2 also tripped at this time, most likely due to the momentary voltage increase on the 230 KV bus at Come By Chance resulting from the impedance decrease and phase unbalance caused by the closing of the line in parallel with TL202. The 230 KV overvoltage level experienced at Come By Chance was most likely marginally, i.e. at the 110% trip setting, as the third bank in service at this time (C3) did not trip. Shortly after the trips the banks were put back in-service by the ECC.

- At 0933 hours breaker B11L06 was closed at Bay d’Espoir to put TL206 in-service (it was already closed at the Sunnyside end). The breaker only closed two phases of the line to be in parallel with TL202, see DFR trace - previous Figure 3-16. It then tripped on disagreement. This was followed by the overvoltage tripping of two of three in-service capacitor banks at Come By Chance. An attempt was made to close the breaker again at 1422 hours but it again failed to latch closed. It was successfully closed at 1436 hours while in local control.

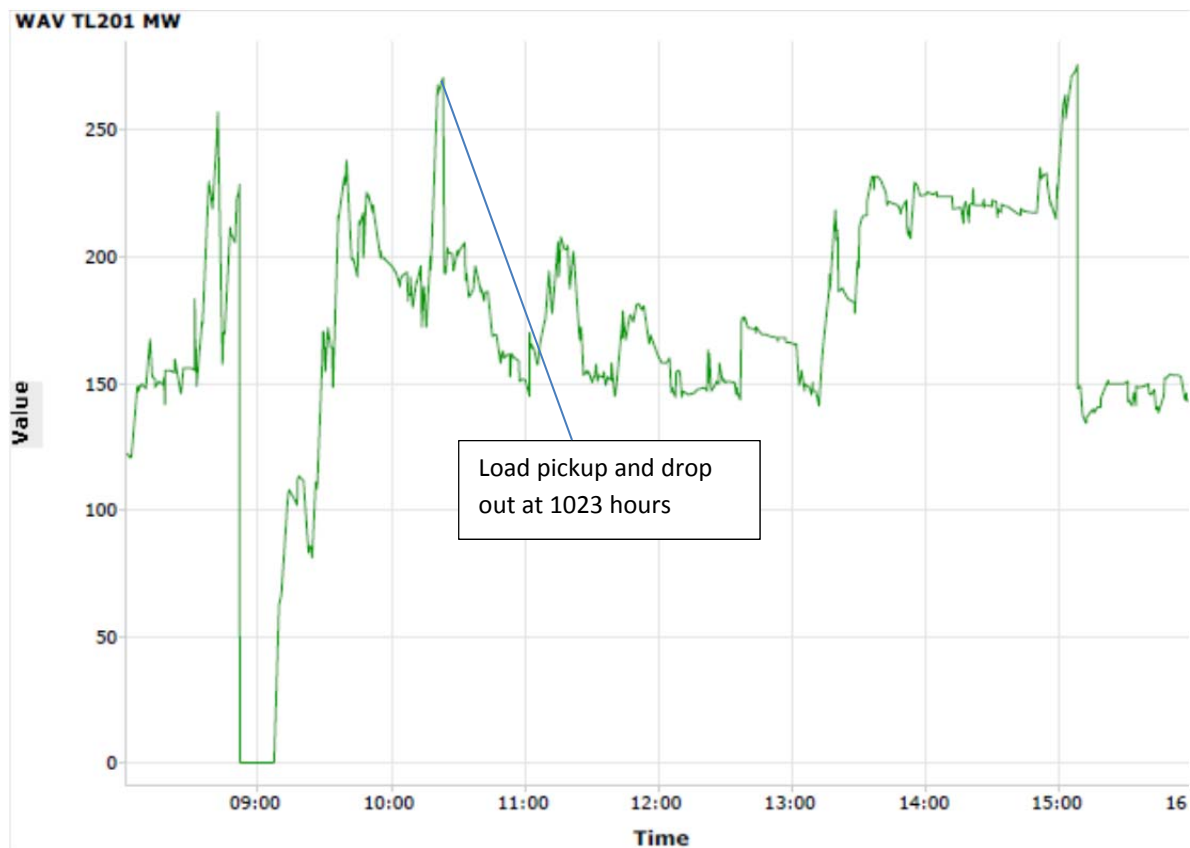
Figure 3-17: TL201 MW Loading from 0800 to 1600 Hours

- At 1008 hours the Granite Canal unit was put on line. The unit was loaded up to 29 MW at 1013 hours.
- At 1023 hours there was a significant load increase followed by a drop of approximately 60 MW in the St. John's area, related to activity at the NP stations at Stamps Lane and Molloy's Lane, see Figure 3-17. This led to a system overvoltage and the tripping of capacitor banks C1, C2, C4 at Come By Chance.

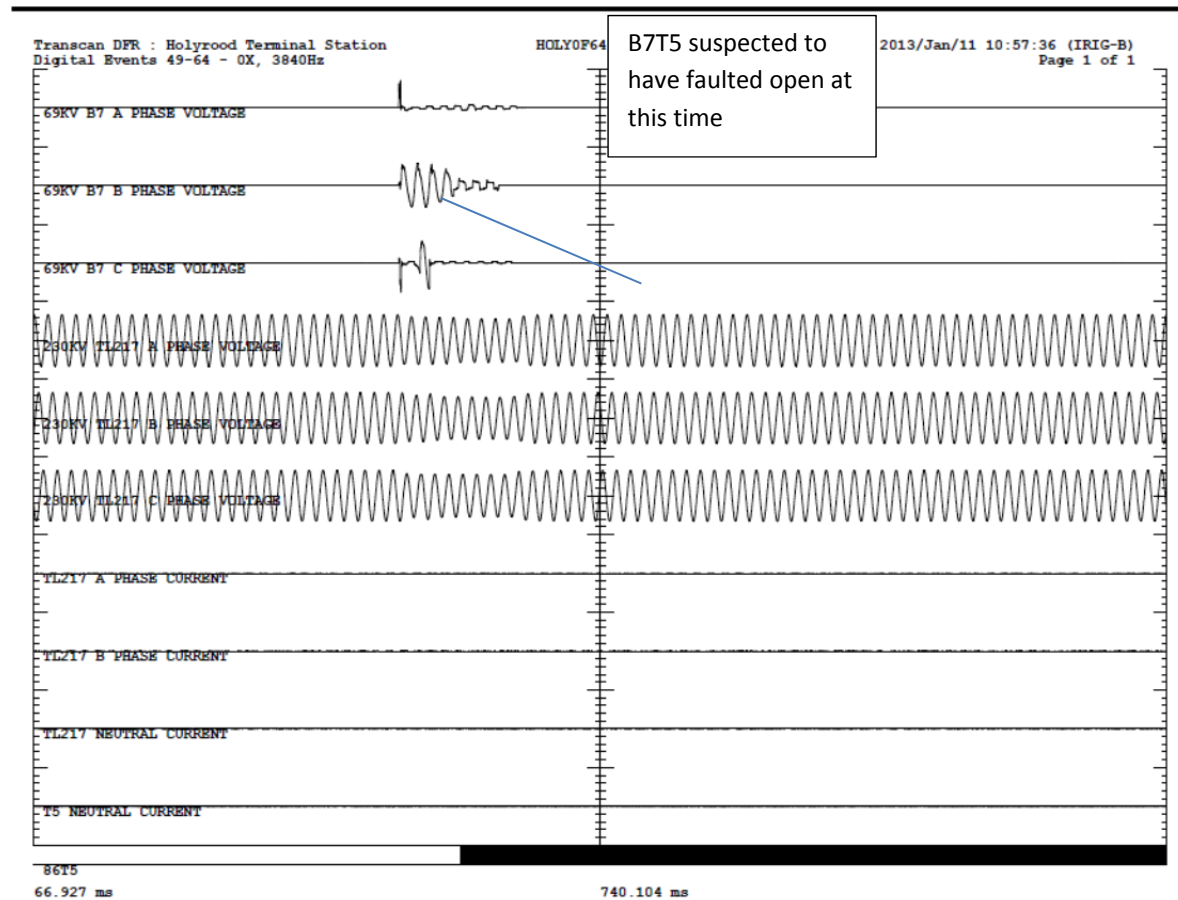
Figure 3-18: Holyrood DFR Trace at 1057 Hours Showing Suspected Fault to Breaker B7T5

- At 1057 hours NP breaker 38L-B closed and tripped at Seal Cove. The Holyrood breaker, B7T5, faulted (it was open at the time) when energized from 38L, see Figure 3-18. The lockouts associated with T5 (86T5) and the 66 KV bus (86B6B7) both operated via instantaneous differential protection, transformer and bus respectively. The fault was cleared by breaker B7L38 at Holyrood and by NP 38L-B at Seal Cove.

- At 1057 hours the Holyrood lockouts 86B6B7 and 86T5 operated when an attempt was made to energize the 66 KV bus B6B7 from NP's line 38L. As breaker B7T5 was open at the time and, given there was a fault as recorded in the DFR trace (see previous Figure 3-18), the fault location is, in all likelihood, on or in the breaker. This was also indicated by the protection operations (in both zones). A and B phases were involved, most likely related to the severe salt contamination. The fault was cleared by 38L protection at NP's Seal Cove station.

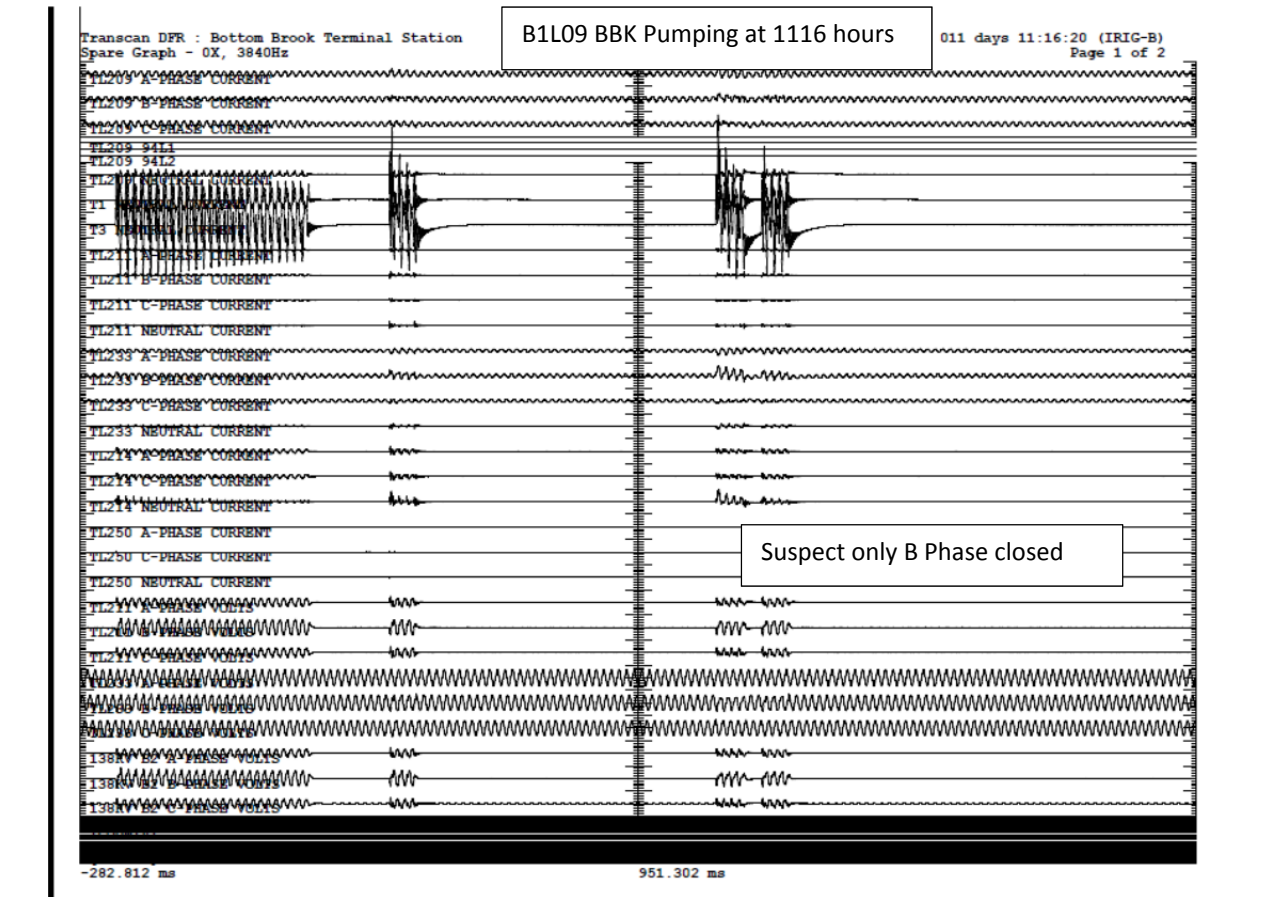
**Figure 3-19: Bottom Brook DFR Trace at 1116 Hours Showing BBK Breaker B1L09 Pumping**

- At 1116 hours the Bottom Brook breaker B1L09 was closed by the ECC but opened and closed multiple times due to suspected breaker air problems. TL214 and the Doyles station were connected at the time. The breaker ended up open, see Figure 3-19.

- At 1116 hours there was an issue with breaker B1L09 at Bottom Brook when it was closed to energize the station. It 'pumped' multiple times before ending up tripped. This can be seen in the Bottom Brook DFR trace, previous Figure 3-19. It is suspected that it only closed B phase. TL214 and the Doyles station were energized during the pumping operations.
