1 Q. In response to CA-NLH-017 Hydro stated that:

- 1. January 11, 2013 Power System Outage Report**
- 2. Remedial Actions from the January 11, 2013 System Events**

**Unit 1 Failure – Holyrood  
Life Safety Review  
SWOP # 2013000599  
January 11, 2013**

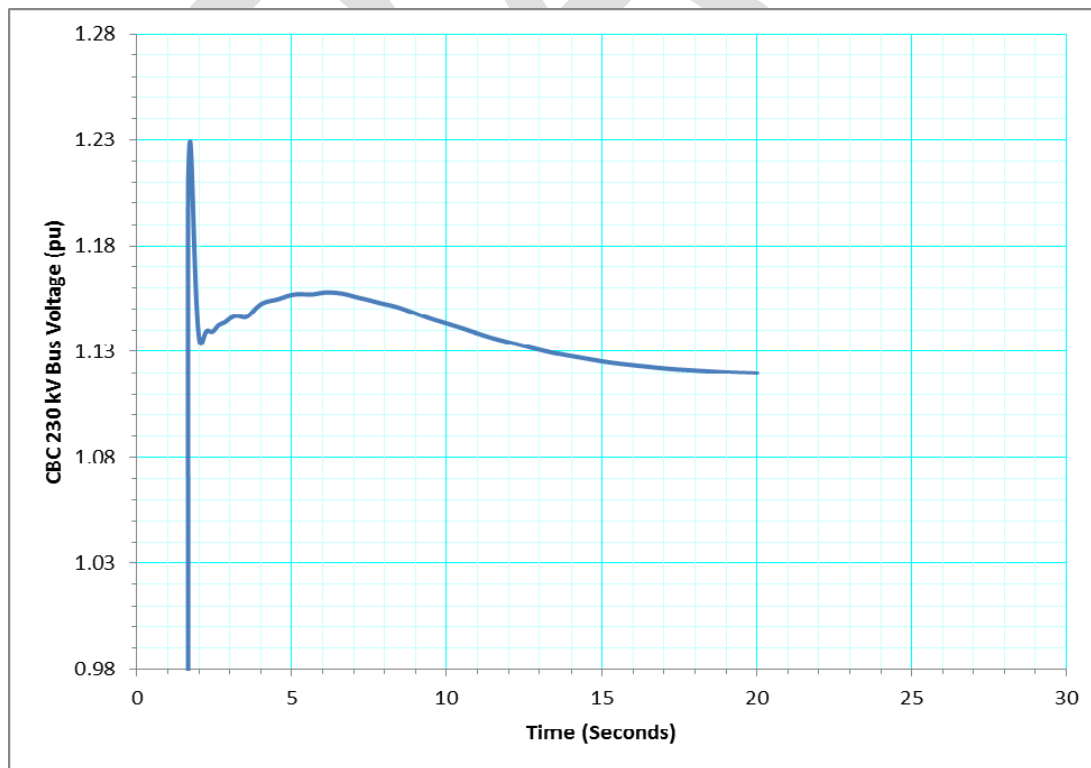
Figure 2 – CBC 230 kV Bus Voltage Following SLG Fault on TL201

1. The SLG fault on TL201 resulted in the tripping of the line. This trip resulted in the isolation of load in St. John's area. This resulted in the interruption of 287 MW flow on TL201 at Western Avalon Terminal Station.
2. Voltages at Come-by-Chance Terminal Station become elevated due to the sudden loss of load. As illustrated in Figure 2. The overvoltages presented below would result in the tripping of the Come-By-Chance capacitor banks.

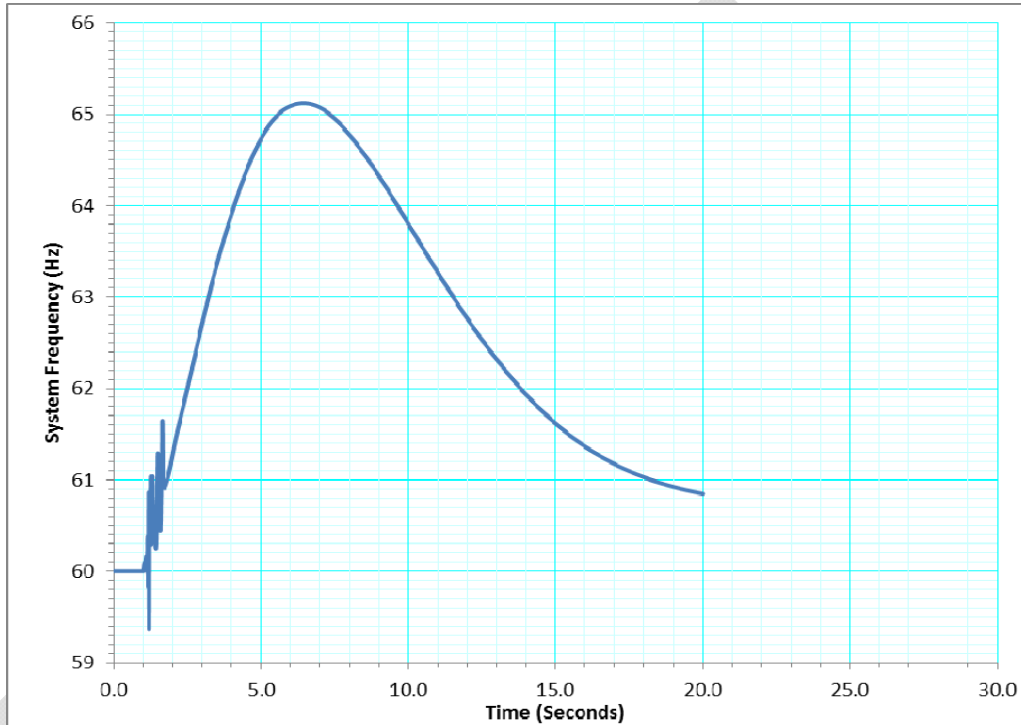
**Figure 3 – CBC 230 kV Bus Frequency Following SLG Fault on TL201**

3. The loss of load results in a significant increase in system frequency. As illustrated in Figure 3, the simulated frequency reaches a maximum value in excess of 65.1 Hz. It should be noted, however, that the simulation does not include the modelling of overfrequency protection that would result in the tripping of units. The tripping of units would reduce the magnitude of the overfrequency condition.

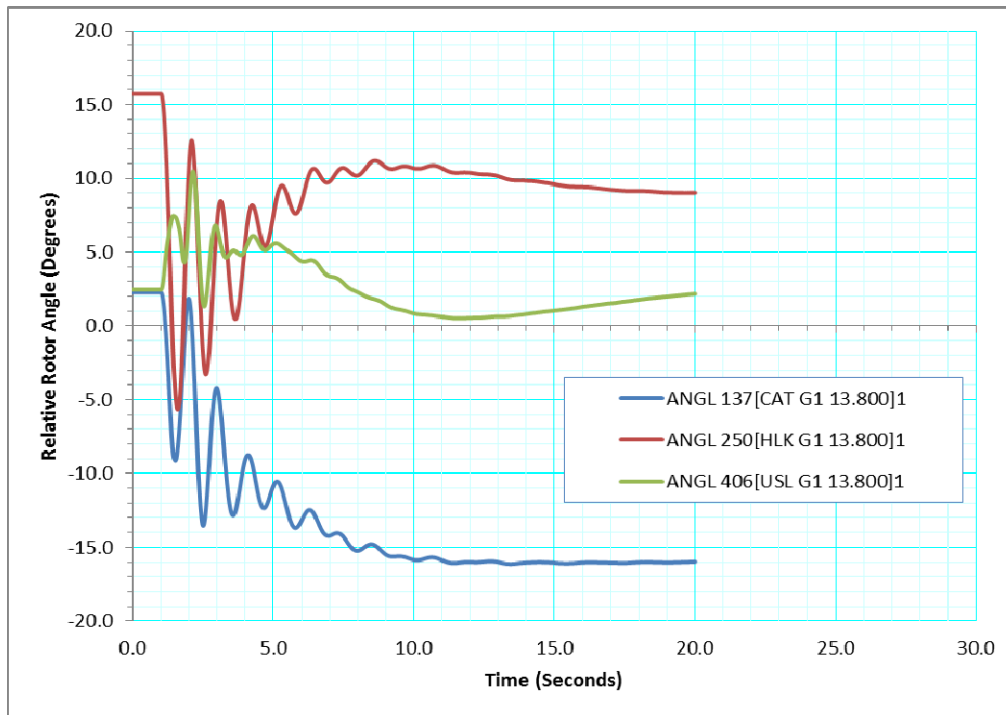
**Figure 4 – Machine Angular Stability Following SLG Fault on TL201**

4. Despite the loss of load, the simulation indicates that angular stability is maintained for the units across the system. This is illustrated in Figure 4.

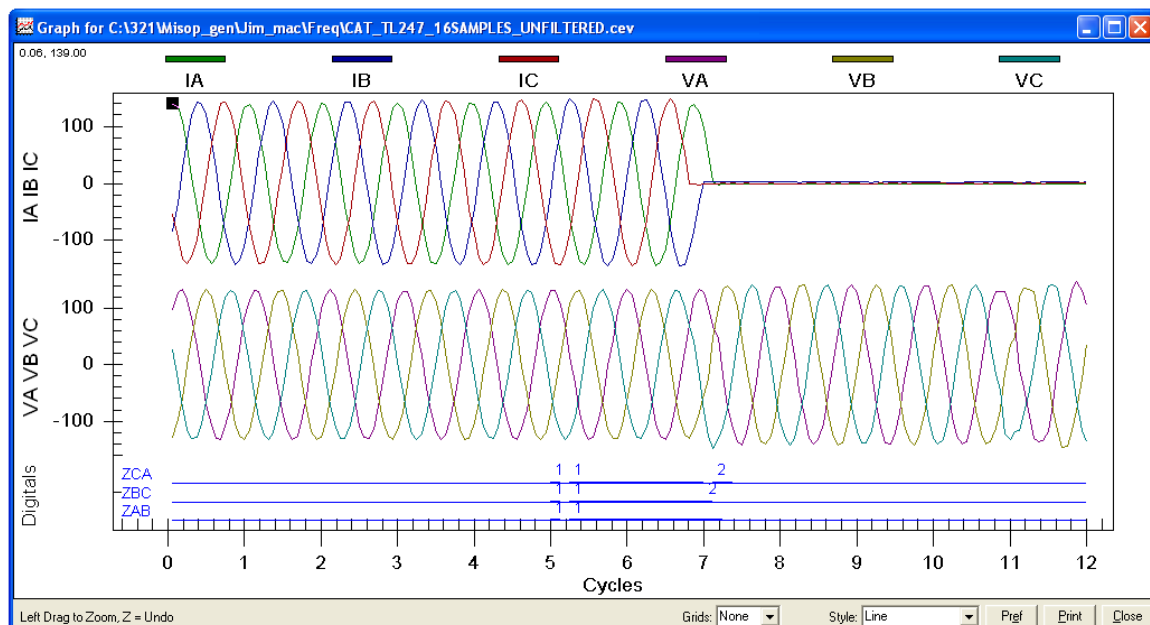
On the 11th of January 2013 several SEL 321 relay's phase distance elements operated while there was no fault on the power system. Fig.1 is an oscillographic capture of the voltages, currents and digitals as recorded by the relay at the time of the operation. From this we can see that the power system did not experience a fault at the time of the relay operation.

Fig.1 Oscillographic record extracted from SEL 321-3 relay, the oscillography shows the voltages, currents and digitals at the time of the relay operation. From this record we can see that all three phase-to-phase elements (ZAB, ZBC and ZCA) asserted.

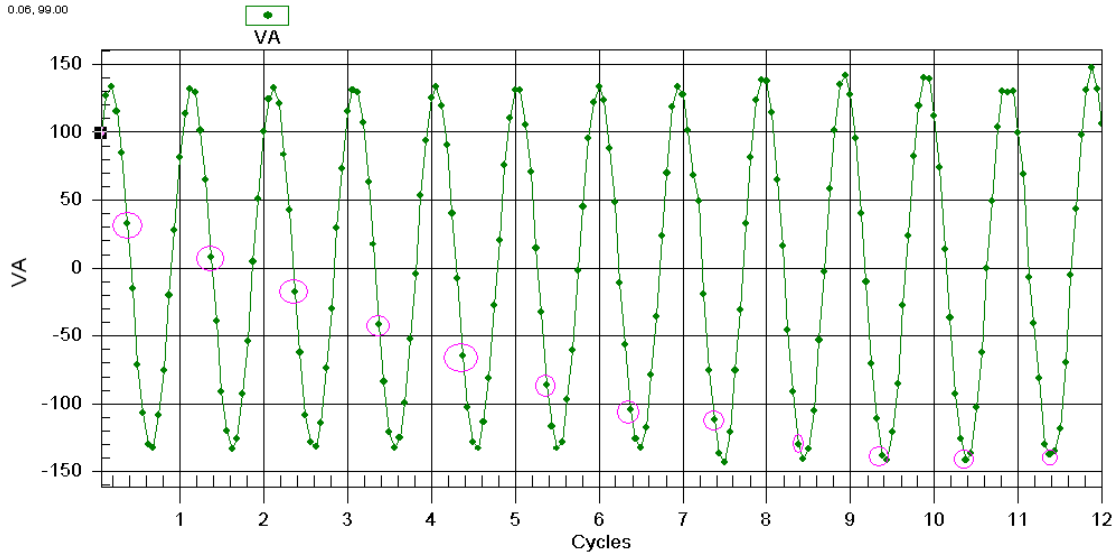
At the time of the relay operation the relay's tracking frequency was out of synchronism with that of the power system frequency. What this means is that the relay is designed to sample the primary power system quantities (voltage and current) at 16 samples per cycle (spc), however at the time of the relay operation the relay was not sampling the primary system at this rate, this can be seen when examining the A-phase voltage, as shown in Fig.2.

Fig.2. Is an oscillographic plot of the “A-phase” voltage, the oscillography indicates when the wave form was sampled by the relay.

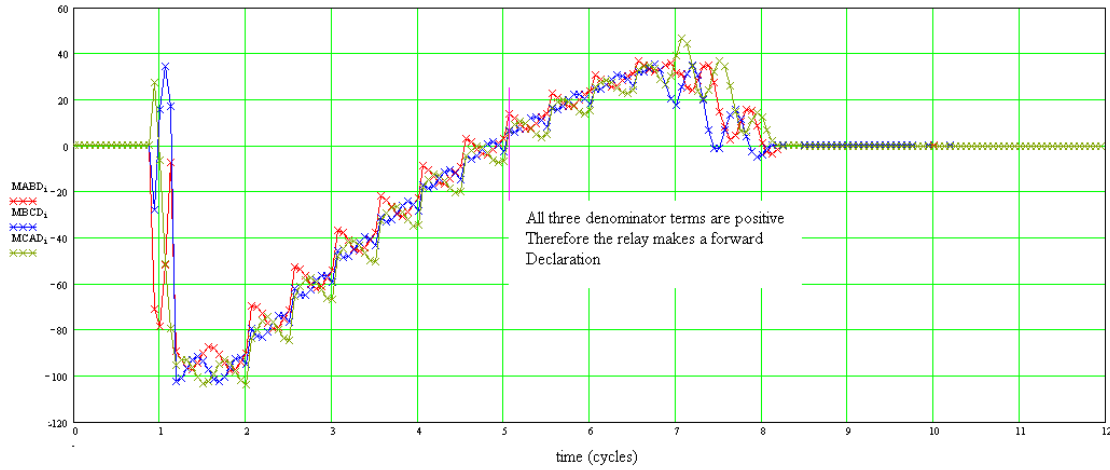
Fig.6 Plot of the denominator terms (directional term), from this plot it can be seen that at cycle 5.125 all three terms become greater than 0.5 and the relay declares the fault as forward.

From Fig.6 we can see that the denominator terms become positive greater than 0.5 at about 5.125 cycles. Fig.7 is a plot of the m-calculations of the phase-to-phase distance elements the equations for the phase to phase elements is as follows:

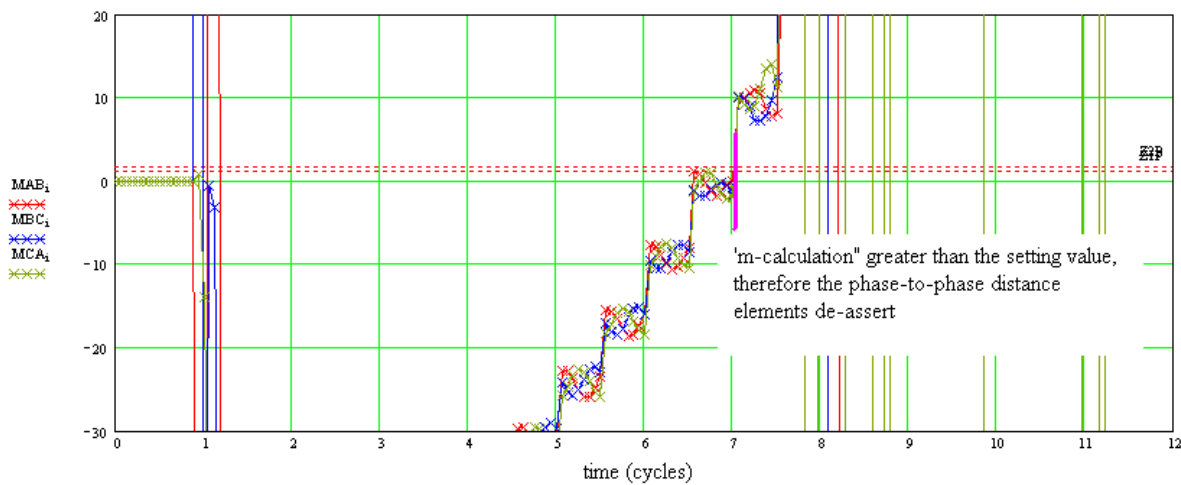
Fig.7. Plot of the “m-calculations” of the phase-to-phase distance elements.

If we examine Fig.6 and 7 we see that at time 5.125 cycles the denominator calculation for all three phase-to-phase distance elements becomes greater than 0.5 and at the same time the m-calculations for all three phase loops is less than the set values (Z1P , Z2P). Therefore at time 5.125 cycles all three distance elements assert their output, (this can be seen when examining the oscillographic record shown in Fig.1). At time of 7 cycles the 'm-calculation' impedance value is greater than the set value and all three distance elements de-assert, this can again be confirmed by the oscillographic record.

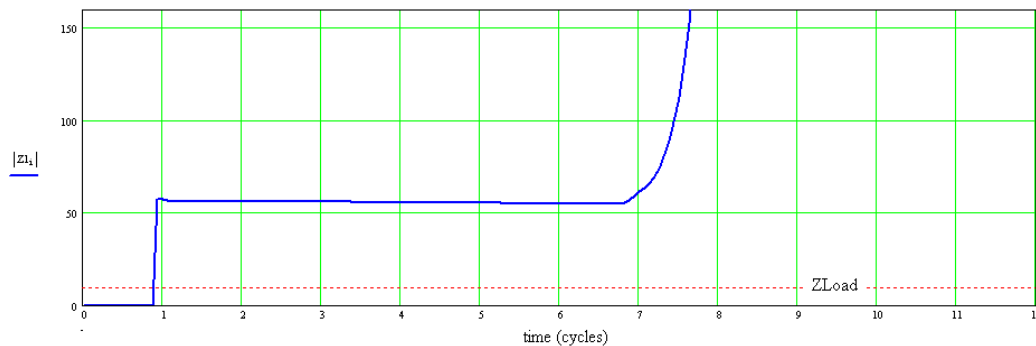
Fig.8 Plot of the positive sequence impedance magnitude.

Fig.8 shows that even if the relay is not tracking the system frequency correctly, the positive sequence impedance retains its correct value (within reason) because the positive sequence voltage and current will have the same error and by dividing these two quantities with each other that have the same relative errors, the errors basically cancel each other and the positive sequence impedance is preserved.

As stated previously the reason for the distance elements operating is that the operating and polarizing quantities were not at the same frequency and this resulted in the operating quantity rotating with respect to the restrain quantity. Also recall that one of the conditions to allow the phase-to-phase distance elements to operate is that the load encroachment element must not be asserted. Load encroachment calculates the positive sequence impedance of the load using the instantaneous positive sequence voltage and current (this means that the voltage and currents are at the same frequency with respect to each other). A plot of the positive sequence impedance is shown in Fig.8

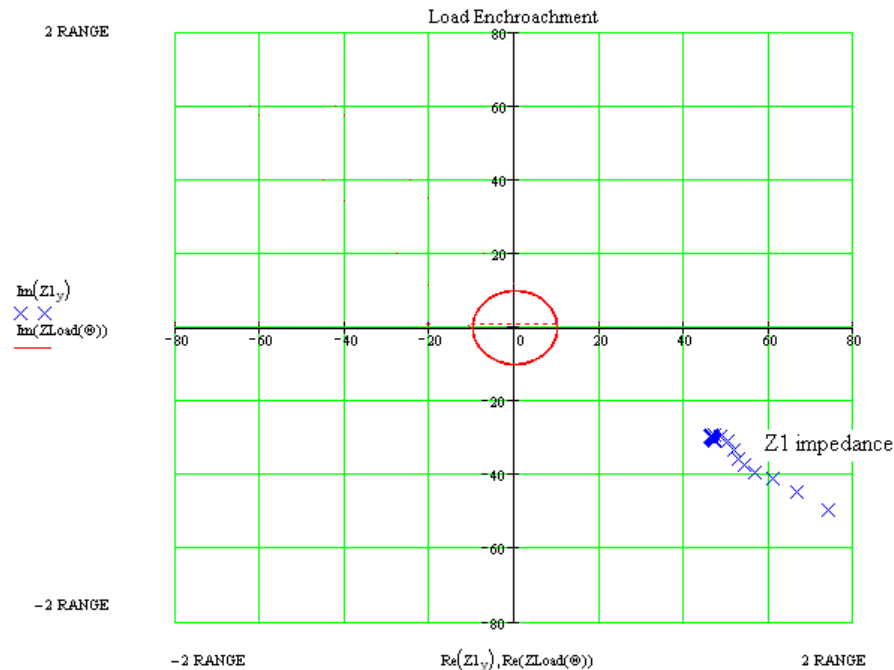
Fig.9 Plot of the load encroachment element characteristic, and the positive sequence impedance, note that the phase-to-phase distance elements fall within the load encroachment element.

With these settings the relay would have prevented the distance elements from asserting, however it must be pointed out that with these settings the load encroachment element will not block the relay for operating for any genuine phase-to-phase fault and the reason for this is that the phase-to-phase distance elements are a subset of the load encroachment element as shown in Fig. 9.

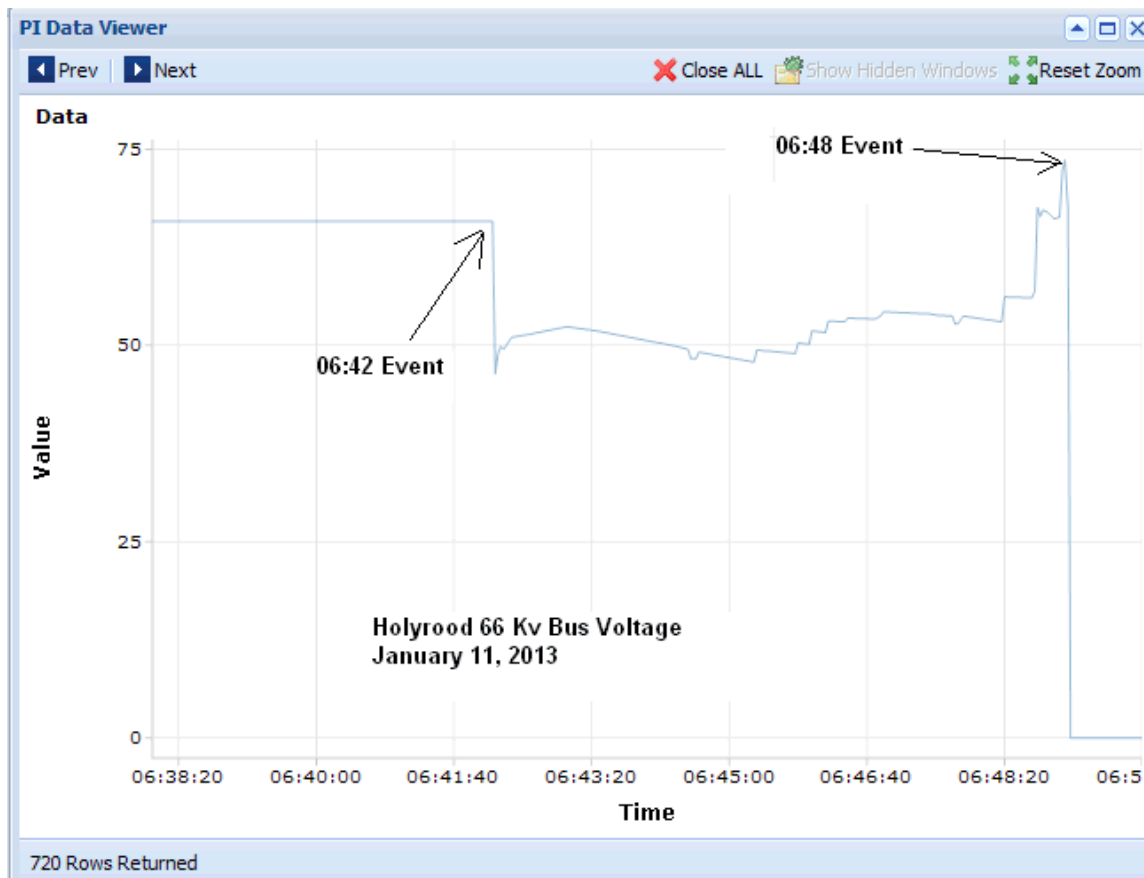
The removal of the generating units and other transmission system voltage support equipment resulted in a severe depression in system voltage to approximately 80% of normal voltage levels (See Figure 1).

**Figure 1: Voltage depression experienced in the Holyrood Terminal Station during January 11, 2013 06:42 fault event**

When Unit 1 was removed from operation in response to the terminal station electrical fault, the North AC Pump consequentially shut down. The South AC Pump tripped offline due to the voltage depression that was experienced during the terminal station electrical fault (See Figure 1). It did not restart with the loss of the North AC Pump, as is expected when the station service supply is available. The DC Pump started in response to the loss of the AC pumps and the resultant drop in lubricating oil pressure. However, it did not deliver sufficient lubricating oil to the generator bearings. The lack of sufficient lubricating oil continued for a period of approximately three minutes and fourteen seconds. With the plant completely shut down, many alarms and process upsets were being reviewed and assessed. Plant personnel manually started the 600 V emergency diesel generator D1, which removed the station service supply from the grid and established supply from the diesel generator. This resulted in the South AC Pump starting, recovering sufficient lubricating oil pressure. (See Figure 2 below for plant Distributed Control System {DCS} trends which illustrate this sequence of events.)

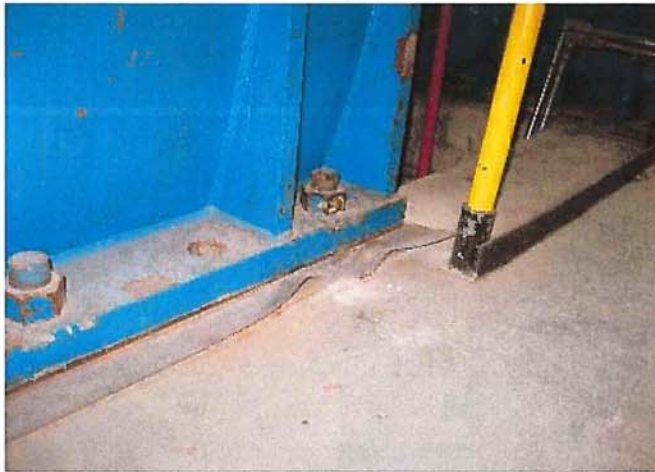
The shims on the generator base had moved and buckled indicating that they had come loose enough to move during the event. Keys and hold down bolts appeared to be intact. See photos below:

Figure 1 Generator Shim – LHS Turbine End

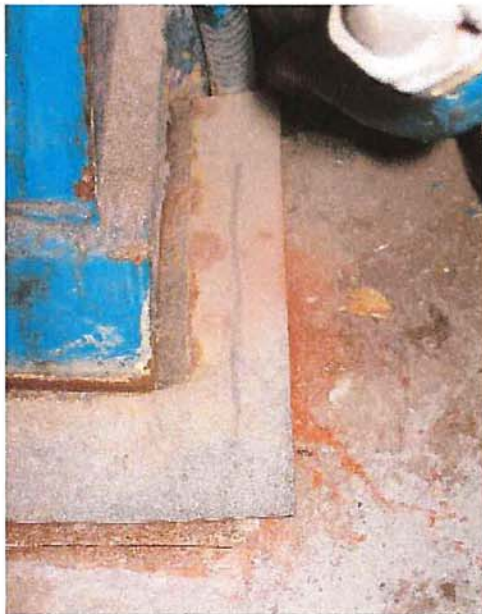
Figure 2 Generator Shim – RHS Collector End

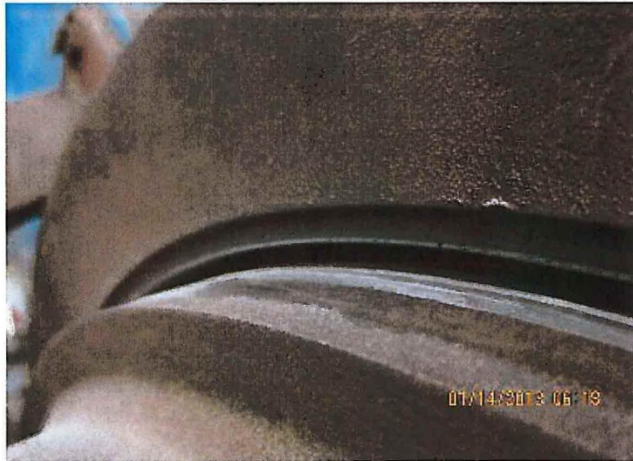
Outer oil deflector clearance was measured on the #3 and #4 bearings. On both bearings there was no clearance on the bottom. On #3 the upper clearance was 0.180" and on #4 the upper clearance was 0.160". Normal for these bearings would be about 0.005" at the bottom and 0.020" at the top. Oil deflector damage had occurred. Also it appeared that the journals were sitting more than 0.100" low. This could indicate damaged bearings.

Figure 3 Bearing #4 – upper oil deflector clearance

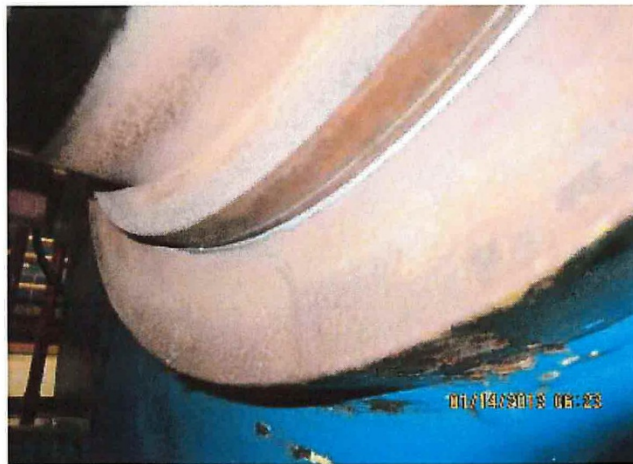
Figure 4 Bearing #4 – lower oil deflector clearance

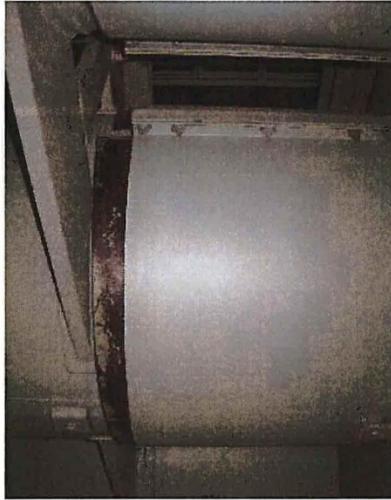
The B-phase bus duct on the mezzanine level appeared to have been distressed. On this duct only, the liners at each coupling had migrated out from under the connector rings. See Photos below.

Figure 5 B-Phase Duct

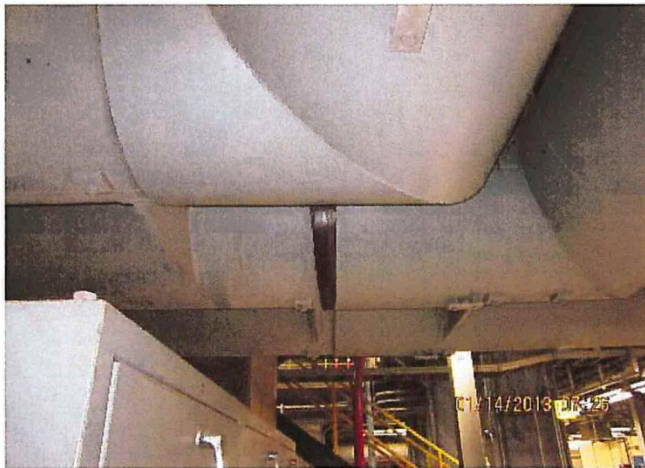
Figure 6 B-Phase Duct
